## **EXECUTIVE SUMMARY**

TranSystems has been retained by the City of Fort Lauderdale to perform bridge inspections and prepare bridge inspection reports for each of the City's bridges as part of the project Structural Bridge Engineering Consulting Services Master Plan, RFQ No. 946-11310. Inspections were completed and reports prepared for 46 of the City's bridges. The remaining five bridges in the City's inventory were not inspected because they are in the process of being replaced.

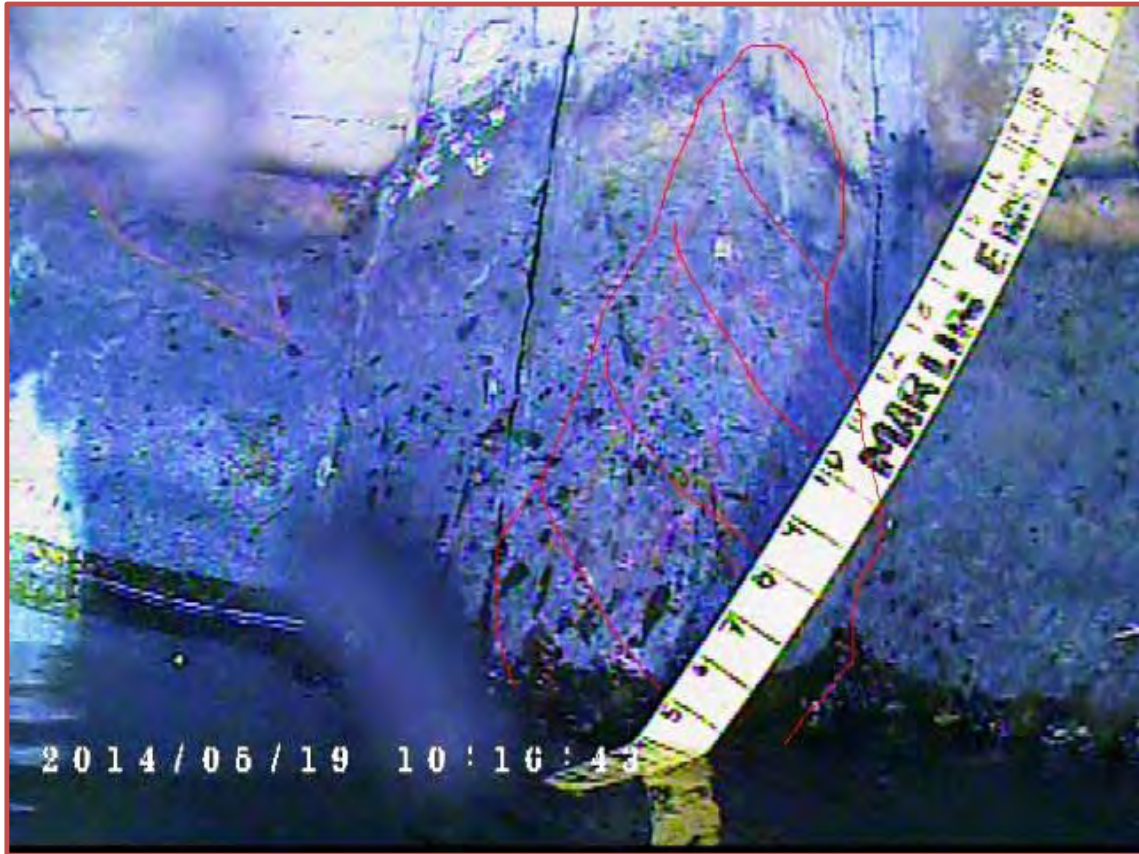
Description: Top: NW backwall transition to wingwall has a delamination. **UW Photo 05.**  
Bottom: The backwalls have random diagonal cracks up to 1/64" wide. **UW Photo 06.**

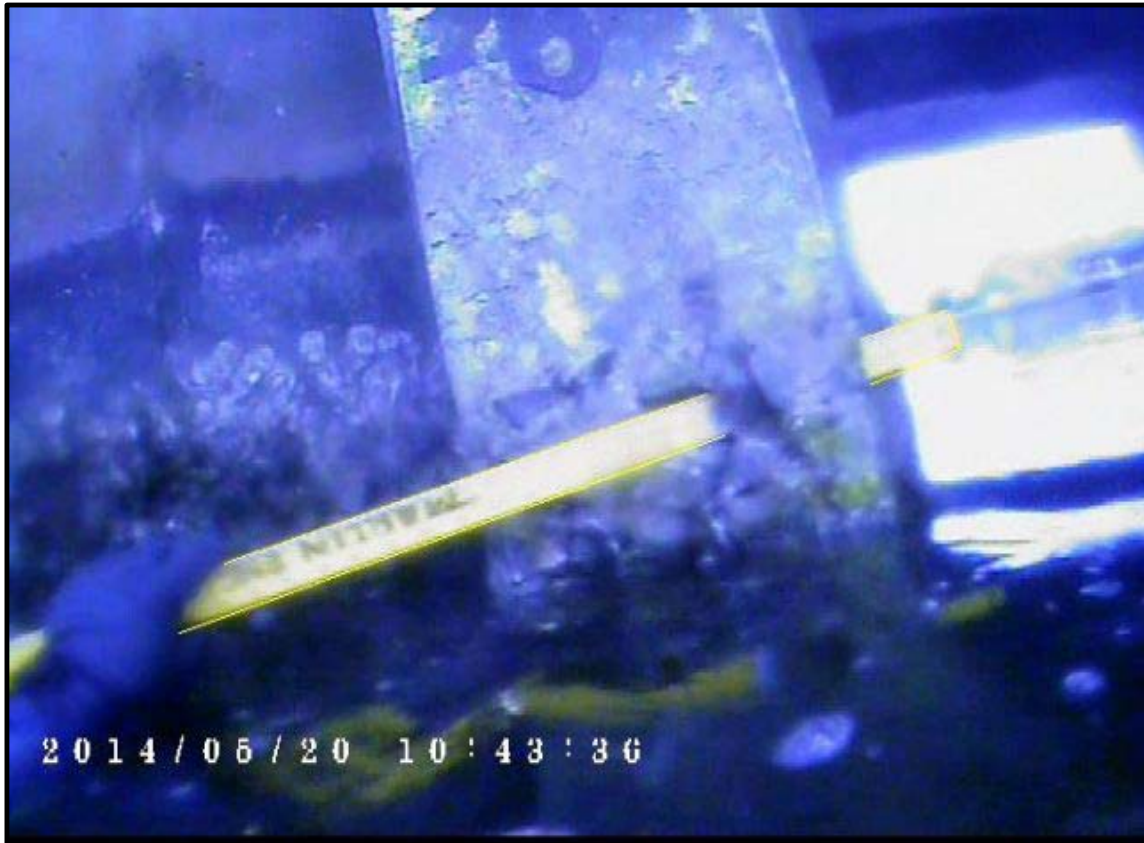
Description: Top: Pile 2-1, the built-up section is spalled/delaminated. **UW Photo 01.**  
Bottom: Pile 2-4, SW corner spall, at and below the high watermark. **UW Photo 02.**

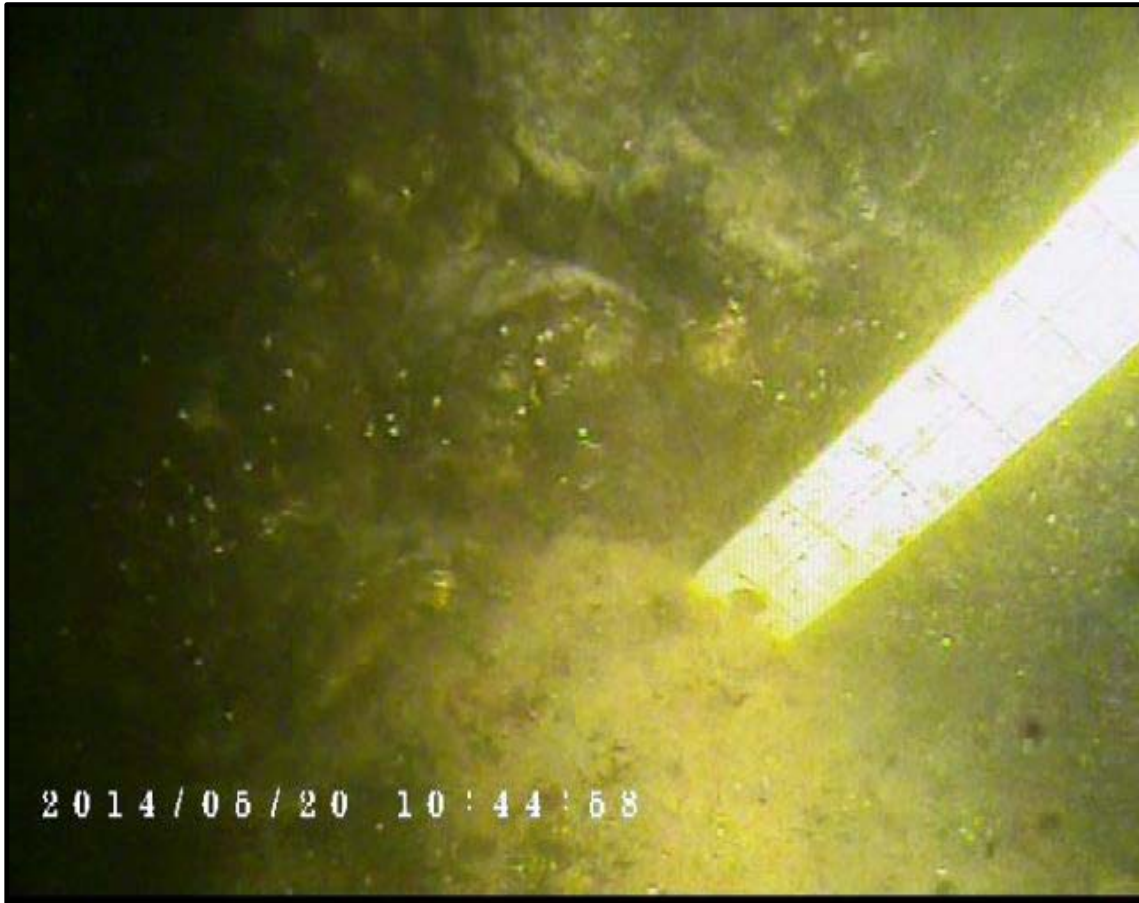
Description: Open joints between sheet piles up to 1-1/4", with backfill leakage. **UW Photo 05.**

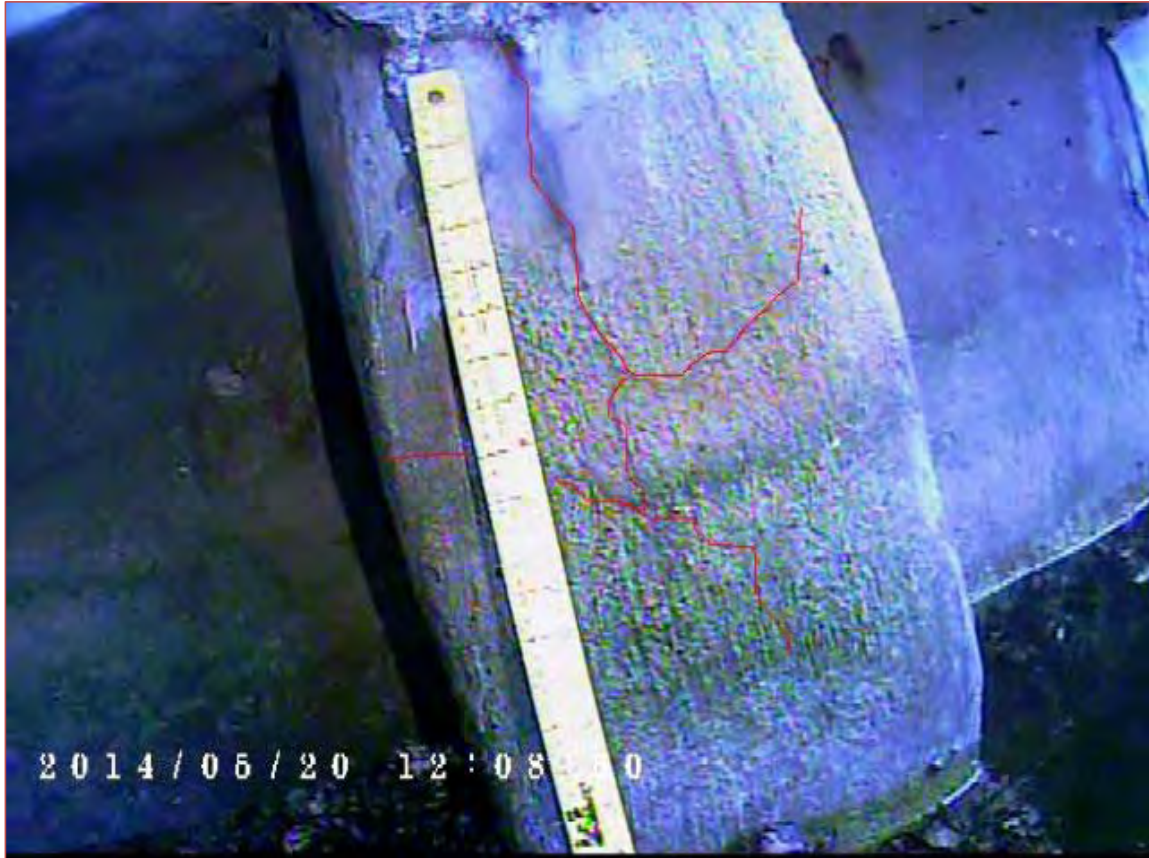
Description: Top: Piles have cracking up to 1/64", with minor CBO. **UW Photo 05.**  
Bottom: Both Abutment caps, horizontal cracks along the repaired areas. **UW Photo 06.**

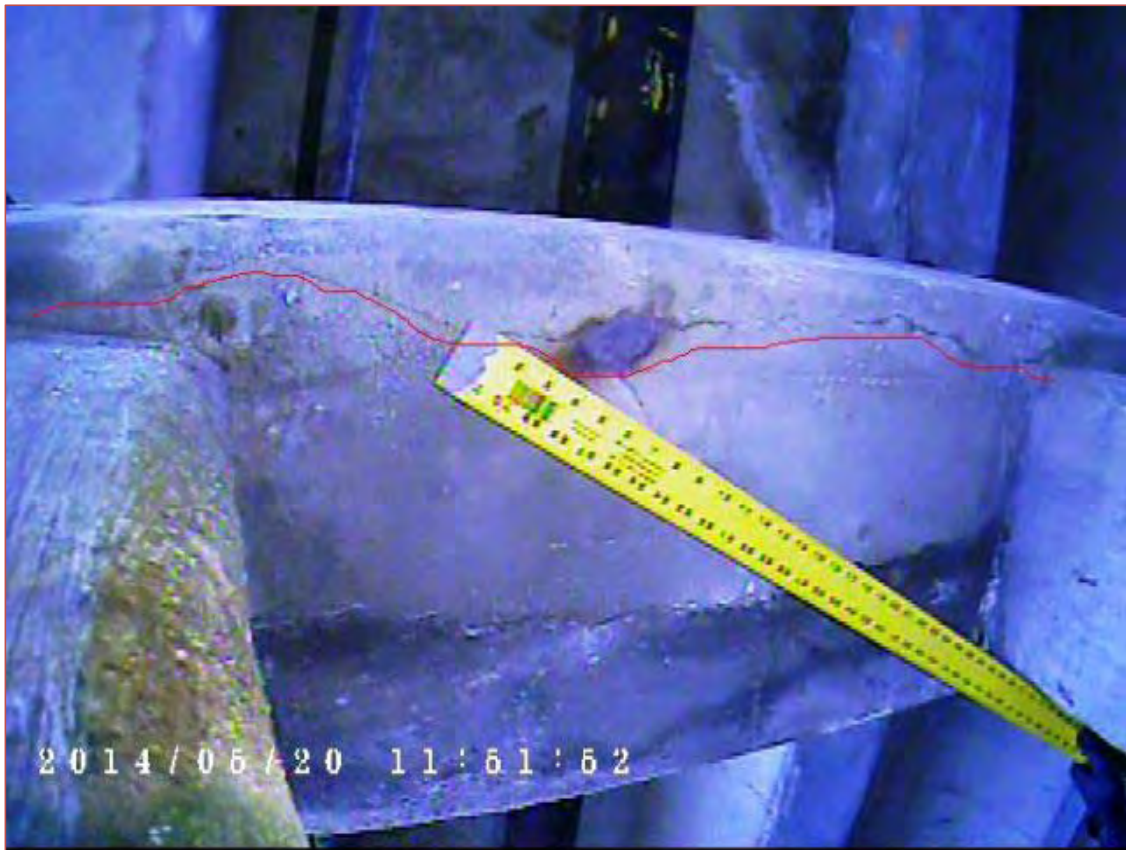
Description: Top: Bent 2 cap underside, North end, spall/void, with associated cracks. **UW Photo 07.**  
Bottom: Bent 2 cap, bottom West edge, crack with corrosion bleed-out. **UW Photo 08.**

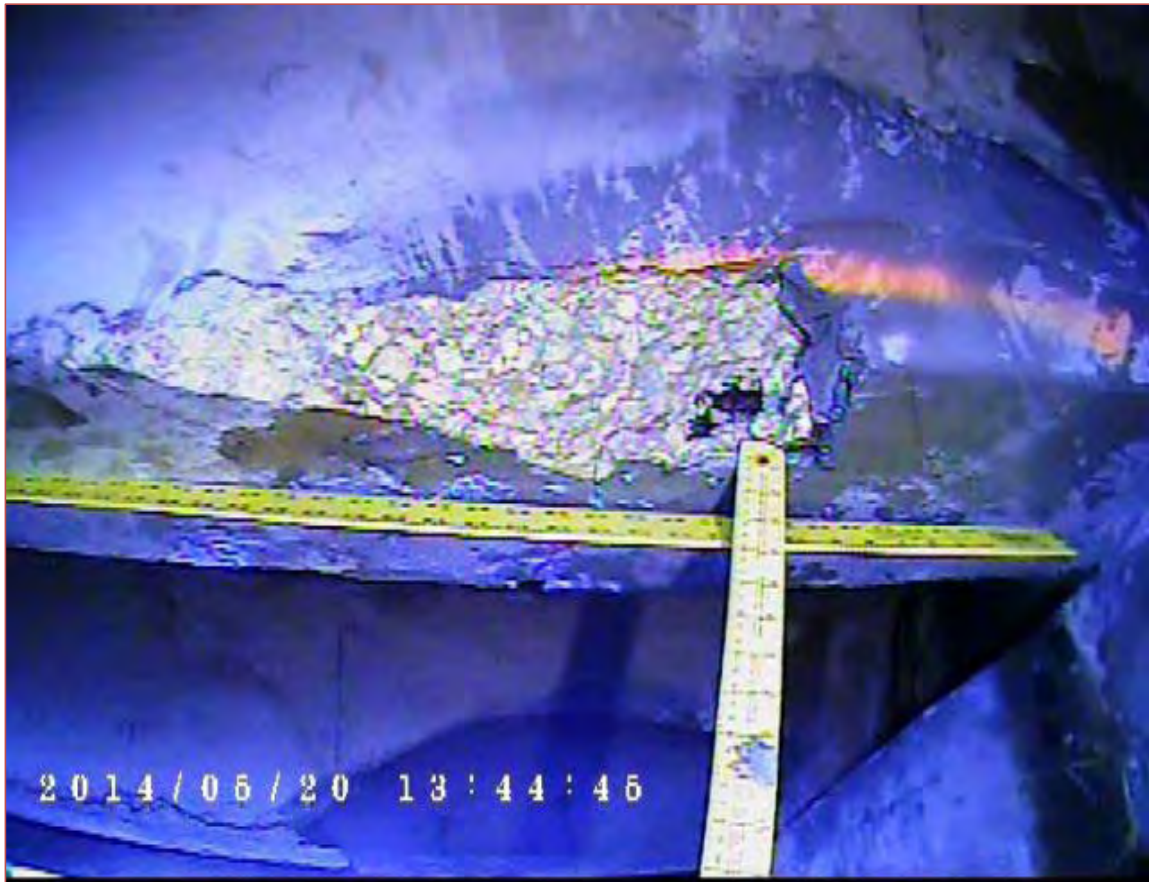
Description: Top: Beam 2-3, bottom edge spall/delamination with exposed rebar. **UW Photo 05.**  
Bottom: Closure pour between Beam 1-1 and 1-2, unsound with rebar. **UW Photo 06.**

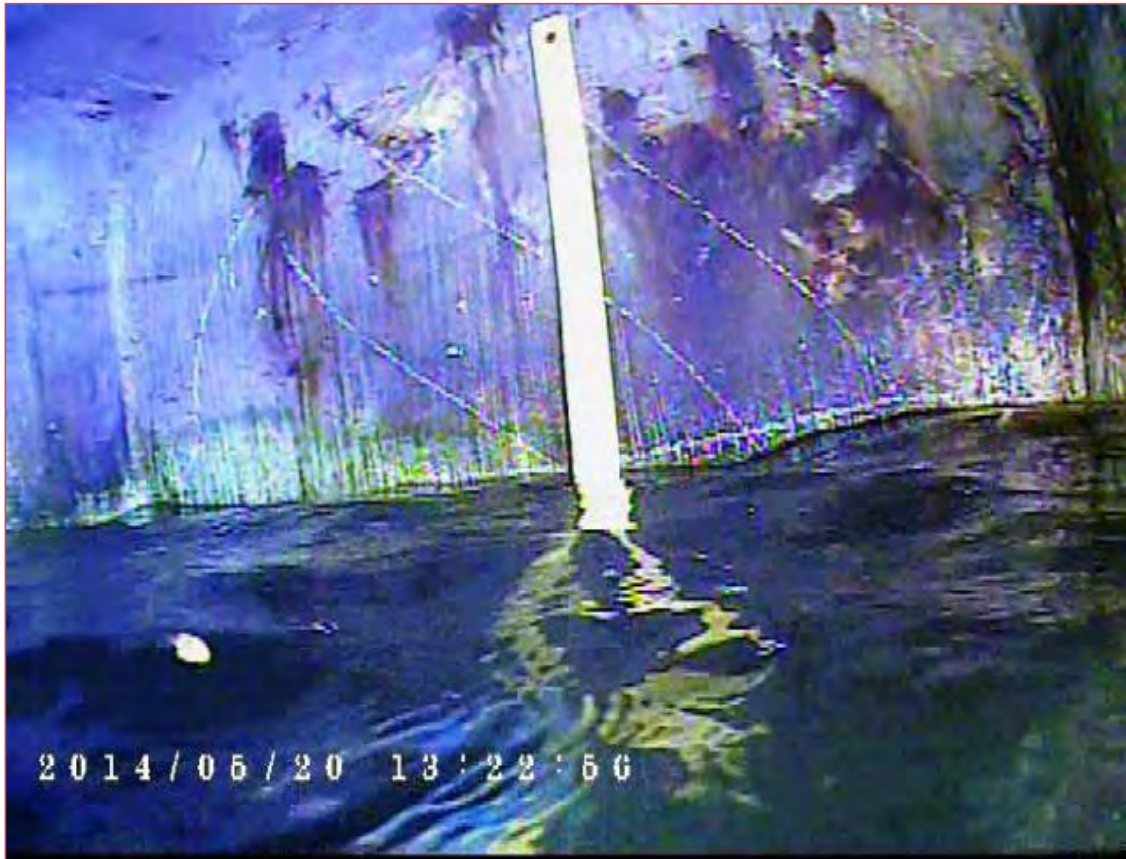
Description: Top: Abutment backwalls, cracks with corrosion bleed-out throughout . **UW Photo 15.**  
Bottom: Retaining walls have cracks with corrosion bleed-out throughout. **UW Photo 16.**

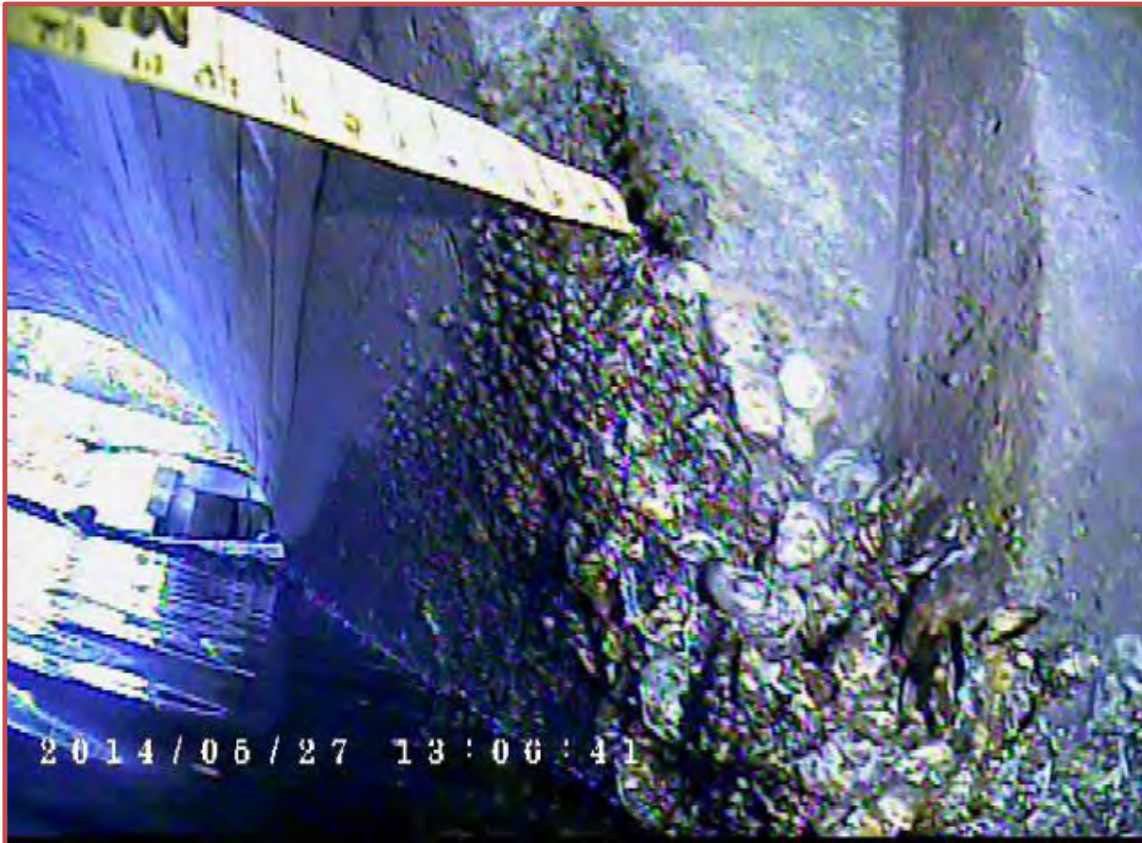
Description: Top: Arch exhibits scaling up to 1/8", along the high watermark. **UW Photo 01.**  
Bottom: Pile 1-2, NW and NE corners, spall/delamination. **UW Photo 02.**

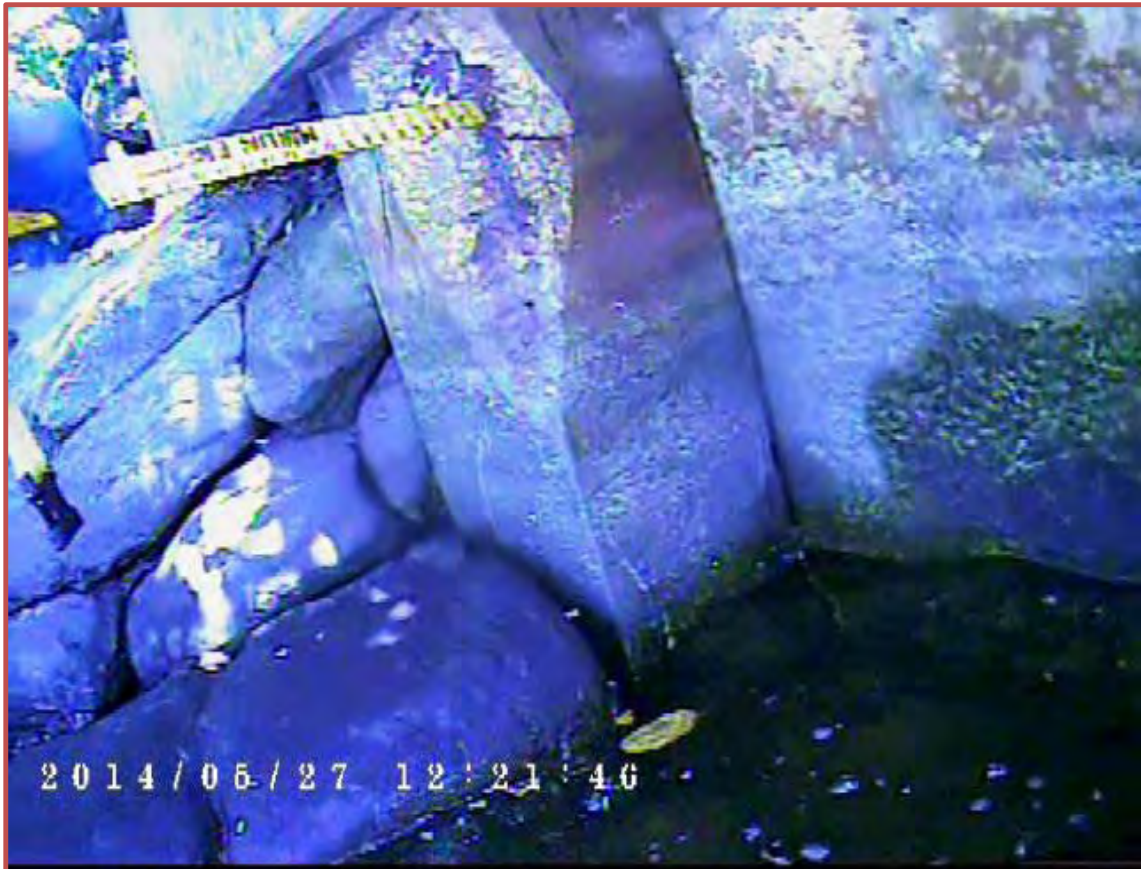
Description: Pile 1 at the NW wingwall, has a spall/delamination 24" x 12" x 2", with exposed rebar 50% section loss. **UW Photo 11.**

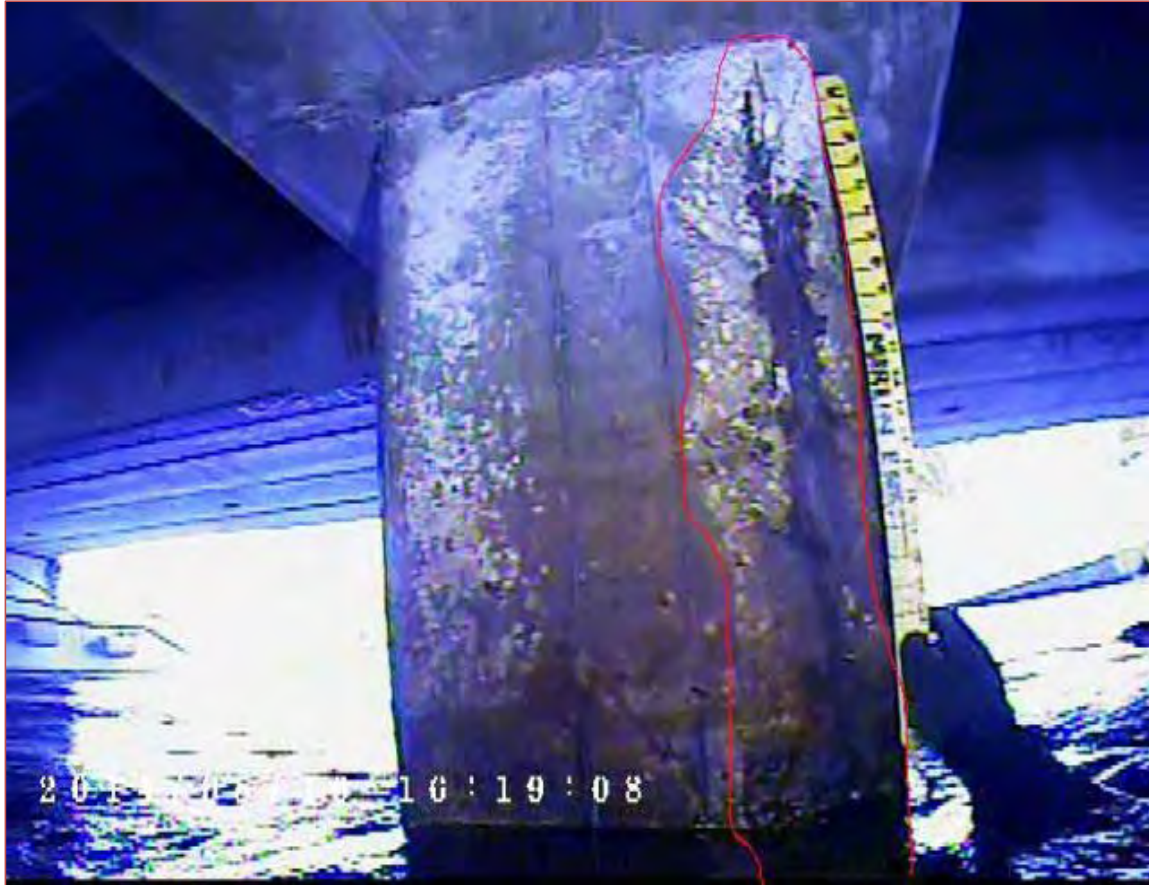
Description: Top: Pile 3-6, SW corner has a spall with (1) exposed rebar. **UW Photo 05.**  
Bottom: Pile 3-6, SW corner spall, (1) exposed rebar underwater. **UW Photo 06.**

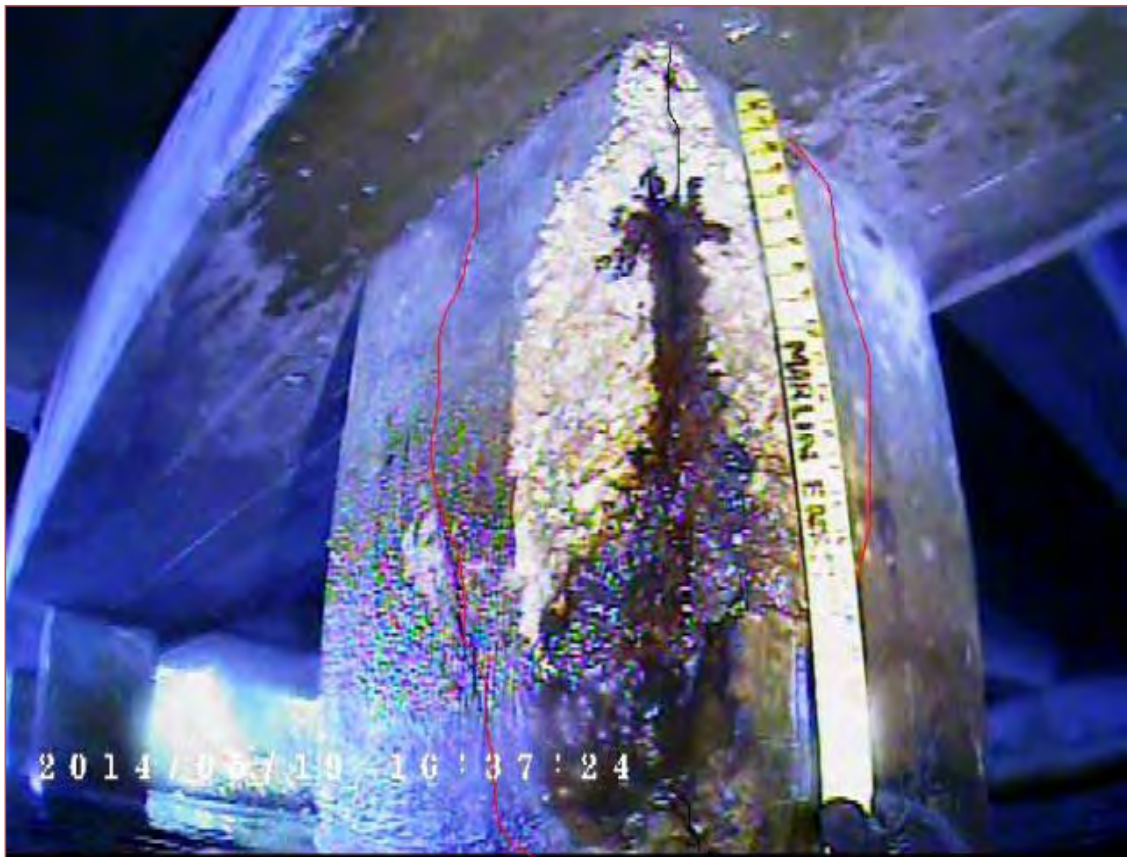
Description: Top: Pile 4-4, NE corner, spall/delamination with (1) exposed rebar. **UW Photo 07.**  
Bottom: Pile 4-6, SE corner has a spall with (1) exposed rebar. **UW Photo 08.**

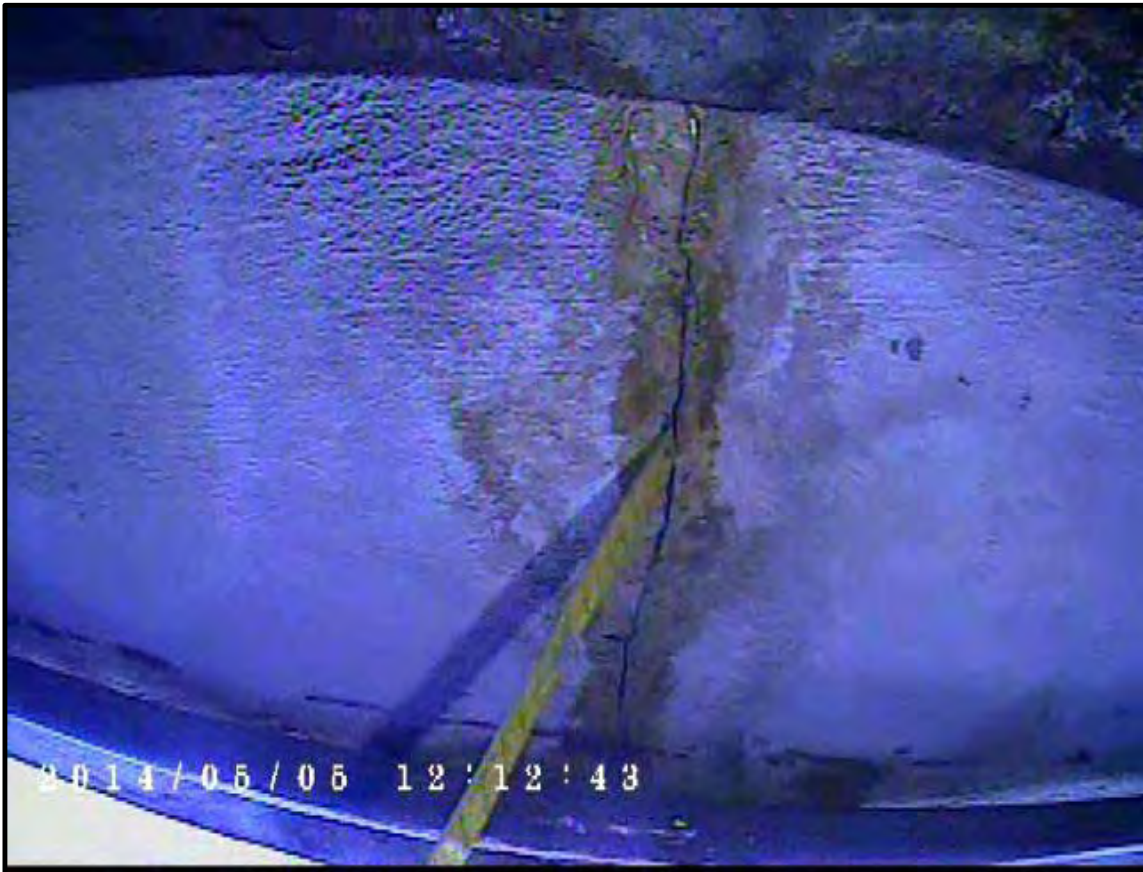
Description: Top: West overhang, the cracks have open to 1/8" W. **UW Photo 01.**

Bottom: Deck underside patches have unsound areas with cracks. **UW Photo 02.**

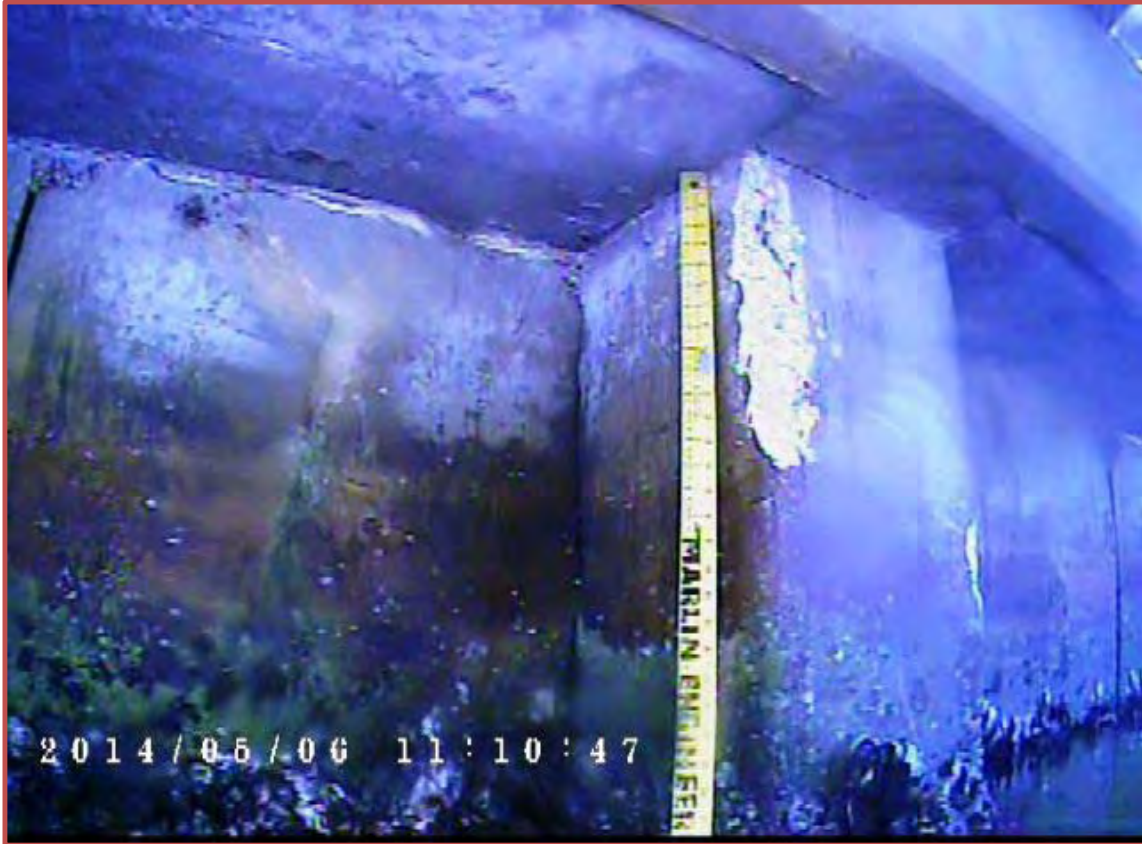
Description: Top: Pile 4-4, South face at the cap, spall/delamination. **UW Photo 01.**  
Bottom: Abutment 1 backwall east of Pile 1-4, spall. **UW Photo 02.**

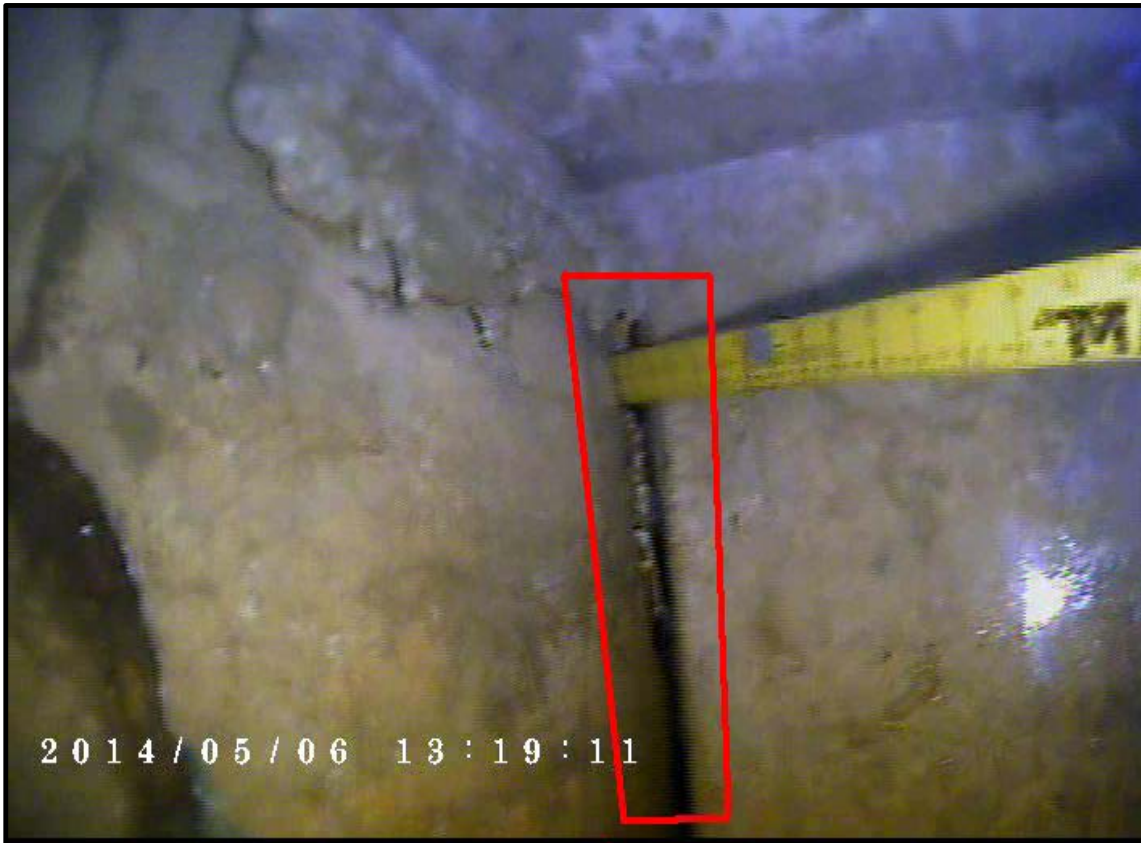
Description: Top: Abutment 1 backwall, east side of Pile 1-2, delamination. **UW Photo 07**  
Bottom: Abutment 1 backwall, behind Piles 1-2, spall. **UW Photo 08**

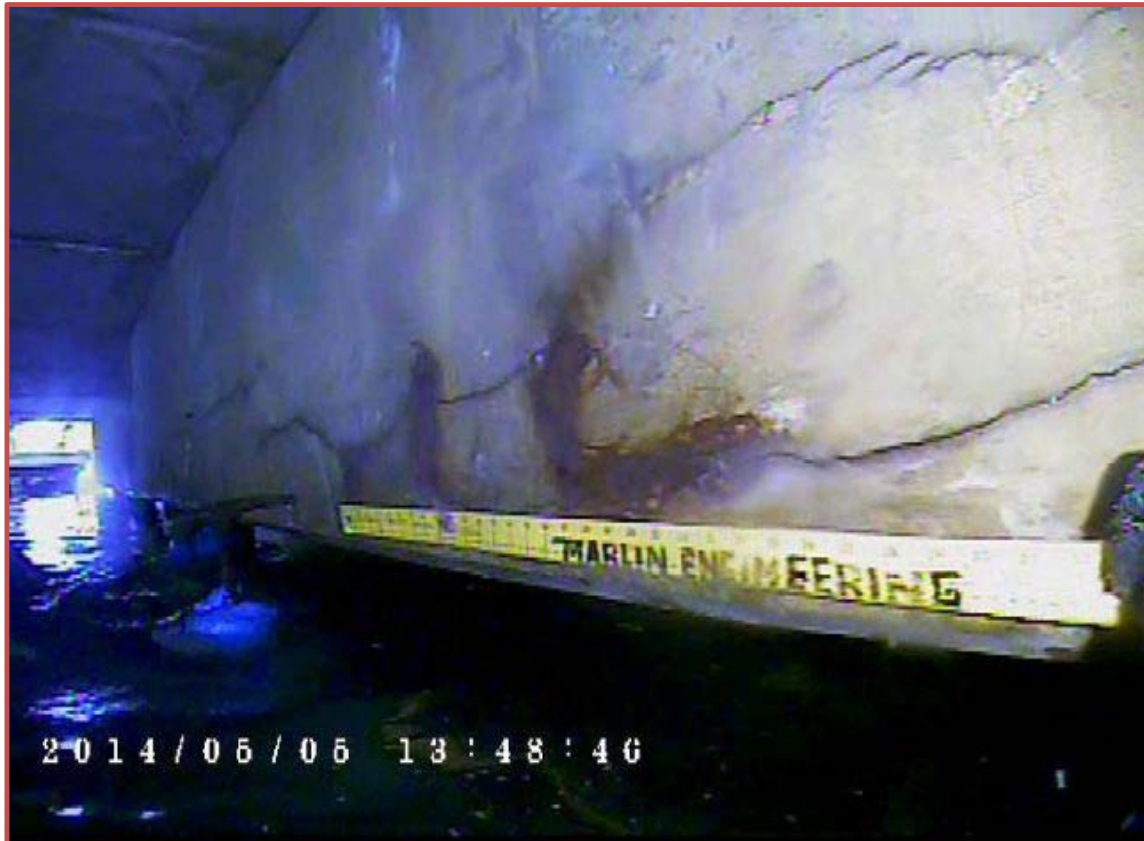
Description: Top: Abutment 1 cap has a delamination, with associated cracks. **UW Photo 01.**  
Bottom: Bent 2 cap, both faces delaminations with associated cracks. **UW Photo 02.**

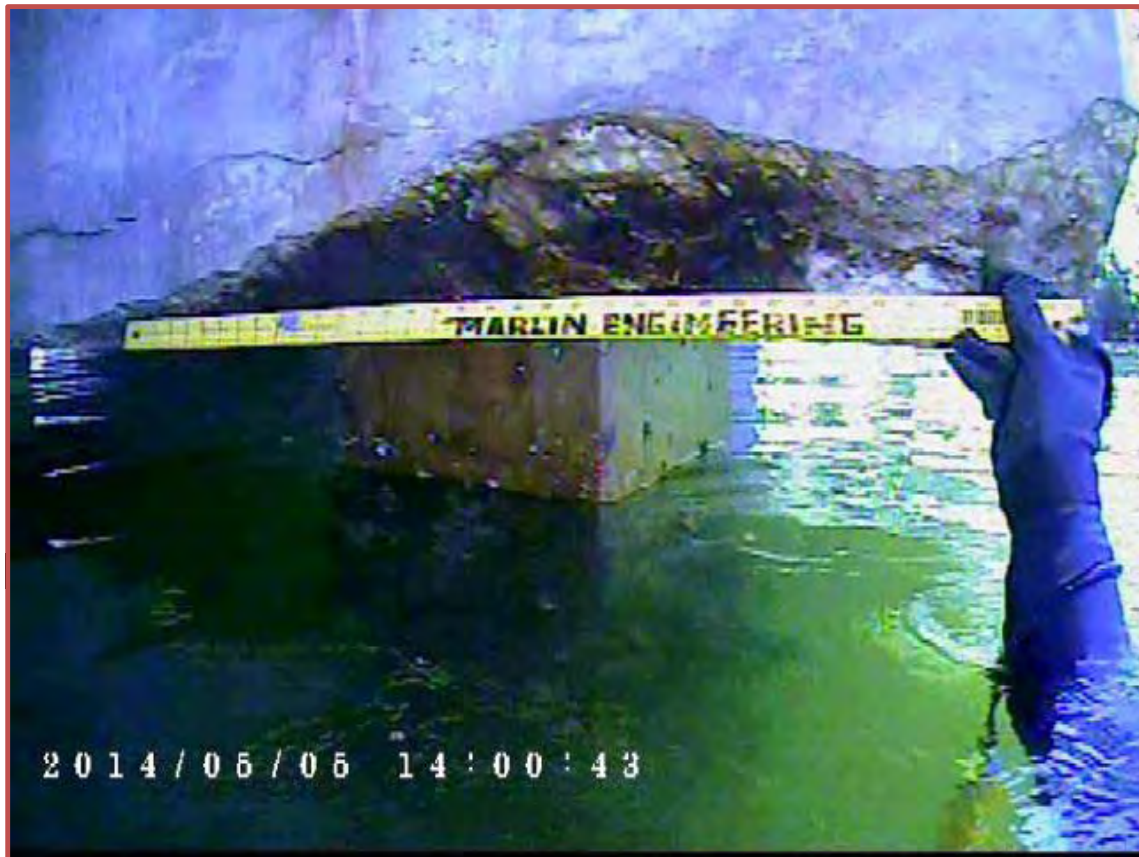
Description: Bent 2 cap, NE end, spall/delamination with (1) exposed rebar. **UW Photo 03.**

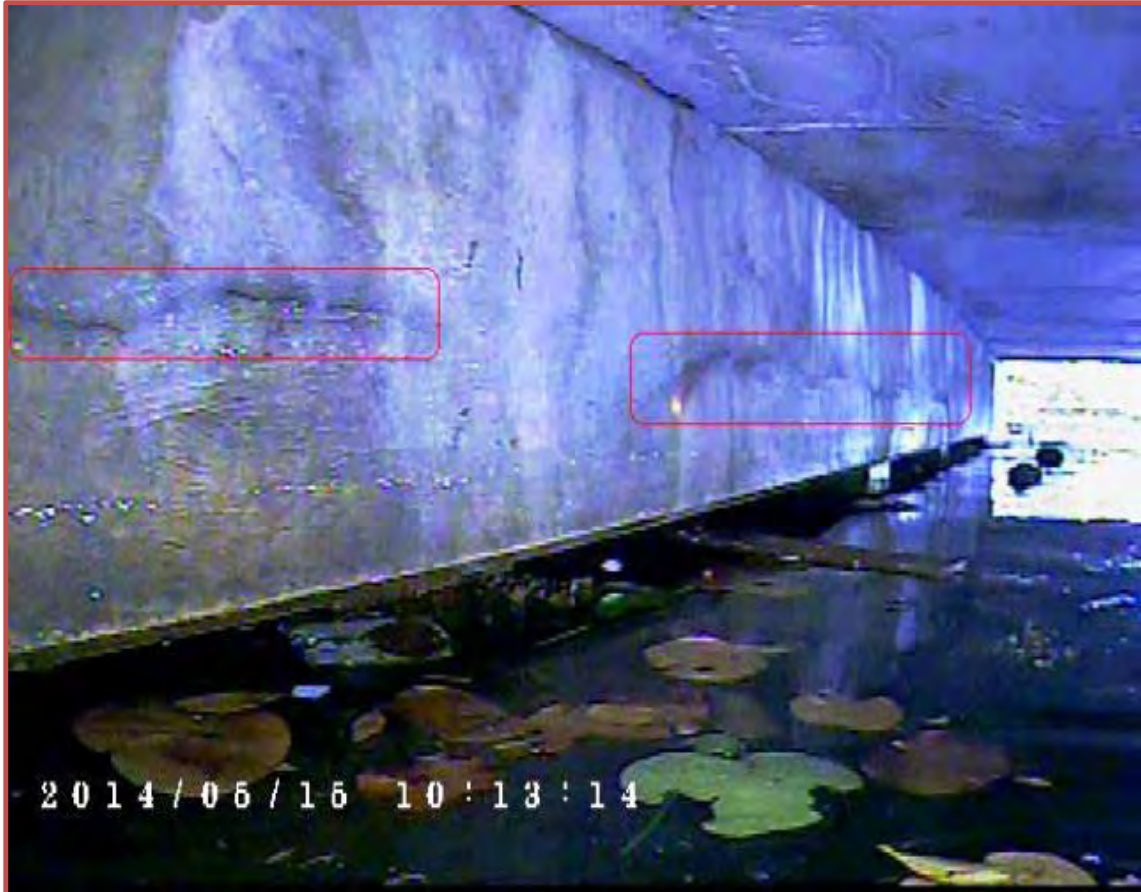
Description: Top: Abutment caps are intermittently delaminated along the entire length. **UW Photo 03.**  
Bottom: Bent caps 2 and 3 full length x up to 1/8" horizontal vertical cracks. **UW Photo 04.**

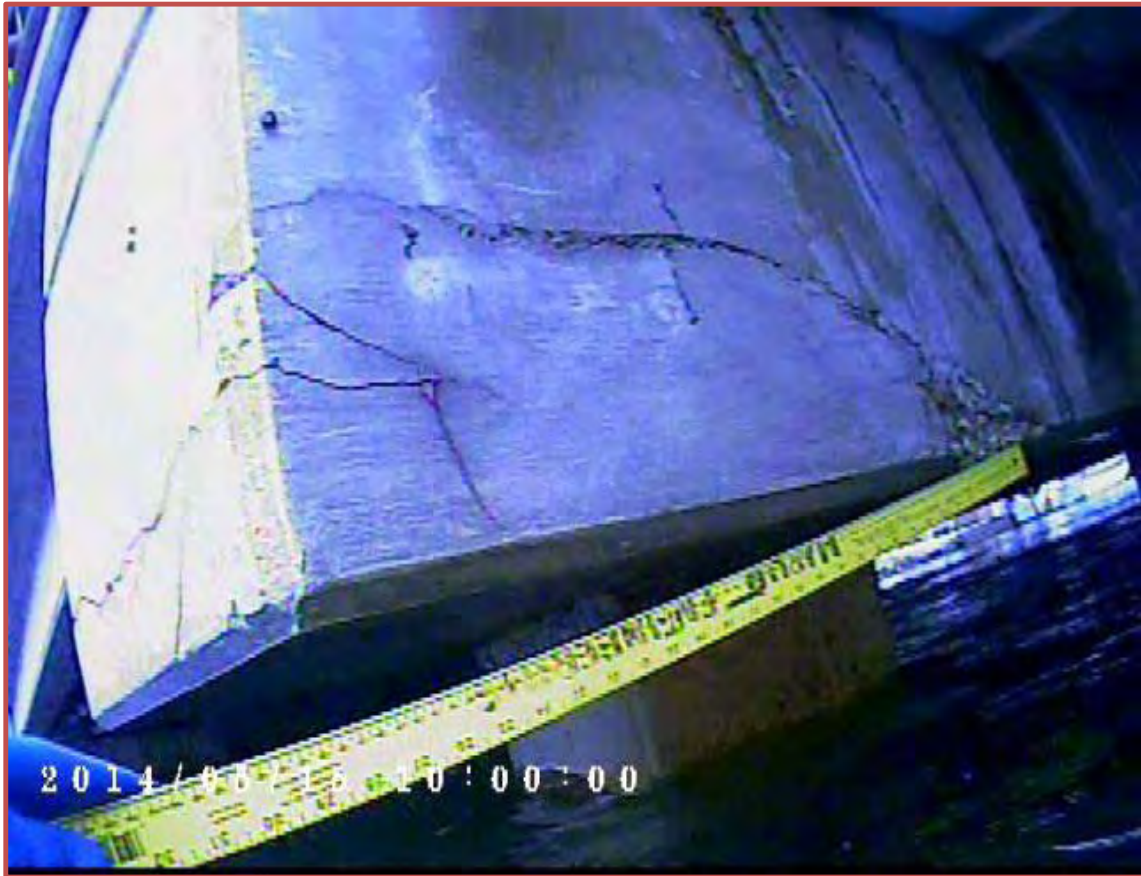
Description: Top: Bent cap 2, South end delaminated with a spall on the West face. **UW Photo 05.**  
Bottom: Bent cap 3, West face spall/delamination, up to cap length. **UW Photo 06.**

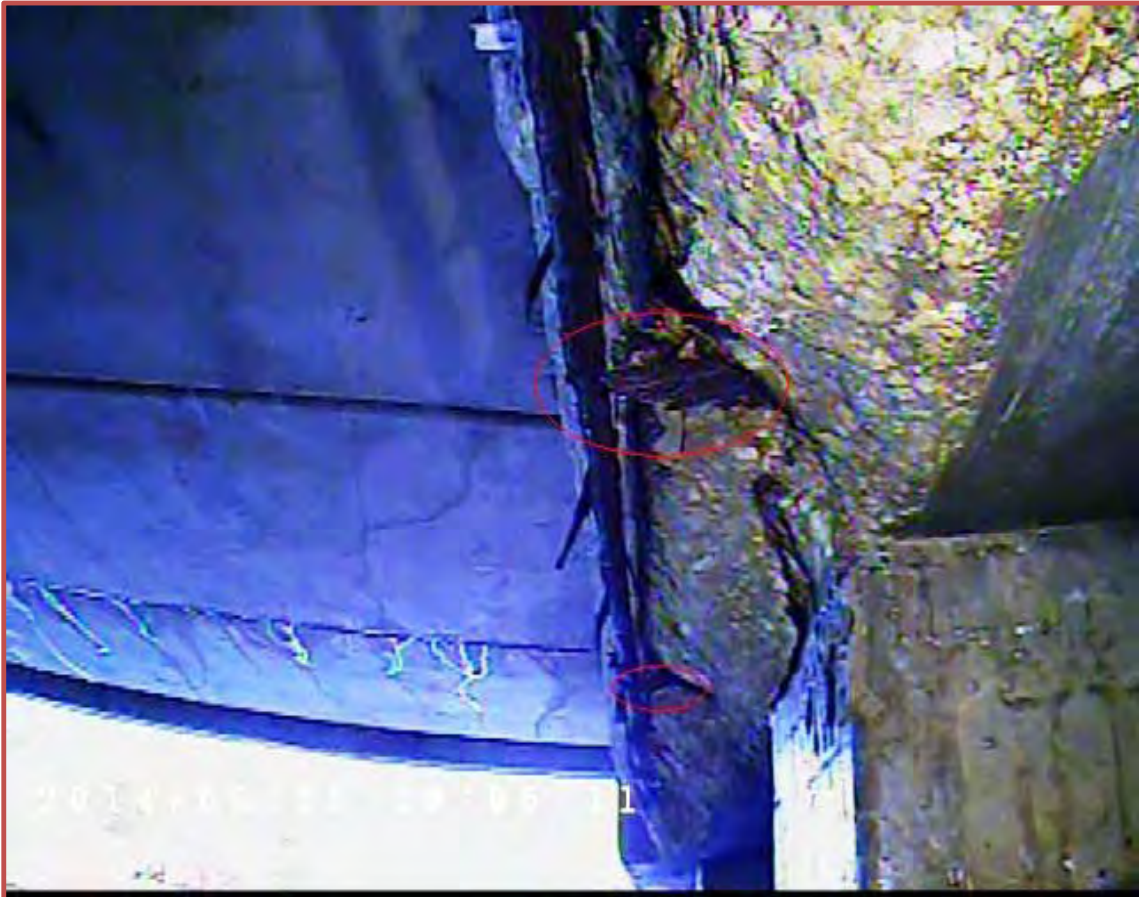
Description: Top: Bent cap 3, West face, spall/delamination, exposed rebar. **UW Photo 07.**  
Bottom: Seawall, South end of Abutment 4 has a void, minor loss of fill. **UW Photo 08.**

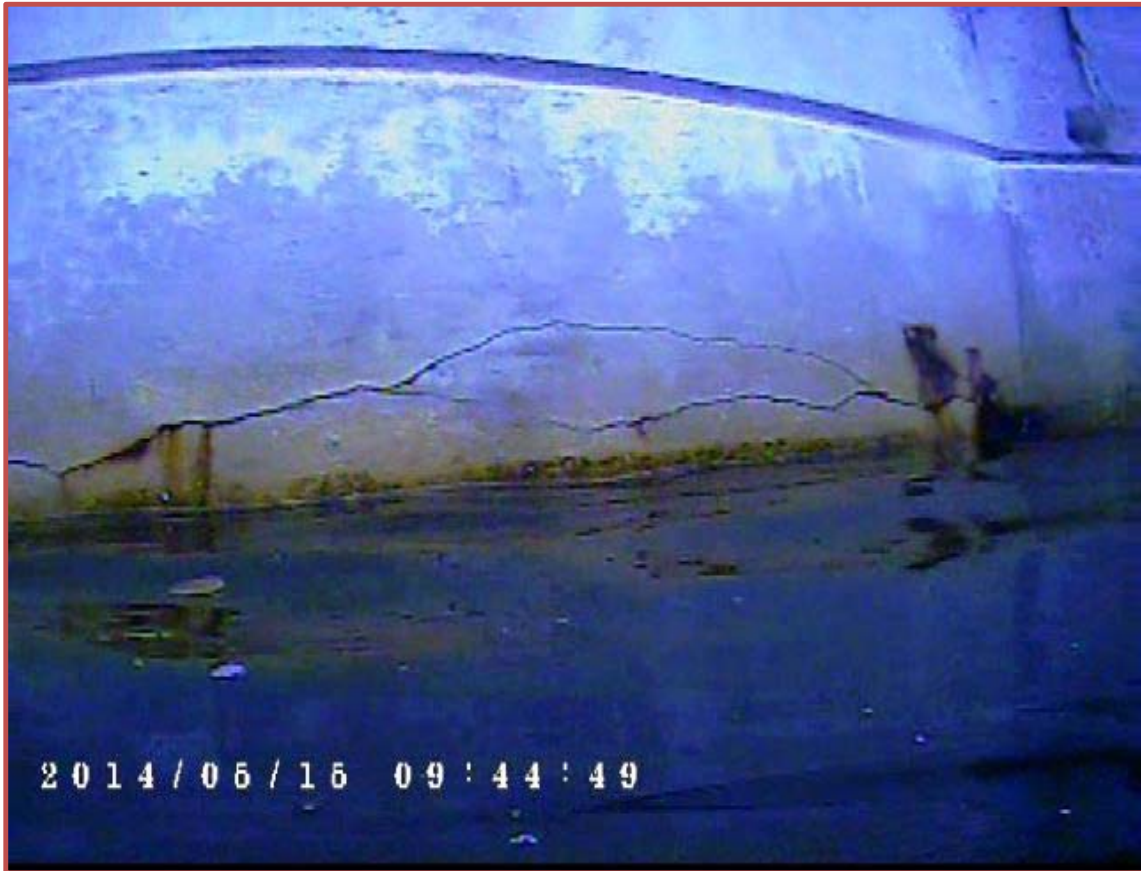
Description: Top: SW wingwall cap delamination, with associated cracks up to 1/8". **UW Photo 09.**  
Bottom: SW wingwall transition, delamination, with associated cracks. **UW Photo 10.**

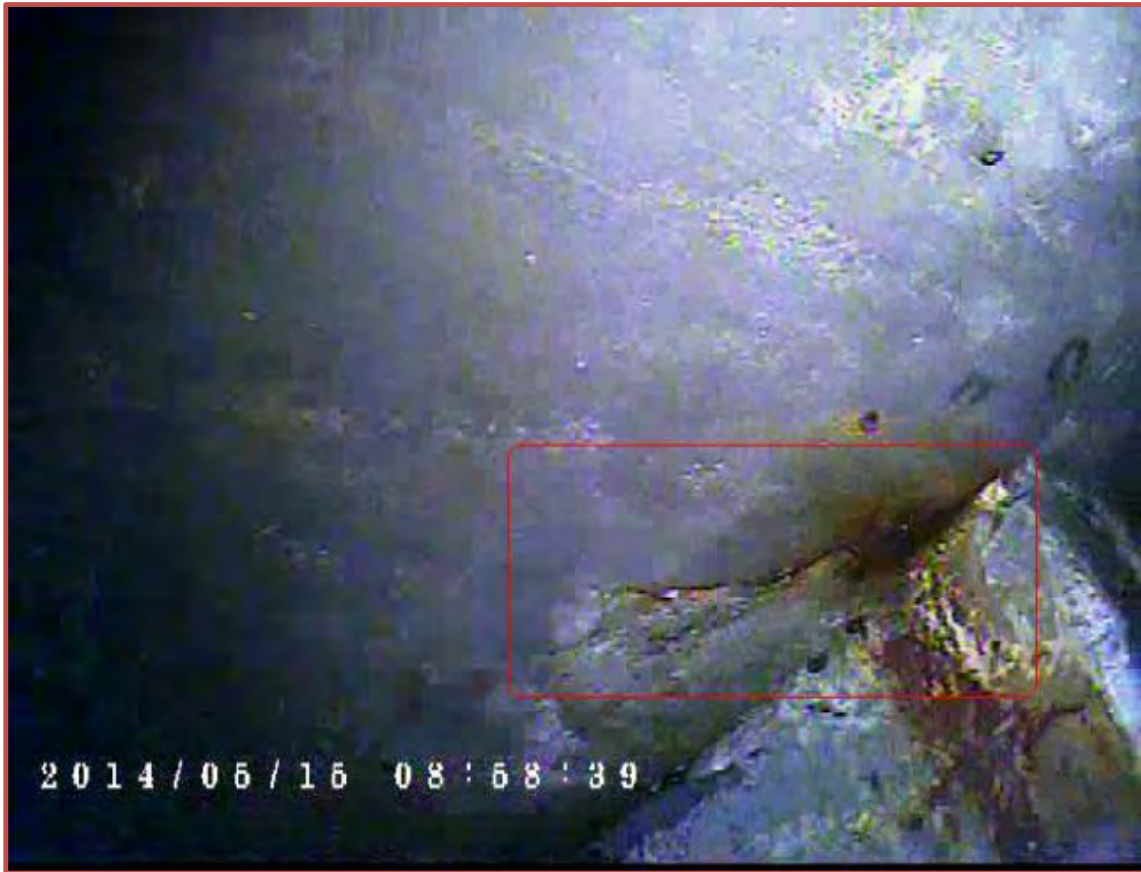
Description: Top: Bent 2 cap intermittent horizontal cracks, with corrosion bleed-out. **UW Photo 03.**  
Bottom: Bent 3 cap West face, intermittent delaminated areas. **UW Photo 04.**

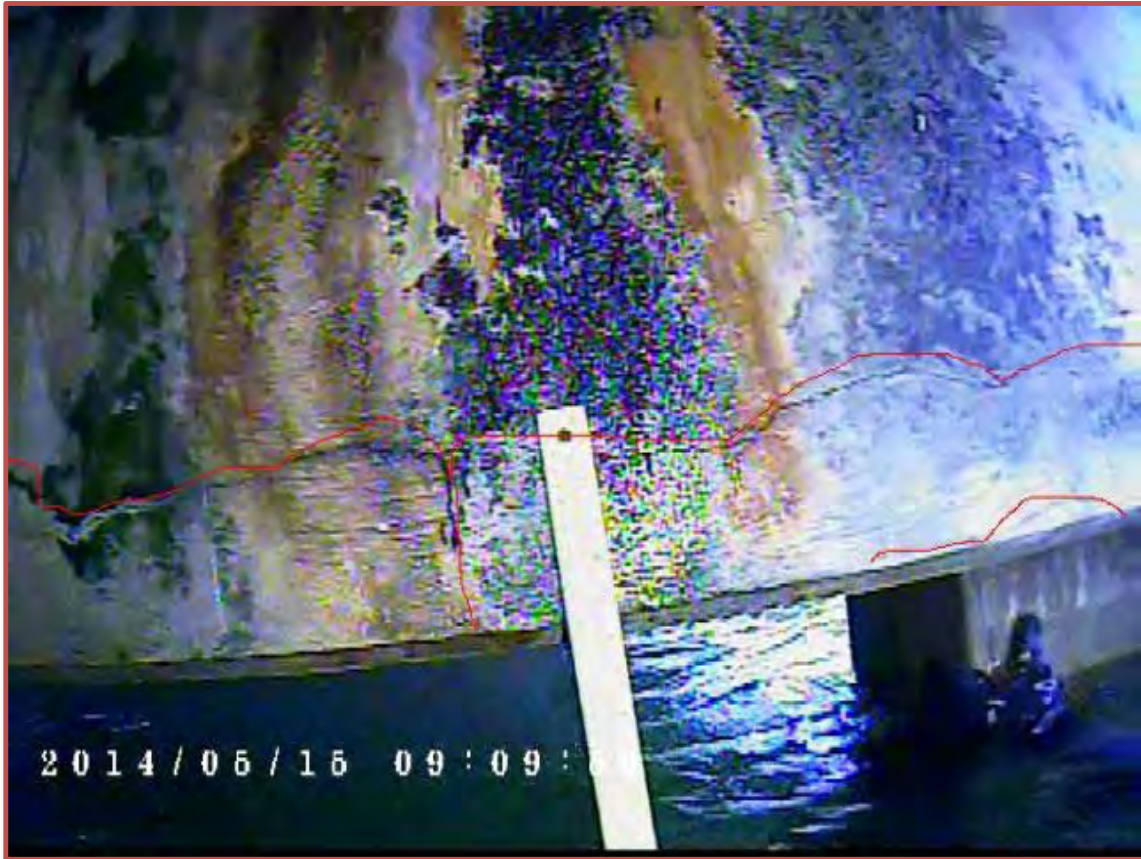
Description: Top: Bent 3 cap East face, intermittent delaminated areas. **UW Photo 05.**  
Bottom: SW wingwall cap, delamination, with cracks up to 1/8" wide. **UW Photo 06.**
