## **EXECUTIVE SUMMARY**

TranSystems has been retained by the City of Fort Lauderdale to perform bridge inspections and prepare bridge inspection reports for each of the City's bridges as part of the project Structural Bridge Engineering Consulting Services Master Plan, RFQ No. 946-11310. Inspections were completed and reports prepared for 46 of the City's bridges. The remaining five bridges in the City's inventory were not inspected because they are in the process of being replaced.

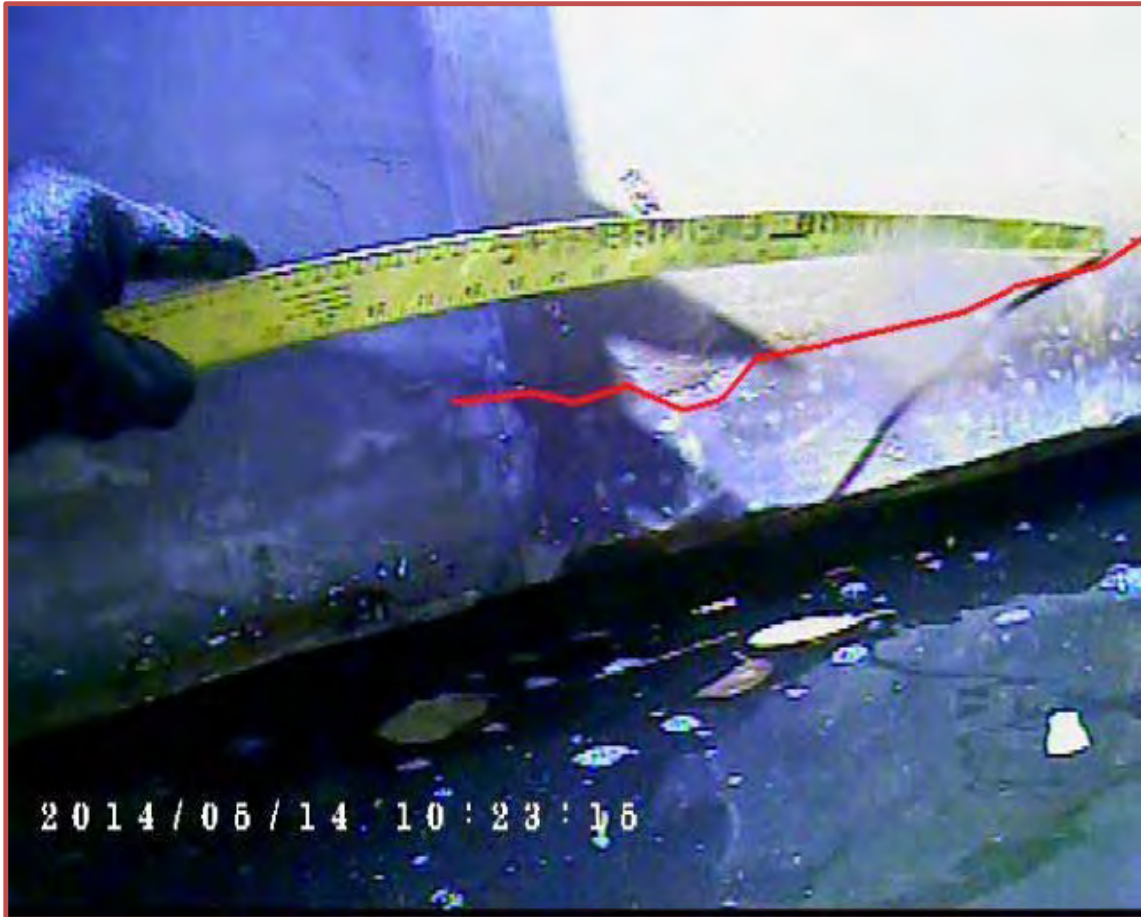
Description: NW retaining wall delamination with associated cracks up to 1/32" wide. **UW Photo 03.**

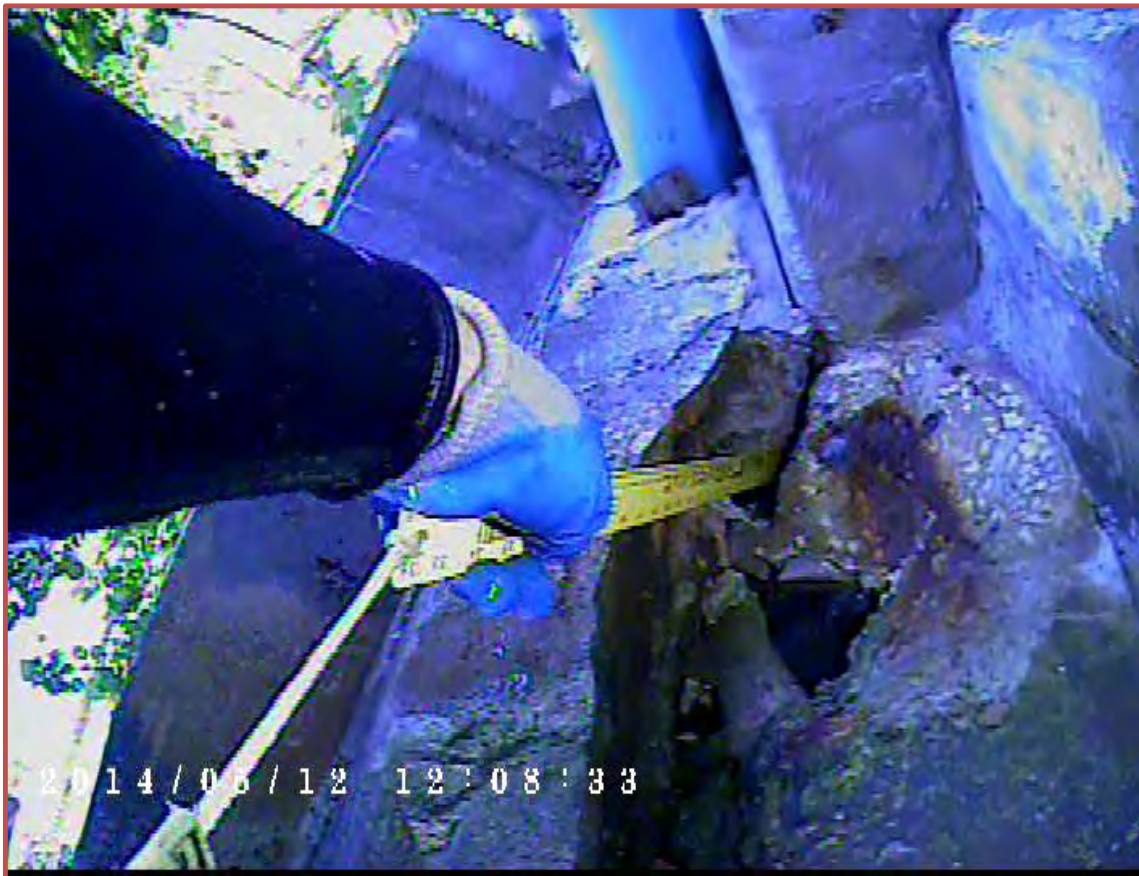
Description: NW wingwall transition joint, 36" of penetration void/spall/delamination. **UW Photo 07.**

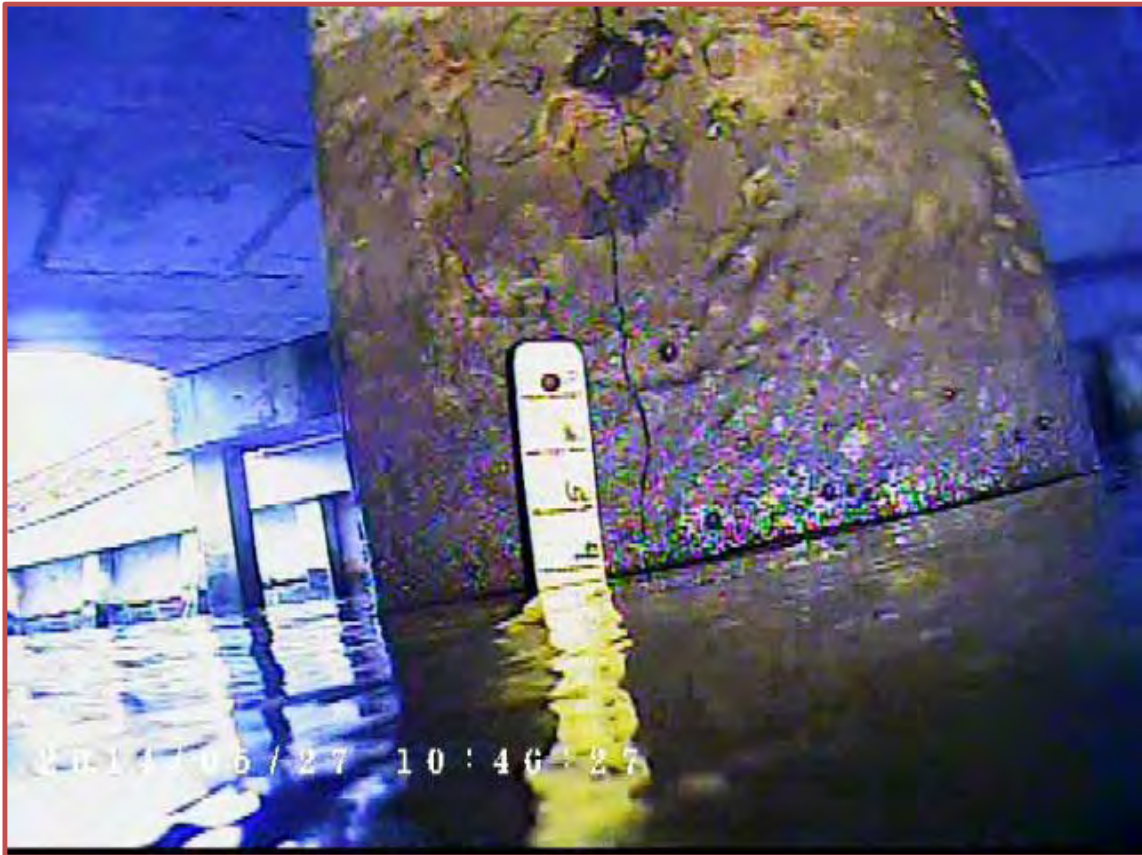
Description: Top: Pick-up points, shallow spalls with exposed steel and vertical cracks. **UW Photo 01.**  
Bottom: Pick-up points, shallow spalls and vertical cracks up to 1/16". **UW Photo 02.**

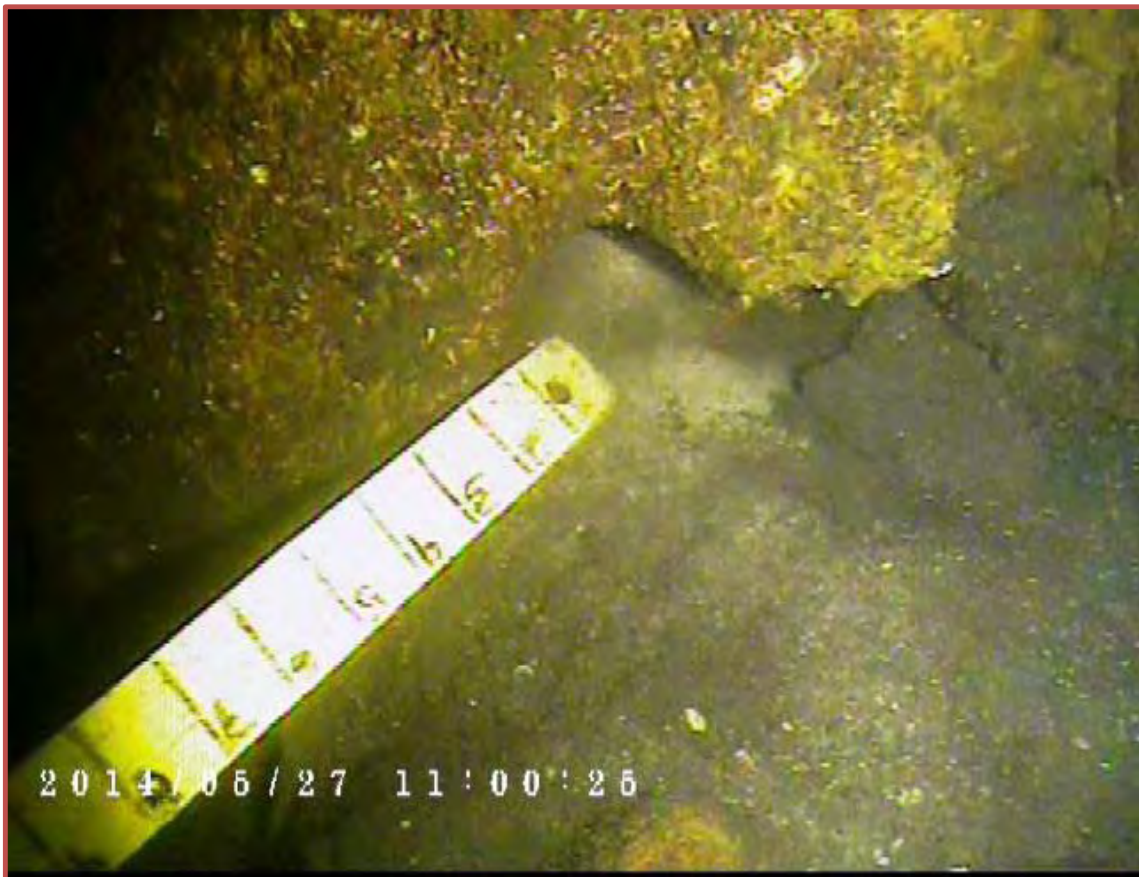
Description: East retaining wall has a spill 14" x 12" x 12", at the groundline at the joint between Piles 4-7 and 4-8, with active backfill leakage. **UW Photo 07.**

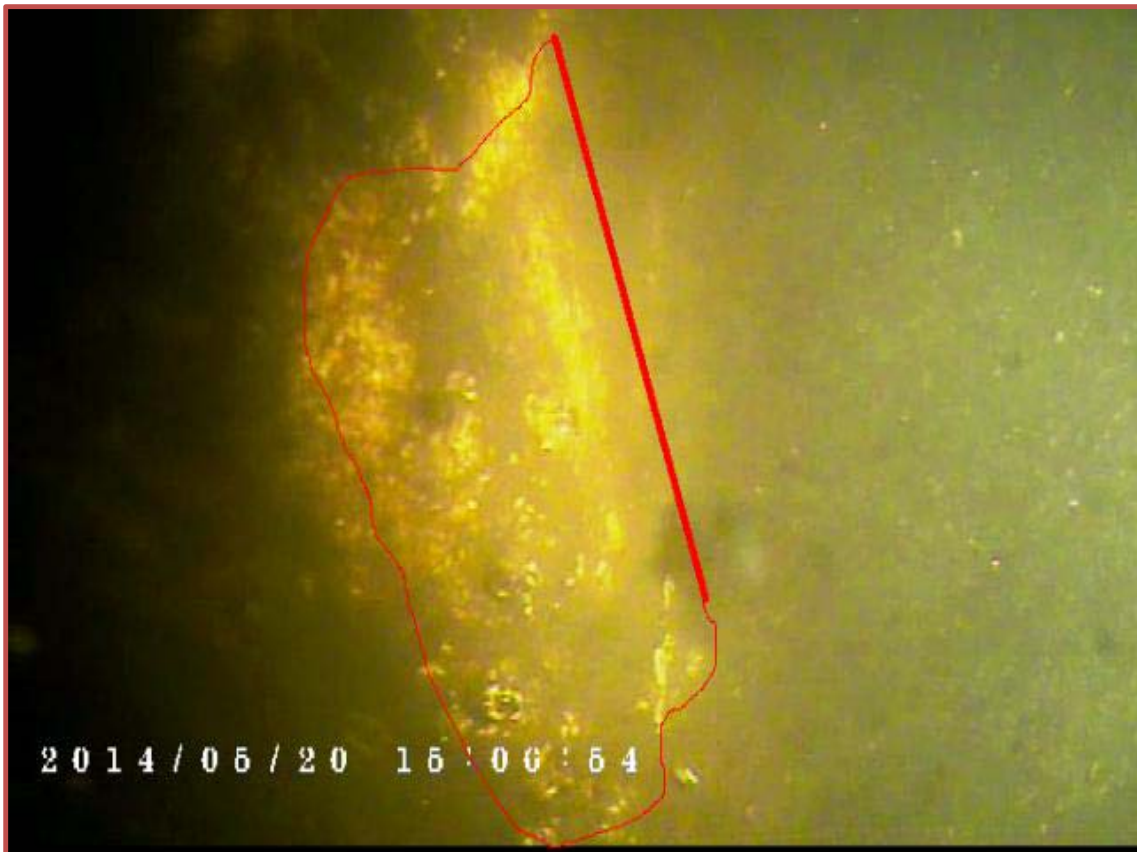
Description: Pile 5-7, NE corner spall 10" x 4" x 3/4", starting 42" below the cap. **UW Photo 03.**
