## **EXECUTIVE SUMMARY**

TranSystems has been retained by the City of Fort Lauderdale to perform bridge inspections and prepare bridge inspection reports for each of the City's bridges as part of the project Structural Bridge Engineering Consulting Services Master Plan, RFQ No. 946-11310. Inspections were completed and reports prepared for 46 of the City's bridges. The remaining five bridges in the City's inventory were not inspected because they are in the process of being replaced.

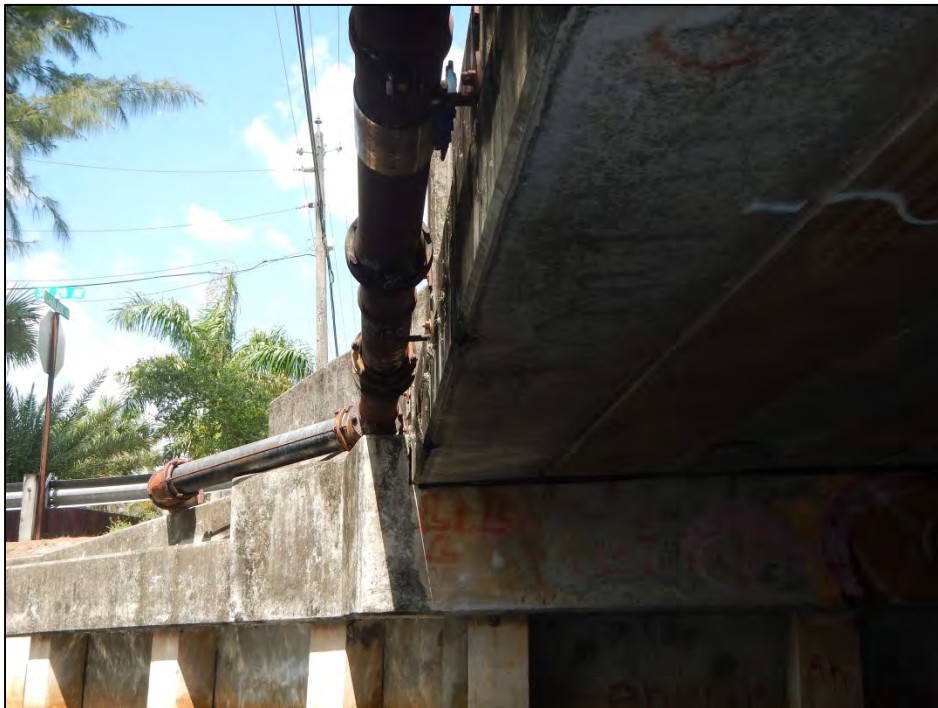
Utilities Mounted at South Fascia

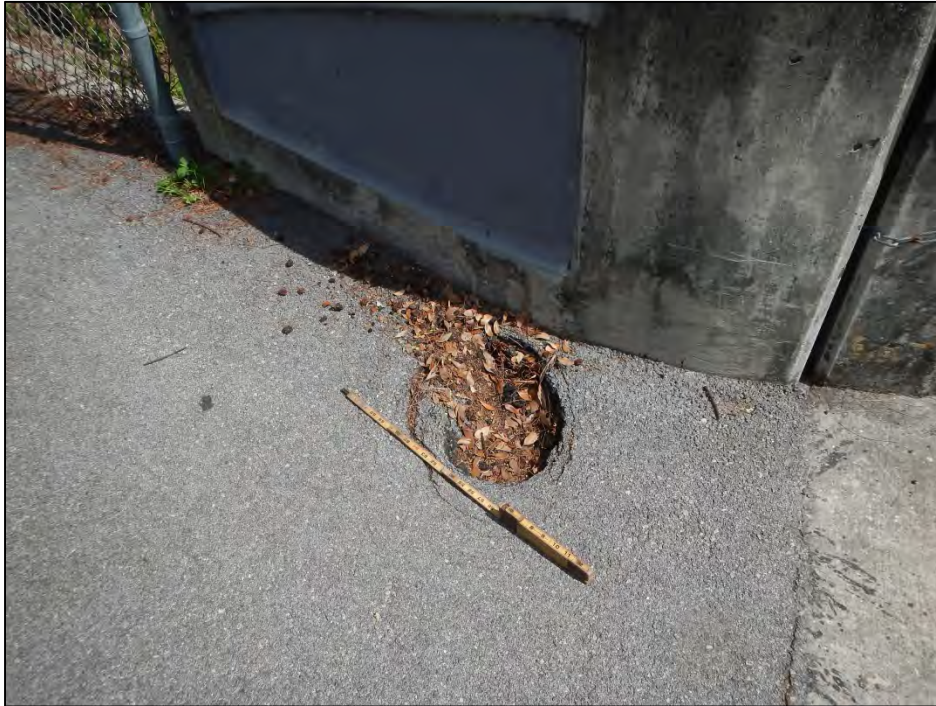
Photo 1 – The northwest approach sidewalk exhibits settlement.

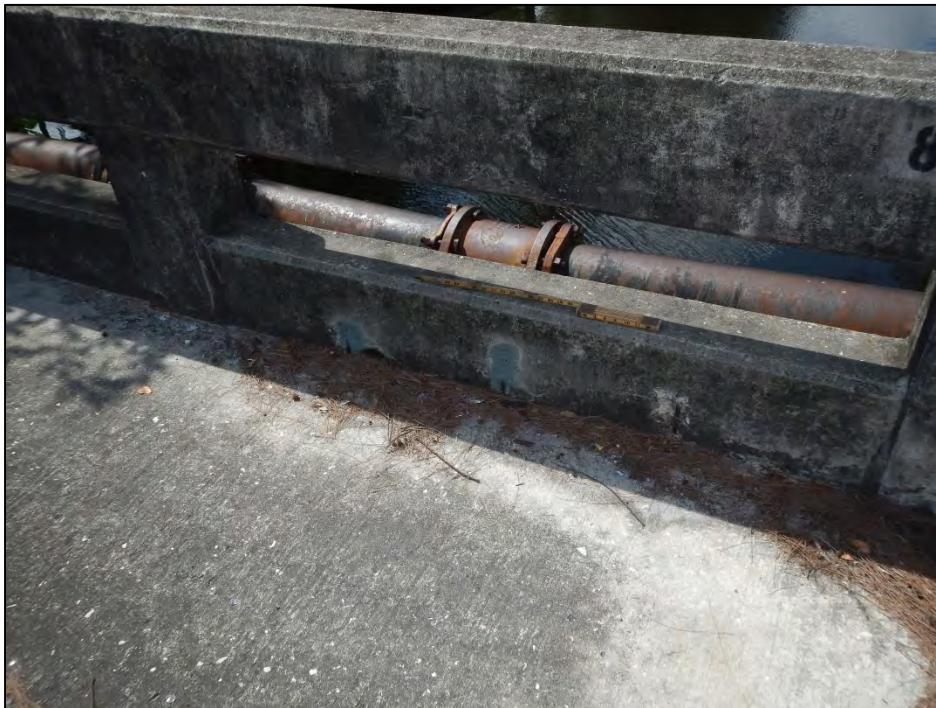
Photo 2 – The north side of the south railing exhibits spalls with exposed steel.

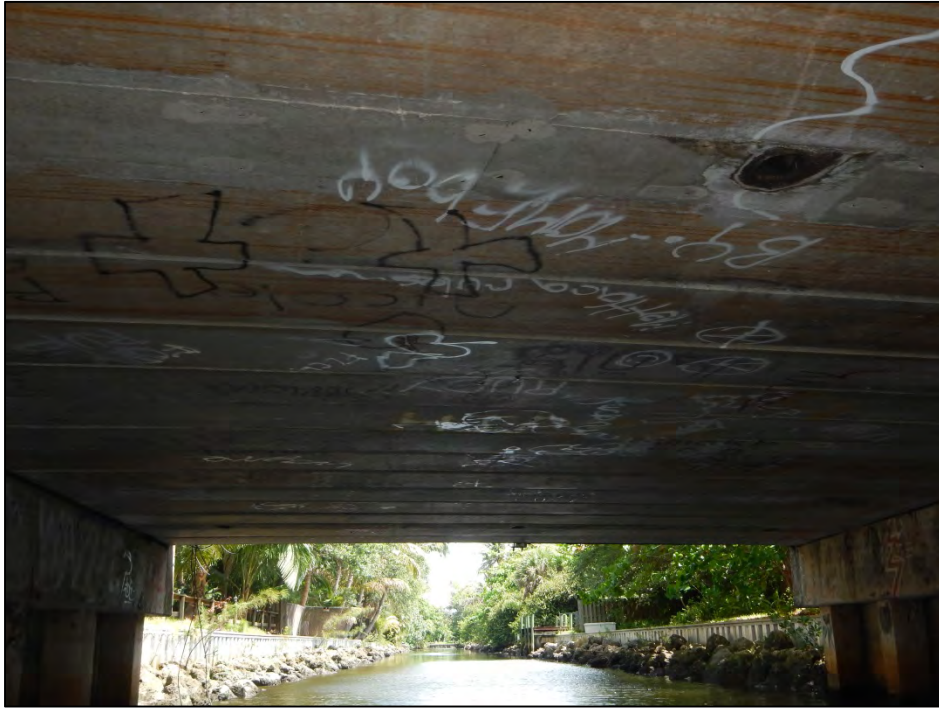
Photo 3 – The deck underside exhibits graffiti.

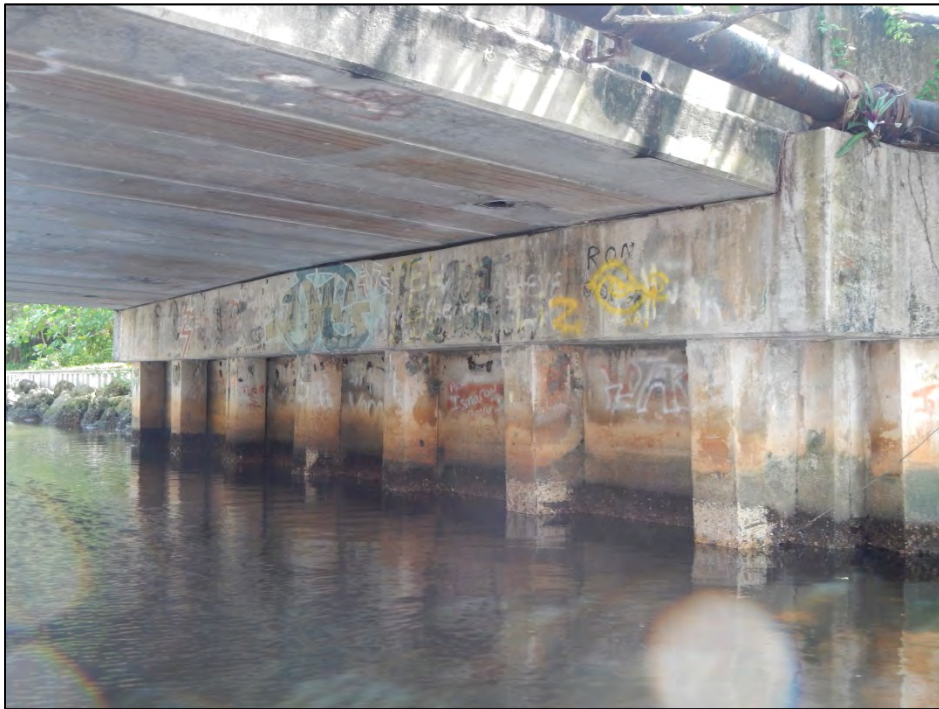
Photo 4 – Abutment 2 exhibits graffiti.

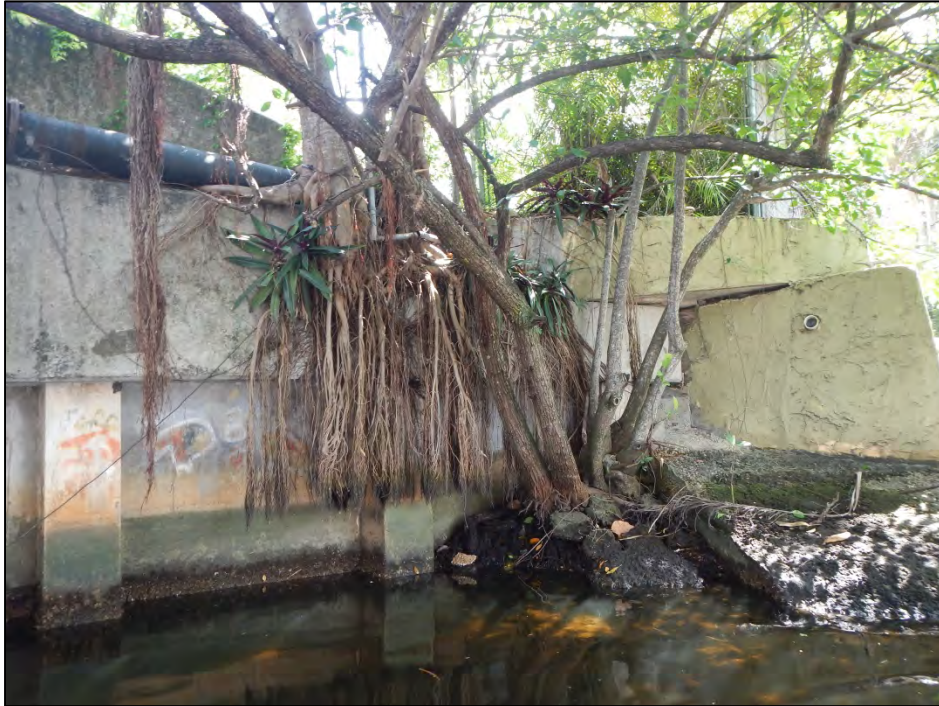
Photo 5 – A tree is growing in the southeast corner.

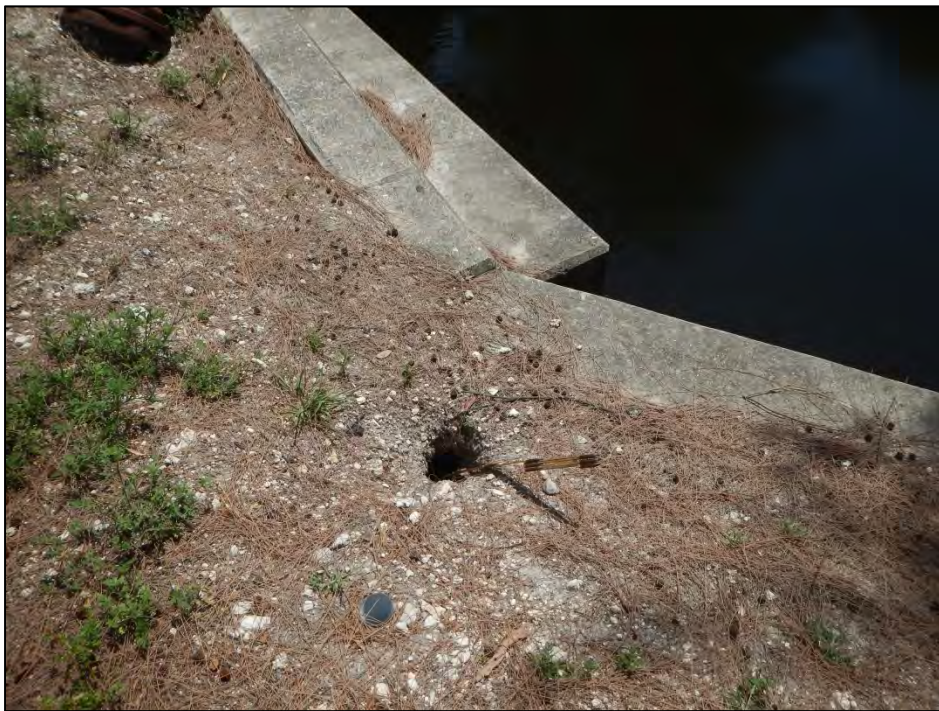
Photo 6 – The southwest retaining wall exhibits a washout behind the bulkhead cap.

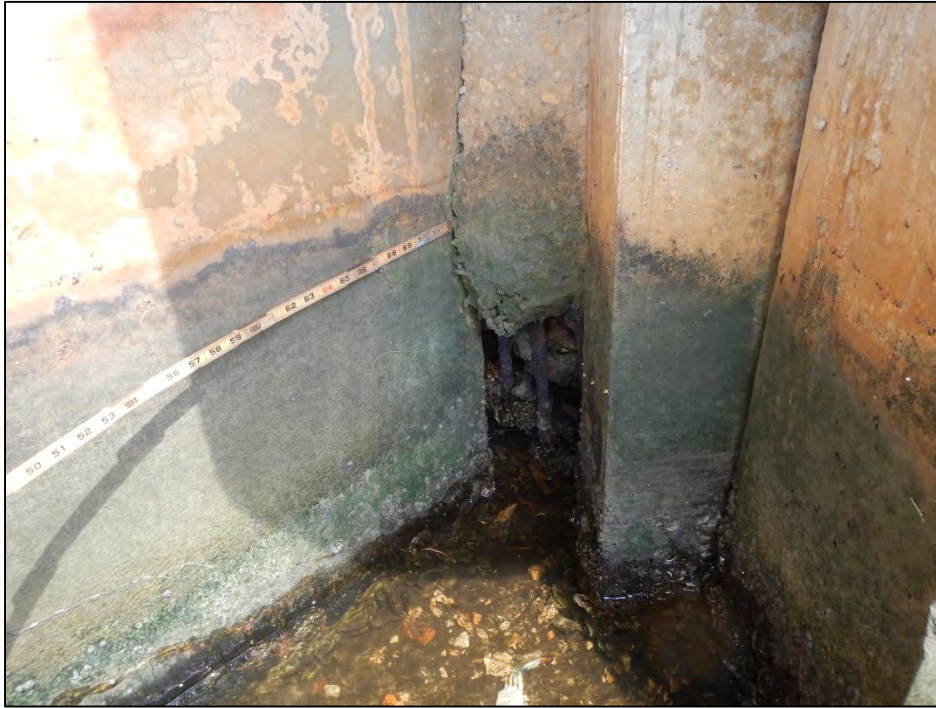
Photo 7 – The southwest retaining wall is open and exposes corroded steel.

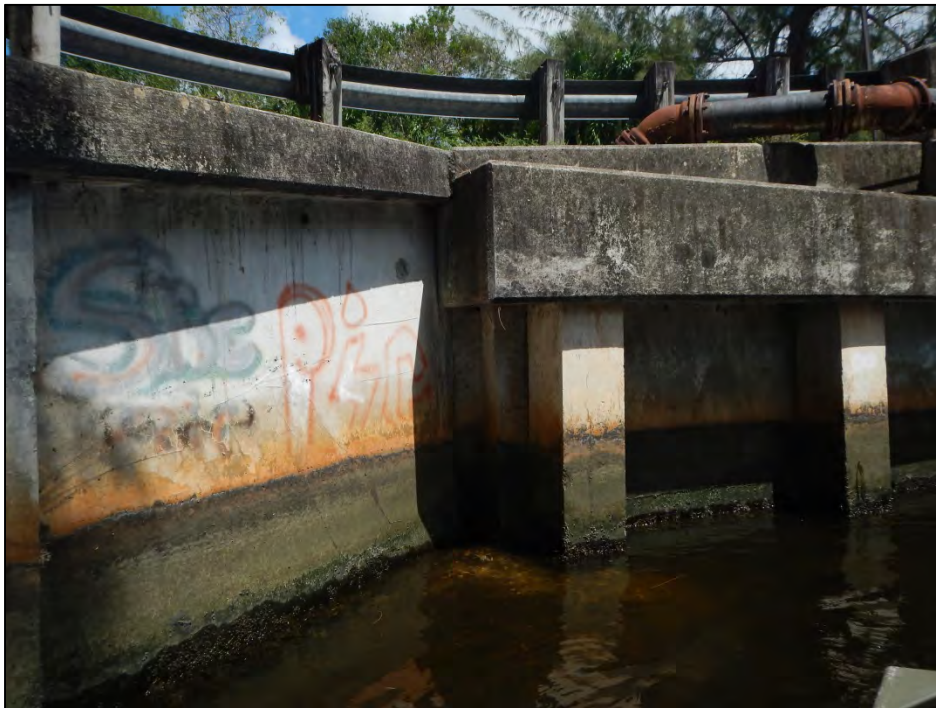
Photo 8 – The southwest backwall exhibits diagonal cracks and graffiti.

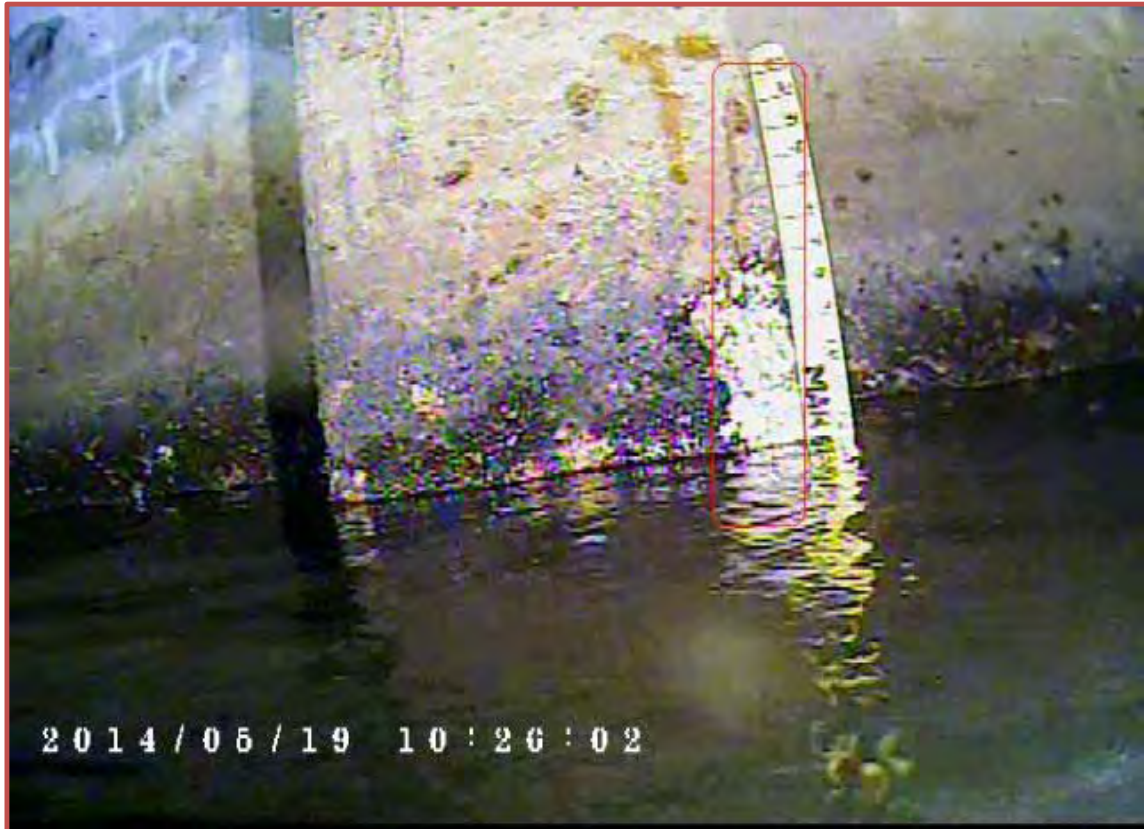
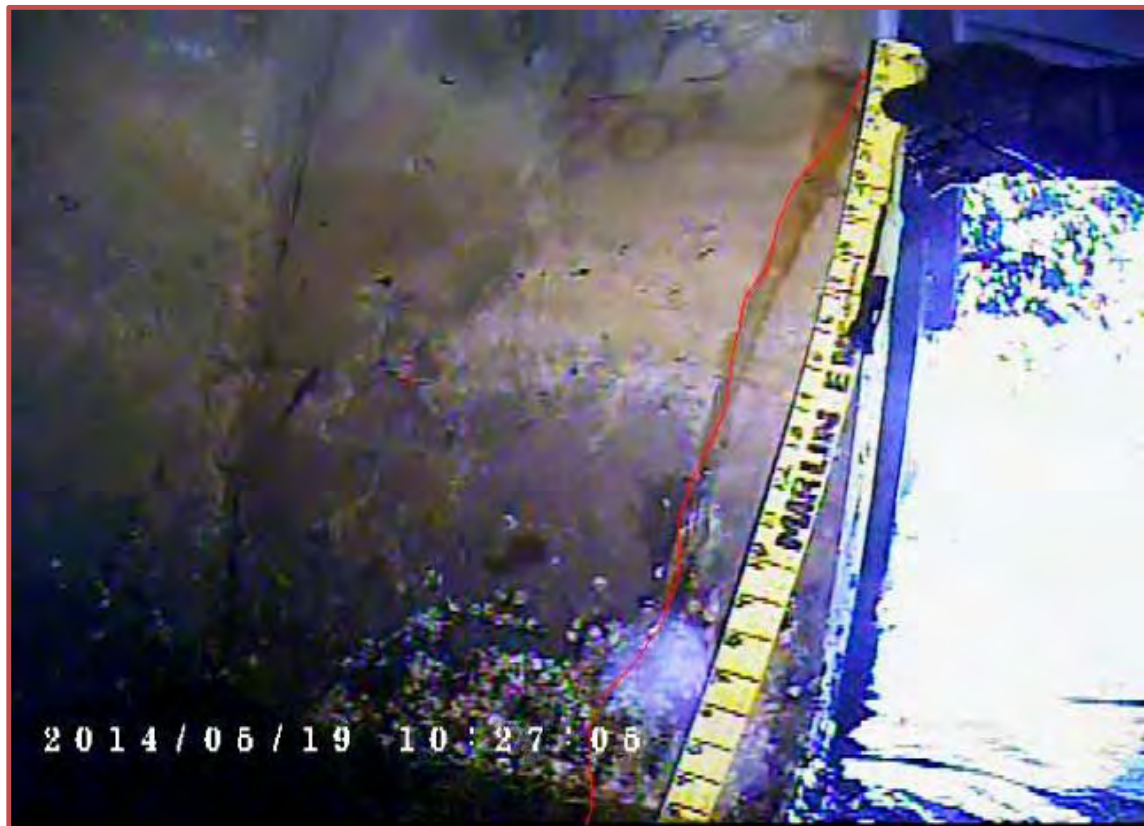
Description: Top: Pile 2-4, SW corner delamination, starting at the high watermark. **UW Photo 01.**  
Bottom: Several of the Piles have up to 36" x 1/64" vertical cracks. **UW Photo 02.**

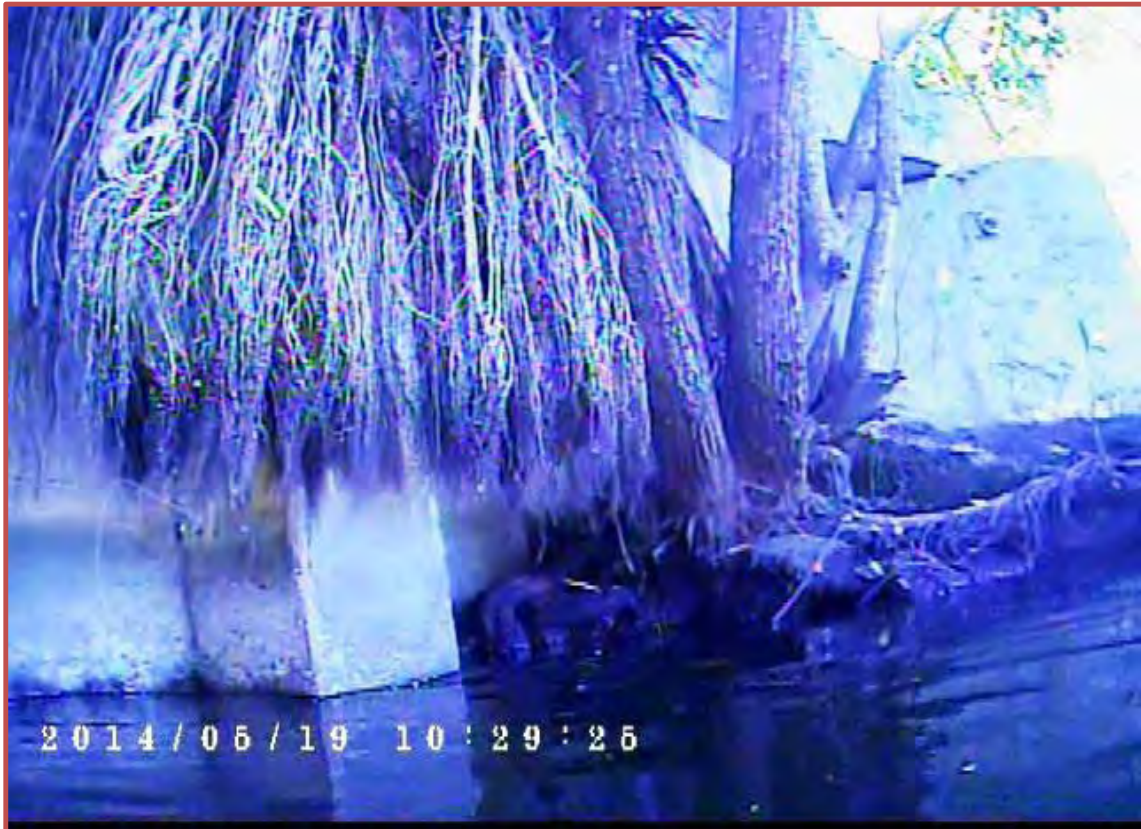
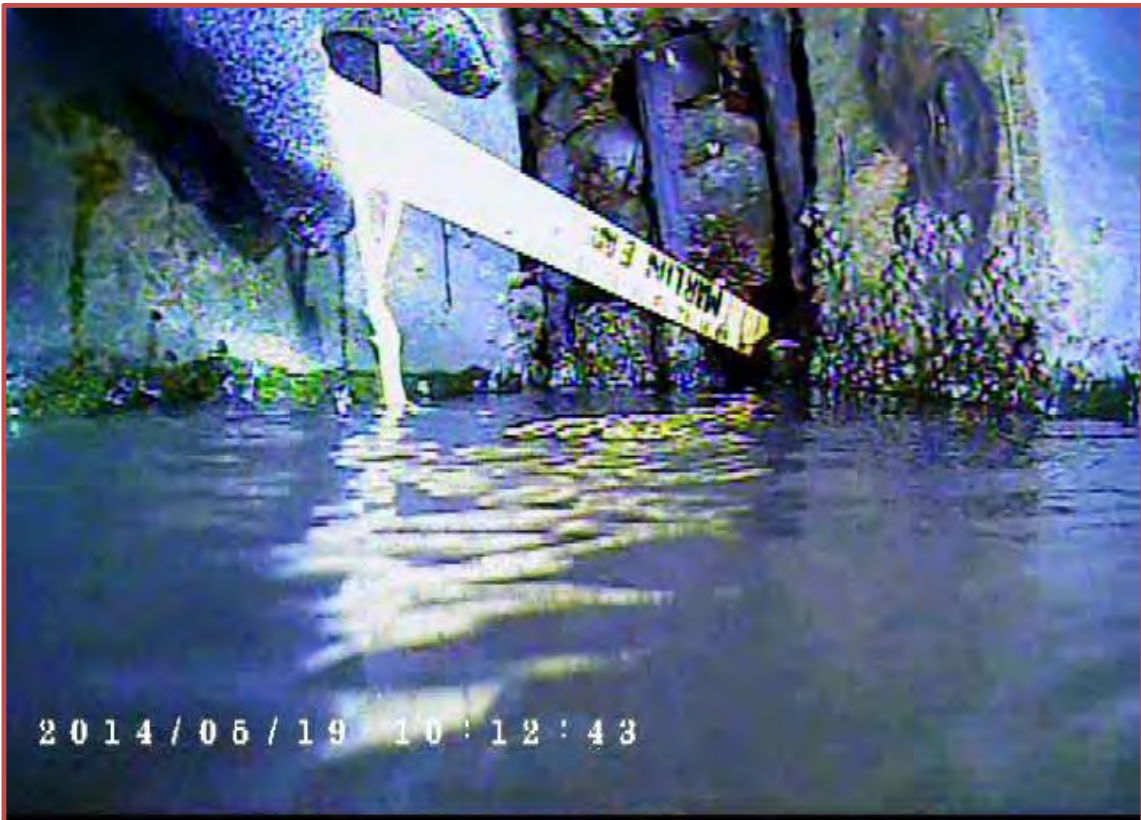
Description: Top: Tree growing in the South channel adjacent to SE retaining wall. **UW Photo 03.**  
Bottom: SE retaining wall to backwall joint is open, exposing rebar. **UW Photo 04.**

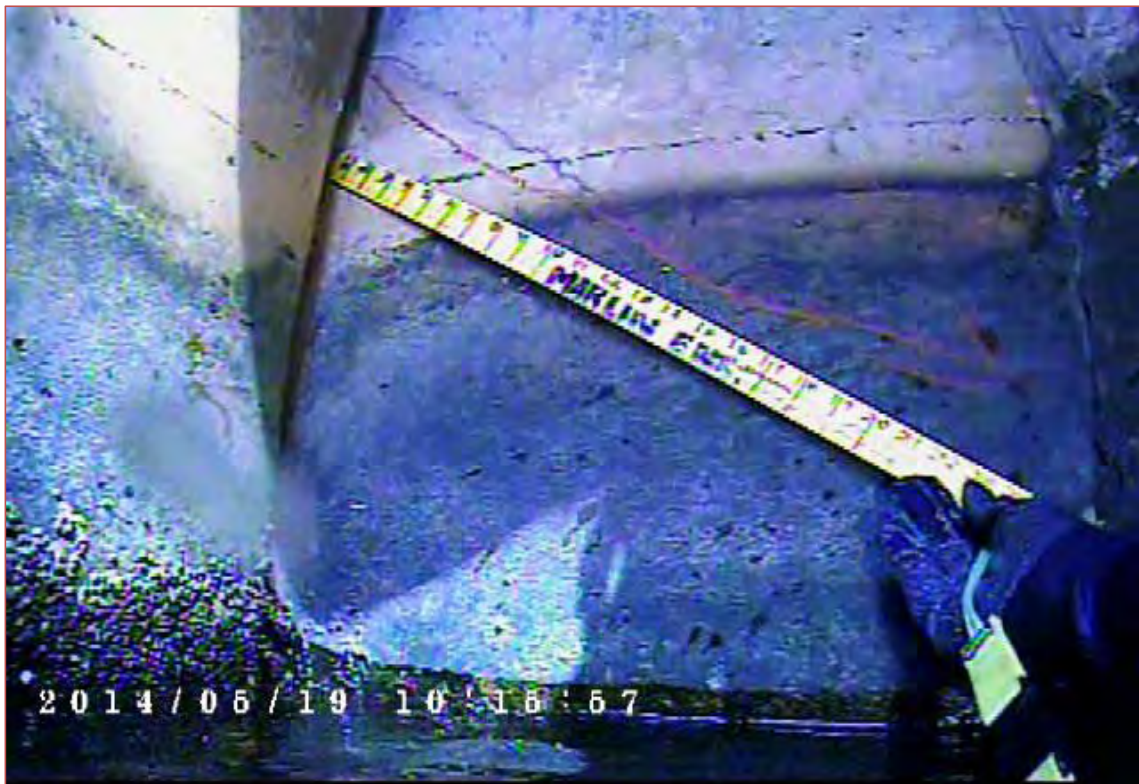
Description: Top: NW backwall transition to wingwall has a delamination. **UW Photo 05.**  
Bottom: The backwalls have random diagonal cracks up to 1/64" wide. **UW Photo 06.**

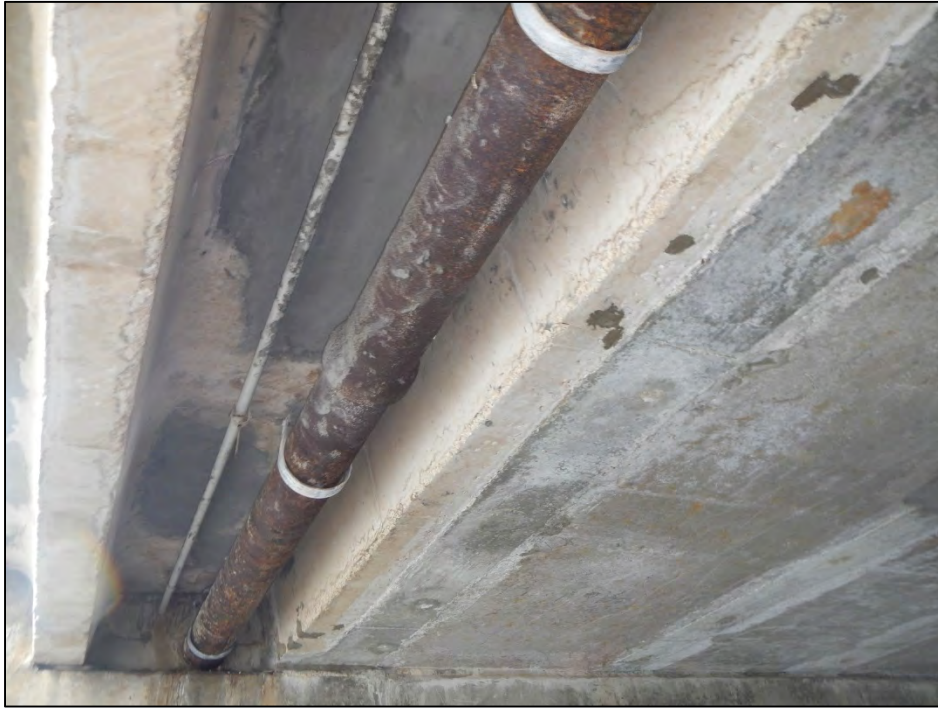
Utilities Mounted under South Sidewalk

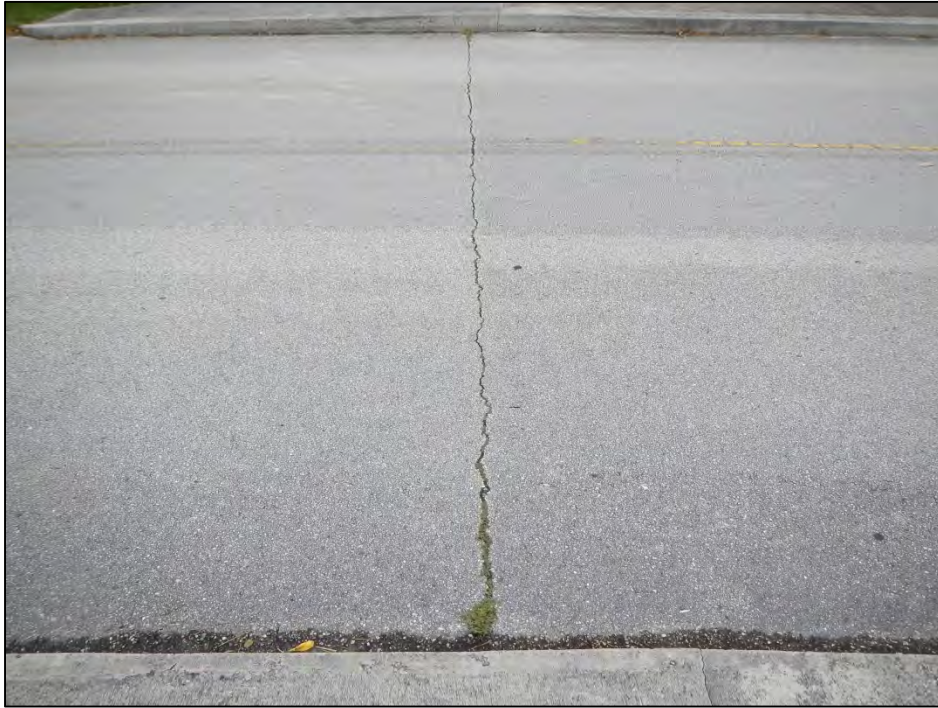
Photo 1 – Abutment 1 joint seal transverse crack.

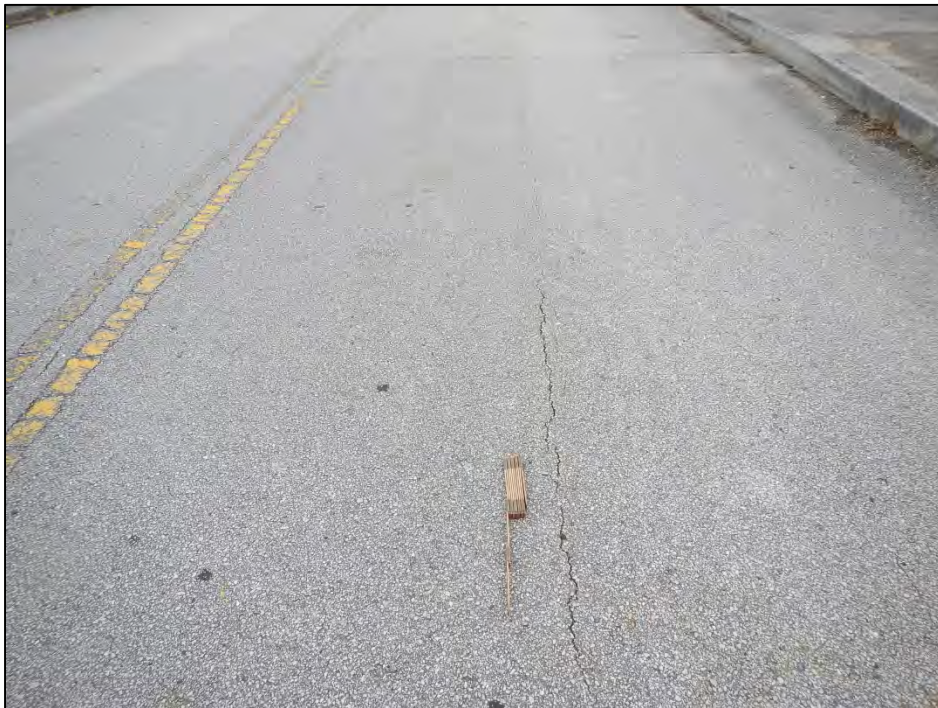
Photo 2 – Westbound deck top longitudinal cracks.

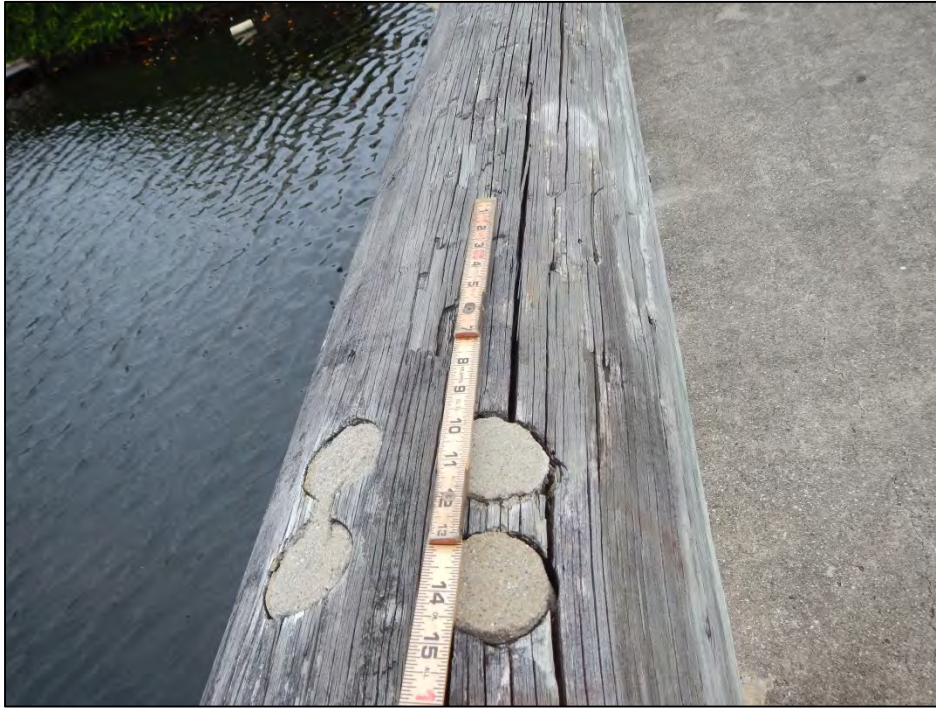
Photo 3 – Timber rail splitting.

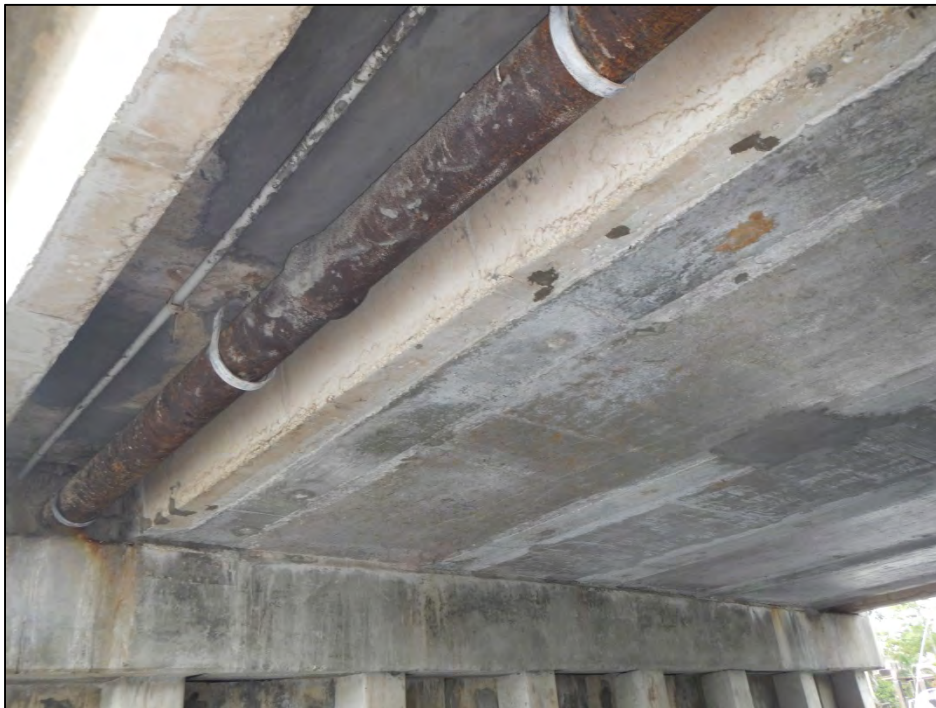
Photo 4 – Deck underside general view of repairs.

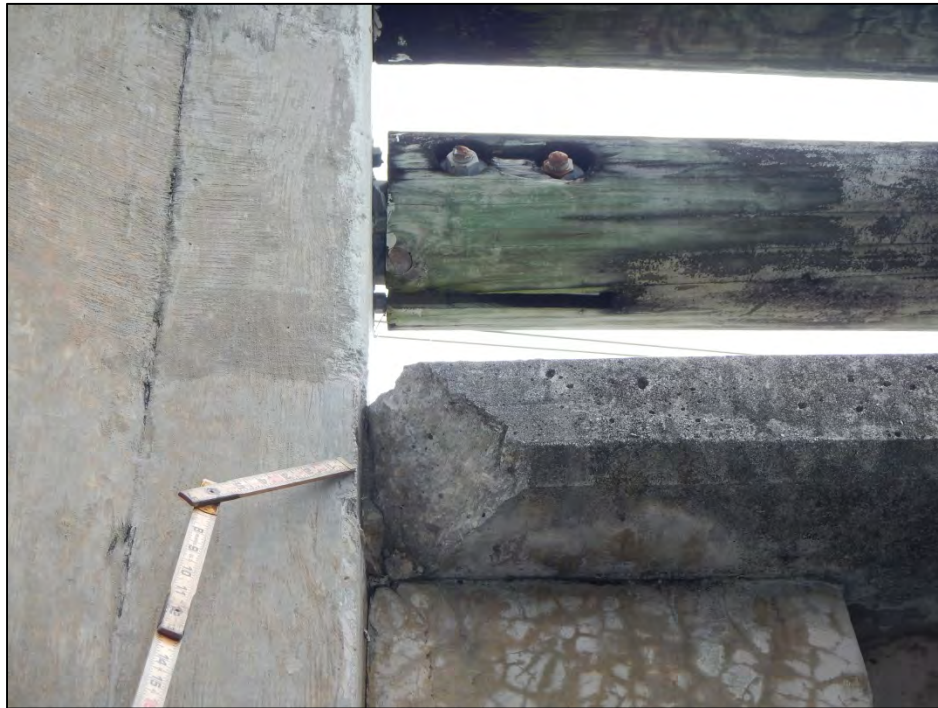
Photo 5 – The east end of the north fascia exhibits a spall over Abutment 2.

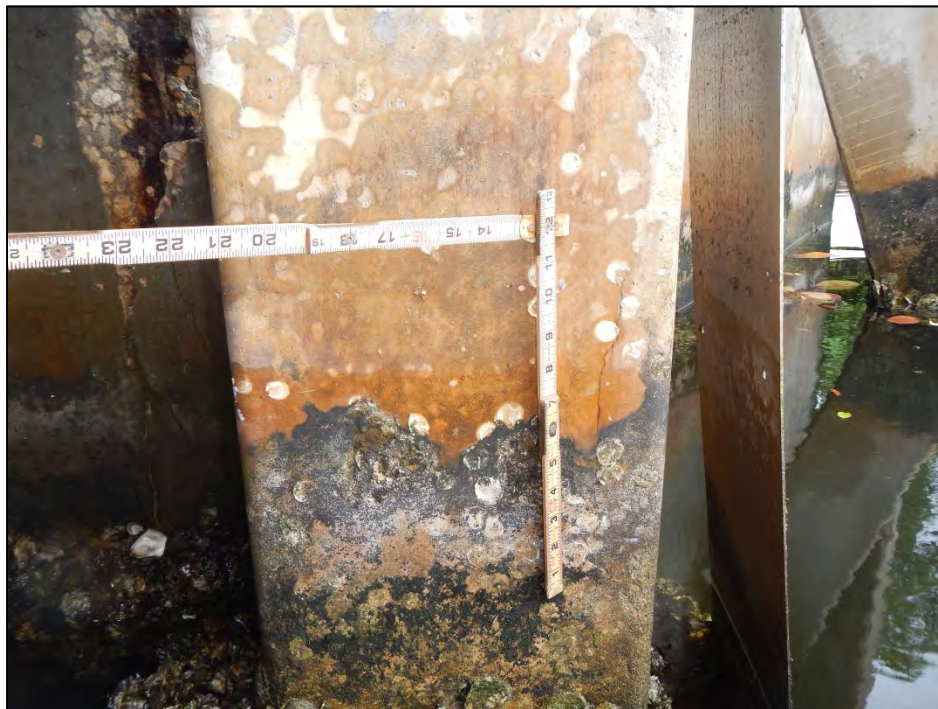
Photo 6 – The southwest corner of Pile 2-8 exhibits a vertical crack.

\_Pile 2-8, SW corner spall 14" x 4" x 1", at and below the high watermark. **INCREASE.**

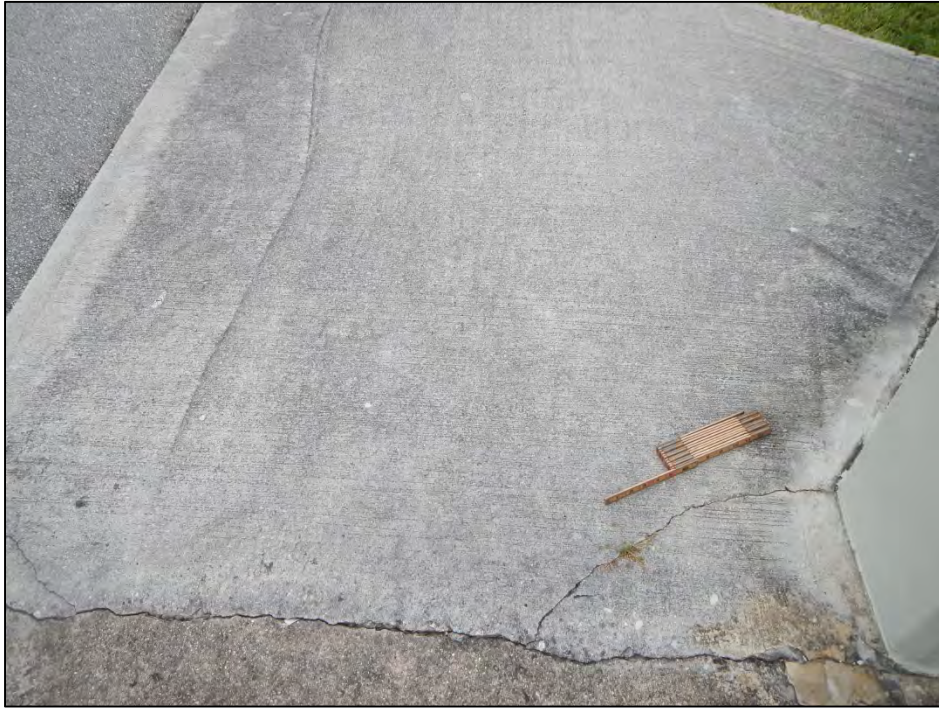
Photo 7 – The southeast approach sidewalk exhibits diagonal cracks.

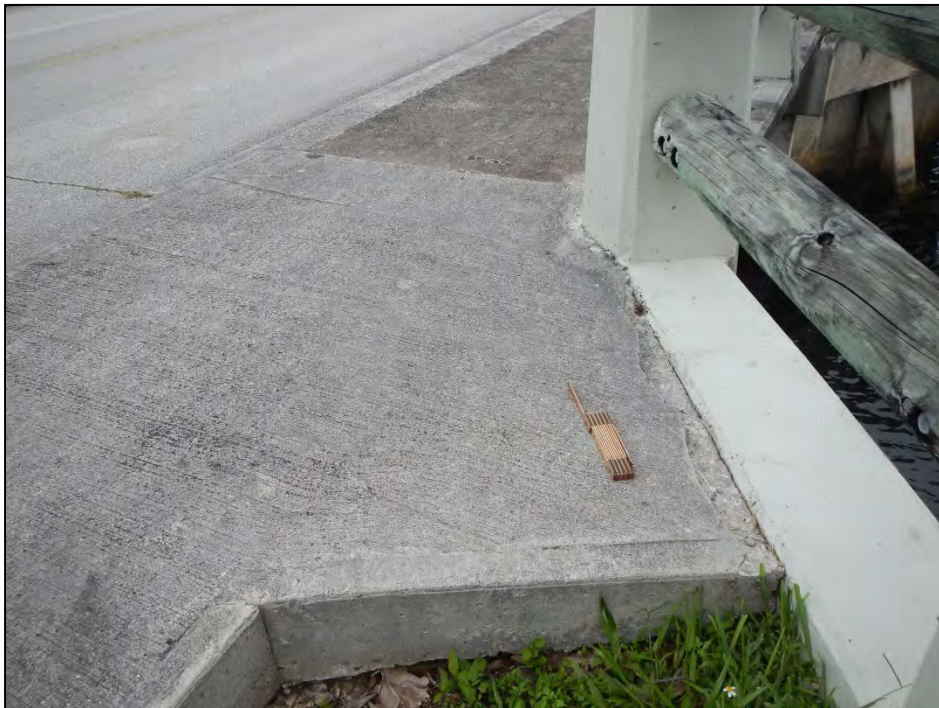
Photo 8 – The northeast approach sidewalk exhibits a spall.

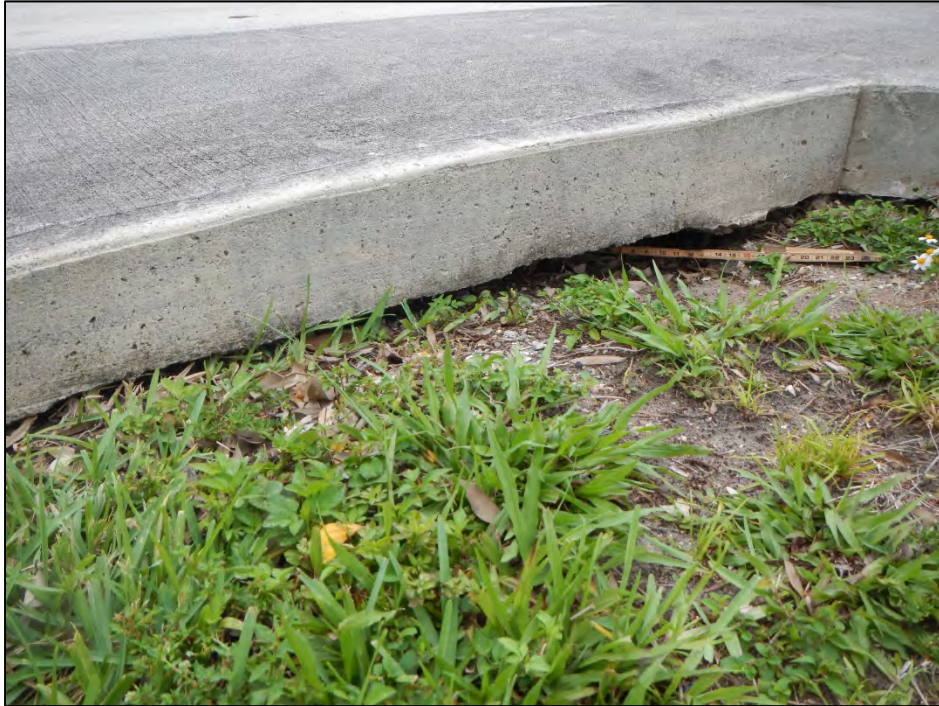
Photo 9 – The northeast approach sidewalk has an area of undermining.

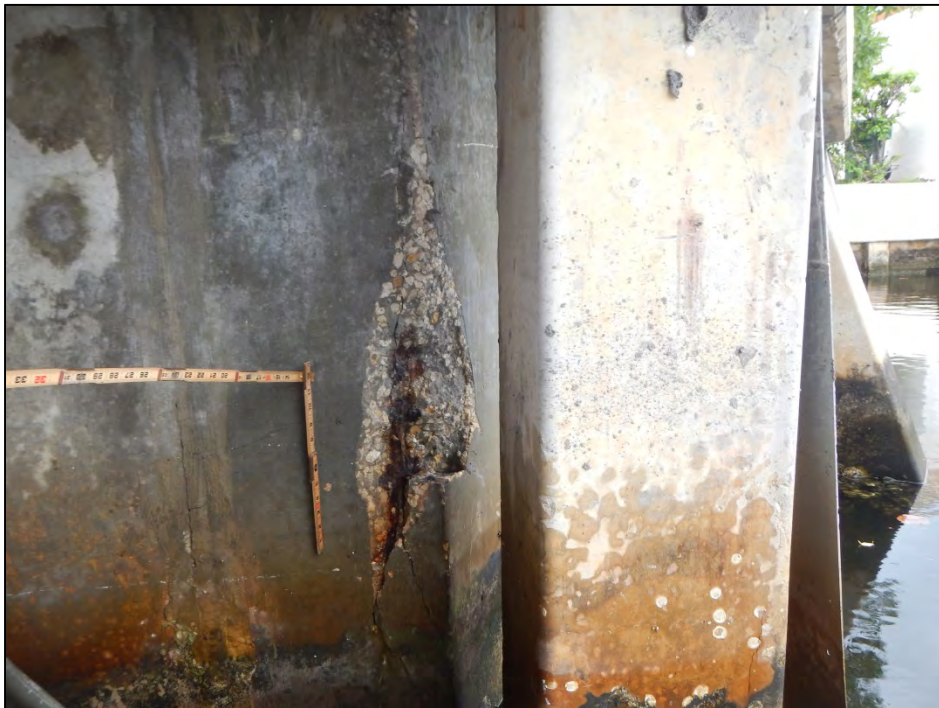
Photo 10 – The south end of the Abutment 2 backwall exhibits a spall/delamination.

\_Abutment 2 backwall adjacent to the NE transition retaining walls has a spall/delamination 5' x 12" x 3", with exposed rebar. **UW Photo 03. INCREASE.**

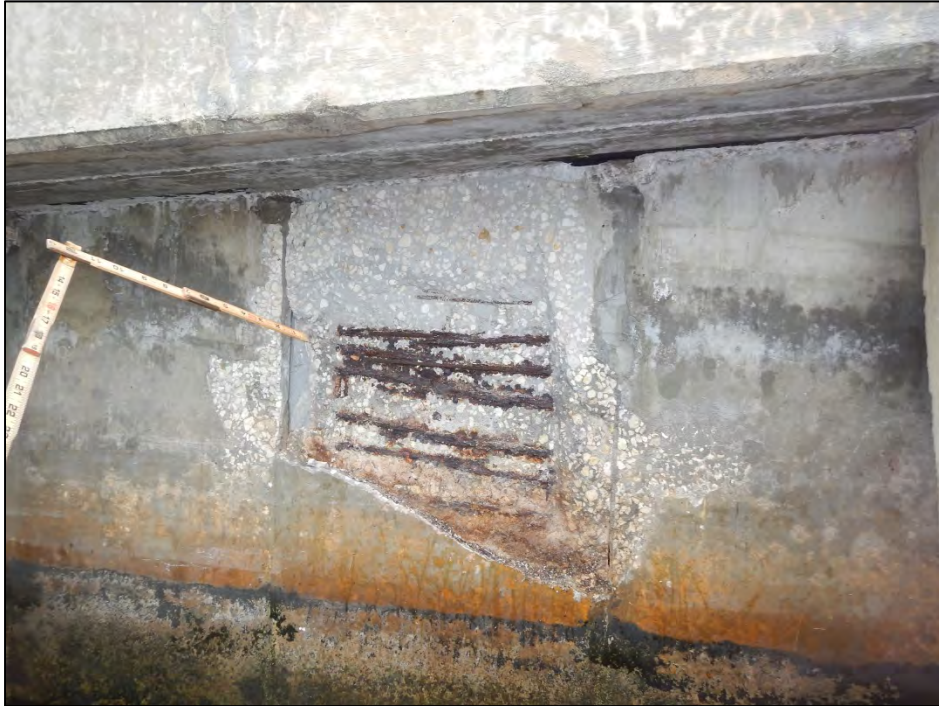
Photo 11 – The south face of the southwest retaining wall exhibits a spall/delamination.

\_SW retaining wall has a spalled/delaminated area 36" x 31" x 2", with exposed rebars up to 75% section loss, starting at the cap. **UW Photo 04. NEW.**

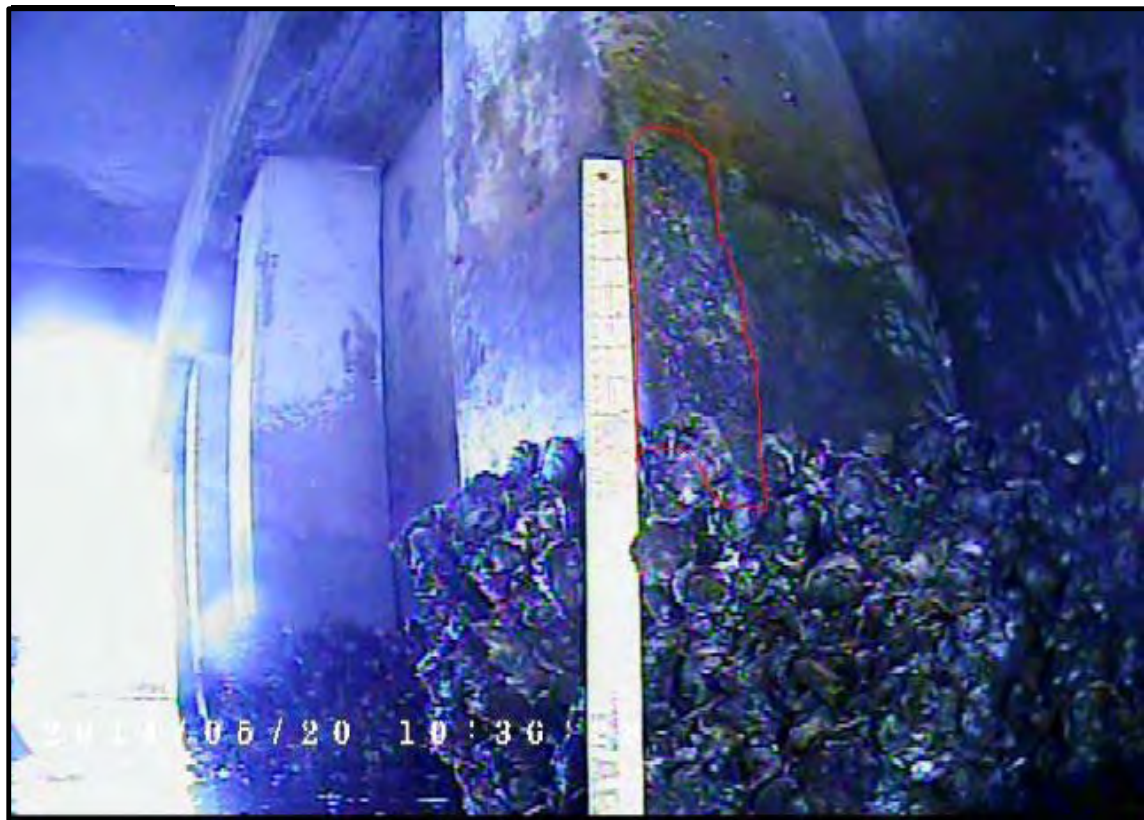
\_Pile 2-1 is a built-up Pile in the top 4'. This built-up section is spalled/delaminated up to 3" deep, with exposed rebar (3/8" section remaining) in all four faces. **UW Photo 01. INCREASE.**

\_Pile 2-4, SW corner spall 11" x 4" x 1/2", at and below the high watermark. **UW Photo 02. NEW.**

Description: Top: Pile 2-1, the built-up section is spalled/delaminated. **UW Photo 01.**  
Bottom: Pile 2-4, SW corner spall, at and below the high watermark. **UW Photo 02.**

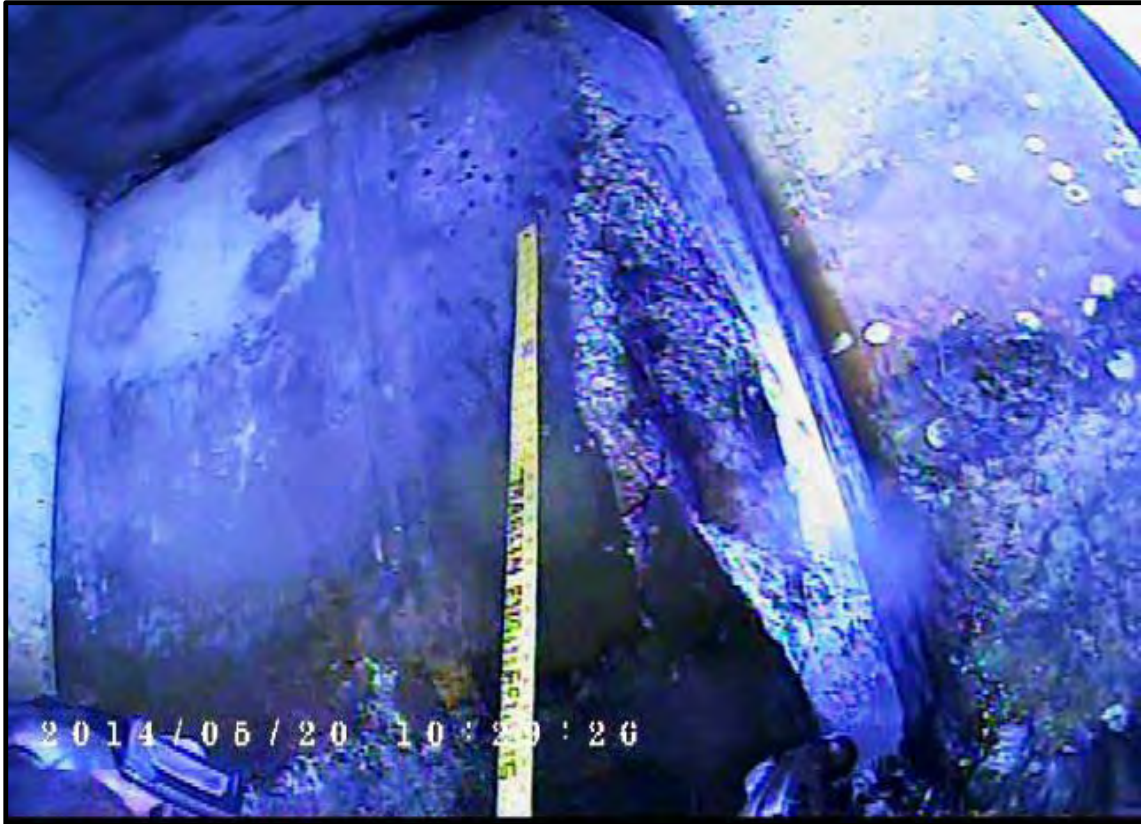
Description: Top: Abutment 2 backwall adjacent to the NE transition spill/delamination. **UW Photo 03.**  
Bottom: SW retaining wall, spalled/delaminated area. **UW Photo 04.**

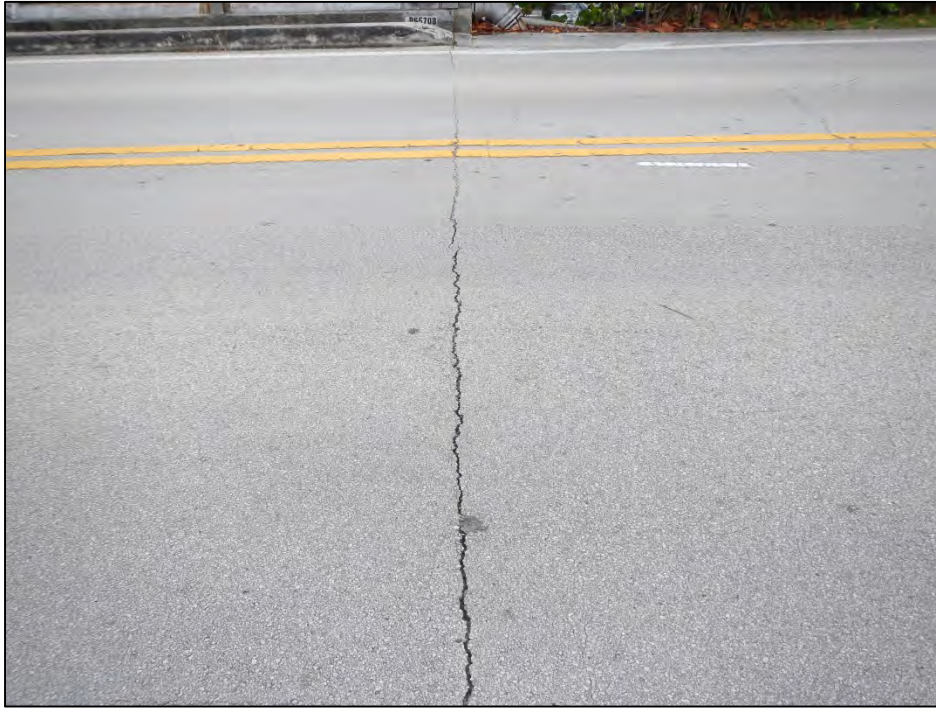
Photo 1 – End Bent 1 joint seal transverse crack.

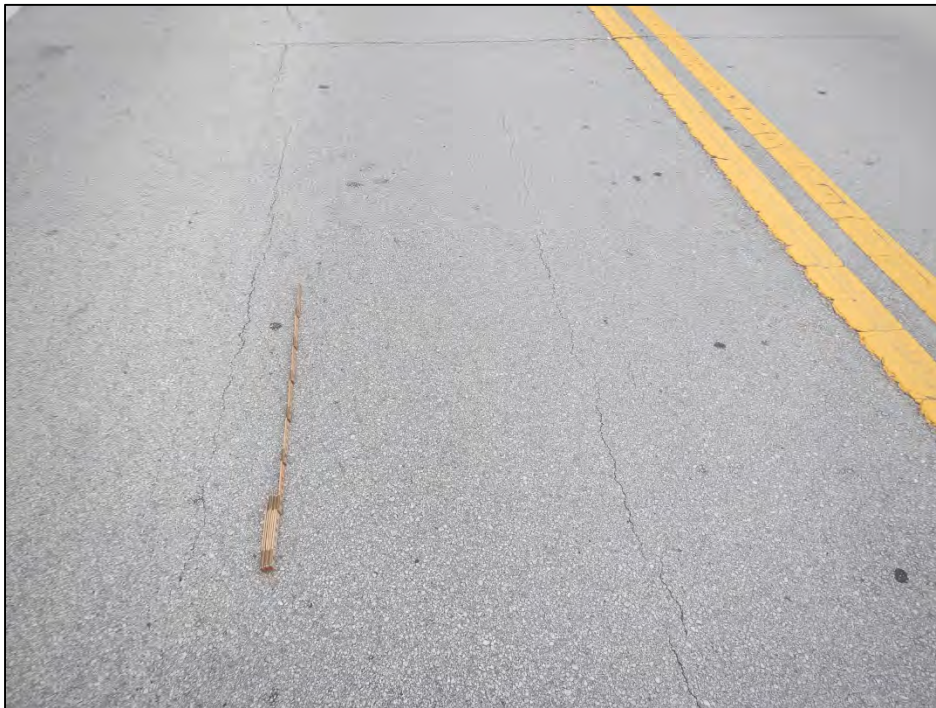
Photo 2 – Deck top longitudinal cracks over joints between slab units.
