## **EXECUTIVE SUMMARY**

TranSystems has been retained by the City of Fort Lauderdale to perform bridge inspections and prepare bridge inspection reports for each of the City's bridges as part of the project Structural Bridge Engineering Consulting Services Master Plan, RFQ No. 946-11310. Inspections were completed and reports prepared for 46 of the City's bridges. The remaining five bridges in the City's inventory were not inspected because they are in the process of being replaced.

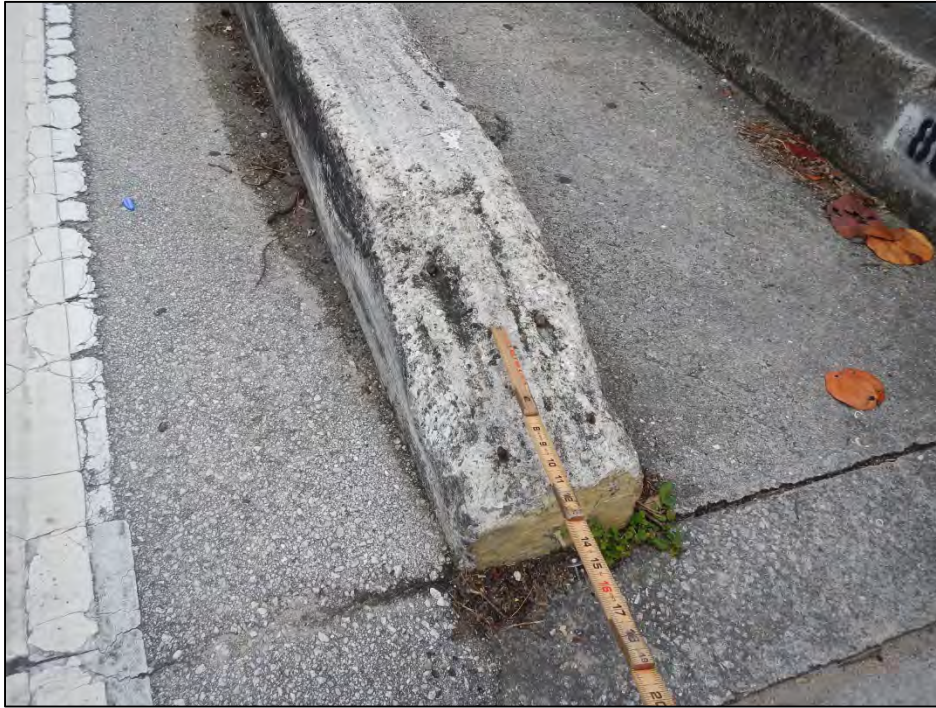
Photo 3 – East curb south end spall with exposed steel.

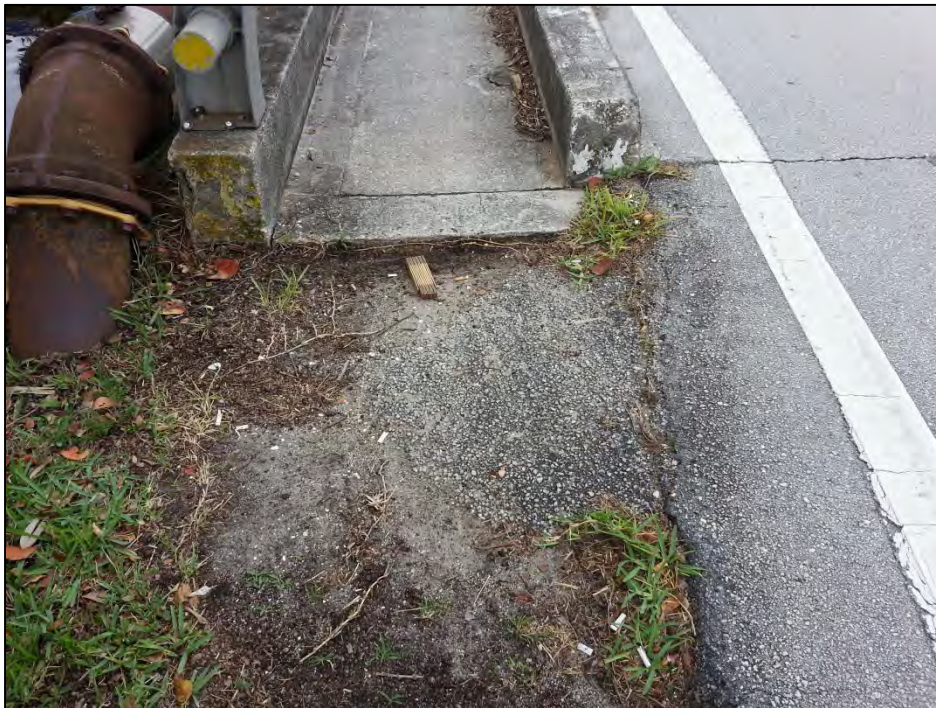
Photo 4 – Southwest corner bridge sidewalk has a drop-off at the end, creating a trip hazard.

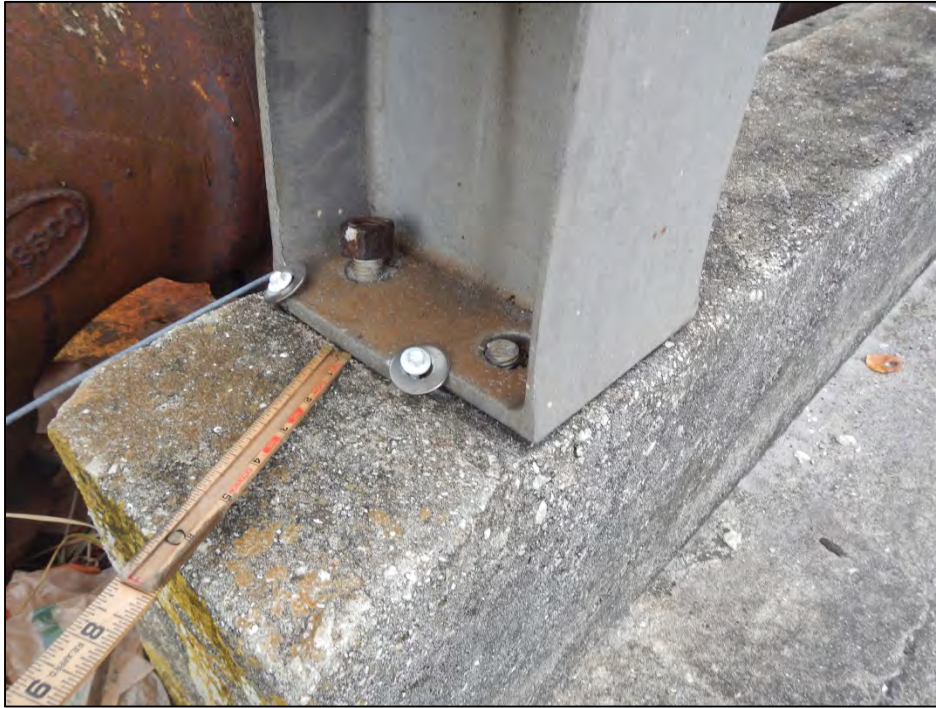
Photo 5 – West railing Post I-2L exhibits 2 of 4 anchor bolt nuts missing.

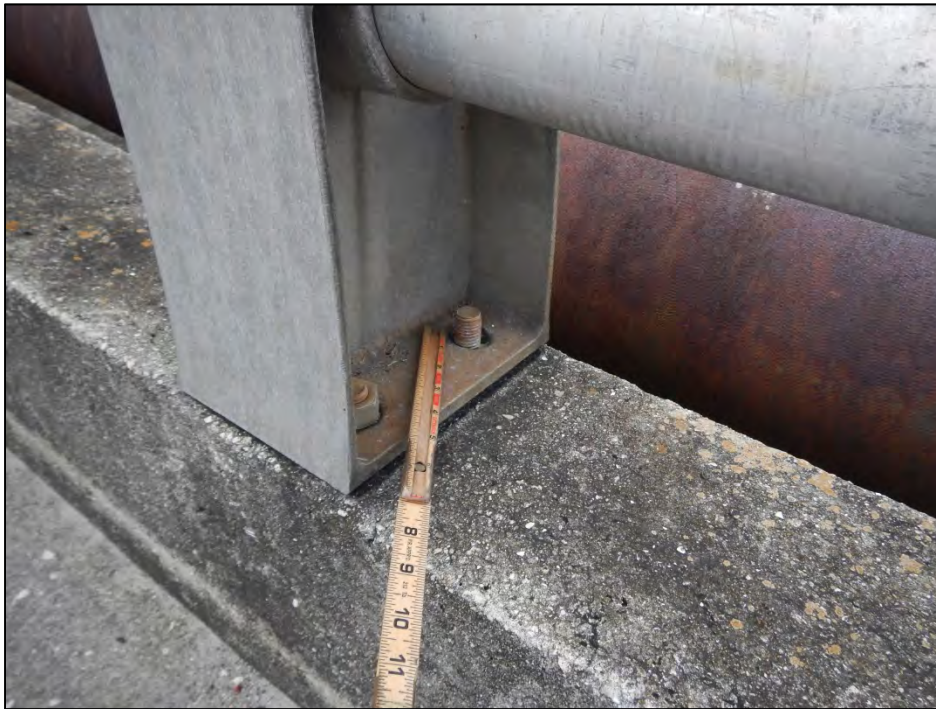
Photo 6 – West railing Post I-2L is missing 2 of 4 anchor bolt nuts.

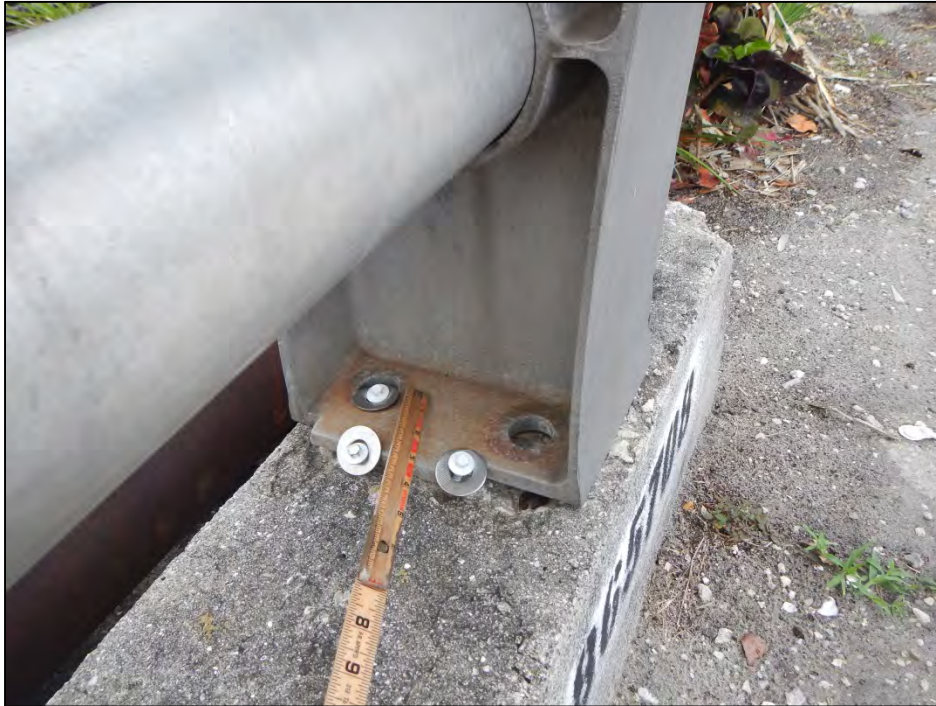
Photo 7 – West railing Post 3 not secured to rail. Note attempt to secure post.

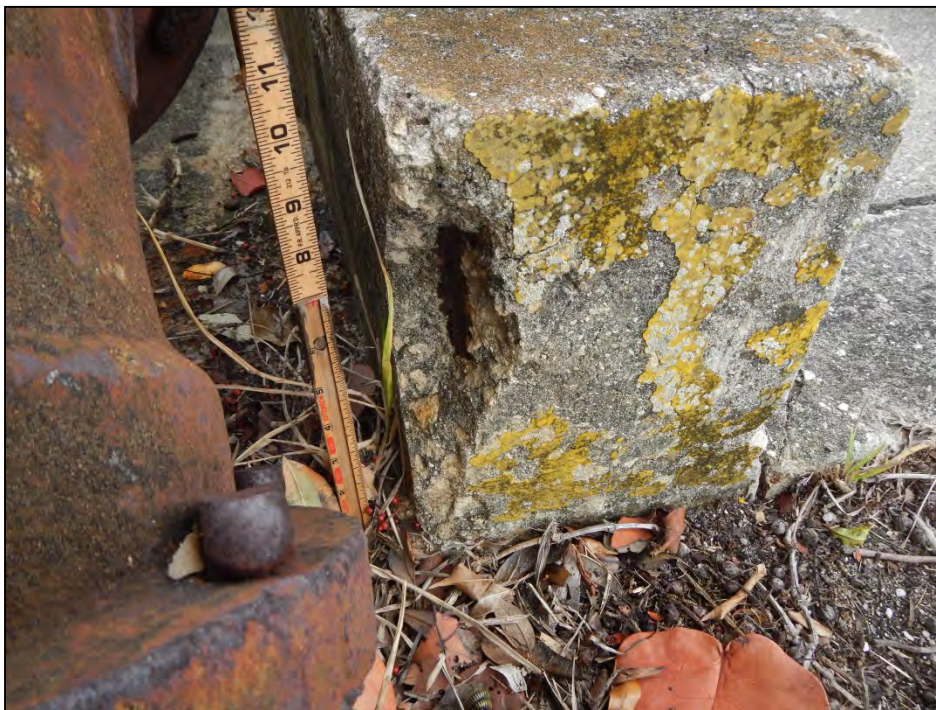
Photo 8 – West railing has a spall with exposed steel at the south end.

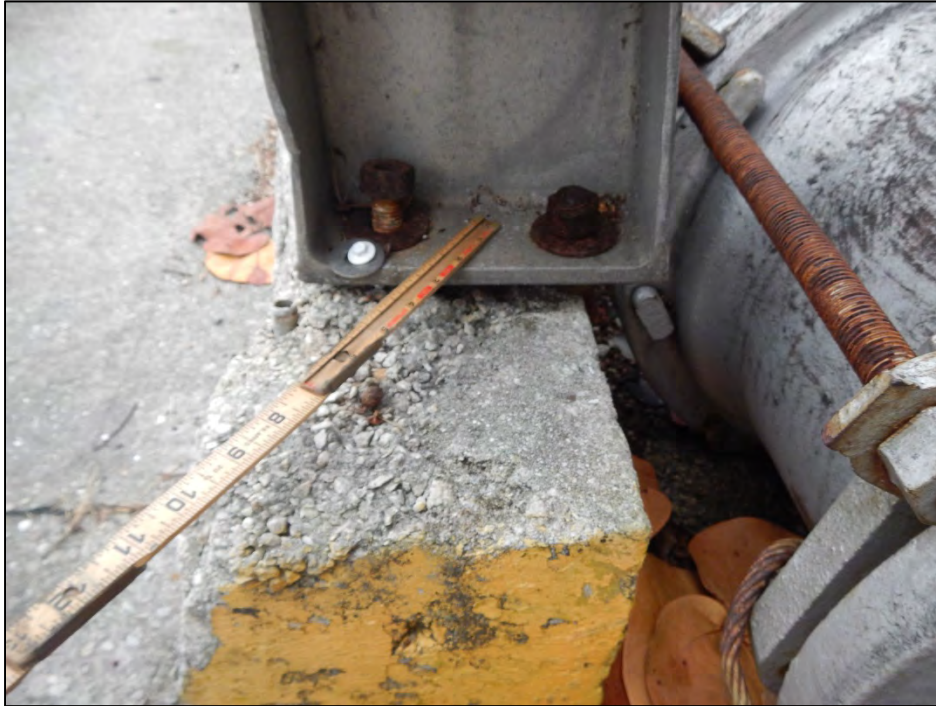
Photo 9 – East railing Post 1 has an improper repair.

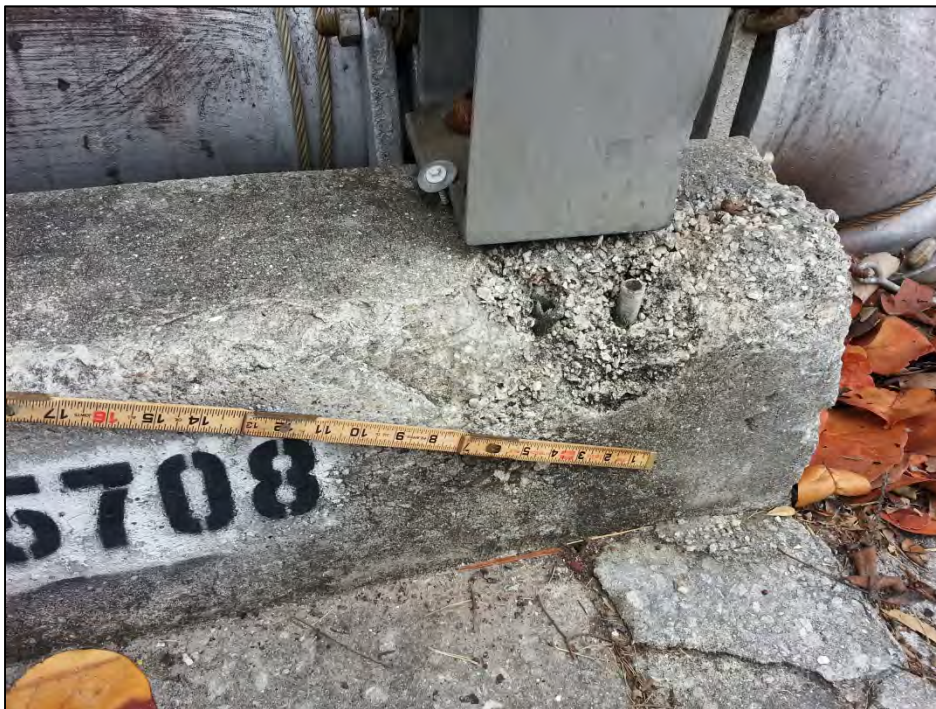
Photo 10 – East railing has a spall with exposed steel at the south end.

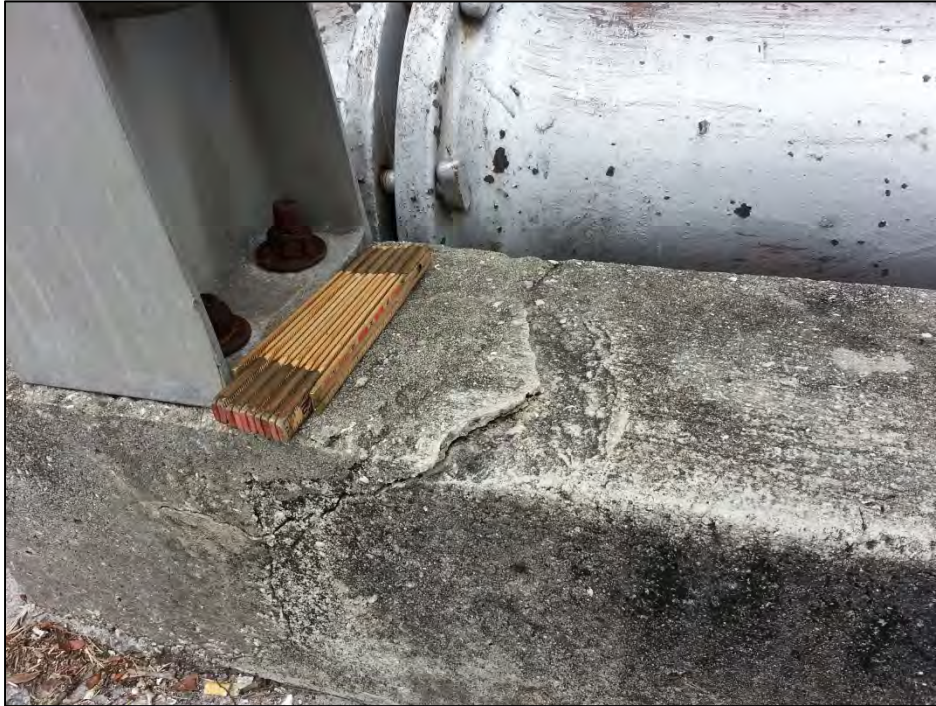
Photo 11 – East railing has a delamination at the north end.

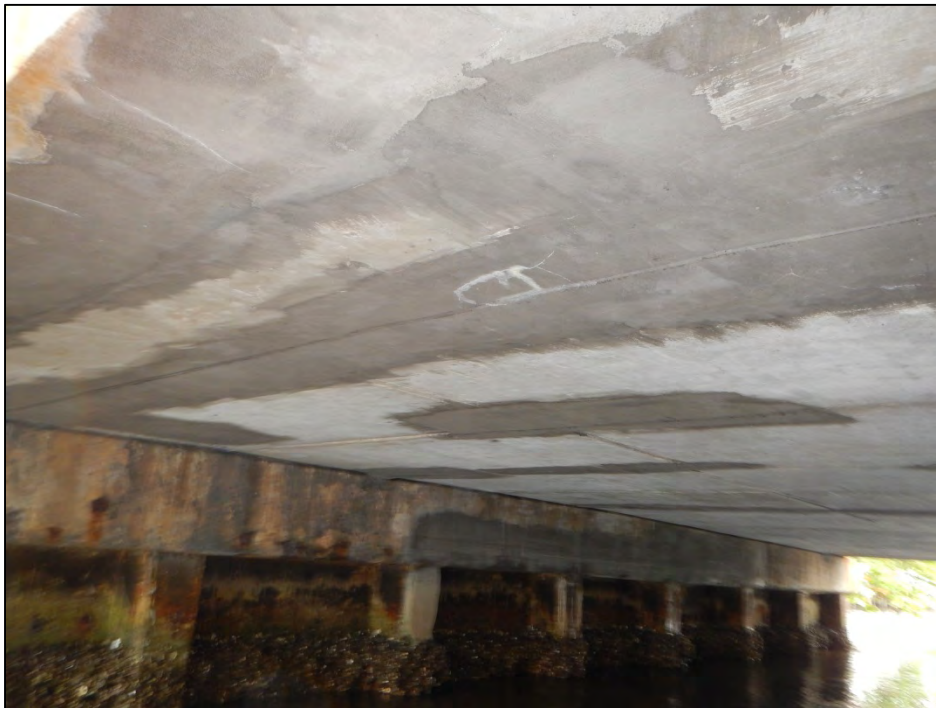
Photo 12 – Typical repaired areas at deck underside and abutment cap.

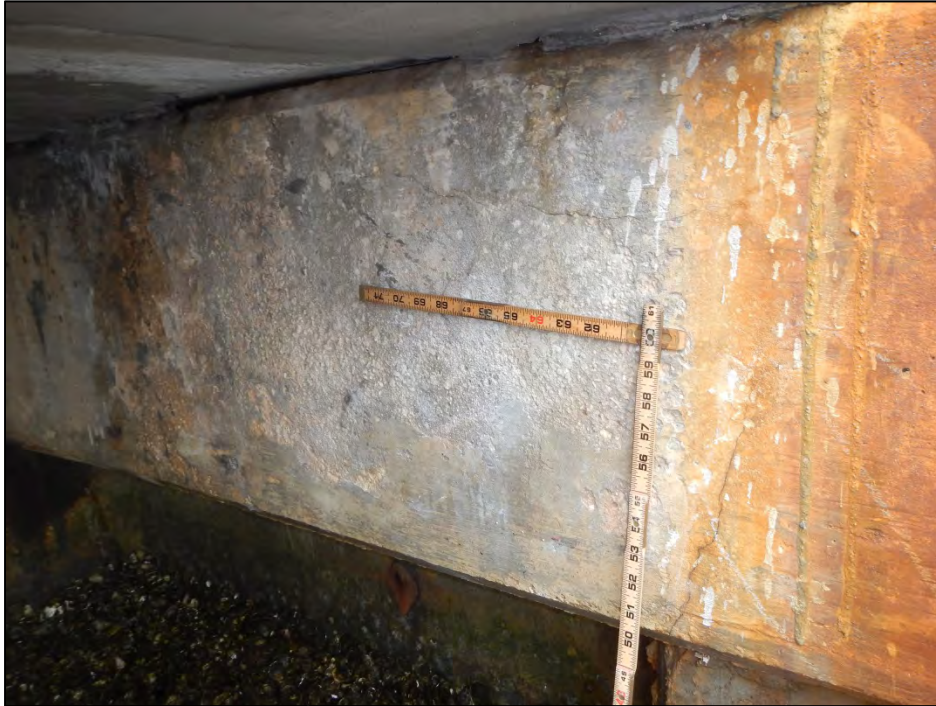
Photo 13 – Abutment I cap has a horizontal crack at the east end.

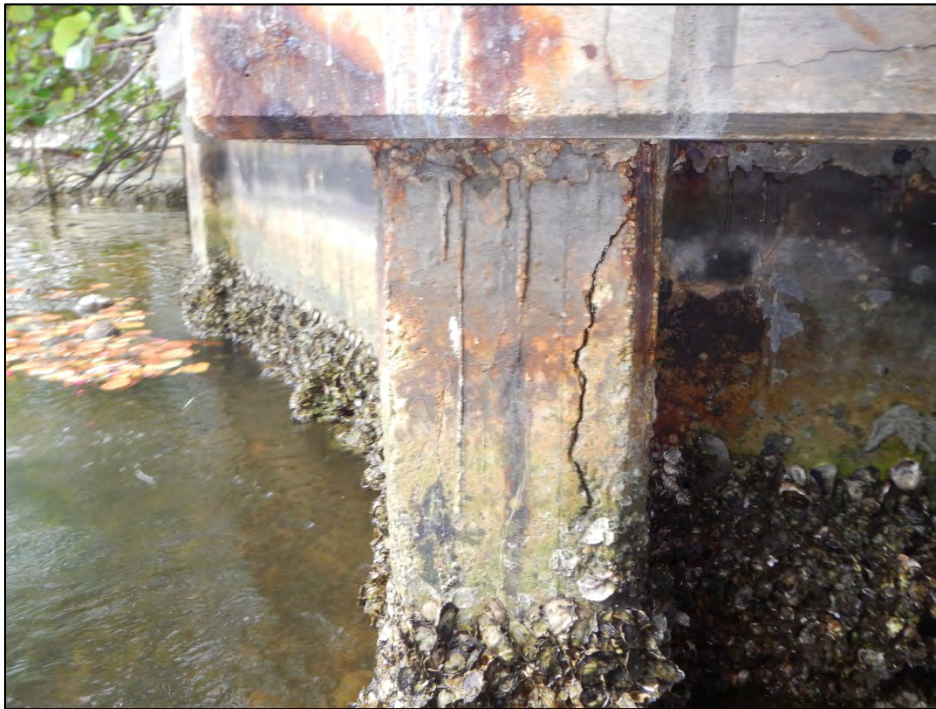
Photo 14 – Pile I-8 exhibits a vertical crack.

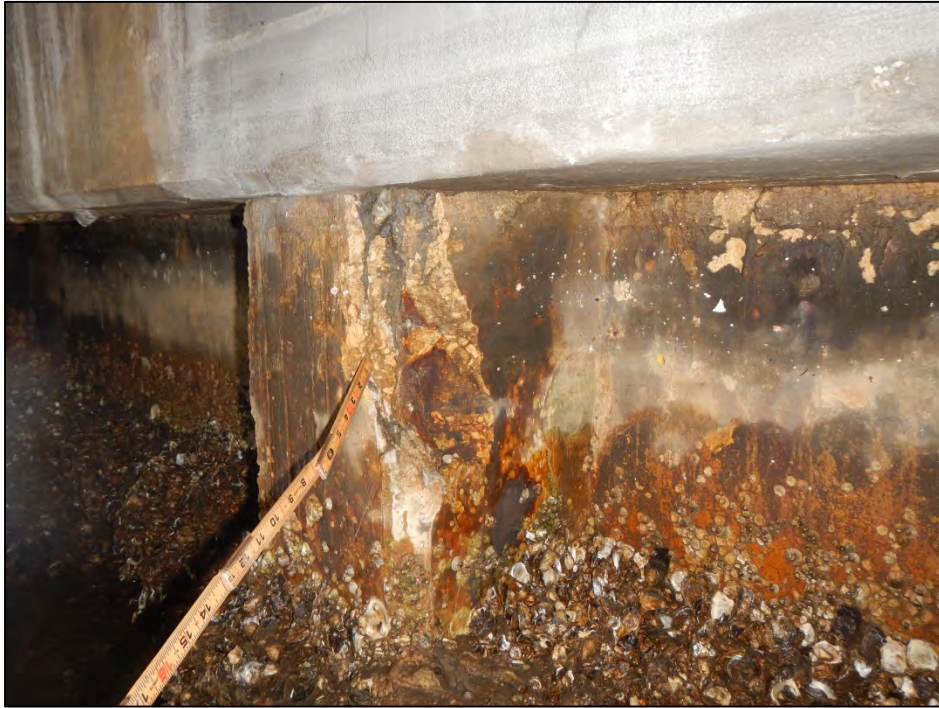
Photo 15 – Pile 2-4 exhibits a spall with corroded exposed steel.

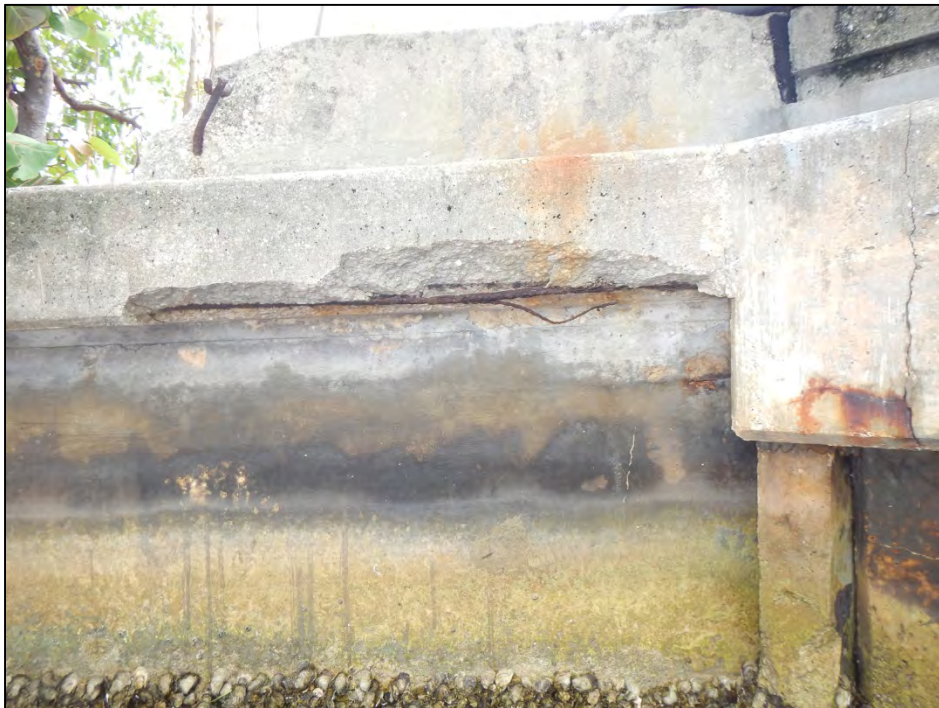
Photo 16 – Southeast wingwall cap exhibits a spall with exposed steel.

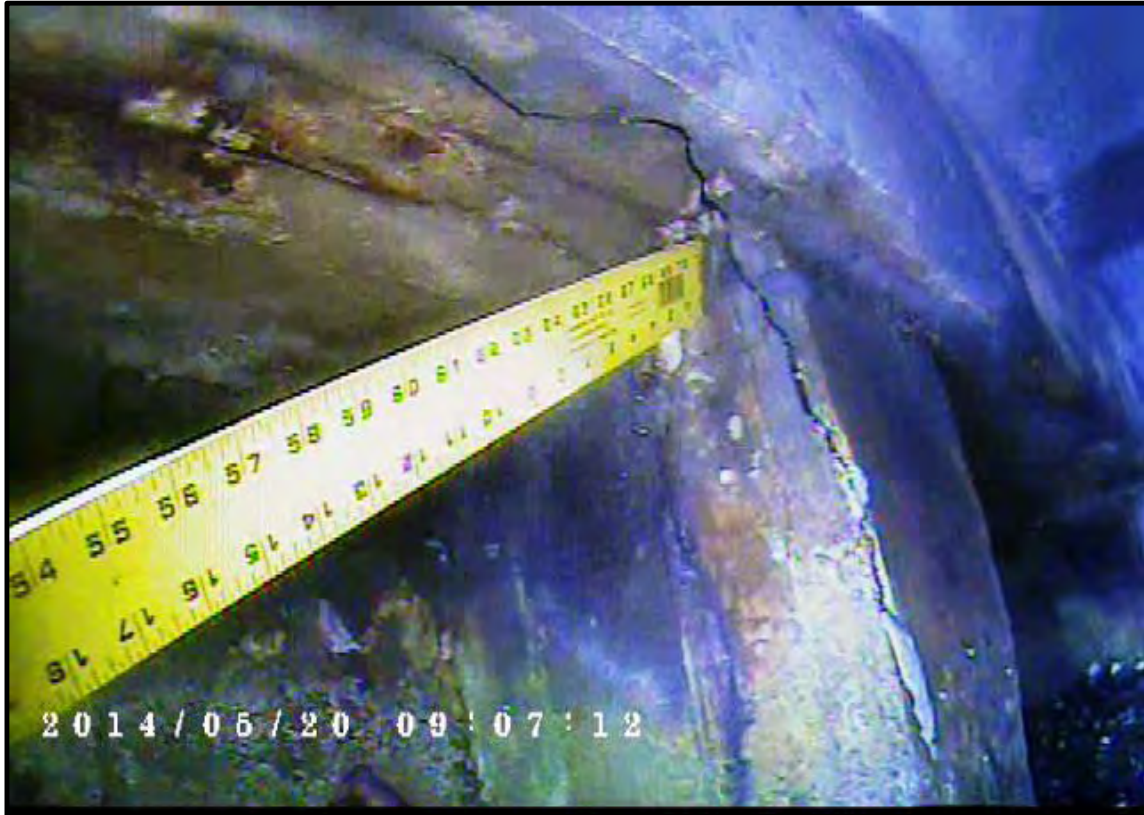
\_All sixteen piles have a 3' high band of deterioration from the cap down. These deterioration generally consists of vertical cracks up to 1/4" wide, outlining spalls/delaminations in the corners of the piles with heavy corrosion bleed-out. **INCREASE**

\_Pile 1-2, typical cracking on piles. **UW Photo 01.**

Description: Top: Pile 1-2, typical cracking on piles. **UW Photo 01.**

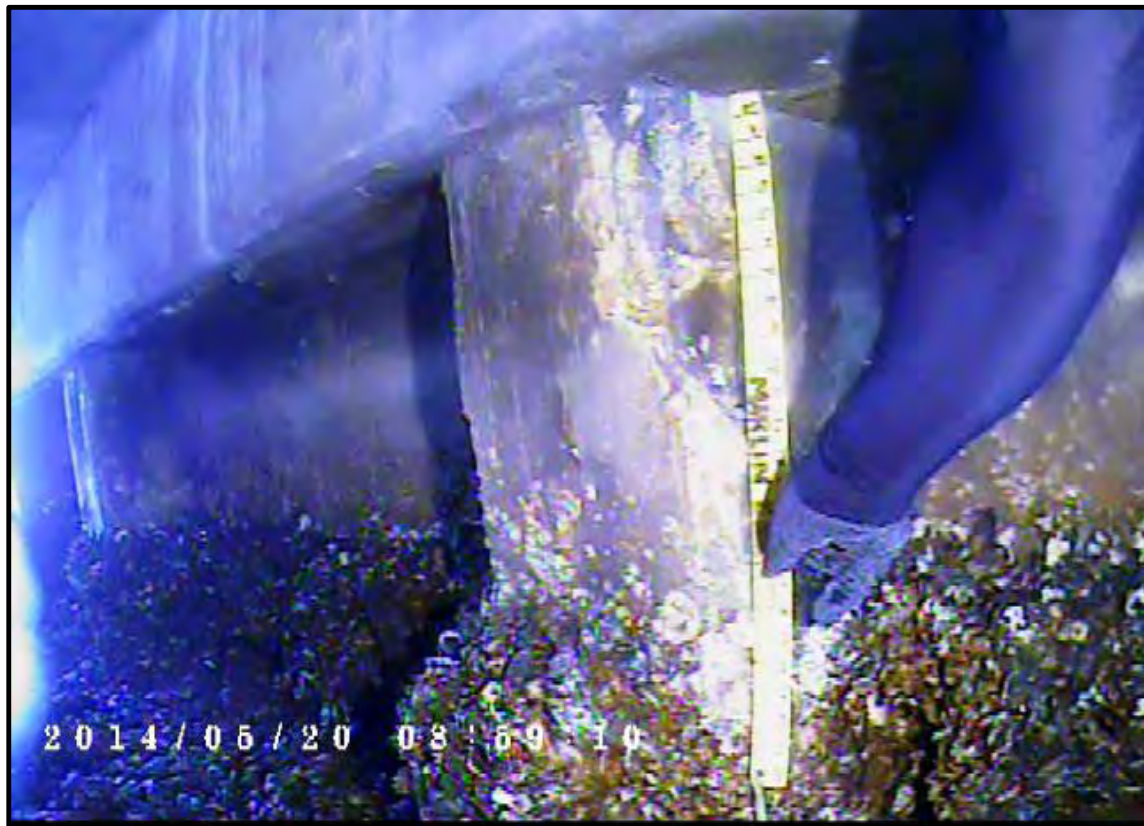
\_Pile 2-4, spall/delamination with exposed rebar. **UW Photo 02.**

Bottom: Pile 2-4, spall/delamination with exposed rebar. **UW Photo 02.**

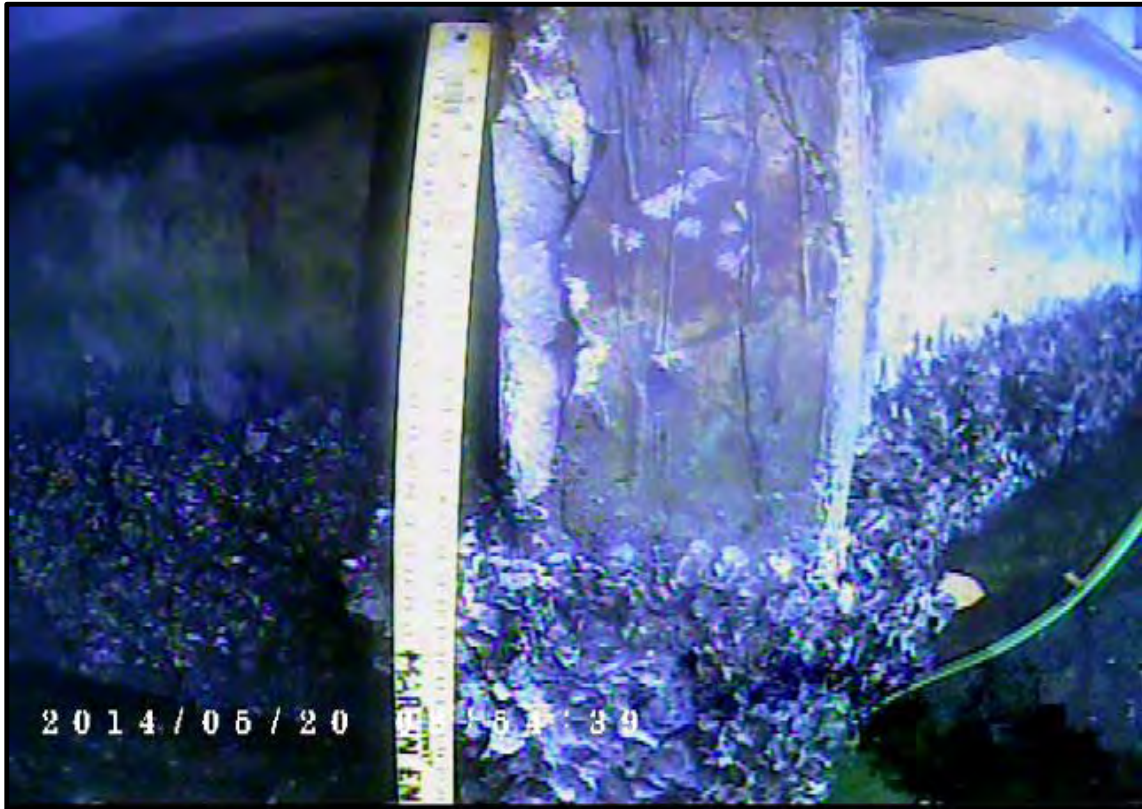
\_Pile 2-8, spall/delamination with exposed rebar. **UW Photo 03.**

Description: Top: Pile 2-8, spall/delamination with exposed rebar. **UW Photo 03.**  
Bottom: Abutment backwalls have random areas of cracking with CBO. **UW Photo 04.**

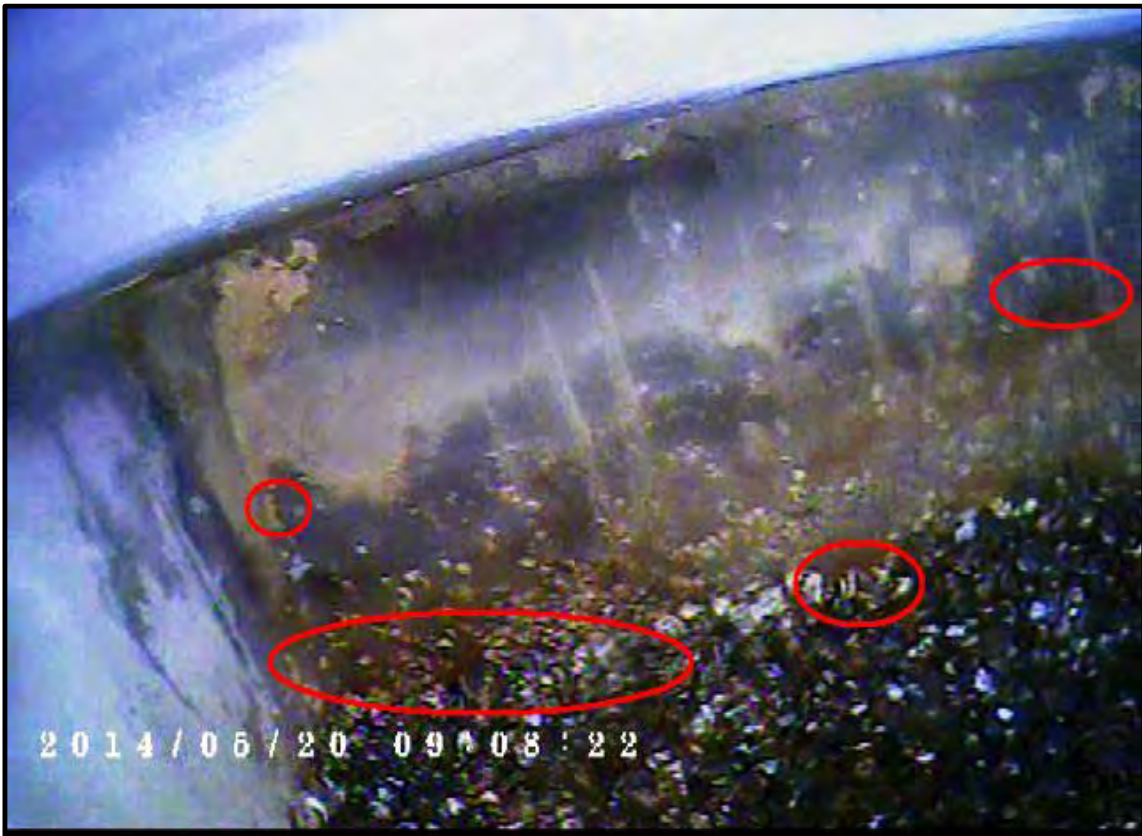
\_Both abutment backwalls exhibit random areas of hollow sound and cracking up to 1/32" wide with areas of corrosion bleed-out. **UW Photo 04. INCREASE**

\_Both backwalls have delaminations up to 12" x 12", and cracking up to 1/16"W with corrosion bleed-out.

\_Repair the spall at the SE retaining wall cap and delaminations at both backwalls as needed.

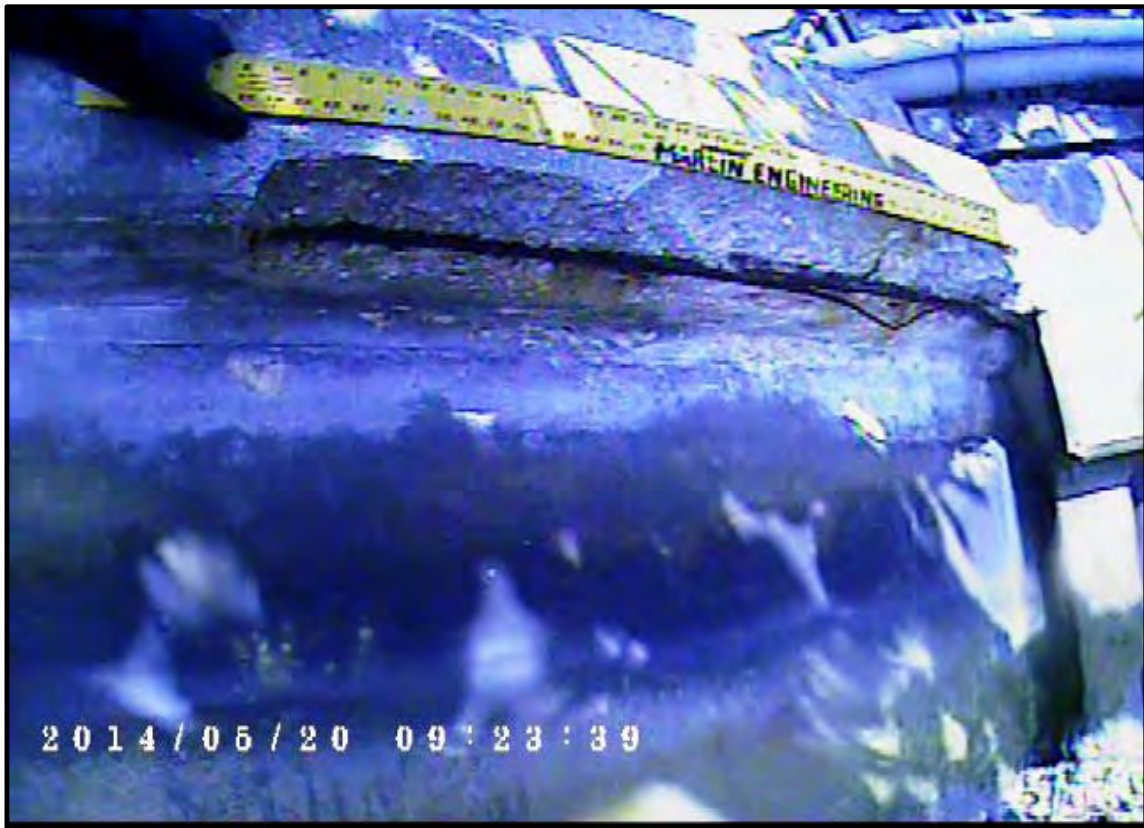
\_SE retaining wall cap has a spall 42" x 9" x 3-1/2", with (1) exposed rebar 100% section loss.

Description: SE retaining wall cap, spall with exposed rebar 100% section loss. **UW Photo 05.**

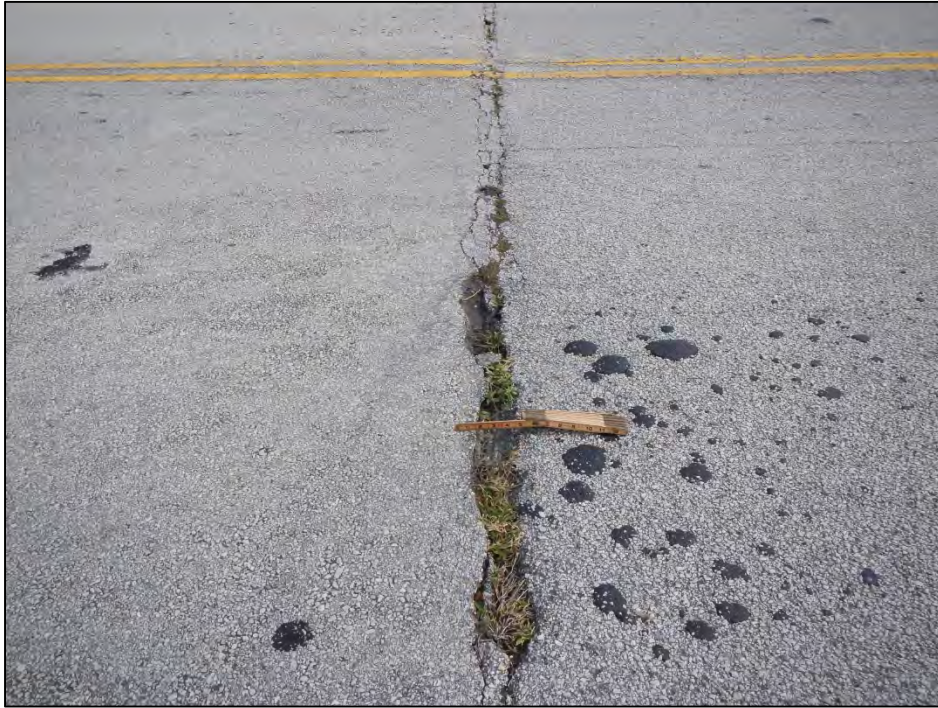
Photo 1 – End Bent 1 joint seal transverse crack.

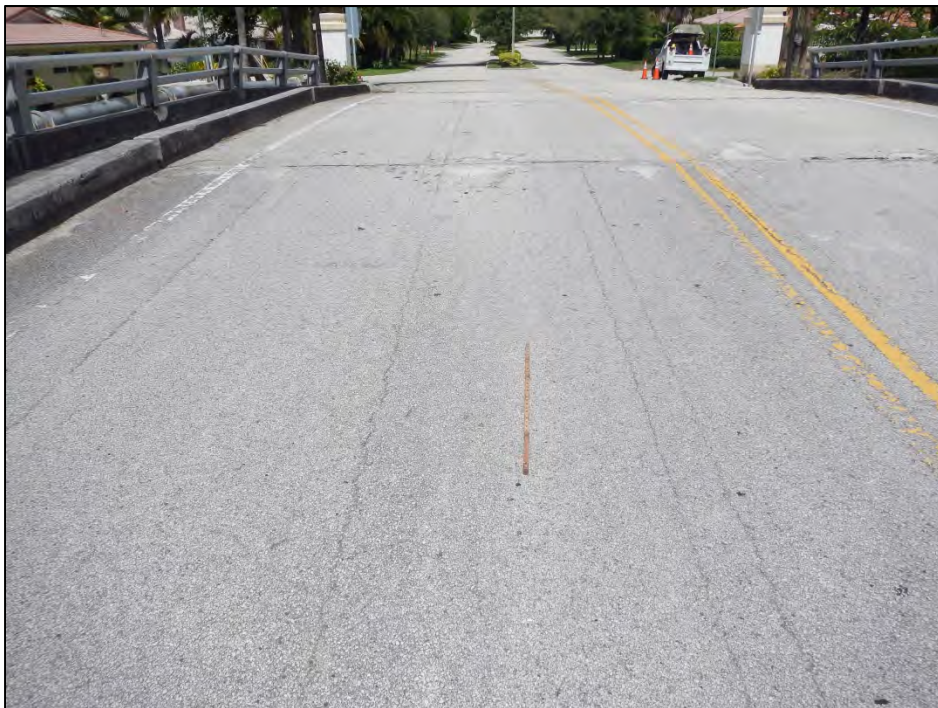
Photo 2 – Deck top longitudinal cracks.

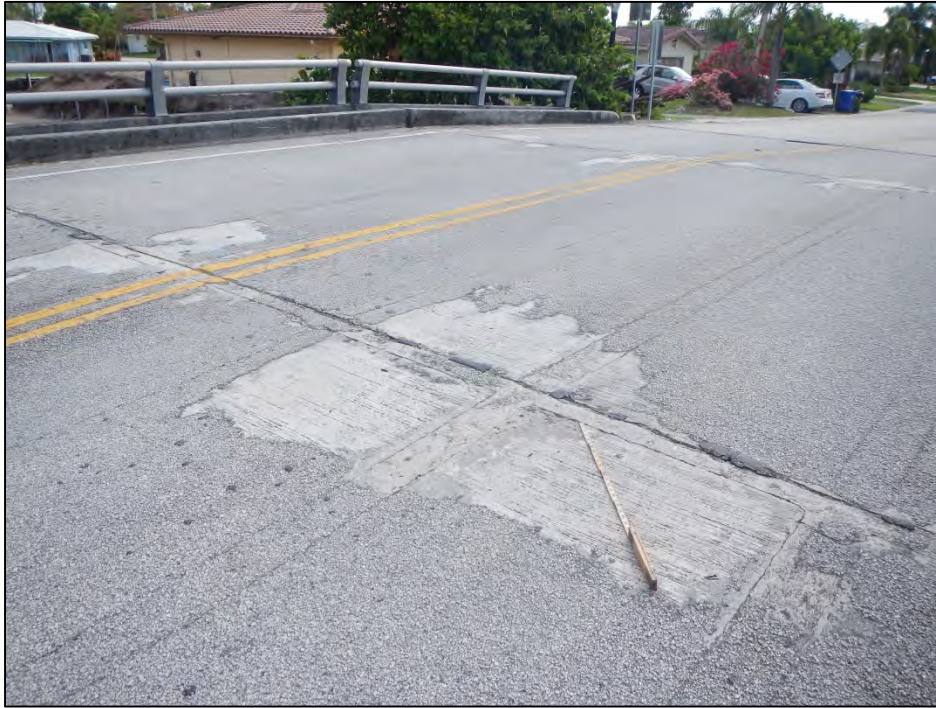
Photo 3 – Disintegrated asphalt over Bent 2.

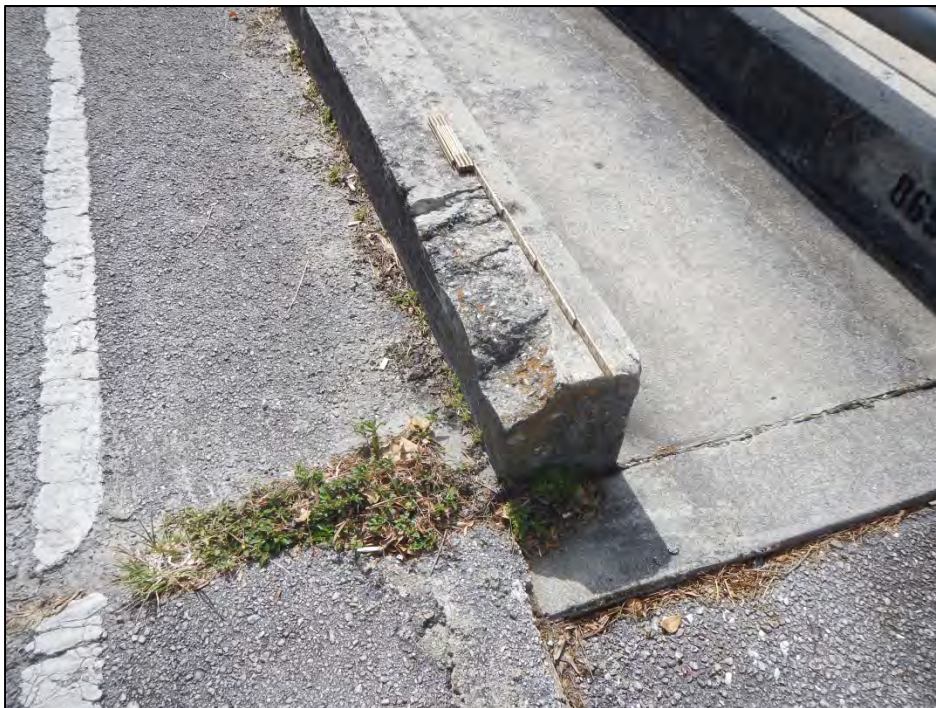
Photo 4 – The south curb over End Bent 1 exhibits a spall.

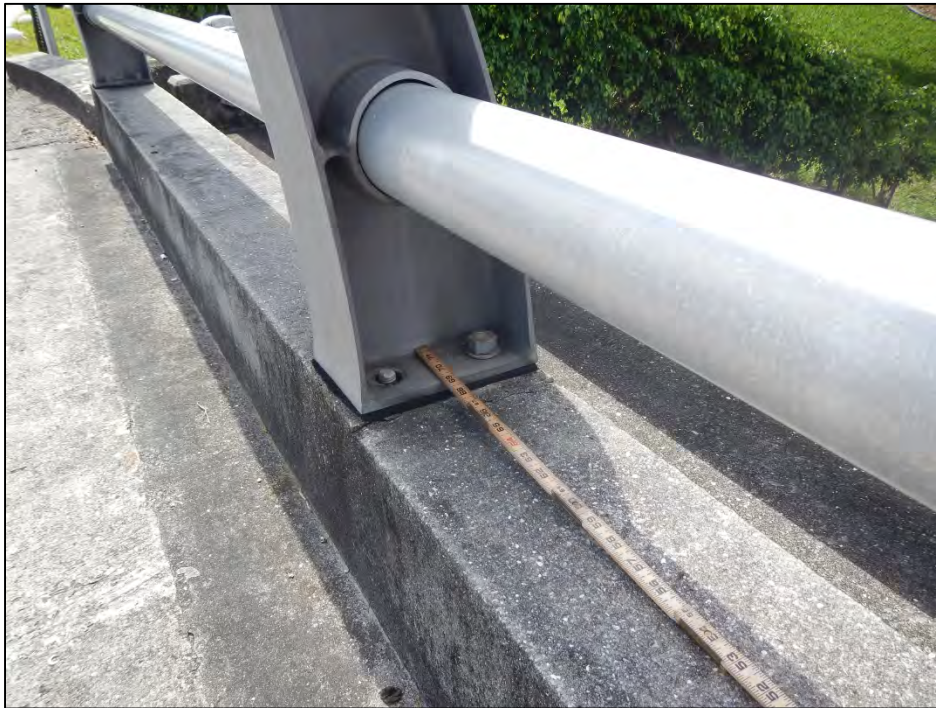
Photo 5 – Post 3-2 Right is missing an anchor bolt nut.

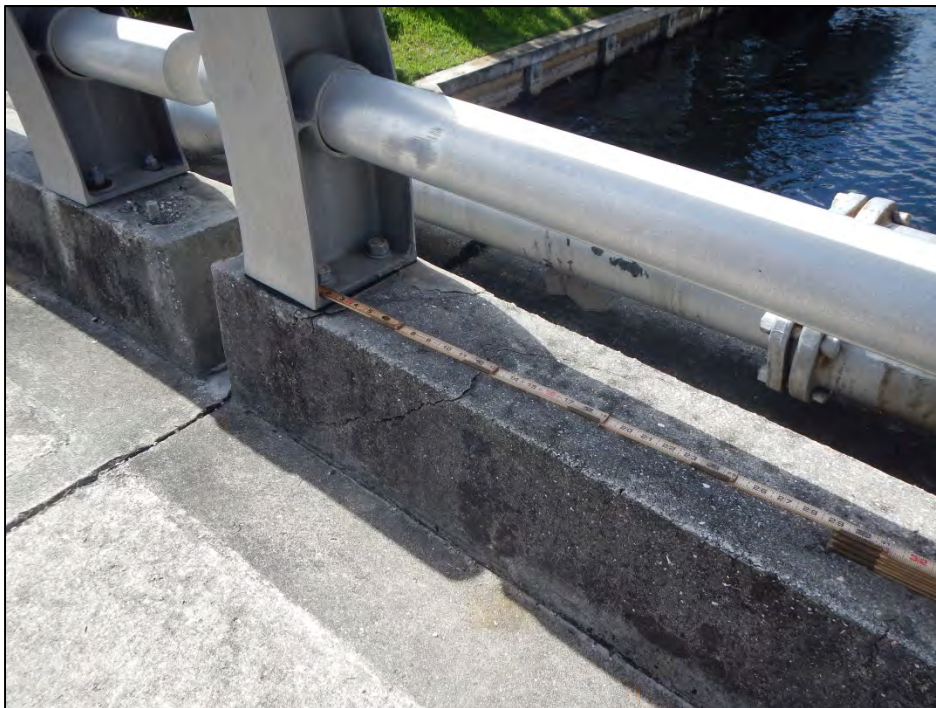
Photo 6 – Delamination at Post 2-3 Right.

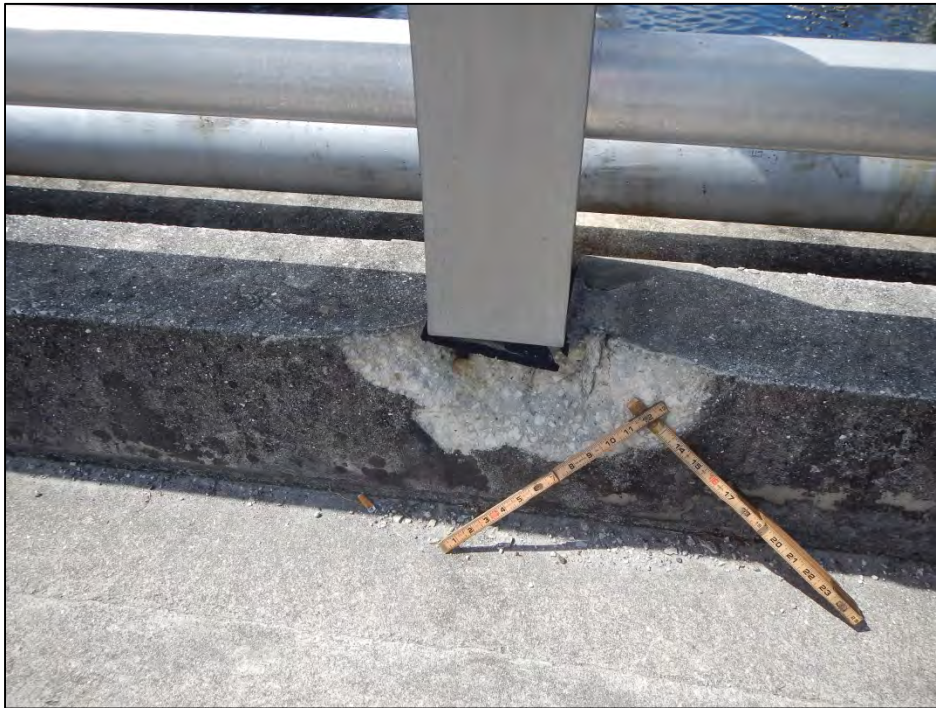
Photo 7 – Spall with exposed steel below Post 2-2 Right.

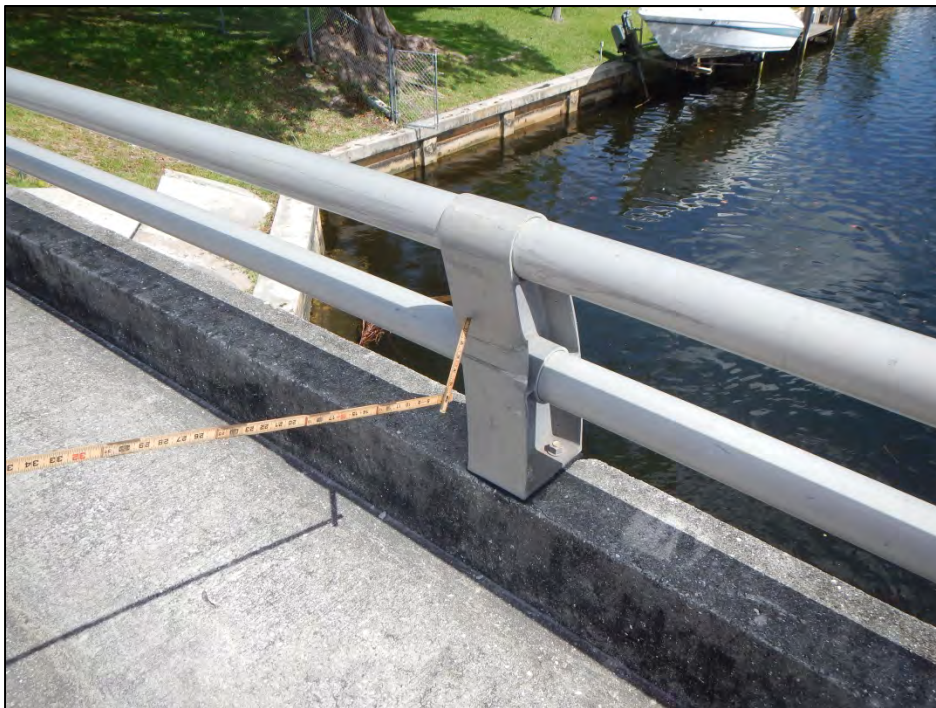
Photo 8 – Post 2-2 Left exhibits impact damage.

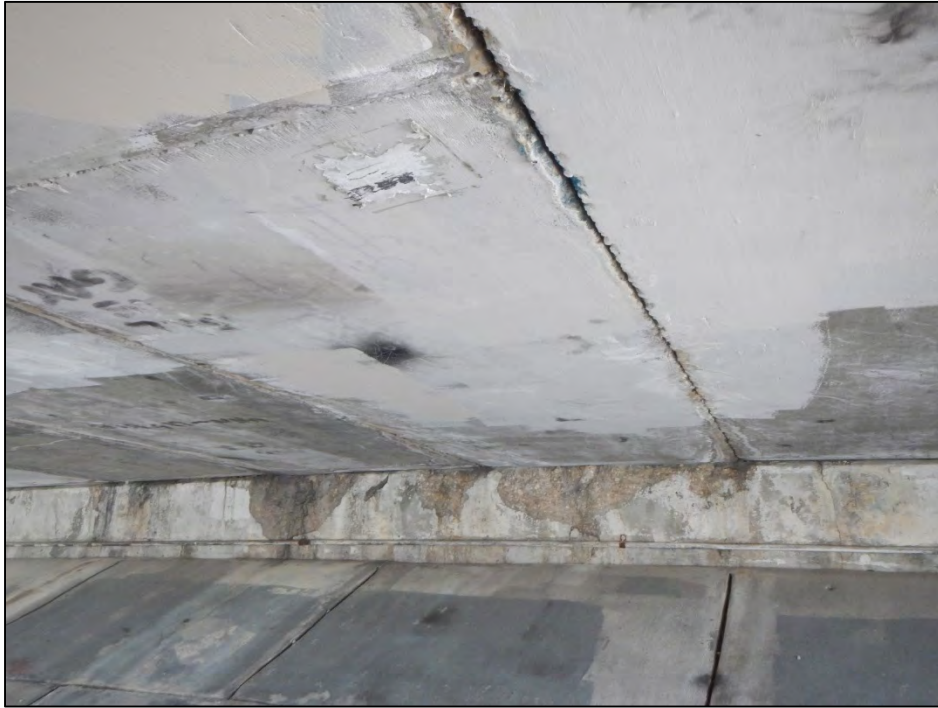
Photo 9 – End Bent 1 cap exhibits spalls between Slab Units 1-5 and 1-7.

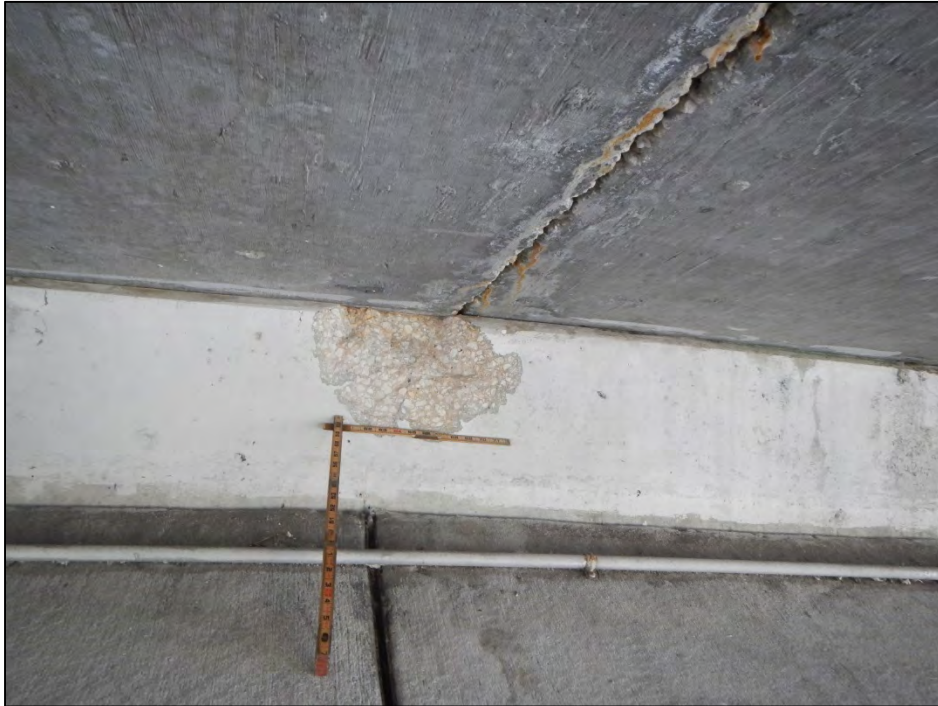
Photo 11 – End Bent 4 cap exhibits a spall between Slab Units 3-7 and 3-8.

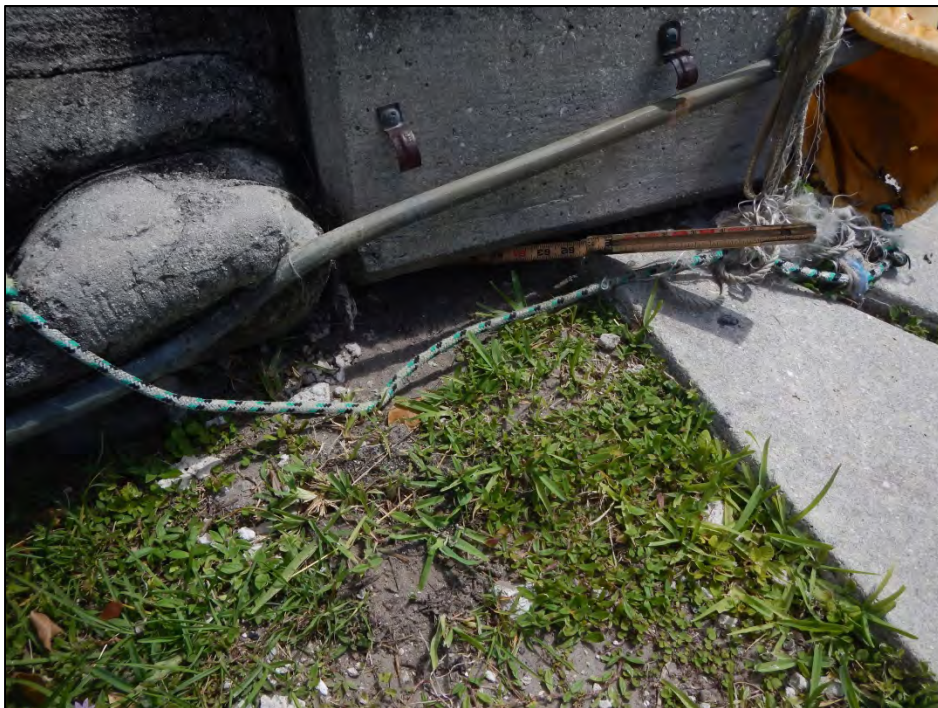
Photo 12 – The south end of End Bent 1 cap is undermining.

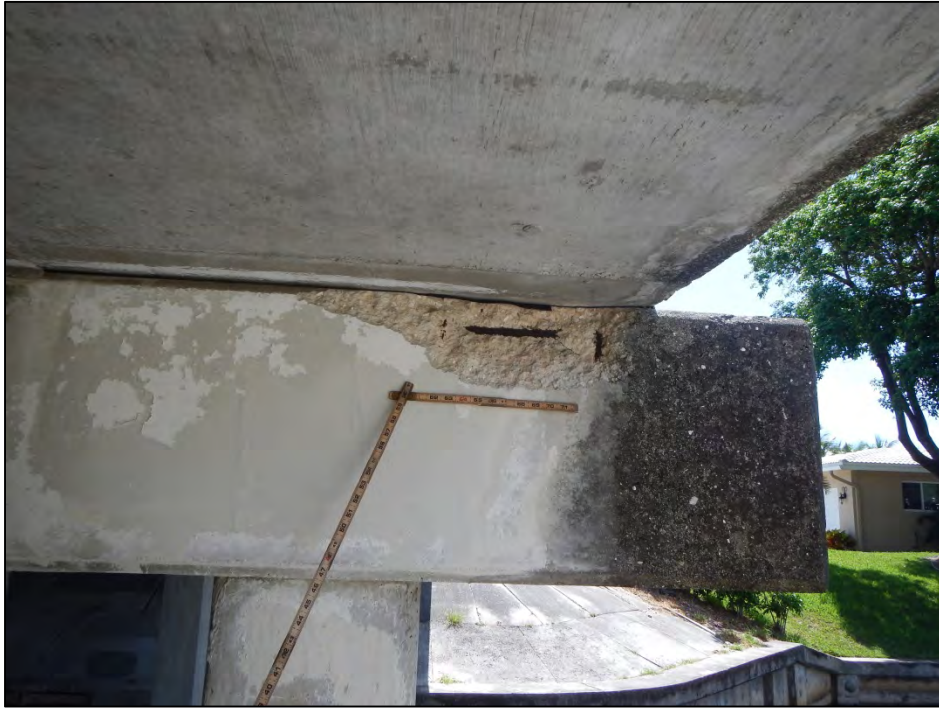
Photo 13 – The south end of Bent 2 cap exhibits a spall with exposed steel.
