## **EXECUTIVE SUMMARY**

TranSystems has been retained by the City of Fort Lauderdale to perform bridge inspections and prepare bridge inspection reports for each of the City's bridges as part of the project Structural Bridge Engineering Consulting Services Master Plan, RFQ No. 946-11310. Inspections were completed and reports prepared for 46 of the City's bridges. The remaining five bridges in the City's inventory were not inspected because they are in the process of being replaced.

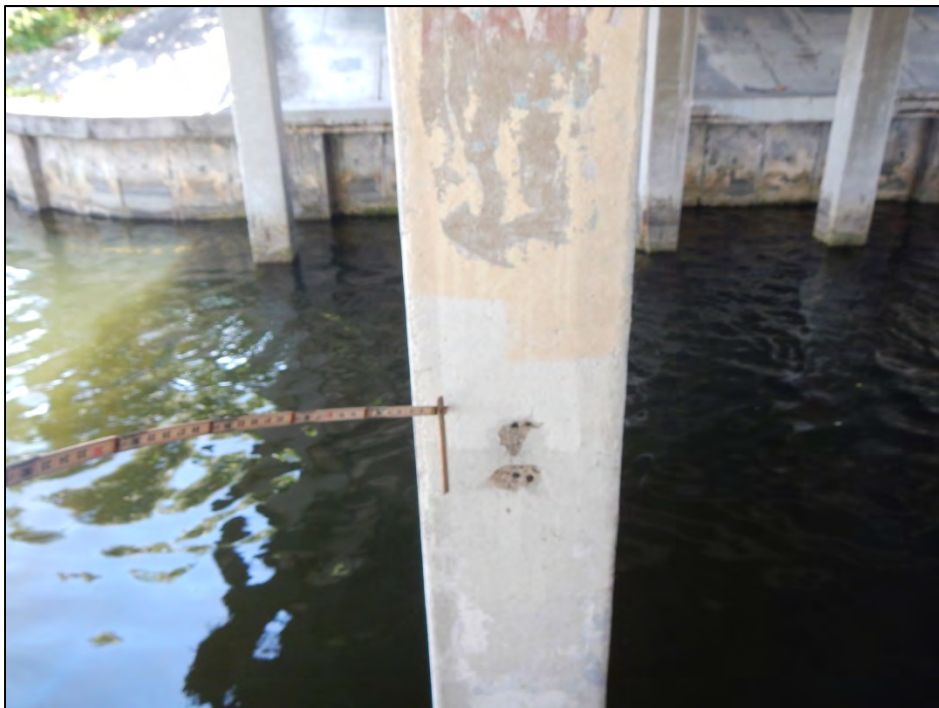
Photo 14 – The west face of Pile 2-2 exhibits a popout.

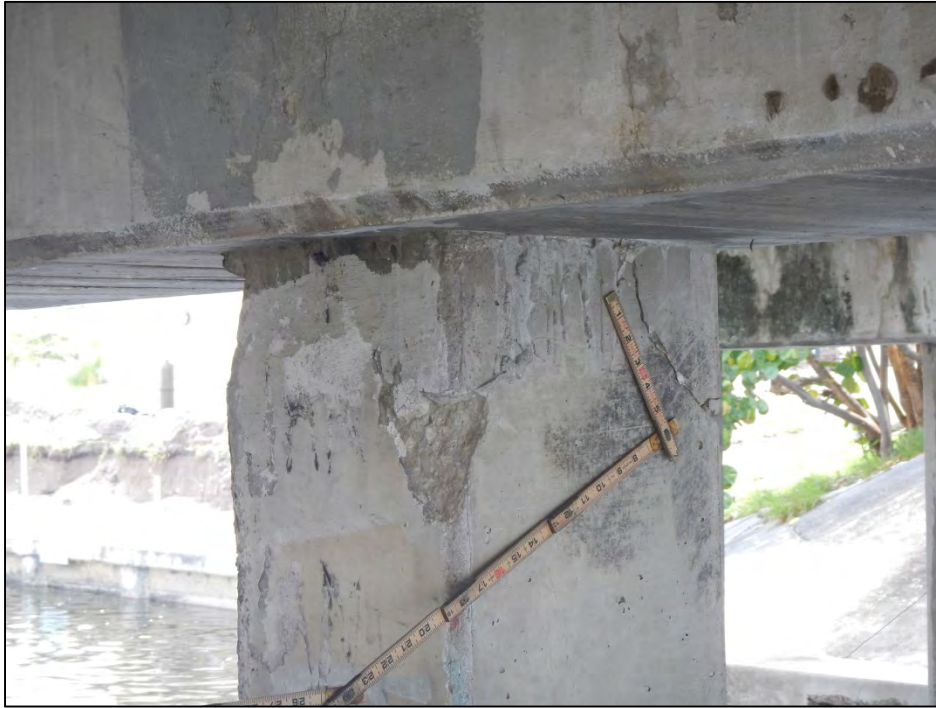
Photo 15 – Pile 2-4 adjacent to the cap exhibits spalls/delaminations.

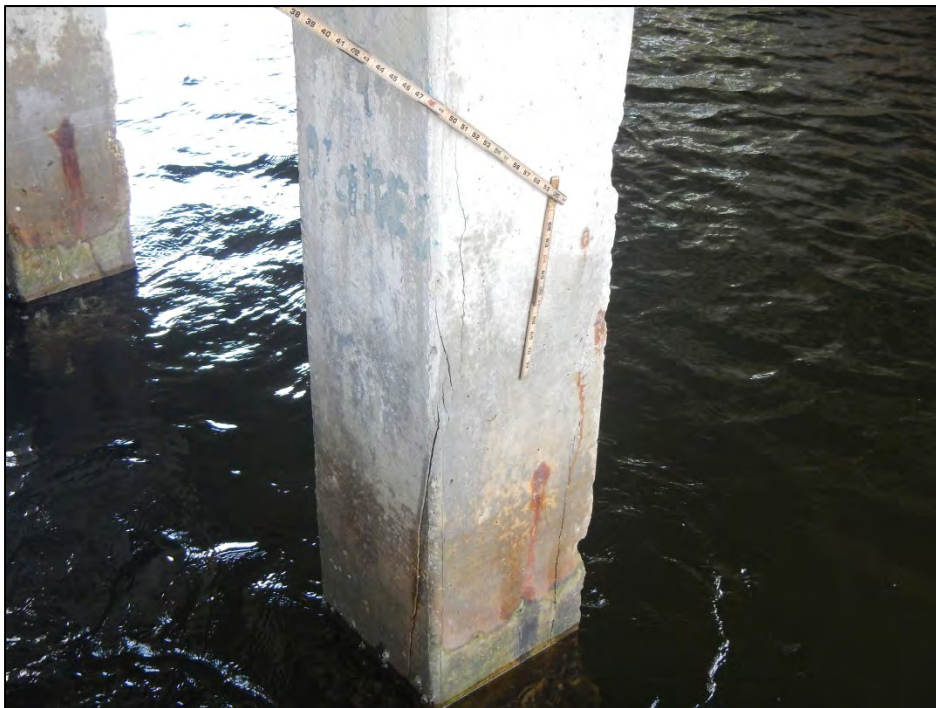
Photo 16 – The southeast and southwest corners of Pile 2-5 exhibit spalls/delaminations.

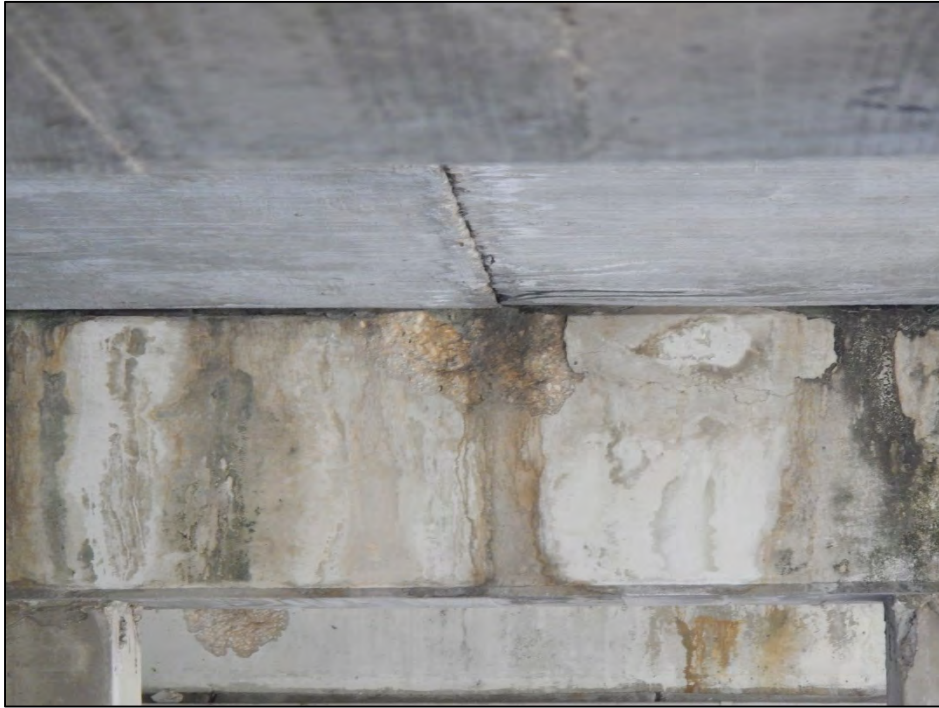
Photo 17 – Bent 3 cap exhibits a spall between Slab Units 2-8 and 2-9.

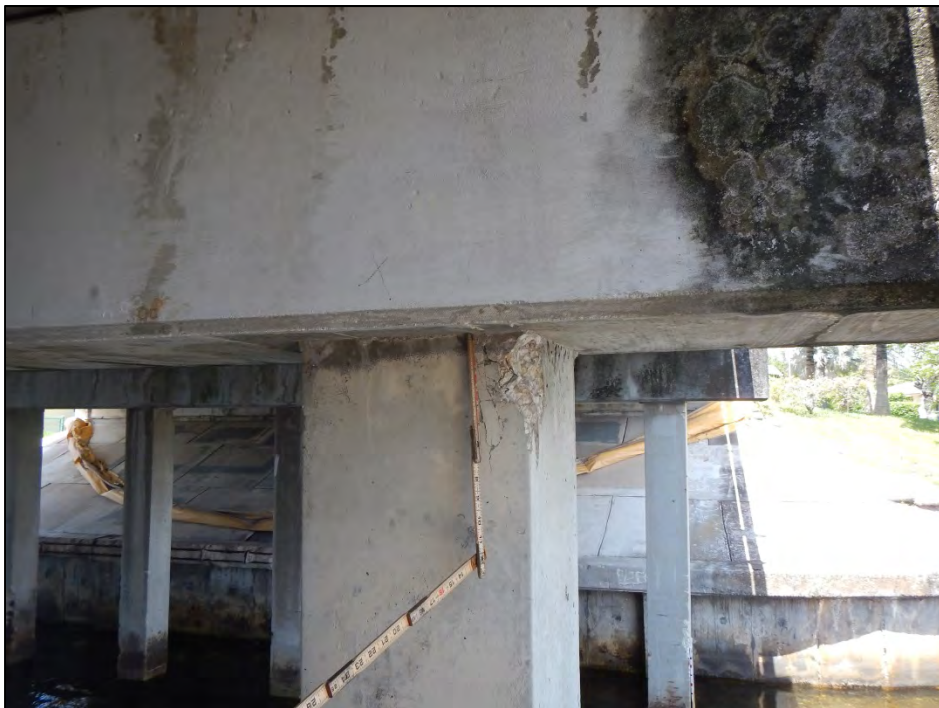
Photo 18 – The northeast corner of Pile 3-1 exhibits a spall.

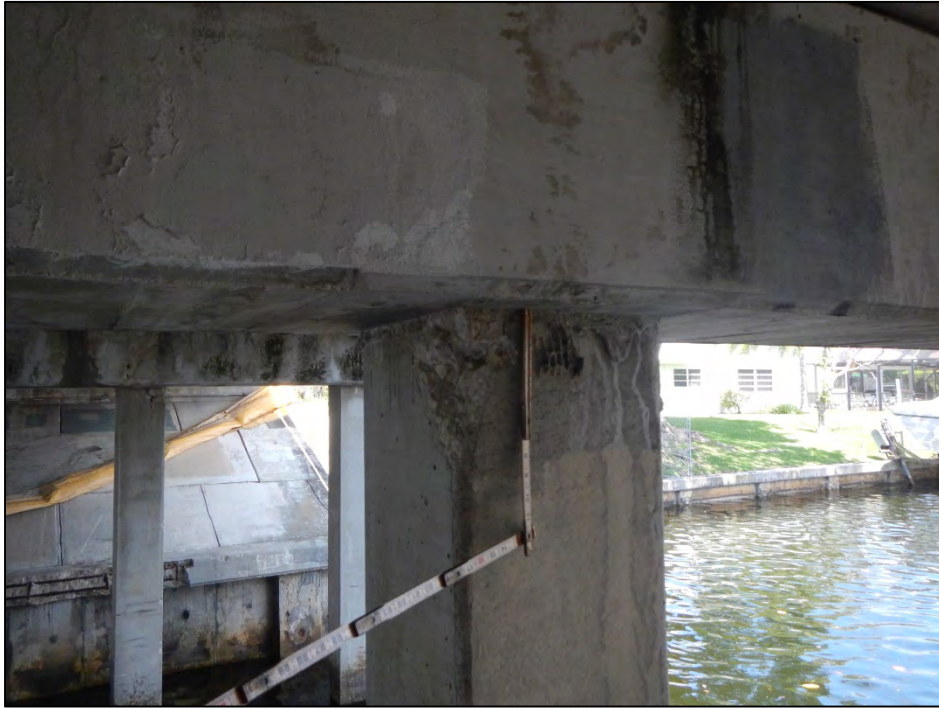
- Pile 3-2, southeast corner, adjacent to cap, 9 in. x 8 in. x 2 in. spall/delamination. See Condition Photo 19.
- The northwest corner of Pile 3-3, 8 ft. below the cap, has a 5 ft. x 8 in. x 3 in. spall with an exposed prestressed cable with 100% section loss. Also, in the northeast corner, 9 ft. below the cap, there is a 2 ft. x 8 in. delamination with corrosion staining.

Photo 19 – The southeast corner of Pile 3-2 exhibits a spall.

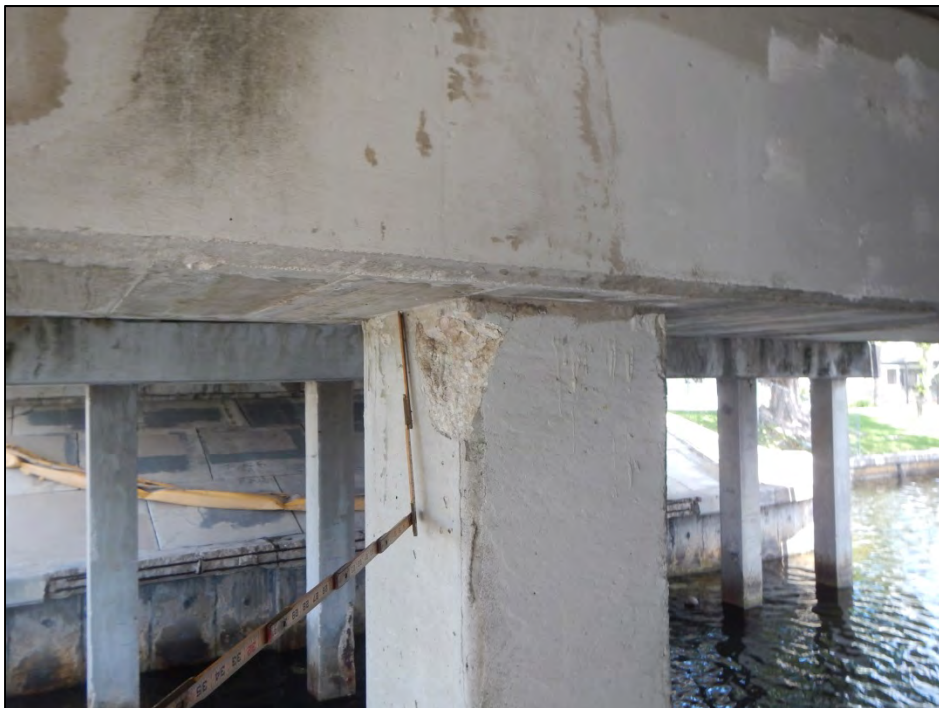
- Pile 3-6, southeast and northwest corners, adjacent to cap, there are up to 8 in. x 8 in. x  $1\frac{1}{2}$  in. spall/delaminations with exposed steel. See Condition Photo 20.

Photo 20 – The southeast corner of Pile 3-6 exhibits a spall.

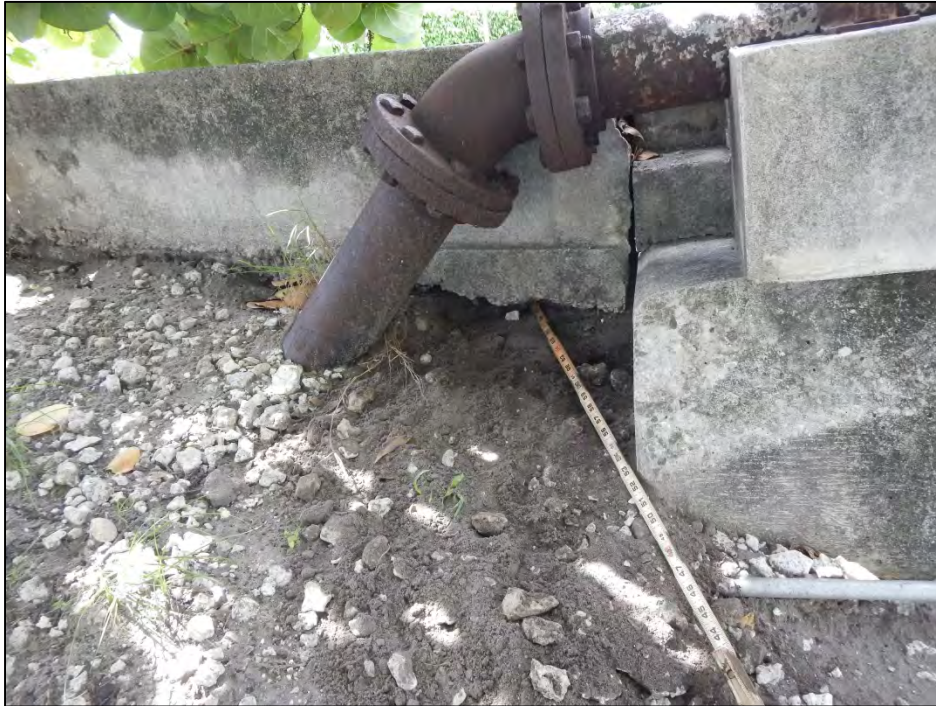
- There is a 2 ft. long x 1 in. high x more than 3 ft. deep under area of undermining at the north side of the east approach slab at Abutment 4 and the sidewalk. See Condition Photo 21.
- The longitudinal joints between the approach slab and the northeast and northwest approach sidewalks are not sealed. See Condition Photo 22 and 23.

Photo 21 – Northeast corner approach slab undermining.

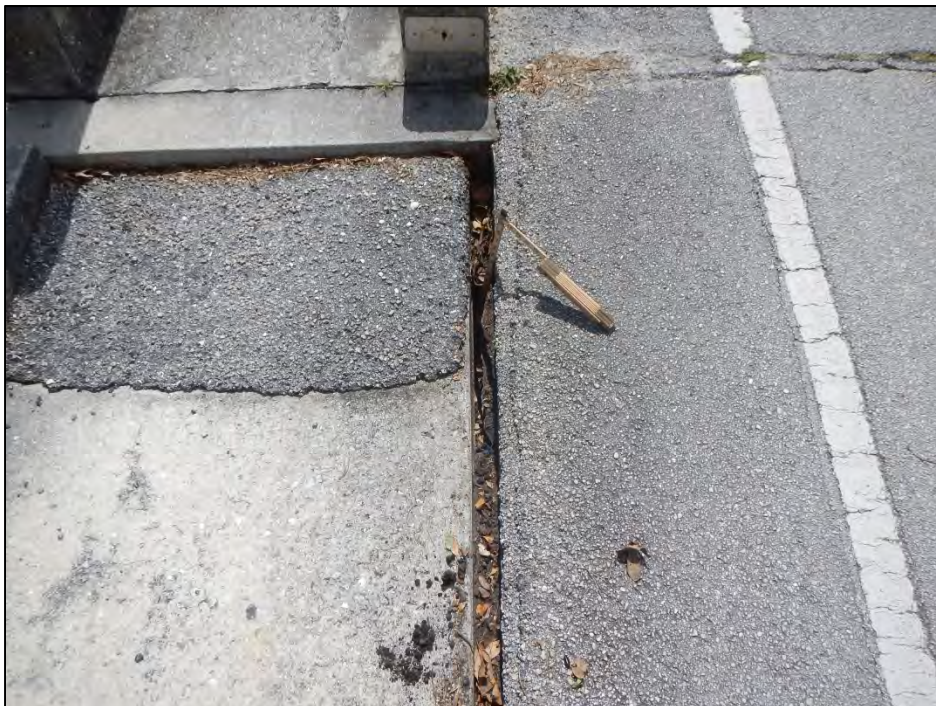
Photo 22 – Northwest approach slab between the sidewalk is not sealed.

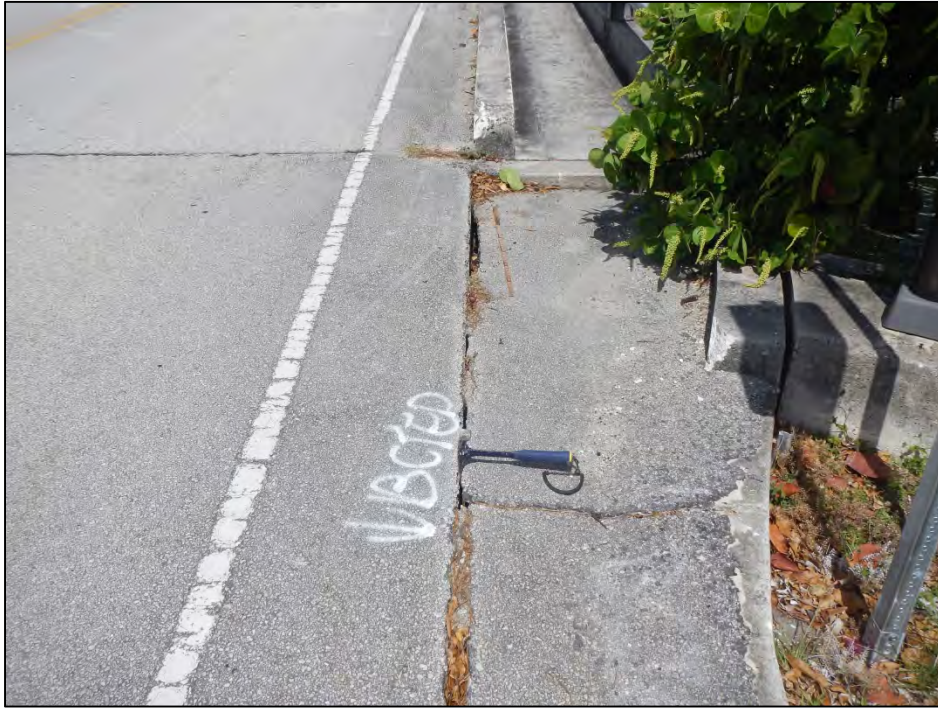
Photo 23 – Northeast approach slab between the sidewalk is not sealed.

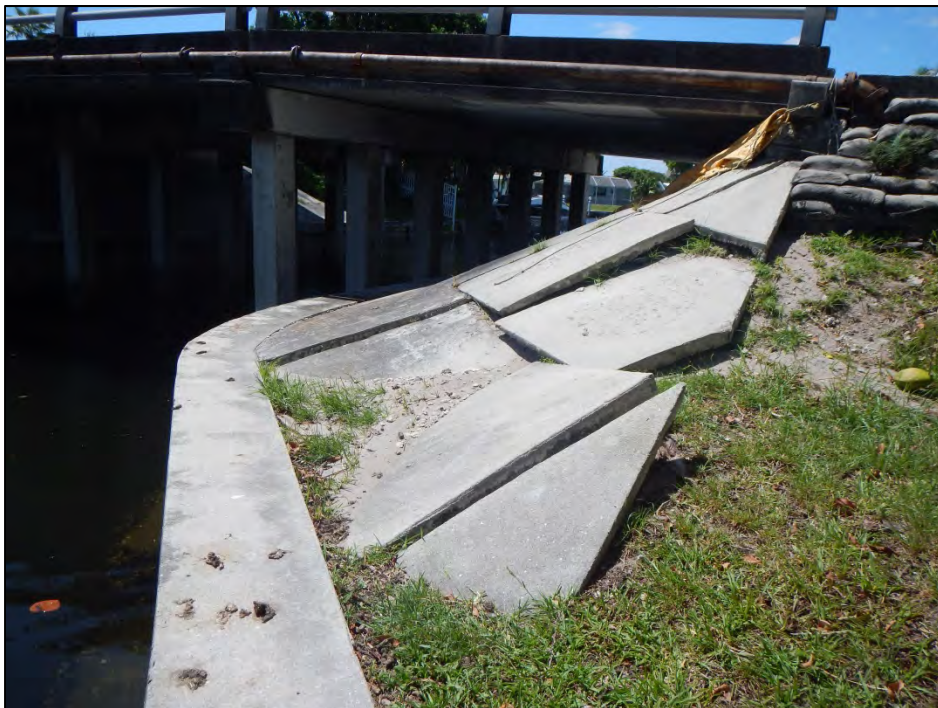
- Sections of the concrete slope pavement throughout the northwest slope are displaced, undermined, missing and have up to 6 in. of settlement. See Condition Photo 24.
- Several sections under Span 3 have settled up to 5 in. and exhibit a hollow sound. See Condition Photo 25.
- The undermining and settlement of the west slope pavement is apparently due to fill loss through the sheet pile joints of the seawall.
- The joints in the concrete slope pavement are not sealed.
- The northeast radius area is overgrown with vegetation.

Photo 24 – Northwest slope protection displacement.

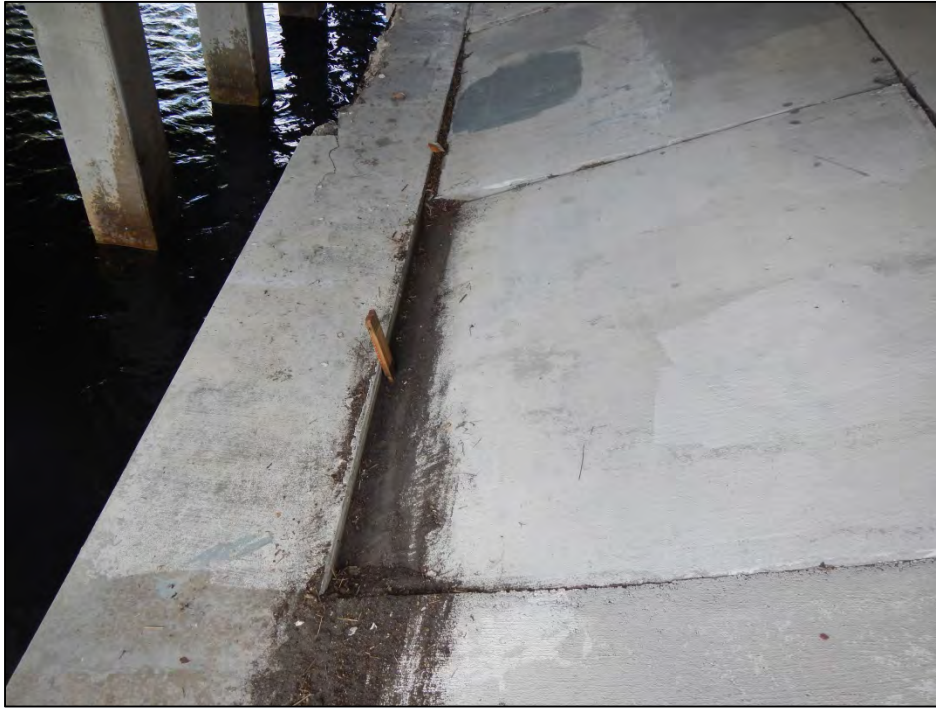
Photo 25 – Slope protection under Span 3 settlement.

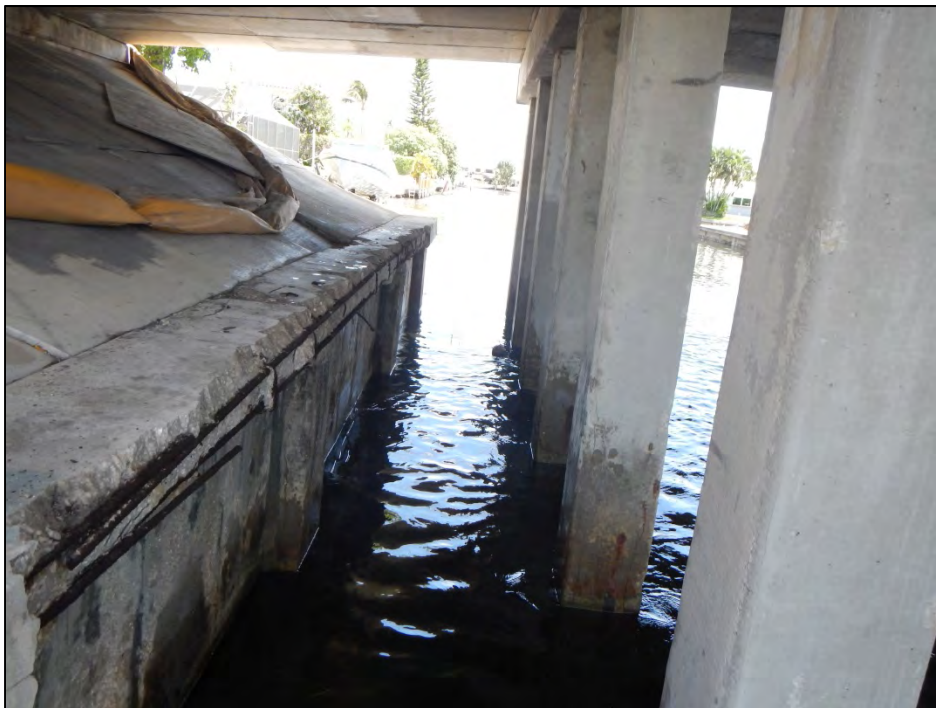
- There is light pitting and corrosion of the steel sheet pile walls.
- The west and east bulkhead caps have an up to 40 ft. x 10 in. x 3 in. spall/delaminations with exposed steel below the bridge. Previously noted as 35 ft. long. See Condition Photo 26 and Underwater Inspection Report Photo 5.
- The bulkhead piles, caps and sheet piles have up to  $\frac{1}{16}$  in. wide vertical and horizontal cracks, some with corrosion bleedout.
- The sheet piling of the bulkheads have heavy scale damage. See Underwater Inspection Report Photo 6.

Photo 26 – West bulkhead cap at End Bent I exhibits a spall/delamination with exposed steel.

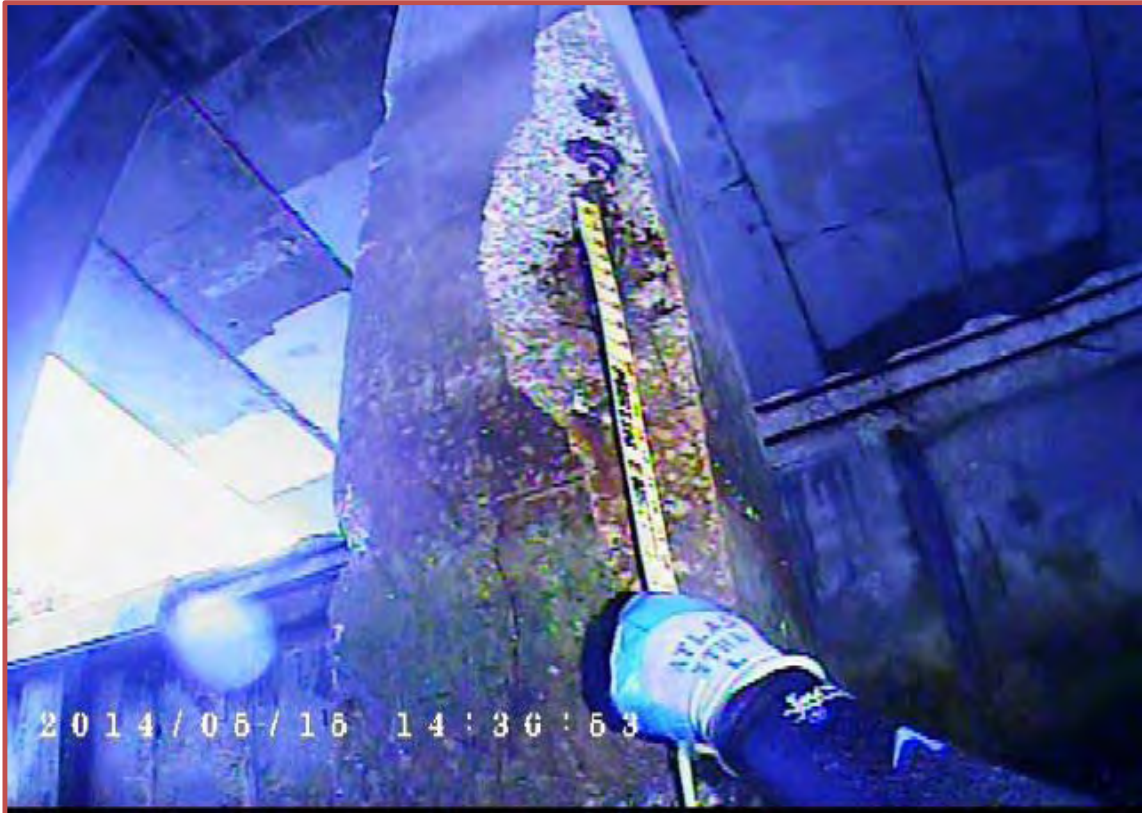
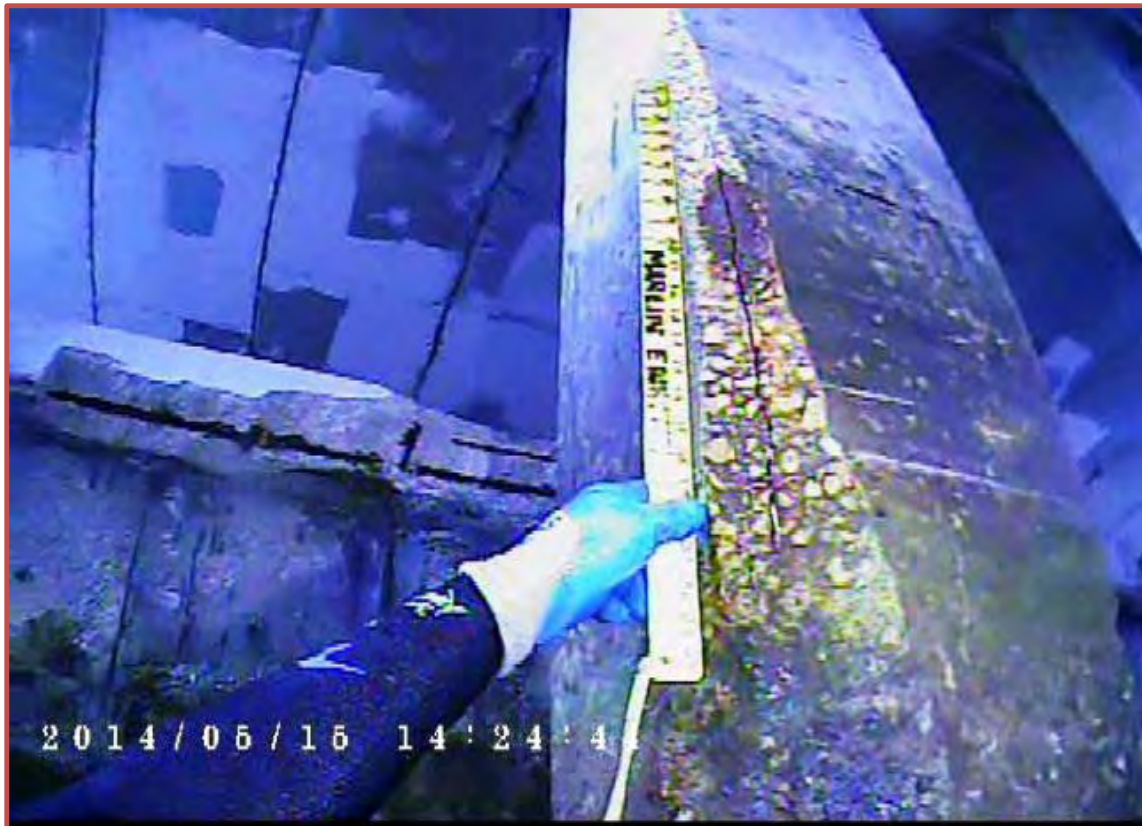
Description: Top: Pie 2-5, All faces spall/delamination, exposed pre-stressed strand. **UW Photo 01.**  
Bottom: Pile 3-3, NW corner spall/delamination starting at the cap. **UW Photo 02.**

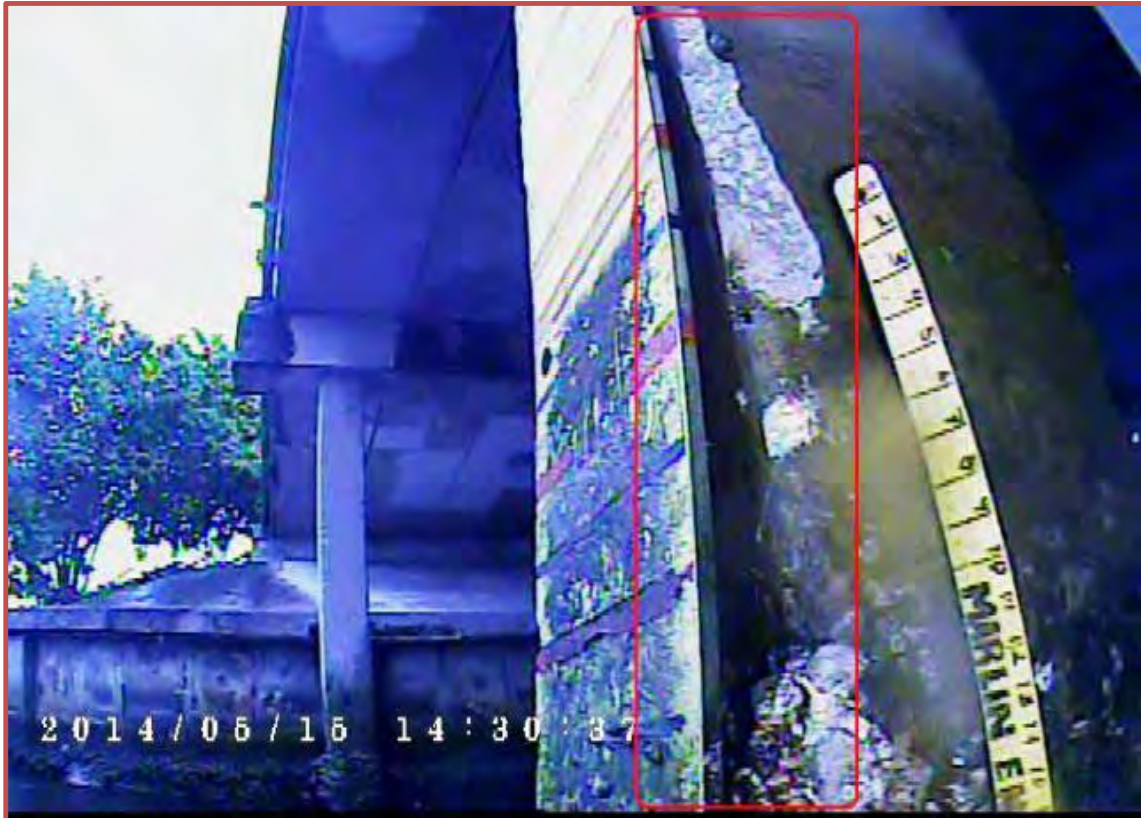
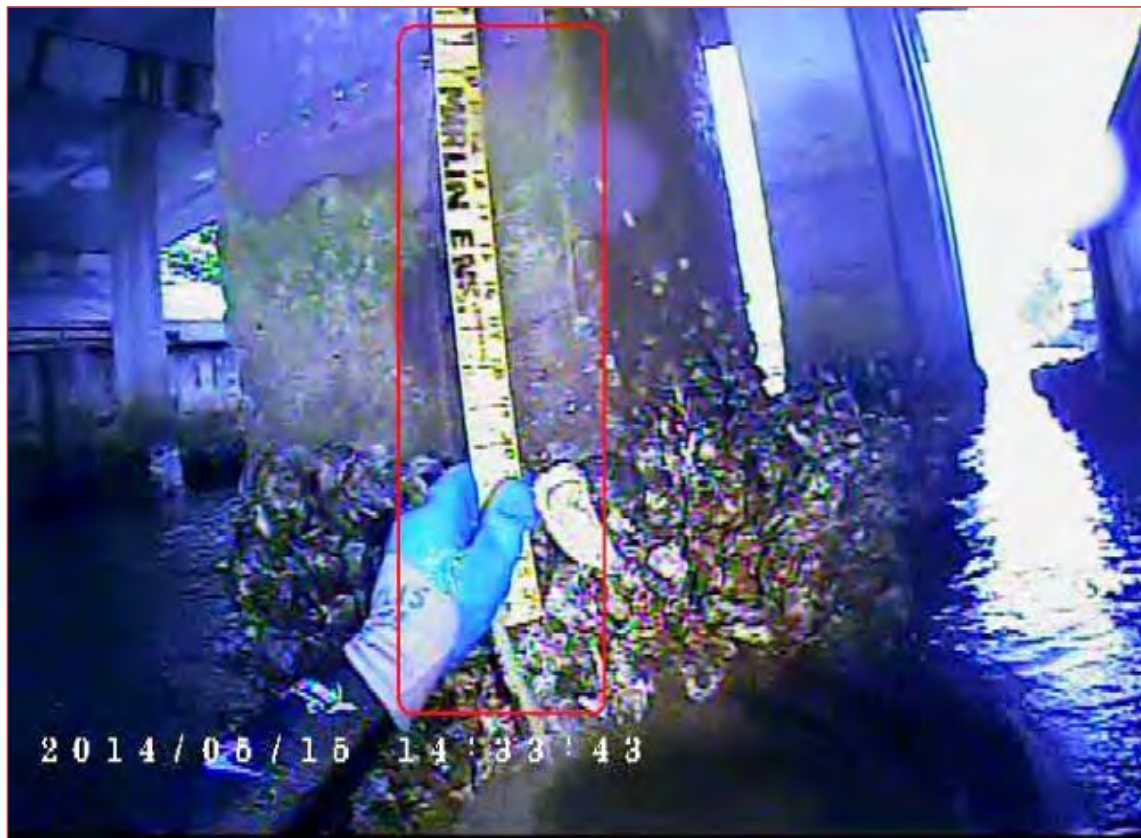
\_Pile 2-1, SE corner delamination 14" x 4", with corrosion bleed-out, starting 9' below the cap.

Description: Top: Pile 2-1, NW corner spall/delamination, starting 9' below the cap. **UW Photo 03.**  
Bottom: Pile 2-3, NW and SW corner delaminations, with CBO. **UW Photo 04.**

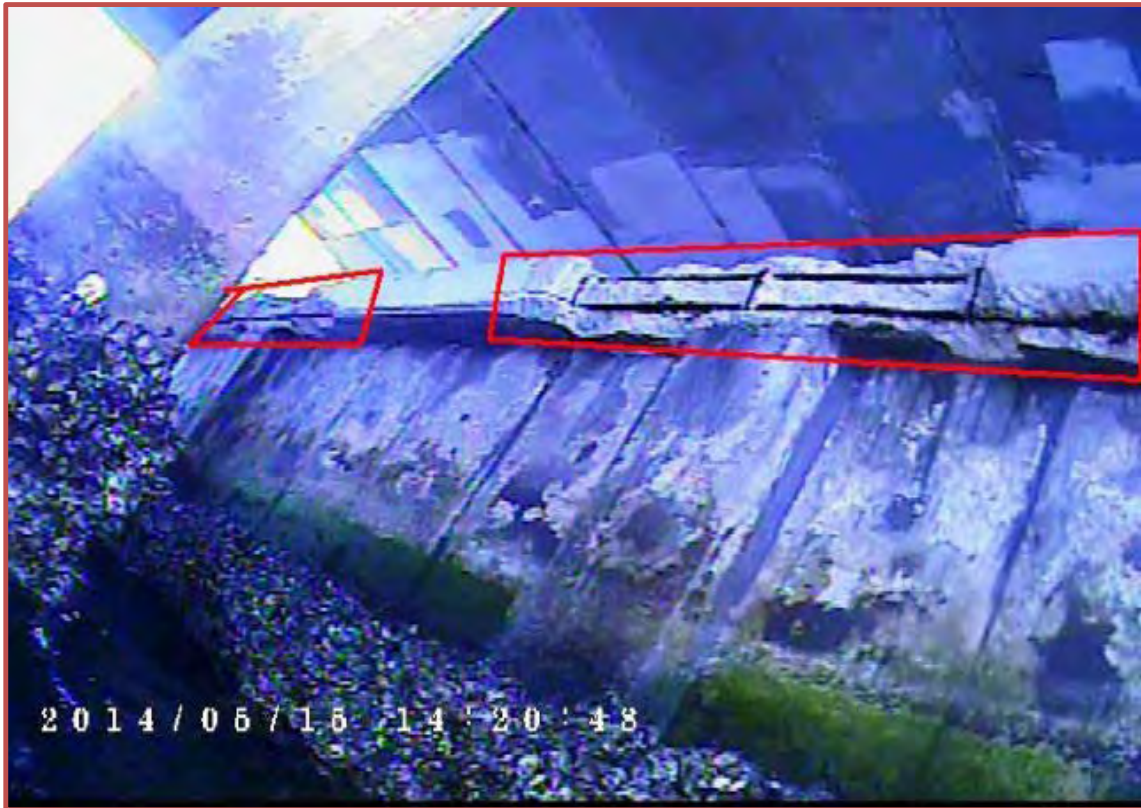
Description: Top: West and East bulkhead caps spall/delaminations, with rebar. **UW Photo 05.**  
Bottom: Bulkhead panels have heavy scale damage up to 1/8" D. **UW Photo 06.**

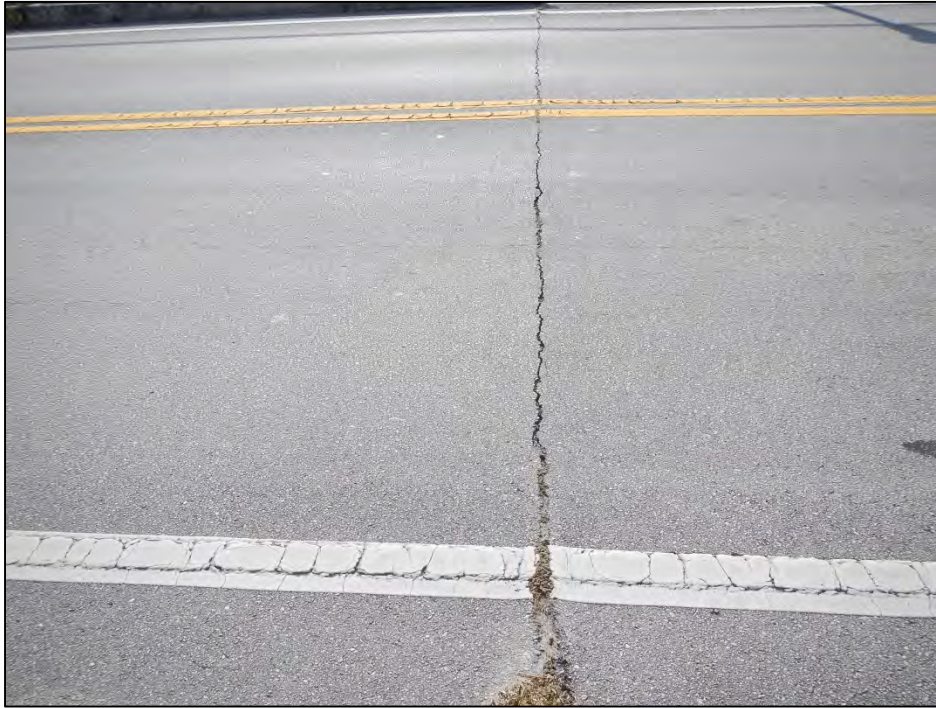
Photo 1 – End Bent 1 joint seal transverse crack.

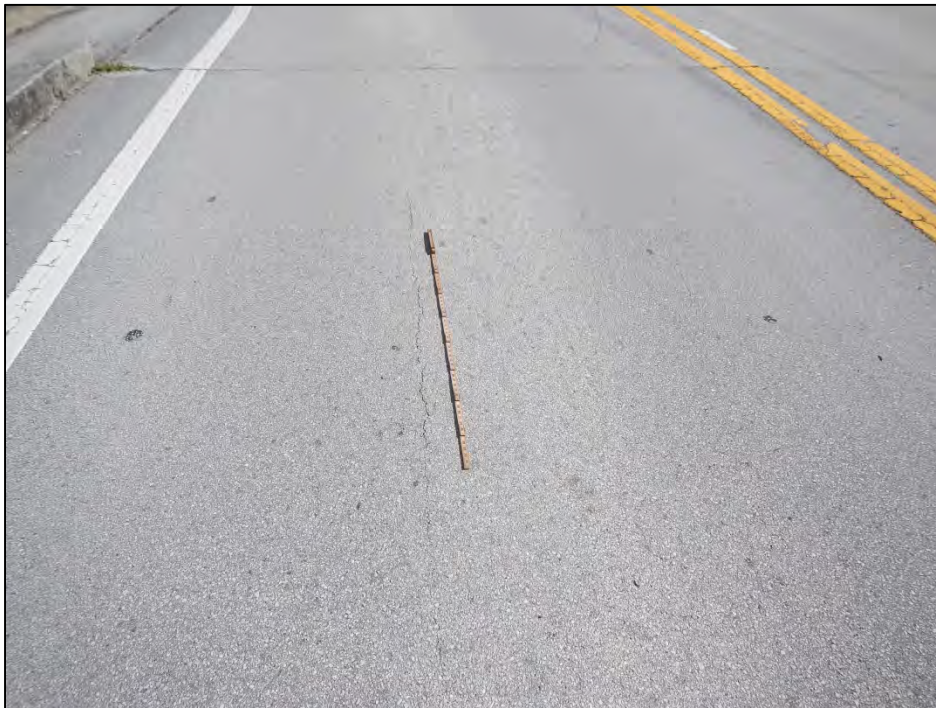
Photo 2 – Deck top longitudinal crack over Span 3.

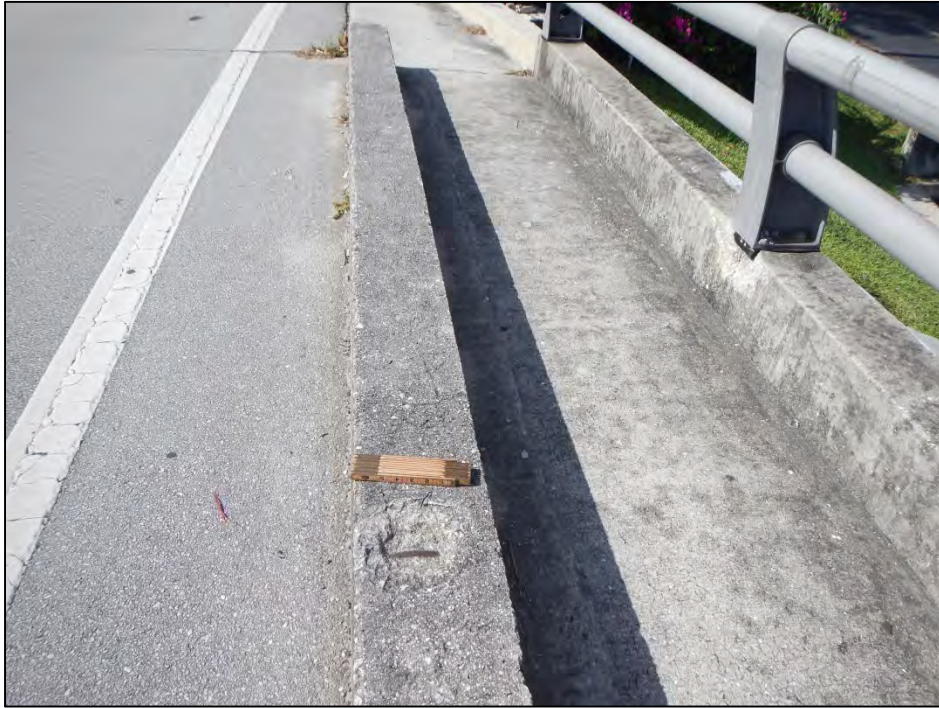
Photo 3 – The left curb over Span I has a spall with exposed steel.

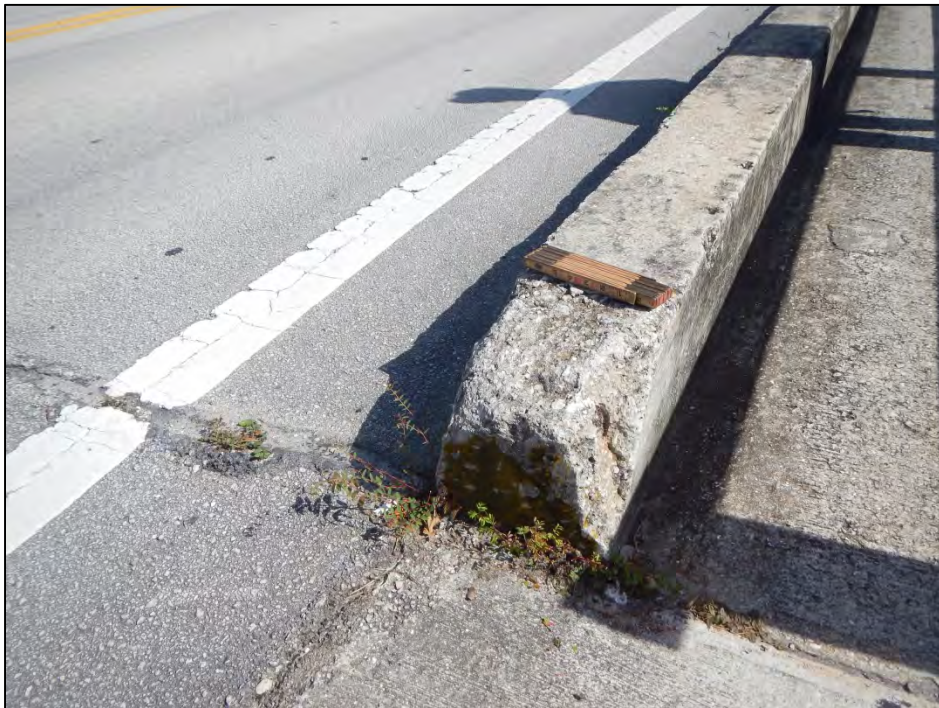
Photo 4 – The right curb over Span I has a spall with exposed steel.

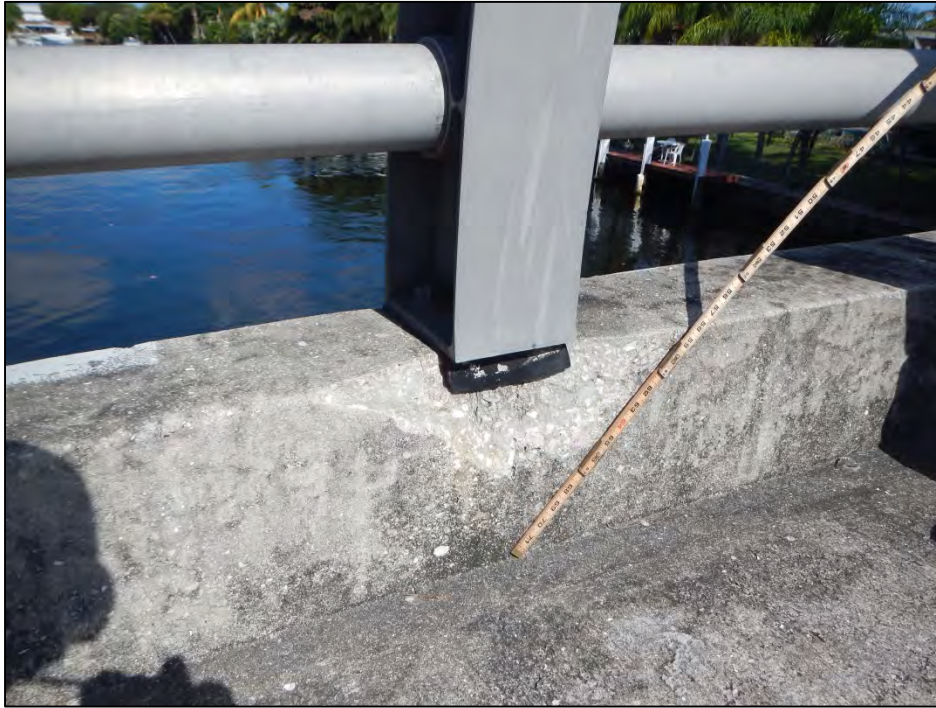
Photo 5 – The concrete parapet below Post I-2 exhibits a spall with exposed steel.

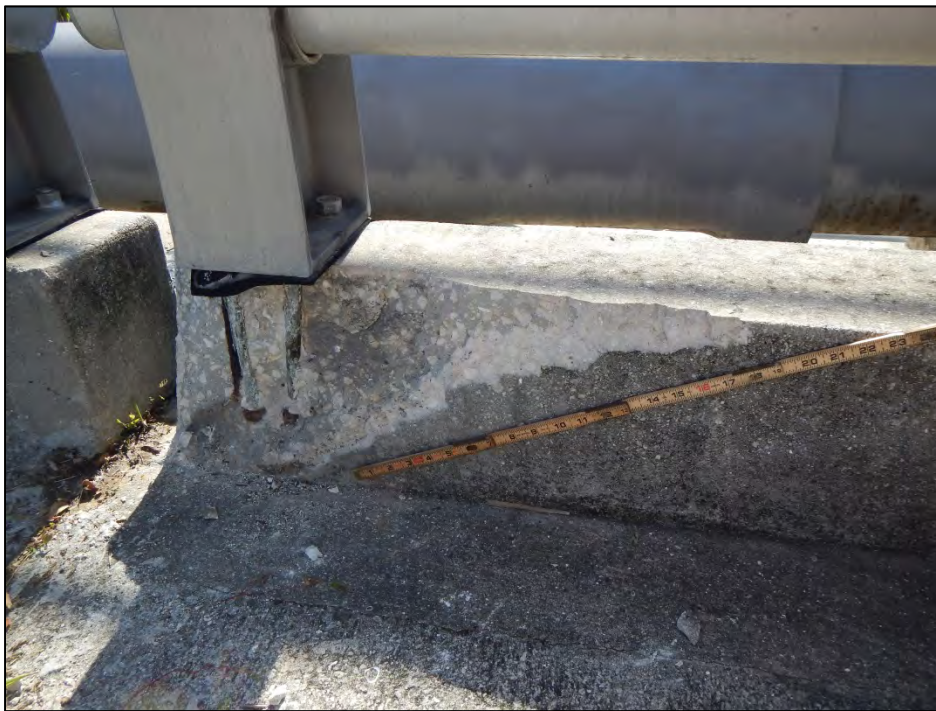
Photo 6 – The concrete parapet below Post I-3 right exhibits a spall with exposed anchors.

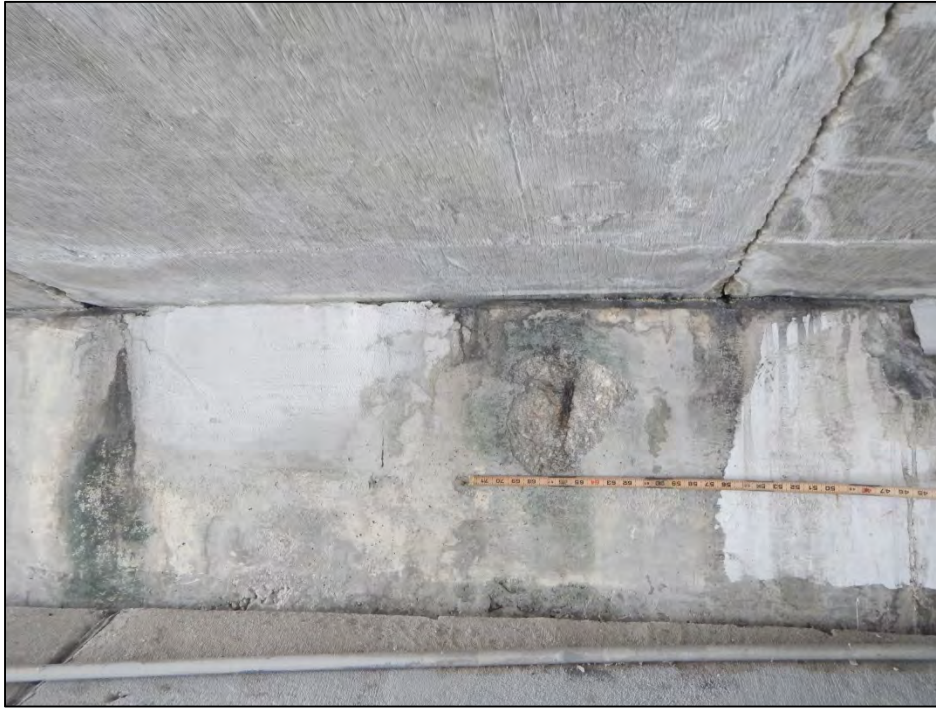
Photo 7 – Abutment 1 cap has a spall under Slab Unit 1-7.

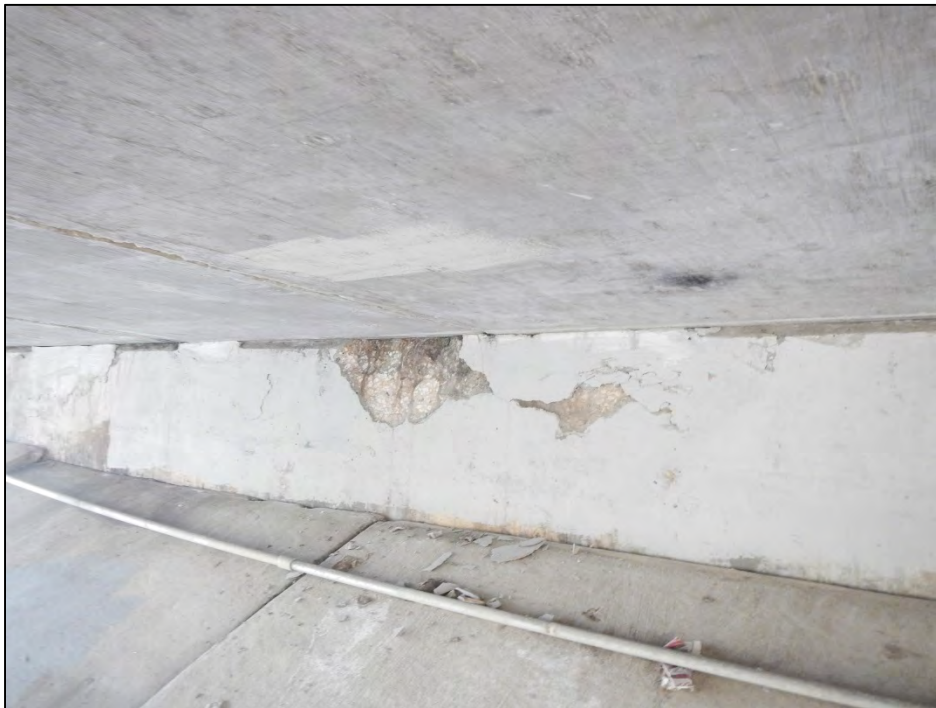
Photo 8 – Abutment 4 cap exhibits a spall under Slab Units 3-3 and 3-4.

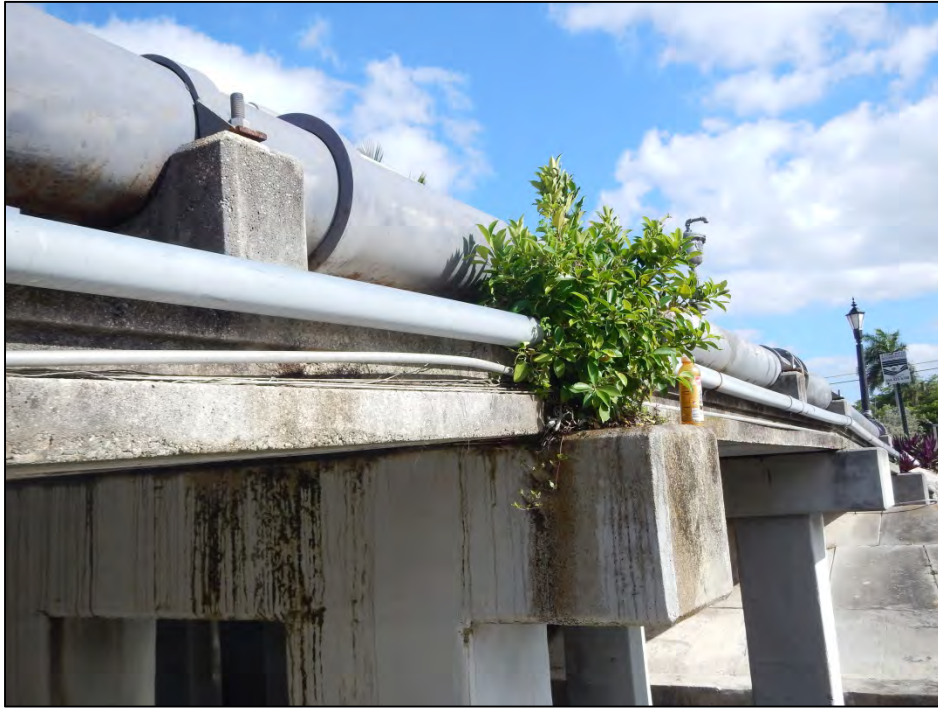
Photo 9 – There is minor vegetation growth between the caps and the Slab Units at the east end of Bent 2.

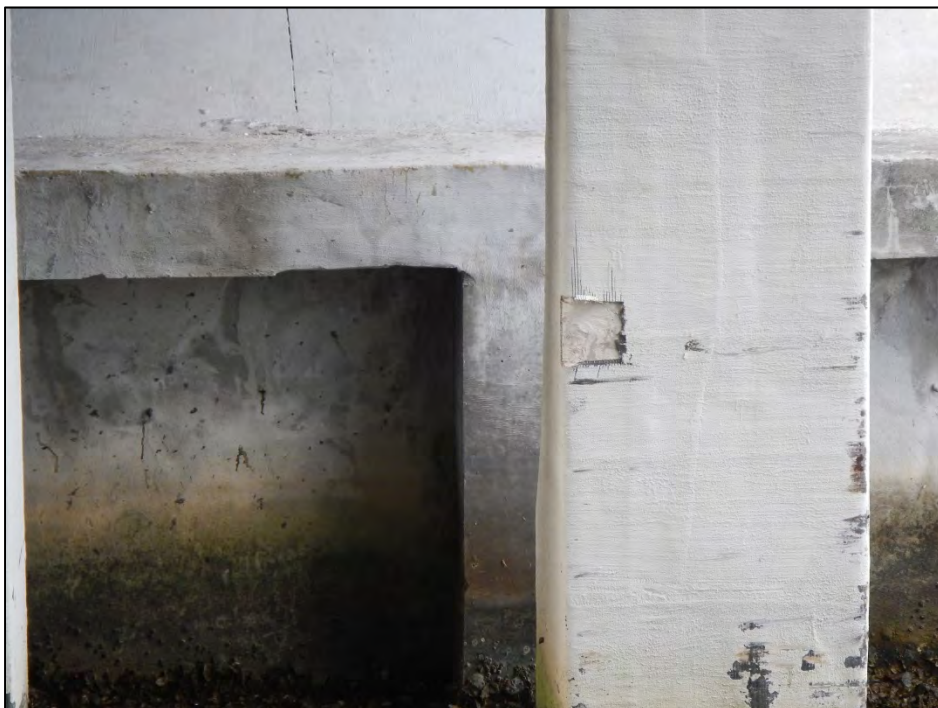
Photo 10 – The northeast corner of Pile Jacket I-I exhibits a spall.

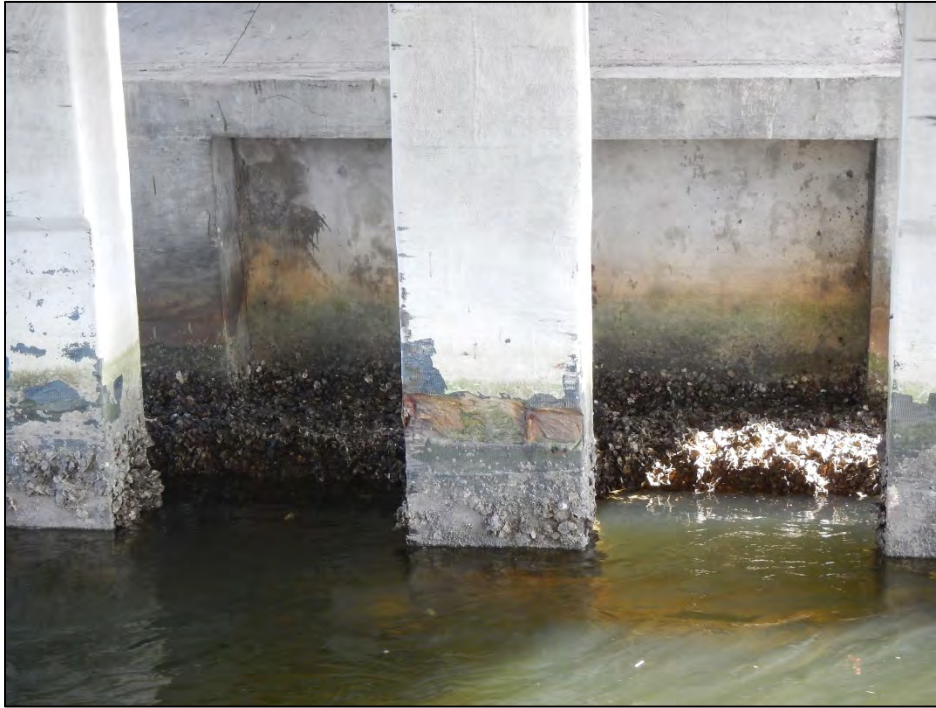
Photo 11 – The south face of Pile 3-4 exhibits a spall with exposed steel.

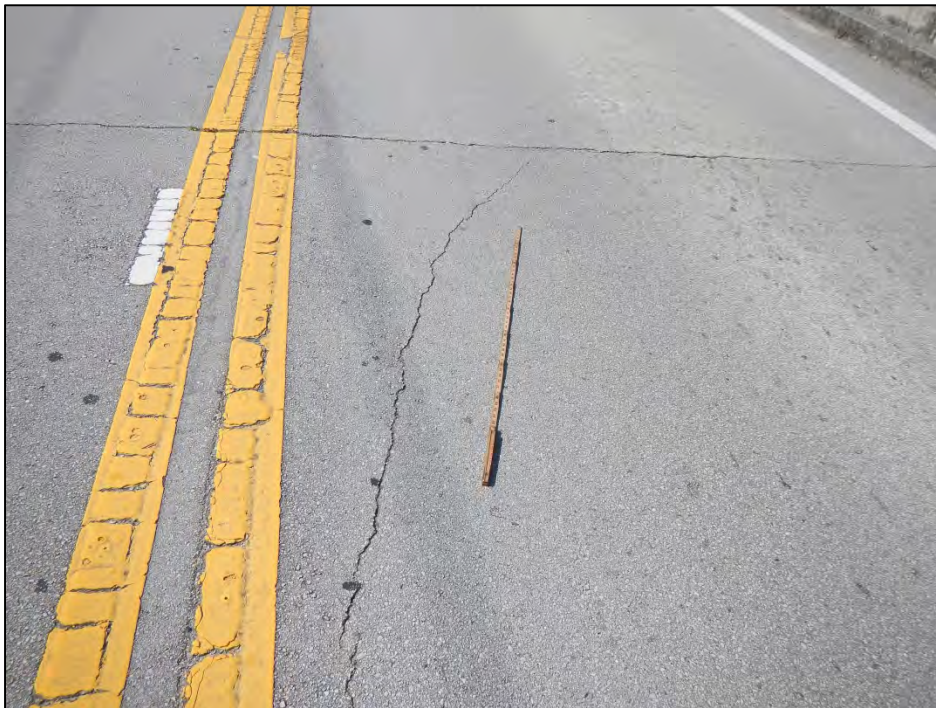
Photo 12 – The north approach slab exhibits a longitudinal crack.

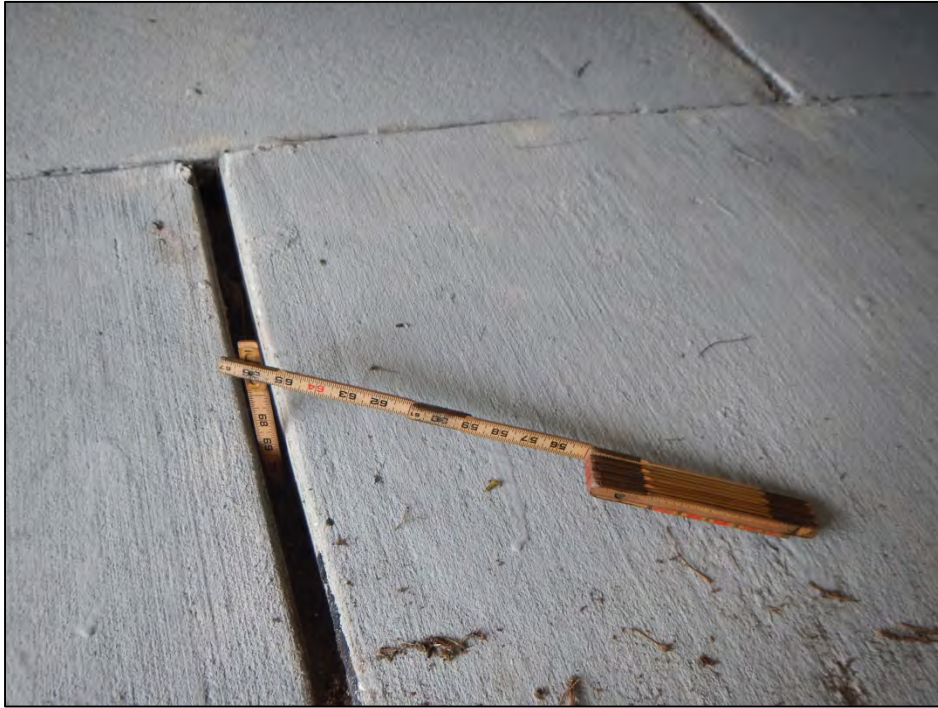
Photo 13 – Concrete panels are not sealed below Slab Unit I-10.
