## **EXECUTIVE SUMMARY**

TranSystems has been retained by the City of Fort Lauderdale to perform bridge inspections and prepare bridge inspection reports for each of the City's bridges as part of the project Structural Bridge Engineering Consulting Services Master Plan, RFQ No. 946-11310. Inspections were completed and reports prepared for 46 of the City's bridges. The remaining five bridges in the City's inventory were not inspected because they are in the process of being replaced.

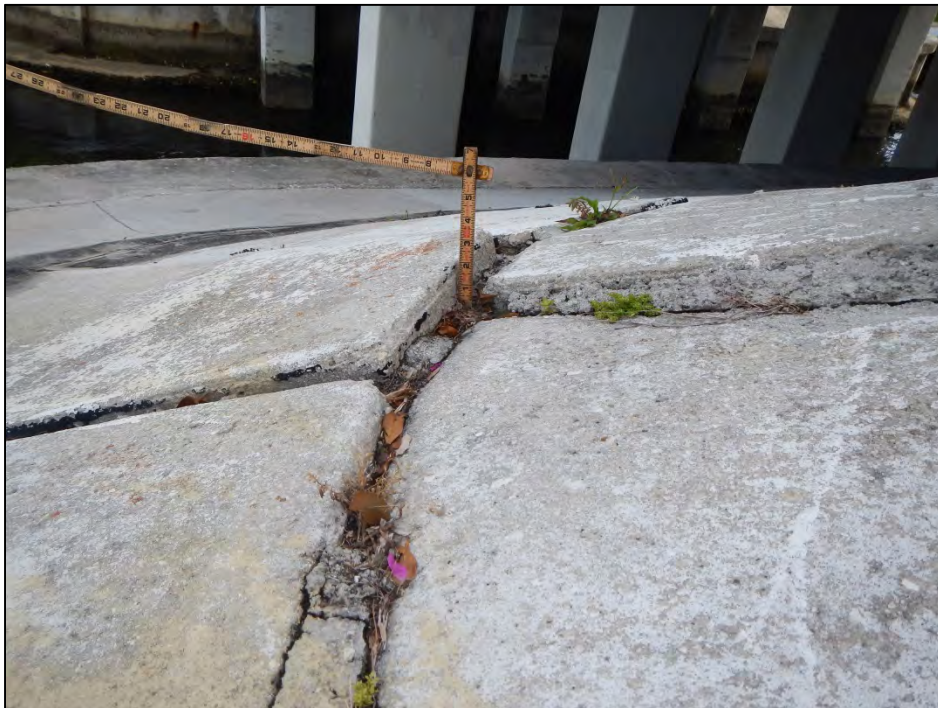
Photo 14 – The southwest slope protection exhibits settlement.

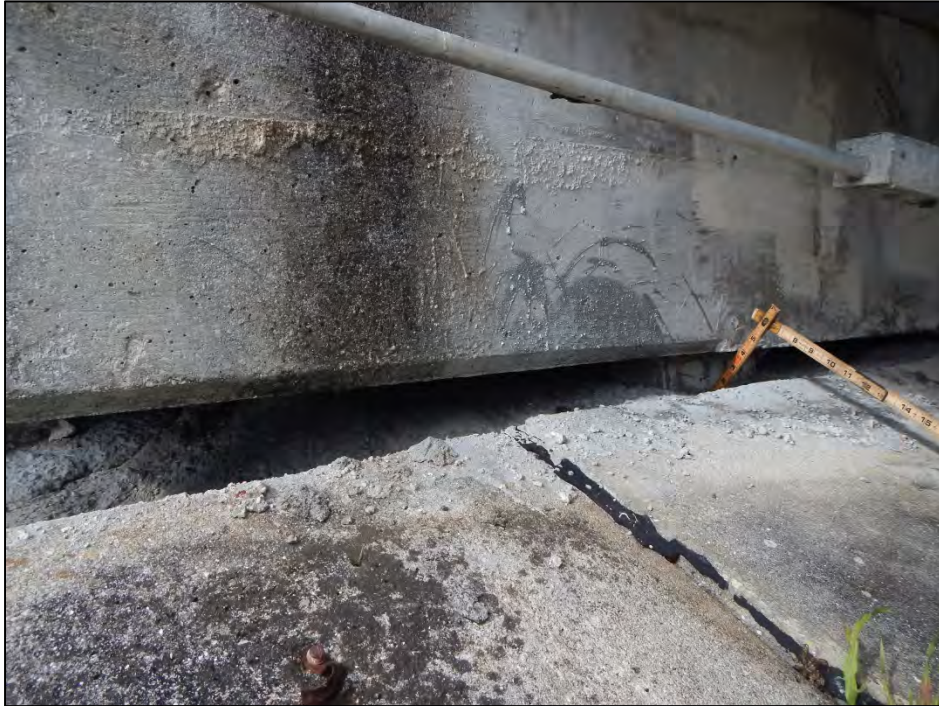
Photo 15 – The End Bent I cap has separated from the slope protection.

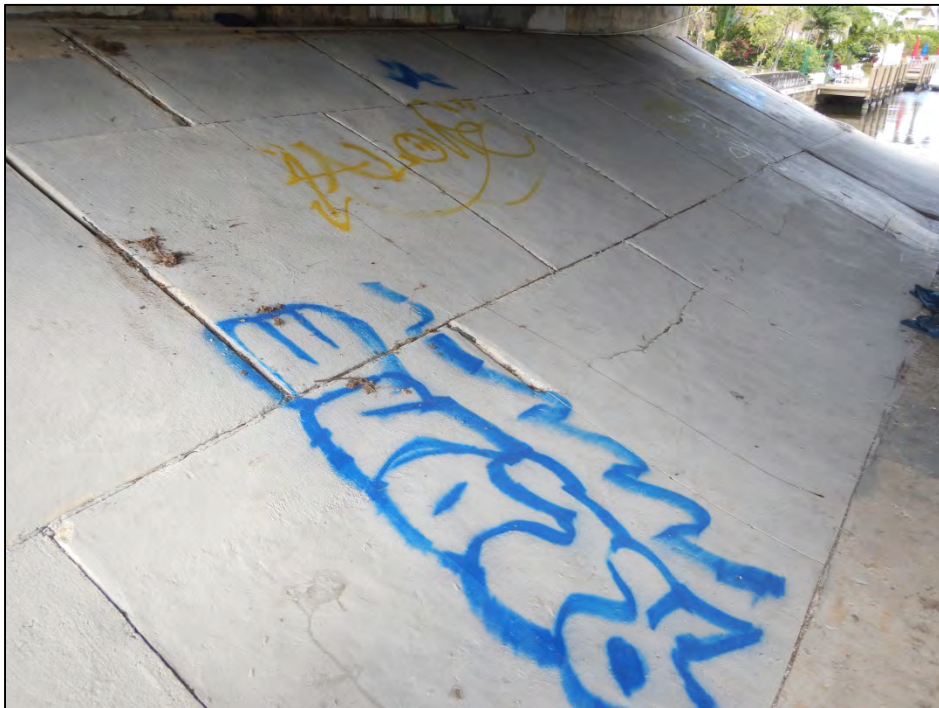
Photo 16 – The End Bent I slope protection exhibits graffiti.

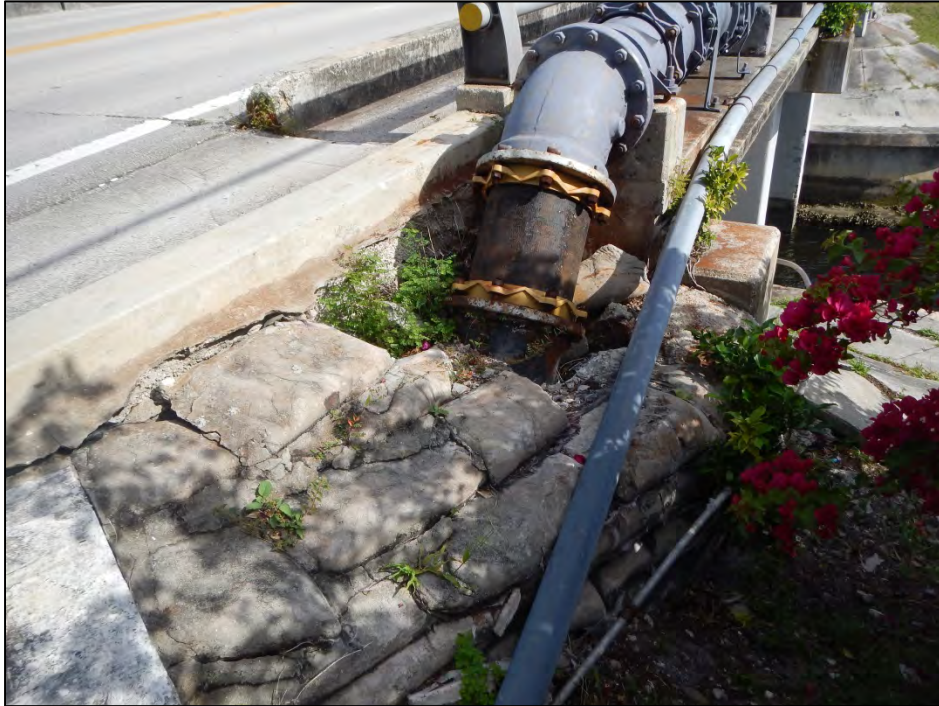
Photo 17 – The southeast corner exhibits a washout area.

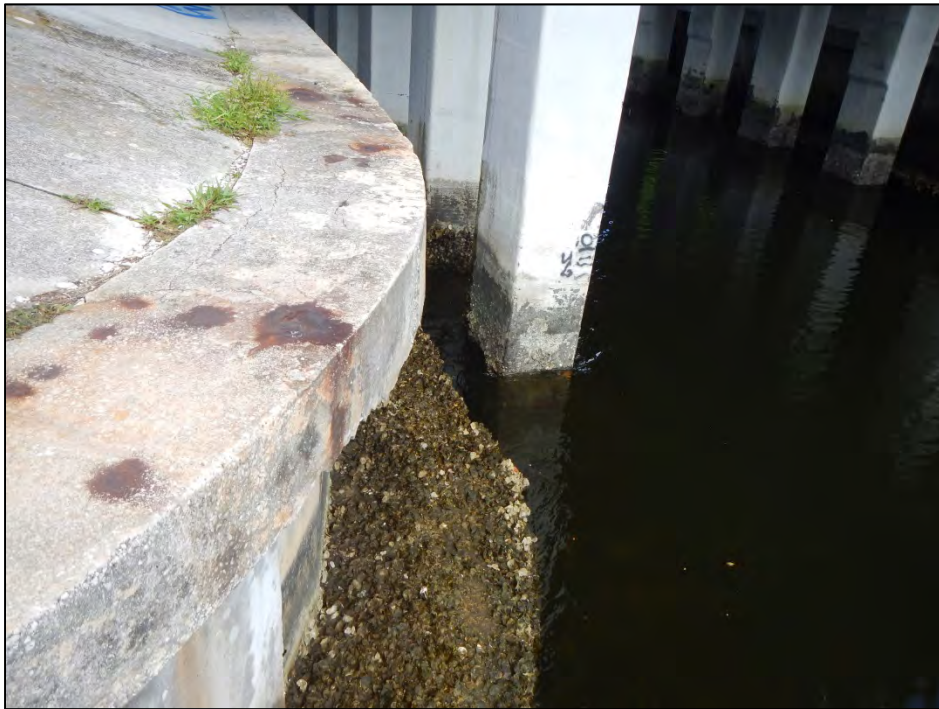
Photo 18 – The End Bent I bulkhead cap exhibits cracking.

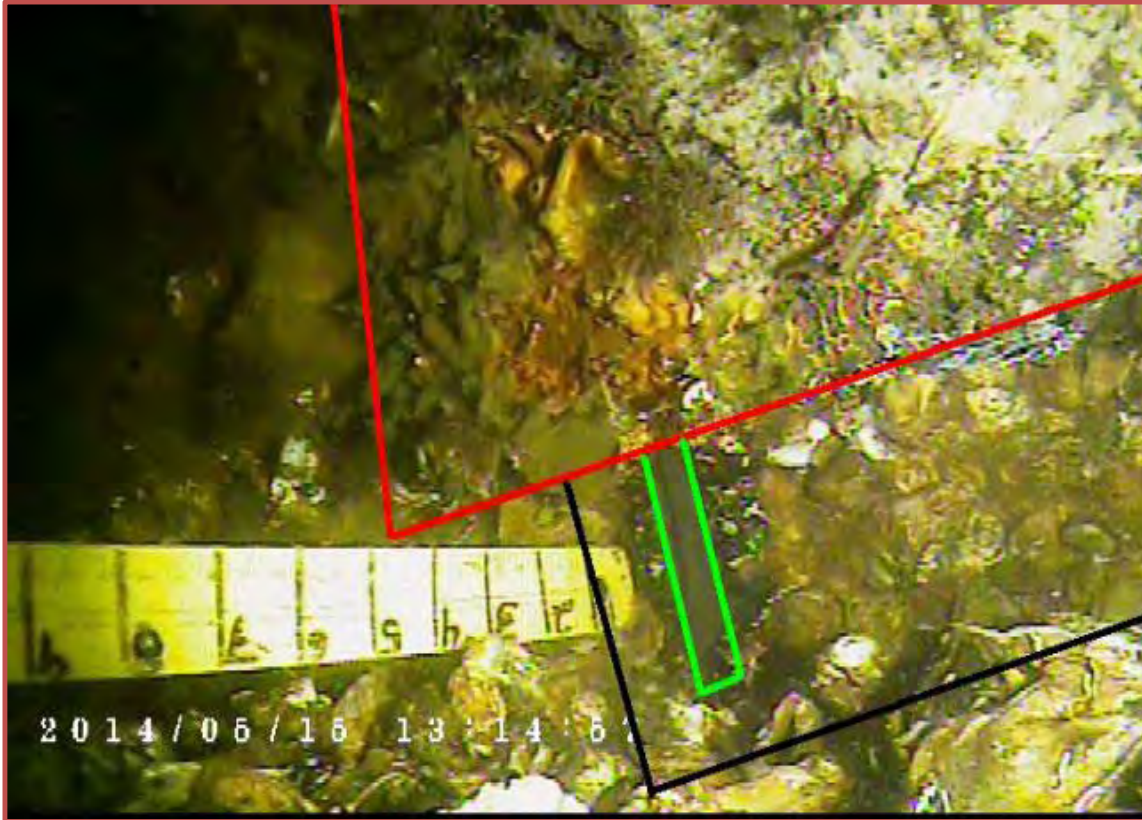
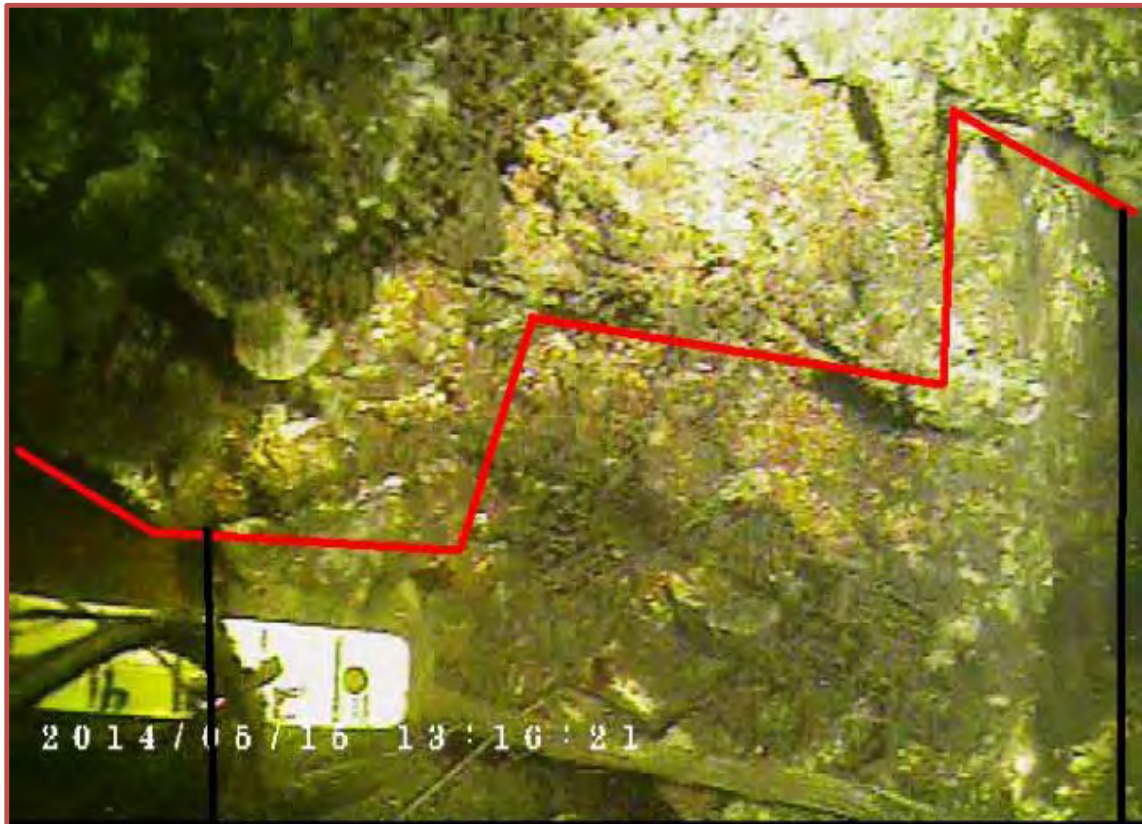
\_Pile Jacket 2-6, East and South faces, 24" above at the groundline has up to 2" deep area of soft concrete. The concrete in the lower 24" on all four faces has voids/washouts with (6) pieces of exposed vertical rebar with light corrosion also the original pile is exposed in areas. **UW Photo 01. NO CHANGE.**

Description: Top: Pile Jacket 2-6, East and South faces, void with exposed rebars. **UW Photo 01.**  
Bottom: Pile Jacket 2-7, NW corner, void/washout with exposed pile. **UW Photo 02.**

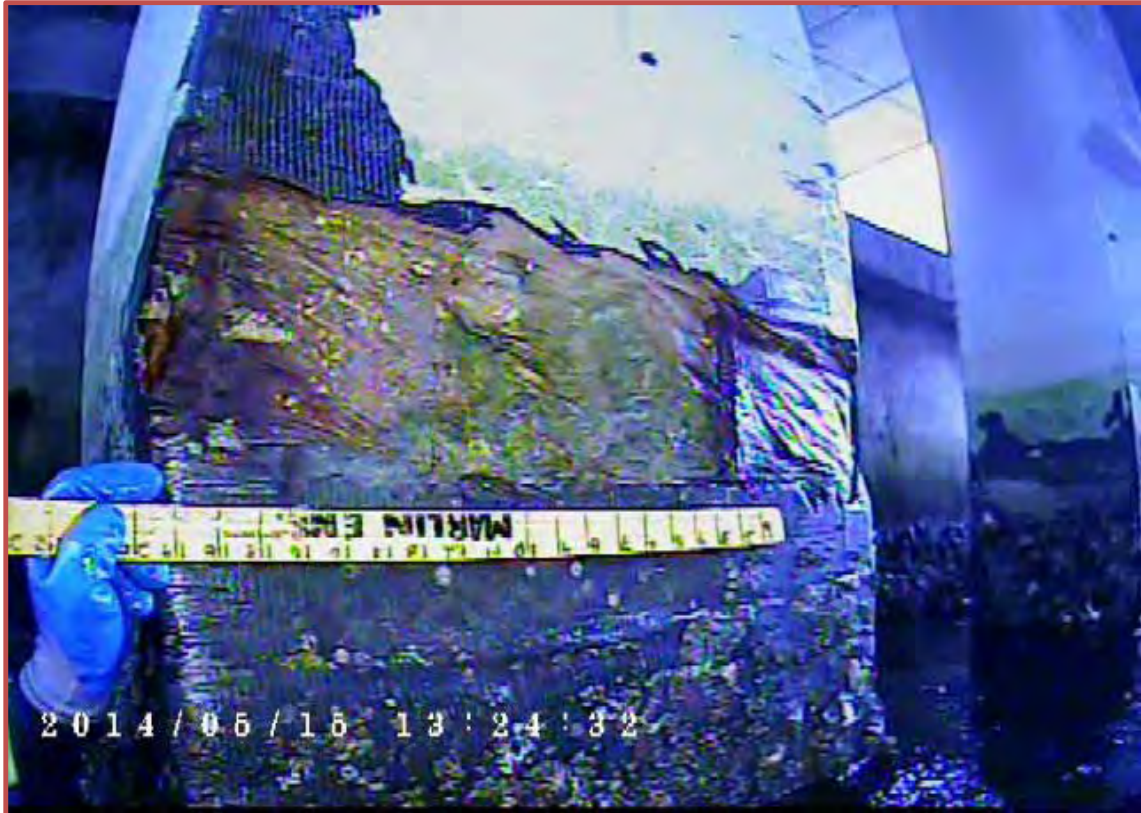
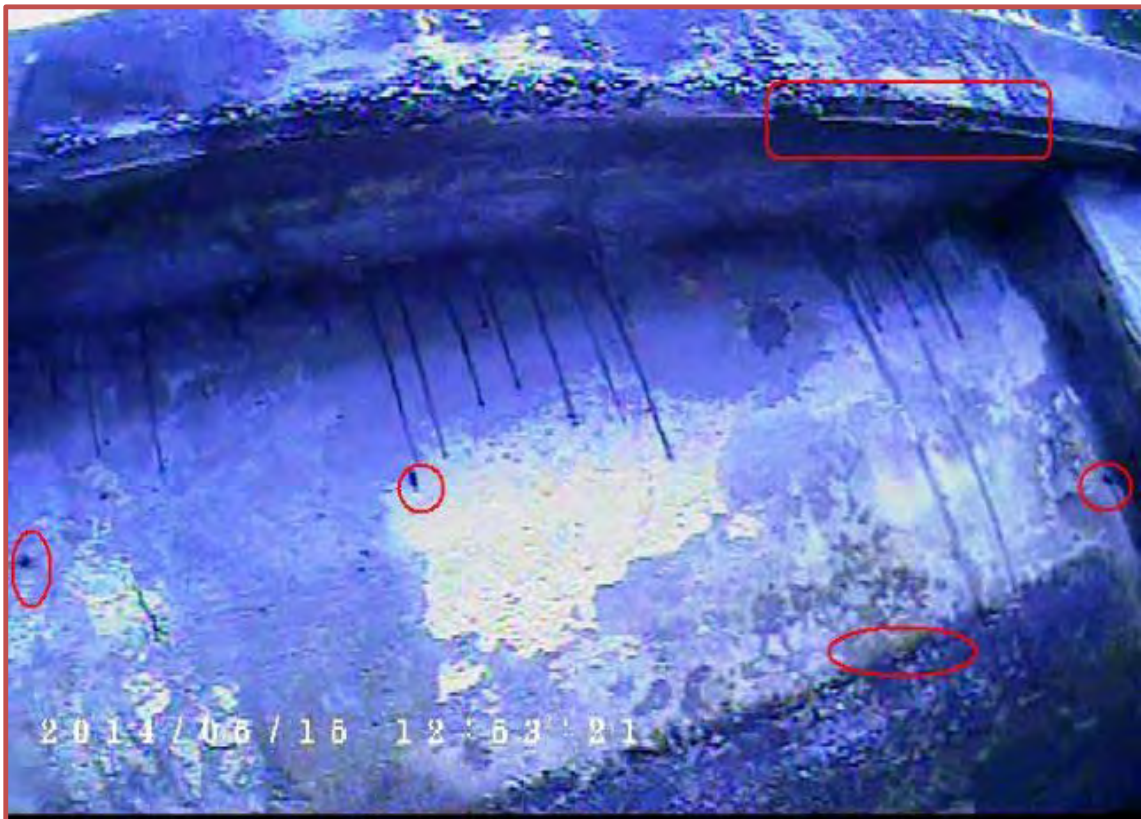
\_Pile Jacket 3-4, South face has a spall 24" x 8" x 1", with (2) exposed rebars, up to 80% section loss. **UW Photo 03. NO CHANGE.**

\_The South and North seawalls exhibit spotty areas of corrosion bleed-out at random locations.

Description: Top: Pile Jacket 3-4, South face, spall, with exposed rebars. **UW Photo 03.**  
Bottom: South and North seawalls spotty areas of corrosion bleed-out. **UW Photo 04.**

\_Repair the spall on Pile Jackets 3-4.

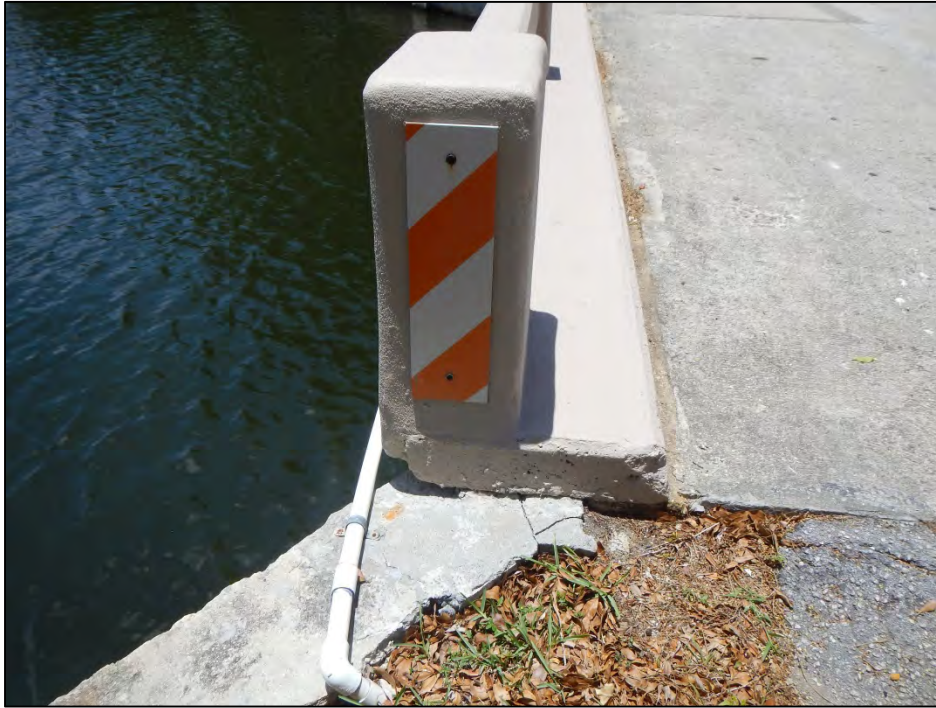
- The diagonal striping on the northwest and southeast object markers is oriented incorrectly. See Condition Photo 1.

Photo 1 – The diagonal warning sign stripes are oriented incorrectly.

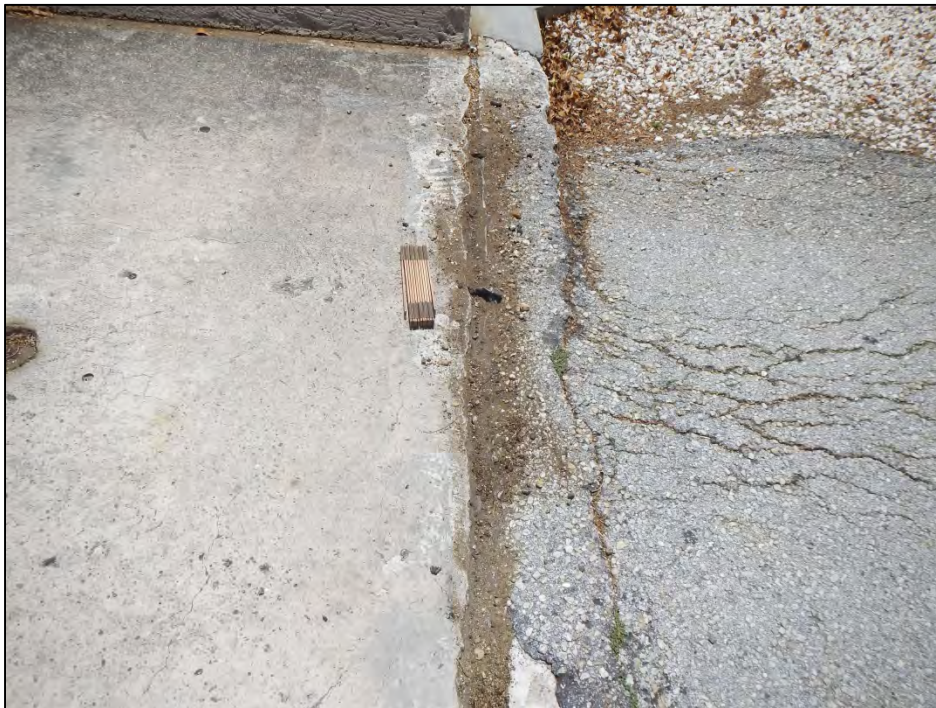
Photo 2 – Abutment I joint seal is deteriorated.

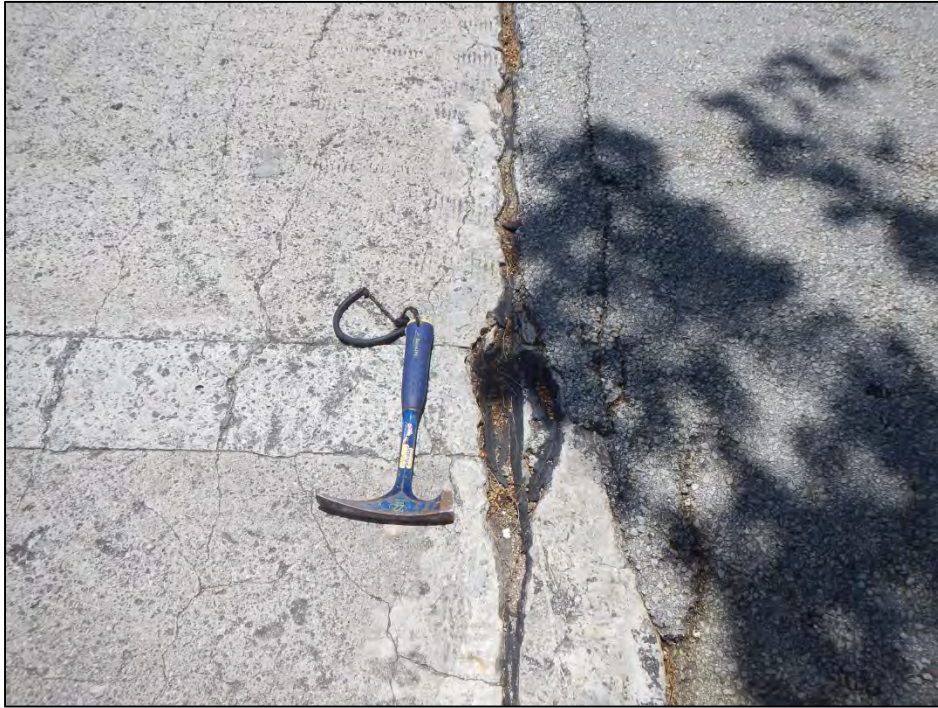
Photo 3 – The center lane over End Bent I exhibits a spall.

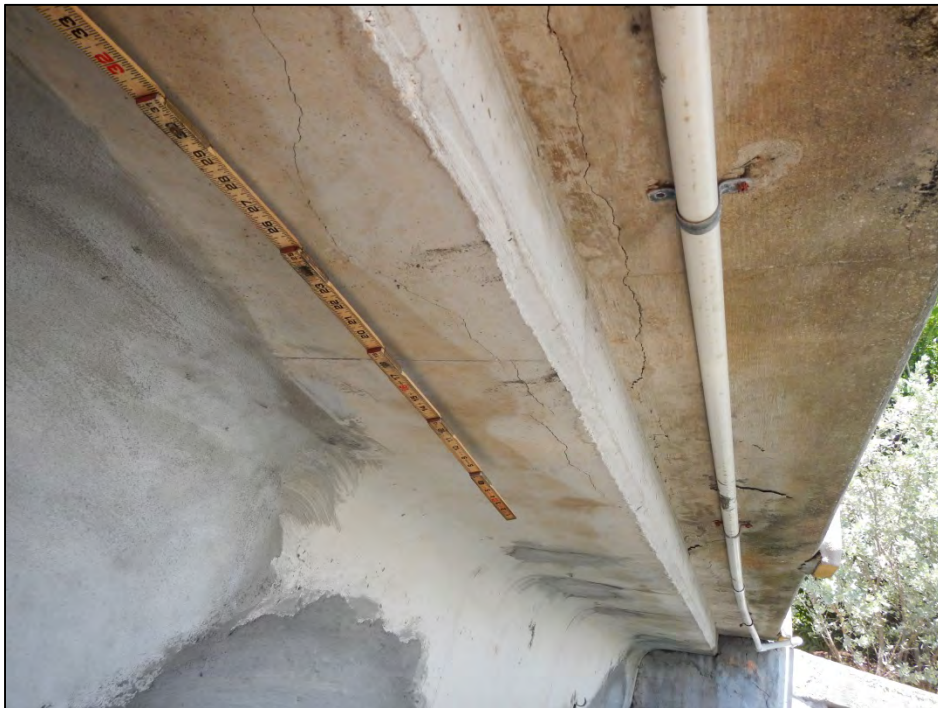
Photo 4 – The south fascia over Span 2 exhibits a long crack and delamination.

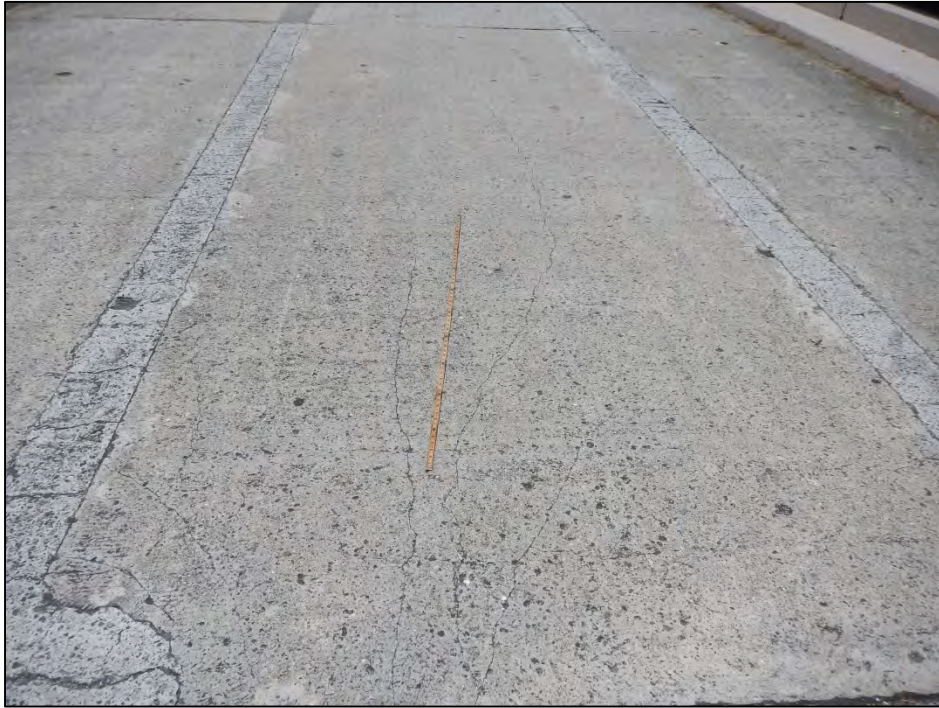
Photo 5 – The deck top exhibits multi-directional cracks.

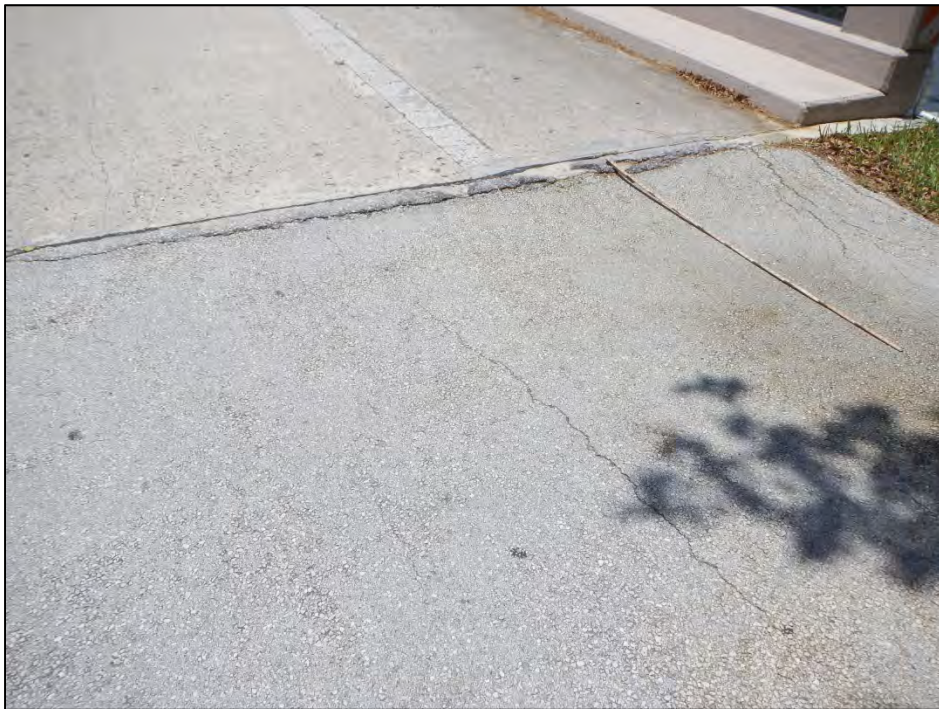
Photo 6 – The east approach roadway exhibits longitudinal cracks.

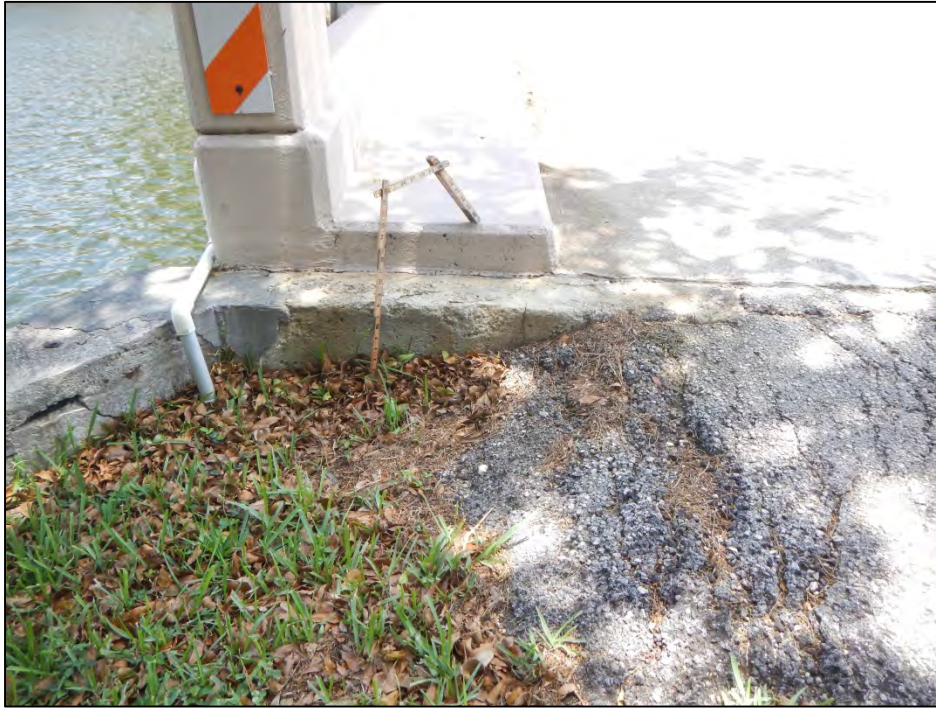
Photo 7 – The northwest corner is missing the sidewalk transition.

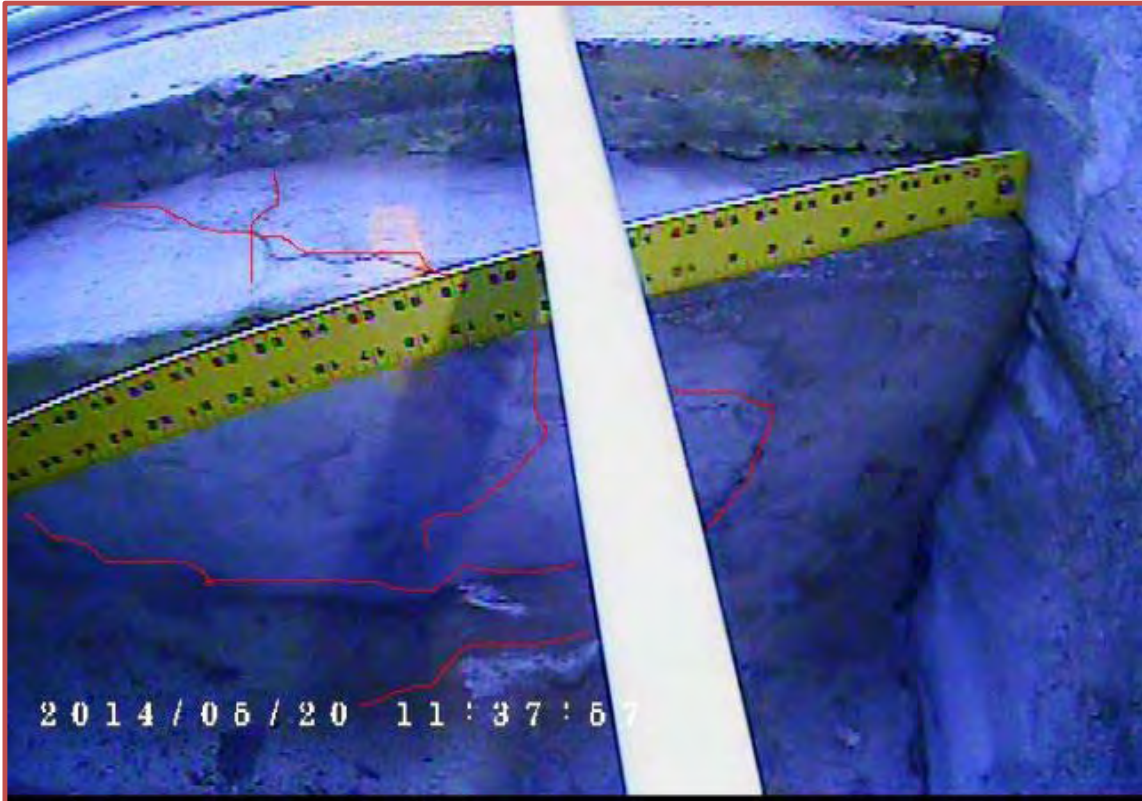
\_South and North underside overhangs exhibit intermittently delamination with efflorescent bleed-out along the entire repaired length. **UW Photo 01. NEW.**

Description: Top: S and N overhangs exhibit delaminations with efflorescence. **UW Photo 01.**

\_Remove all unsound concrete and patch. Also epoxy inject all the cracks as needed.

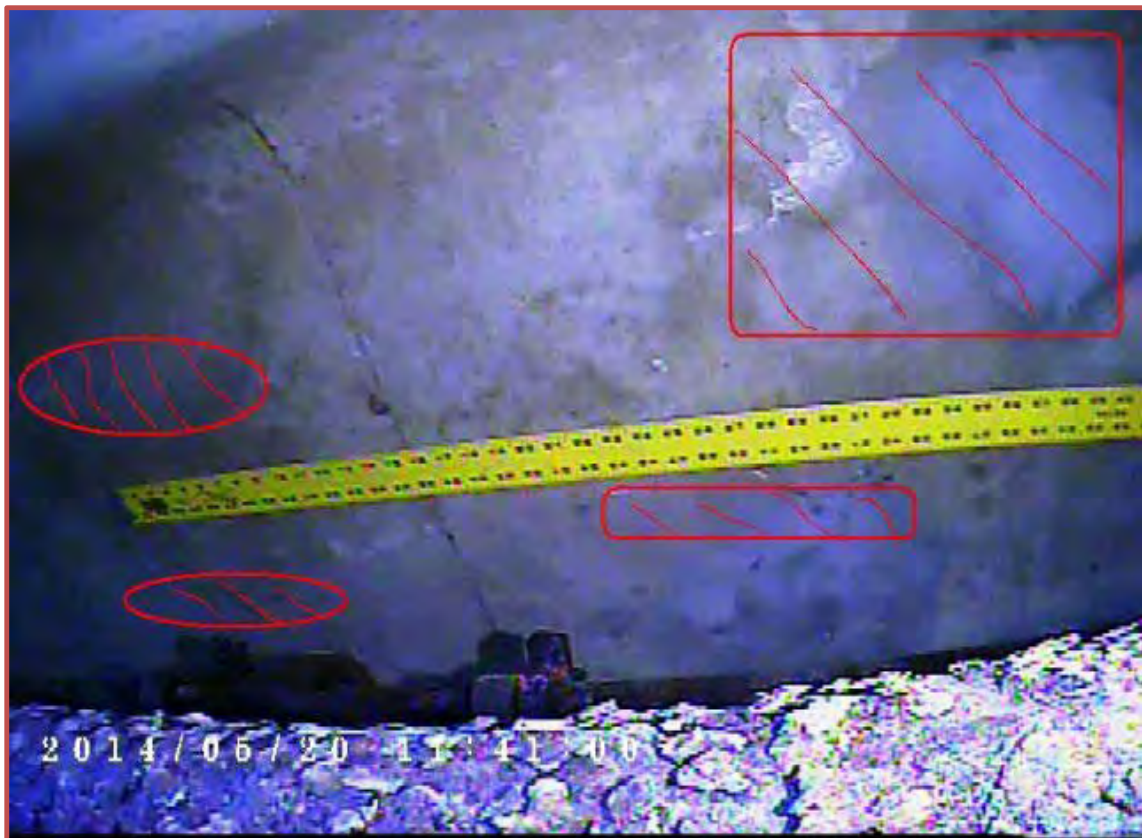
Bottom: All the Bays have intermittently delaminated areas up to 40" x 34". **UW Photo 02.**

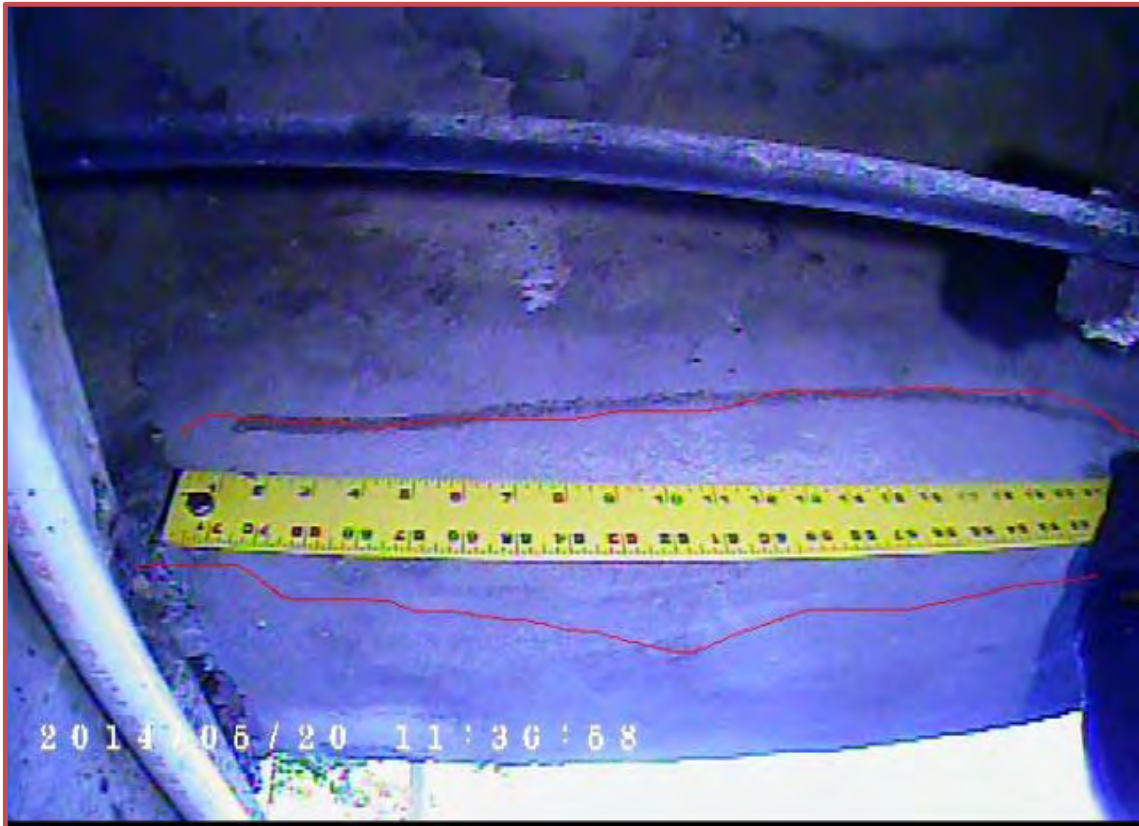
\_The flange undersides of the double tee beams have random shallow delaminated areas ranging from 48" x 18" to 4" x 4". Along the repairs. **UW Photo 03. NEW.**

Description: Top: Flange undersides of double tee beams have shallow delamination. **UW Photo 03.**  
Bottom: Utility under Beams 1-1 and 2-1 is heavily corroded, exposed wires. **UW Photo 04.**

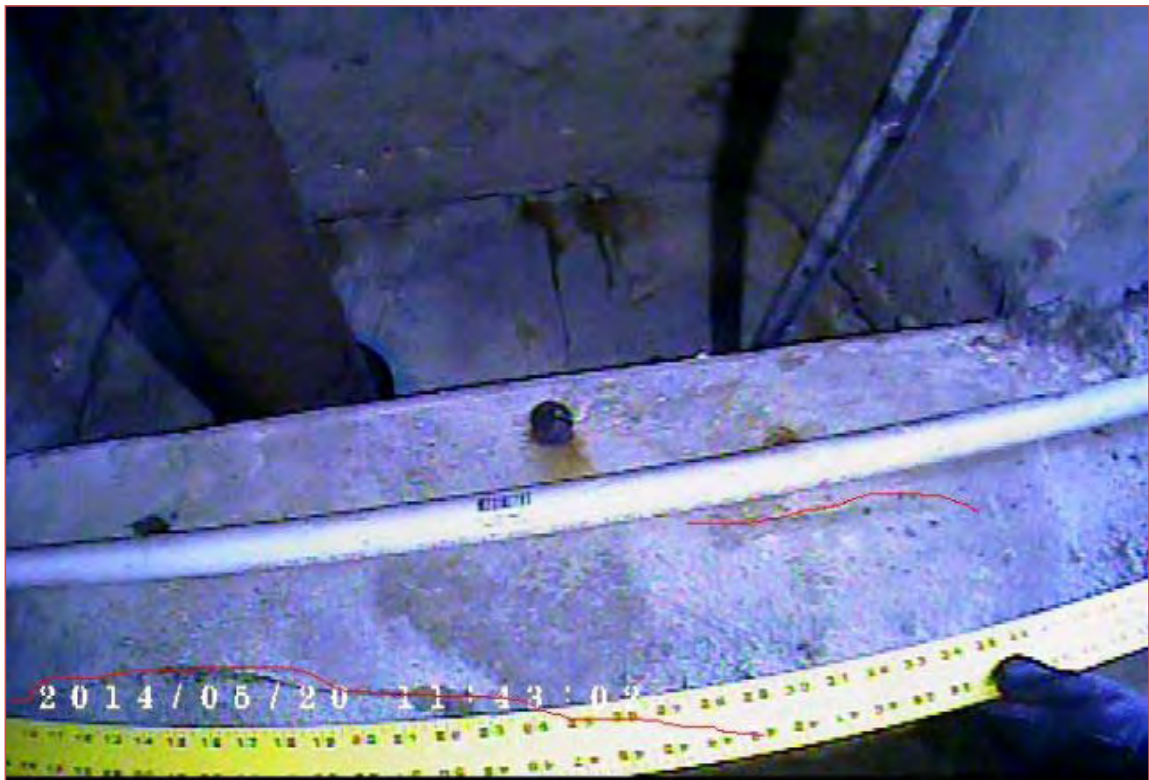
\_Both Abutment caps exhibit horizontal cracks up to 1/64", at random location along the repaired areas.

Description: Top: Piles have cracking up to 1/64", with minor CBO. **UW Photo 05.**  
Bottom: Both Abutment caps, horizontal cracks along the repaired areas. **UW Photo 06.**

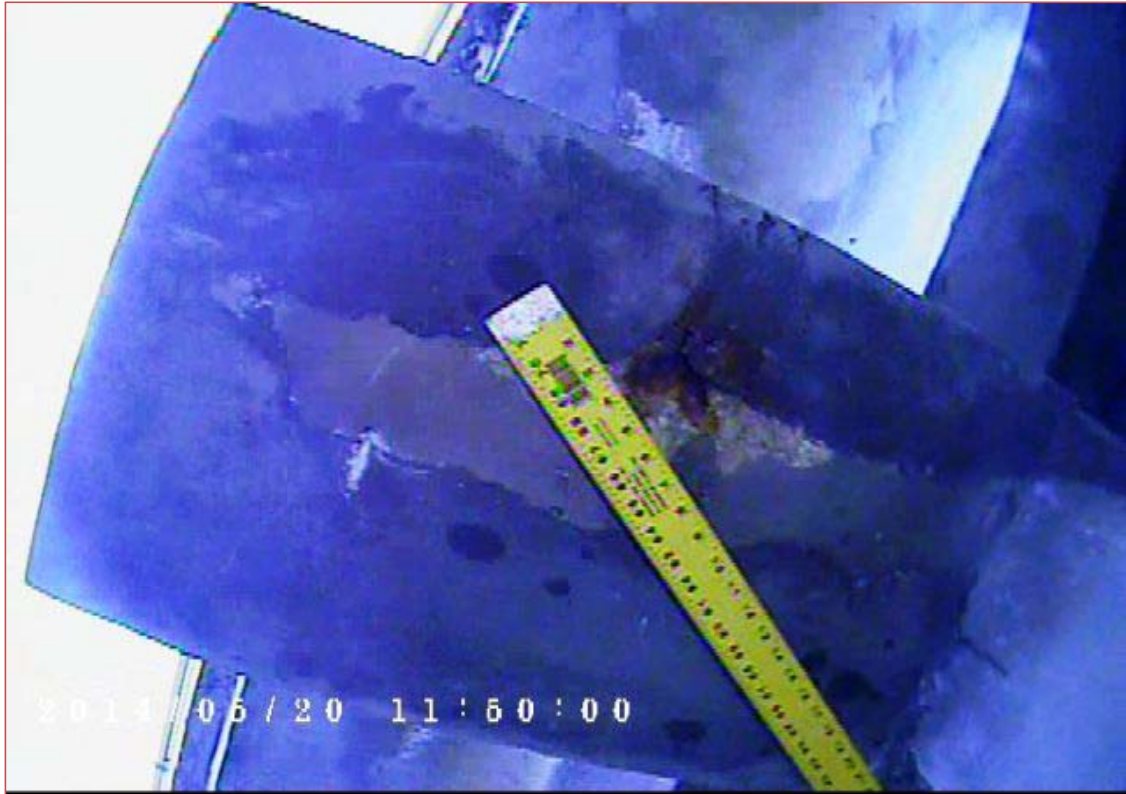
\_The underside of Bent 2 cap at the North end has a spall/void 10" x 3" x 1", with associated cracks up to 1/64", corrosion bleed-out (previously a piece of exposed and corroded rebar with 10% section loss) along the edge of the concrete repair. **UW Photo 07. NO CHANGE.**

Description: Top: Bent 2 cap underside, North end, spall/void, with associated cracks. **UW Photo 07.**  
Bottom: Bent 2 cap, bottom West edge, crack with corrosion bleed-out. **UW Photo 08.**

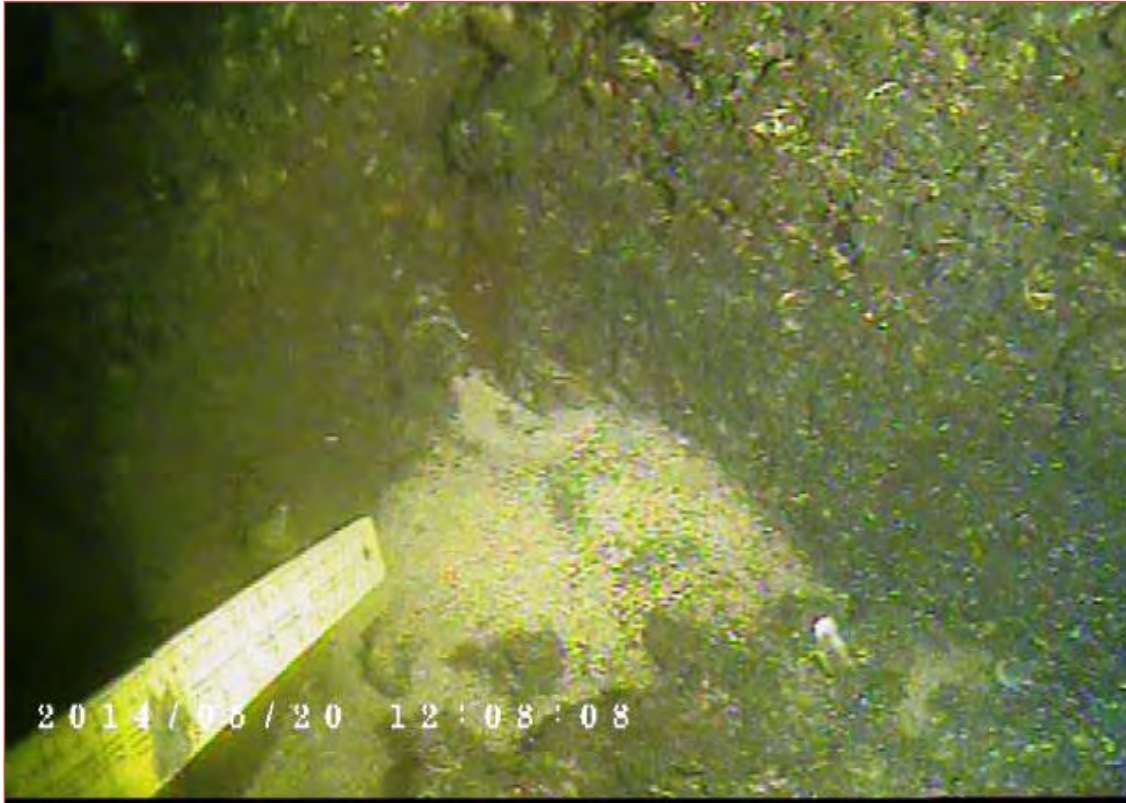
\_All the transition joints to the wingwalls and backwalls are open up to 2", with minor active backfill leakage underwater. **UW Photo 09. NO CHANGE.**

Description: Top: Transition joints to wingwalls & backwalls are open, backfill leakage. **UW Photo 09.**  
Bottom: Abutment 2 backwall NE end, delamination. **UW Photo 10.**

\_Remove all unsound concrete and patch and epoxy inject all the cracks as needed at Abutment 2 NE and SE ends, also seal all four transition joints to wingwalls and backwalls.

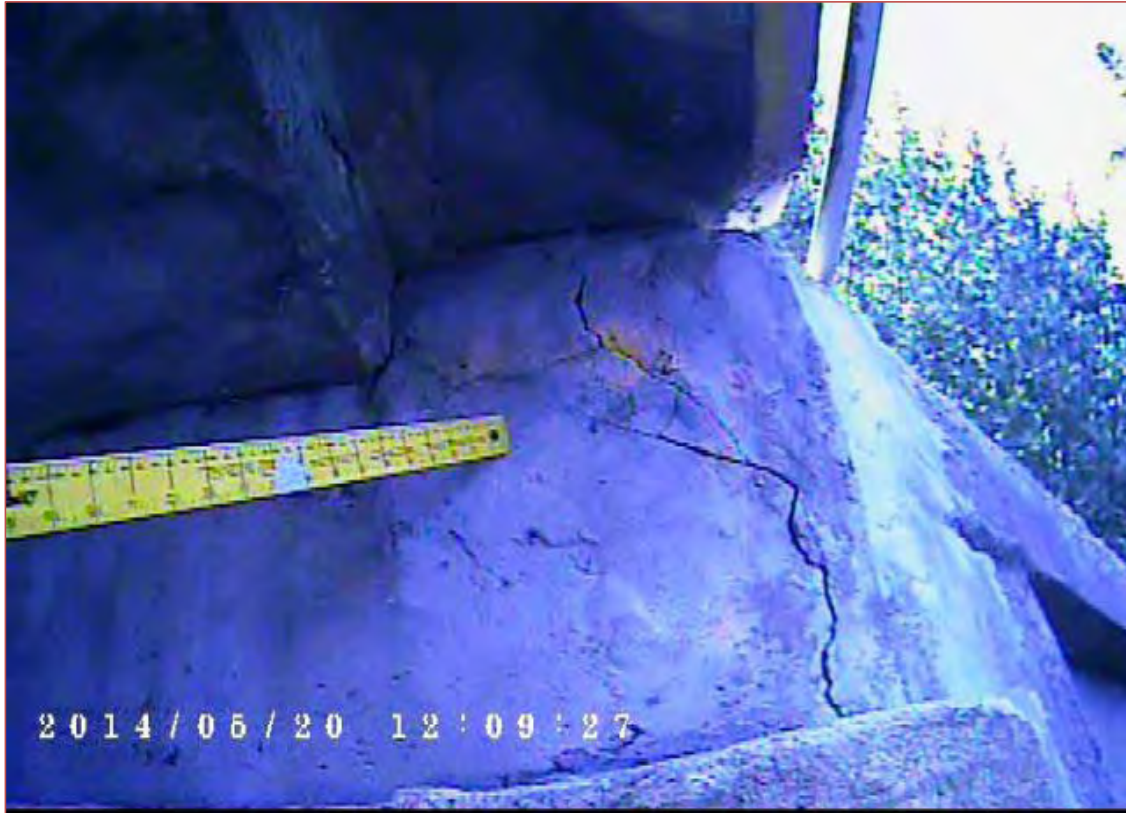
\_Abutment 2 backwall Southeast end has a delamination 24" x 12", with associated cracks up to 1/8", and corrosion bleed out. **UW Photo 11. NEW.**

Description: Top: Abutment 2 backwall SE end, delamination with associated cracks. **UW Photo 11.**  
Bottom: SE wingwall center Pile has a horizontal crack. **UW Photo 12.**

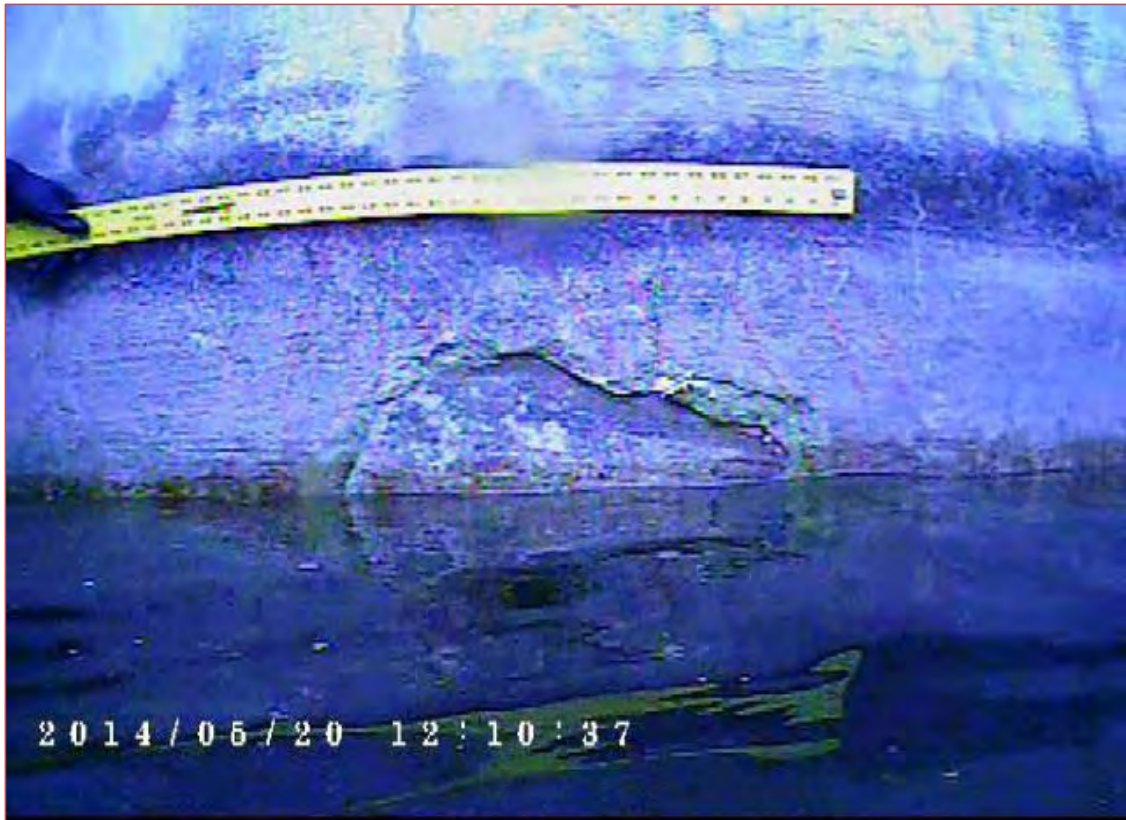
Description: SE wingwall, hollow sounding area, at and below the high watermark. **UW Photo 13.**

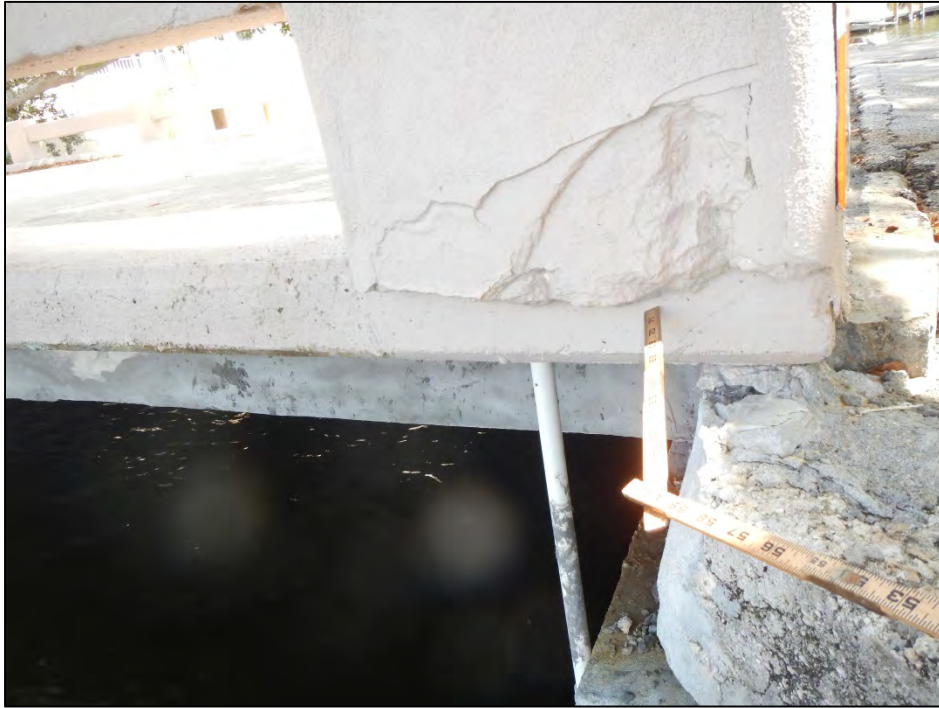
- Post 1-1 left, lower north face has a 1 ft. 5 in. x 9 in. x 1 in. spall/delamination. See Condition Photo 1.
- The horizontal rails along both sides have minor horizontal cracks up to  $\frac{1}{64}$  in. wide.

Photo 1 – Post I-I left exhibits a spall/delamination.

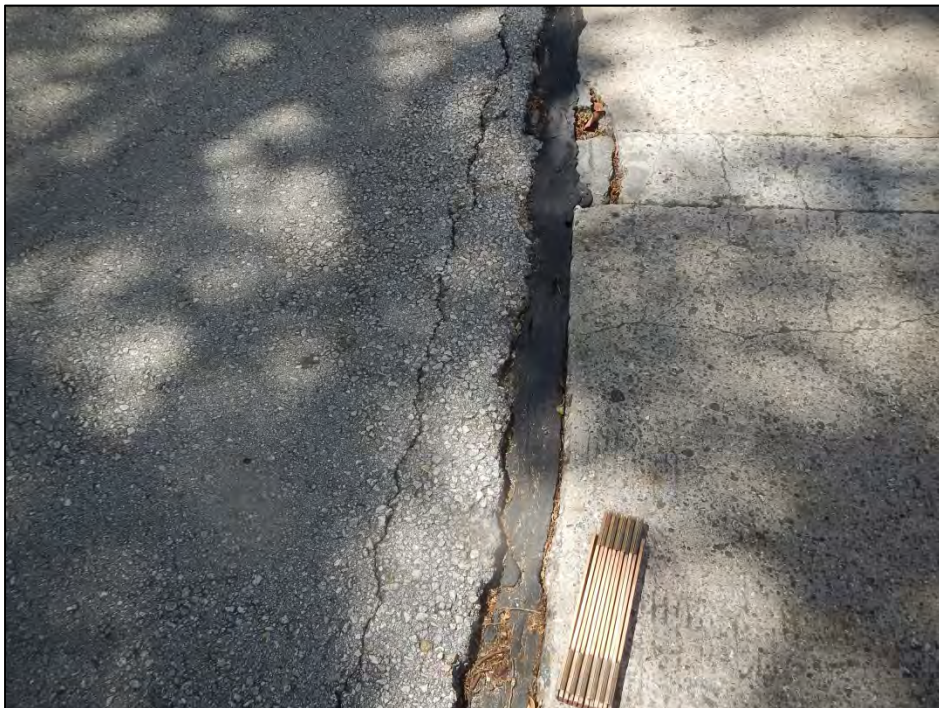
Photo 2 – The End Bent I joint seal is deteriorated.

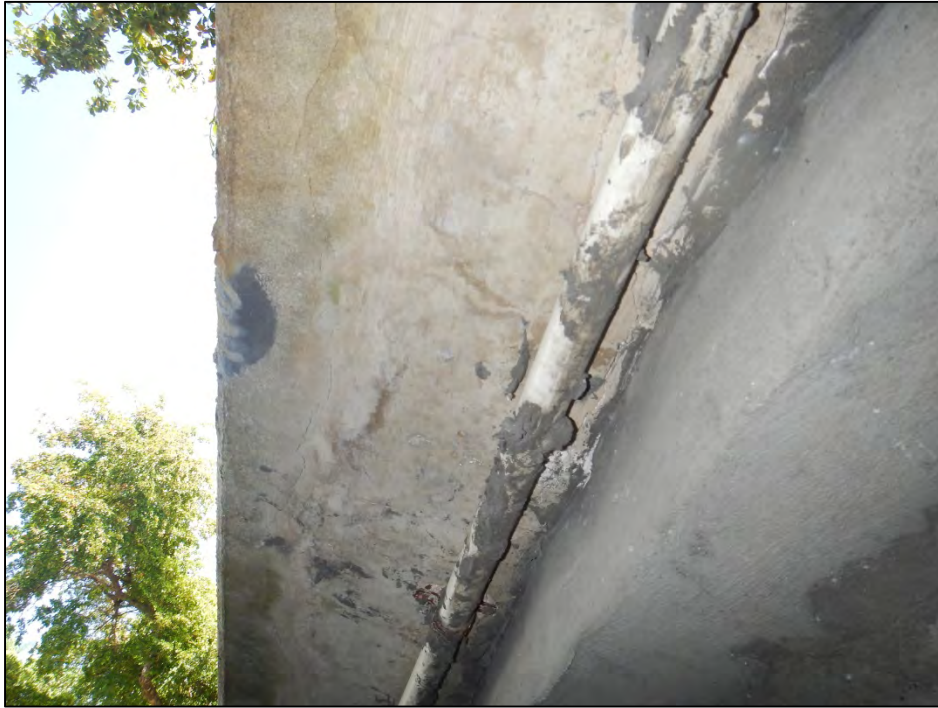
Photo 3 – Beam I-I exhibits longitudinal cracks.

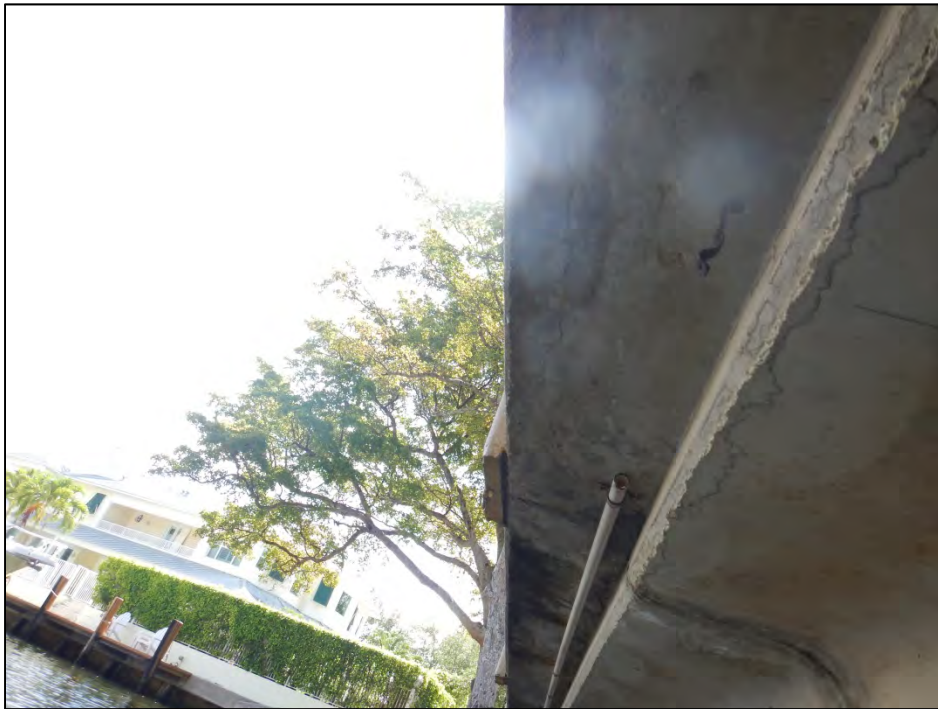
Photo 4 – The right overhang exhibits cracking with delaminations.
