## **EXECUTIVE SUMMARY**

TranSystems has been retained by the City of Fort Lauderdale to perform bridge inspections and prepare bridge inspection reports for each of the City's bridges as part of the project Structural Bridge Engineering Consulting Services Master Plan, RFQ No. 946-11310. Inspections were completed and reports prepared for 46 of the City's bridges. The remaining five bridges in the City's inventory were not inspected because they are in the process of being replaced.

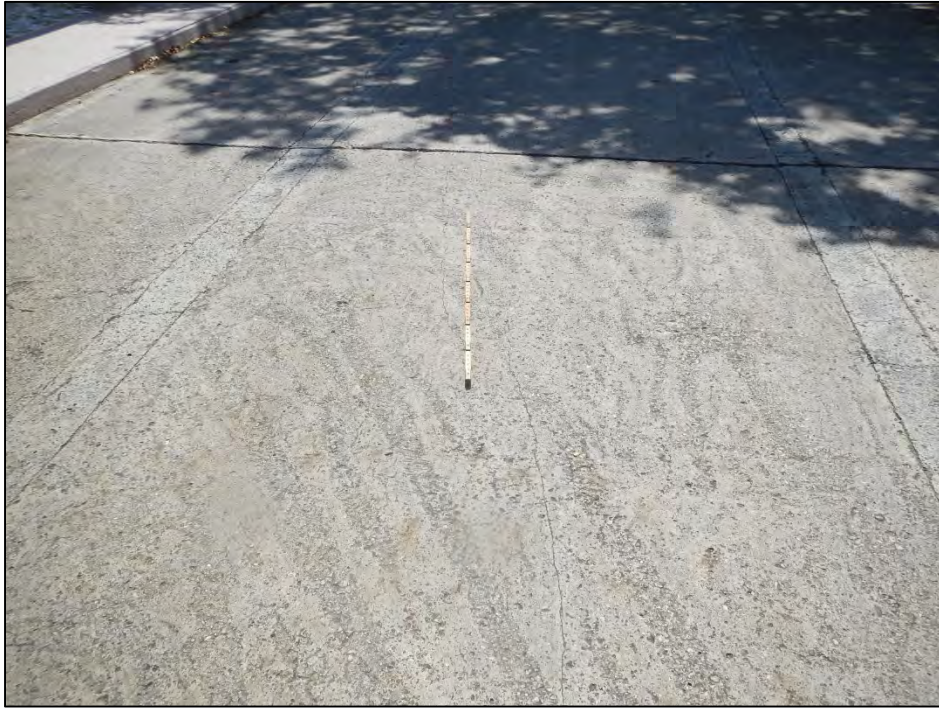
Photo 5 – The deck top over Span 2 exhibits longitudinal cracks.

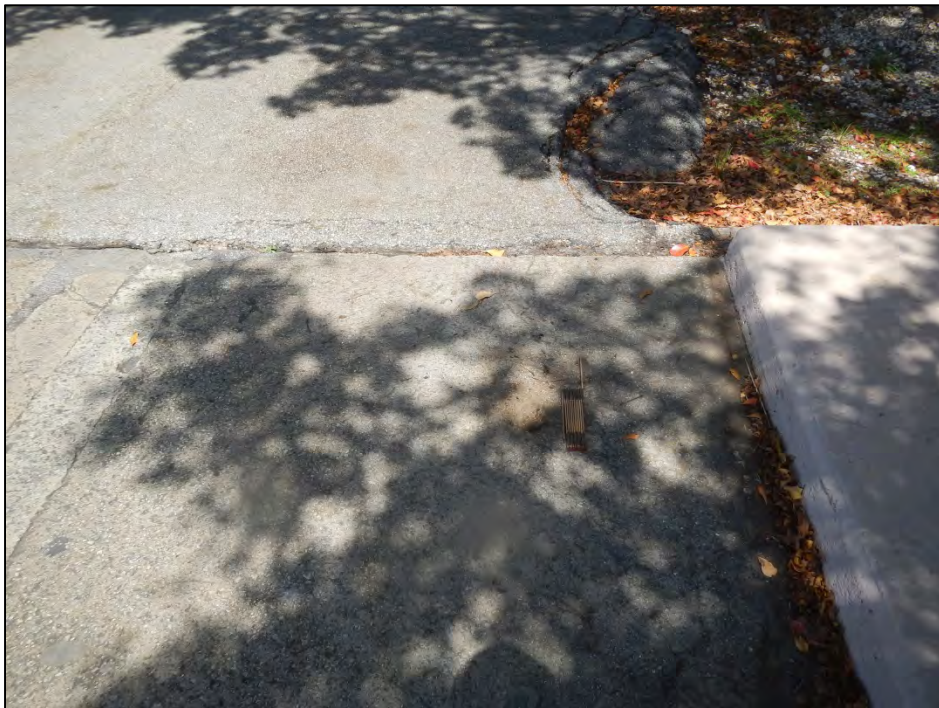
Photo 6 – The deck top exhibits an unpatched pick up point.

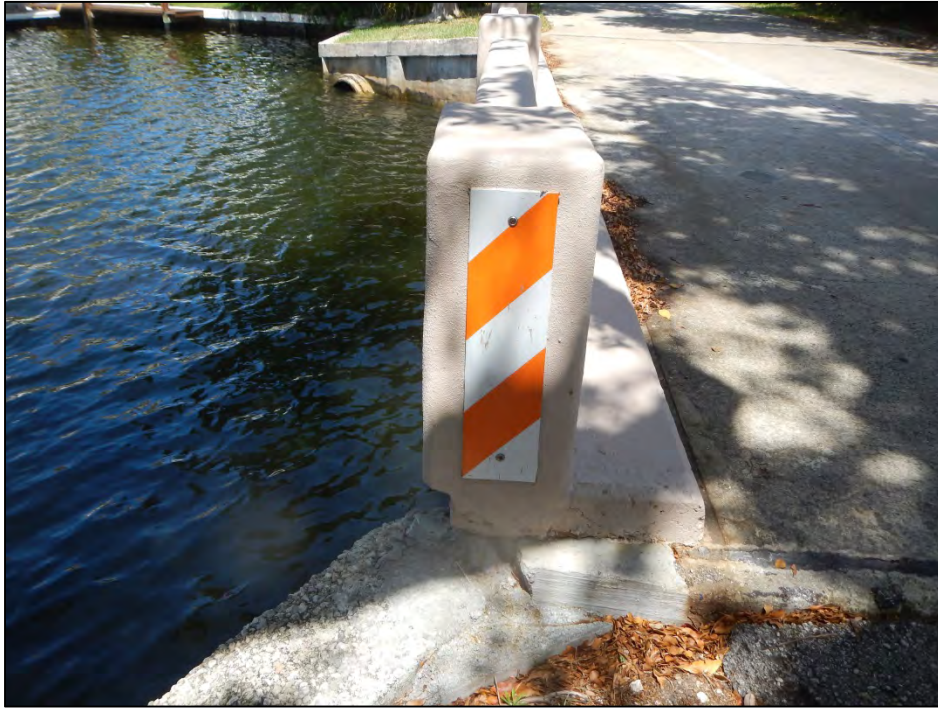
Photo 7 – The northwest corner object marker diagonal striping is oriented incorrectly.

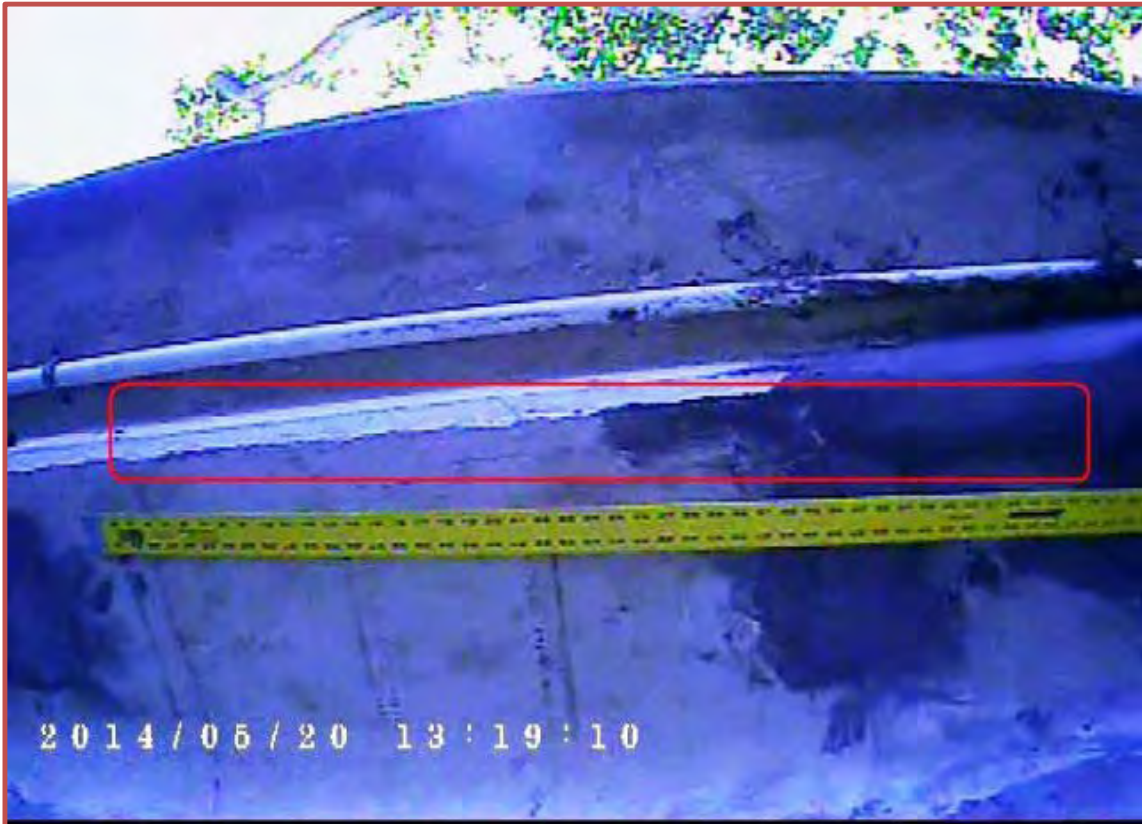
Description: Top: Outer edges of the Beam flanges, horizontal cracks. **UW Photo 01.**  
Bottom: Underside of the top flanges of the beams, spall/delaminations. **UW Photo 02.**

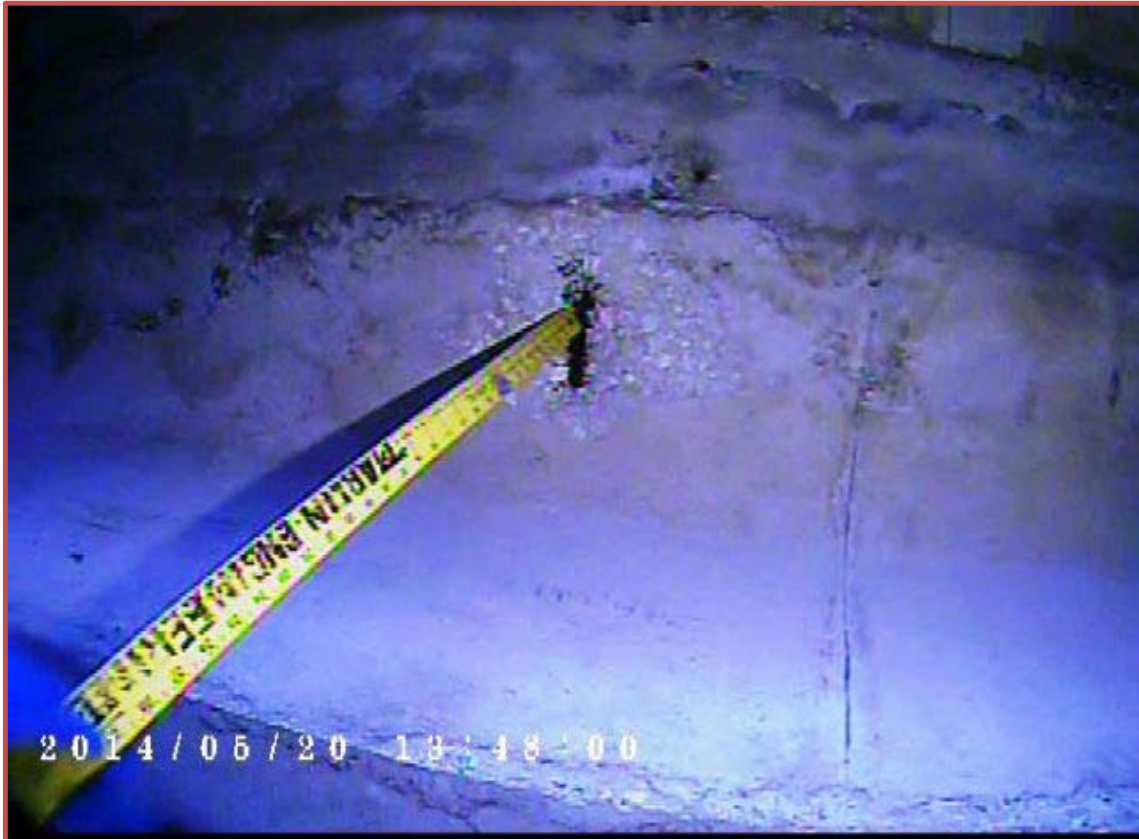
Description: Top: Underside of the top flanges of the beams, spall/delamination. **UW Photo 03.**  
Bottom: Delaminated areas along the beams bottom flanges. **UW Photo 04.**

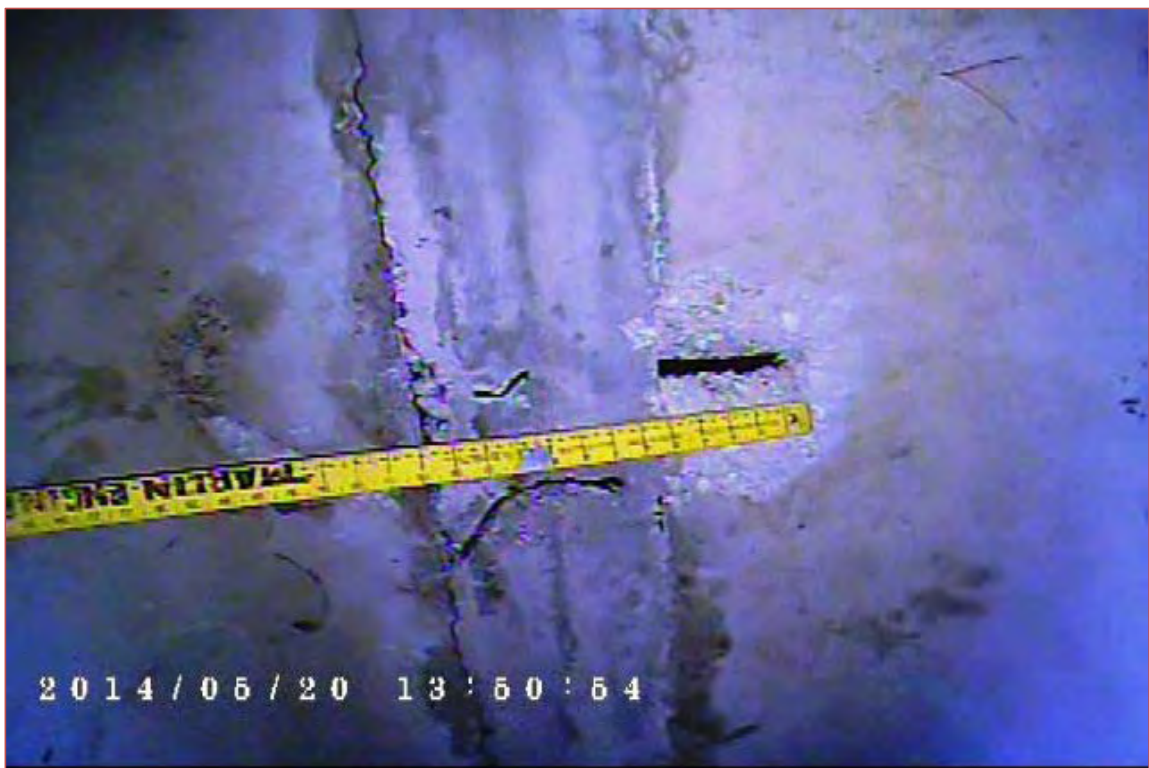
Description: Top: Beam 2-3, bottom edge spall/delamination with exposed rebar. **UW Photo 05.**  
Bottom: Closure pour between Beam 1-1 and 1-2, unsound with rebar. **UW Photo 06.**

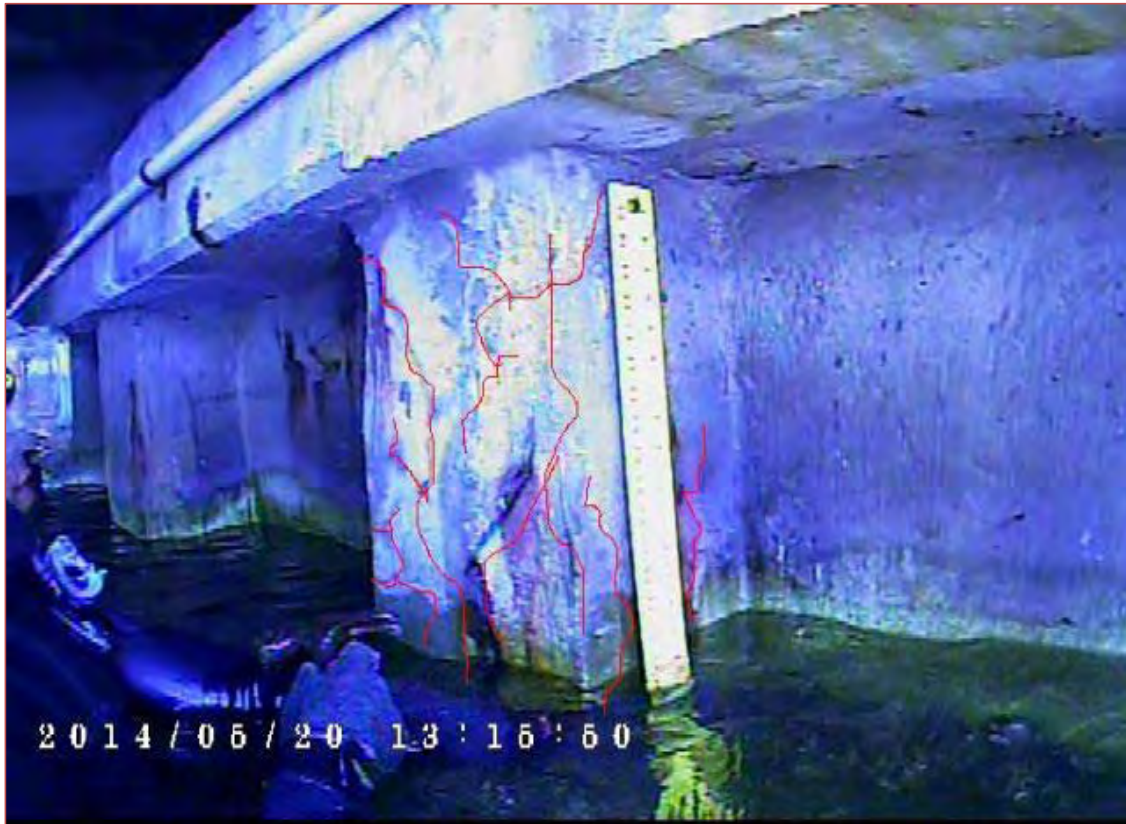
Description: Top: Pile 1-1, East face exhibits cracking with corrosion bleed-out. **UW Photo 07.**  
Bottom: Pile 1-4, NE corner spall, with exposed rebar and cracking. **UW Photo 08.**

\_Remove all unsound concrete and patch. Also epoxy inject all the cracks as needed at the following Piles; 1-1, 1-4, 1-5, 1-6, 2-1, 2-2 and 2-5.

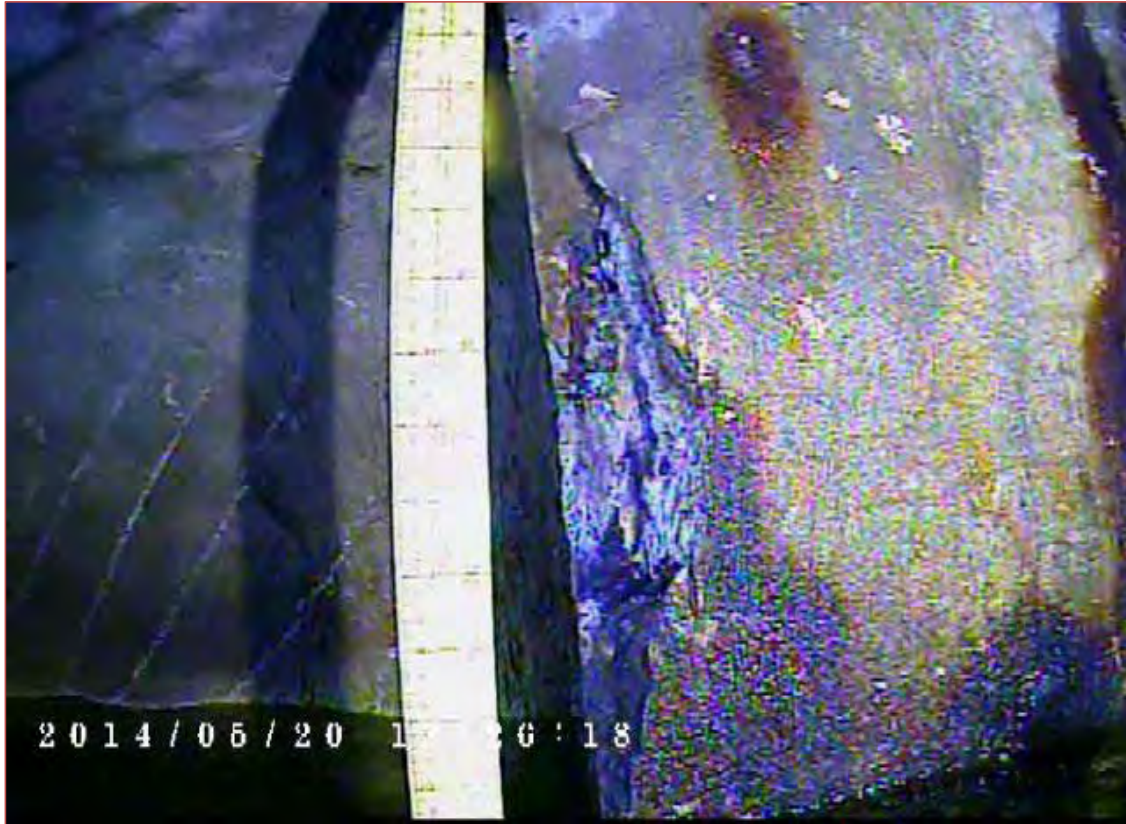
Description: Top: Pile 1-5, SE corner, spall, with exposed rebar and cracking. **UW Photo 09.**  
Bottom: Pile 1-6, East face cracking with corrosion bleed-out. **UW Photo 10.**

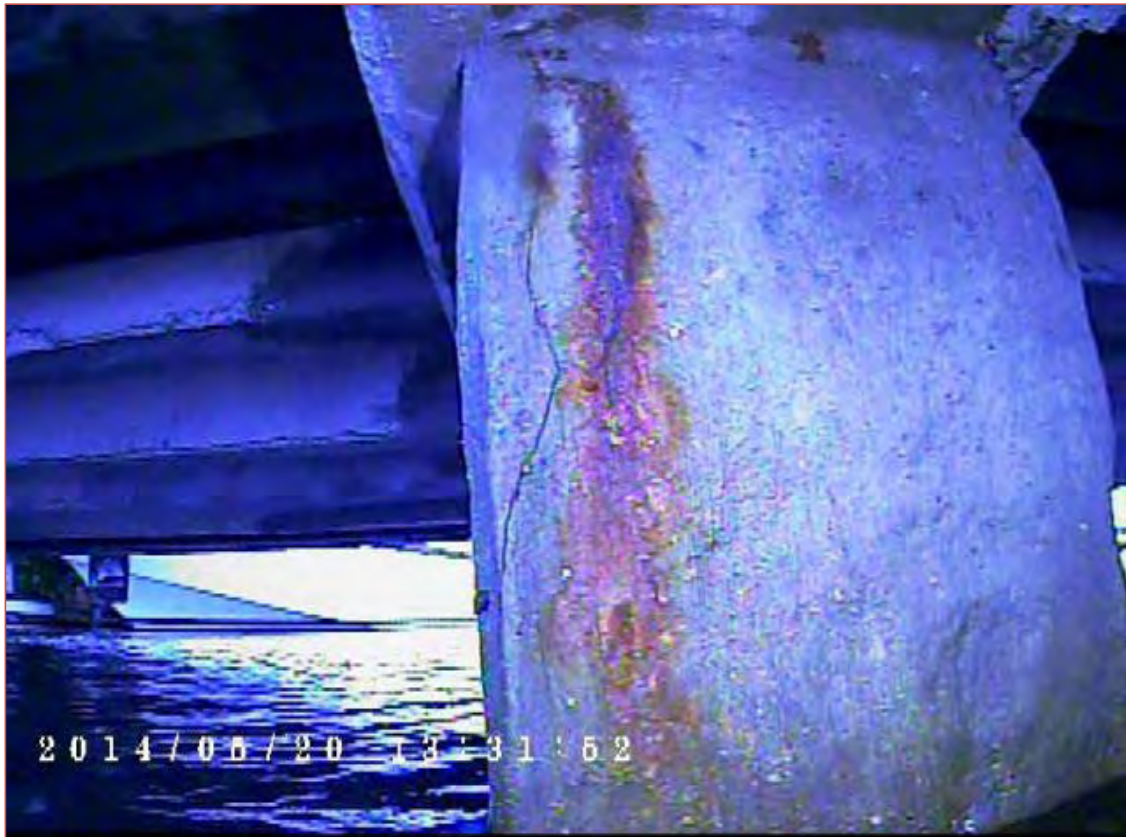
Description: Top: Pile 2-1, cracking with corrosion bleed-out and hollow sound. **UW Photo 11.**  
Bottom: Abutment 1 cap horizontal cracks, near the bottom edge. **UW Photo 12.**

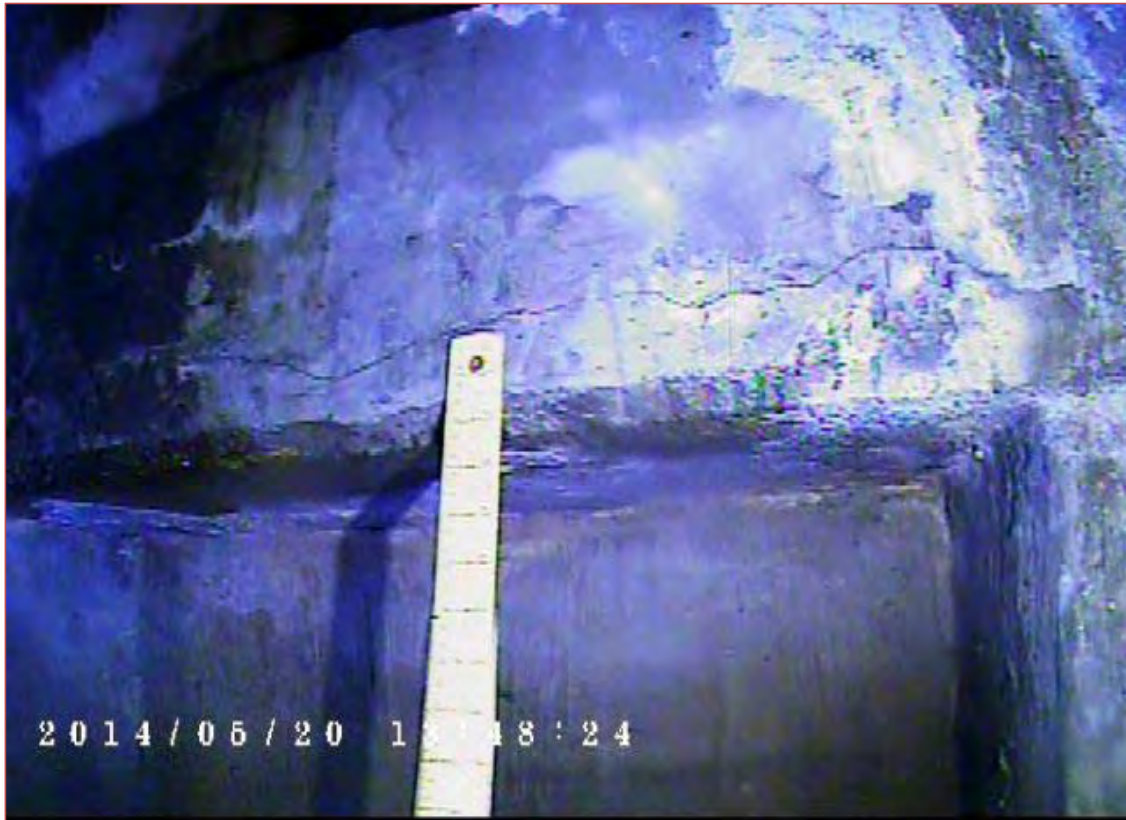
Description: Top: Abutment 2 cap horizontal cracks, near the bottom edge. **UW Photo 13.**  
Bottom: Bent 2 cap between Piles 2-5 and 2-6, bottom horizontal crack. **UW Photo 14.**

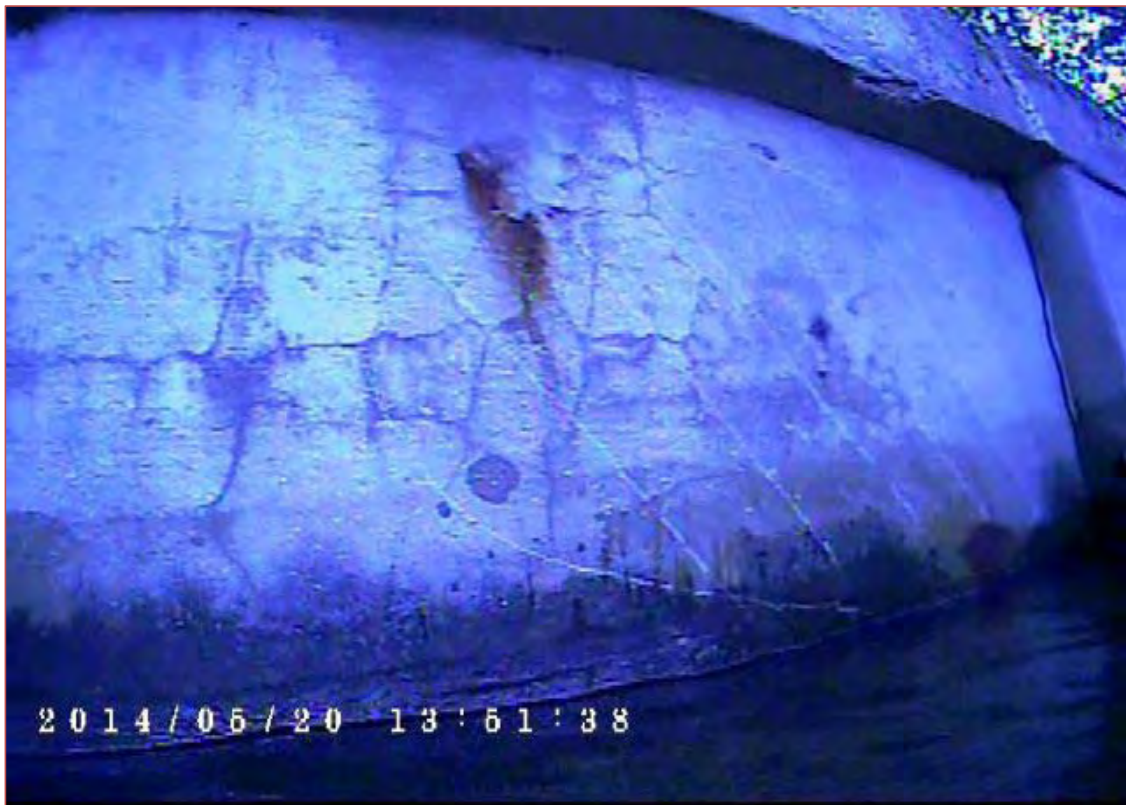
- The retaining walls and abutment backwalls have up to 1/32 in. wide cracks with corrosion bleedout throughout. See Underwater Inspection Report Photos 15 and 16.
- There are several spalls/delaminations up to 1 ft. 3 in. x 3 in. x 1 in. intermittently along the retaining wall caps, with exposed rebars and associated cracks up to 1/16 in. wide. See Underwater Inspection Report Photo 17.
- The transition joints between the northwest, southwest and northeast retaining walls and the backwalls have re-opened up to 1 1/2 in. wide and have minor backfill leakage. See Underwater Inspection Report Photo 18.
- The southeast retaining wall, center pile, has separated from the wall leaving a space up to 1/8 in. wide, starting from the cap and extending to the ground line. See Underwater Inspection Report Photo 19.

Description: Top: Abutment backwalls, cracks with corrosion bleed-out throughout . **UW Photo 15.**  
Bottom: Retaining walls have cracks with corrosion bleed-out throughout. **UW Photo 16.**

\_Remove all unsound concrete and patch and epoxy inject all the cracks as needed at Abutment 1 and 2 backwalls.

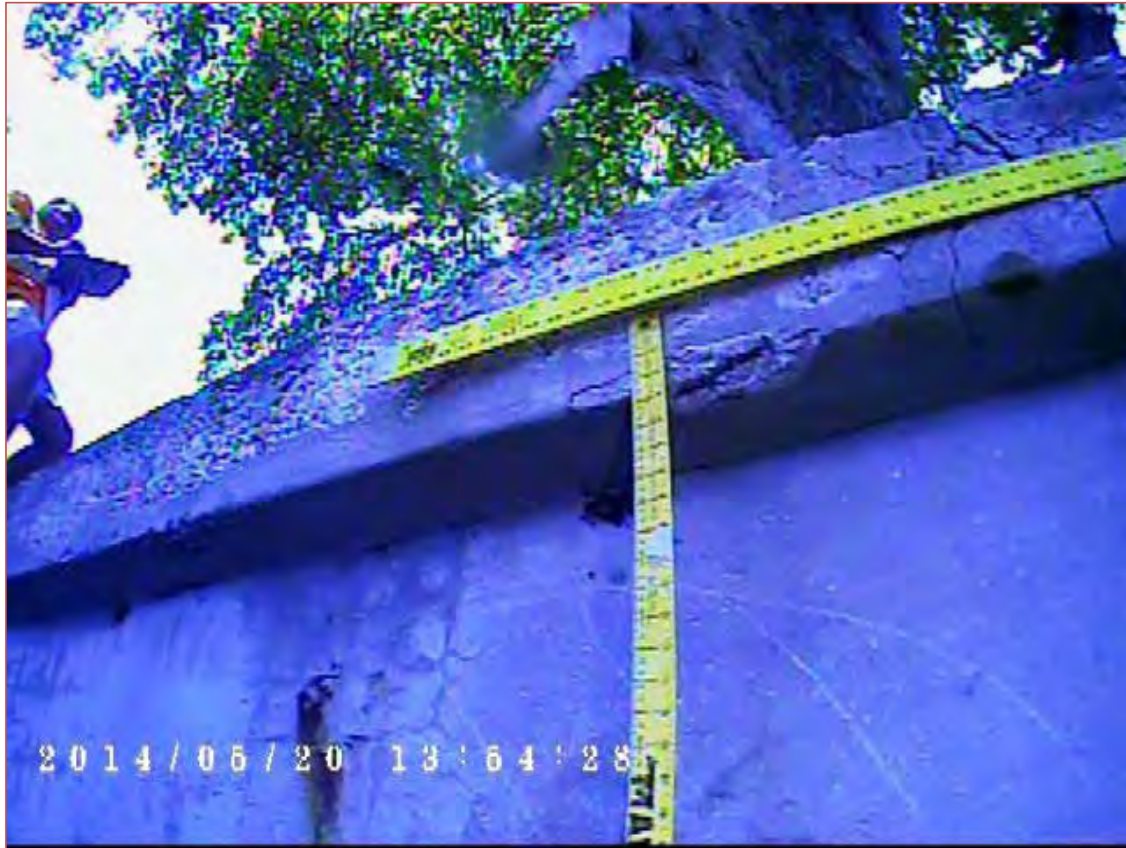
Description: Top: Spall/delaminations intermittently along the retaining wingwalls caps. **UW Photo 17.**  
Bottom: NW transition joint repair has reopen underwater up to 1-1/2". **UW Photo 18.**

\_Seal all four transition joints to wingwalls and backwalls. Also remove all unsound concrete and patch and epoxy inject all the cracks as needed.

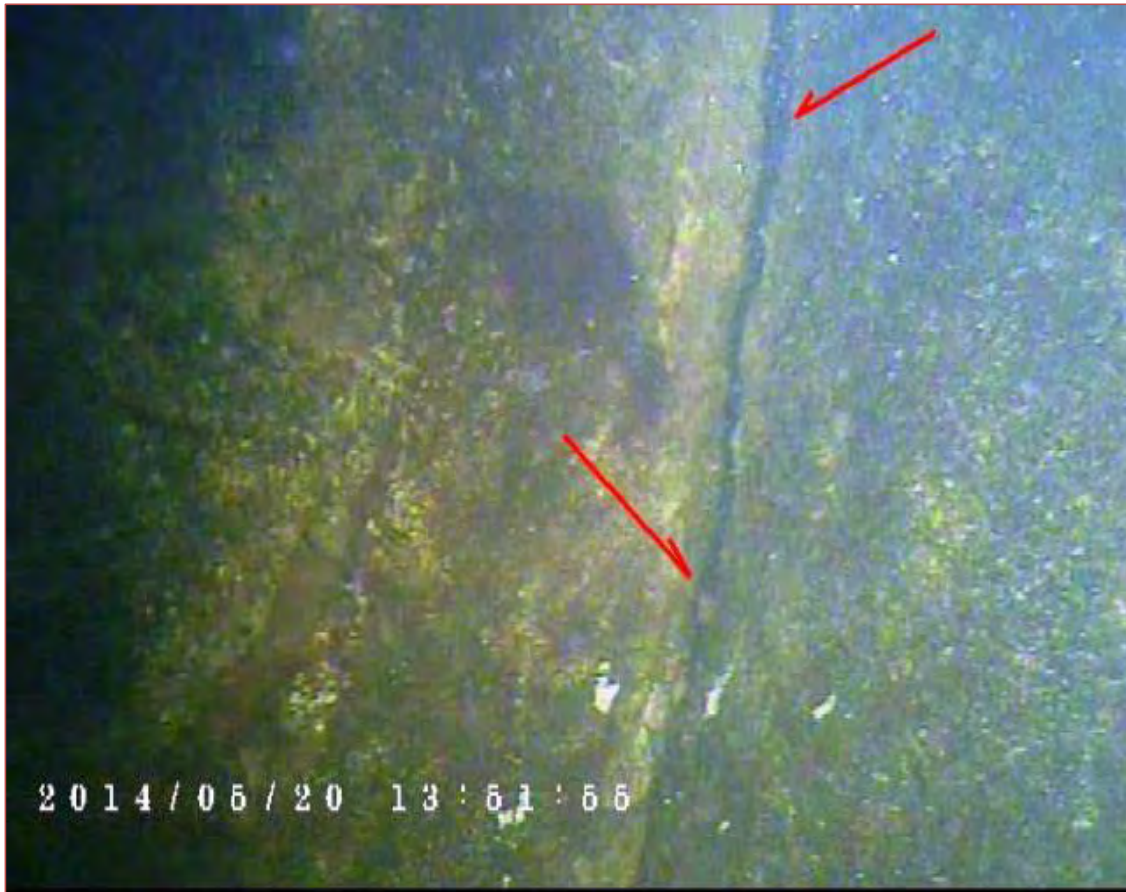
\_The SE retaining wall, center Pile has separated from the wall leaving a space up to 1/8" wide, starting from the cap and extending to the ground-line. **UW Photo 19. NEW.**

Description: SE retaining wall, center Pile has separated from the wall leaving a space up to 1/8" wide.  
**UW Photo 19.**

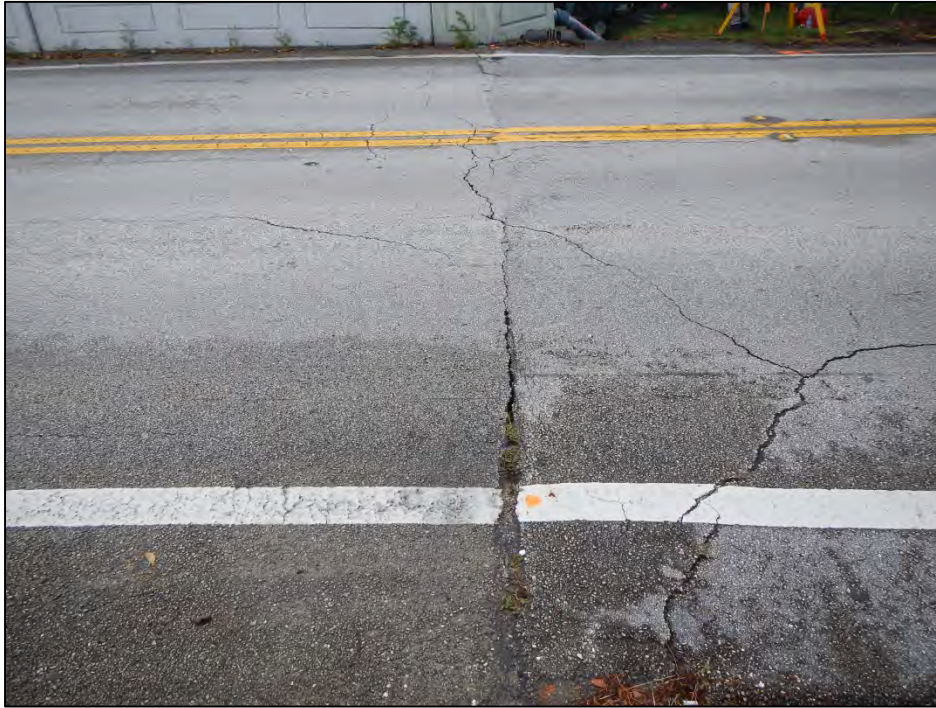
Photo 1 – End Bent 1 joint seal transverse crack.

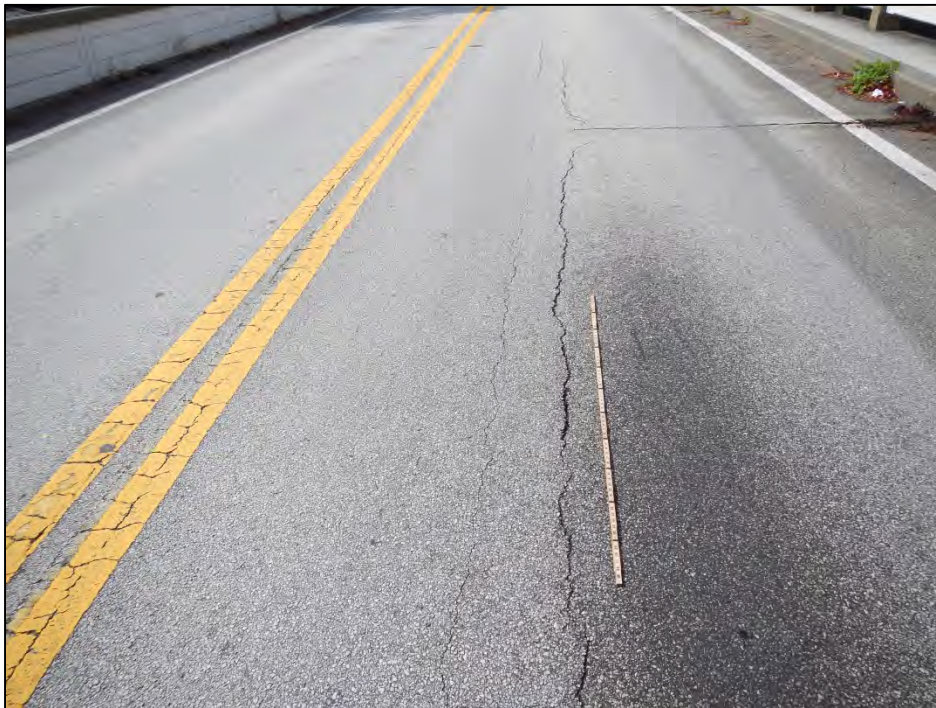
Photo 2 – Deck top longitudinal cracks.

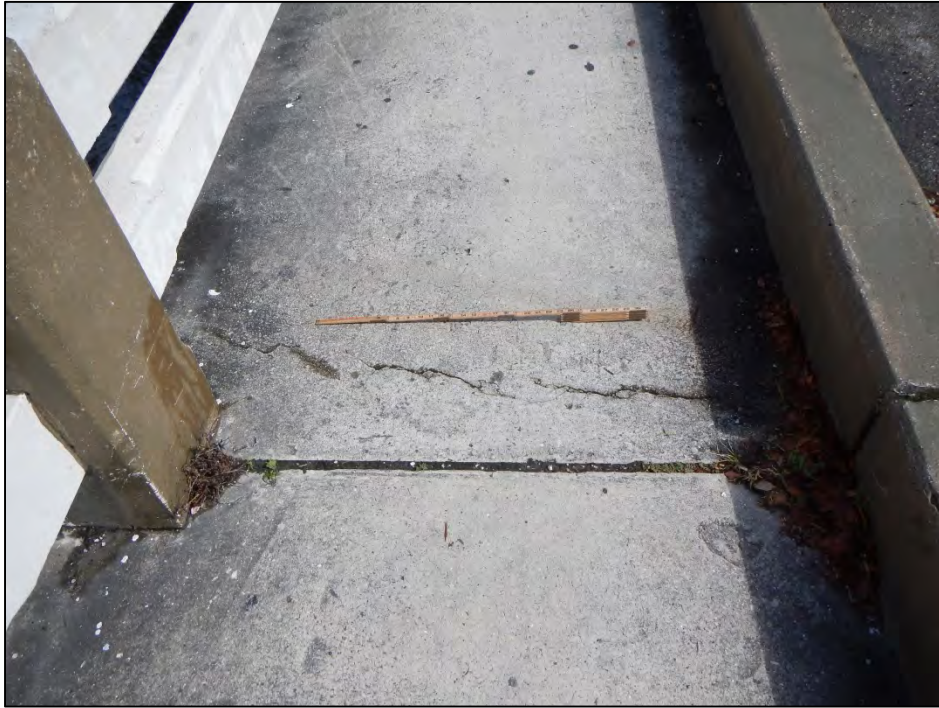
Photo 3 – West sidewalk transverse crack.

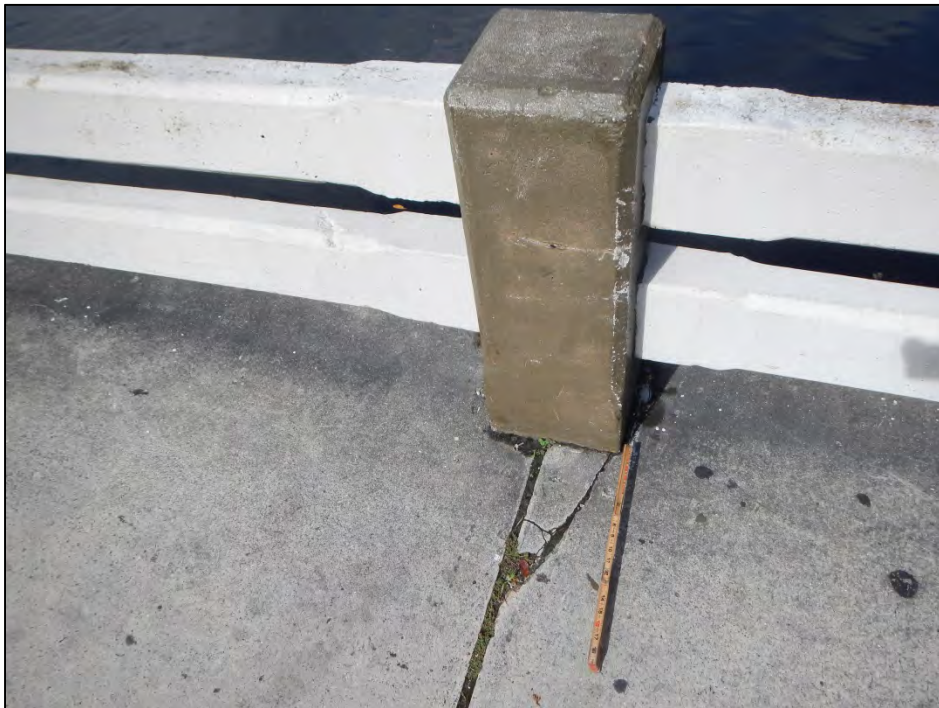
Photo 4 – West sidewalk delamination over Bent 3.

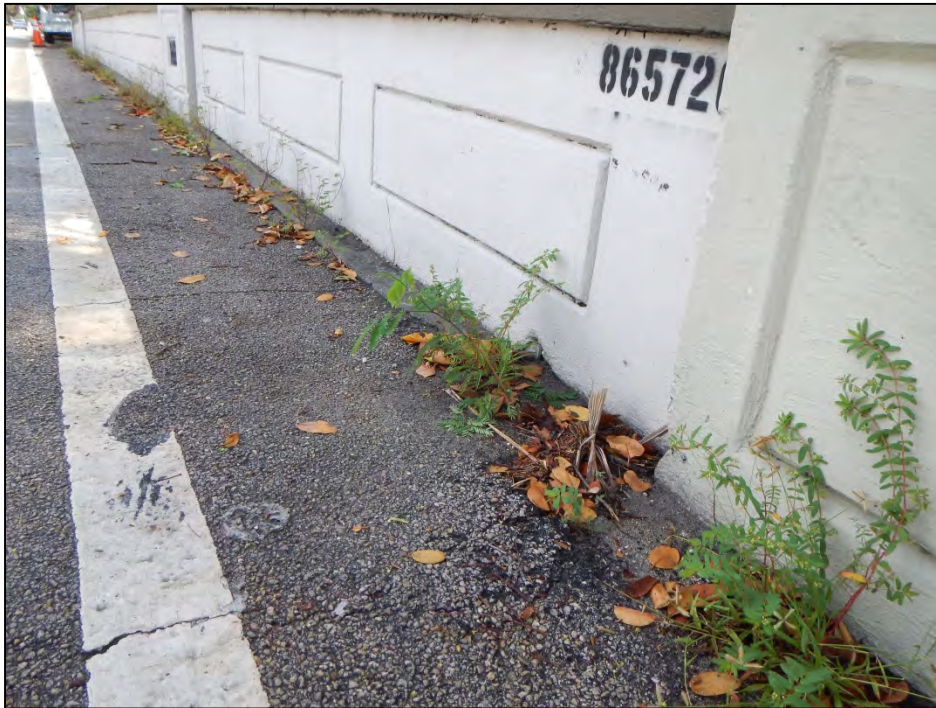
Photo 5 – East shoulder vegetative growth and debris.

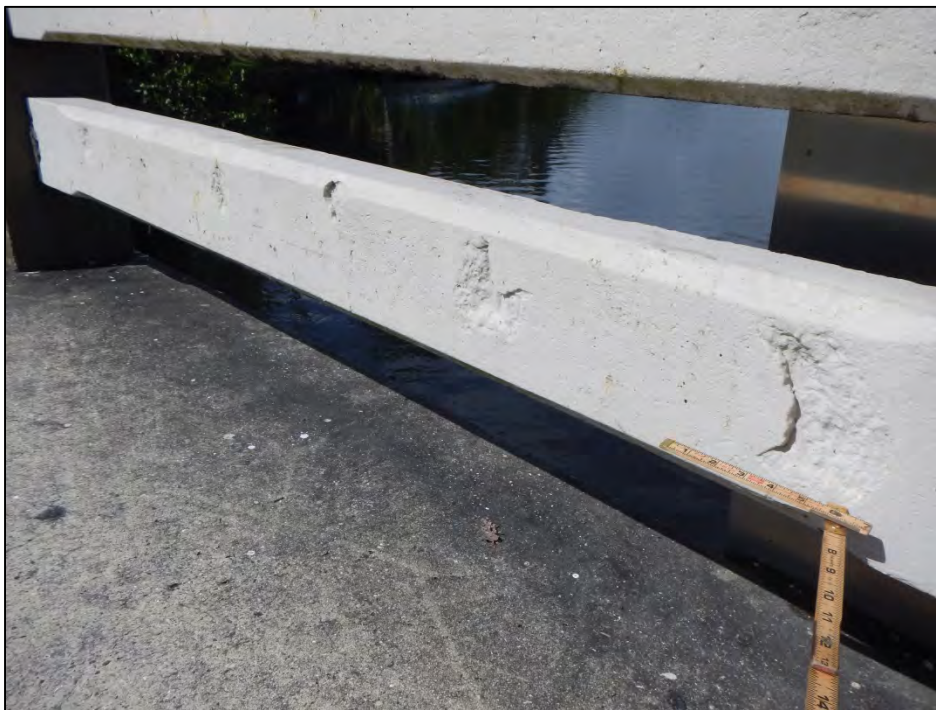
Photo 6 – Left rail between Posts 1-3 and 1-4 exhibits 6 spalls.

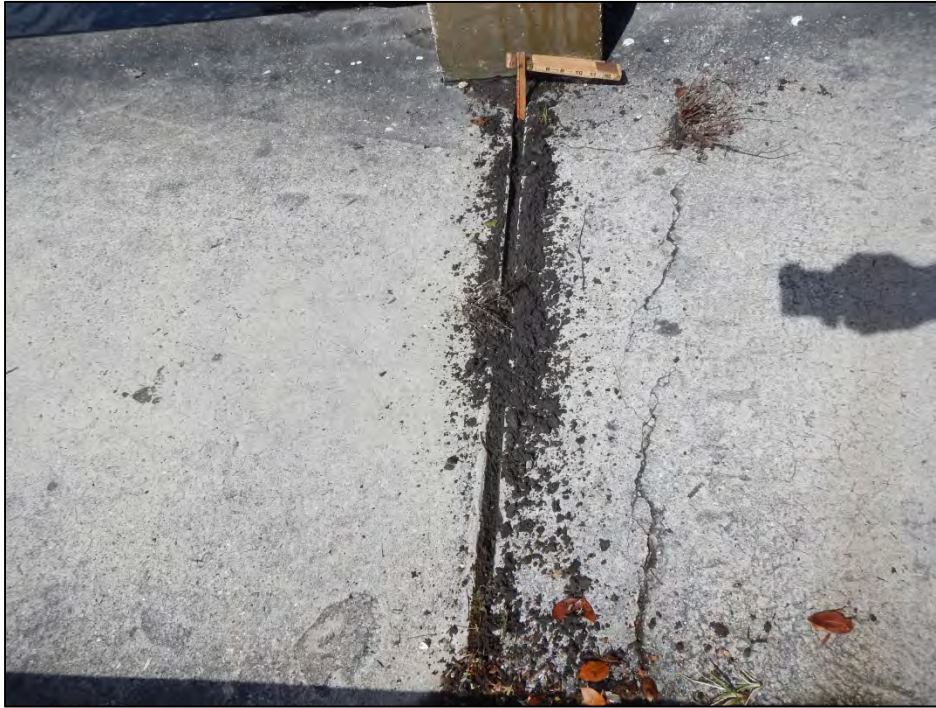
- The sealant in the left sidewalk joints is deteriorated and the joints are filled with dirt and debris. See Condition Photo 7.

Photo 7 – Joint seal at the west sidewalk is deteriorated and filled with debris.

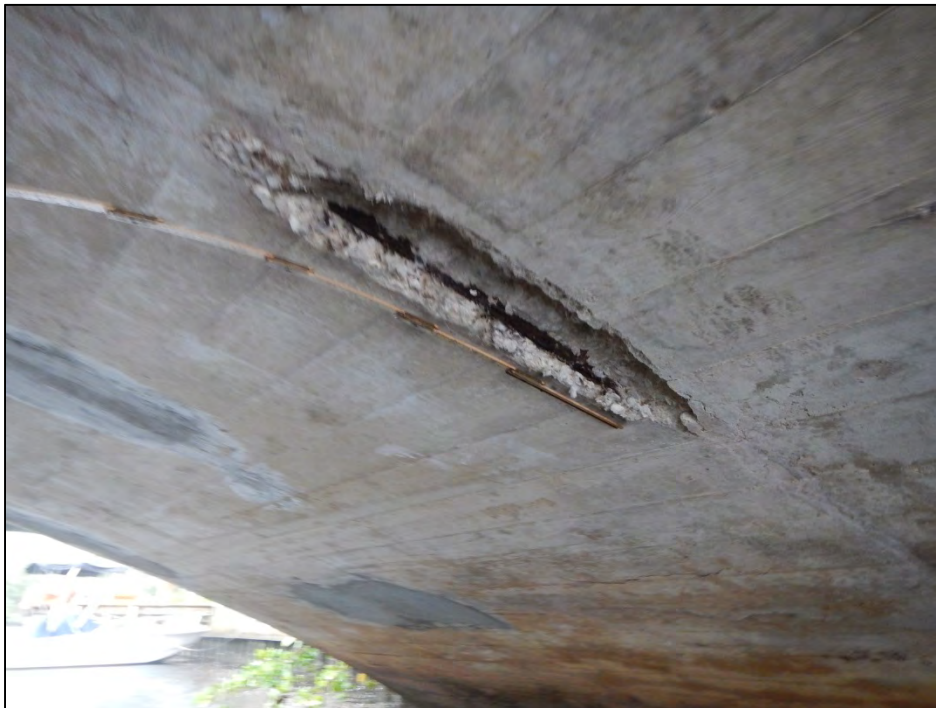
Photo 8 – Span 2 spall with exposed steel.

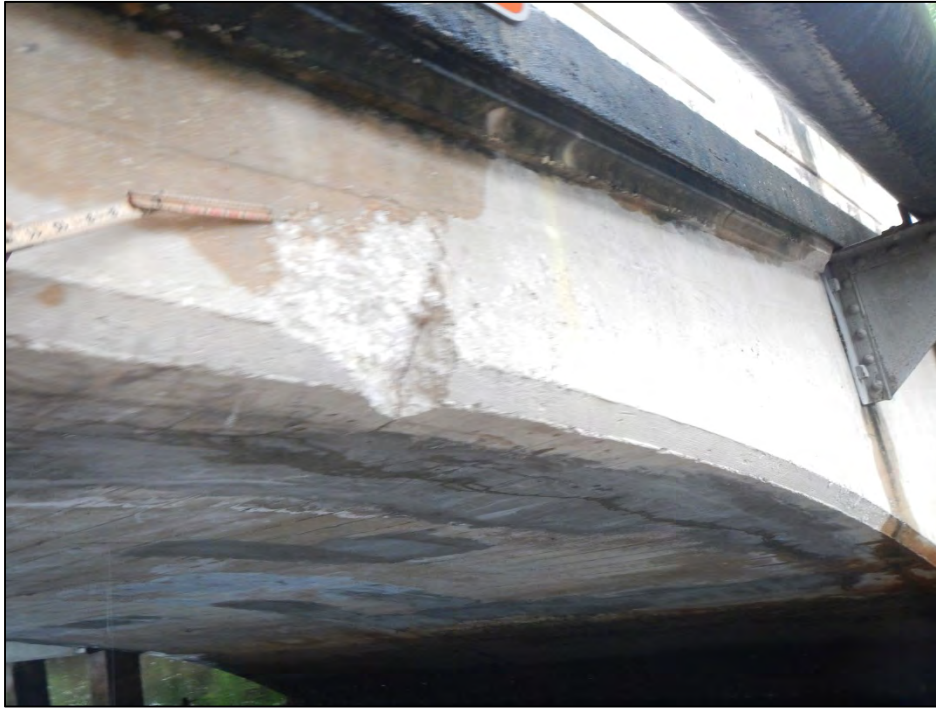
Photo 9 – Span 2 east side spall and delamination at mid span.

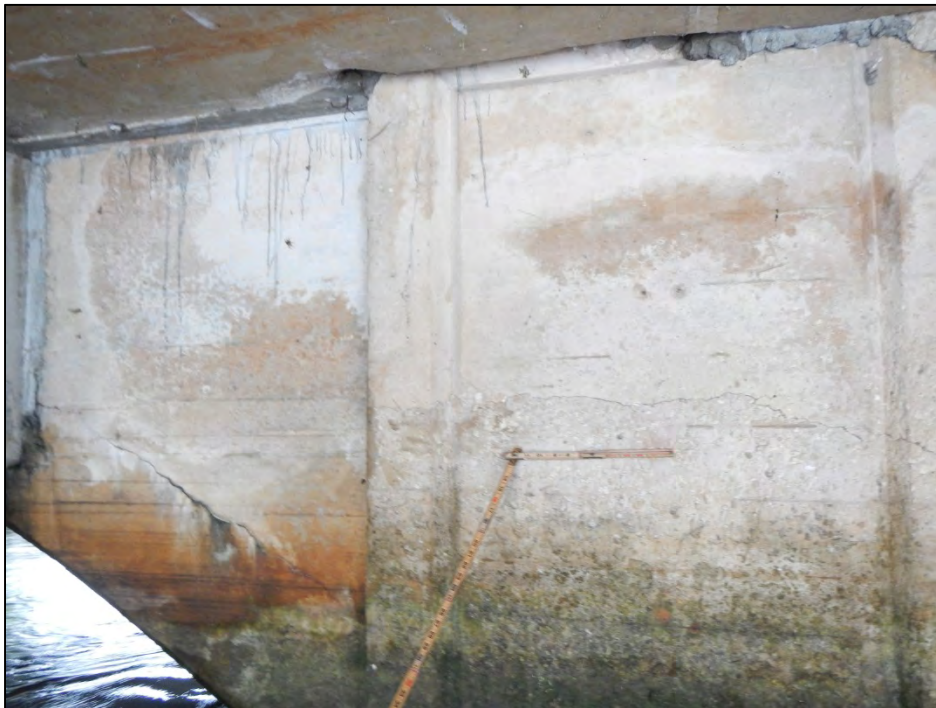
Photo 10 – West side of Pier 2 of the arch – diagonal and horizontal cracks.

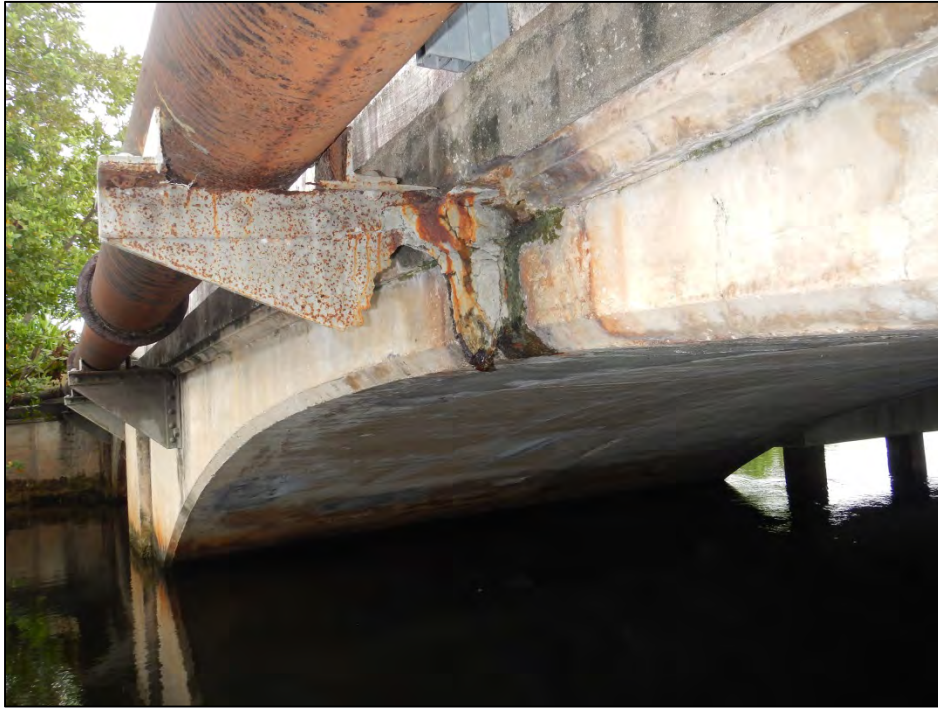
Photo 11 – Utility pipe support at the east side with 100% section loss.

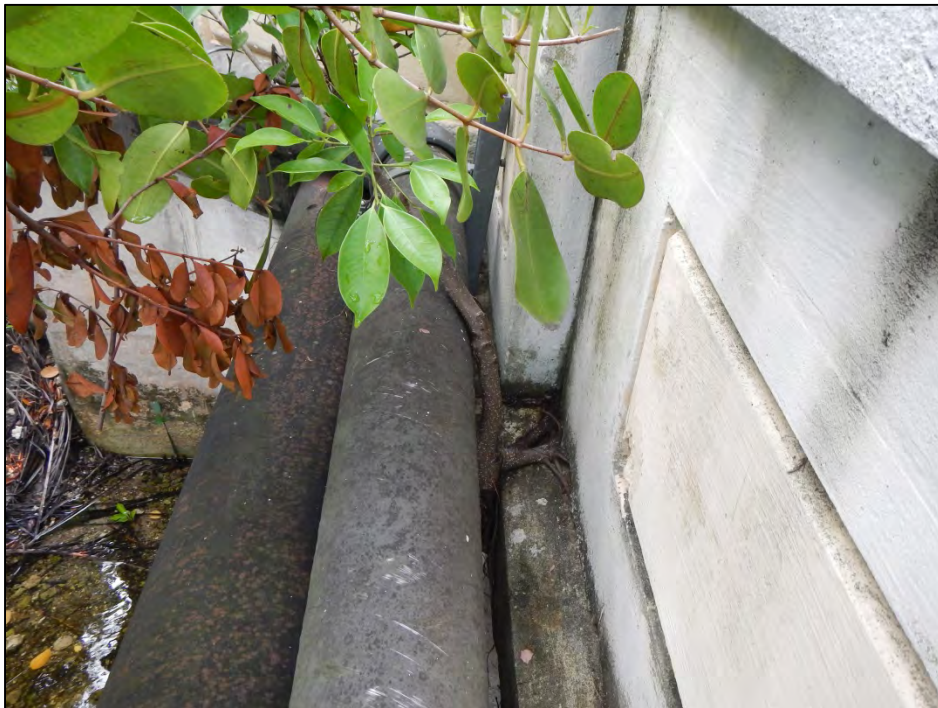
Photo 12 – End Bent 1 at the east side exhibits vegetative growth.

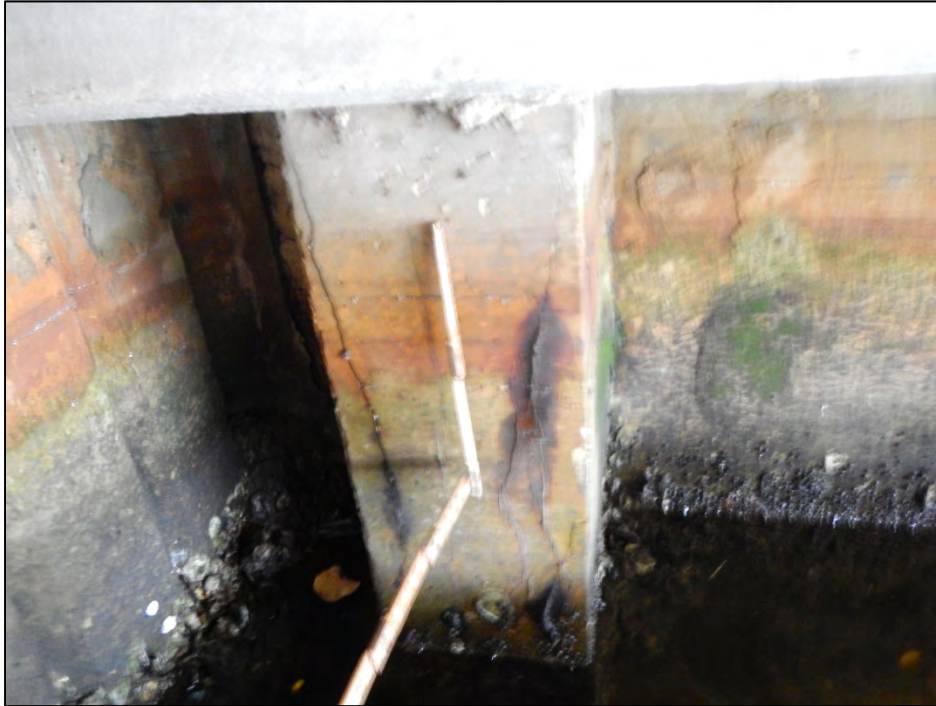
Photo 13 – The north face of Pile 1-3 exhibits vertical cracks with corrosion bleed-out.

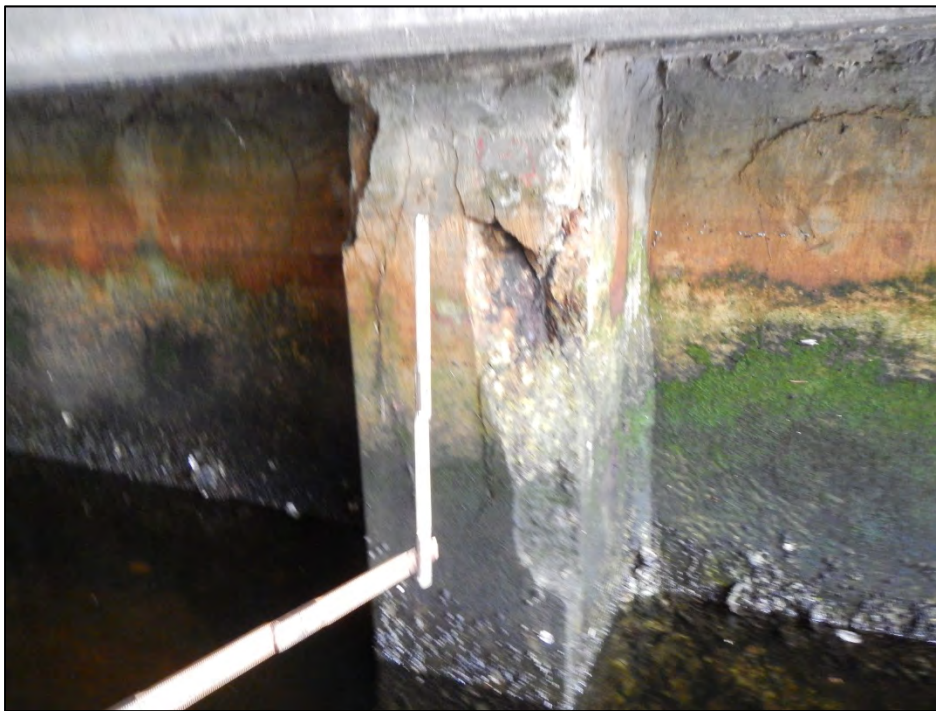
Photo 14 – The northwest corner of Pile 1-2 exhibits spalls and delaminations.

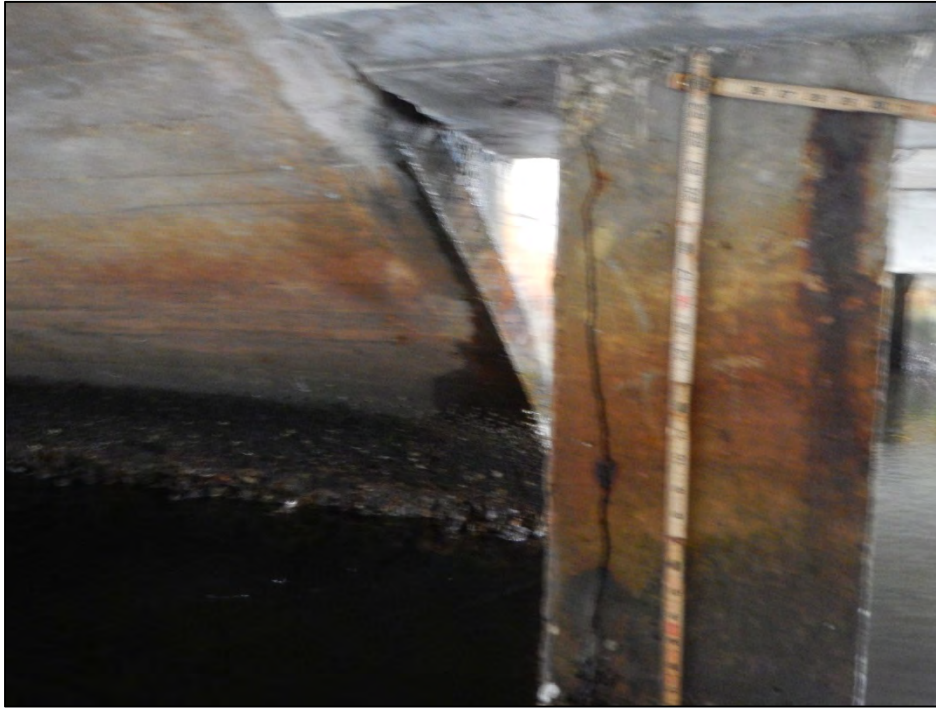
Photo 15 – The north face of the northeast corner of Pile 2-3 exhibits a vertical crack with corrosion bleed-out.
