## **EXECUTIVE SUMMARY**

TranSystems has been retained by the City of Fort Lauderdale to perform bridge inspections and prepare bridge inspection reports for each of the City's bridges as part of the project Structural Bridge Engineering Consulting Services Master Plan, RFQ No. 946-11310. Inspections were completed and reports prepared for 46 of the City's bridges. The remaining five bridges in the City's inventory were not inspected because they are in the process of being replaced.

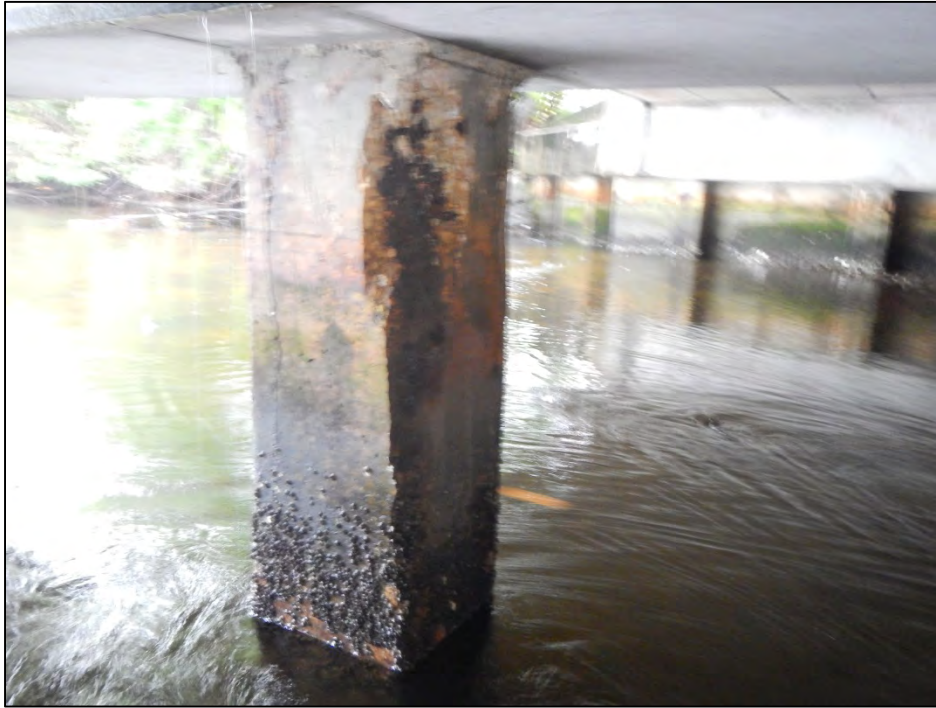
Photo 17 – All faces of Pile 3-2 exhibit spalls with associated cracks with corrosion bleed-out.

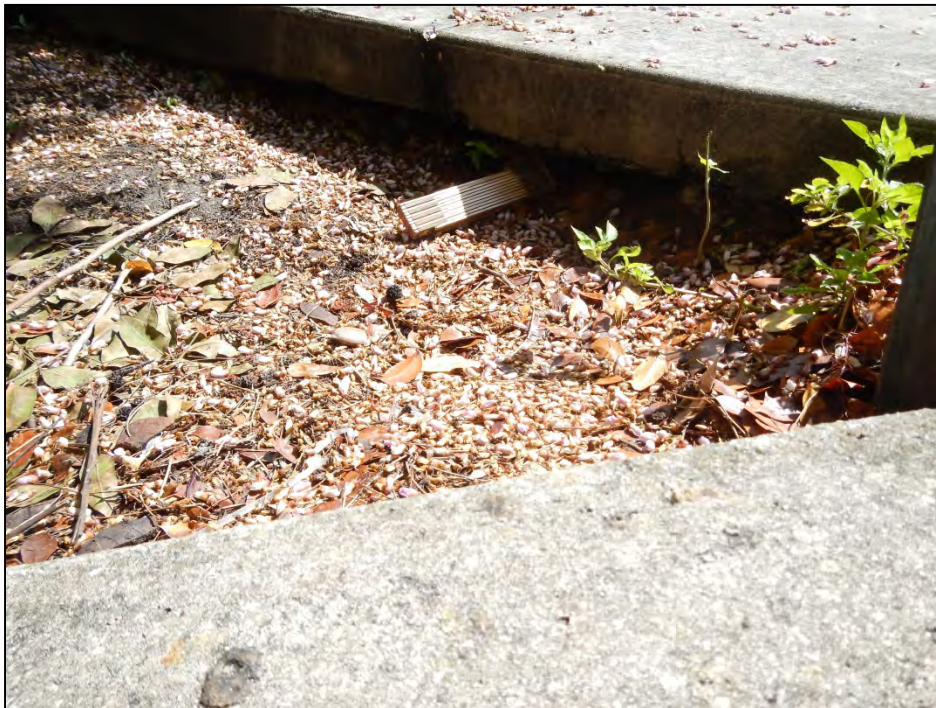
Photo 18 – Northwest approach sidewalk exhibits undermining.

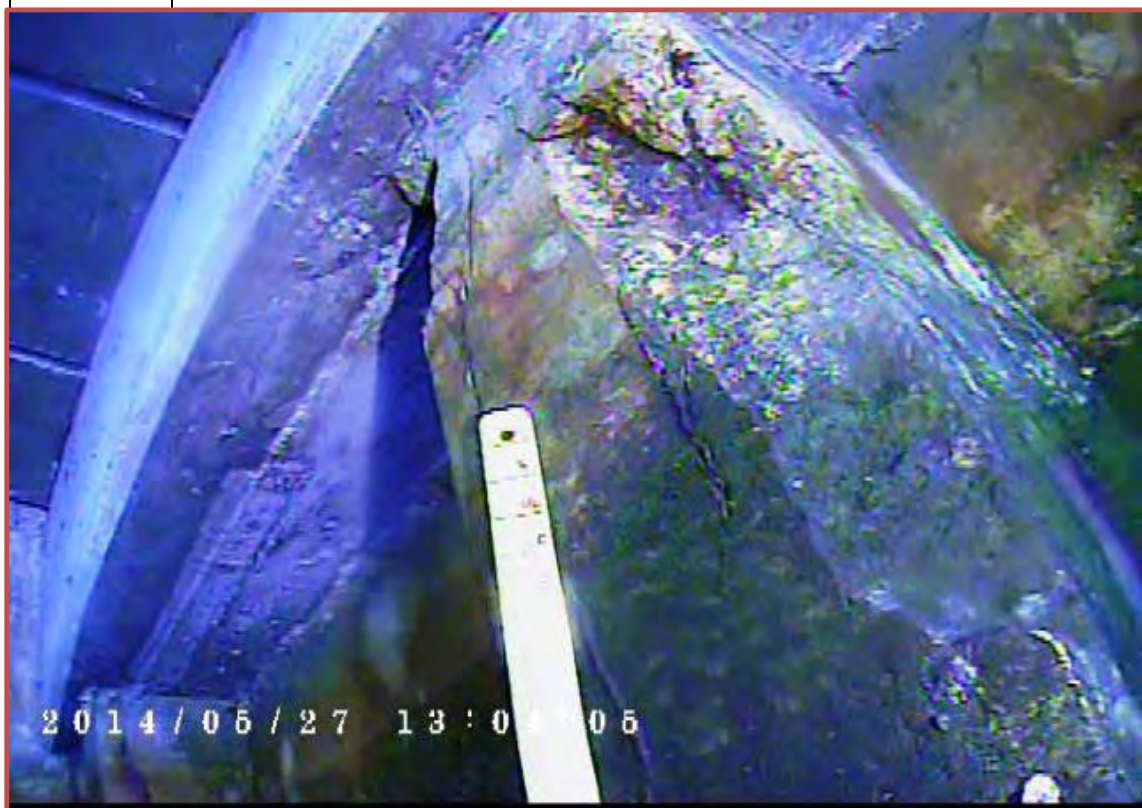
\_Pile 1-2, NW and NE corners have spall/delamination up to 36" x 11" x 2", with exposed rebars up to 60% section loss and associated cracks up to 1/8". Starting at the cap. **UW Photo 02. INCREASE.**

Description: Top: Arch exhibits scaling up to 1/8", along the high watermark. **UW Photo 01.**  
Bottom: Pile 1-2, NW and NE corners, spall/delamination. **UW Photo 02.**

\_Remove all unsound concrete and patch also seal the cracks as needed on all the Piles.

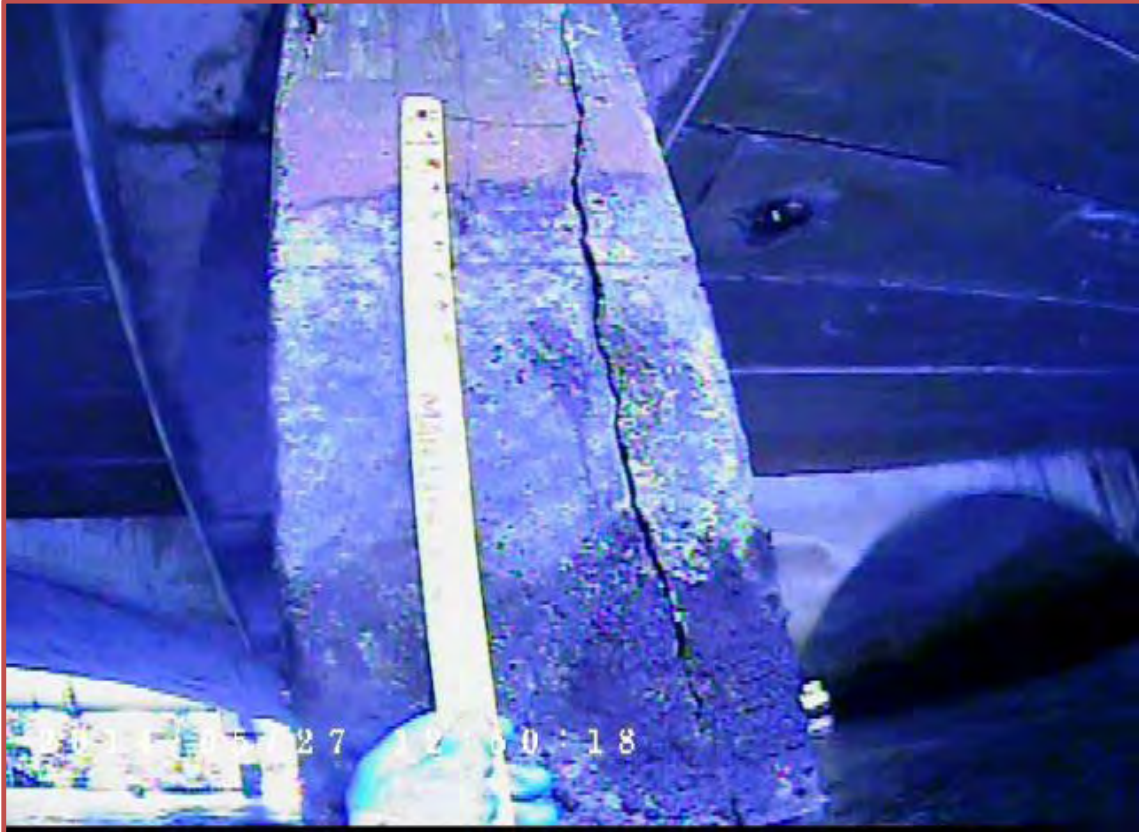
\_Pile 2-1, all four corners are delaminated up to 40" x 10", with associated cracks up to 1/8", and corrosion bleed-out, Starting at the cap. **UW Photo 03. INCREASE.**

Description: Top: Pile 2-1, all four corners are delaminated, with associated cracks. **UW Photo 03.**  
Bottom: Pile 2-3, all four corners are delaminated, with associated cracks. **UW Photo 04.**

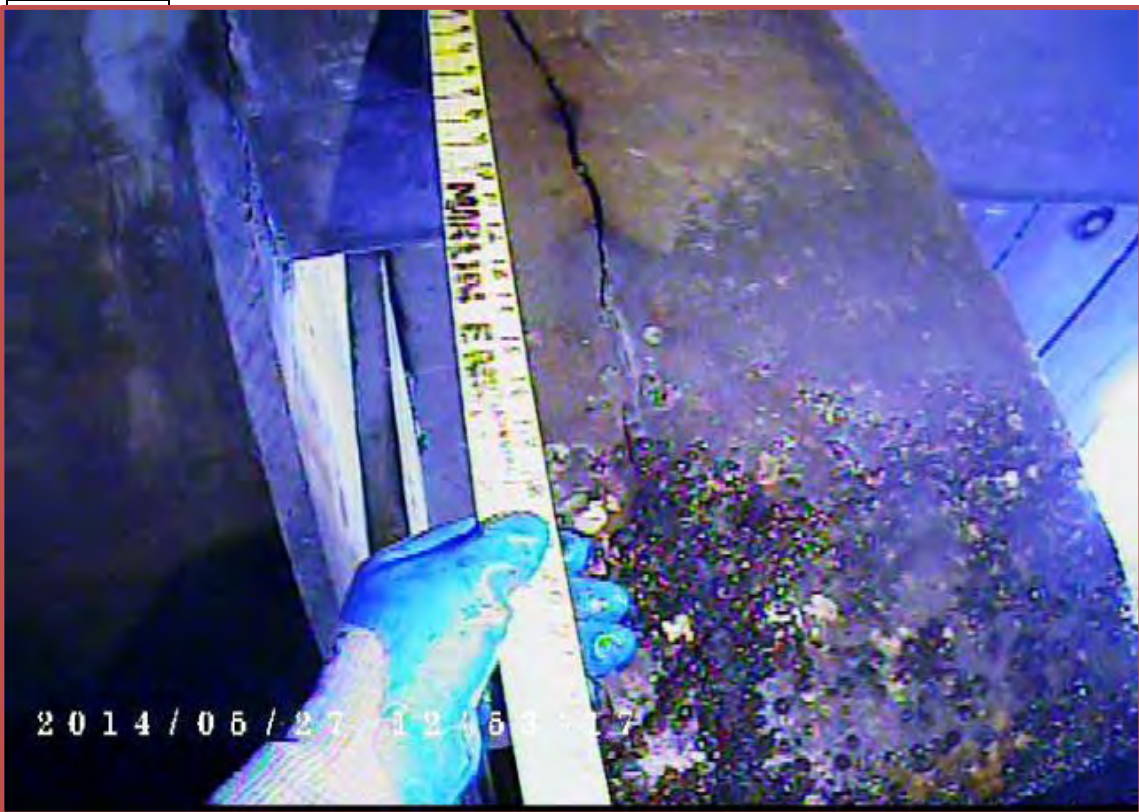
\_Pile 2-3, all four corners are delaminated up to 40" x 10", with associated cracks up to 1/8", and corrosion bleed-out, starting at the cap. **UW Photo 04. INCREASE.**

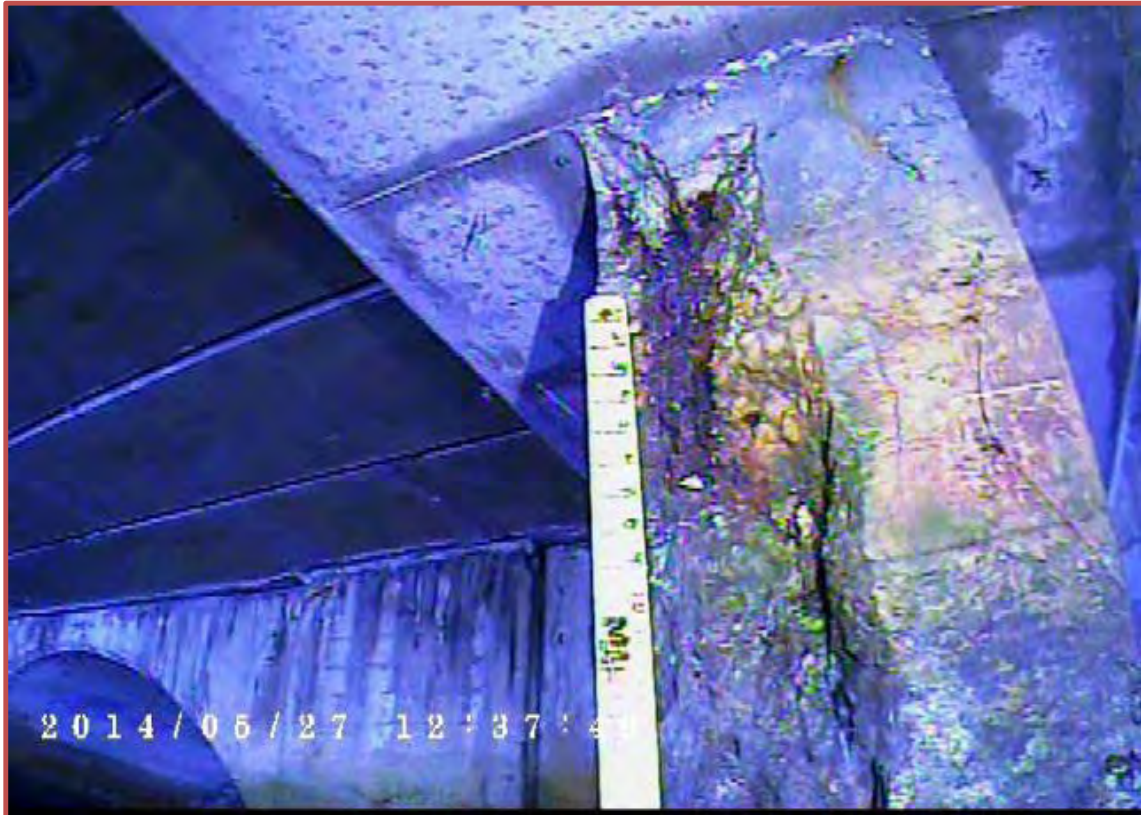
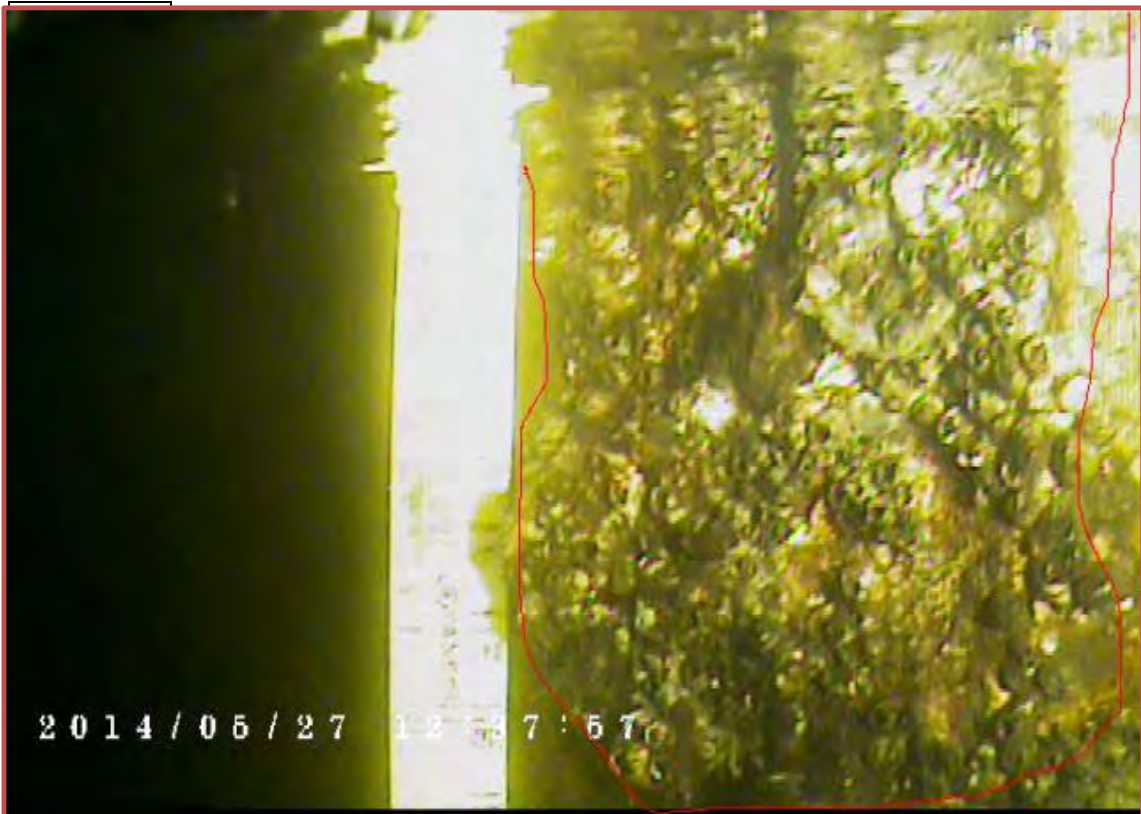
\_Pile 3-2, NE and SE corners and West face have spall/delamination up to 30" x 17" x 2", with exposed rebars up to 50% section loss and associated cracks up to 1/8", and corrosion bleed-out, starting at the cap. **UW Photos 05 and 06. INCREASE.**

Description: Top: Pile 3-2, SE corner, spall/delamination, above water. **UW Photo 05.**  
Bottom: Pile 3-2, SE corner, spall/delamination, below water. **UW Photo 06.**

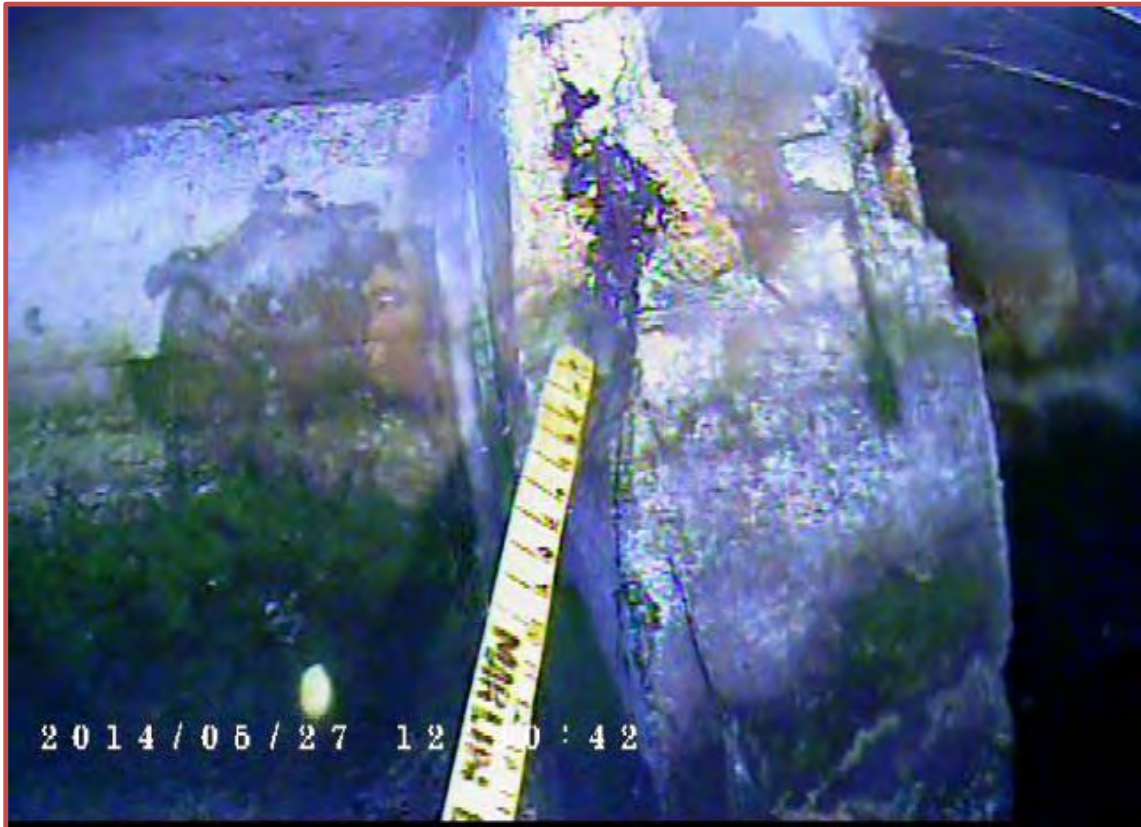
\_Pile 4-2, SW and SE corners have spall/delamination up to 23" x 9" x 2", with exposed rebar 50% section loss and associated cracks up to 1/16", starting at the cap. **UW Photo 07. INCREASE.**

Description: Top: Pile 4-2, SW and SE corners, spall/delamination, w/exposed rebar. **UW Photo 07.**  
Bottom: Several shopping carts in the West channel under Span 1. **UW Photo 08.**

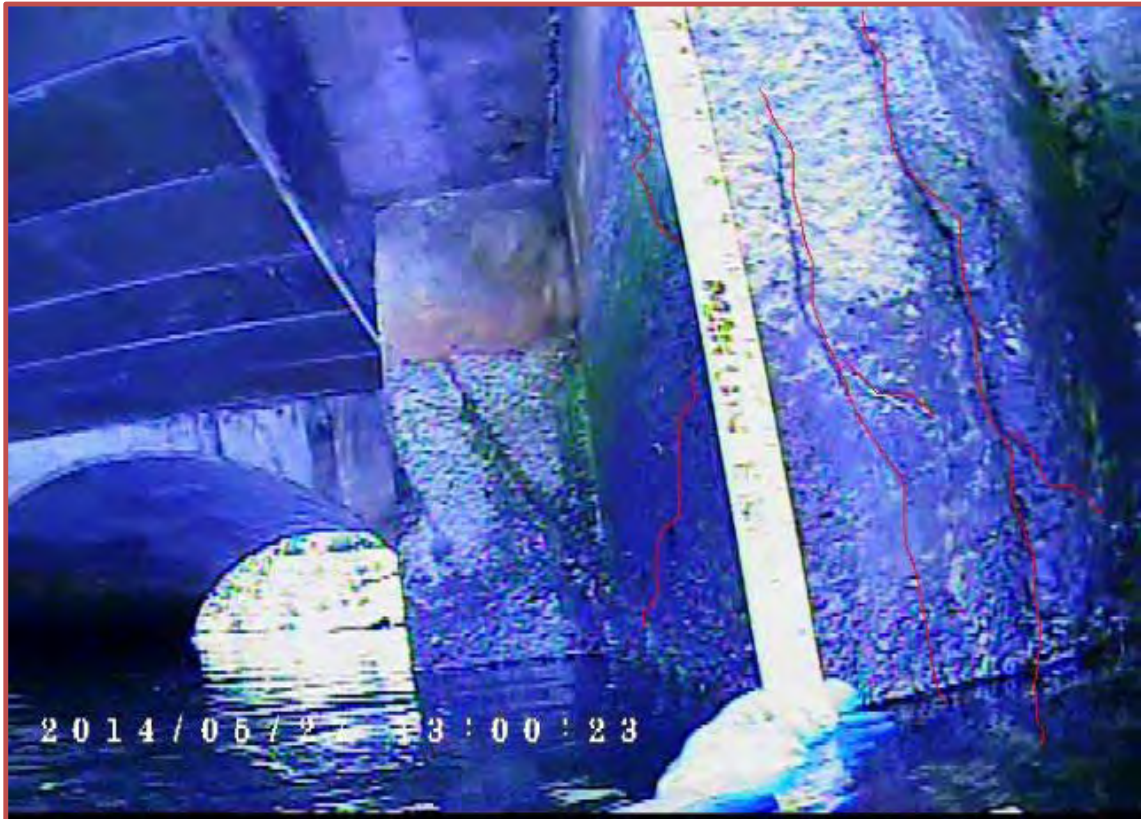
\_Abutment 1 backwall, SW end adjacent to the transition to retaining wall has multiple cracks up to 30" x 1/16", Starting at the cap. **UW Photo 09. NEW.**

Description: Top: Abutment 1 backwall, SW transition to retaining wall, multiple cracks. **UW Photo 09.**  
Bottom: Piles on the SW wingwall delaminations, with associated cracks. **UW Photo 10.**

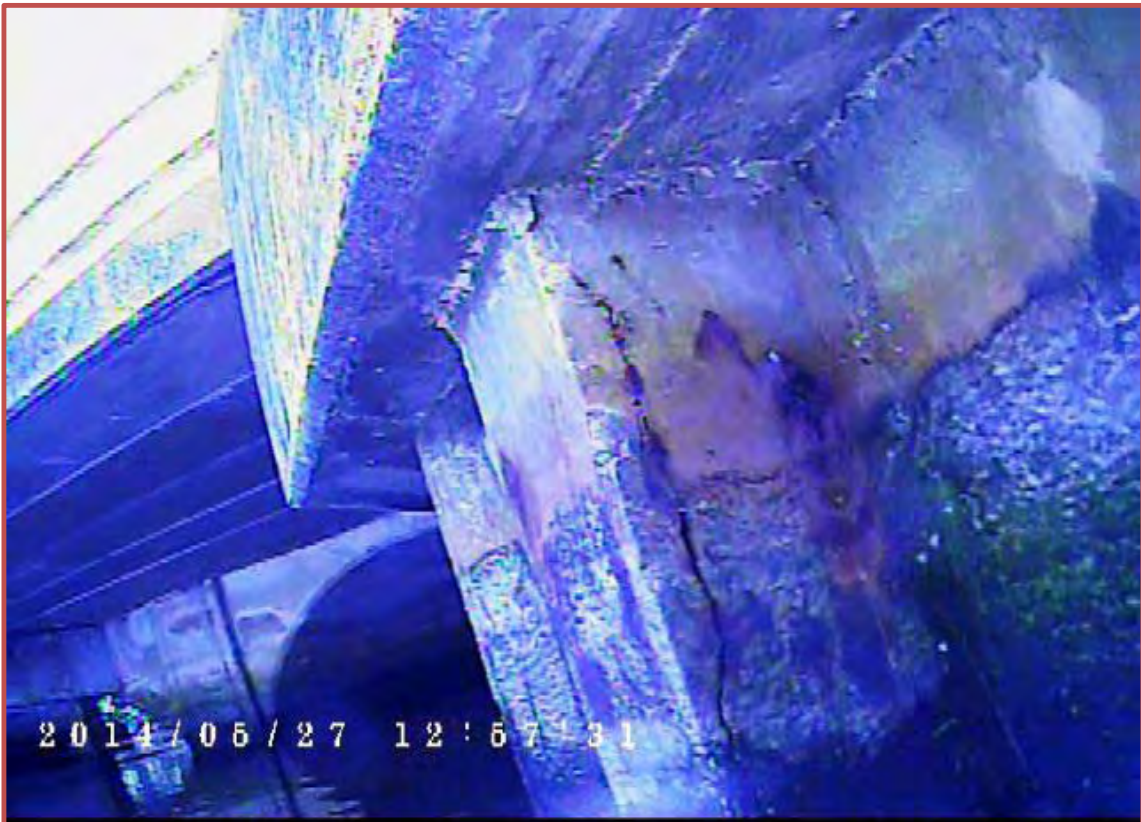
\_Both Piles on the SW wingwall exhibit delaminations up to 40" x 10", with associated cracks up to 1/8", and corrosion bleed-out, Starting at the cap. **UW Photo 10. INCREASE.**

\_Remove all unsound concrete and patch also seal the cracks as needed on all the wingwall Piles.

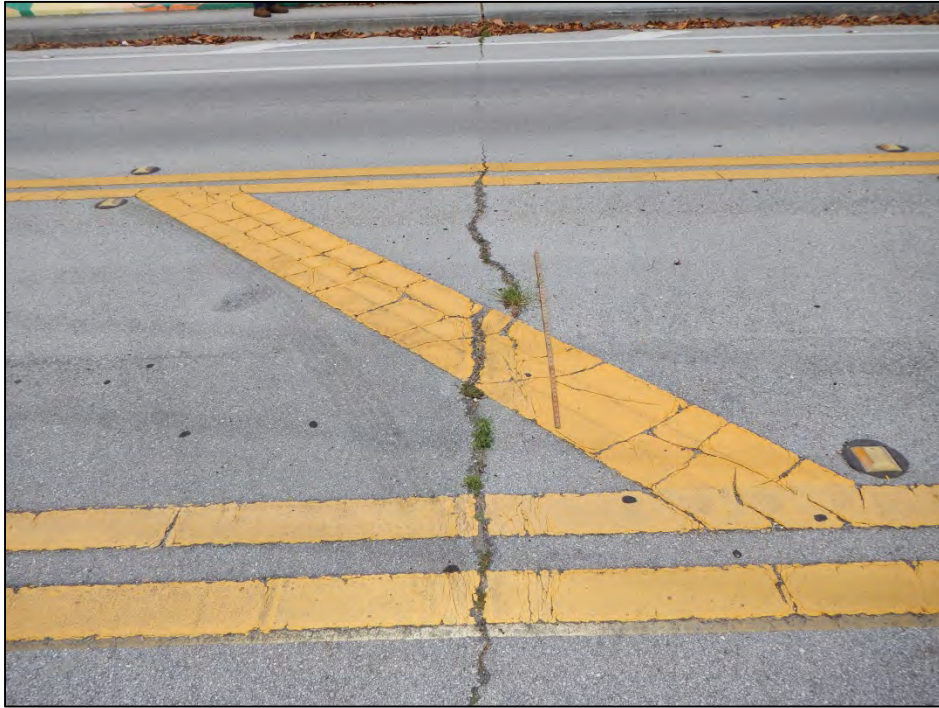
Photo 1 – Transverse crack in asphalt over joint at Abutment 2.

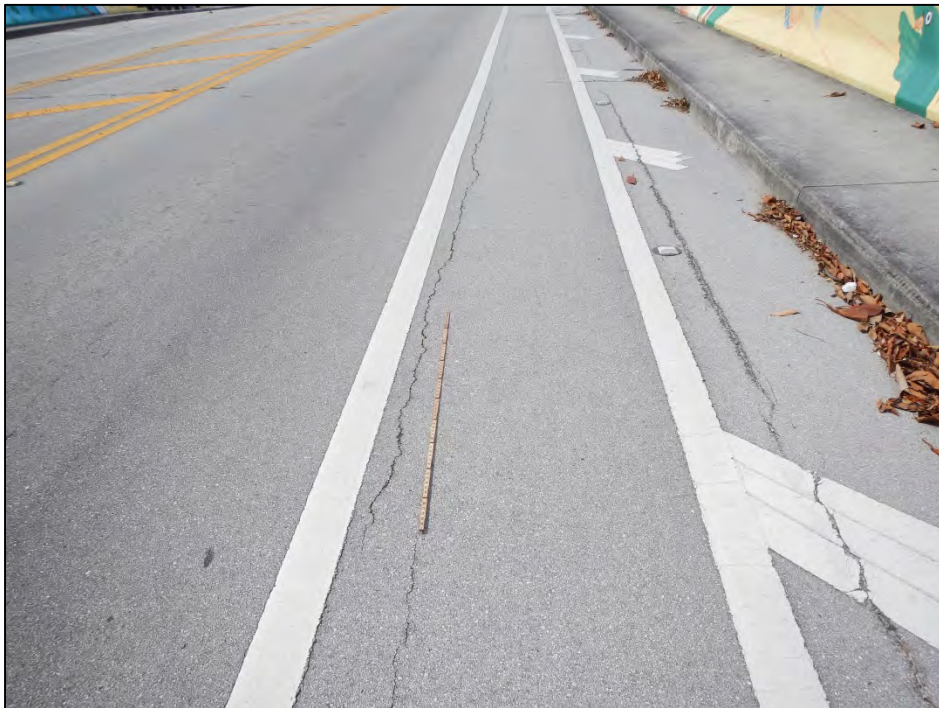
Photo 2 – Longitudinal cracks in asphalt over joints between slab units.

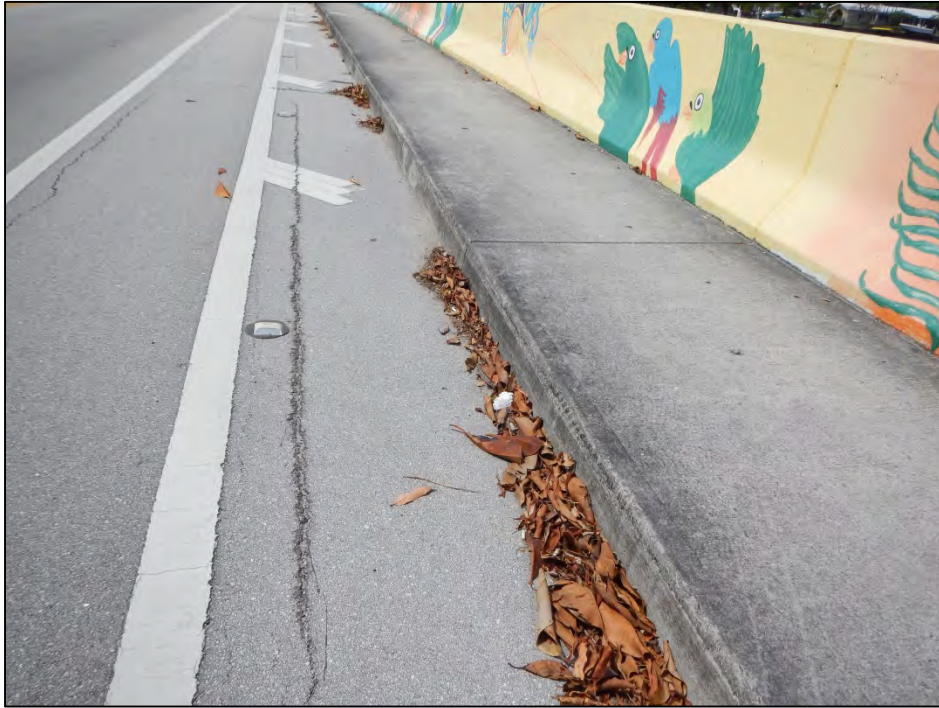
Photo 3 – Dirt and Debris in shoulder area.

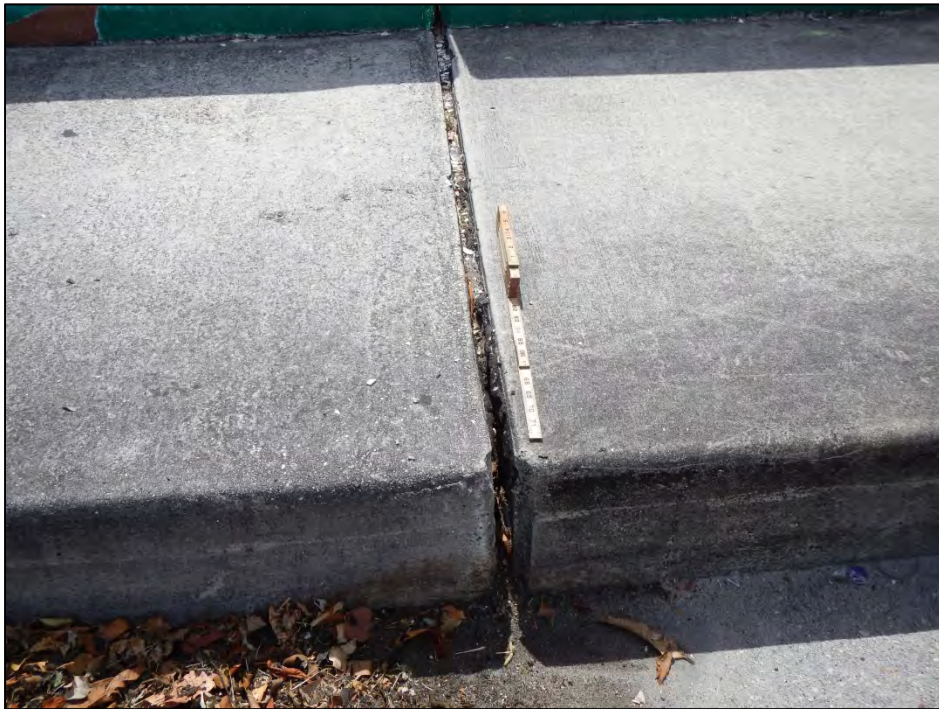
- The sidewalk joints are heavily deteriorated. See Condition Photo 4.

Photo 4 – Sidewalk joint over Bent 2.

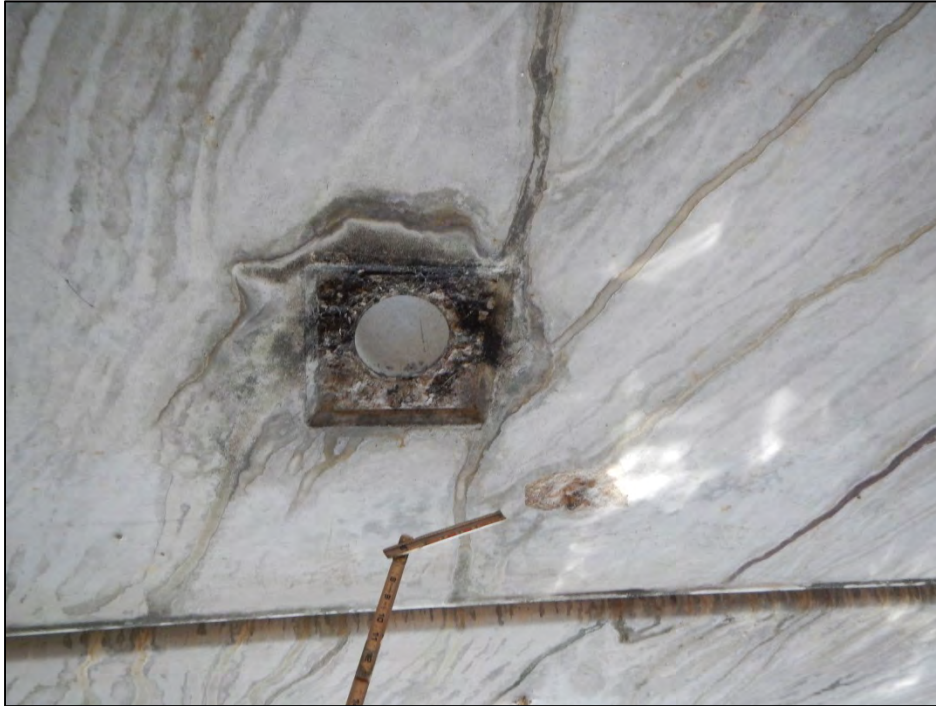
Photo 5 – Spalls near vent holes in Slab 1-2.

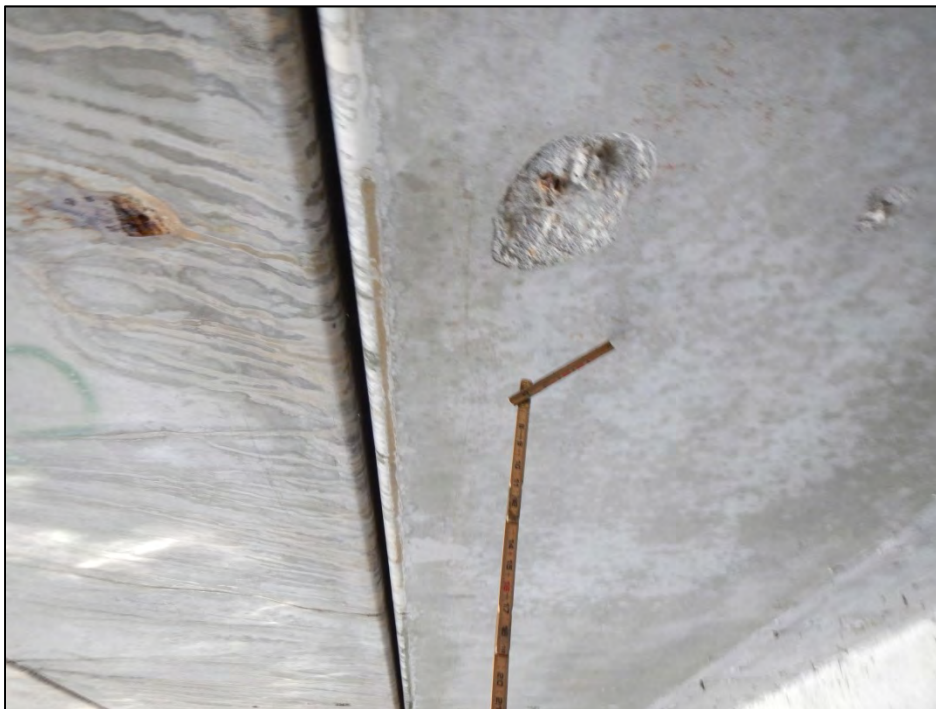
Photo 6 – Slab 1-4 exhibits a spall adjacent to slab 1-3.

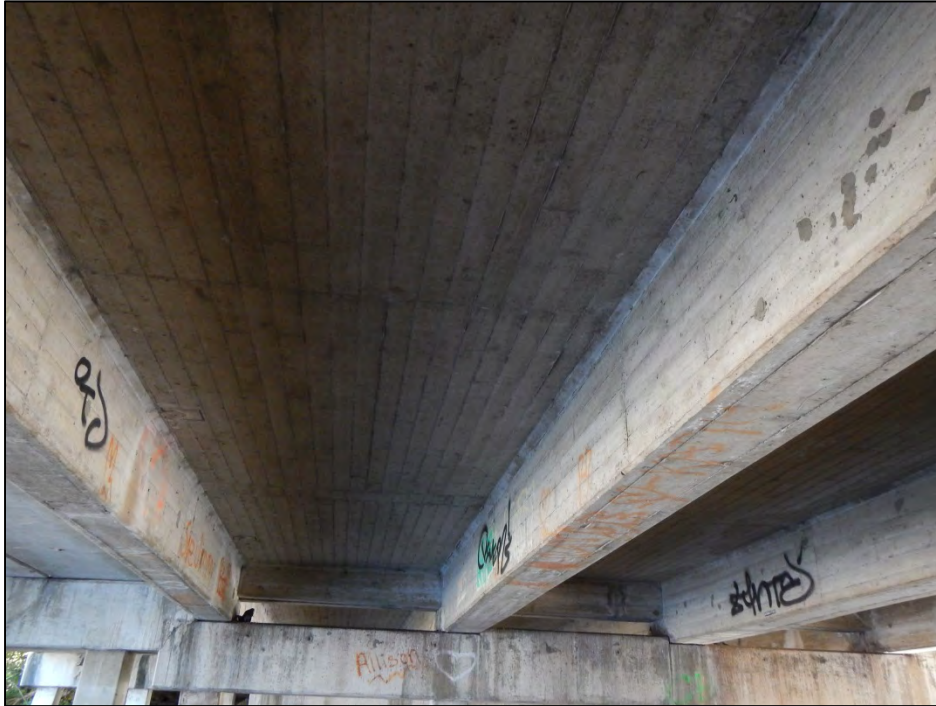
Photo 7 – Span 3 concrete beams exhibit graffiti.

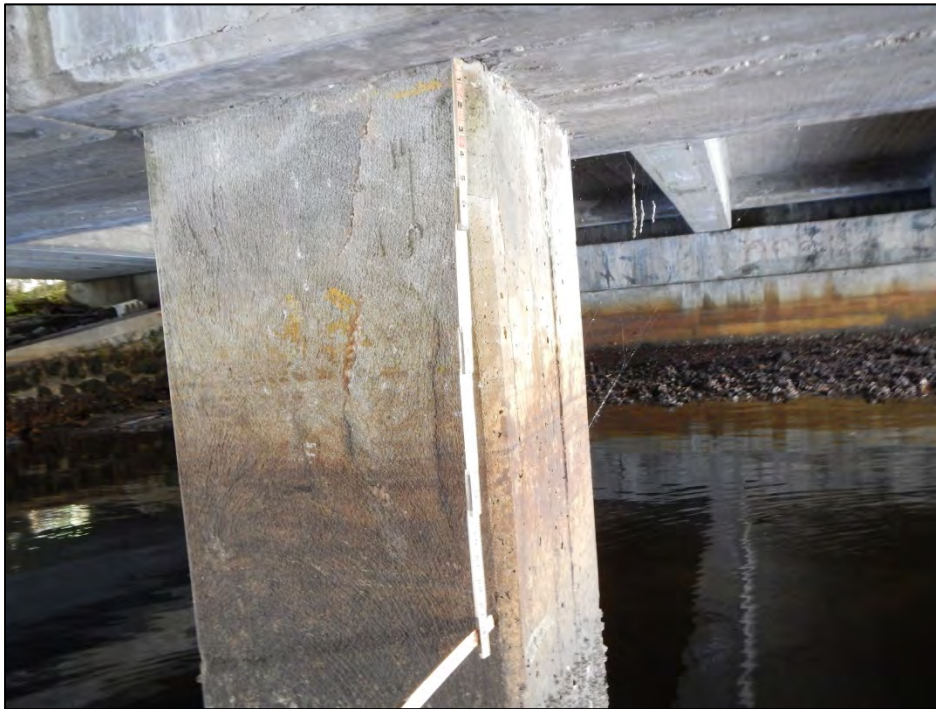
Photo 8 – Delamination at the northwest corner of Pile 2-5.

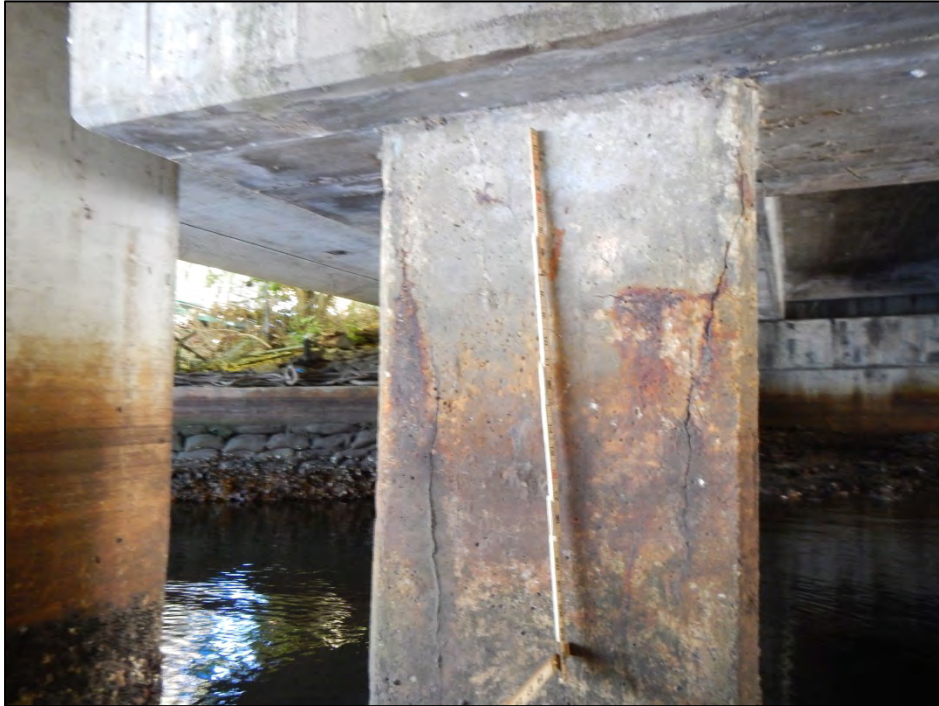
Photo 9 – The north face of Pile 2-7 exhibits vertical cracks.

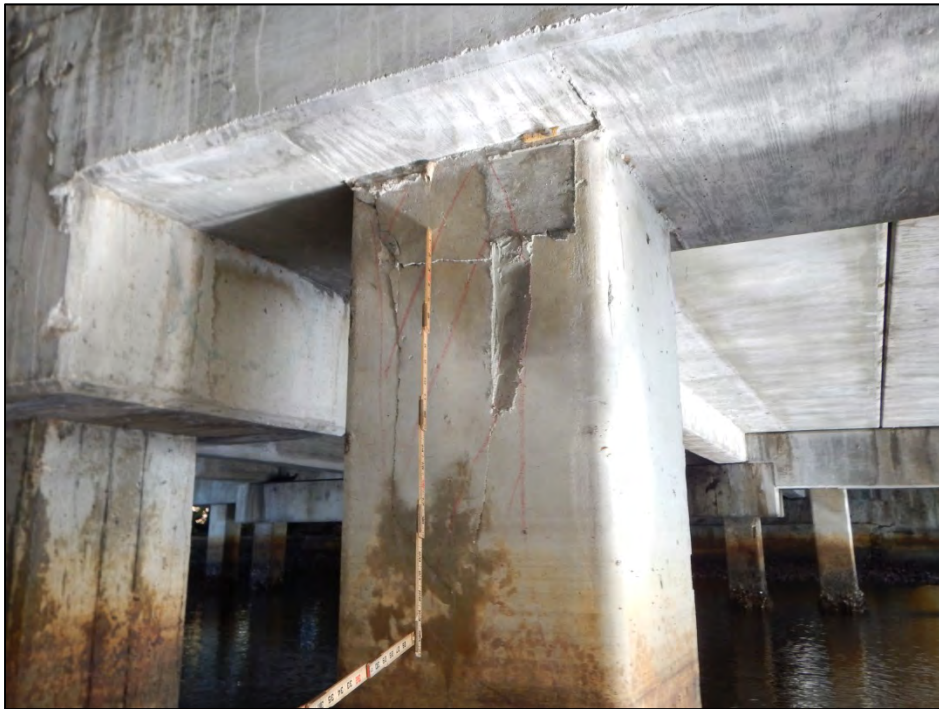
Photo 10 – Cracks and delaminations in the north face of Pile 3-3.

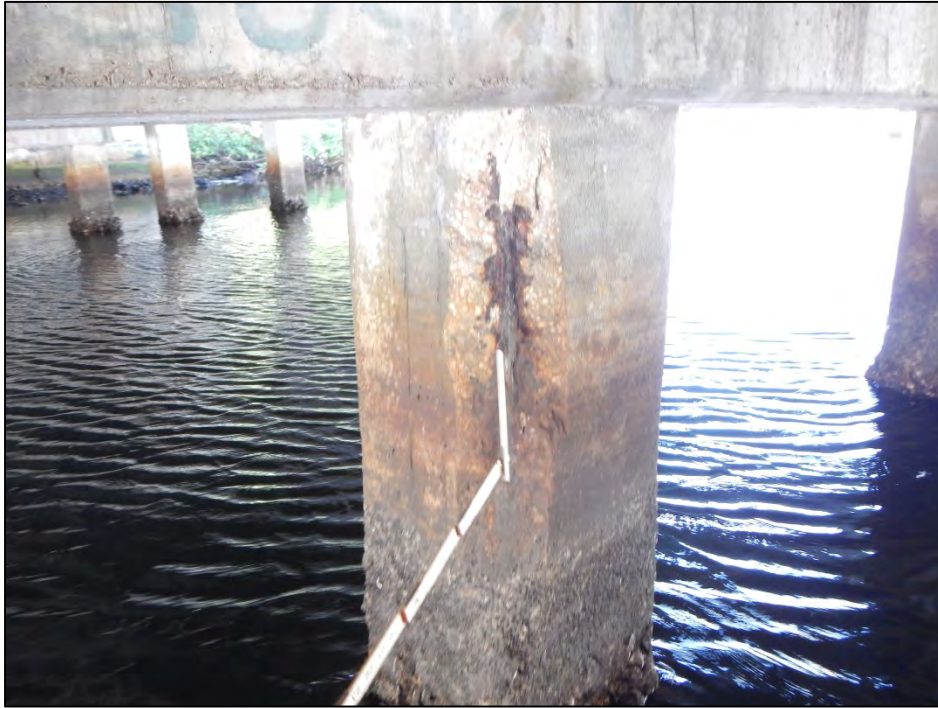
Photo 11 – Spall/delamination with exposed steel at the southwest corner of Pile 3-6.

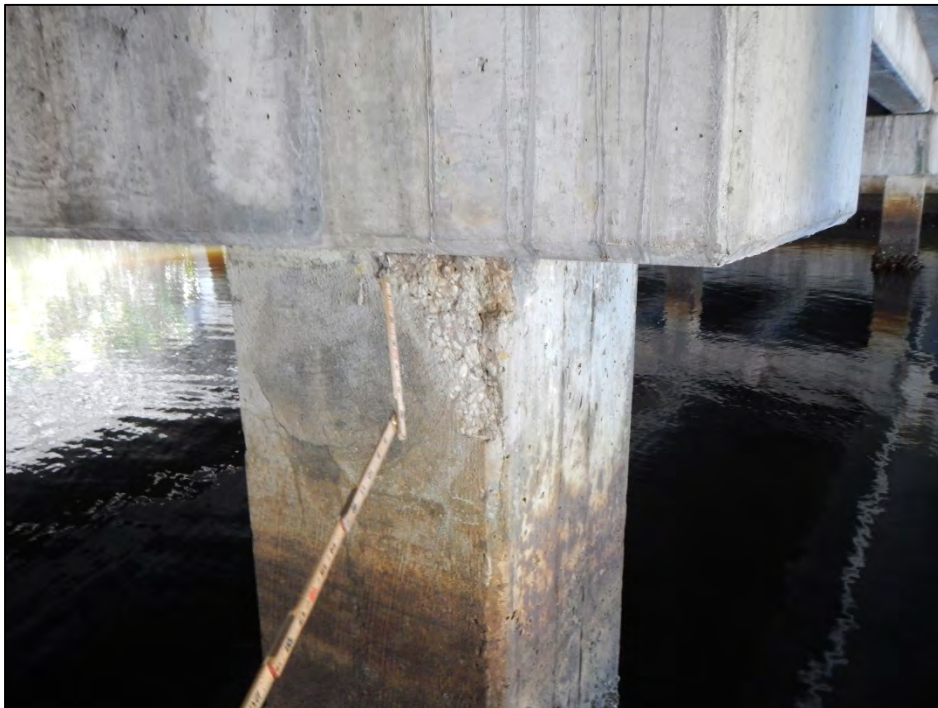
Photo 12 – The southeast corner of Pile 3-7 exhibits a delamination.

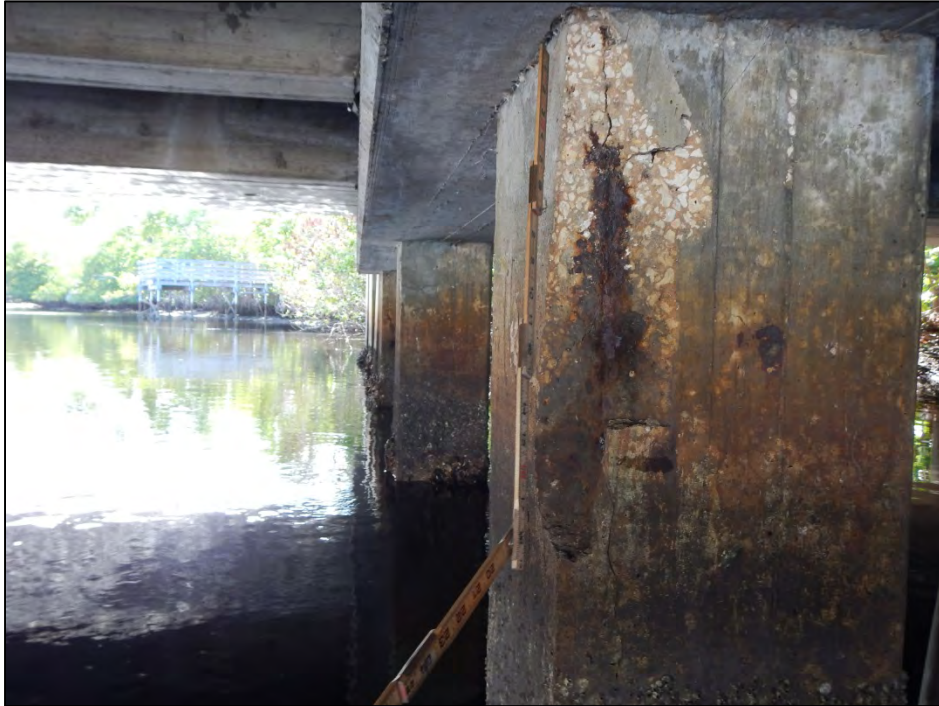
Photo 13 – The southeast corner of Pile 4-6 exhibits a spall with exposed steel.

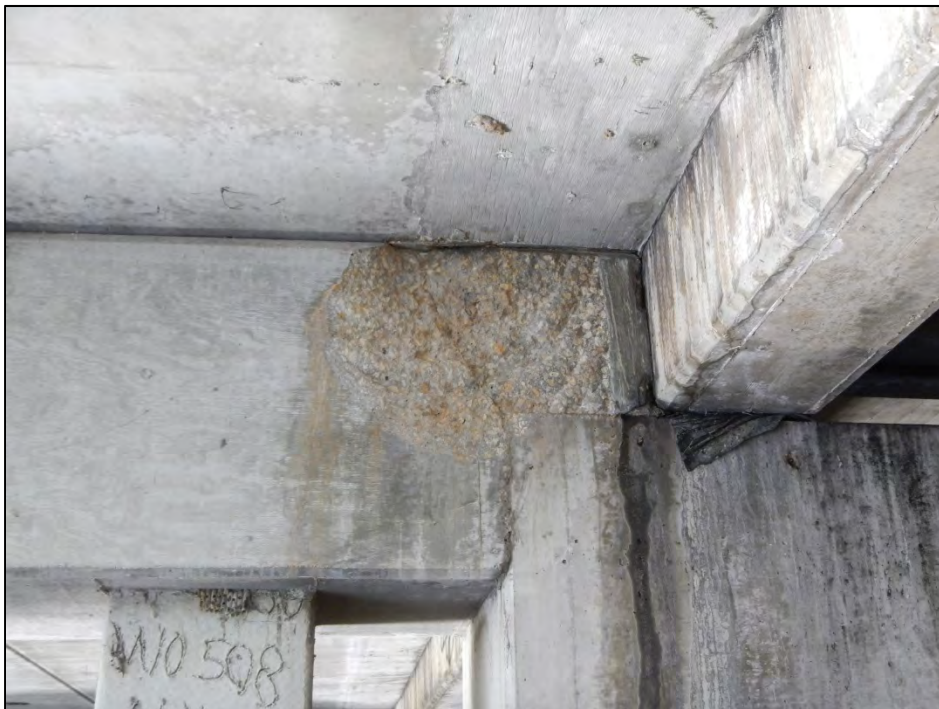
Photo 14 – The south face of Bent 2 cap exhibits a spall.

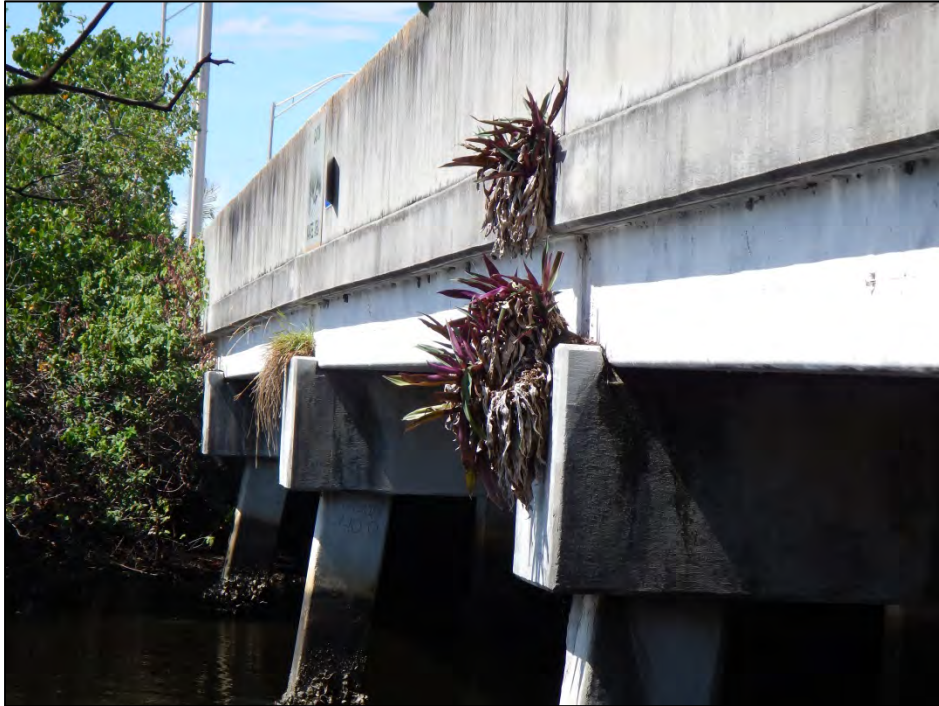
Photo 15 – Vegetation at Bent Caps 2 and 3.

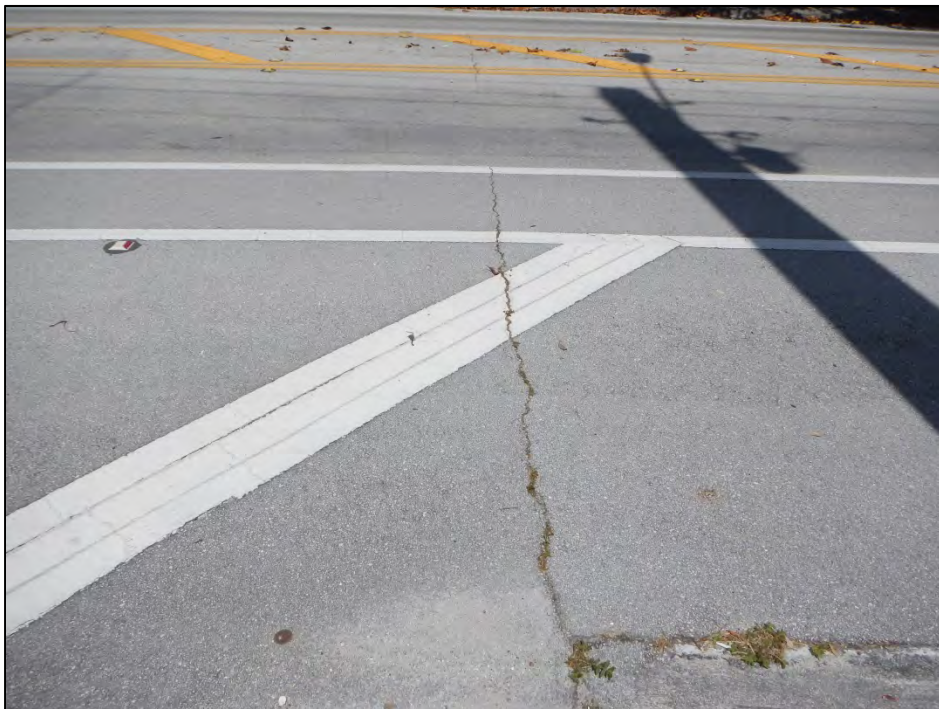
Photo 16 – The south approach roadway exhibits a transverse crack.

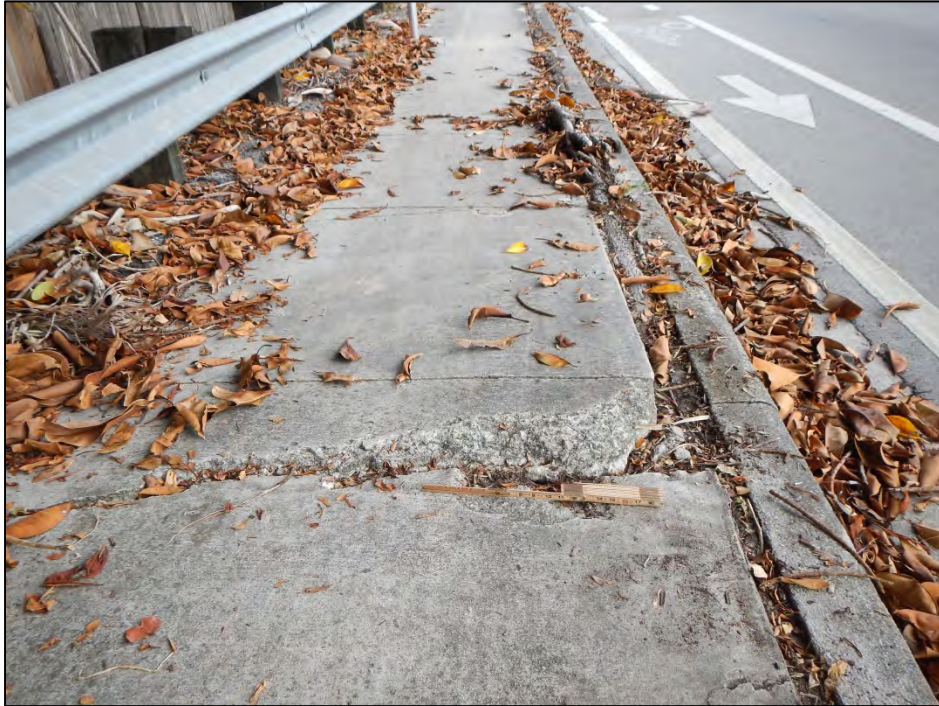
Photo 17 – Southeast sidewalk concrete panel.

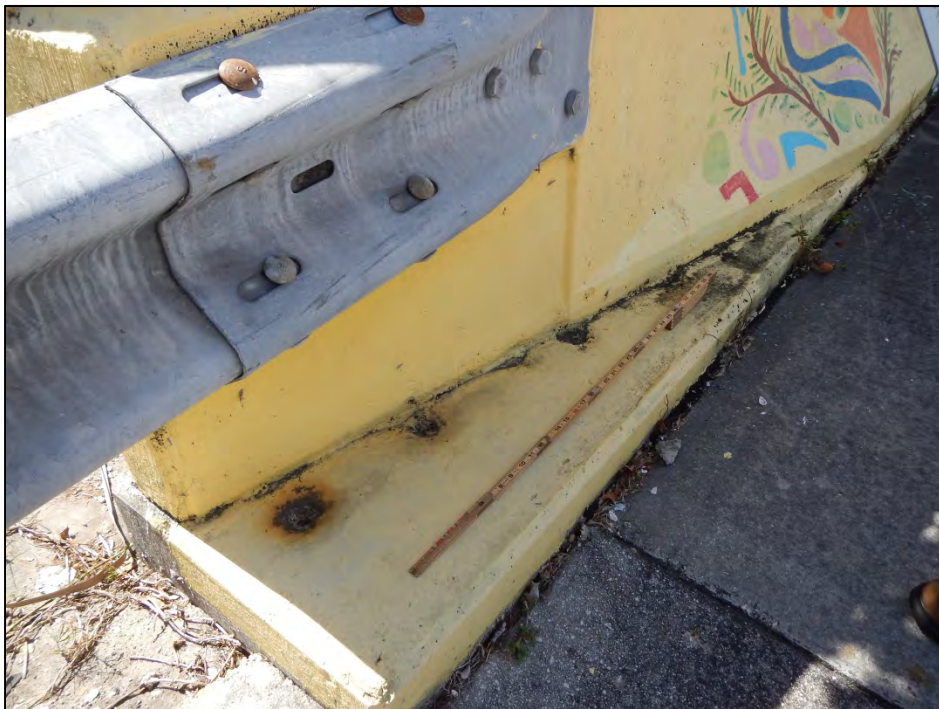
Photo 18 – Southwest approach concrete barrier spalls.

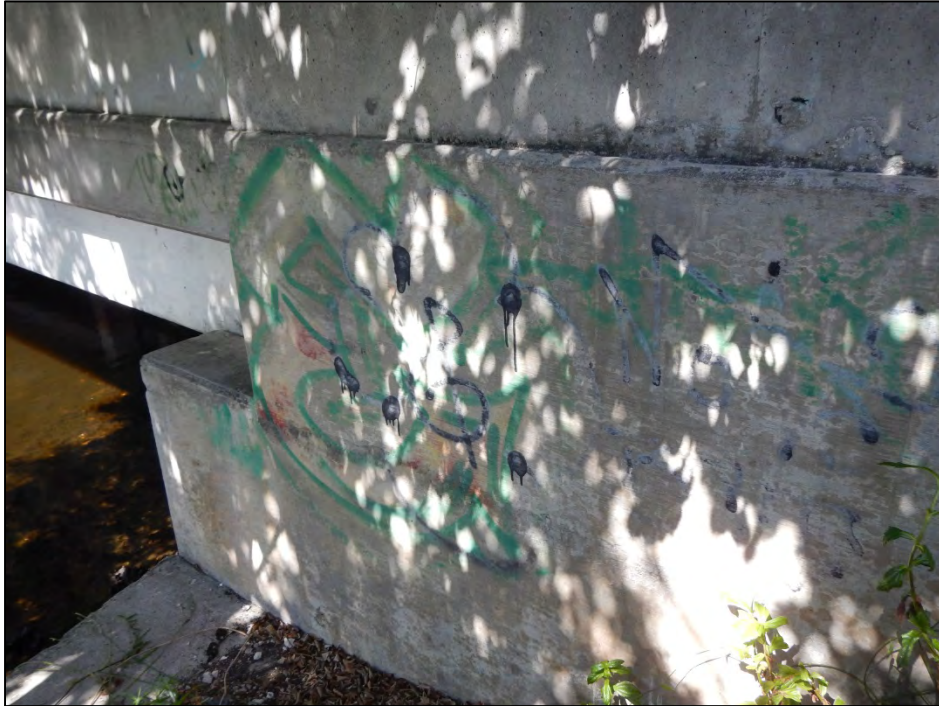
- The west face of the southwest wingwall adjacent to End Bent 1 exhibits graffiti. This condition was not previously noted. See Condition Photo 19.

Photo 19 – Graffiti at the west face of the southwest wingwall.
