## **EXECUTIVE SUMMARY**

TranSystems has been retained by the City of Fort Lauderdale to perform bridge inspections and prepare bridge inspection reports for each of the City's bridges as part of the project Structural Bridge Engineering Consulting Services Master Plan, RFQ No. 946-11310. Inspections were completed and reports prepared for 46 of the City's bridges. The remaining five bridges in the City's inventory were not inspected because they are in the process of being replaced.

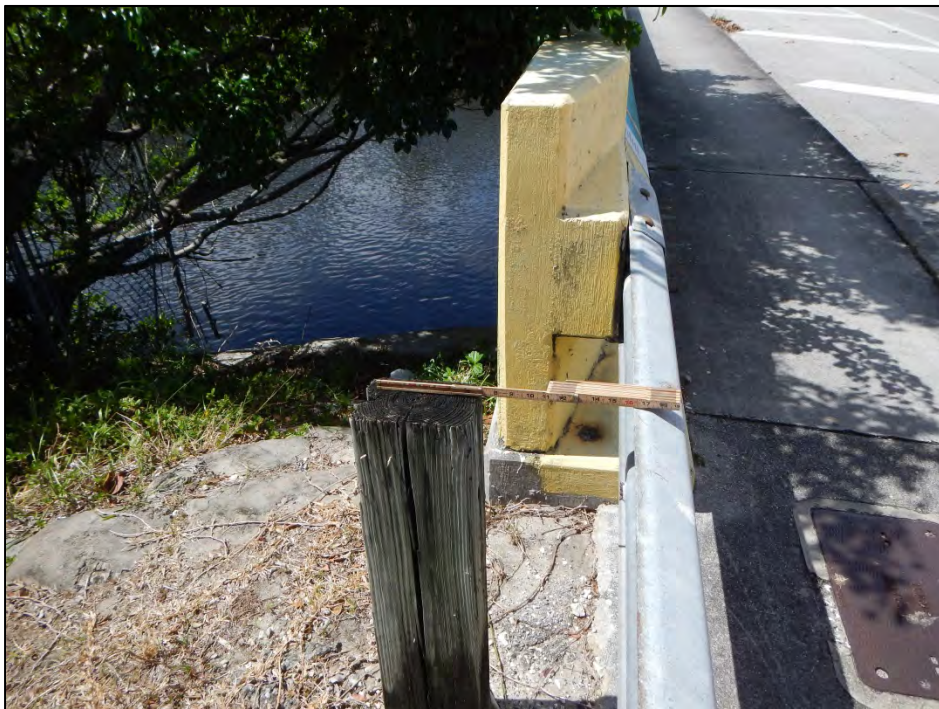
- In general, the guardrail cushion blocks at the northeast and northwest quadrants are heavily deteriorated.
- The 1st guardrail cushion block at the southwest corner and the 2nd, 18th and 19th at the northwest corner are missing. See Condition Photo 20.
- The northwest corner bridge guardrail exhibits impact damage 3ft. north of the approach barrier. This condition was not previously noted. See Condition Photo 21.

Photo 20 – Southwest guardrail cushion block missing.

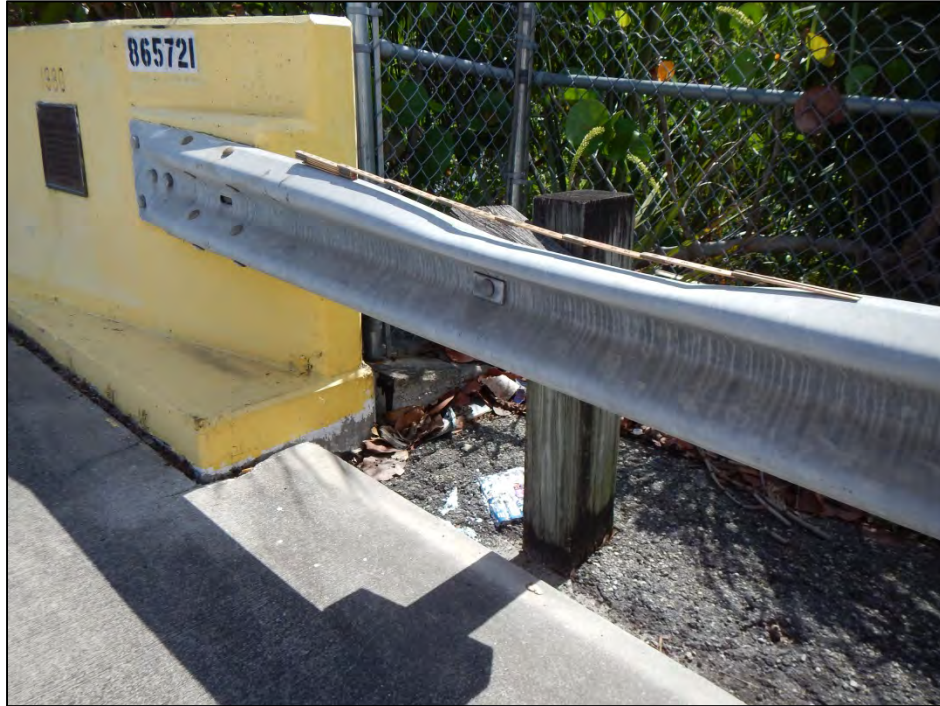
Photo 21 – Northwest guardrail impact damage.

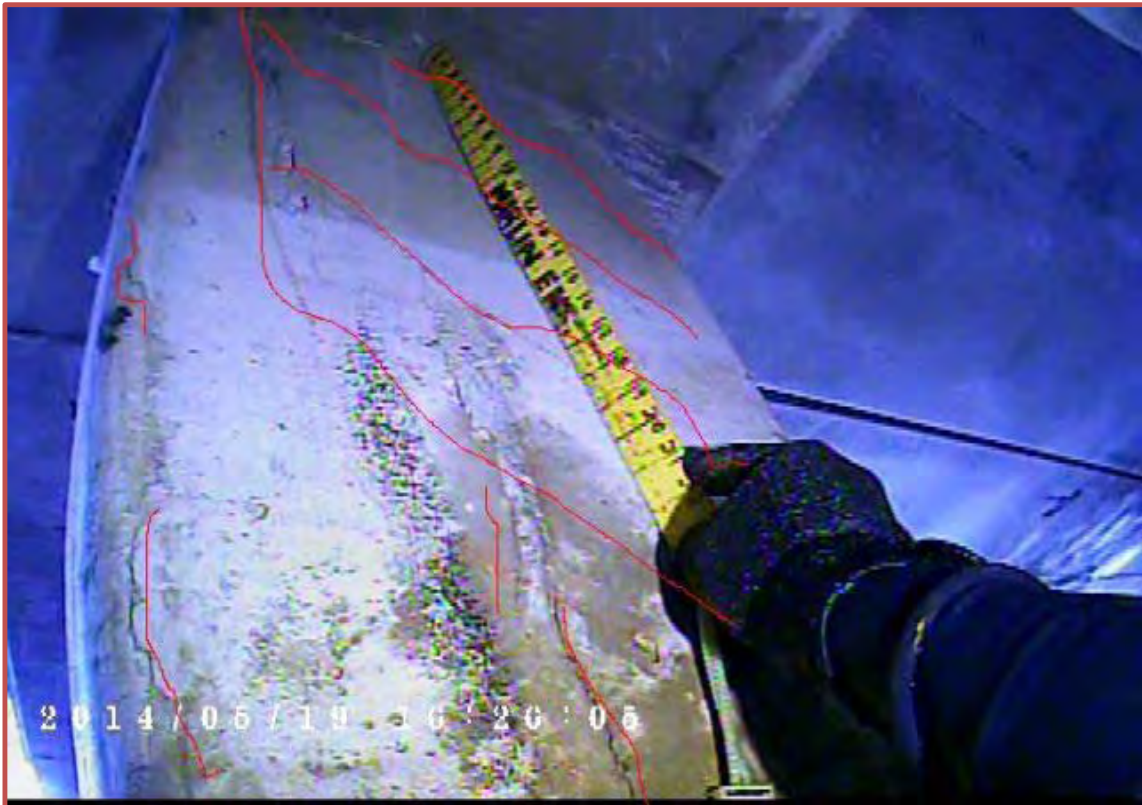
\_Pile 3-3, North and East faces have delaminations up to 28" x 8", with associated cracks up to 1/16" wide, starting at the cap. **UW Photo 01. NO CHANGE.**

Description: Top: Pile 3-3, North and East faces, delamination with associated cracks. **UW Photo 01.**  
Bottom: Pile 2-4, NE corner, spall/delamination, (1) exposed rebar. **UW Photo 02.**

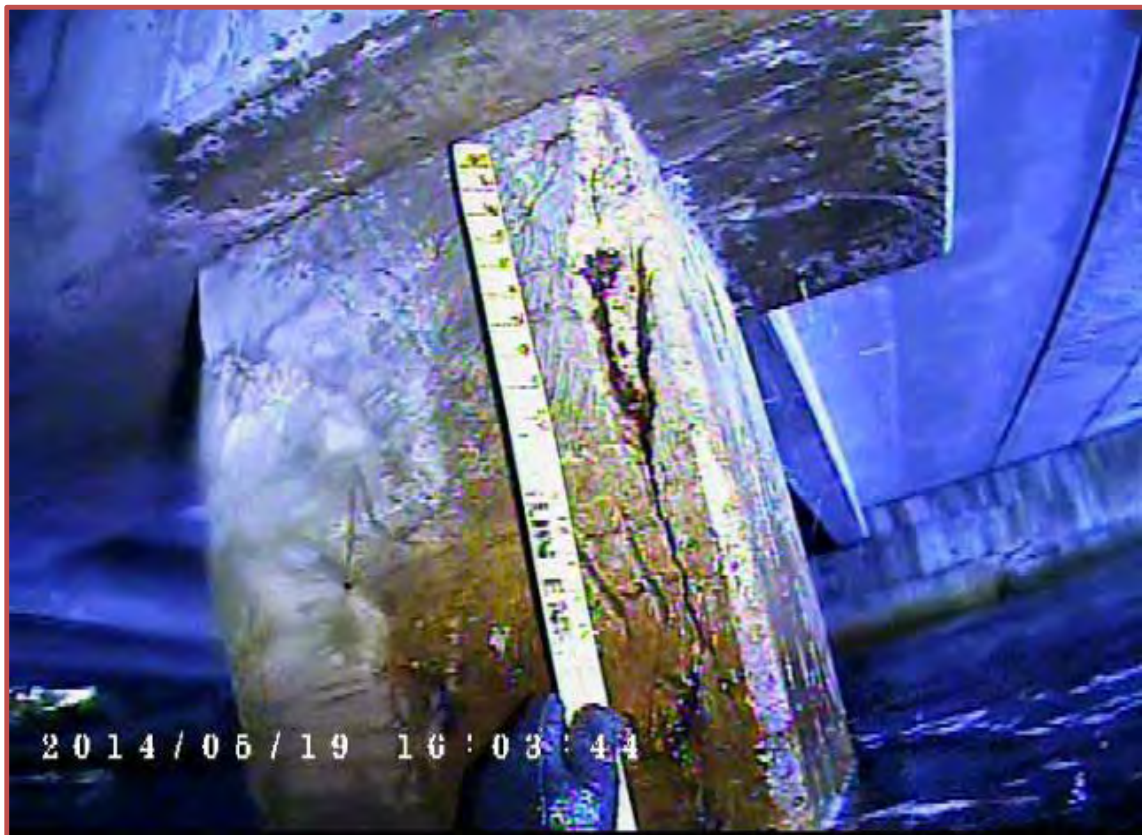
\_Pile 2-4, NE corner has a spall/delamination 36" x 3" x 2", with (1) exposed rebar and associated cracks up to 1/16", **UW Photo 02. INCREASE.** Also on the South, West and East face have cracks up to 1/8" wide with corrosion bleed-out, starting at the cap.

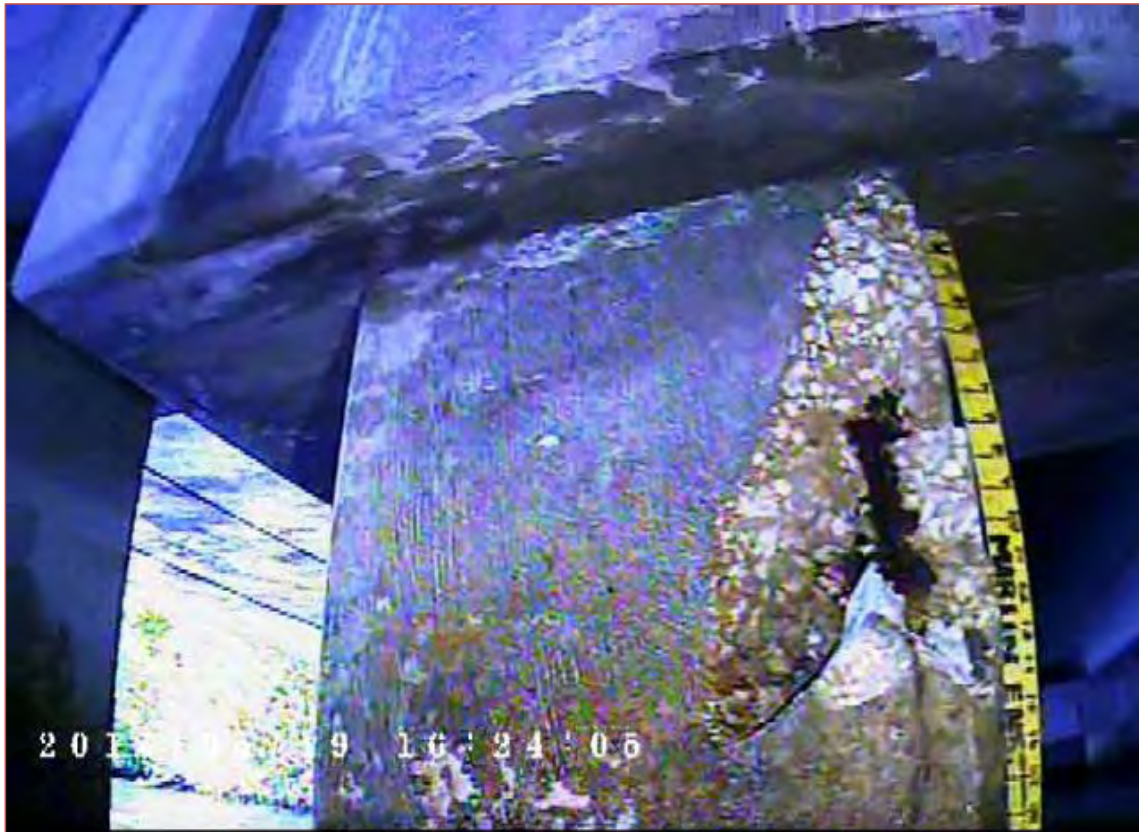
\_Pile 3-4, SE corner has a spall/delamination 28" x 11" x 2", with (1) exposed rebar.

**UW Photo 04. INCREASE.** Also the SW and NE corners have delaminations up to 28" x 6", with corrosion bleed-out, starting at the cap. **NEW.**

Description: Top: Pile 2-5, NE, NW and SW corners delaminations. **UW Photo 03.**  
Bottom: Pile 3-4, SE corner, spall/delamination with (1) exposed rebar. **UW Photo 04.**

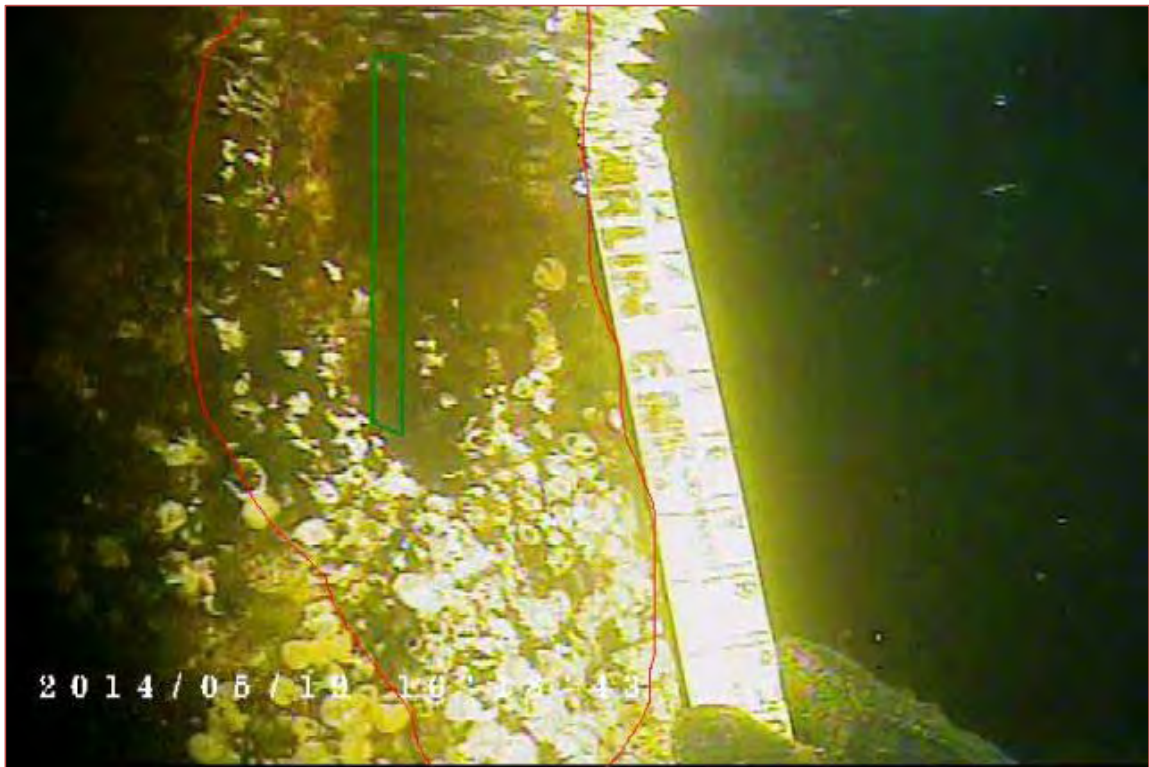
Description: Top: Pile 3-6, SW corner has a spall with (1) exposed rebar. **UW Photo 05.**  
Bottom: Pile 3-6, SW corner spall, (1) exposed rebar underwater. **UW Photo 06.**

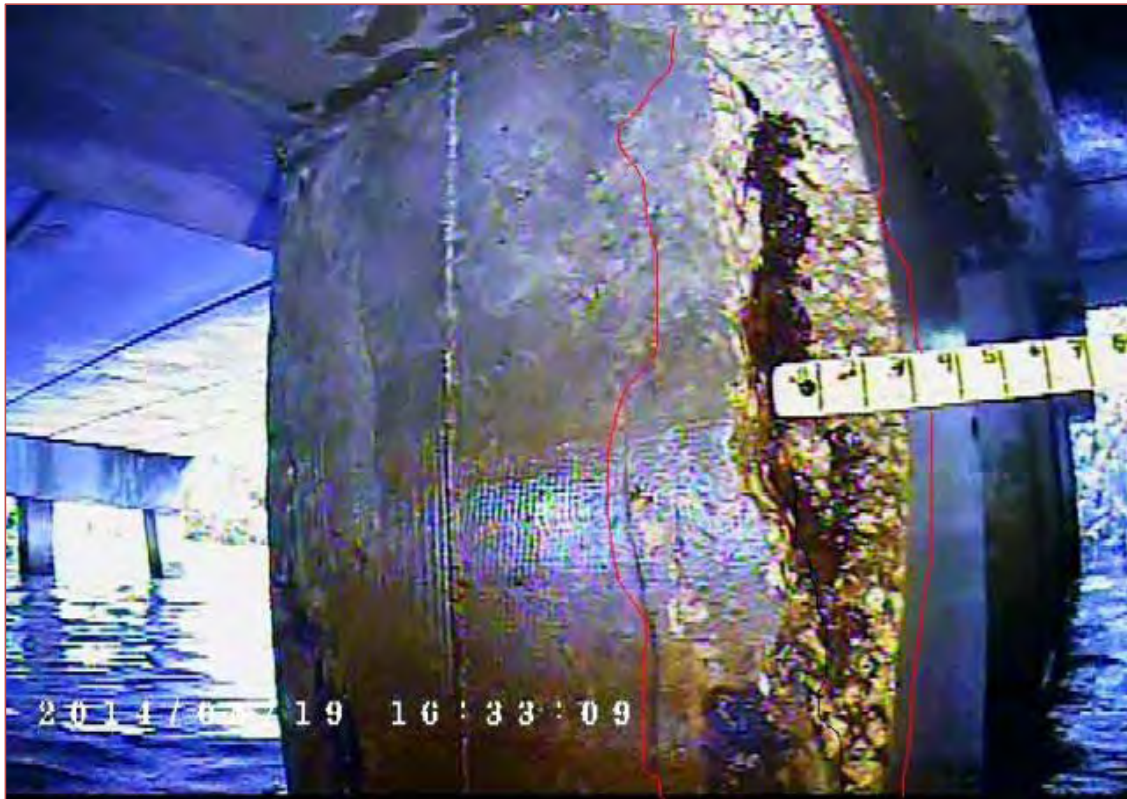
Description: Top: Pile 4-4, NE corner, spall/delamination with (1) exposed rebar. **UW Photo 07.**  
Bottom: Pile 4-6, SE corner has a spall with (1) exposed rebar. **UW Photo 08.**

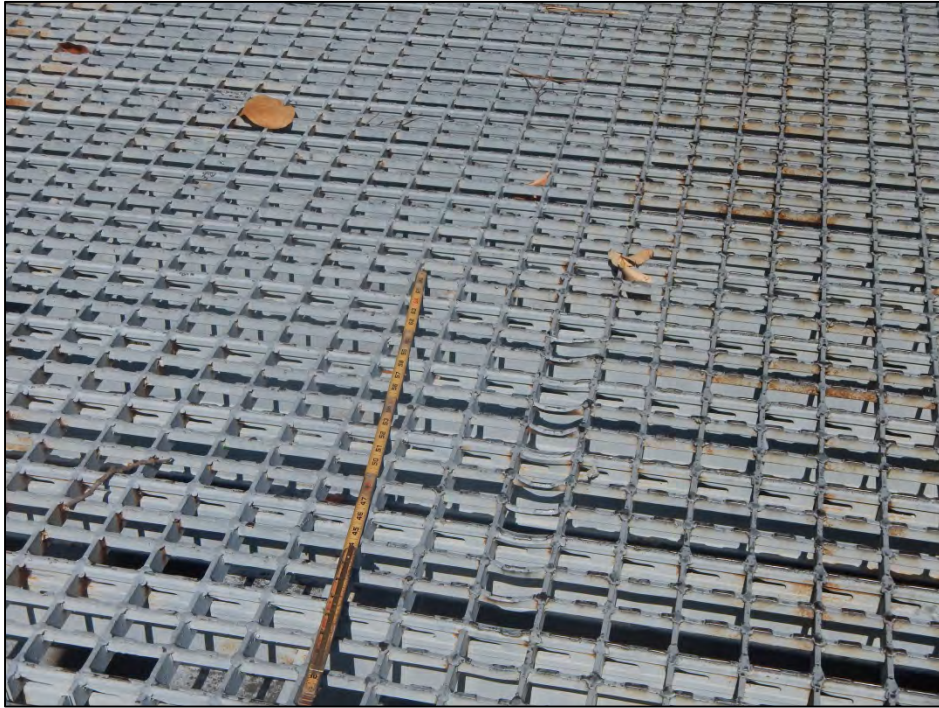
Photo 1 – Damaged and corroded open grid deck.

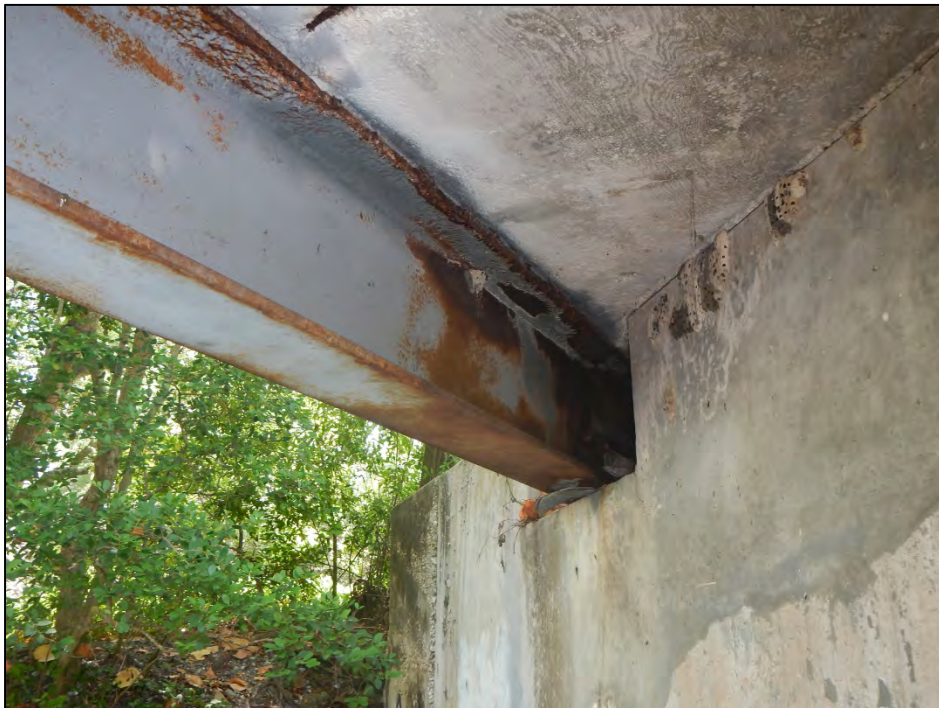
Photo 2 – Corrosion with section loss in Beam 1-8 at Abutment 1.

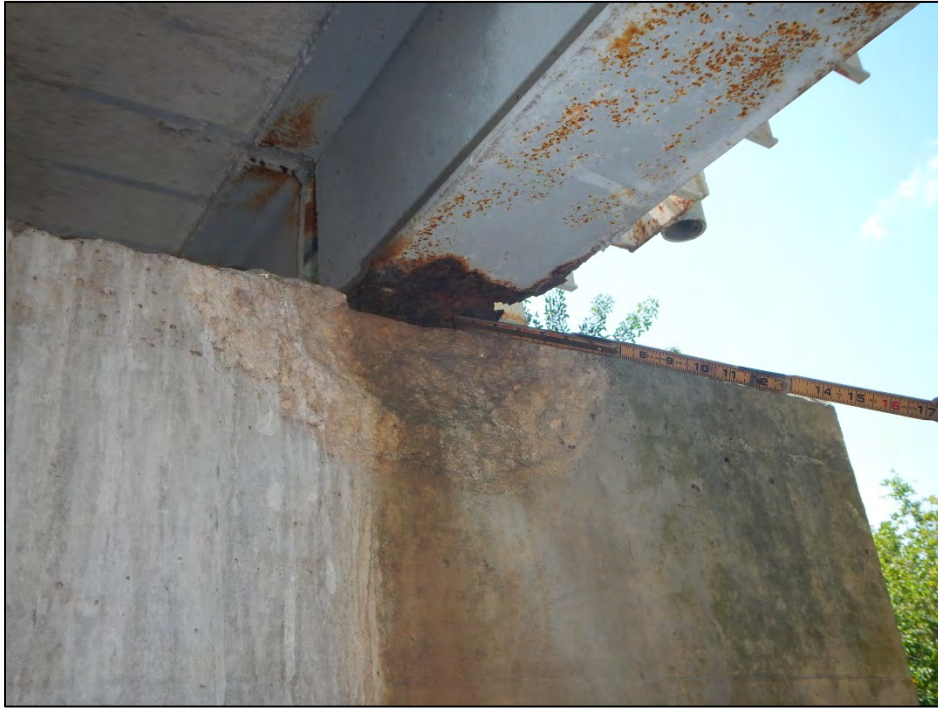
Photo 3 – Section loss on Beam 2-I. Note spall in Bent 2 cap.

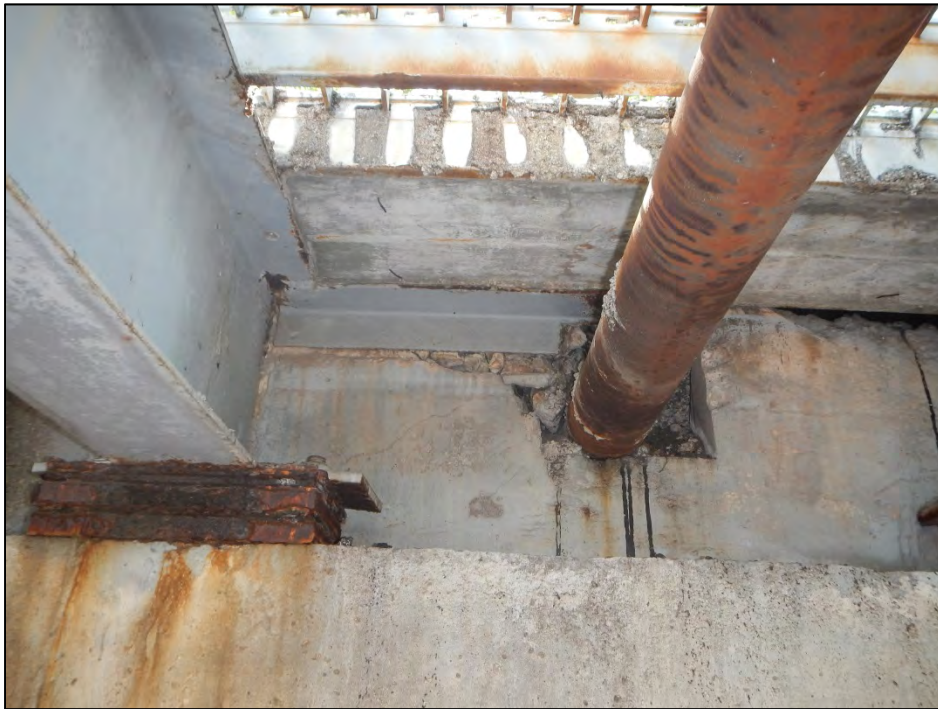
Photo 4 – Typical corrosion on end bent bearings.

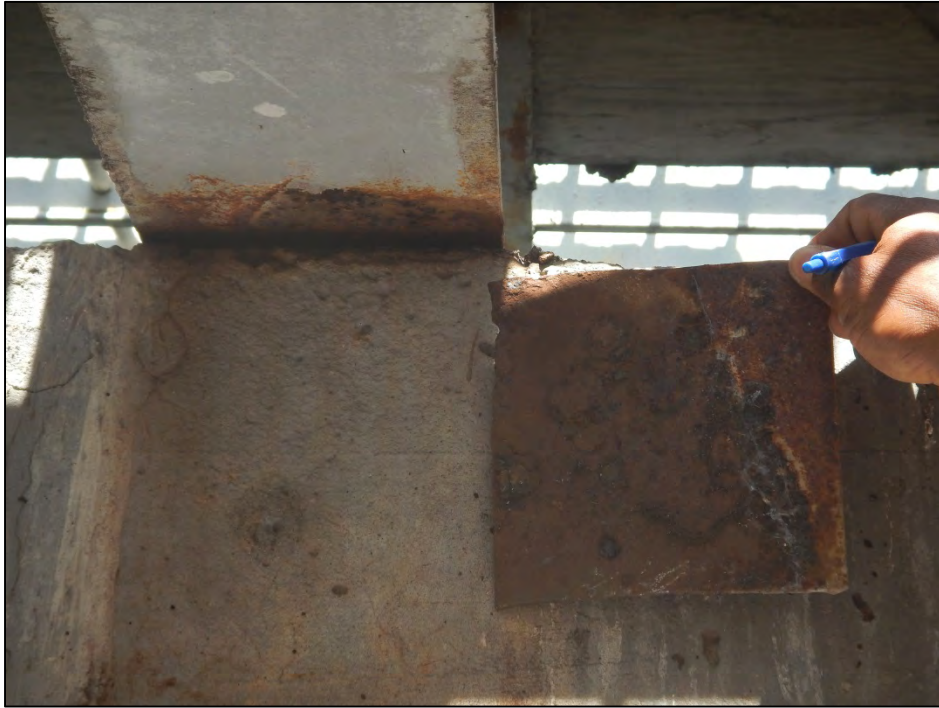
Photo 5 – Loose shim plate at Beam 1-3.

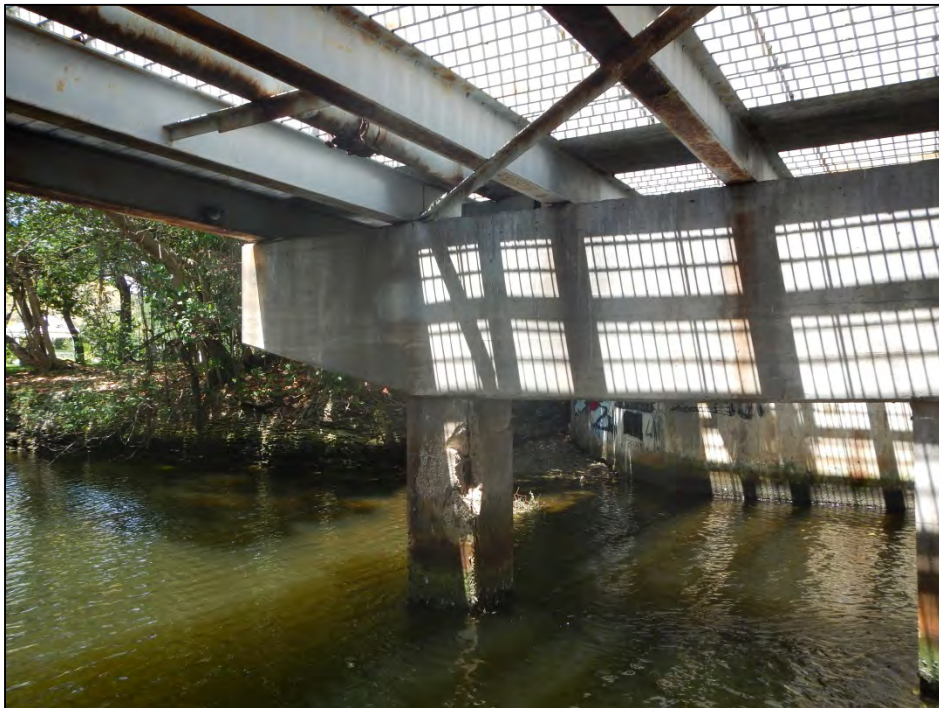
Photo 6 – Spall in Pile Jacket 2-3 with exposed steel.

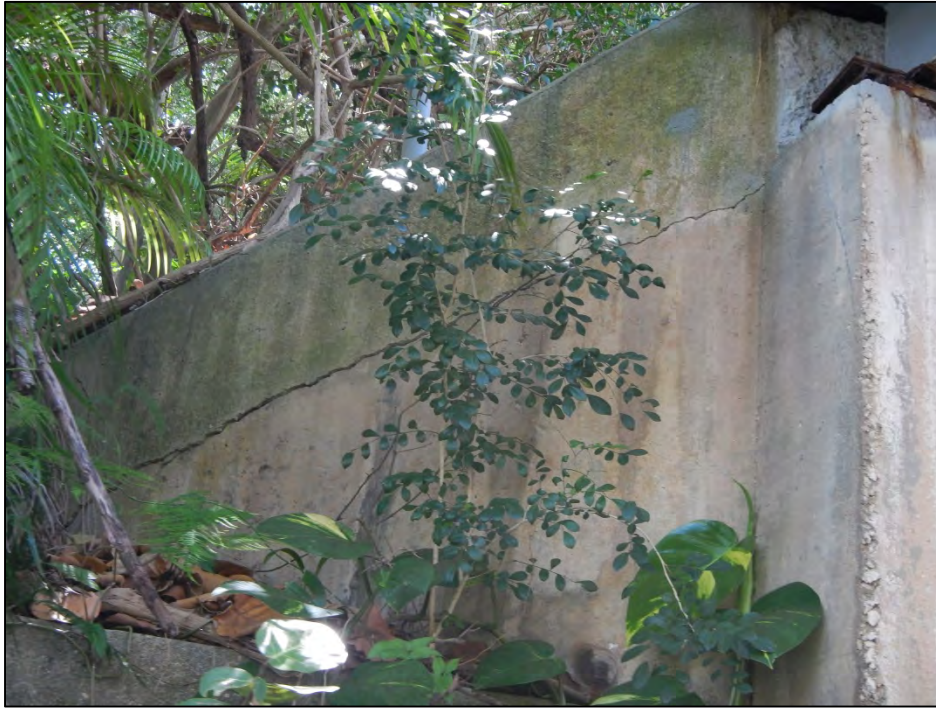
Photo 7 – Crack in NE wingwall.

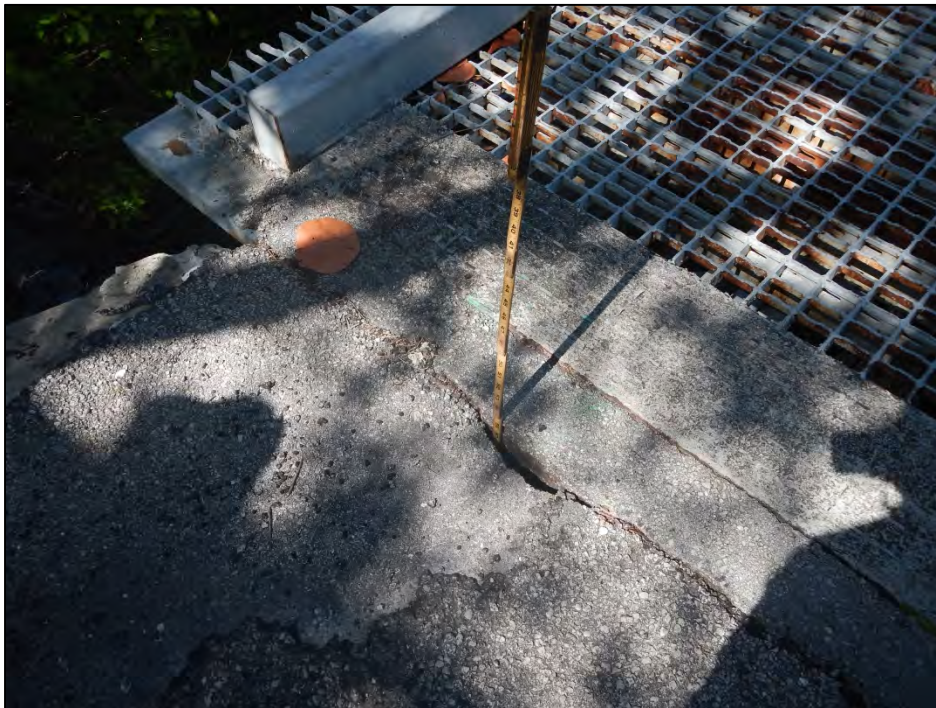
Photo 8 – Full depth void in the west approach roadway/bridge deck transition.

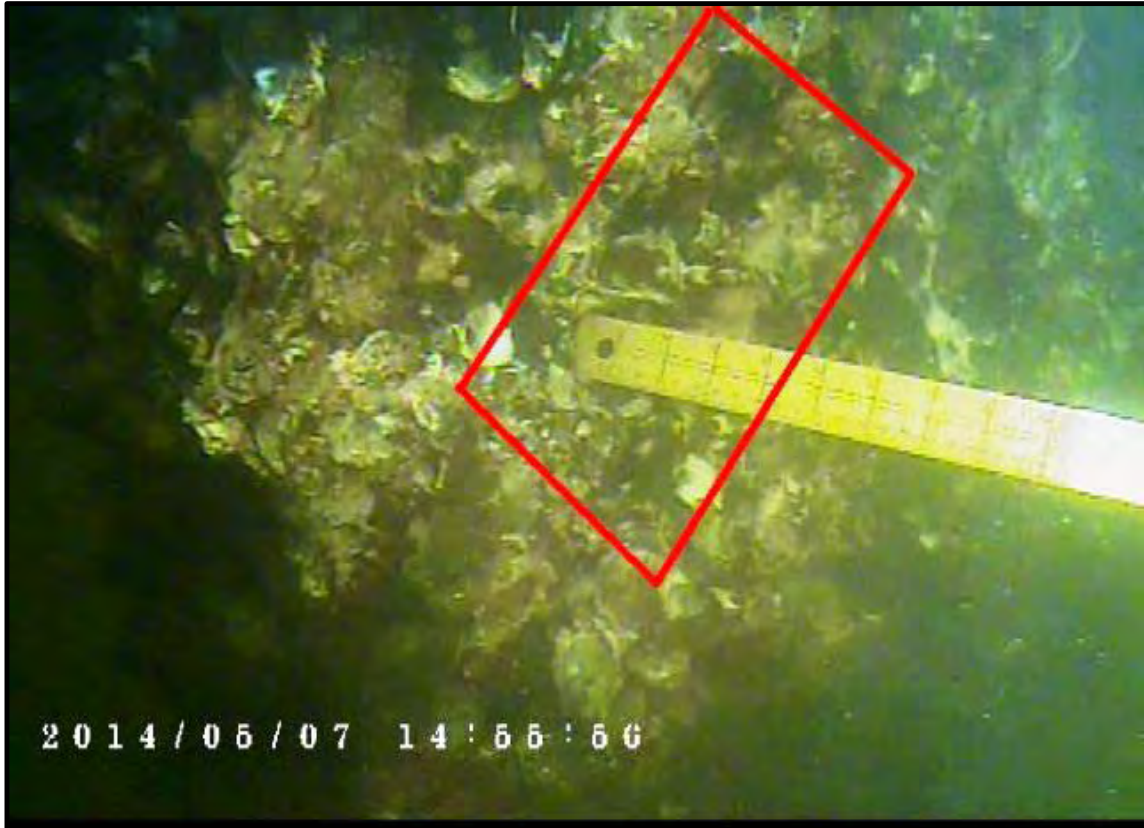
Description: Top: Jacket 2-1, North face, has a washout area. **UW Photo 01.**

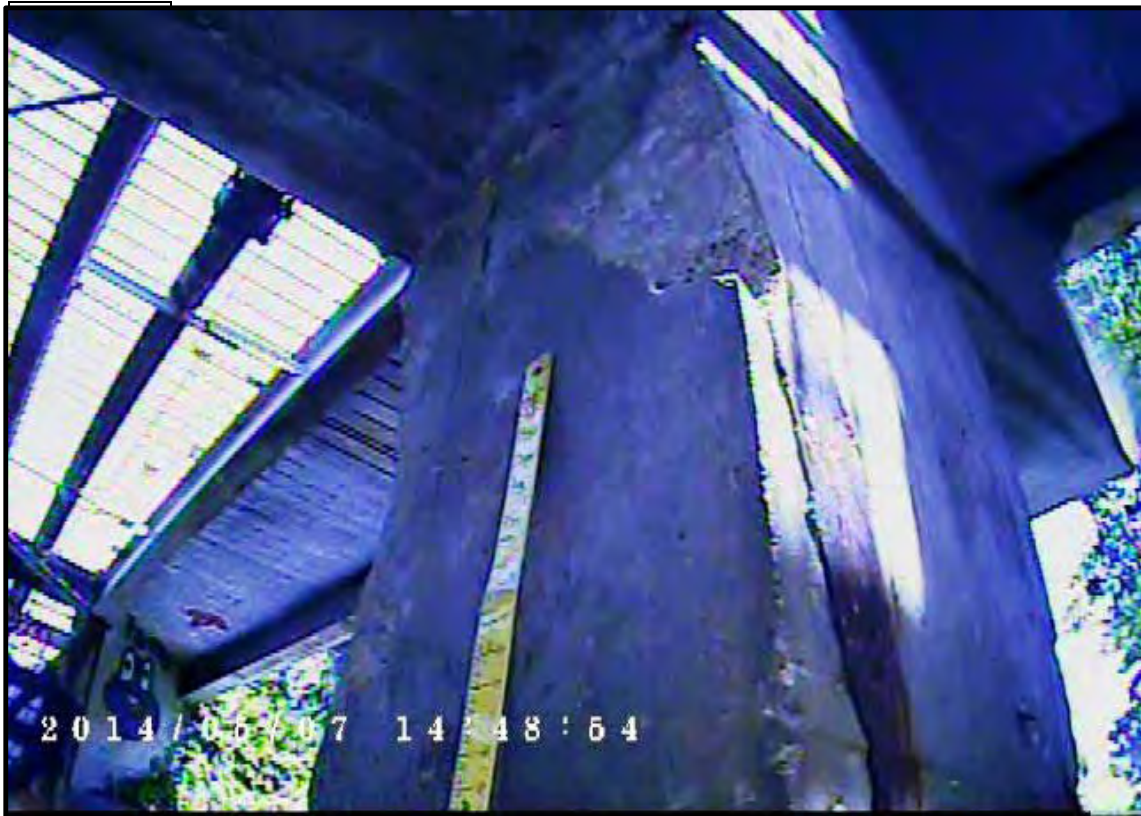
\_PJ 2-2, SW corner has a spall/delamination 44" x 10" x 1-1/2", with associated cracks up to 1/8", with corrosion bleed-out, all faces, starting at the cap. **UW Photo 02. INCREASE**

Bottom: Jacket 2-2, SW corner spall/delamination, with cracks up to 1/8". **UW Photo 02.**

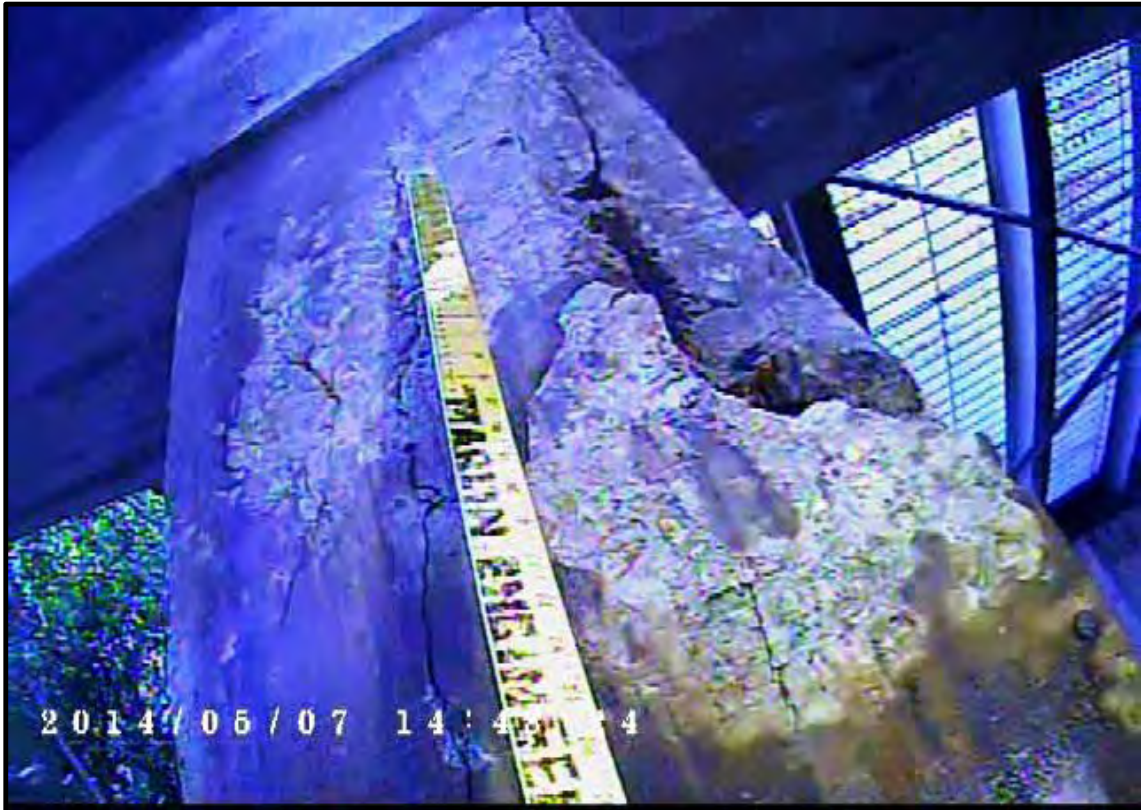
\_PJ 2-3, NE corner has a spall/delamination 48" x 18" x 4", with exposed steel up to 75% section loss. Also all faces are delaminated starting at the cap, with associated cracks up to 1/4" wide.

Description: Top: Jacket 2-3, NE corner spall/delamination, with exposed steel. **UW Photo 03.**  
Bottom: Abutment 1, intermittent undermining up to 2" H, and 40" D. **UW Photo 04.**

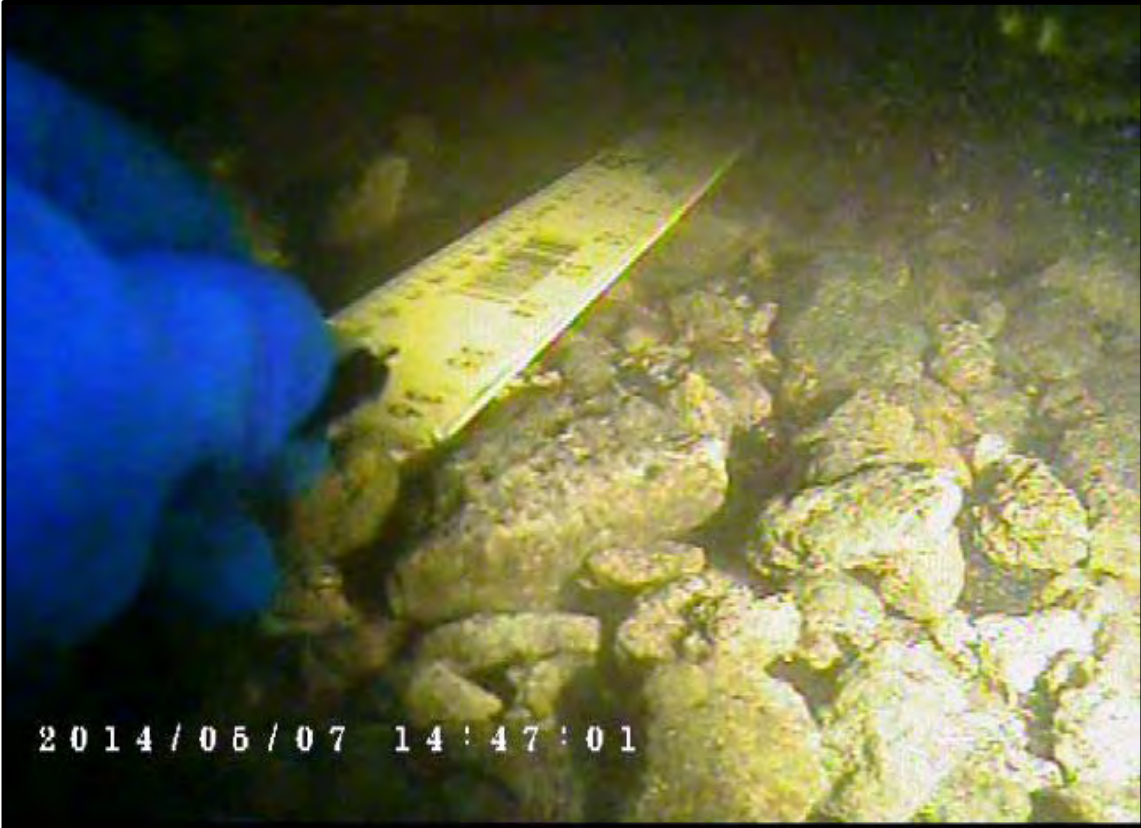
\_Abutment 1 has intermittent undermining the entire length up to 2" H, and 40" penetration. No backfill loss was observed during this inspection cycle. **UW Photo 04. INCREASE**

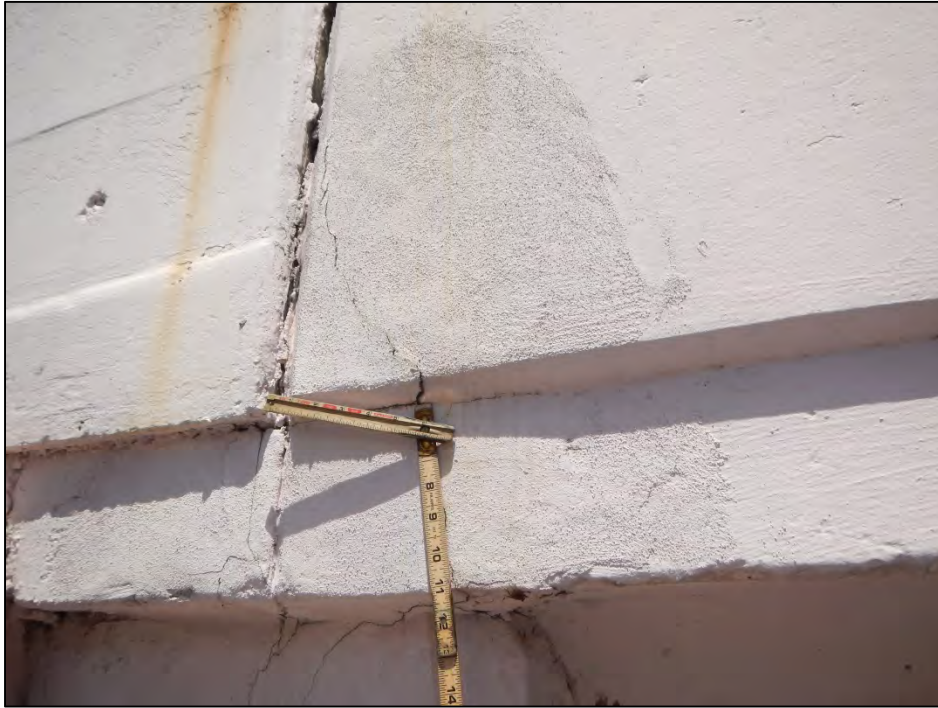
Photo 1 – The west face of the left barrier over End Bent 4 exhibits a delamination.

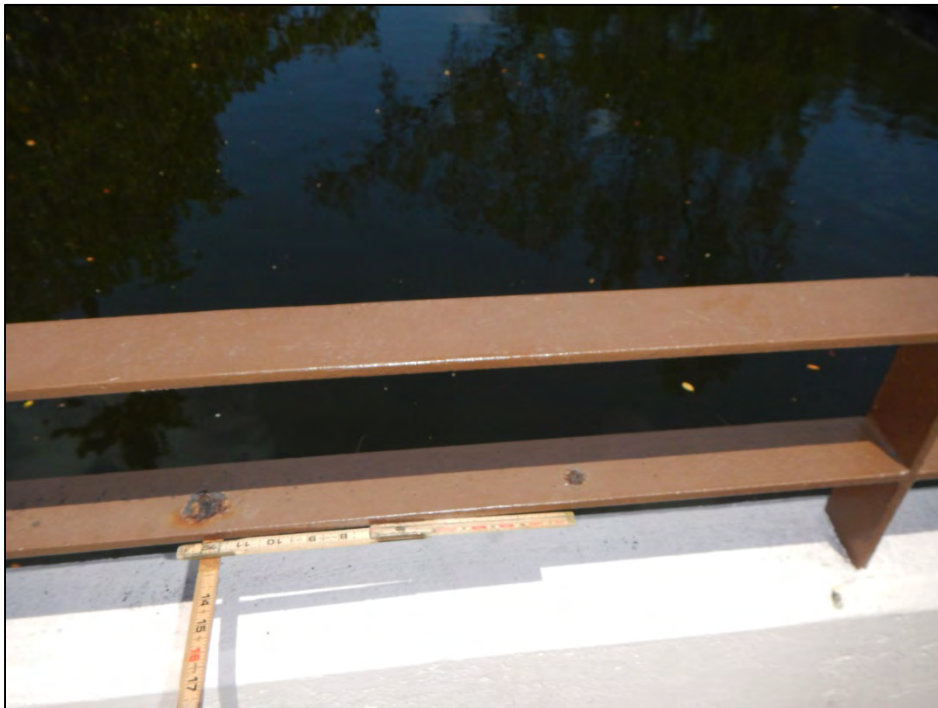
Photo 2 – The east railing at mid span over Span 2 exhibits corrosion.

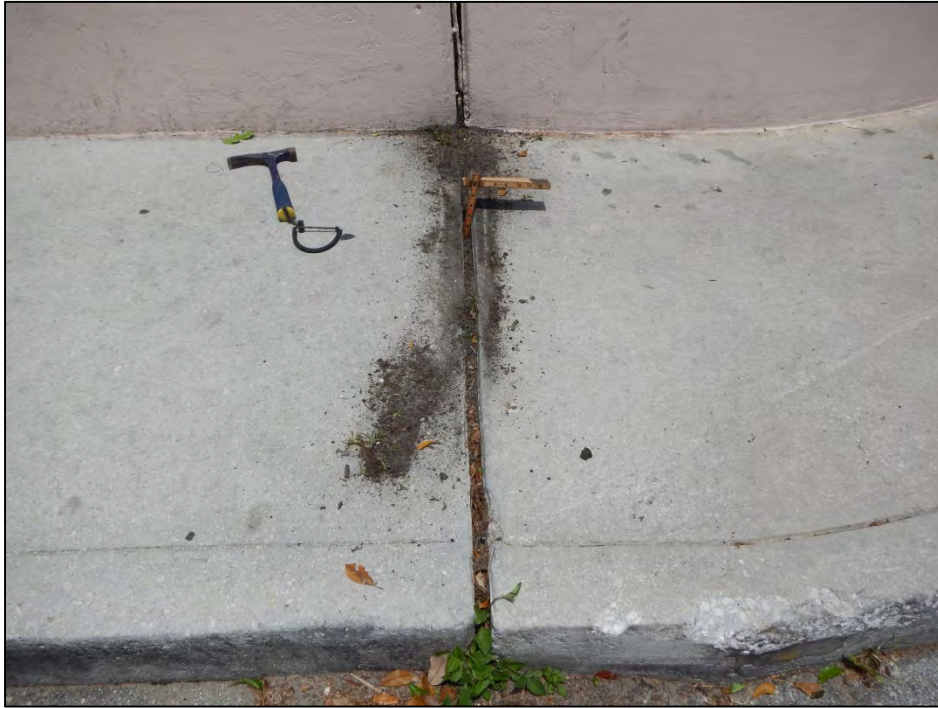
Photo 3 – The right sidewalk joint seal over End Bent 1 is deteriorated.

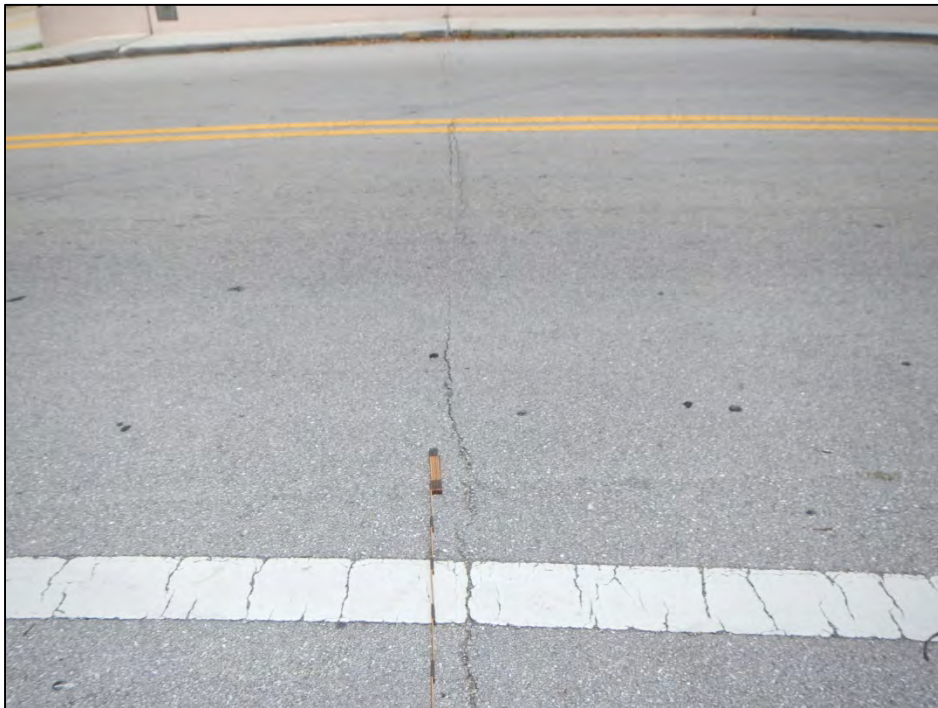
Photo 4 – The deck top exhibits a transverse crack over Bent 3.

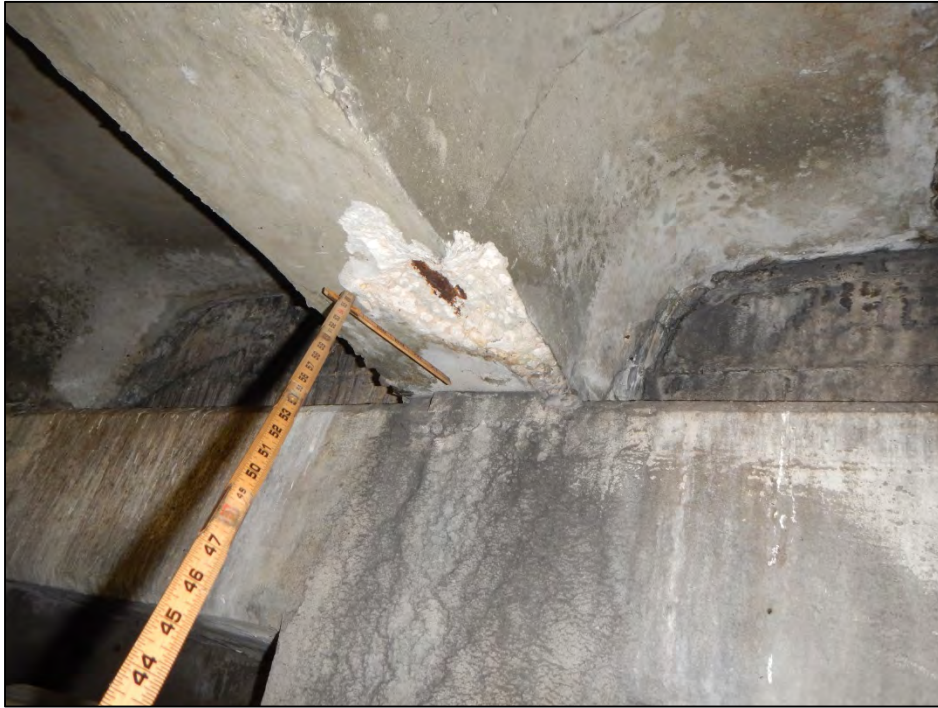
Photo 5 – Beam I-5 right exhibits a spall/delamination with exposed steel.

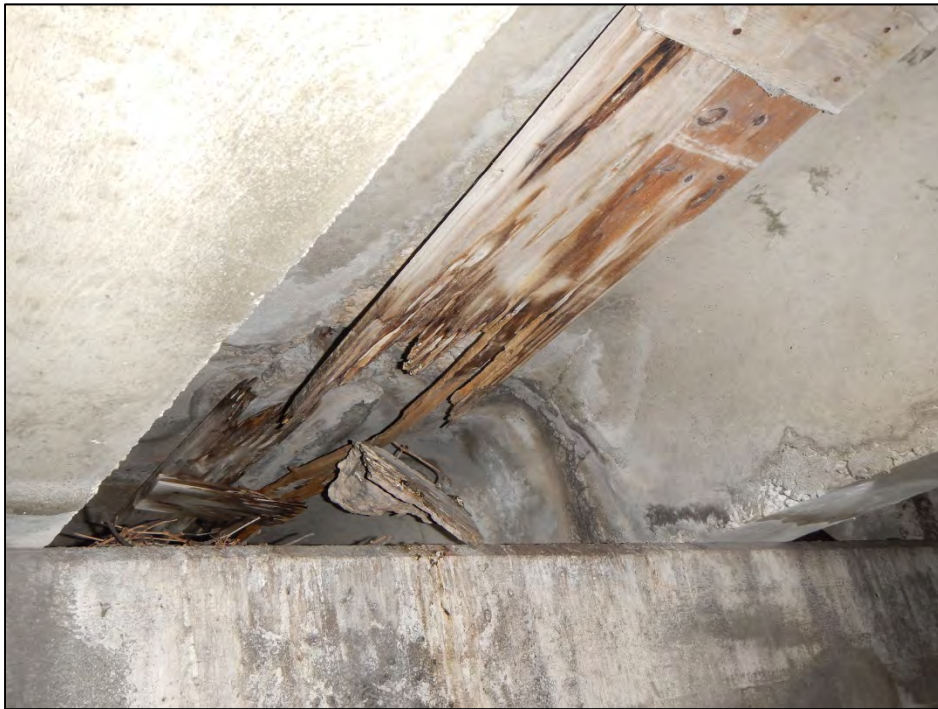
Photo 6 – Pieces of wood form-boards were left in-place along the beams.

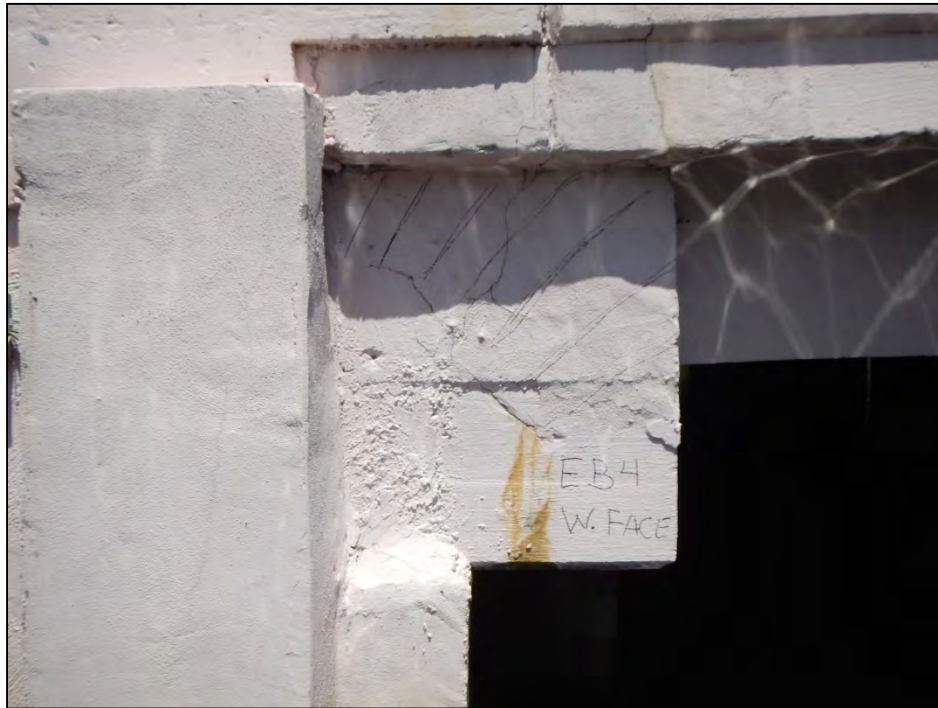
Photo 7 – The west face of Abutment 4 exhibits a delamination.

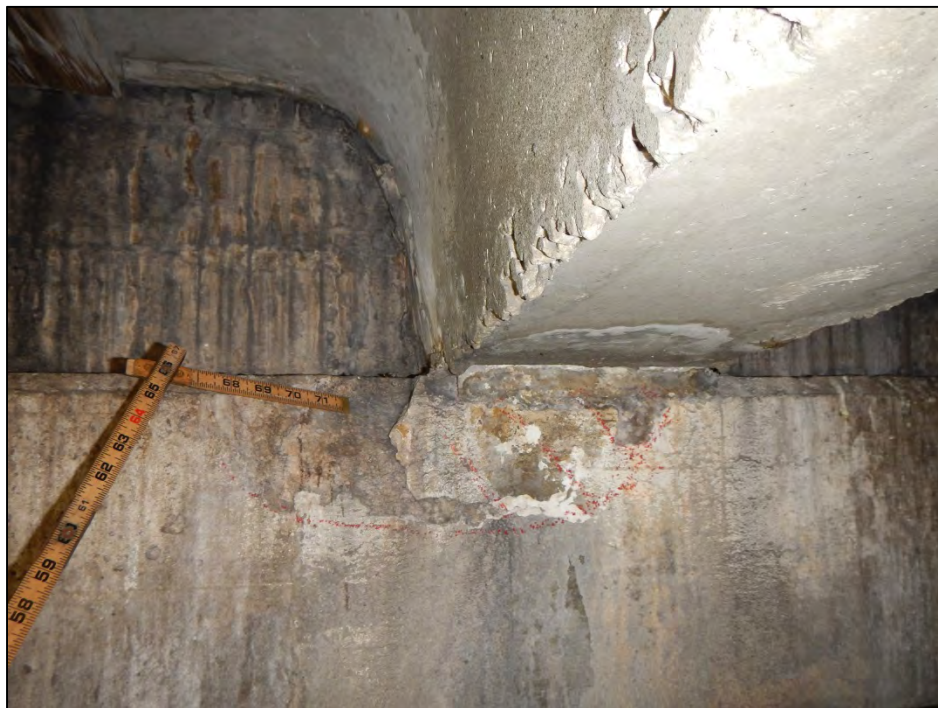
Photo 8 – Abutment 1 cap below Beam 5-I exhibits a spall/delamination.

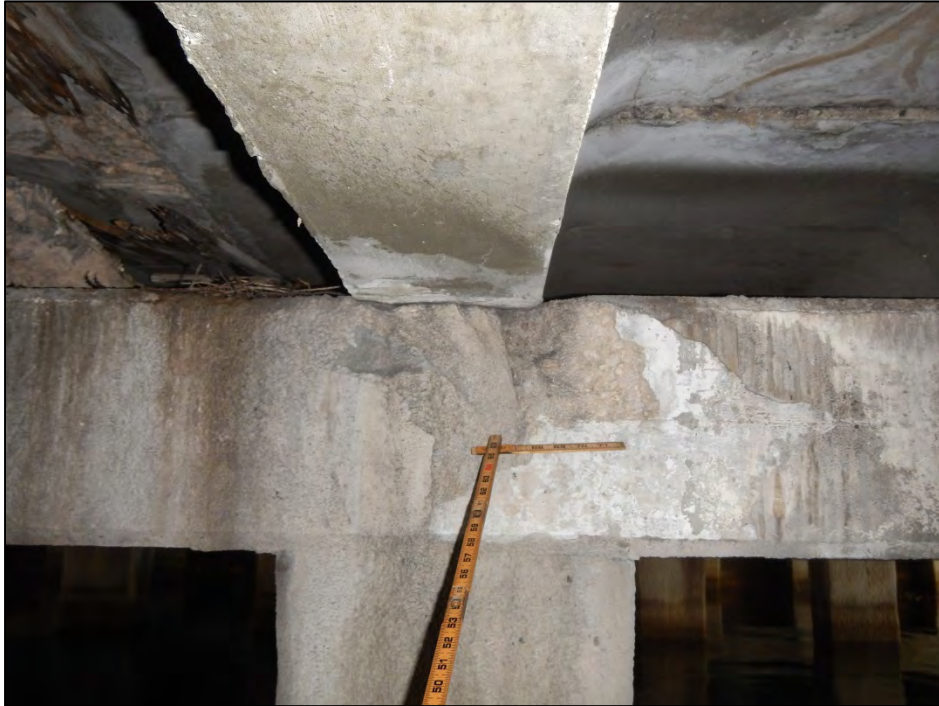
Photo 9 – The north face of Bent 3 cap below Beam 3-3 exhibits a spall.

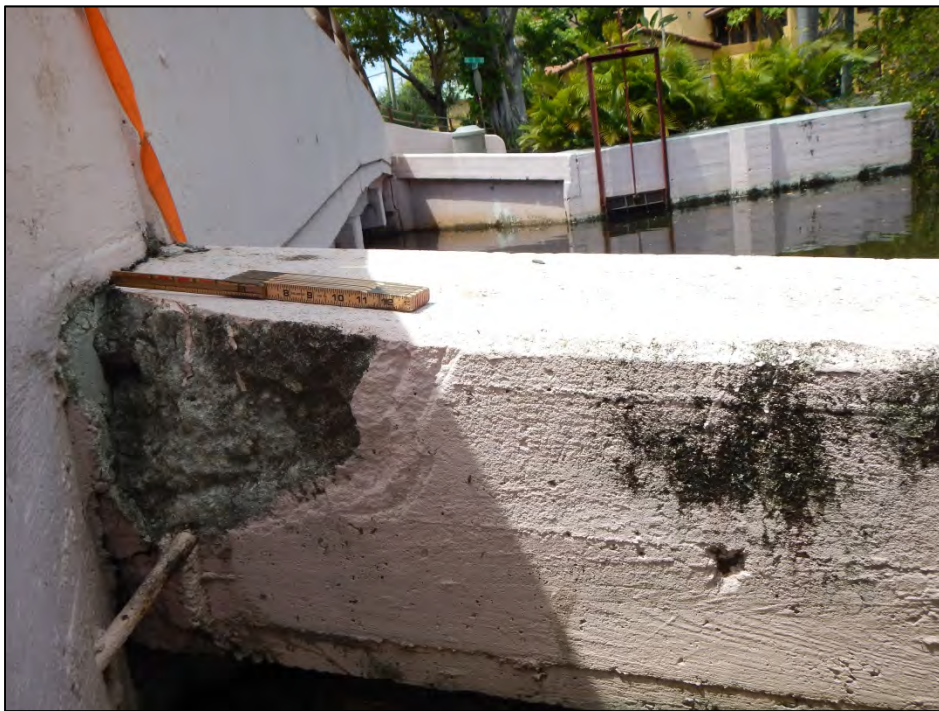
Photo 10 – The southeast retaining wall cap exhibits a spall at Abutment I.
