## **EXECUTIVE SUMMARY**

TranSystems has been retained by the City of Fort Lauderdale to perform bridge inspections and prepare bridge inspection reports for each of the City's bridges as part of the project Structural Bridge Engineering Consulting Services Master Plan, RFQ No. 946-11310. Inspections were completed and reports prepared for 46 of the City's bridges. The remaining five bridges in the City's inventory were not inspected because they are in the process of being replaced.

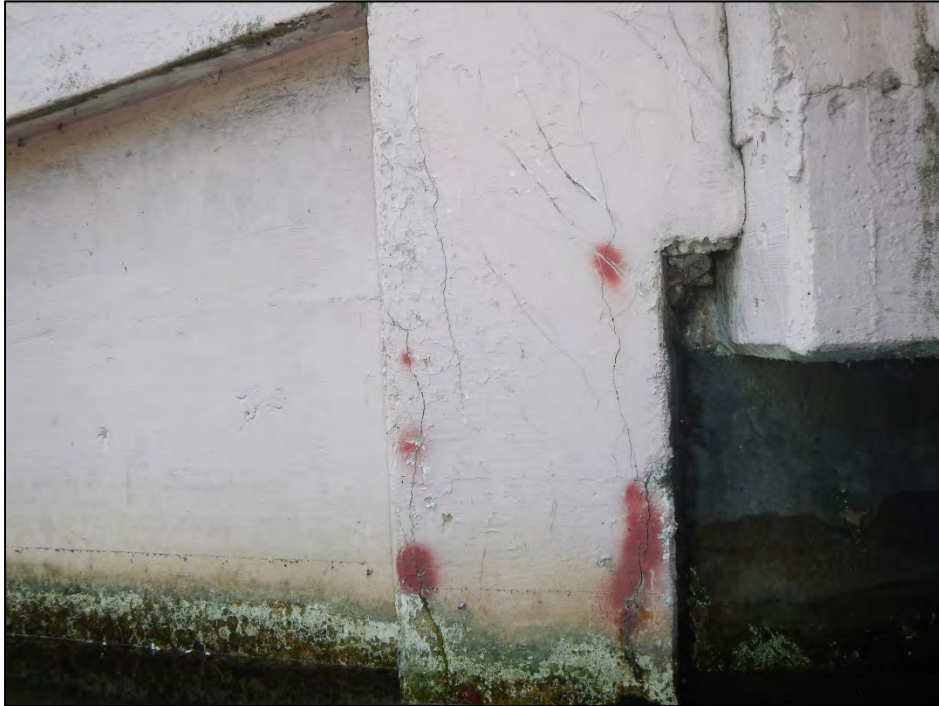
Photo 11 – The first pile of the southeast retaining wall exhibits a delamination with corrosion staining.

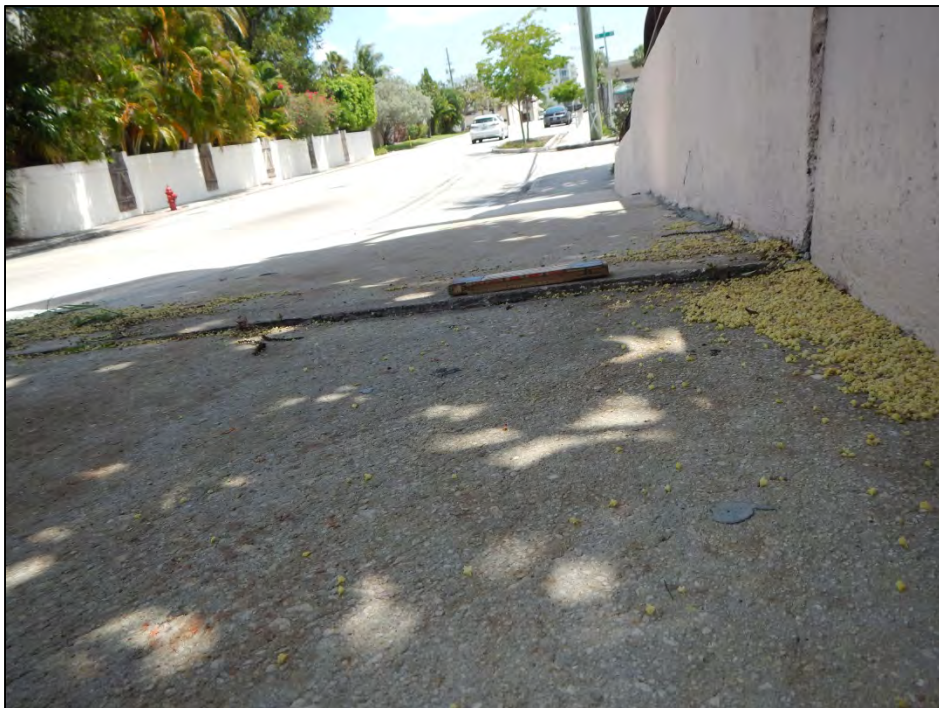
Photo 12 – The left sidewalk over Abutment 1 exhibits a difference in elevation.

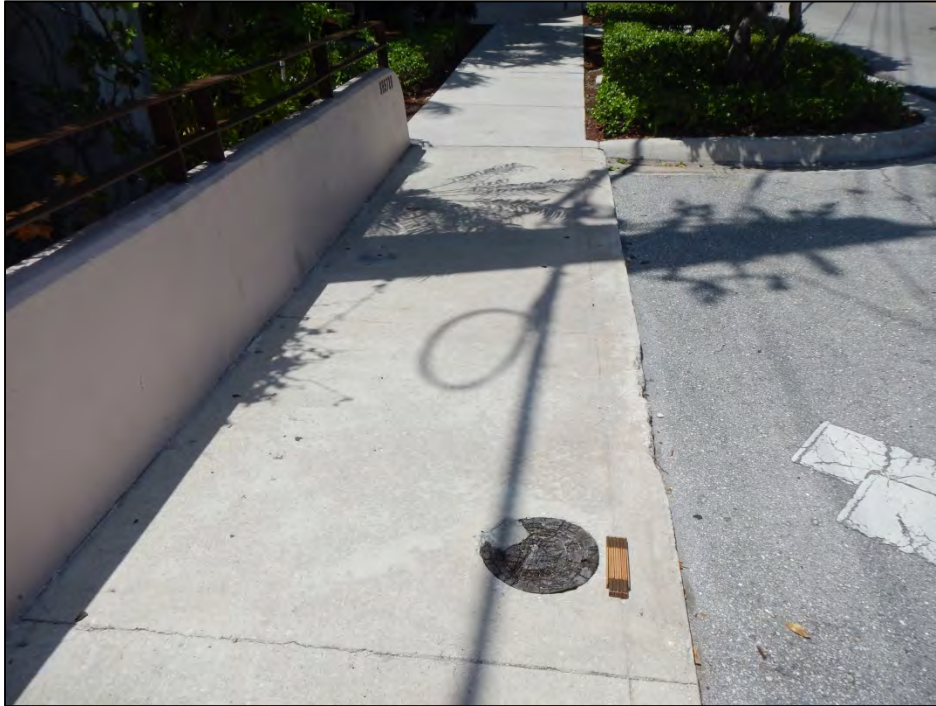
Photo 13 – The northwest approach sidewalk has a 1 ft. diameter timber column.

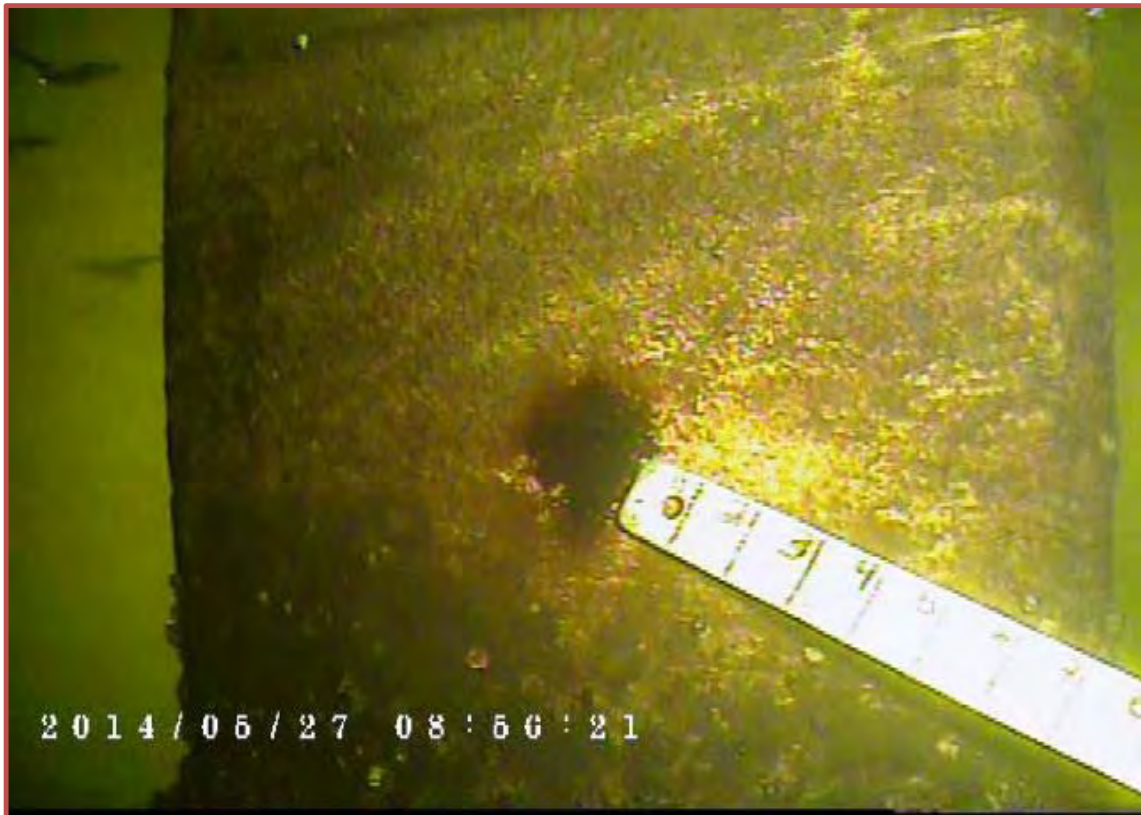
Description: Top: Pile 2-9, West face has a corrosion bleed-out spot, 3' below the cap. **UW Photo 01.**  
Bottom: Several of the jackets, horizontal cracks up to 1/64", in the gunite. **UW Photo 02.**

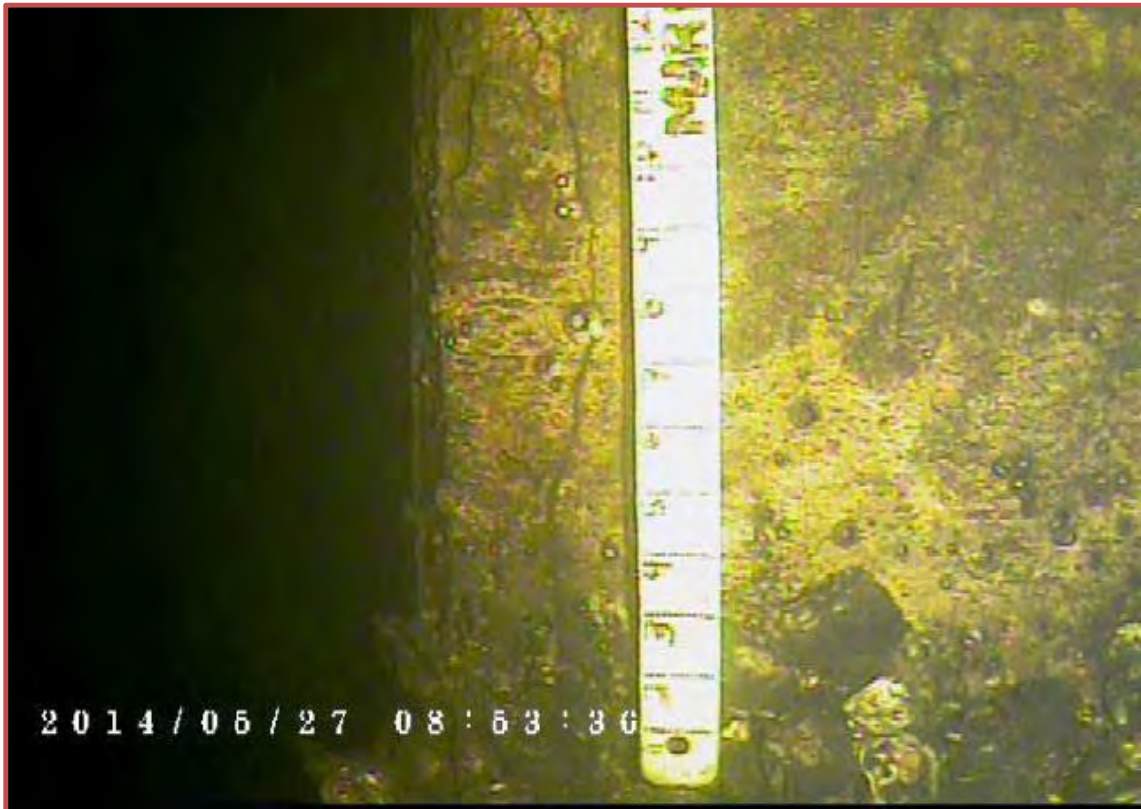
Description: Top: Several of the jackets have vertical cracks up to 1/64", in the gunite. **UW Photo 03.**  
Bottom: Both Abutment have intermittent areas of corrosion bleed-out. **UW Photo 04.**

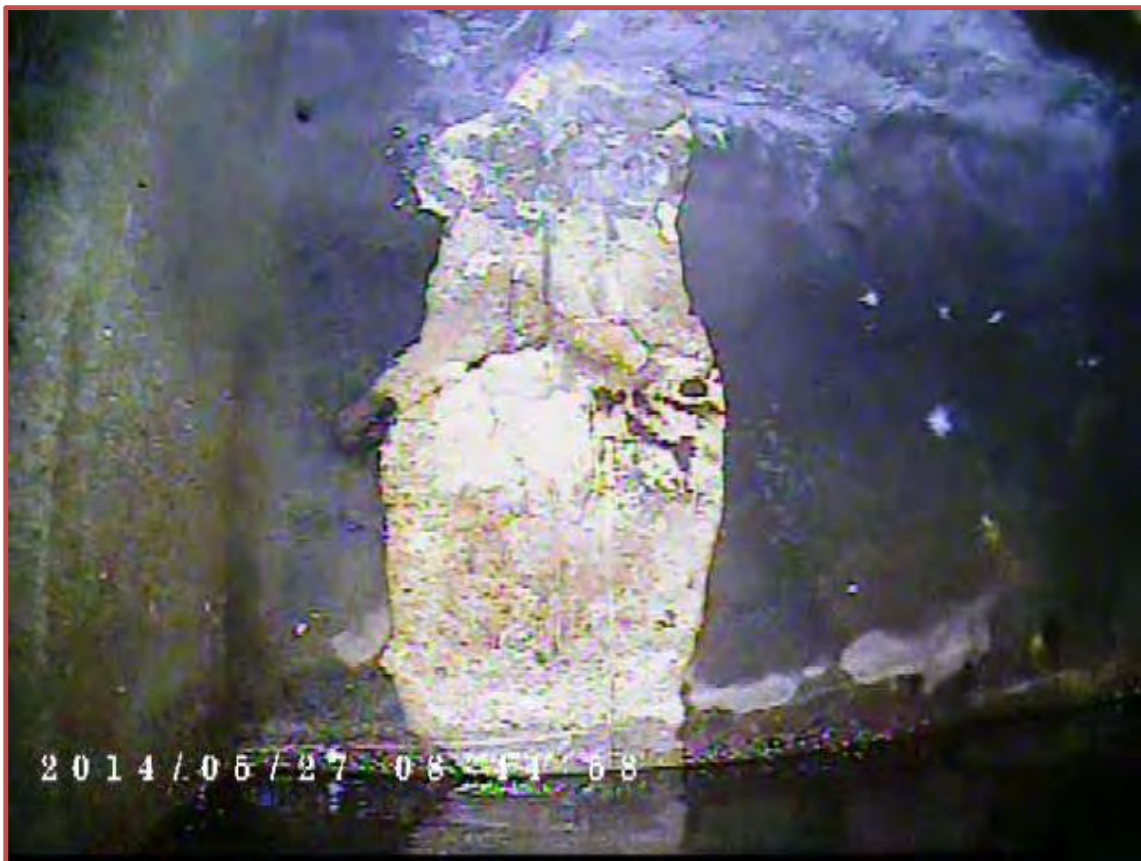
Description: Both Abutments have intermittent areas that the gunite cover is falling. **UW Photo 05.**

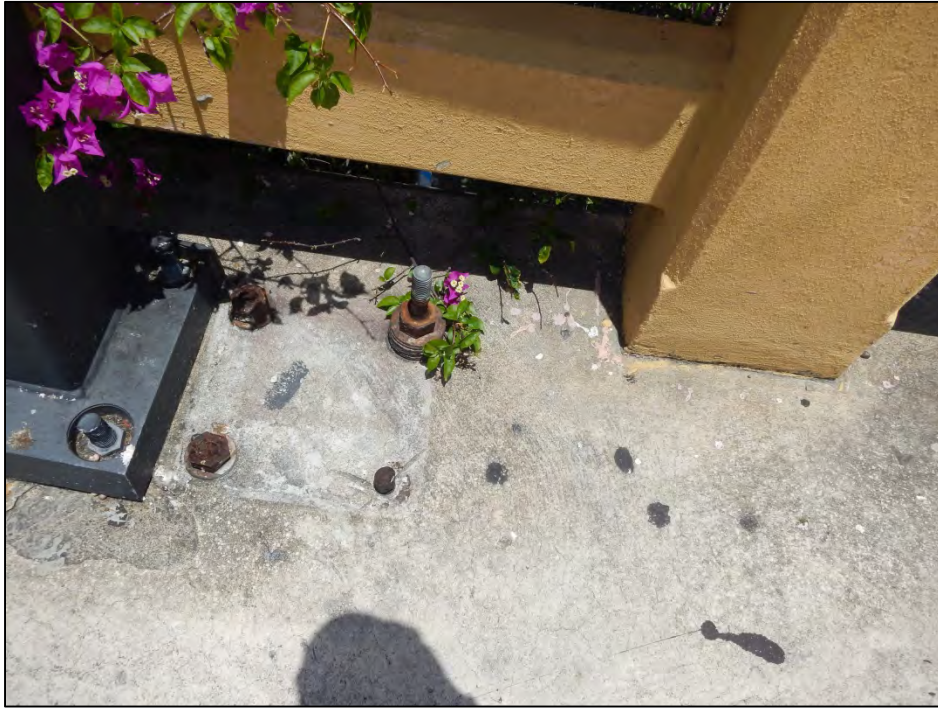
- The left sidewalk over Span 1 between Railing Posts 1-4 and 1-5 exhibits 4 protruding steel rods. This condition was not previously noted. See Condition Photo 1.
- The deck overlay has a 1/4 in. wide longitudinal crack along the construction joints in the outside lanes. See Condition Photo 2.
- There are up to 1/2 in. wide transverse cracks over the eastbound expansion joints. See Condition Photo 3.
- The scuppers are blocked with dirt and debris.

Photo 1 – The left sidewalk between Railing Posts 1-4 and 1-5 exhibits 4 protruding steel rods.

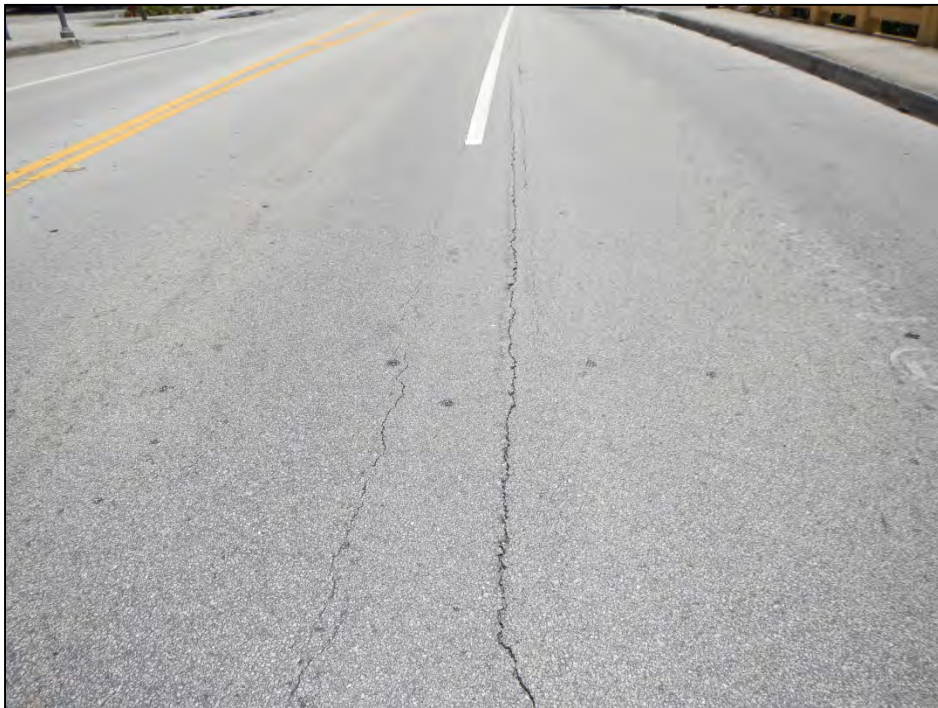
Photo 2 – The deck top exhibits longitudinal cracks.

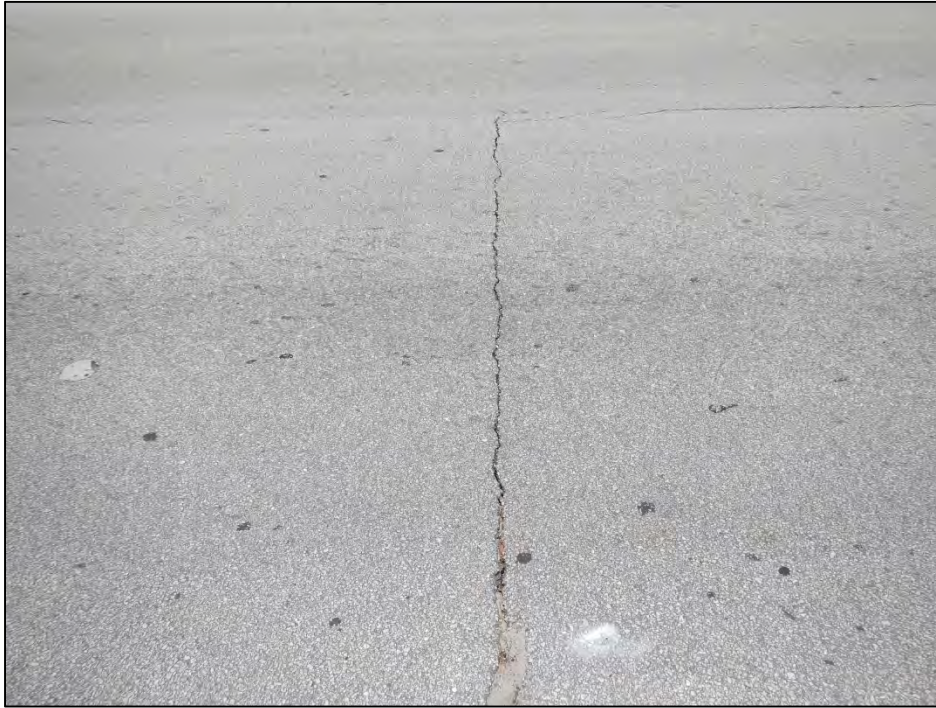
Photo 3 – The eastbound deck top joint exhibits a transverse crack over Bent 2.

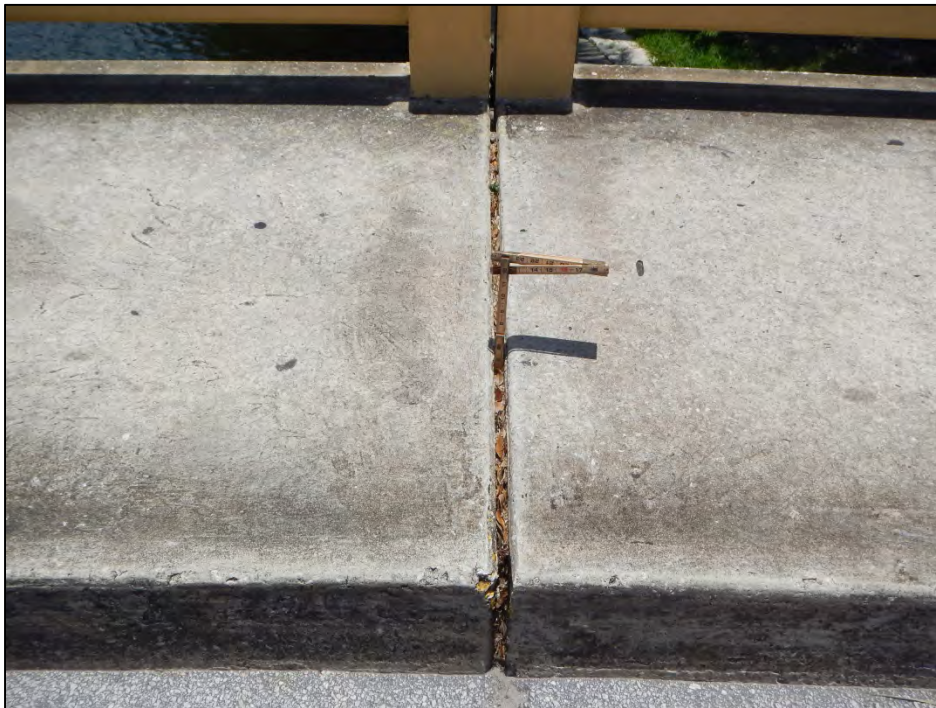
- The sealant in the sidewalk joints is completely deteriorated. See Condition Photo 4.

Photo 4 – The right sidewalk joints exhibit deteriorated sealants.

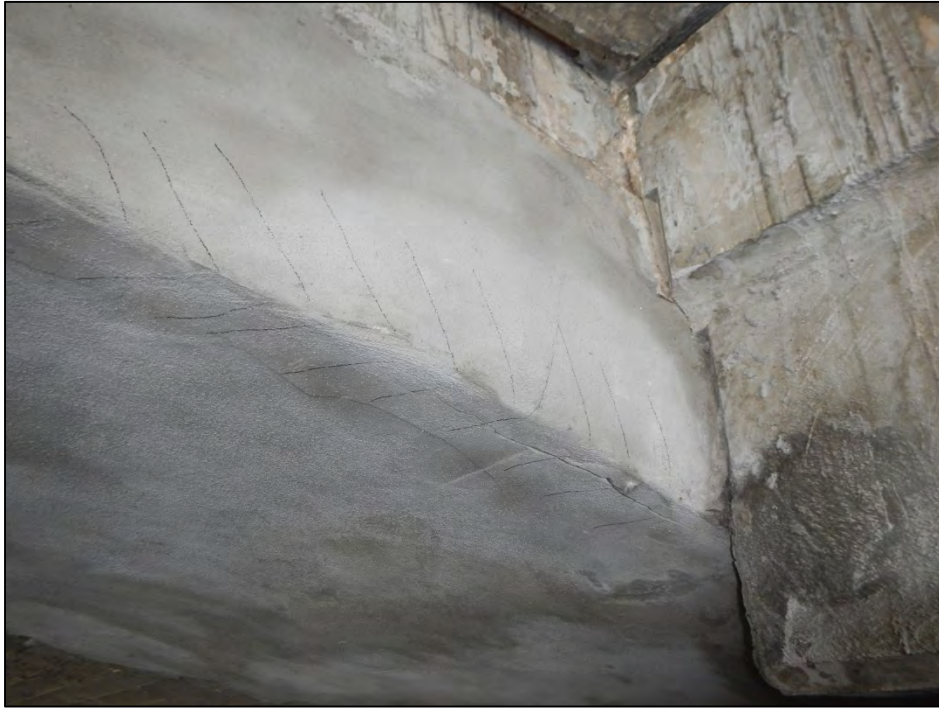
Photo 5 – The northwest end of the arch exhibits shrinkage cracks with hollow sounds.

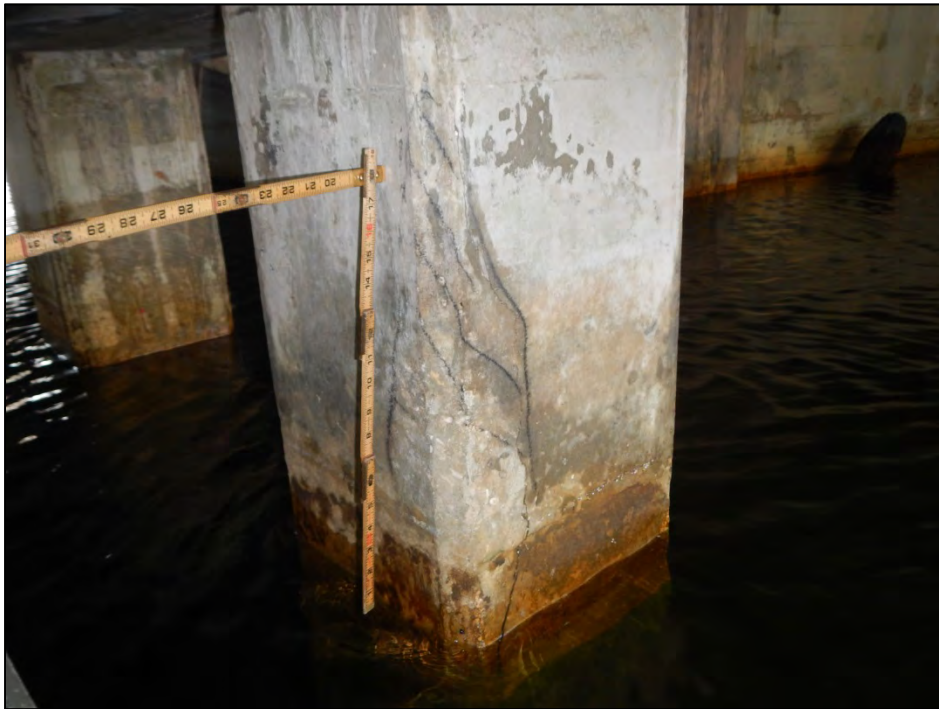
Photo 6 – The southwest corner of Pile 3-6 exhibits a delamination.

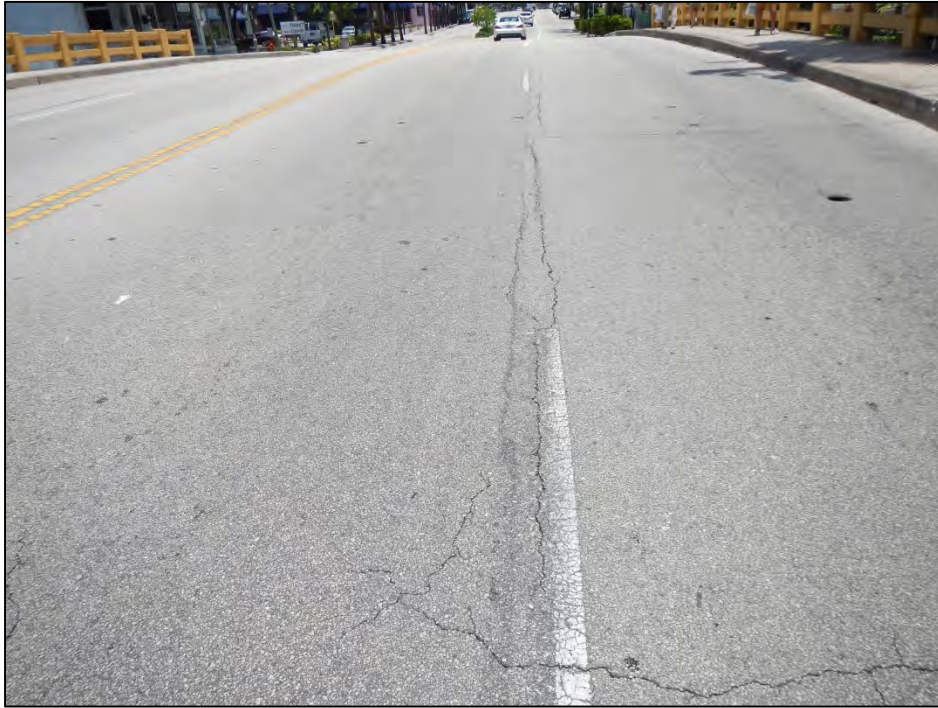
Photo 7 – The south approach slab exhibits longitudinal cracks.

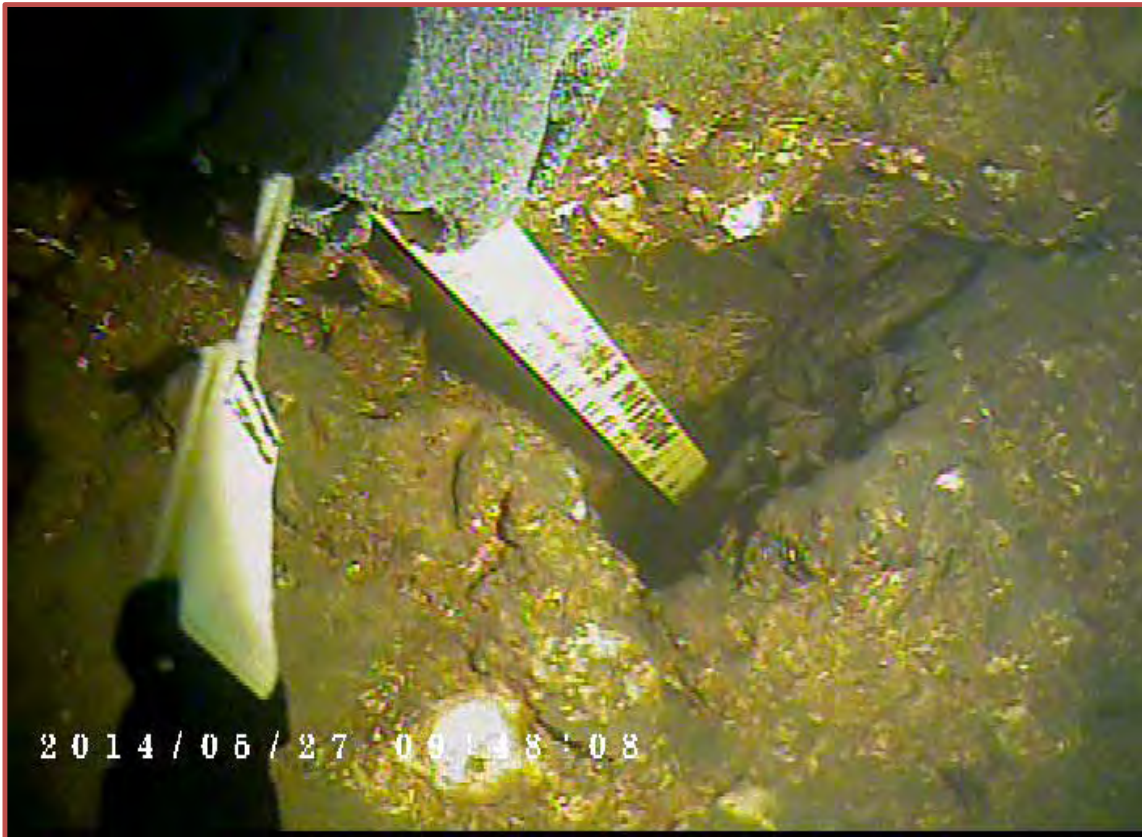
Description: Top: Intermittent voids underwater along the W and E ends of the arch. **UW Photo 01.**  
Bottom: Pile 2-4, NW corner has a vertical crack. **UW Photo 02.**

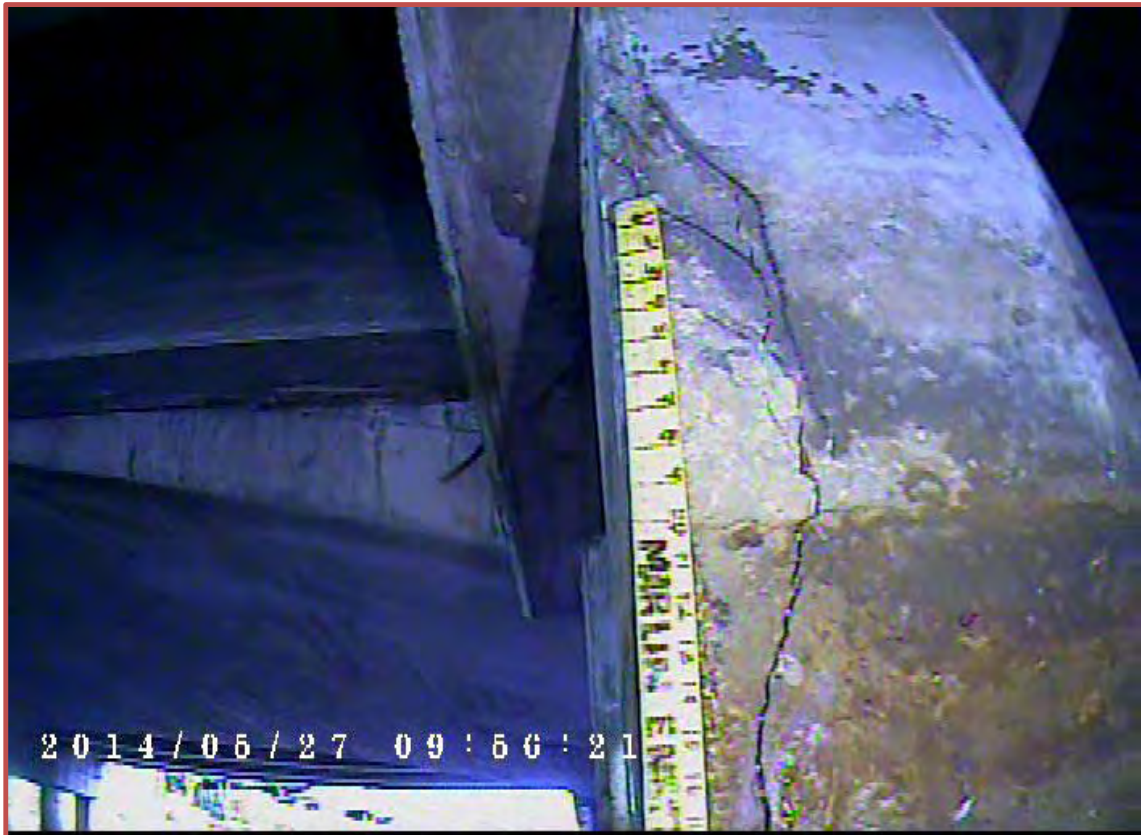
Description: Top: Pile 3-6, SW corner delamination, with corrosion bleed-out. **UW Photo 03.**  
Bottom: Pile 3-8, SW corner spall/delamination, with exposed steel. **UW Photo 04.**

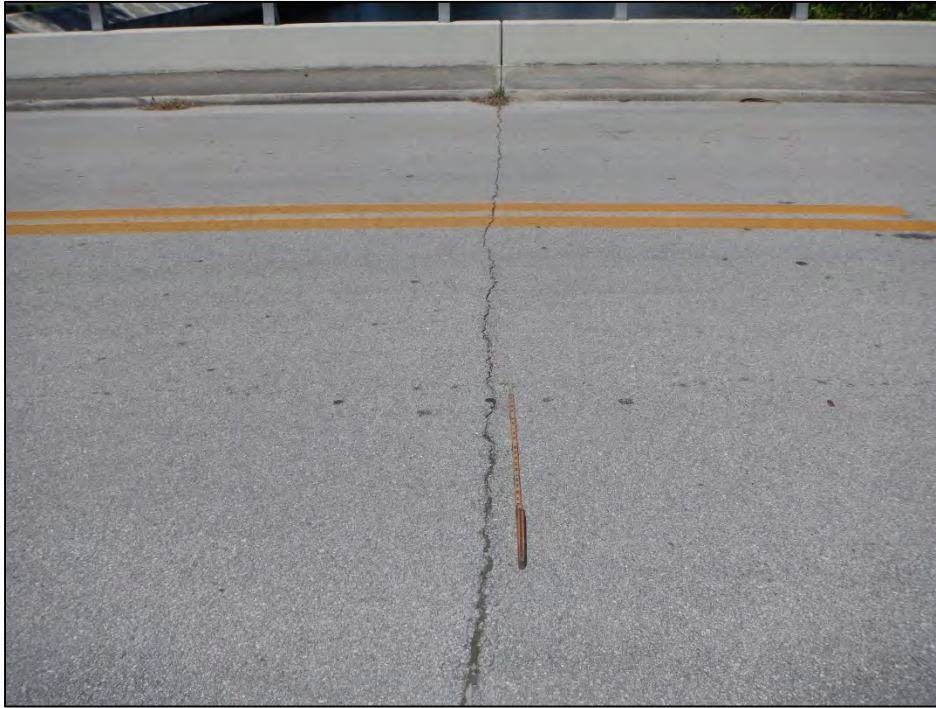
Photo 1 – Transverse cracks in asphalt overlay.

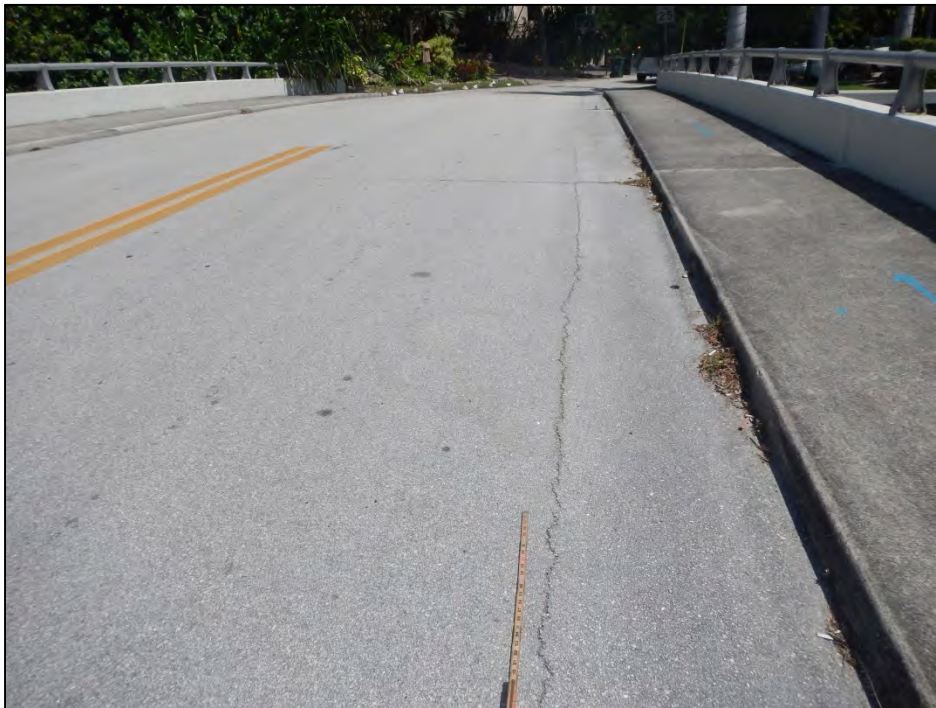
Photo 2 – Longitudinal cracks in asphalt overlay above slab unit joints. Note vegetation at the curb line.

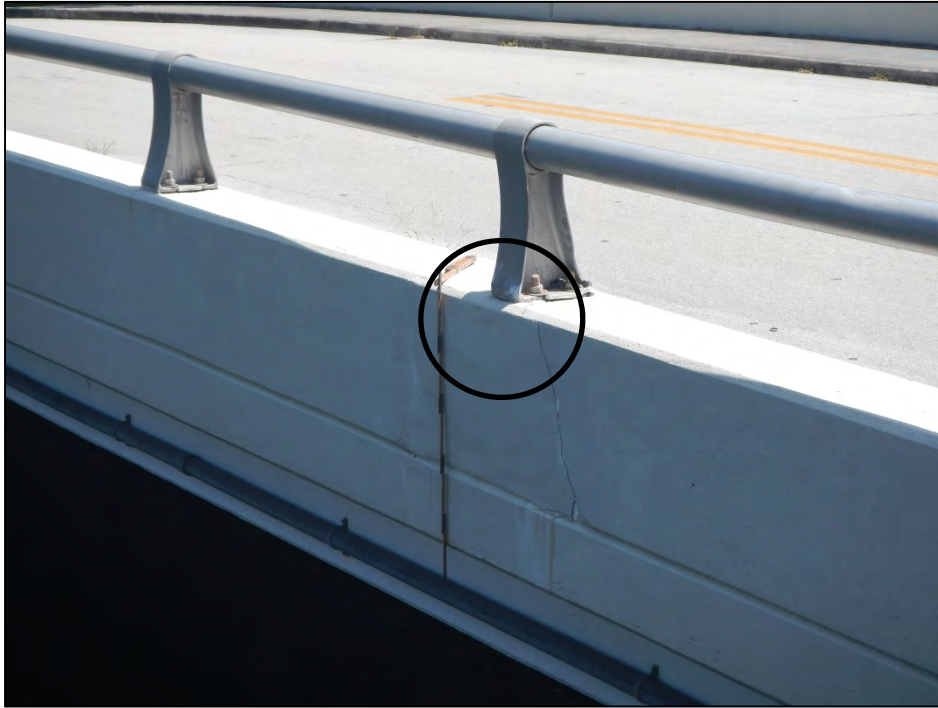
Photo 3 – Delaminated patch in left parapet beneath handrail support.

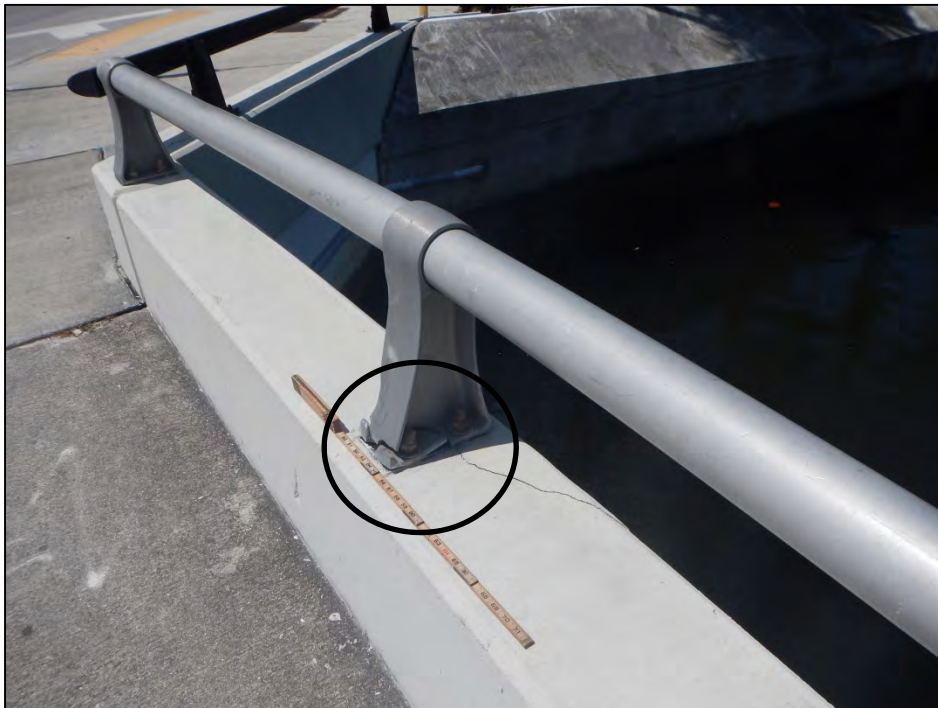
Photo 4 – Fractured handrail support in Span 1 at the left parapet.

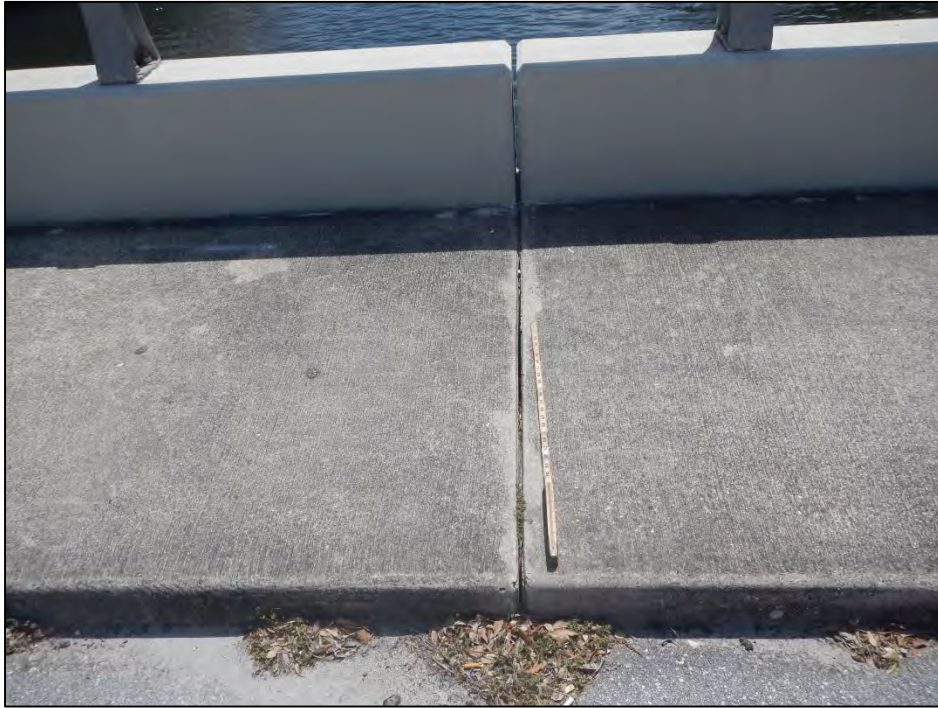
Photo 5 – Deteriorated sidewalk joint.

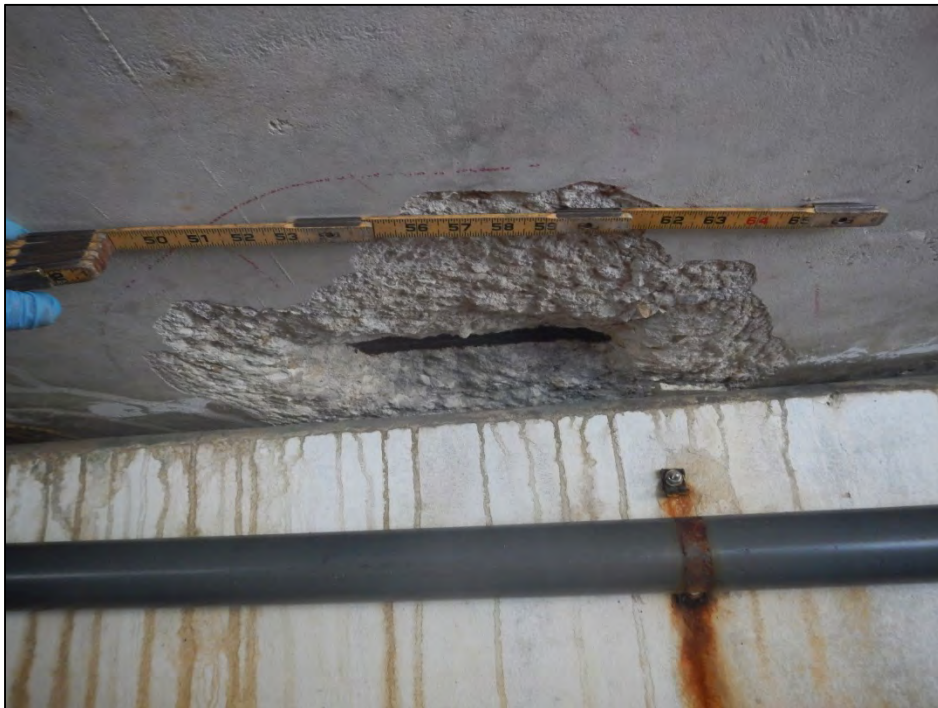
Photo 6 – Spall/Delamination with exposed prestressing strand in Slab Unit 3-6.

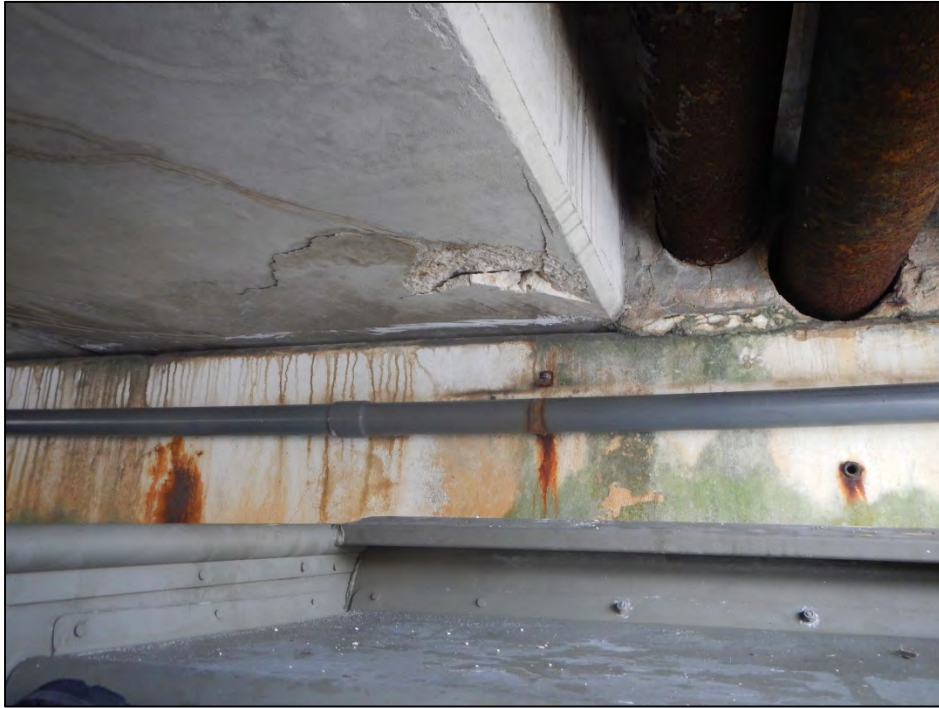
Photo 7 – Spall/Delamination in Slab Unit 3-7 at Abutment 4.

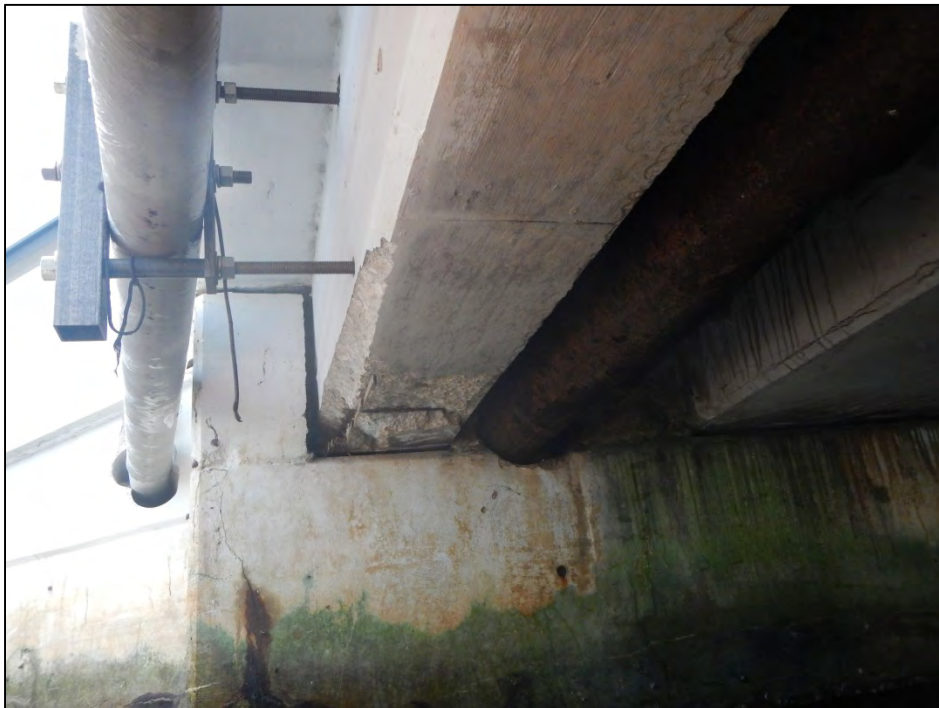
Photo 8 – Spall with exposed steel in the east fascia beam.

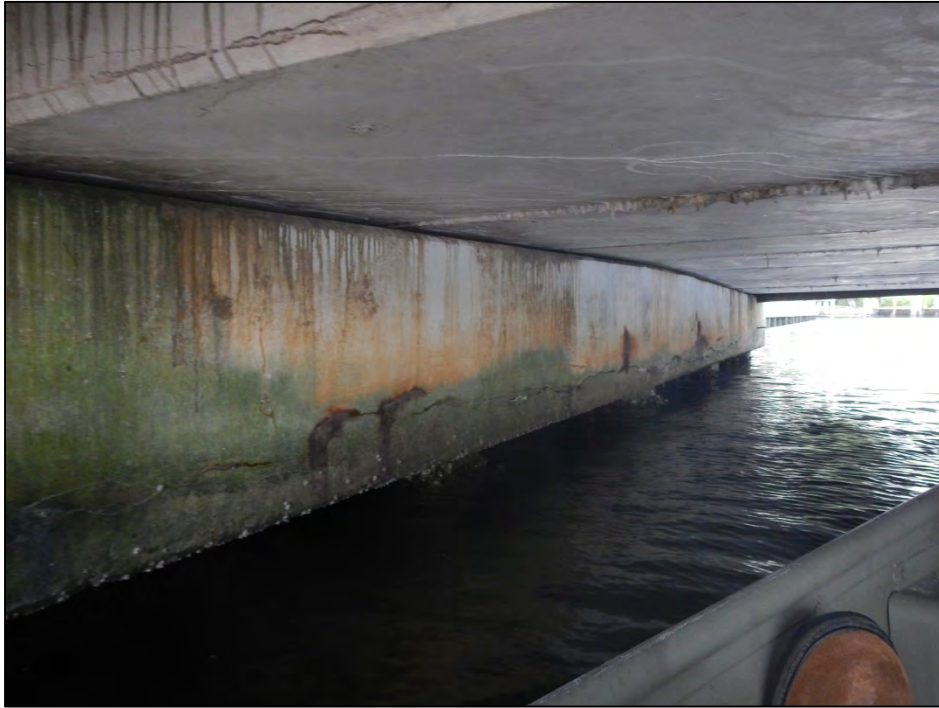
Photo 9 – Delamination at Abutment 1 cap.

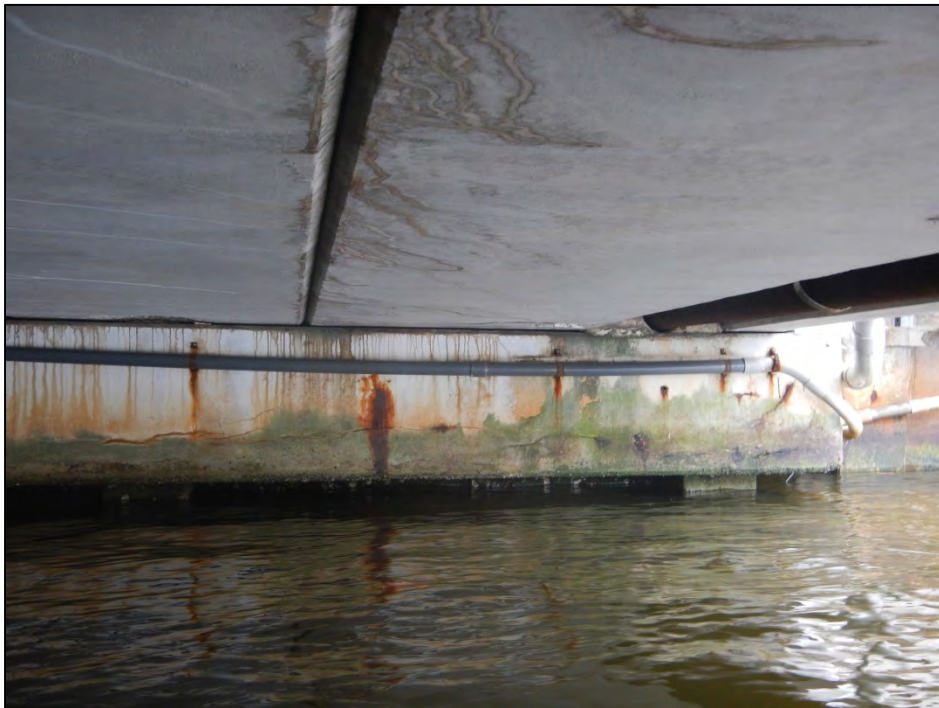
Photo 10 – Delamination at Abutment 4 cap.

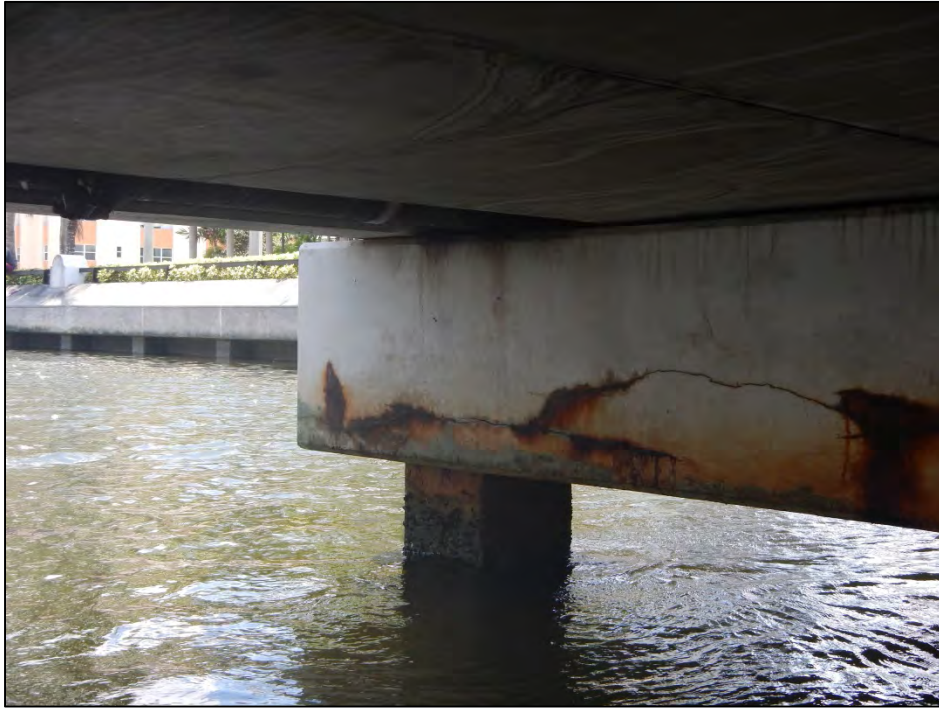
Photo 11 – Delamination in north face of Bent 2 cap.

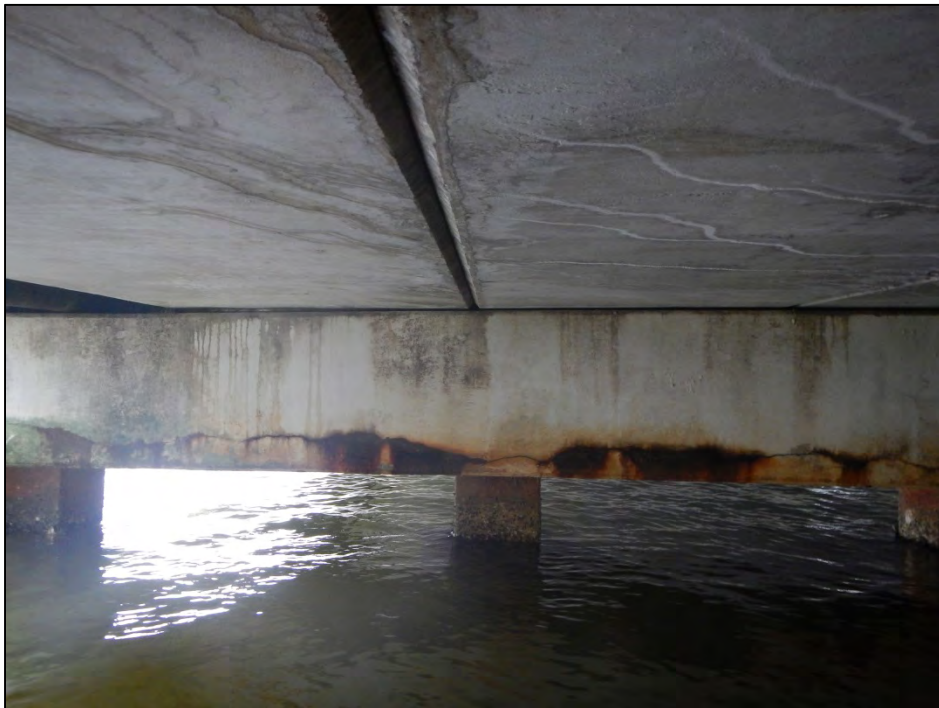
Photo 12 – Delamination in north face of Bent 3 cap.

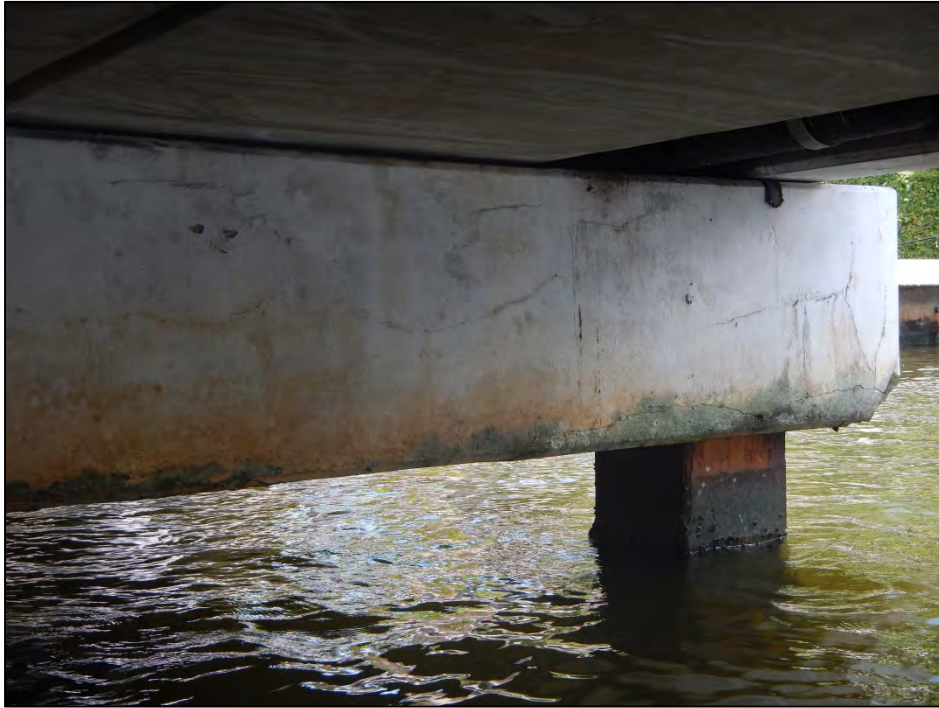
Photo 13 – Spall with corrosion bleedout at the southeast corner of Bent 3 cap.

\_Bent 3 cap, bottom SE corner has a spall 8" x 5" x 3", with associated cracks up to 1/8" wide and corrosion bleed-out. **INCREASE**

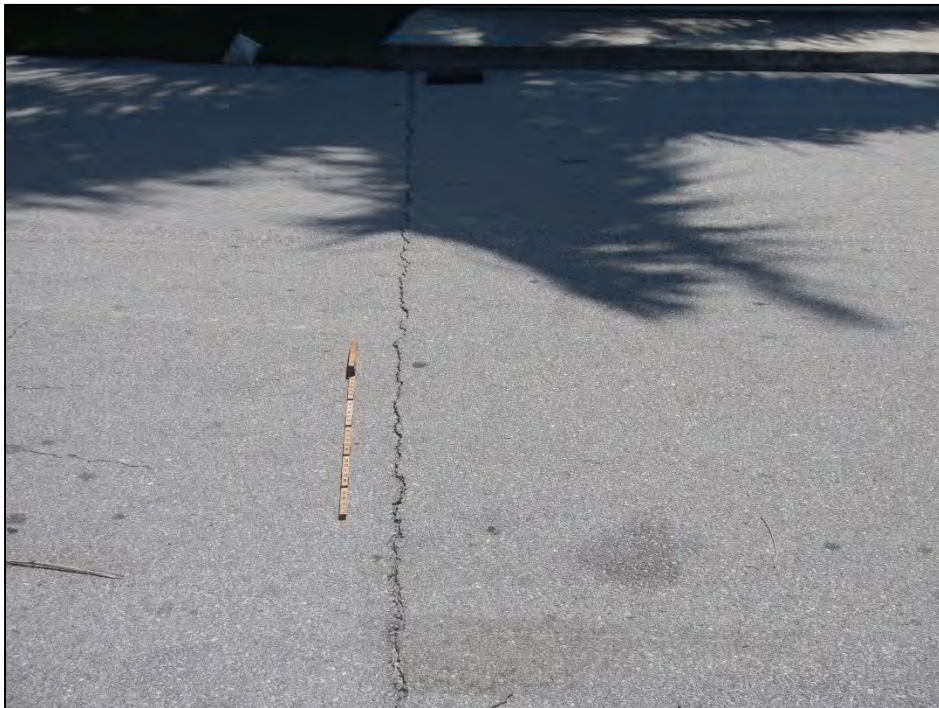
Photo 14 – Crack in asphalt at the roadway transition.

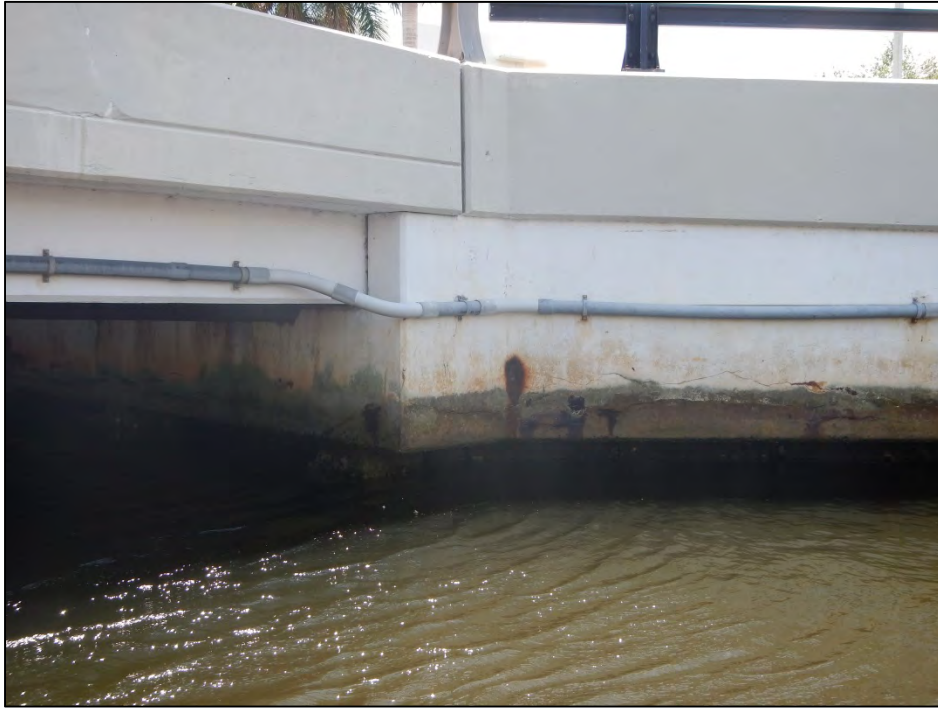
Photo 15 – Delamination at the southwest retaining wall cap.
