## **EXECUTIVE SUMMARY**

TranSystems has been retained by the City of Fort Lauderdale to perform bridge inspections and prepare bridge inspection reports for each of the City's bridges as part of the project Structural Bridge Engineering Consulting Services Master Plan, RFQ No. 946-11310. Inspections were completed and reports prepared for 46 of the City's bridges. The remaining five bridges in the City's inventory were not inspected because they are in the process of being replaced.

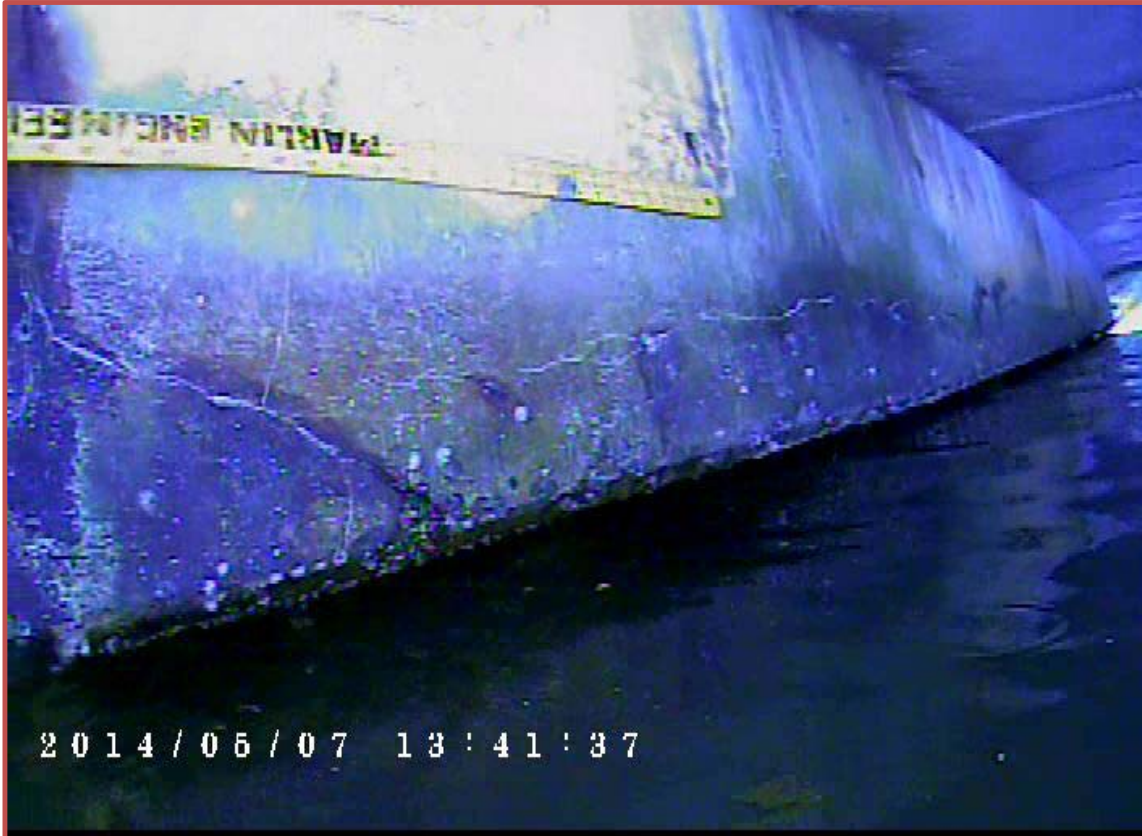
\_Abutment 1 cap has a full length x 18", delamination along the bottom North edge with associated cracks up to 1/8" wide and several areas of corrosion bleed-out. **UW Photo 01. INCREASE**

Description: Top: Abutment 1 cap, delamination along the bottom edge. **UW Photo 01.**  
Bottom: Abutment 4 cap, delamination along the bottom edge. **UW Photo 02.**

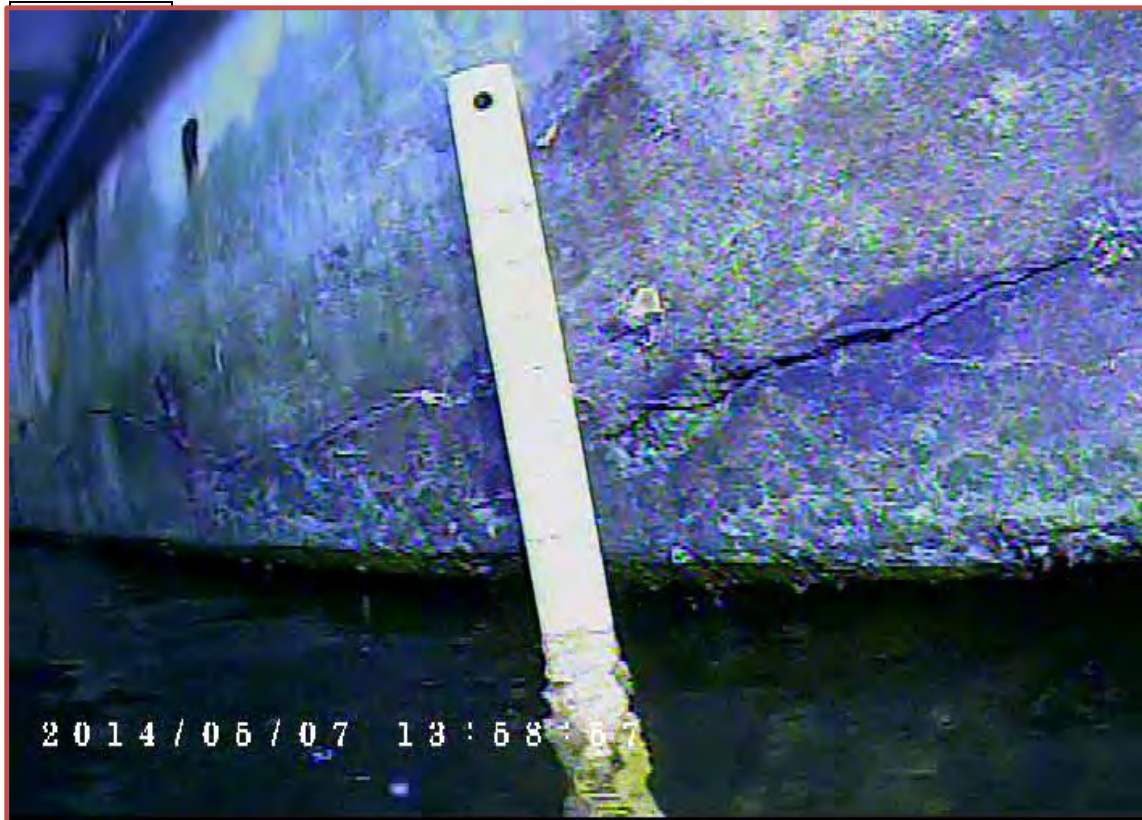
\_Abutment 4 cap has a full length x 18", delamination along the bottom South edge with associated cracks up to 1/8" wide and several areas of corrosion bleed-out. **UW Photo 02. INCREASE.**

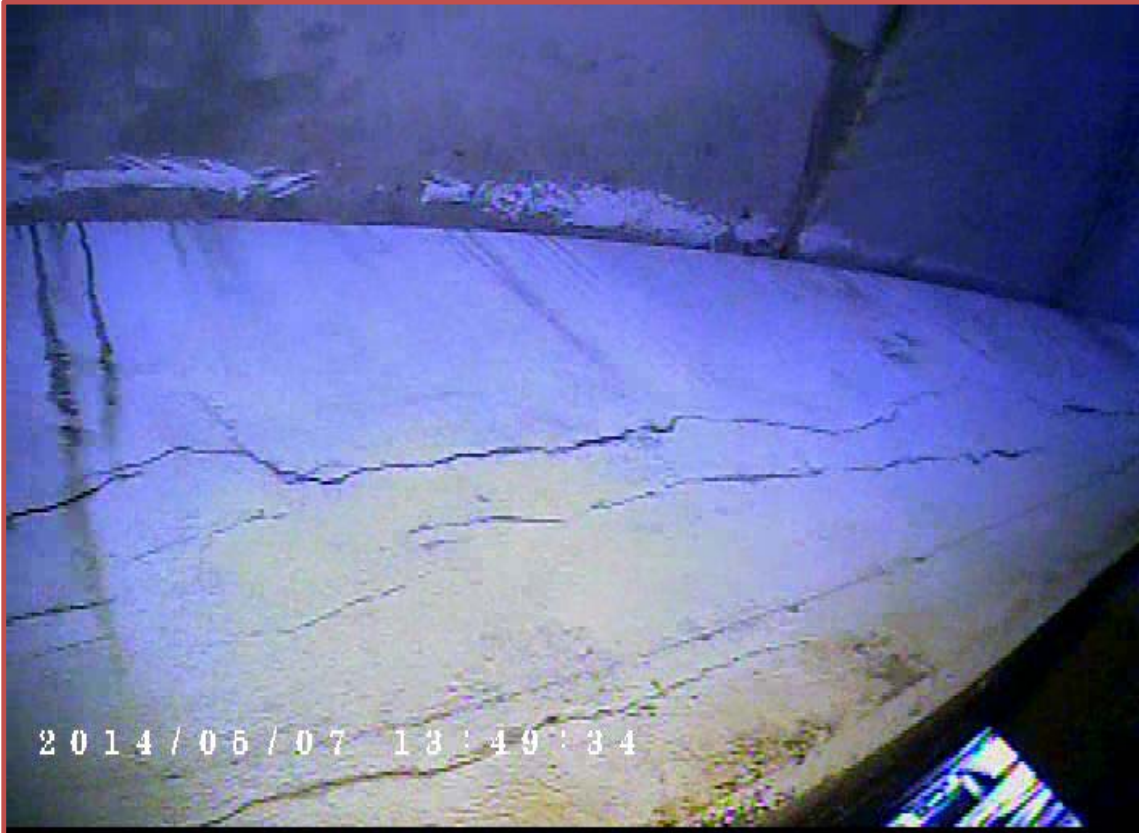
\_Bent 2 cap has a full length x 15", delamination along the bottom edges with associated cracks up to 1/8" wide and corrosion bleed-out. **UW Photo 03. INCREASE**

Description: Top: Bent 2 cap delamination at the bottom edges w/associated cracks. **UW Photo 03.**  
Bottom: Bent 3 cap delamination at the bottom edges w/associated cracks. **UW Photo 04.**

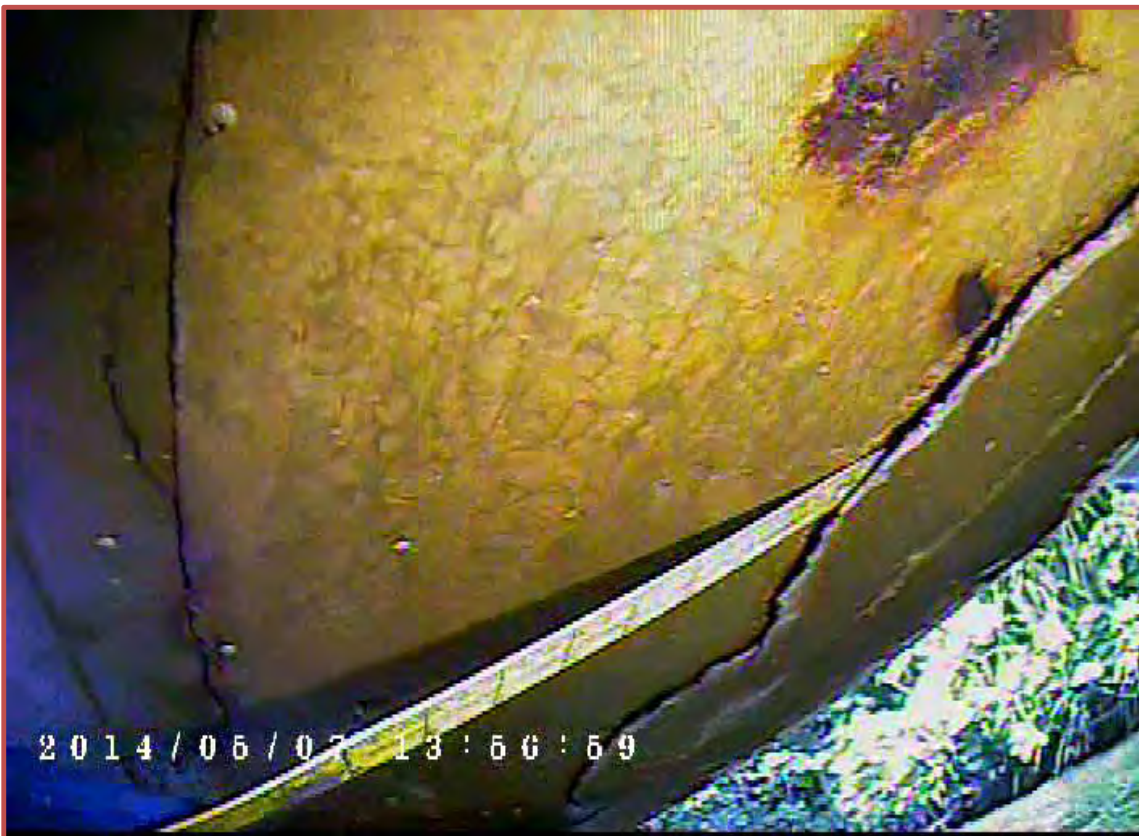
\_Bent 3 cap has a full length x 15", delamination along the bottom edges with associated cracks up to 1/8" wide and corrosion bleed-out, with isolated areas being full cap height.

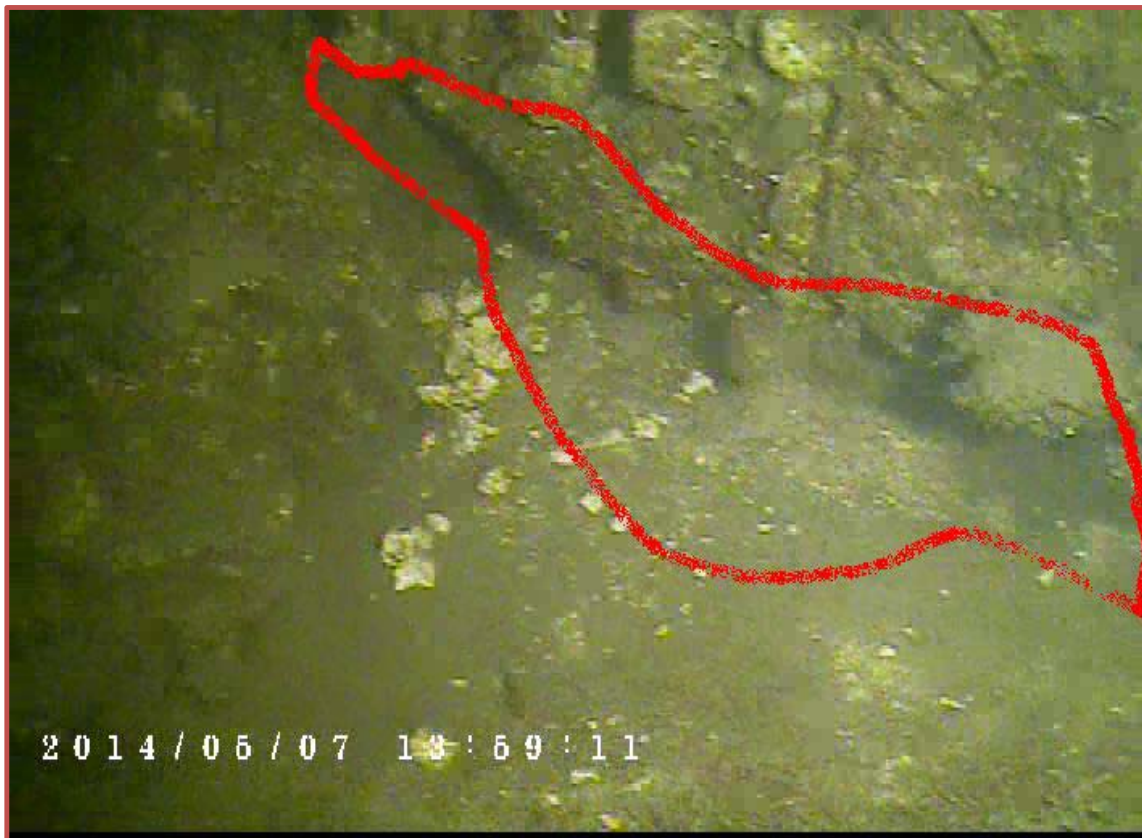
\_The end of the Northeast retaining wall has a void at the transition to the private sector with minor backfill leakage. **UW Photo 05. DECREASE**

Description: NE retaining wall has a void at the transition to the private sector with minor backfill leakage. **UW Photo 05**

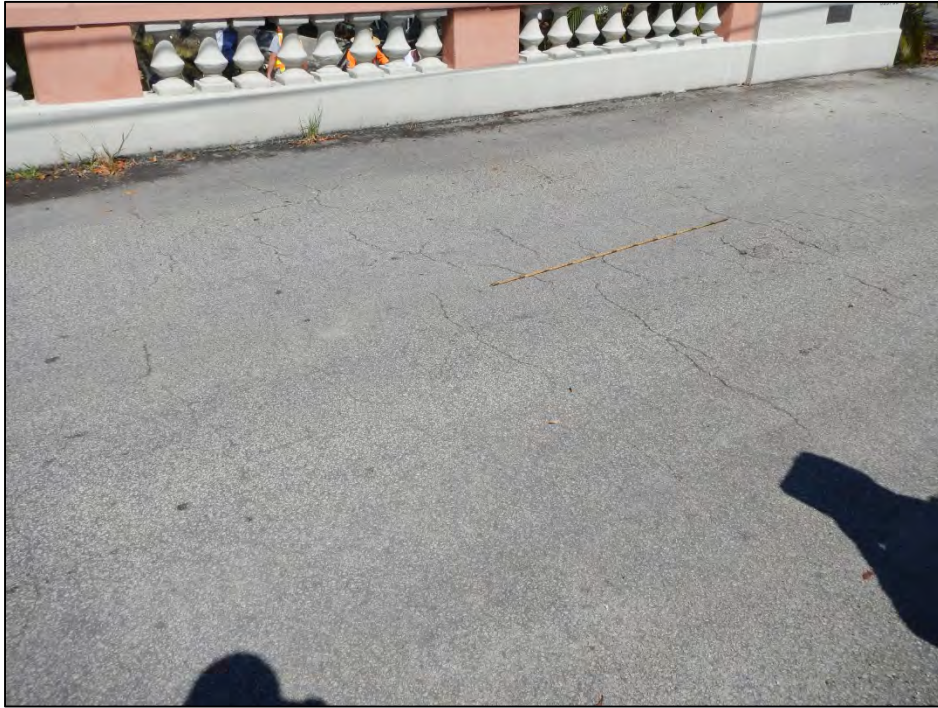
Photo 1 – Delaminated and cracked asphalt overlay.

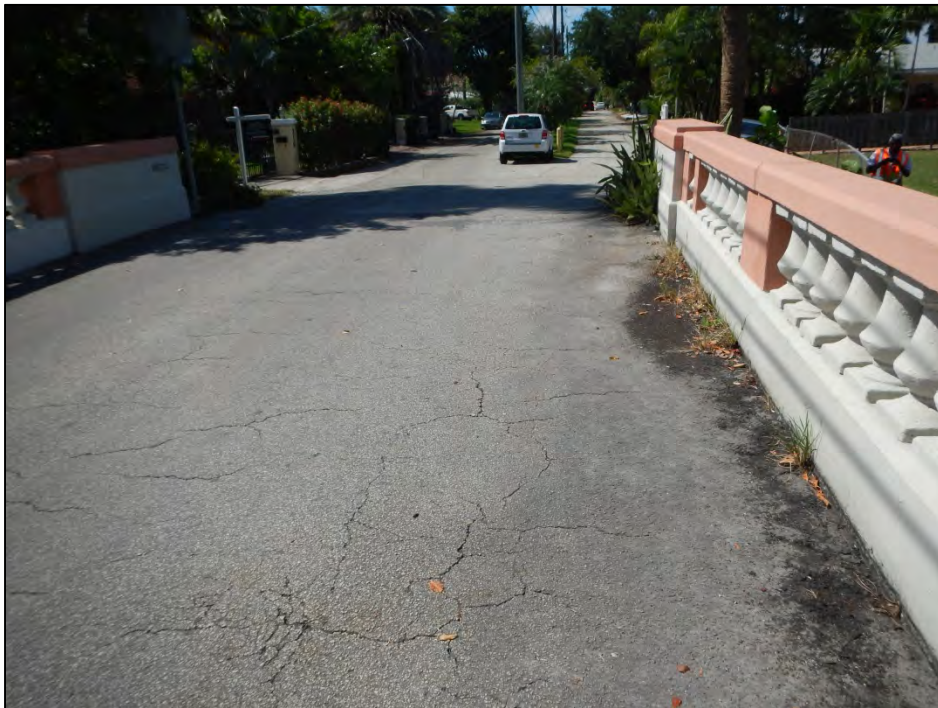
Photo 2 – Depressed area in west half of asphalt overlay near railing.

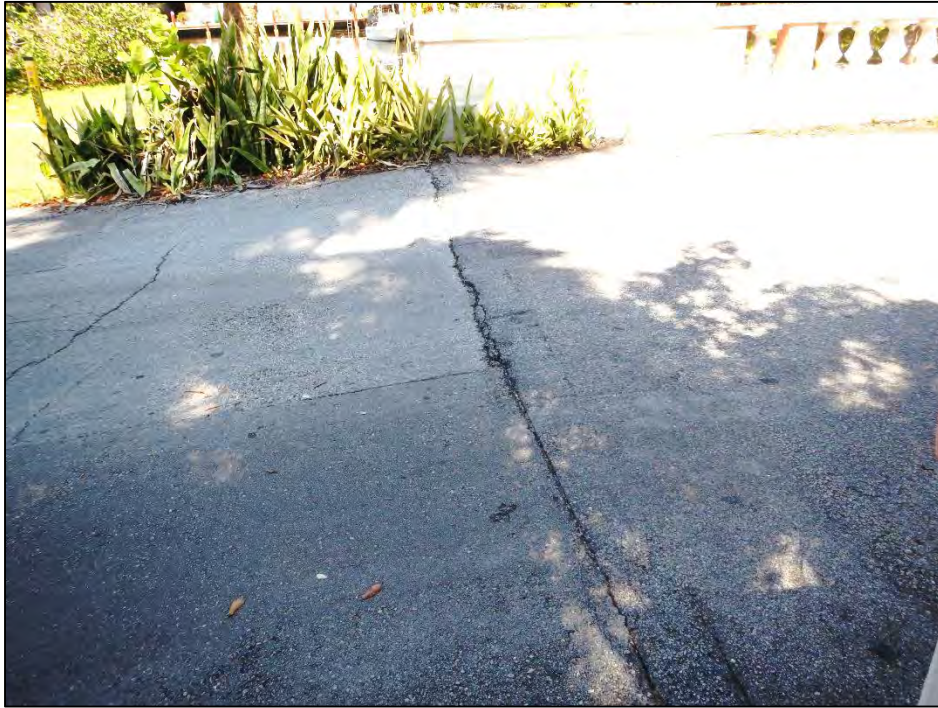
Photo 3 – Condition at south transition from approach to bridge.

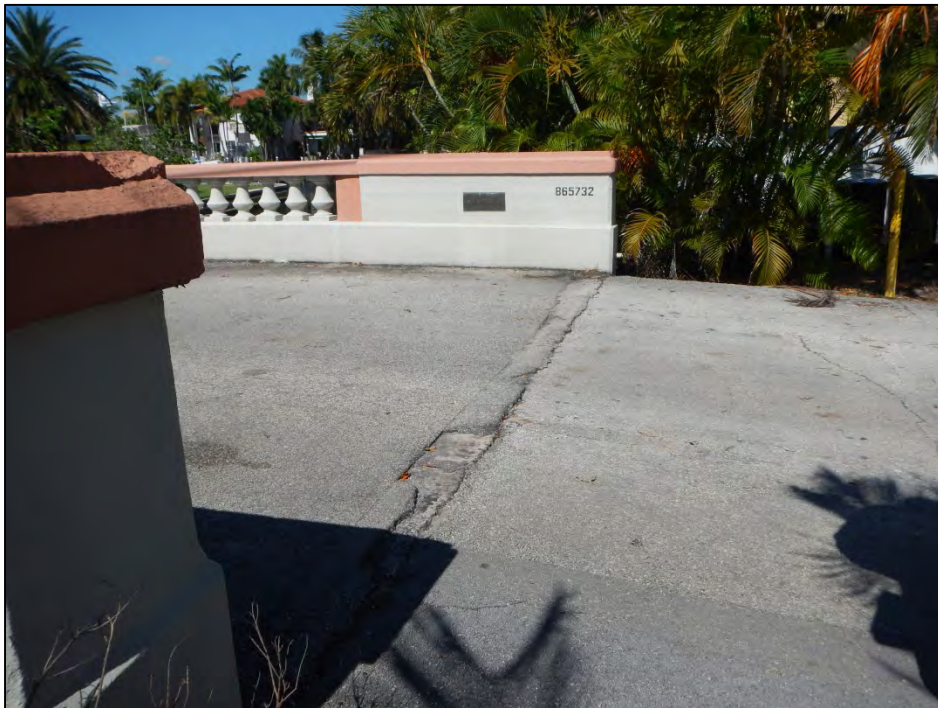
Photo 4 – Condition at north transition from approach to bridge.

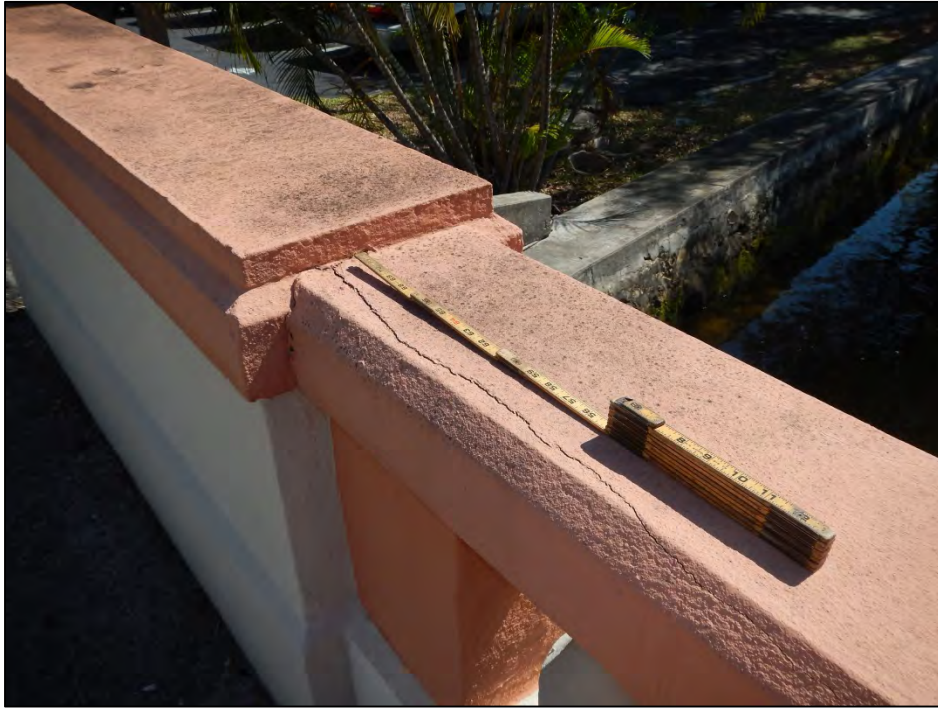
Photo 5 – Crack at north end of east railing.

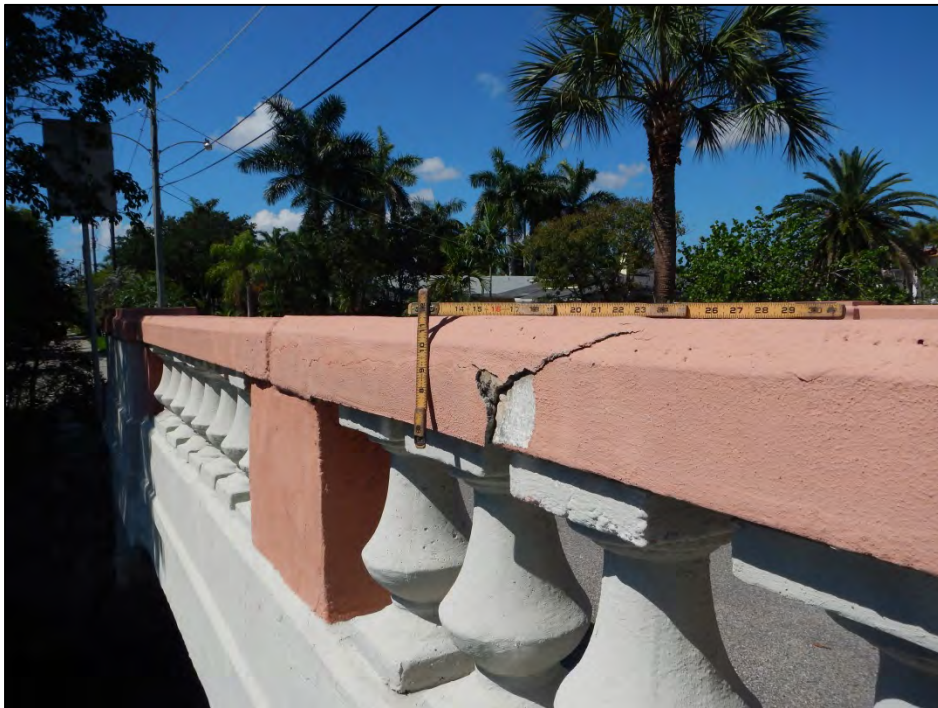
Photo 6 – Delaminated/spalled area near midspan of east railing.

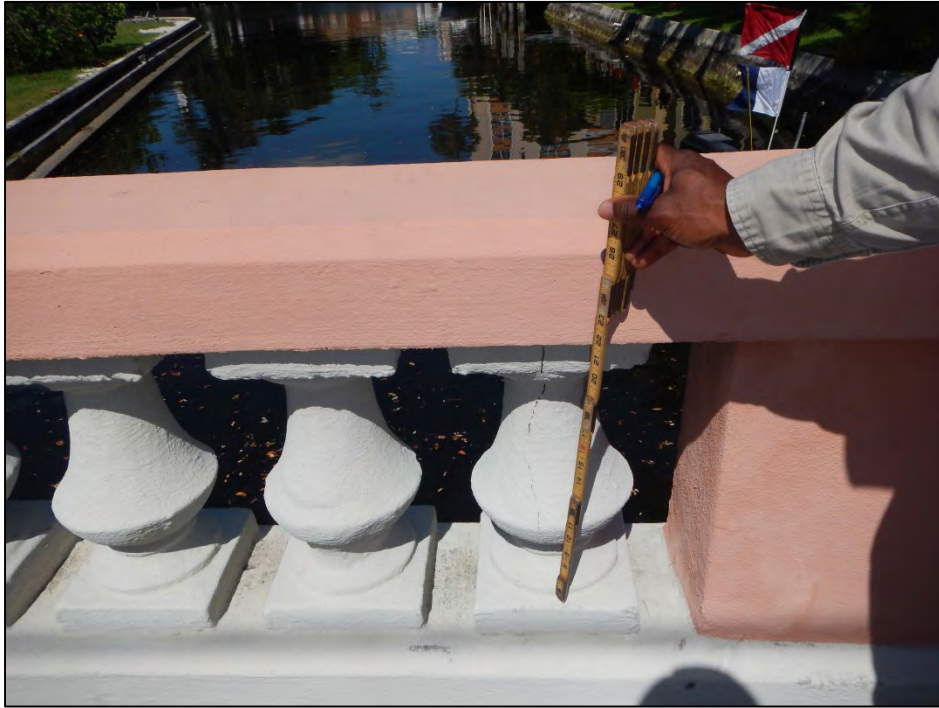
Photo 7 – Crack on 7<sup>th</sup> spindle from south at west railing.

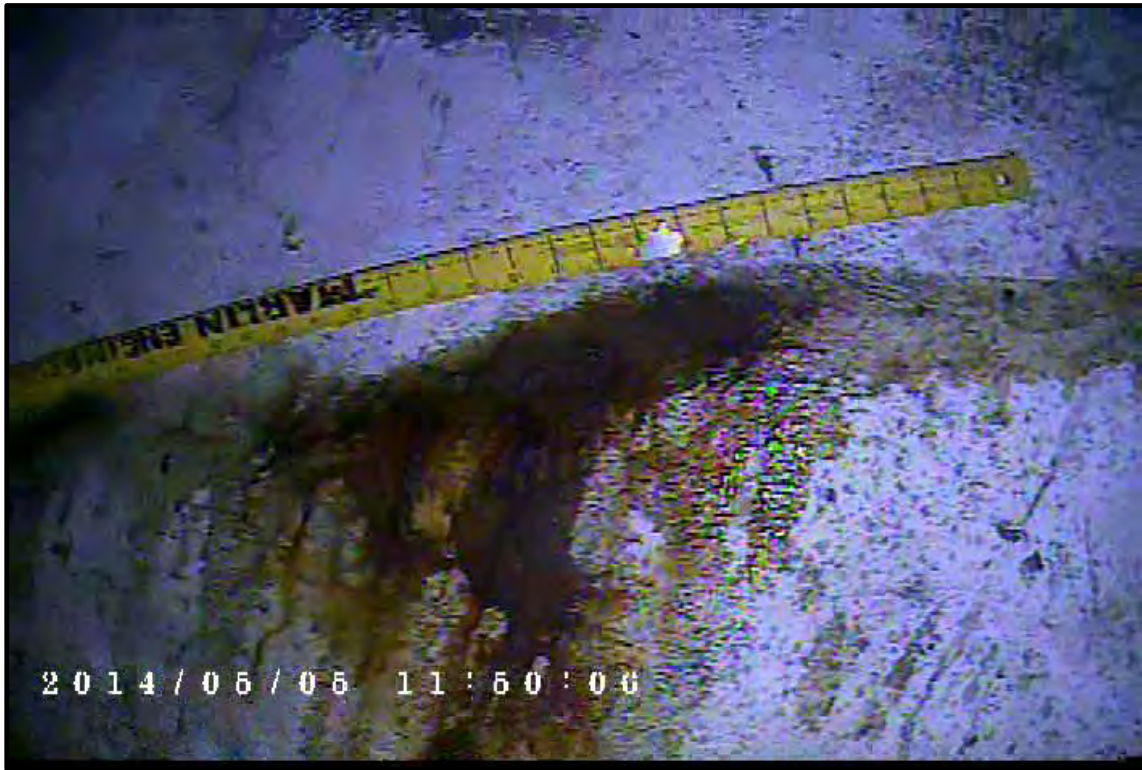
\_Beam 1-1 has a 14" x 12" x 1", spall/delamination in the east face, 3 ft. north of Abutment 1, with exposed rebar and associated crack 4' x 1/64", with corrosion bleed out. **UW Photo 03. NEW**

Description: Top: Beam 1-1 spall/delamination in the east face, 3 ft. north of Abutment 1. **UW Photo 03.**  
Bottom: Beam 1-2 delamination in the west face, 9 ft. North of Abutment 1. **UW Photo 04.**

\_Remove all unsound concrete and patch as needed also epoxy inject all the cracks.

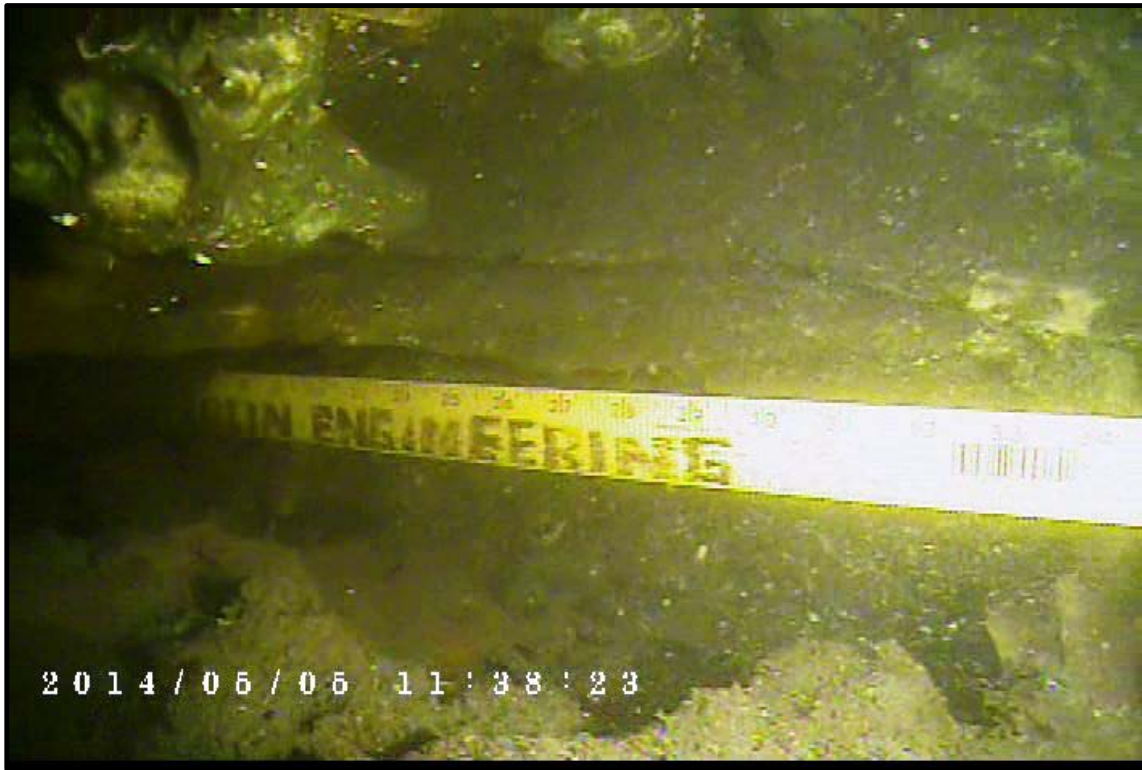
\_Abutment 1, SE corner has a undermined area 36" L x 18" D x 5" H. No backfill loss was found.

Description: Top: Abutment 1, SE corner undermined area with no backfill migration. **UW Photo 05**  
Bottom: Joints between the abutments and the bulkheads are open. **UW Photo 06**

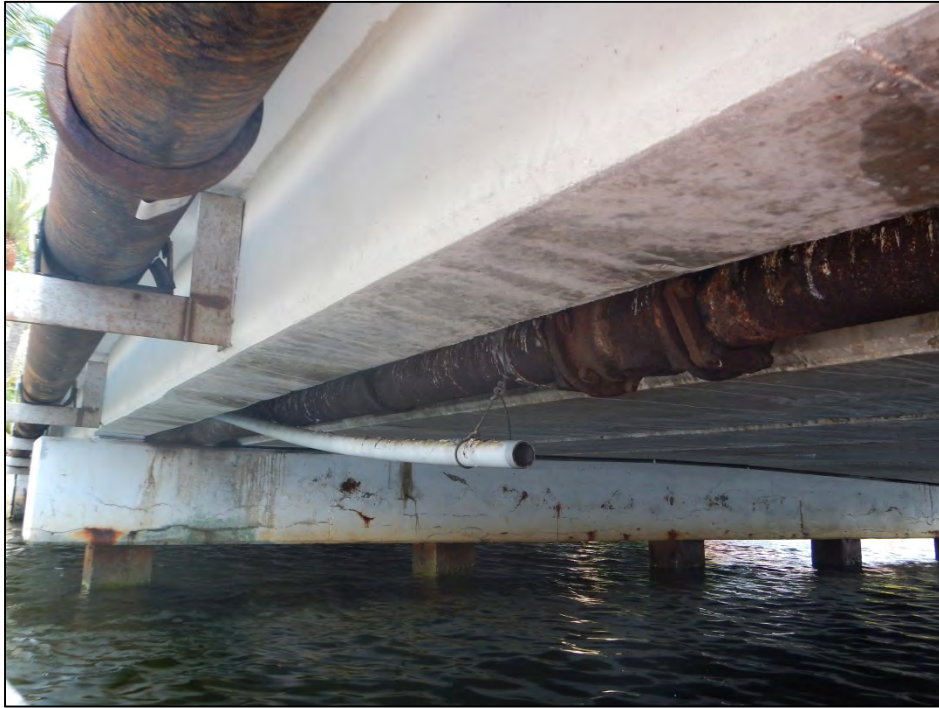
Utilities mounted to deck underside

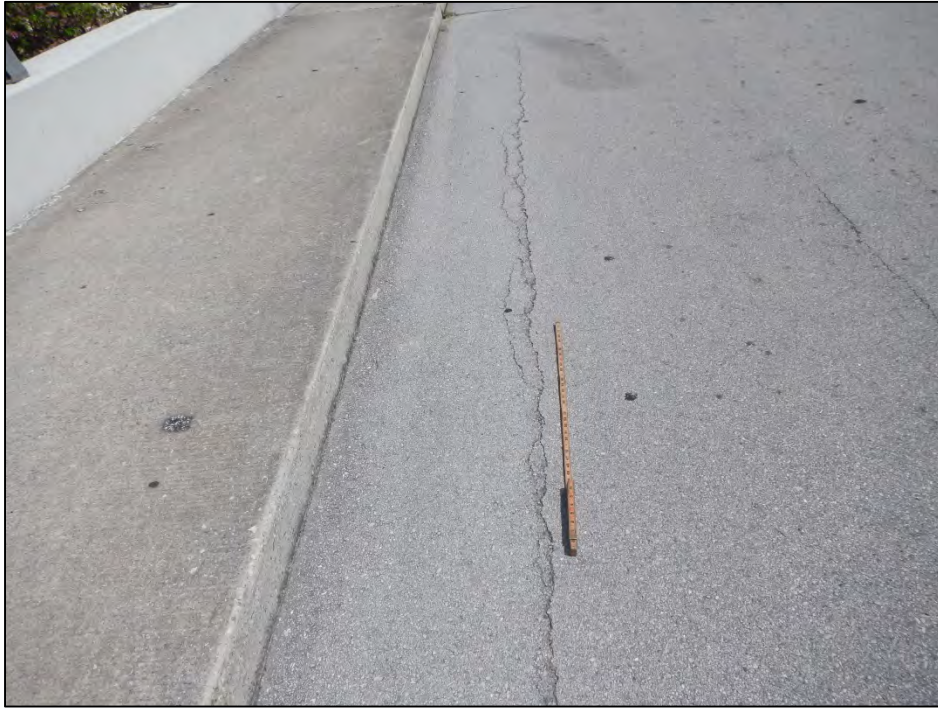
Photo 1 – Longitudinal cracks in asphalt overlay above the slab unit joints.

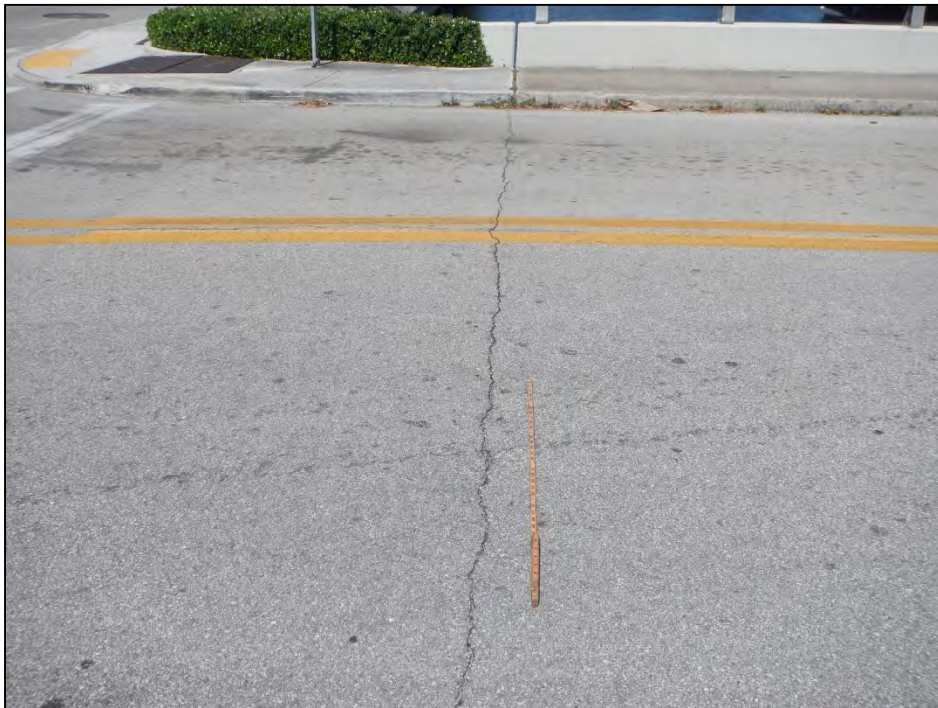
Photo 2 – Transverse crack in the asphalt overlay at Abutment 1.

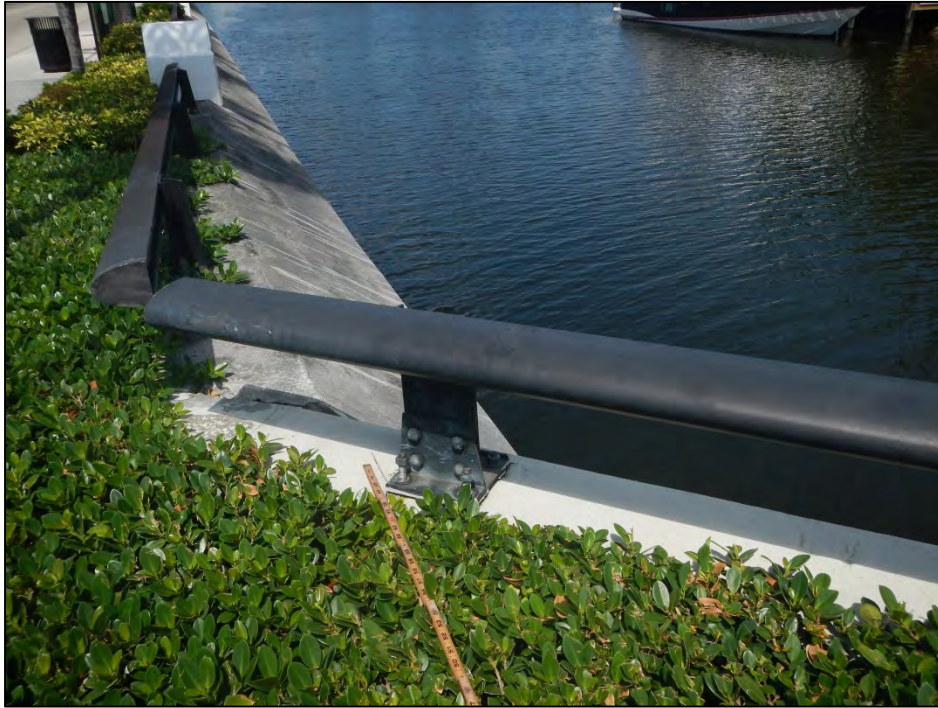
Photo 3 – Loose nuts at the southwest corner of the pedestrian railing.

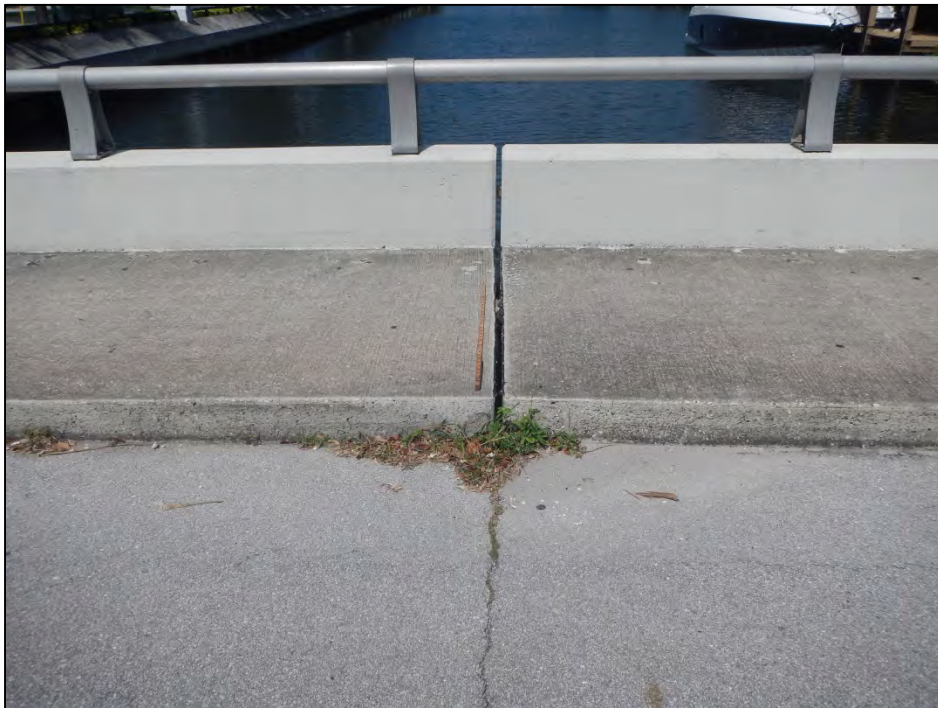
Photo 4 – Deteriorated sidewalk joint.

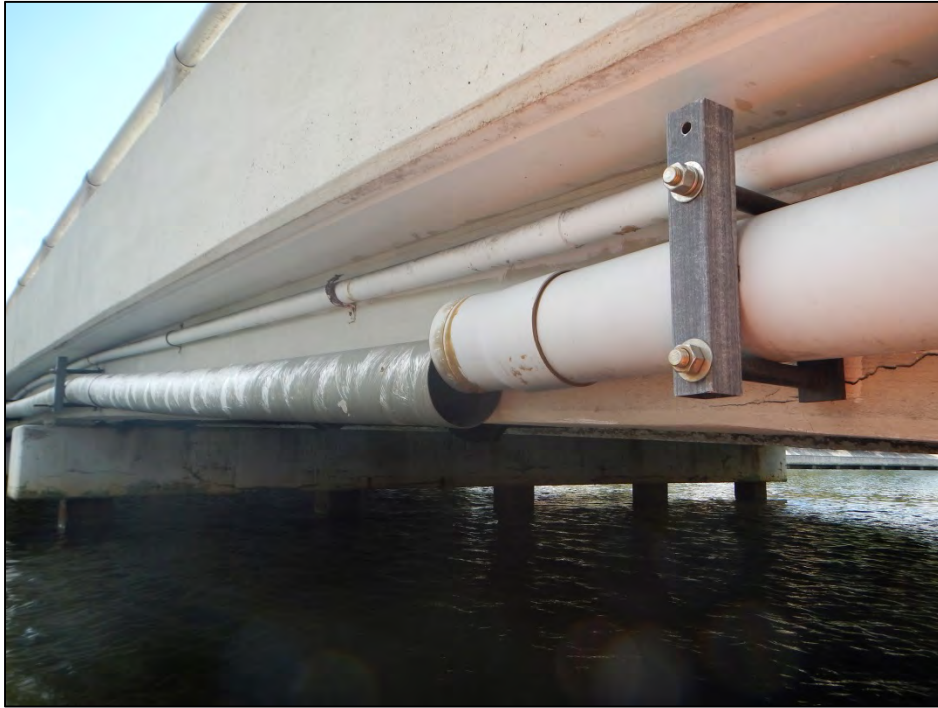
Photo 5 – Disconnected utility pipe attached to Beam 2 in Span 3.

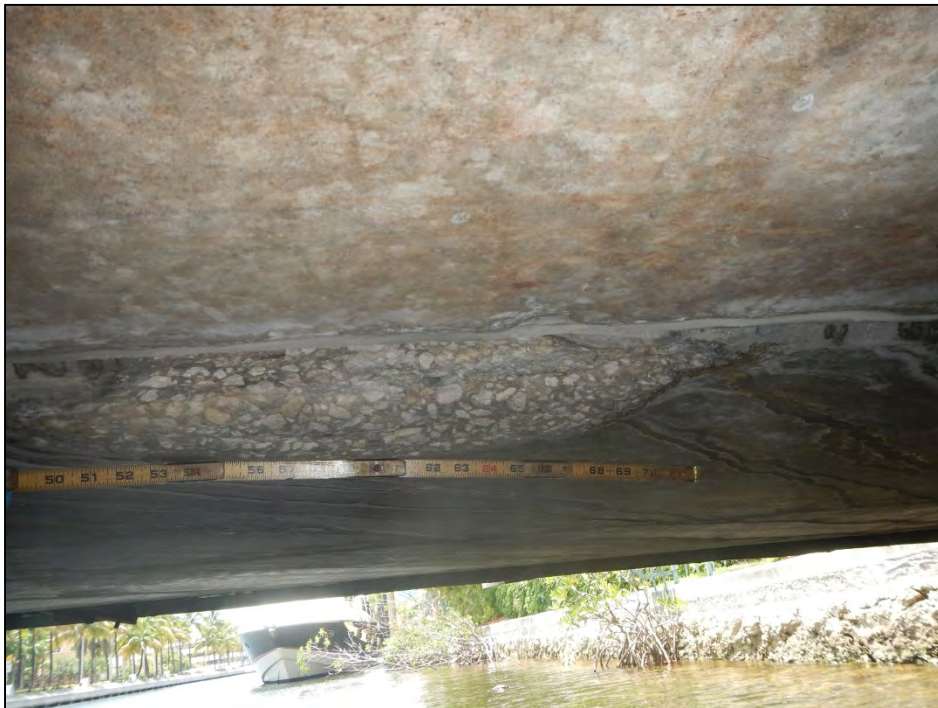
Photo 6 – Spall in Slab Unit 3-1.

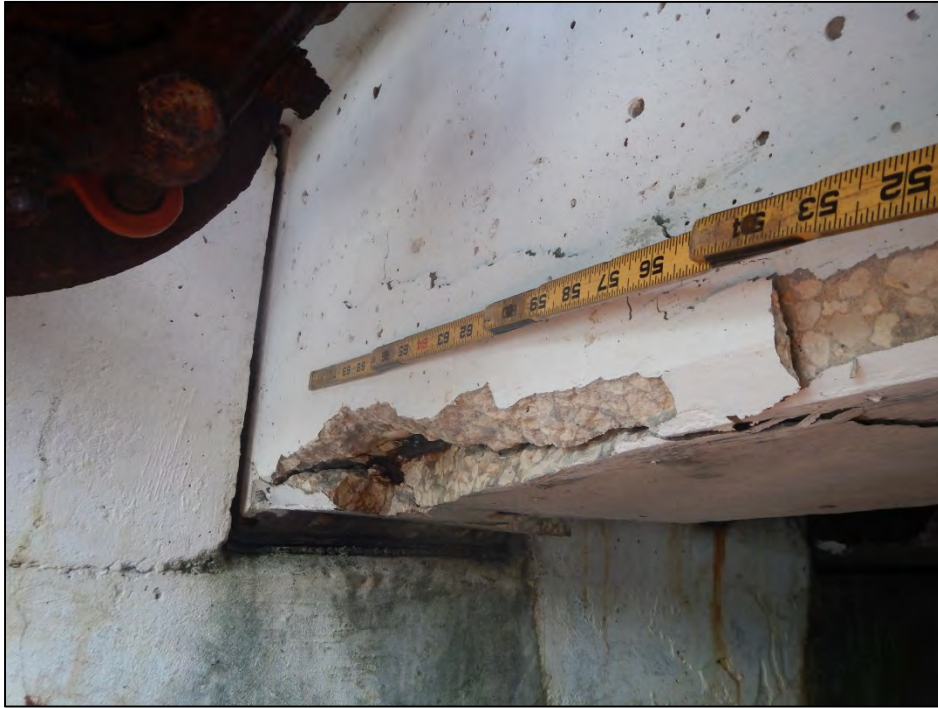
Photo 7 – Spalls with exposed corroded rebar in Beam 3-1.

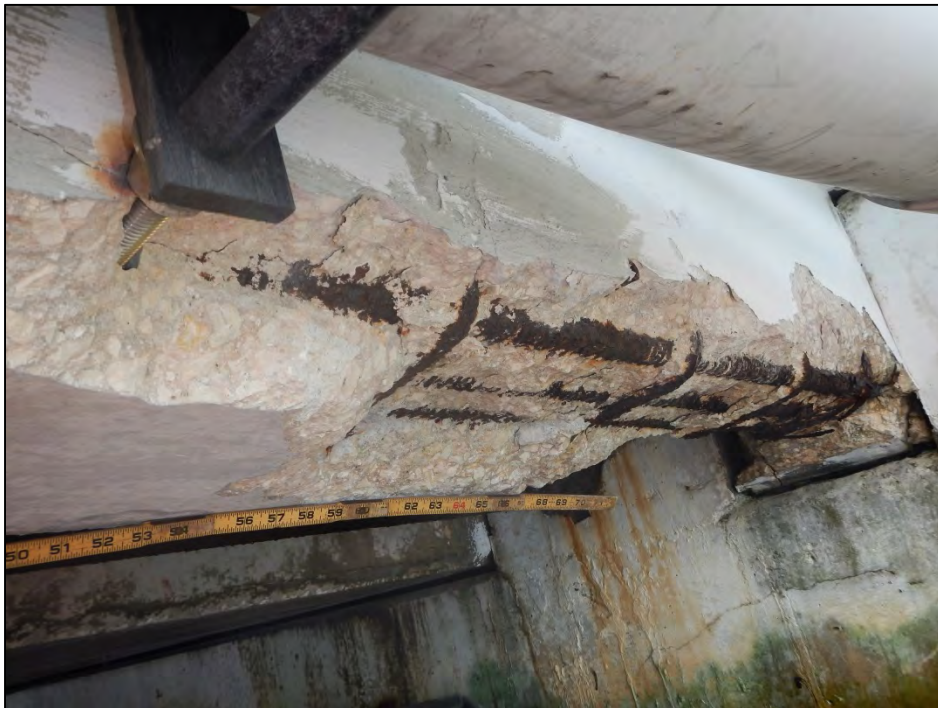
Photo 8 – Spall with exposed corroded rebar in Beam 3-2.

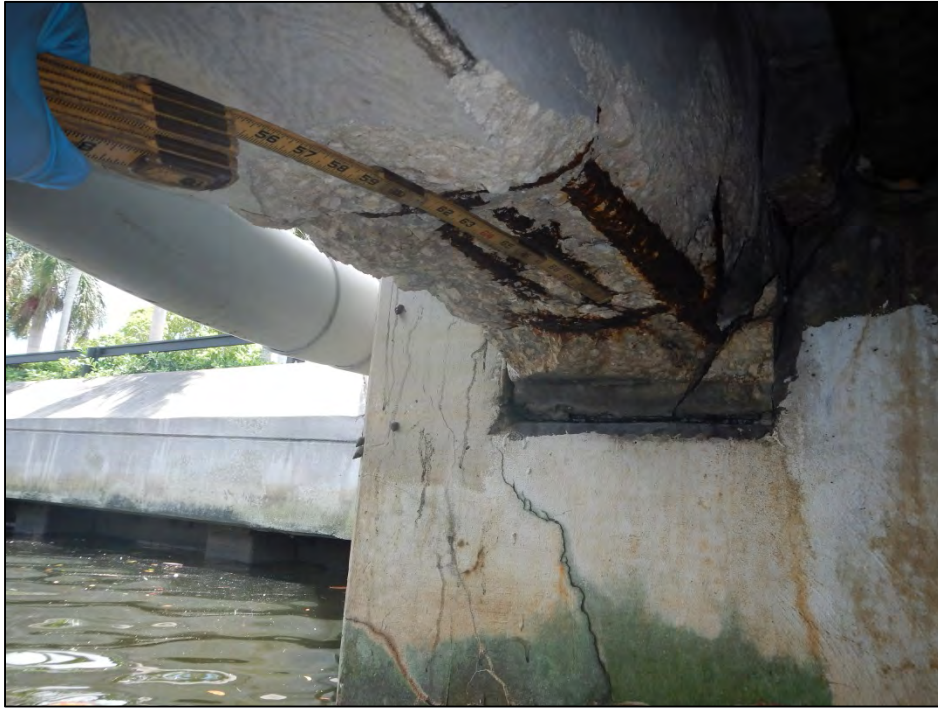
Photo 9 – Spalls with exposed corroded rebar in Beam 1-2.

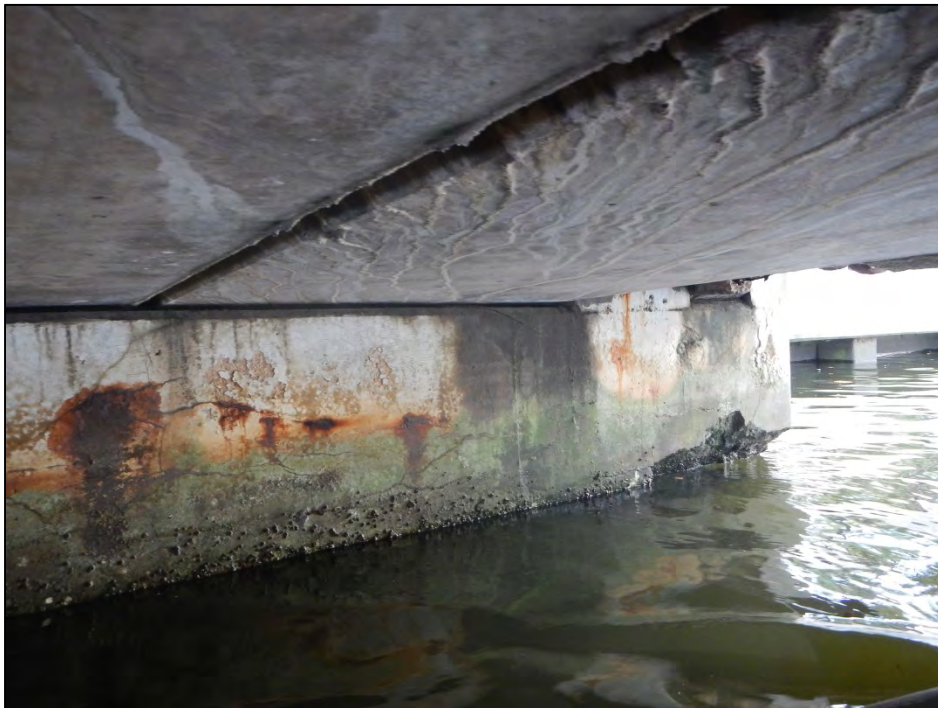
Photo 10 – Spall with exposed corroded rebar at Abutment 1 cap.

Long Term Recommendation(s): <b>Repair concrete and install metalizing at abutment and bent caps.</b> <b>Install jackets at bent piles.</b>		Cost
Design <sup>(1)</sup>		\$ 40,000.00
Construction		\$ 150,000.00
Bridge Construction <sup>(2)</sup>	\$ 140,000.00	
Maintenance of Traffic <sup>(3)</sup>	\$ 10,000.00	
Construction Inspection and Administration <sup>(4)</sup>		\$ 30,000.00
Contingency <sup>(5)</sup>		\$ 30,000.00
TOTAL COST		\$ 250,000.00
<sup>(1)</sup> Design work by same engineer for multiple bridges to be let as single contract. <sup>(2)</sup> Metalizing: \$3,000 per location for concrete; \$12,000 per location for metalizing; Jackets: \$4,000 per pile (20 piles total). <sup>(3)</sup> Daily closures for equipment and material access. Work done from water, under traffic. <sup>(4)</sup> Construction inspection and administration costs estimated 20% of cost for construction, maintenance of traffic and utilities. <sup>(5)</sup> Estimated at 20% of cost for construction, maintenance of traffic and utilities, since no preliminary engineering was prepared as part of this inspection report.

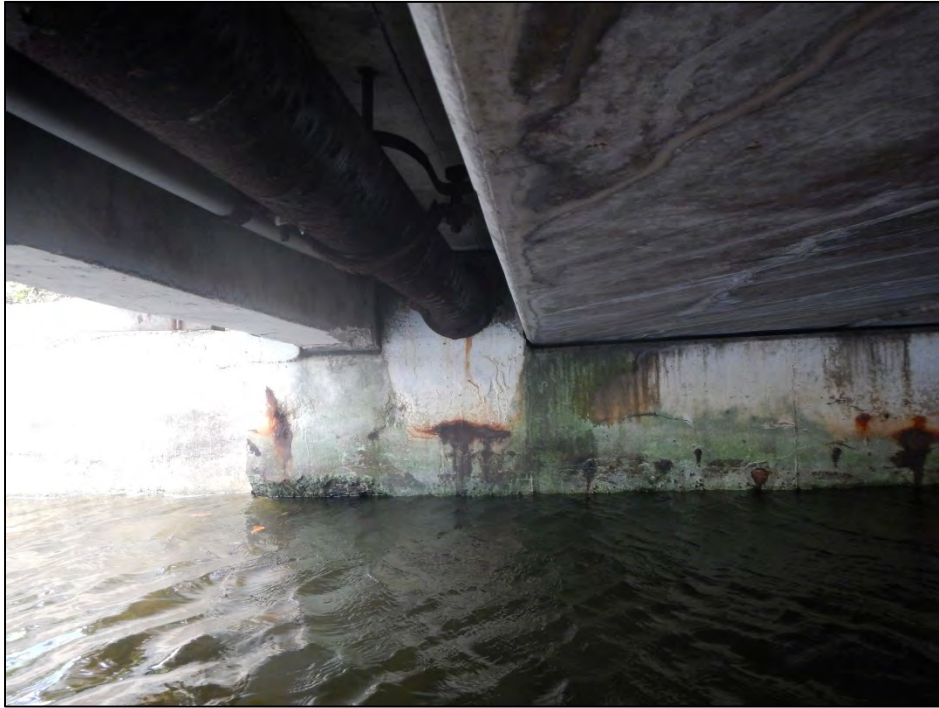
Photo 11 – Spall with exposed corroded rebar at Abutment 4 cap over Pile 4-1.

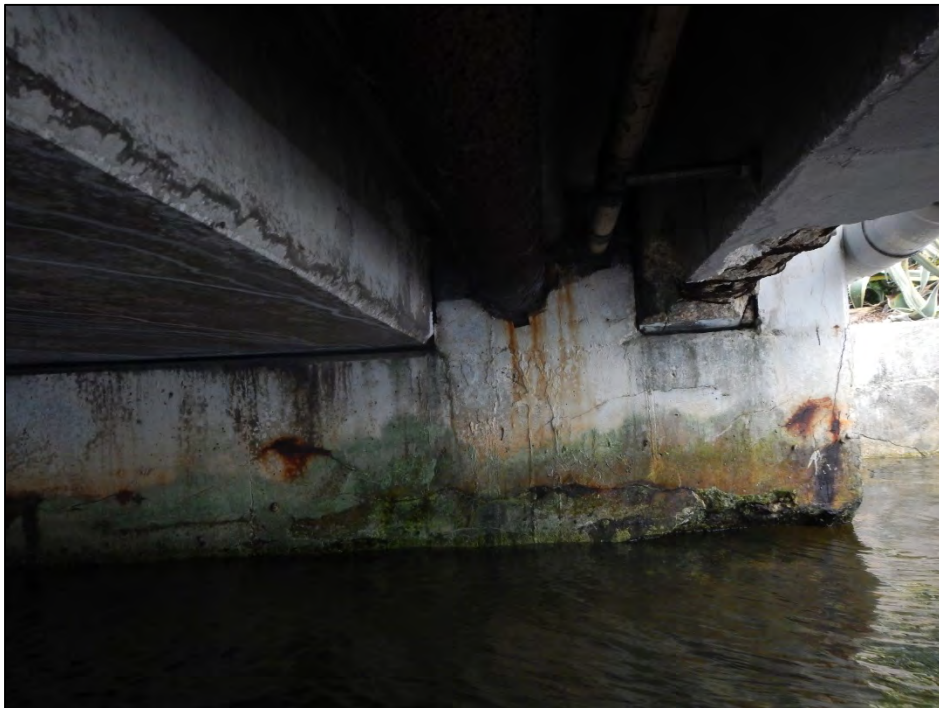
Photo 12 – Spall with exposed corroded rebar at Abutment 4 cap over Pile 4-5.

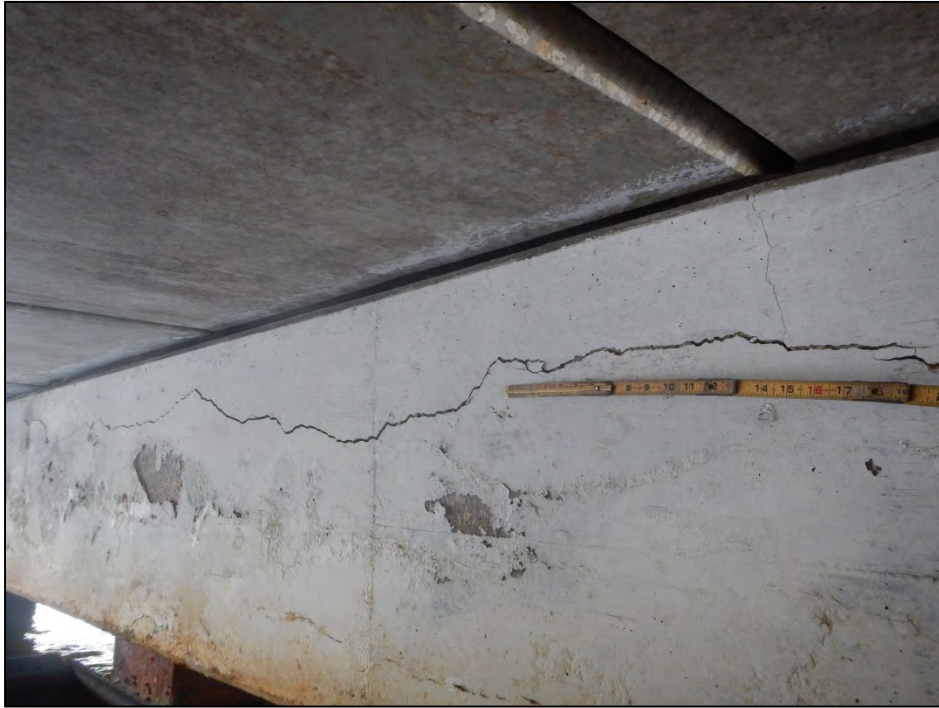
Photo 13 – Delamination in Bent 2 cap.

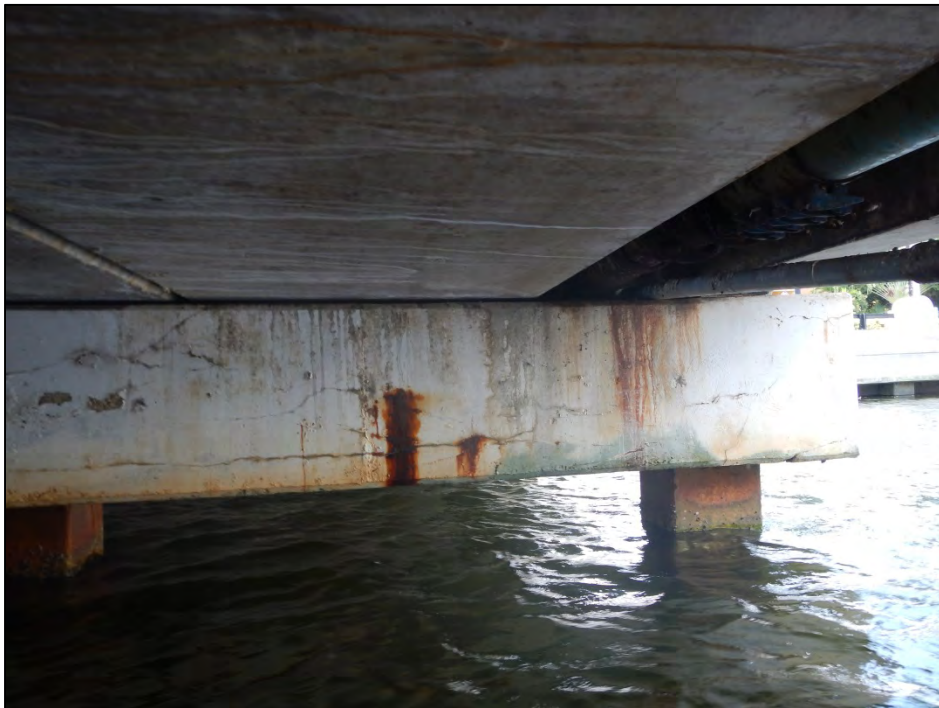
Photo 14 – Corrosion staining on Bent 2 cap.
