## **EXECUTIVE SUMMARY**

TranSystems has been retained by the City of Fort Lauderdale to perform bridge inspections and prepare bridge inspection reports for each of the City's bridges as part of the project Structural Bridge Engineering Consulting Services Master Plan, RFQ No. 946-11310. Inspections were completed and reports prepared for 46 of the City's bridges. The remaining five bridges in the City's inventory were not inspected because they are in the process of being replaced.

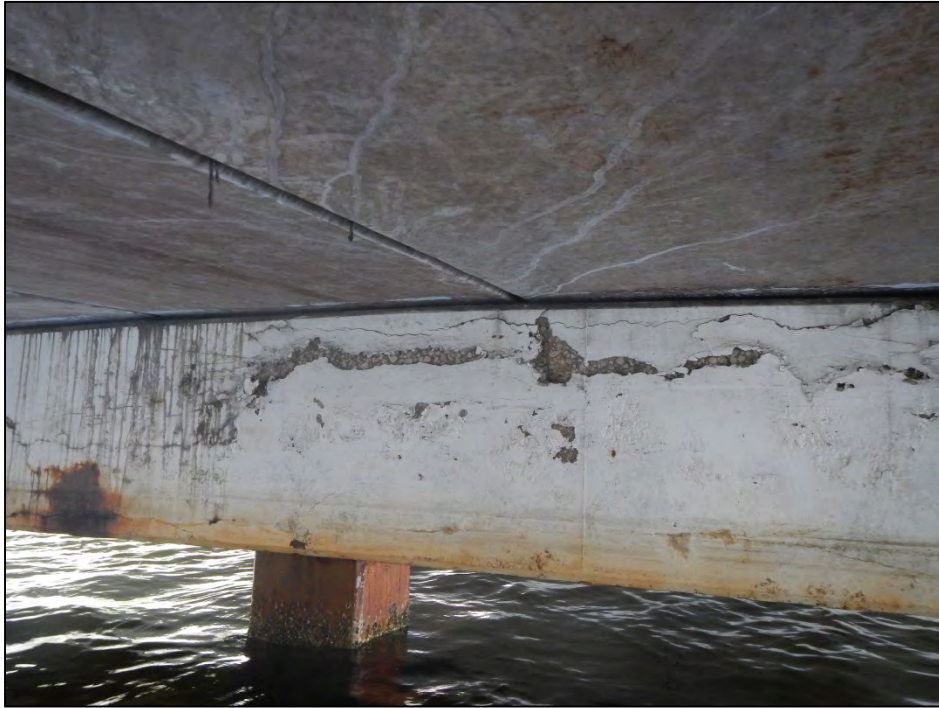
Photo 15 – Spalled/delaminated area in Bent 2 cap.

Long Term Recommendation(s): <b>Repair concrete and install metalizing at abutment and bent caps.</b> <b>Install jackets at bent piles.</b>		Cost
Design <sup>(1)</sup>		\$ 40,000.00
Construction		\$ 150,000.00
Bridge Construction <sup>(2)</sup>	\$ 140,000.00	
Maintenance of Traffic <sup>(3)</sup>	\$ 10,000.00	
Construction Inspection and Administration <sup>(4)</sup>		\$ 30,000.00
Contingency <sup>(5)</sup>		\$ 30,000.00
TOTAL COST		\$ 250,000.00
<sup>(1)</sup> Design work by same engineer for multiple bridges to be let as single contract. <sup>(2)</sup> Metalizing: \$3,000 per location for concrete; \$12,000 per location for metalizing; Jackets: \$4,000 per pile (20 piles total). <sup>(3)</sup> Daily closures for equipment and material access. Work done from water, under traffic. <sup>(4)</sup> Construction inspection and administration costs estimated 20% of cost for construction, maintenance of traffic and utilities. <sup>(5)</sup> Estimated at 20% of cost for construction, maintenance of traffic and utilities, since no preliminary engineering was prepared as part of this inspection report.

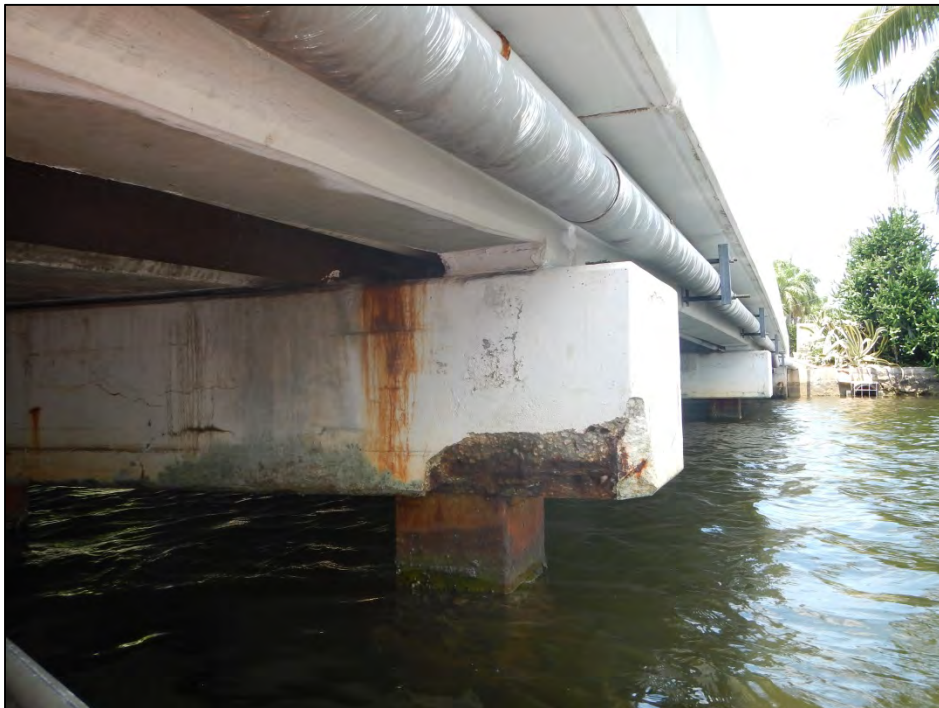
Photo 16 – Spall with exposed corroded rebar at southeast corner of Bent 2 cap.

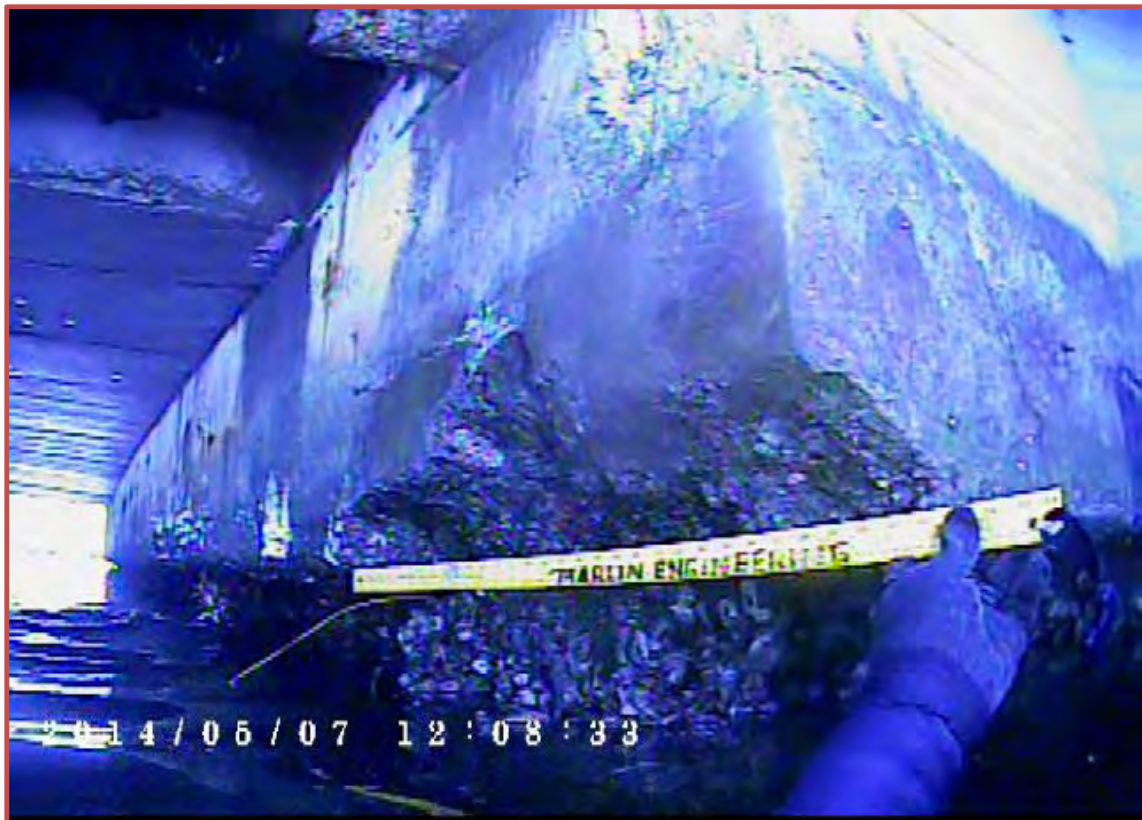
\_Abutment cap 1 over Pile 1-1, has a spall 36" x 4" x 2-3/4", with (1) exposed rebar, 75% section loss.

\_Remove all unsound concrete and patch. Also epoxy inject all the cracks at both abutments caps.

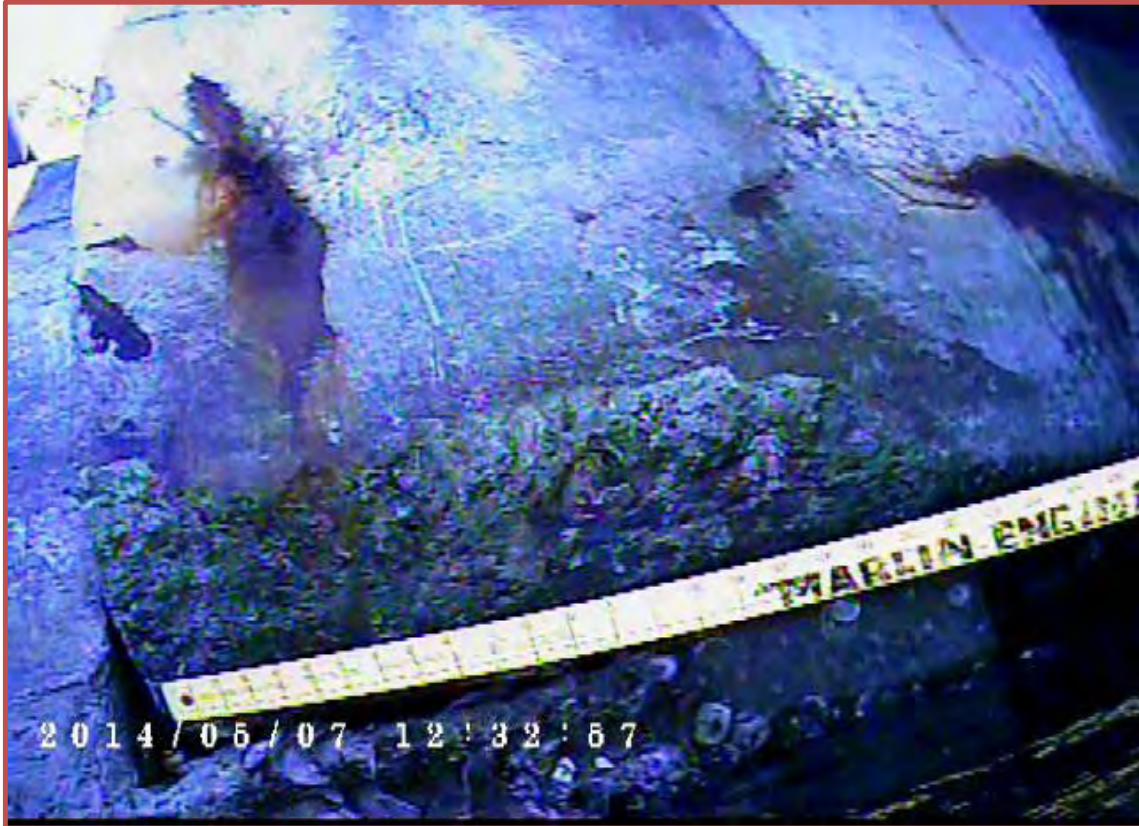
\_Abutment cap 4 over Pile 4-1, has a spall 36" x 8" x 3", with (1) exposed rebar, 50% section loss.

Description: Top: Abutment cap 4 over Pile 4-1, spall with exposed rebar. **UW Photo 03.**  
Bottom: Bent caps have full length x 30" H, delaminated areas with cracks. **UW Photo 04.**

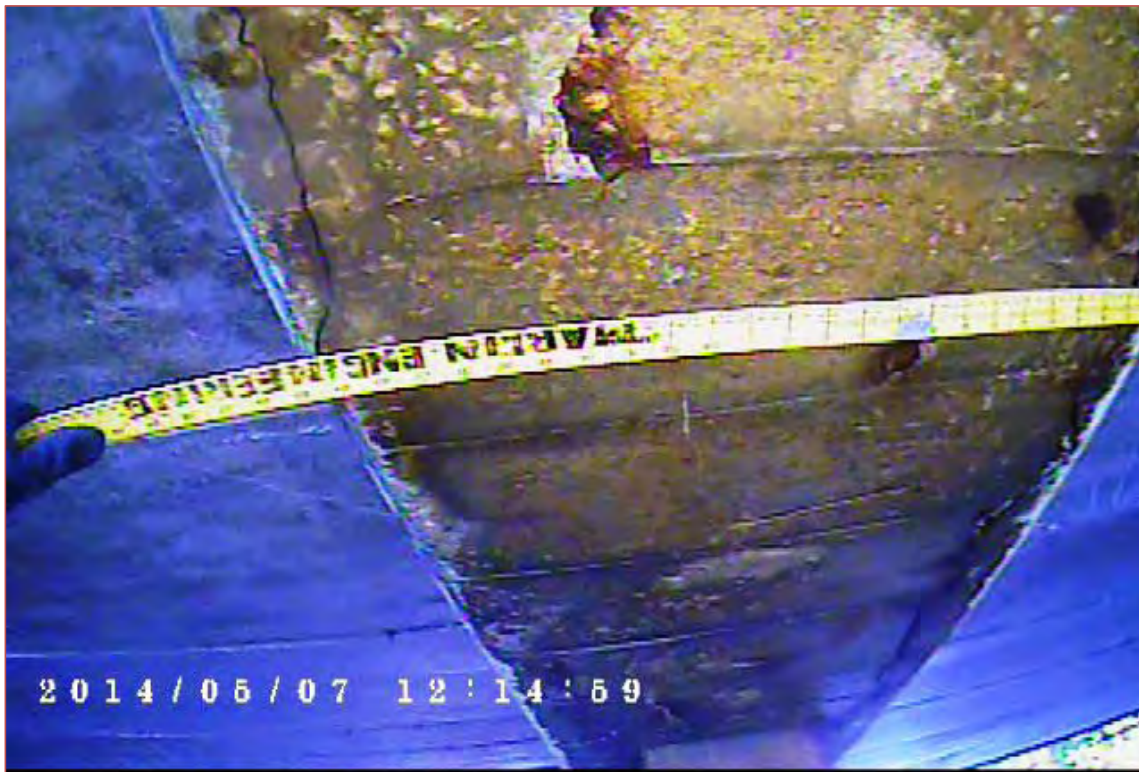
\_Both intermediate Bent Caps have full length x 30" H, delaminated areas with associated cracks and corrosion bleed-out. **UW Photo 04. NO CHANGE**

\_Remove all unsound concrete and patch. Also epoxy inject all the cracks at Bent 2.

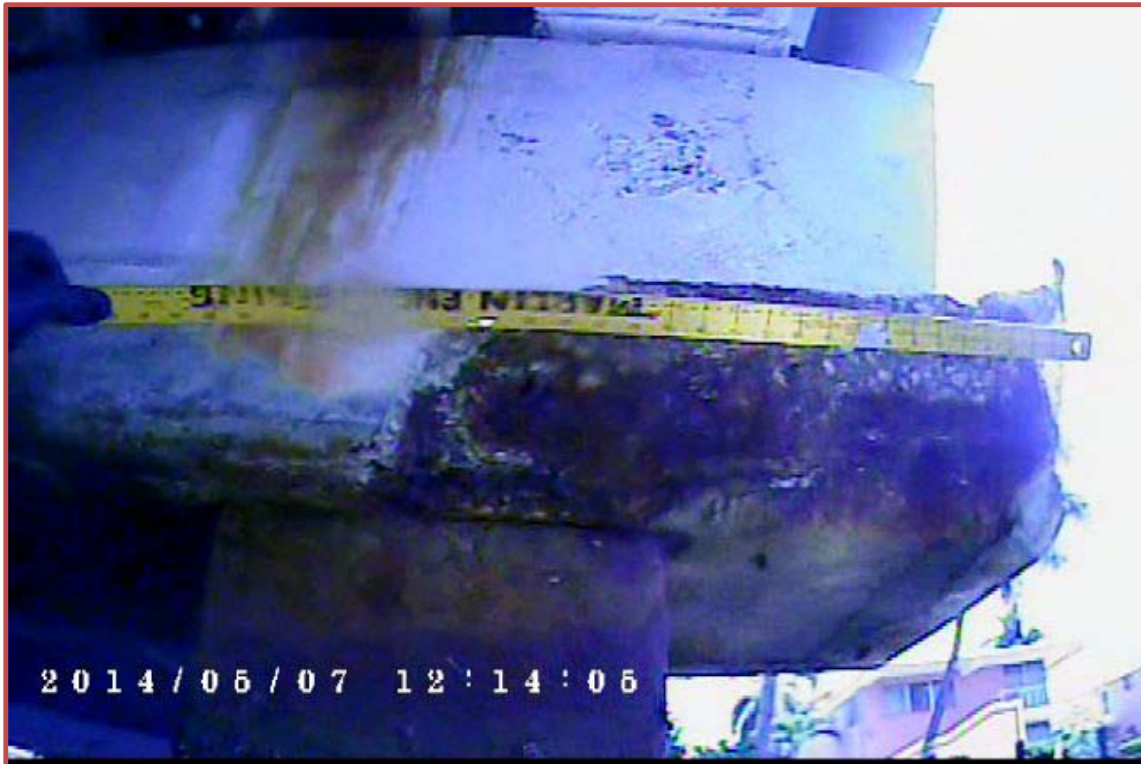
\_Bent 2 cap, SE corner spall 24" x 10" x 2-1/2", with (1) exposed rebar, 50% section loss.

Description: Top: Bent 2 cap, SE corner spall with exposed rebar. **UW Photo 05.**  
Bottom: Retaining wall caps horizontal cracks with delaminations. **UW Photo 06.**

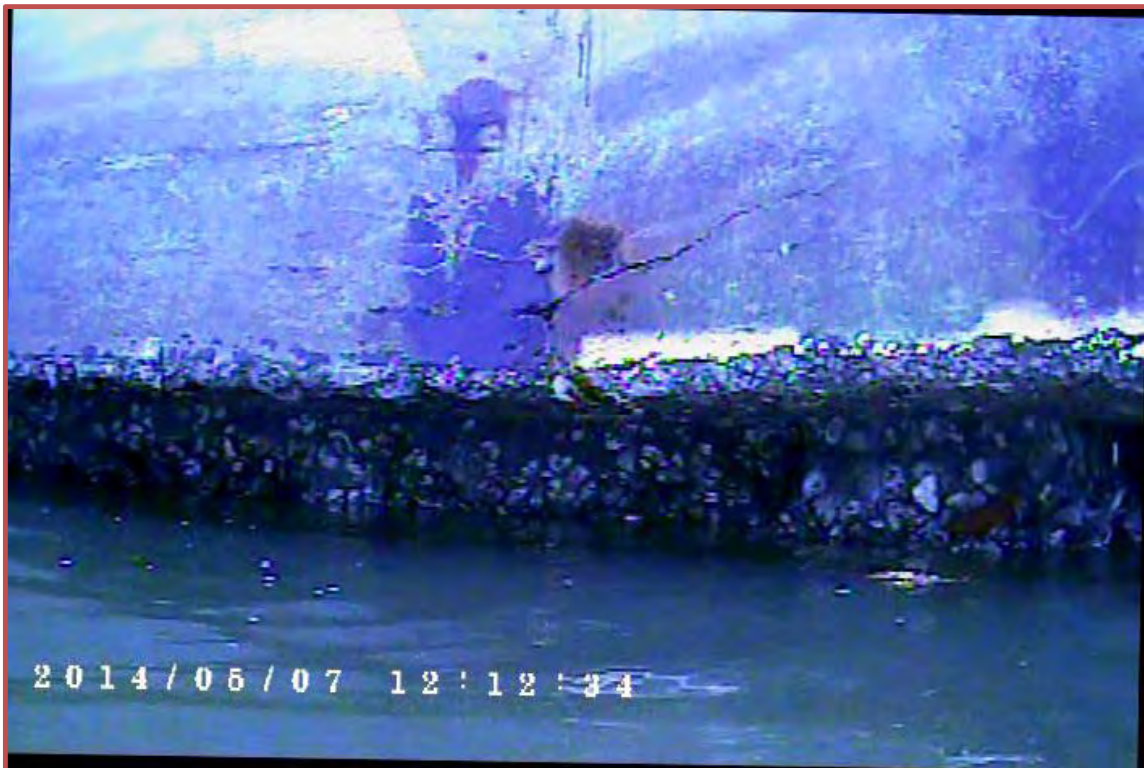
\_All four retaining wall caps have full length x 1/32", horizontal cracks with associated delaminations and corrosion bleed-out. **UW Photo 06. NO CHANGE**

\_Remove all unsound concrete and patch. Also epoxy inject all the cracks retaining wall cap as needed.

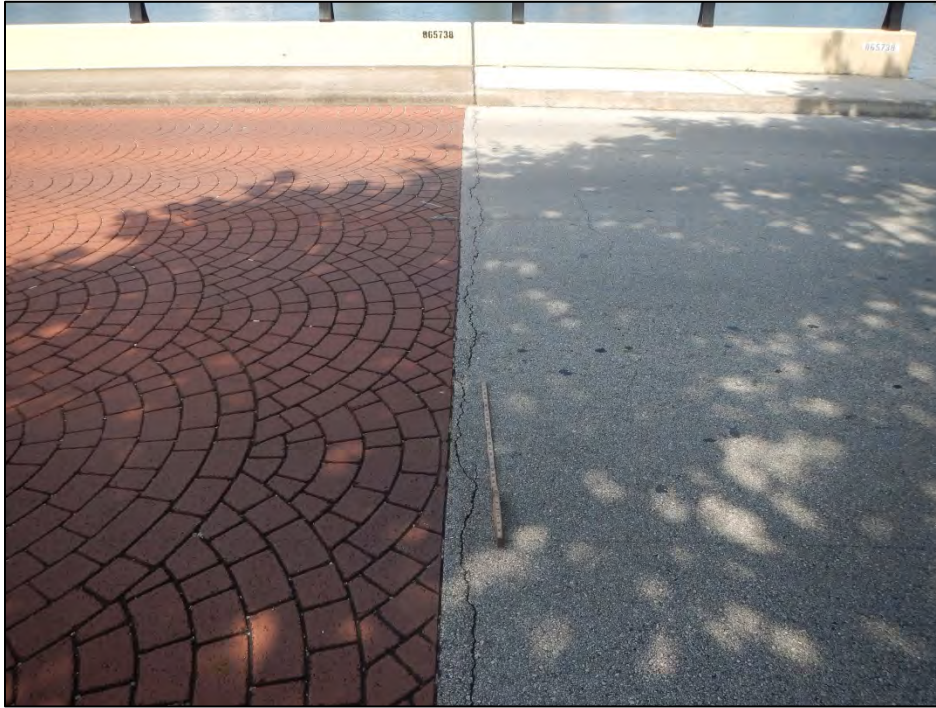
Photo 1 – Cracks in asphalt overlay at abutment. Note no striping present.

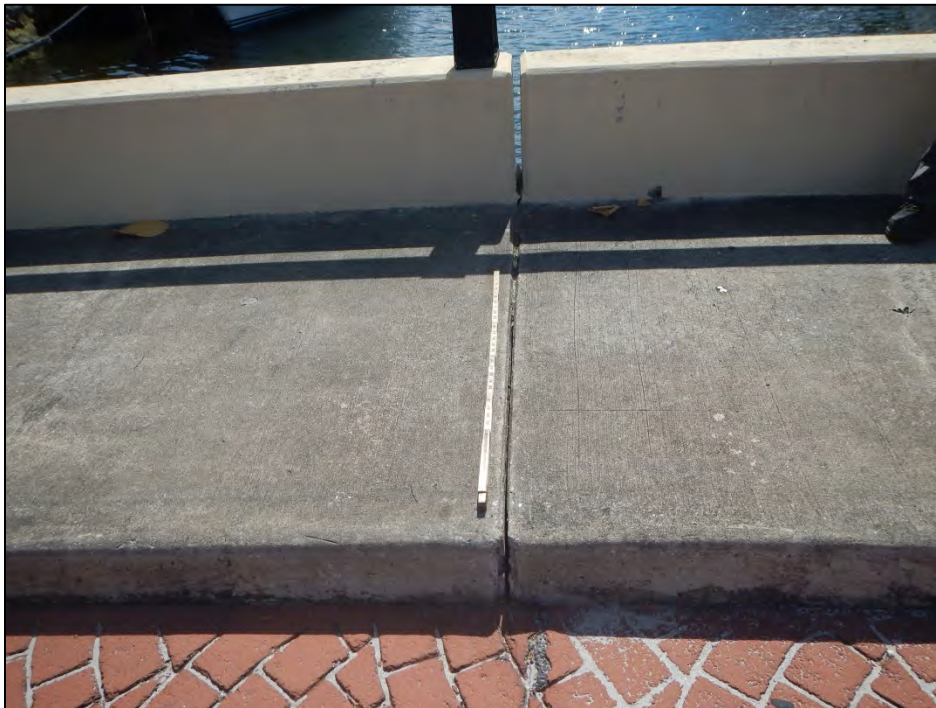
Photo 2 – Sidewalk joints not sealed; they are filled with dirt and debris.

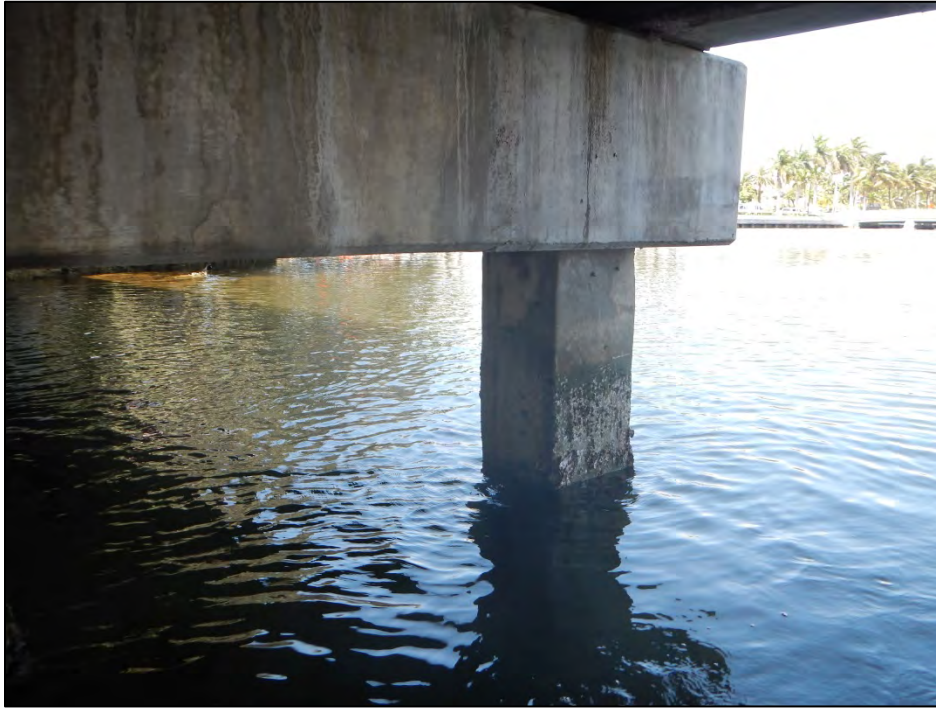
Photo 3 – Crack with corrosion bleedout in Pile 2-I.

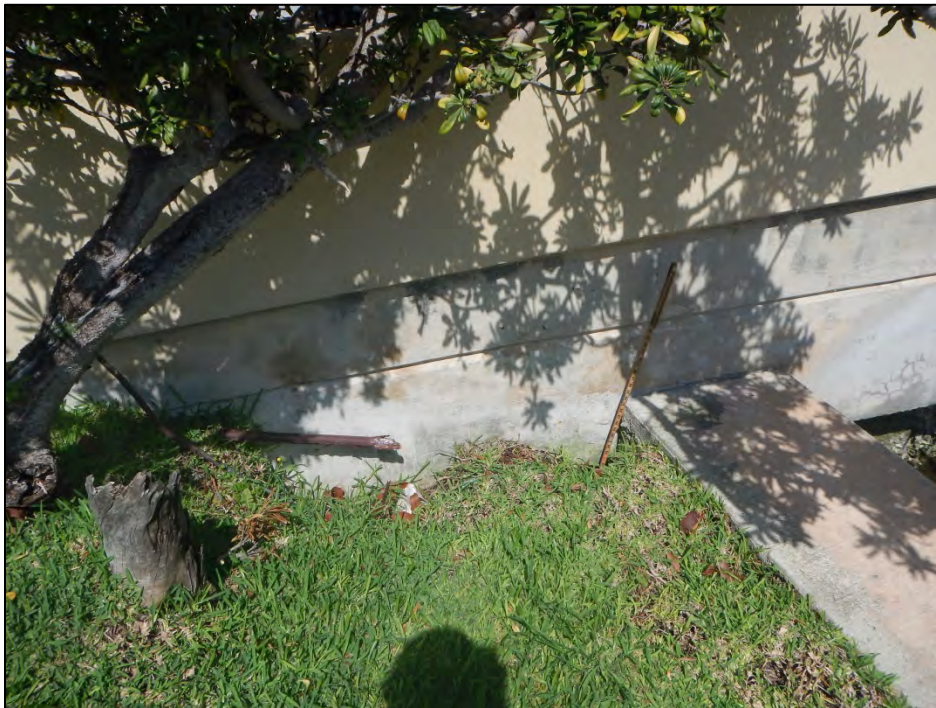
Photo 4 – Backfill void at southeast corner.

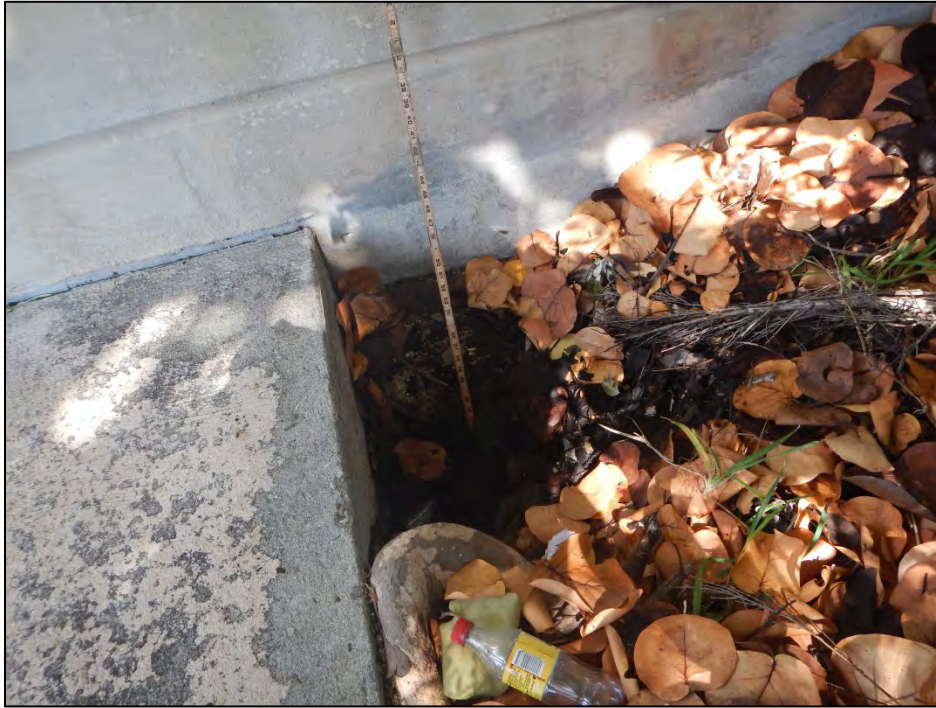
Photo 5 – Open retaining wall joint and backfill void at the northeast corner.

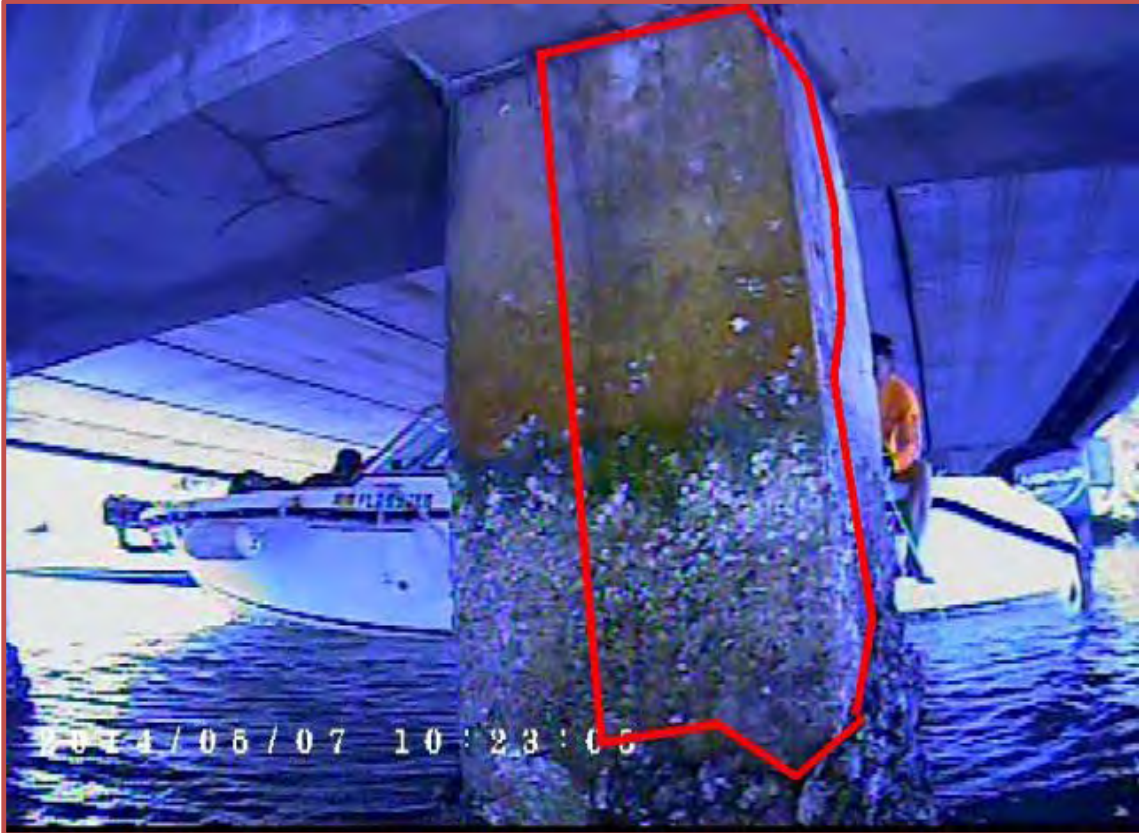
Description: Top: Pile 3-2, NW corner delamination. **UW Photo 03.**

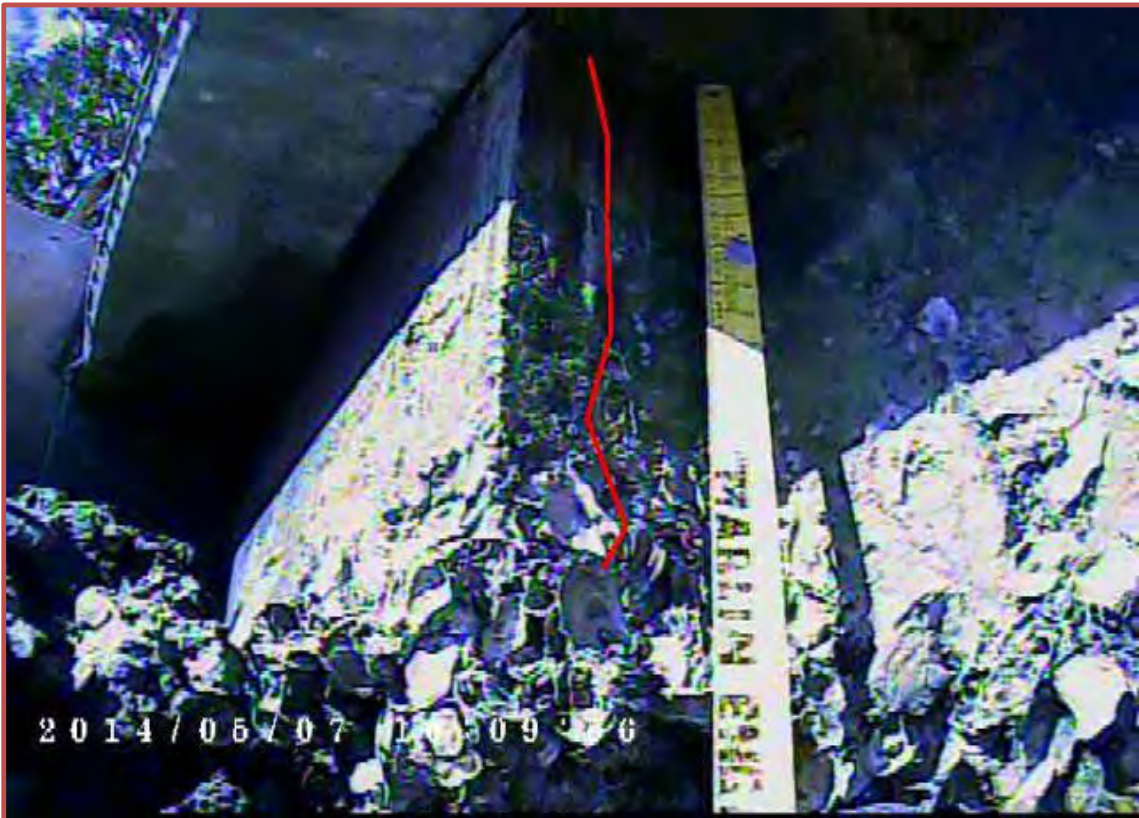
Bottom: Abutment 1 backwall, East side of P 1-5, vertical crack with CBO. **UW Photo 04.**

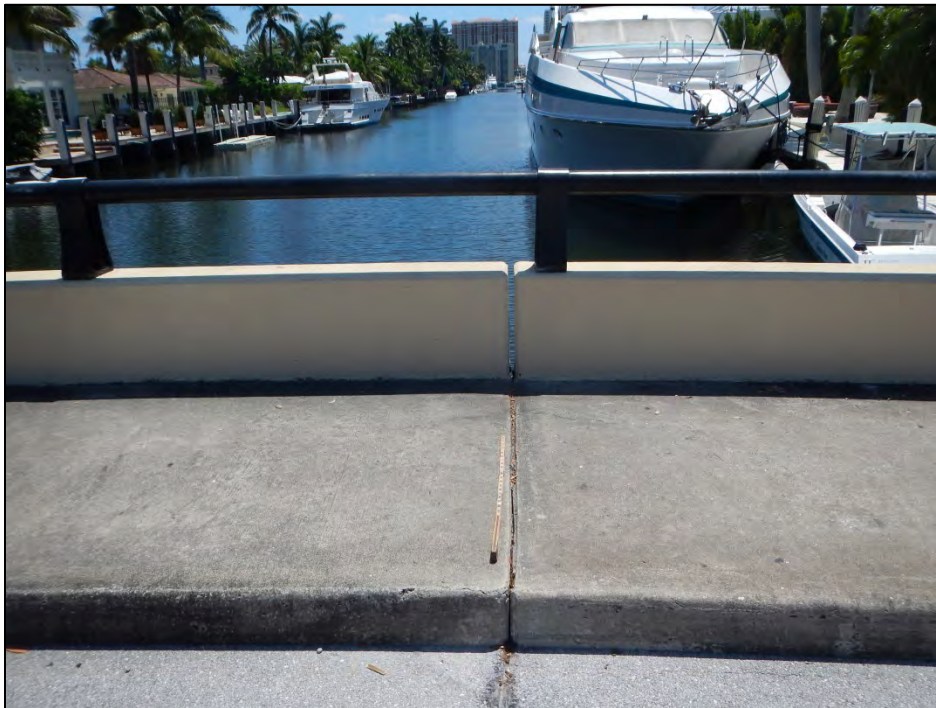
Photo 2 – Deteriorated sidewalk joint sealant filled with dirt and debris.

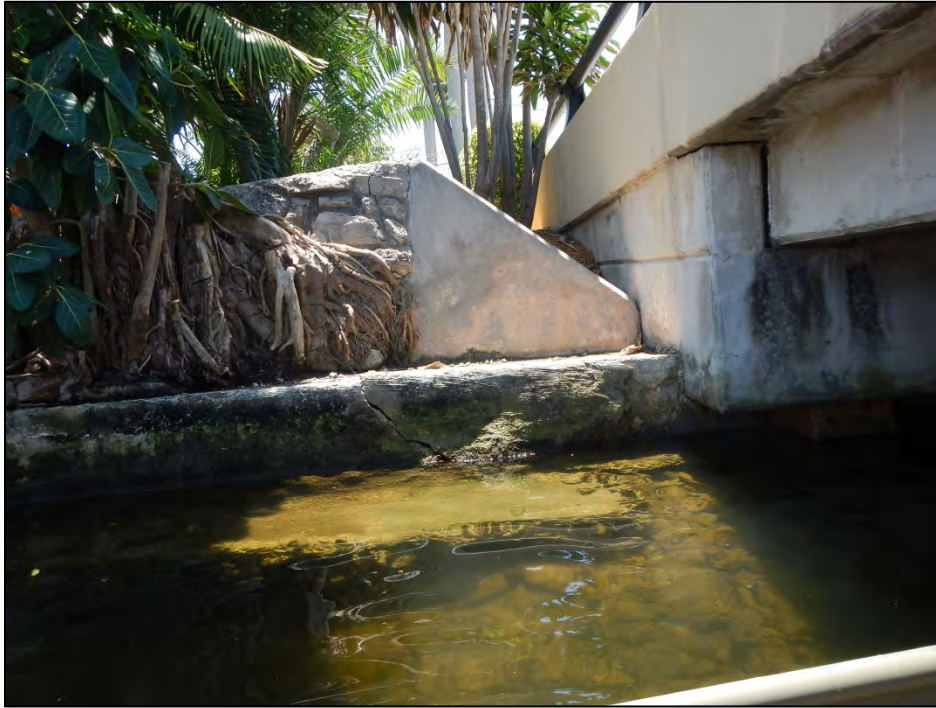
Photo 3 – Tree roots at southeast corner.

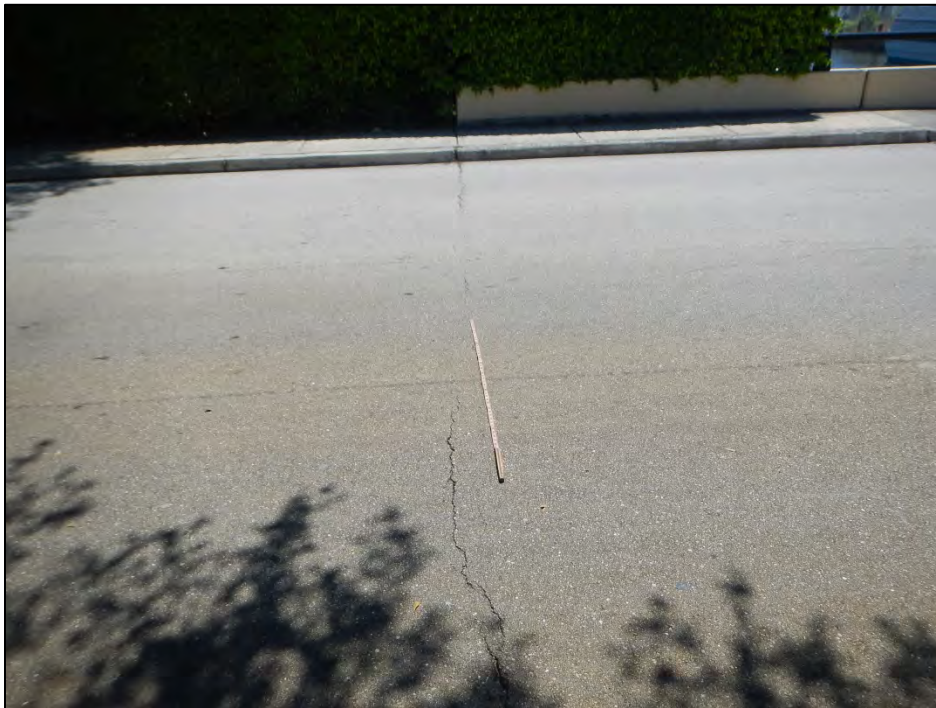
Photo 4 – Typical transverse cracks in asphalt surfacing at end of approach slab.

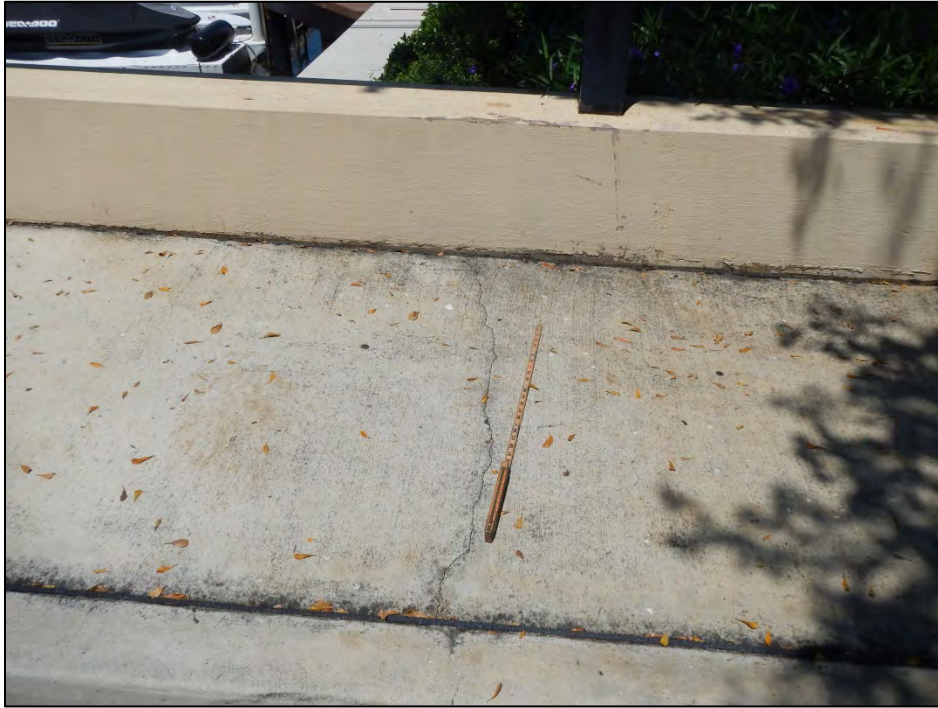
Photo 5 – Cracks in northwest approach sidewalk.

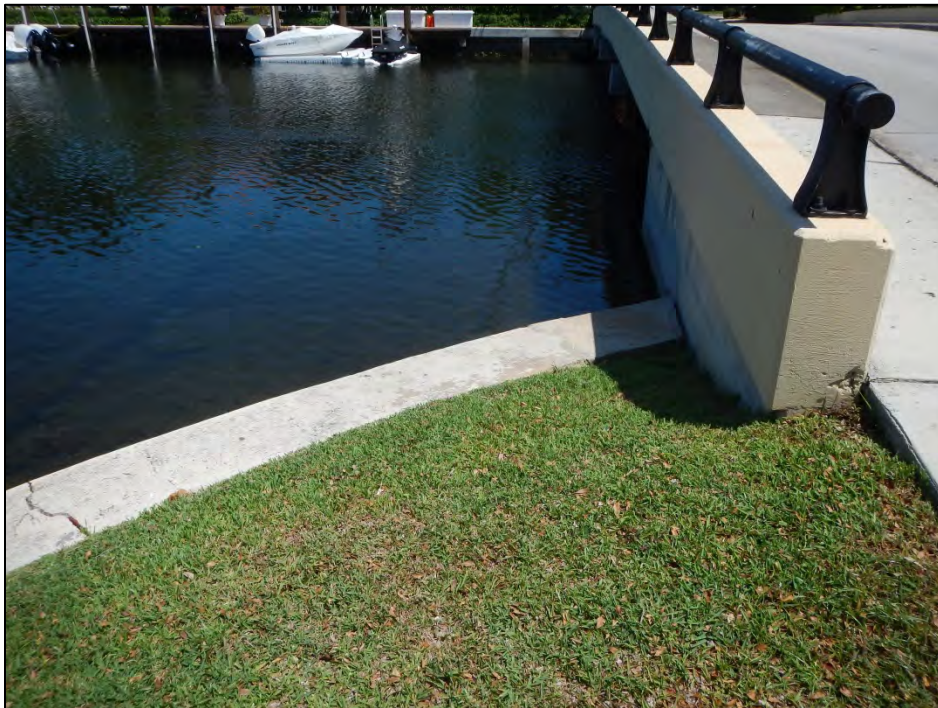
Photo 6 – Washout at southwest corner.

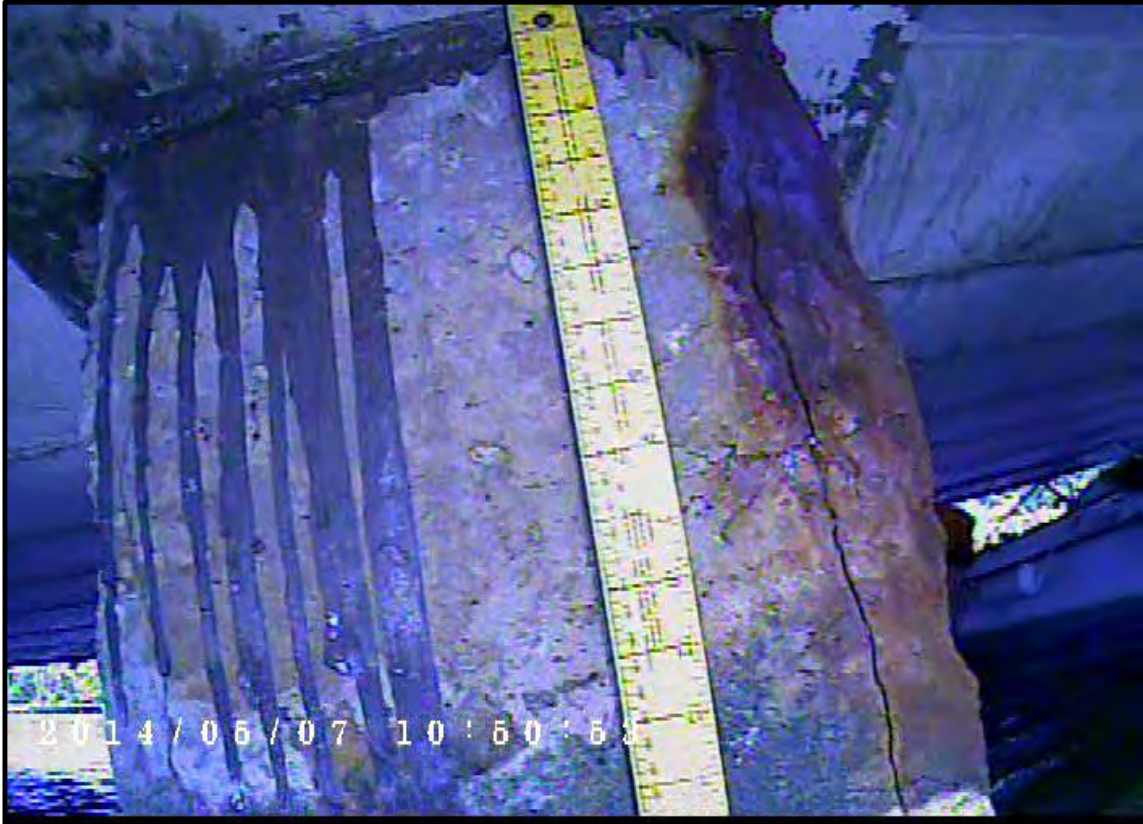
\_Pile 2-6, all four corners are delaminated up to 22" x 11", with corrosion bleed-out, starting below the cap. **UW Photo 01. NO CHANGE**

Description: Top: Pile 2-6, all four corners, are delaminated with corrosion bleed-out. **UW Photo 01.**  
Bottom: NE retaining wall has a delamination. **UW Photo 02.**

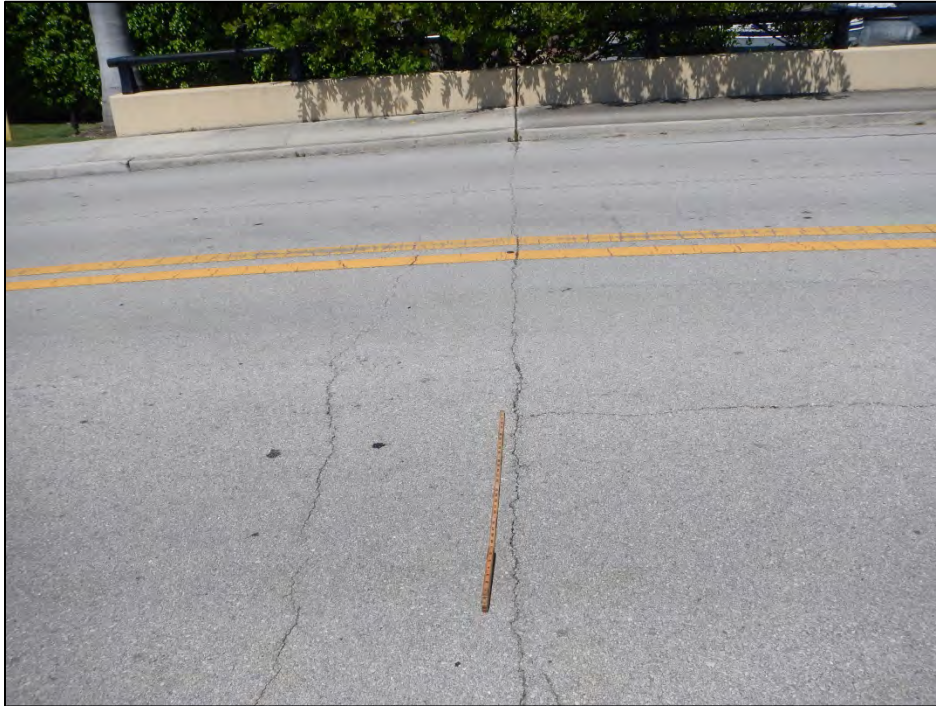
- The asphalt overlay on the slab units has transverse cracks up to  $\frac{1}{8}$  in. wide over the expansion joints and longitudinal cracks up to  $\frac{1}{4}$  in. wide over the slab unit joints. See Condition Photos 1 and 2.

Photo 1 – Transverse cracks in asphalt overlay at Abutment 1.

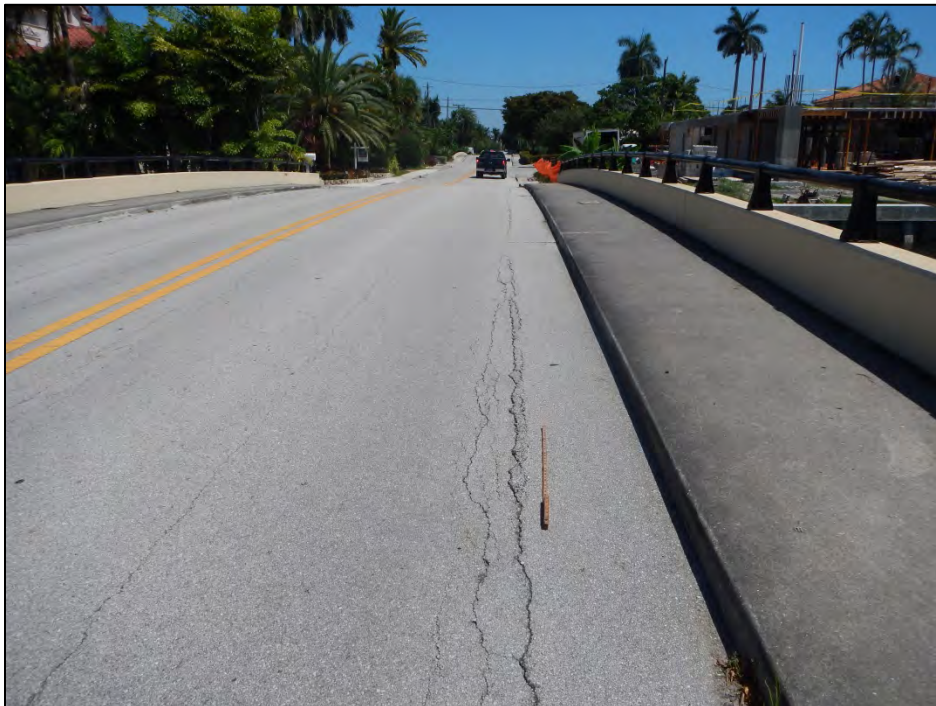
Photo 2 – Longitudinal cracks in asphalt overlay in Span 1.

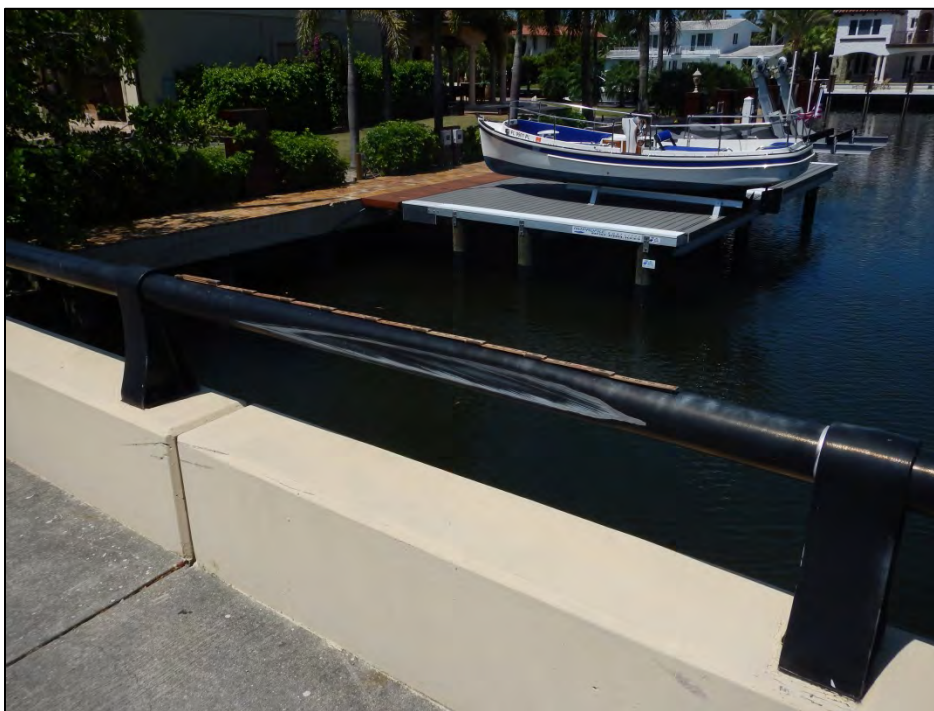
- The left aluminum rail in Span 2 has a 5 ft. long area of moderate impact damage at Bent 2. See Condition Photo 3.

Photo 3 – Impact damage to aluminum rail in Span 2.

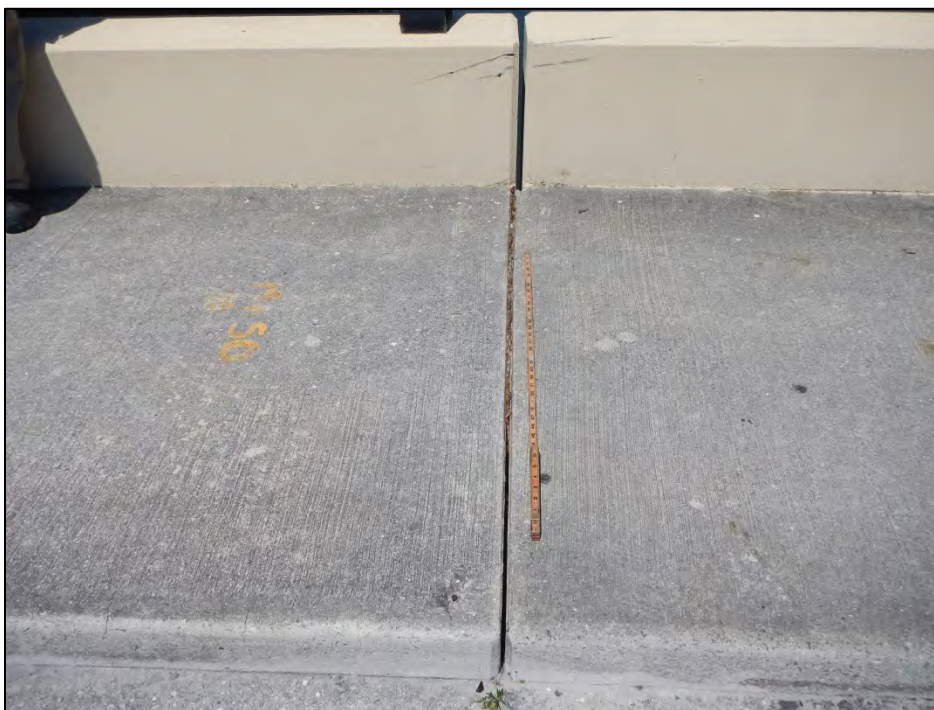
Photo 4 – Sidewalk joints filled with dirt and debris.

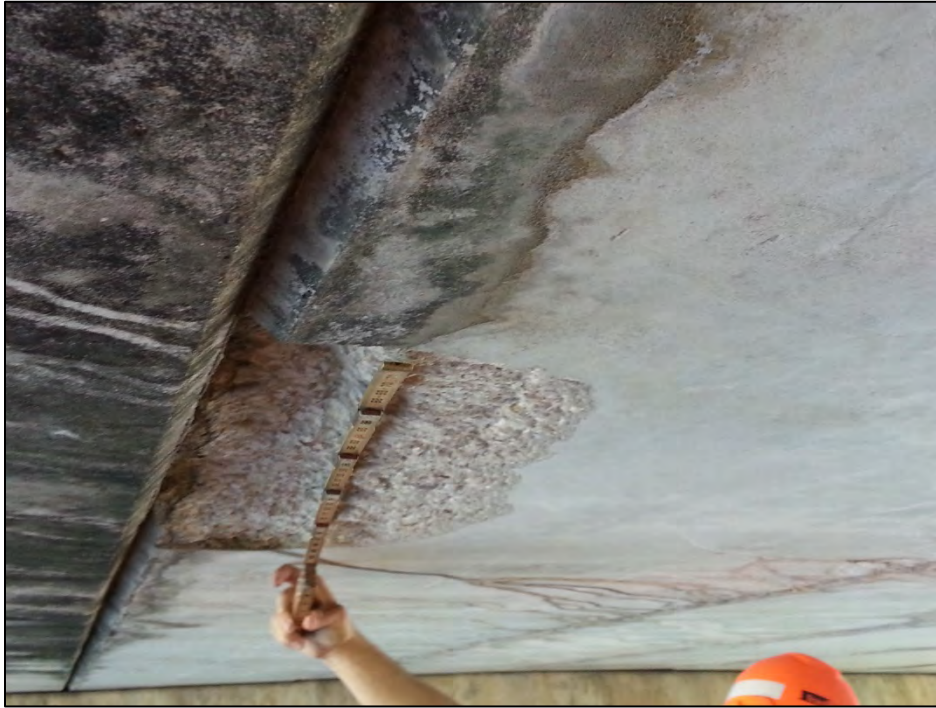
Photo 5 – Spall in Slab Unit 3-6.

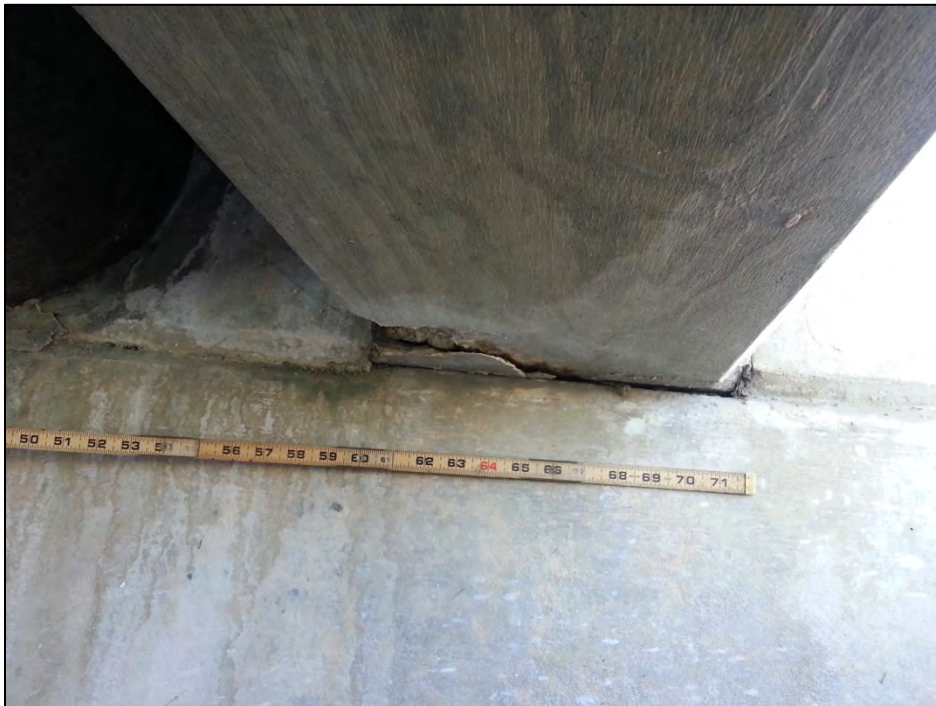
Photo 6 – Spall in Beam 3-2 at Abutment 4.

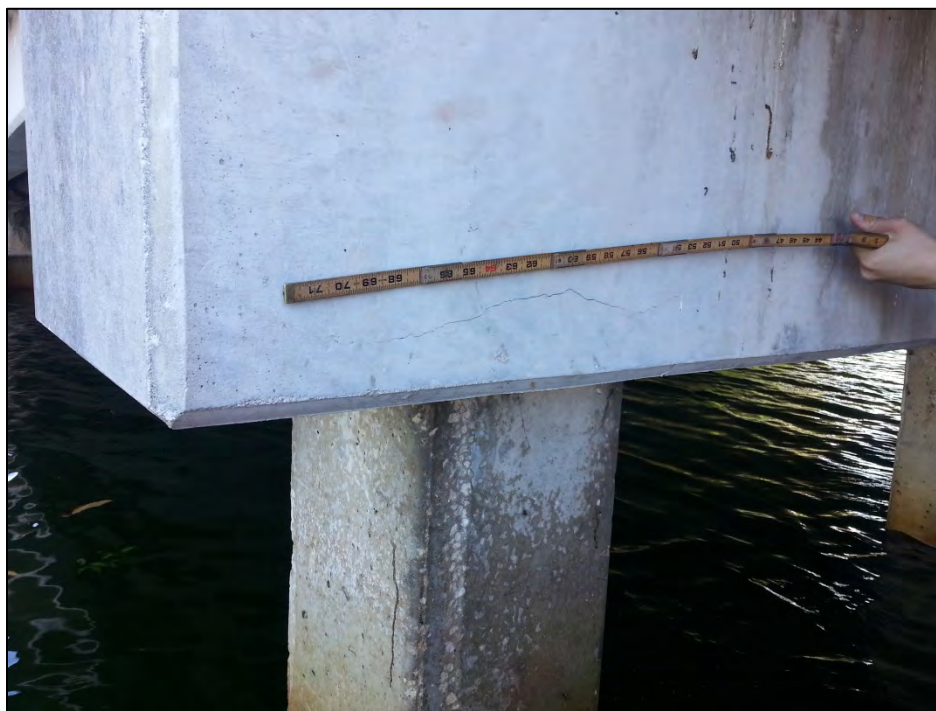
Photo 7 – Delamination in east end of north face of Bent 2 cap.

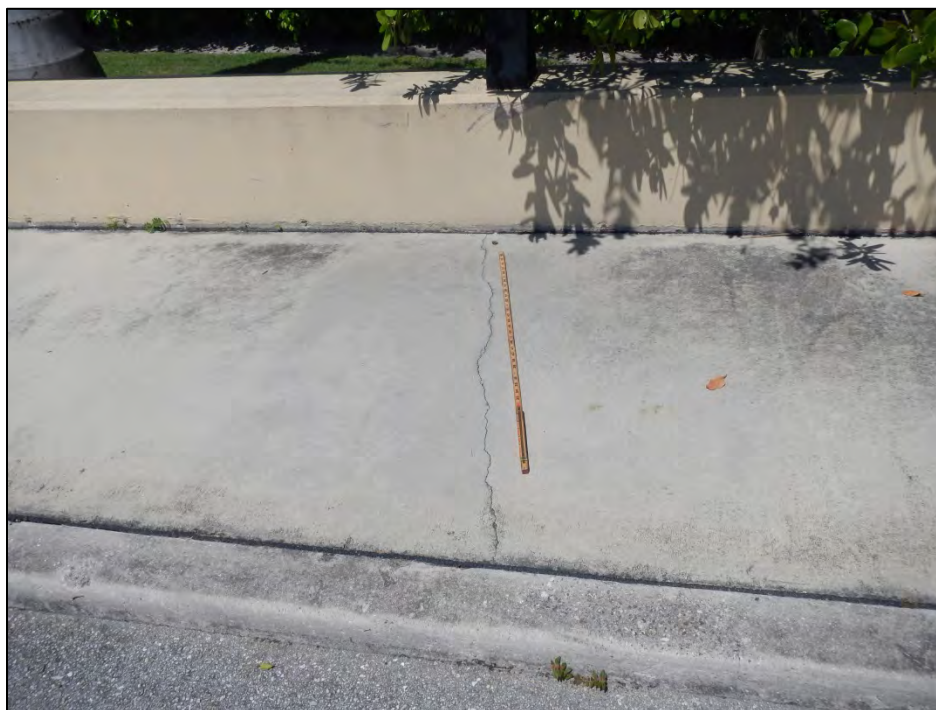
Photo 8 – Crack in southwest approach sidewalk.

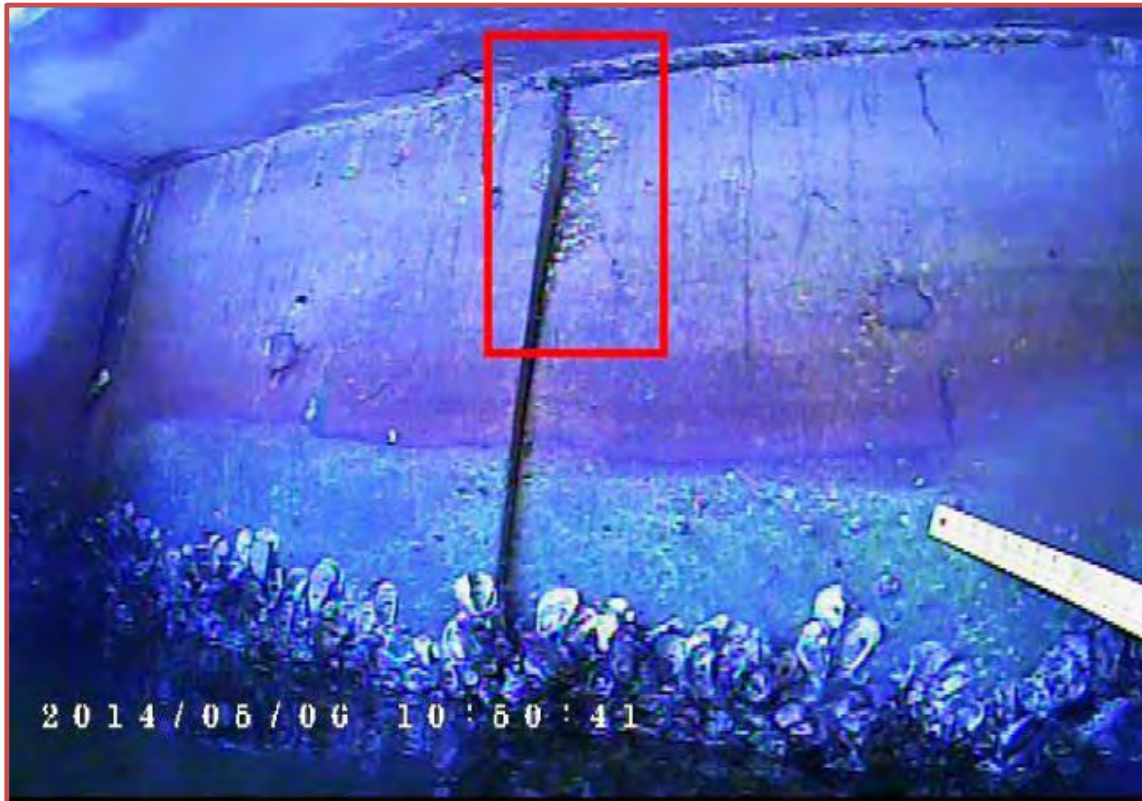
Description: Top: Pile 4-4, South face at the cap, spall/delamination. **UW Photo 01.**  
Bottom: Abutment 1 backwall east of Pile 1-4, spall. **UW Photo 02.**
