## **EXECUTIVE SUMMARY**

TranSystems has been retained by the City of Fort Lauderdale to perform bridge inspections and prepare bridge inspection reports for each of the City's bridges as part of the project Structural Bridge Engineering Consulting Services Master Plan, RFQ No. 946-11310. Inspections were completed and reports prepared for 46 of the City's bridges. The remaining five bridges in the City's inventory were not inspected because they are in the process of being replaced.

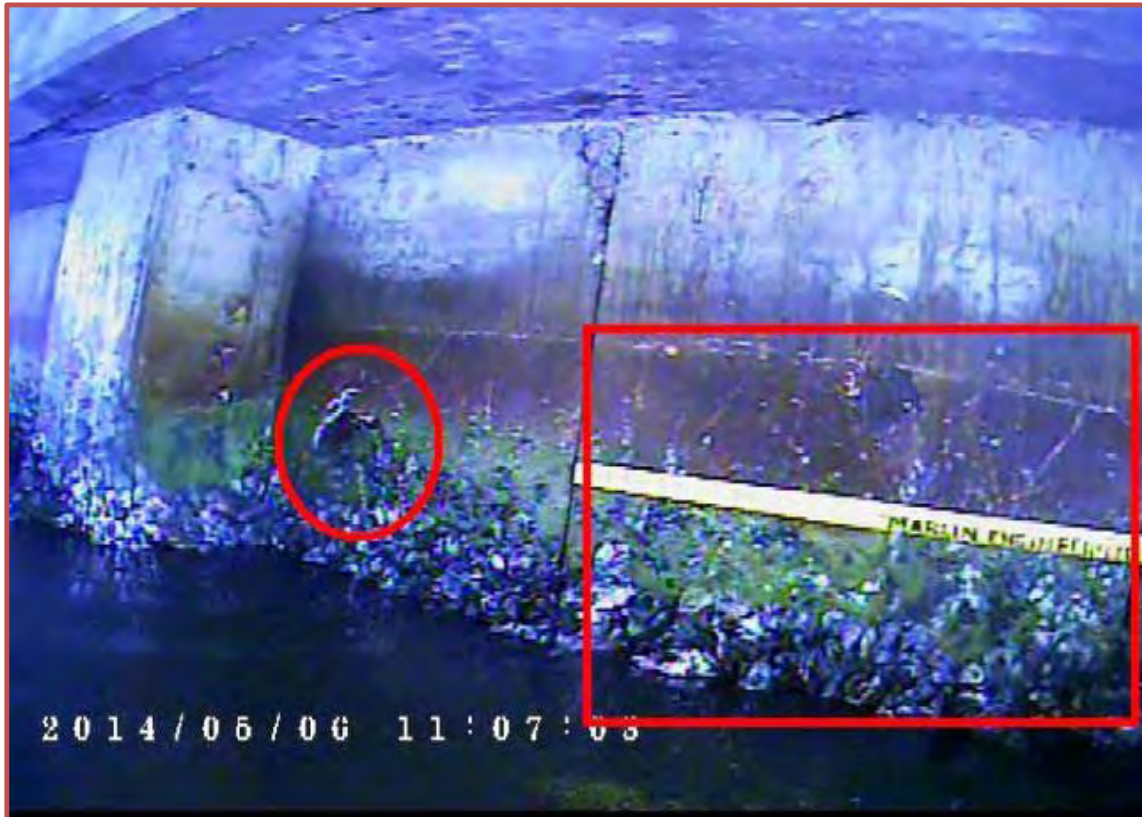
Description: Abutment 4 backwall exhibits hollow sounding areas and multiple cracks. **UW Photo 03.**

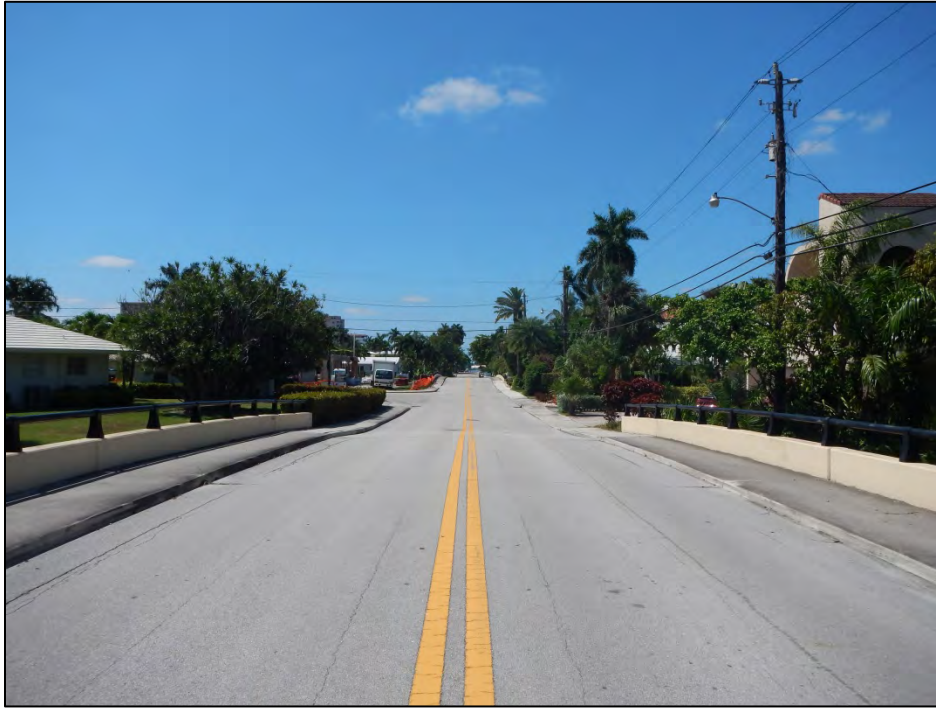
Photo 1 – Longitudinal cracks in asphalt overlay over slab unit joints.

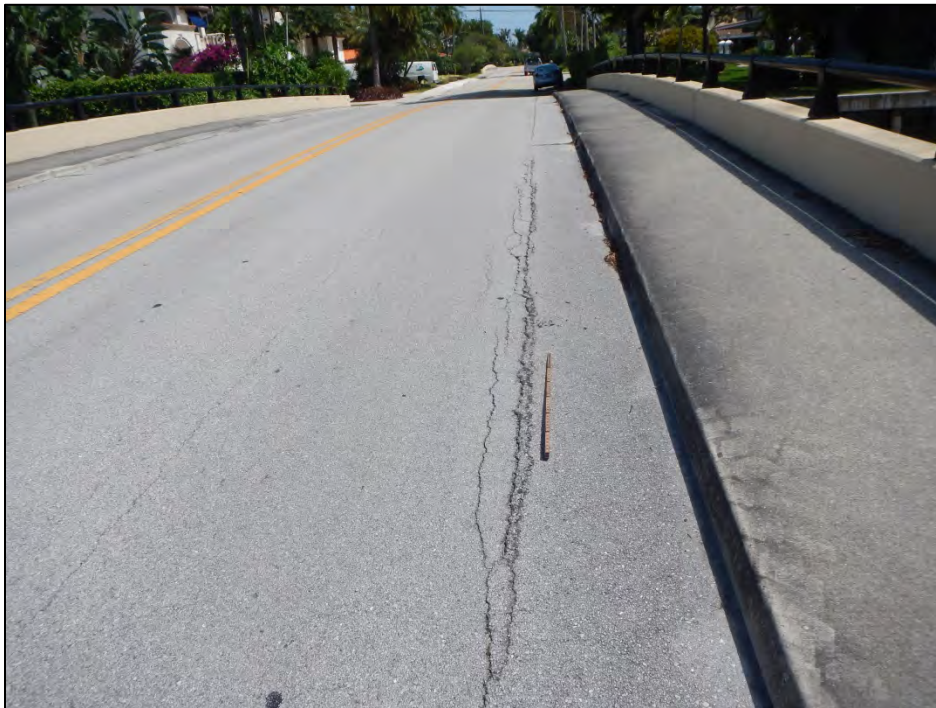
Photo 2 – Longitudinal cracks in asphalt overlay adjacent to right sidewalk.

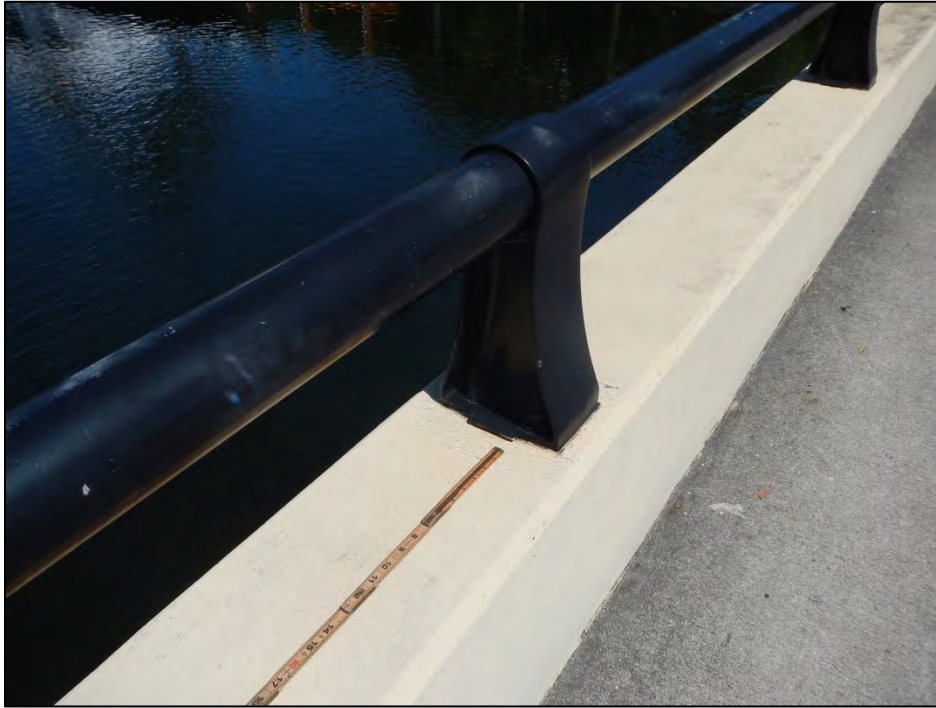
Photo 3 – Missing anchor bolt nuts at left handrail Post 1-3.

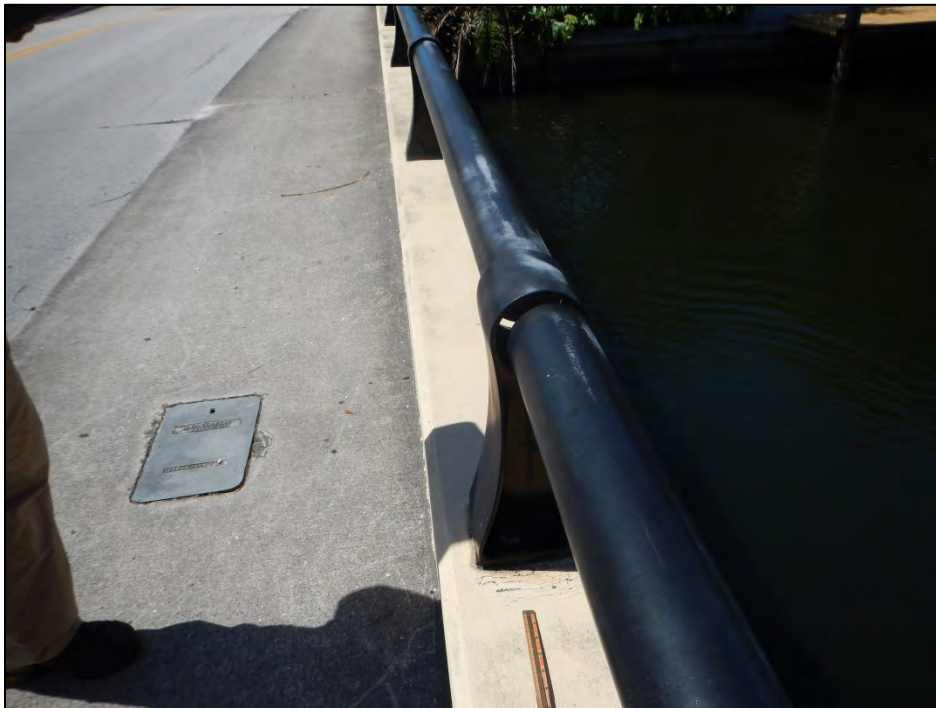
Photo 4 – Handrail pipe does not extend into post.

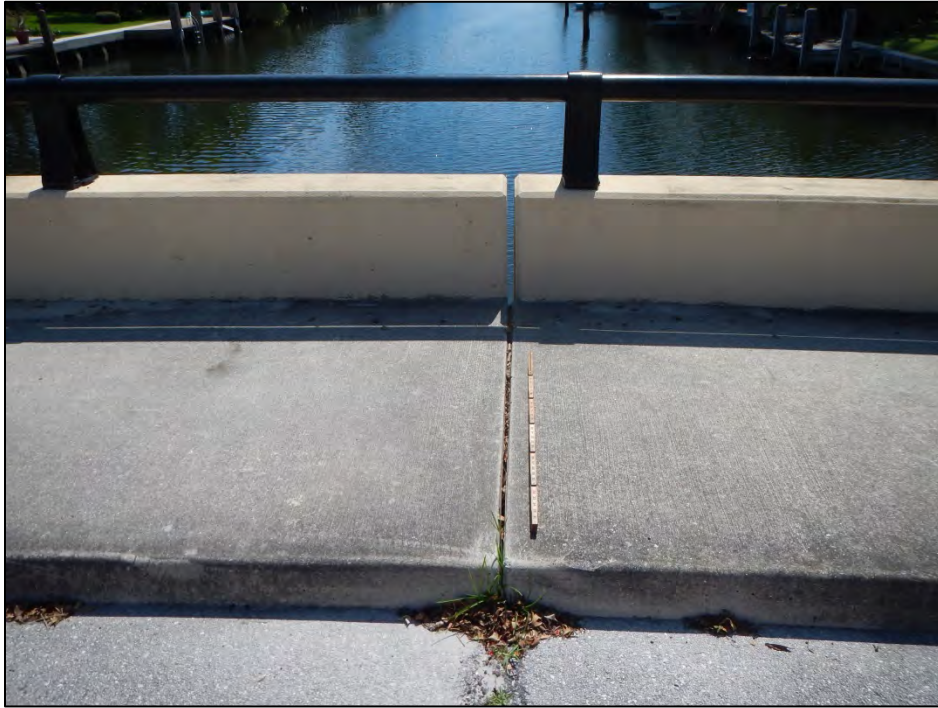
Photo 5 – Deteriorated sidewalk joint sealant; joint filled with dirt and debris.

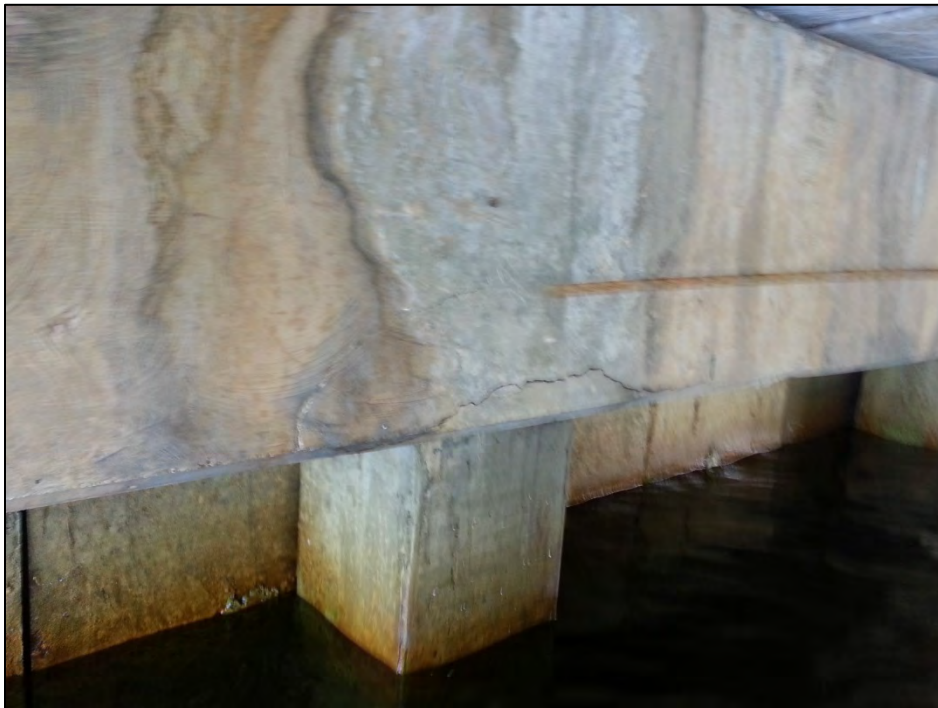
Photo 6 – Delamination in Abutment I cap over Pile I-4.

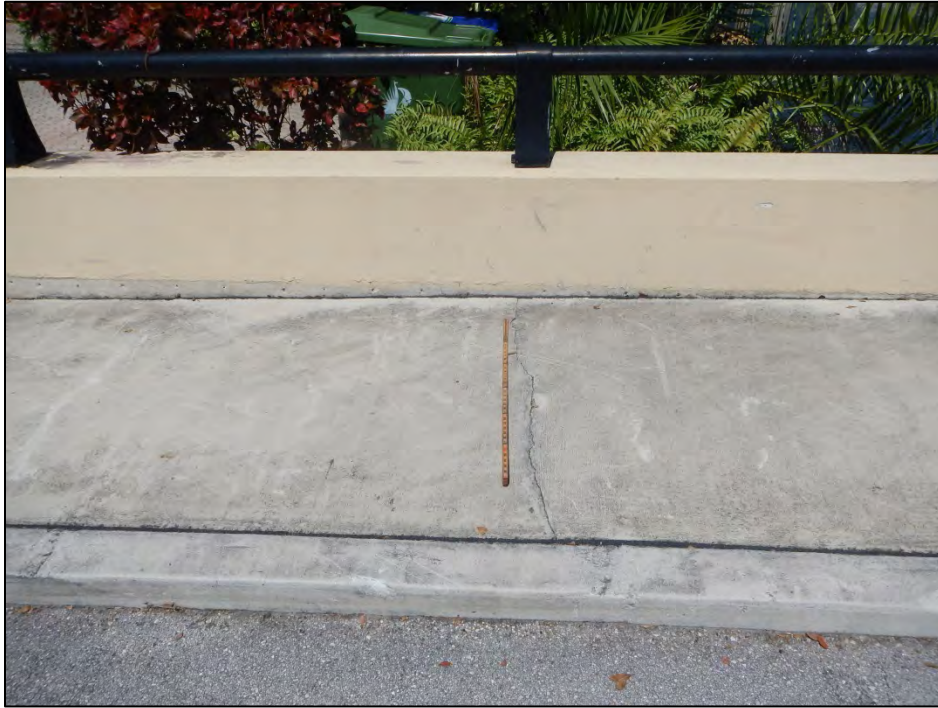
Photo 7 – Transverse crack in southwest approach sidewalk.

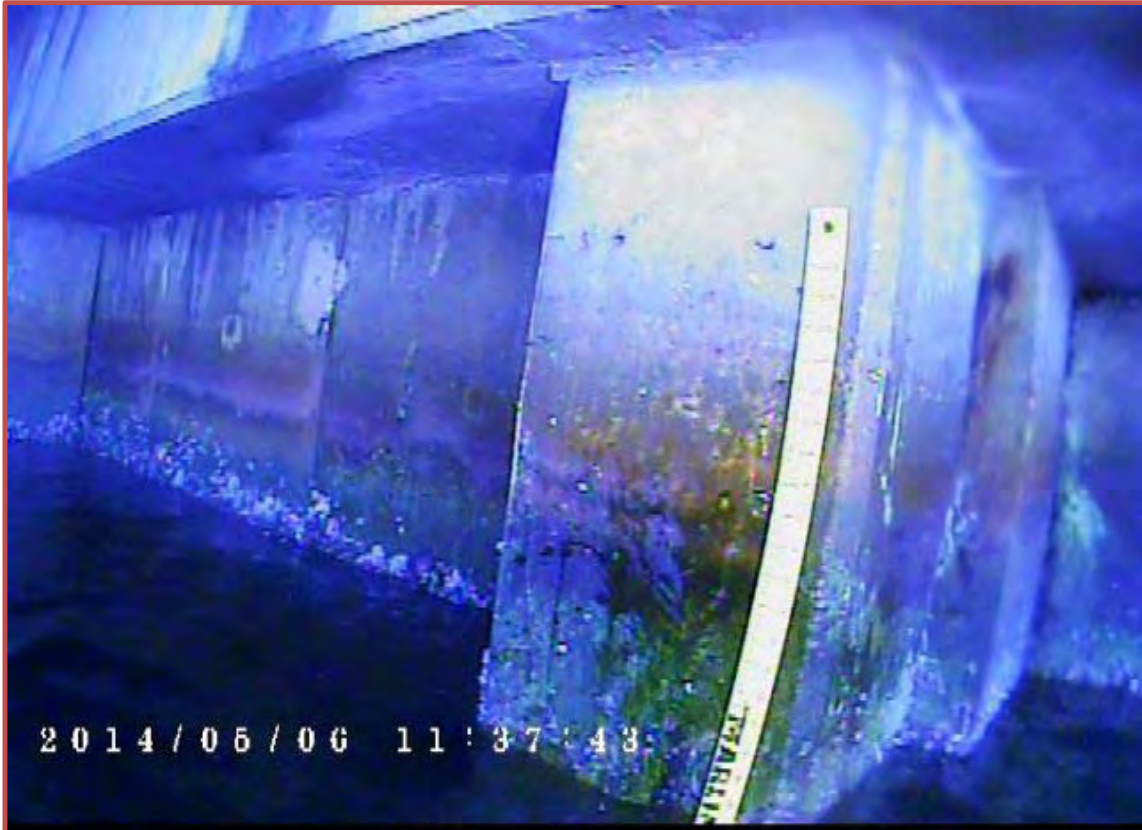
\_Pile 1-1, NE corner delamination 21" x 11", with associated cracks up to 1/32", and corrosion bleed-out, 10" below the cap. **UW Photo 01. NO CHANGE**

Description: Top: Pile 1-1, NE corner delamination with associated cracks. **UW Photo 01.**  
Bottom: Abutment 1 backwall, east side of Pile 1-1, delamination. **UW Photo 02.**

\_Remove all unsound concrete and patch and epoxy inject all the cracks at abutments as needed.

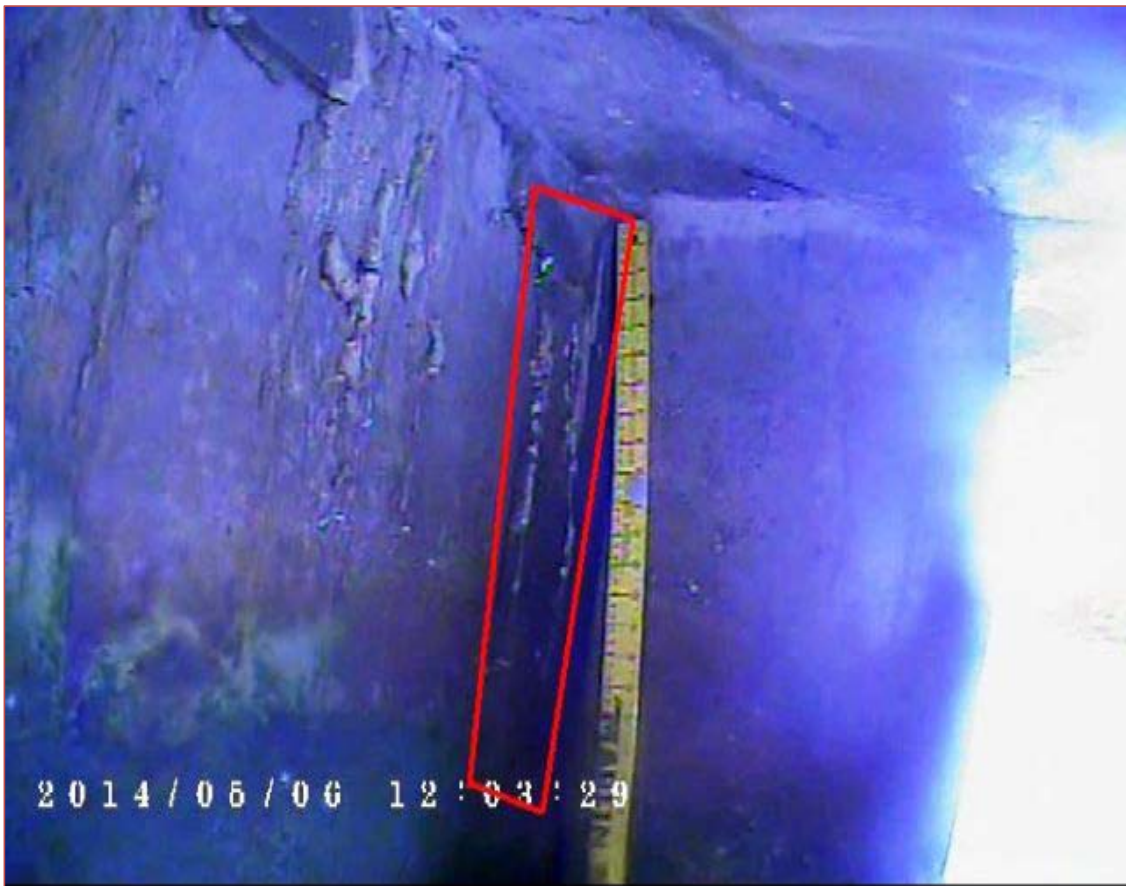
\_Abutment 4 backwall, behind Pile 4-5, delamination 26" x 18", with corrosion bleed-out.

Description: Top: Abutment 1 backwall, west side of Pile 1-1, delamination. **UW Photo 03.**  
Bottom: Abutment 4 backwall, behind Pile 4-5, delamination. **UW Photo 04.**

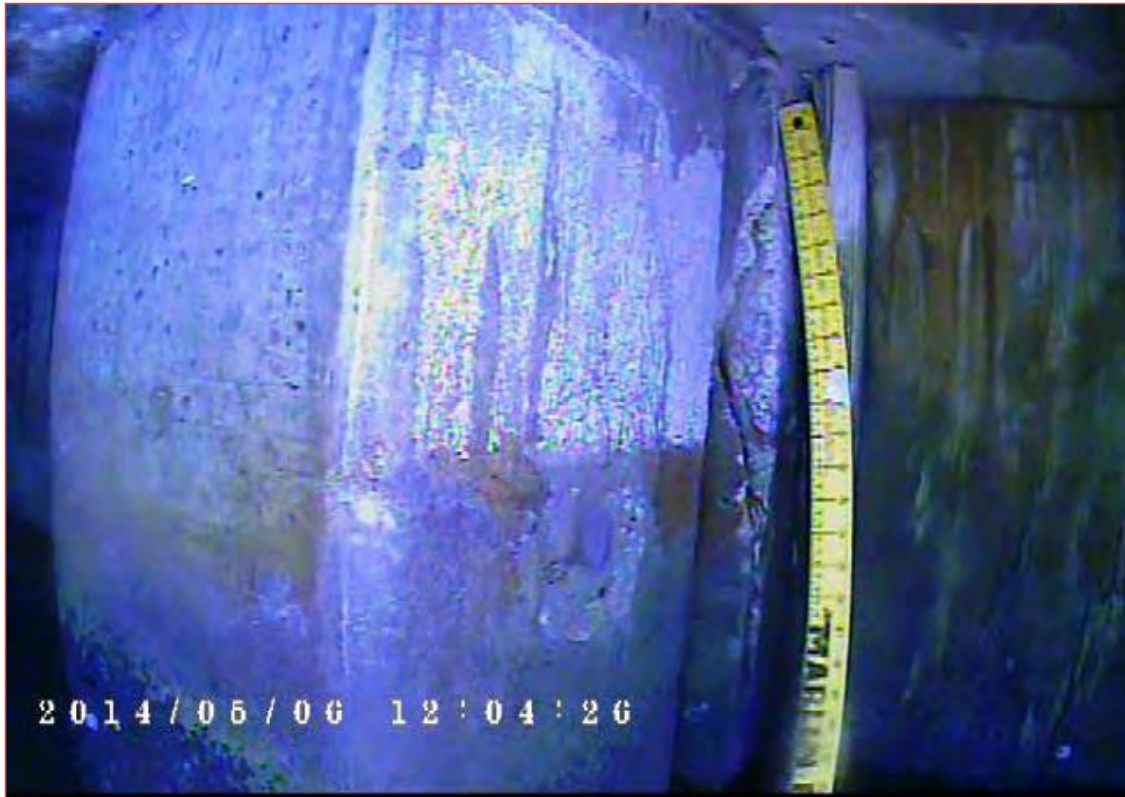
Description: Abutment 4, NE retaining wall at the junction has a delamination. **UW Photo 03.**

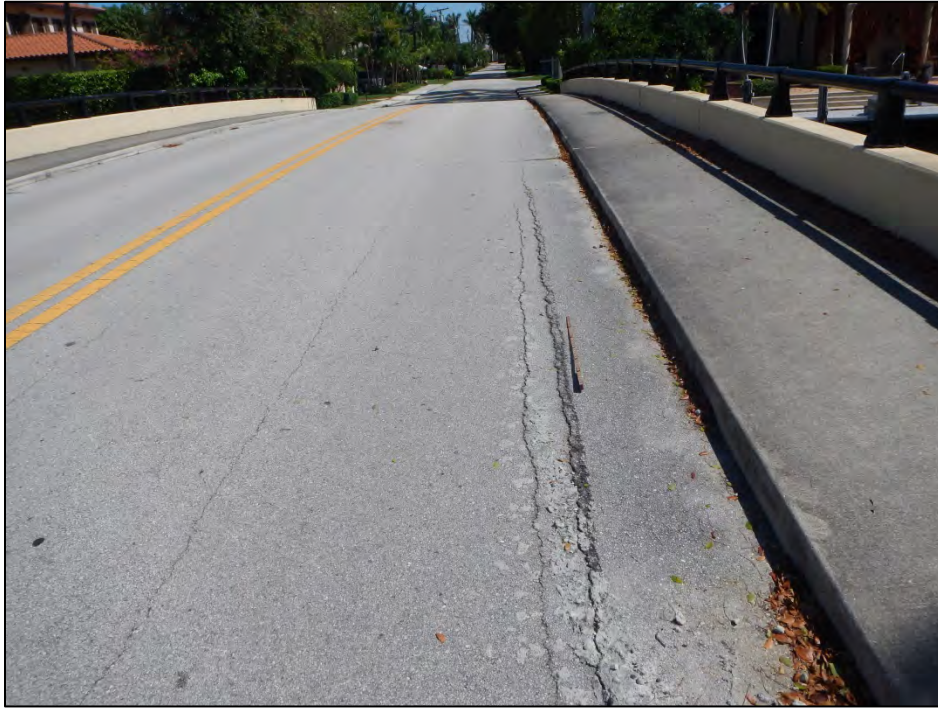
Photo 1 – Longitudinal cracks in asphalt overlay over slab unit joints.

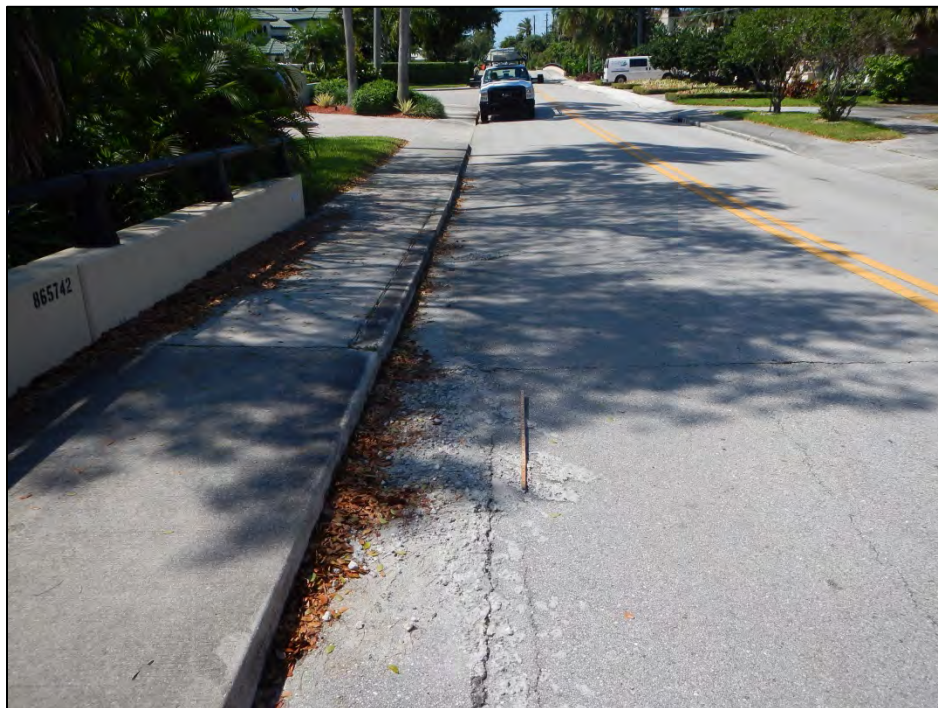
Photo 2 – Spilled concrete adjacent to the right sidewalk at Abutment 1.

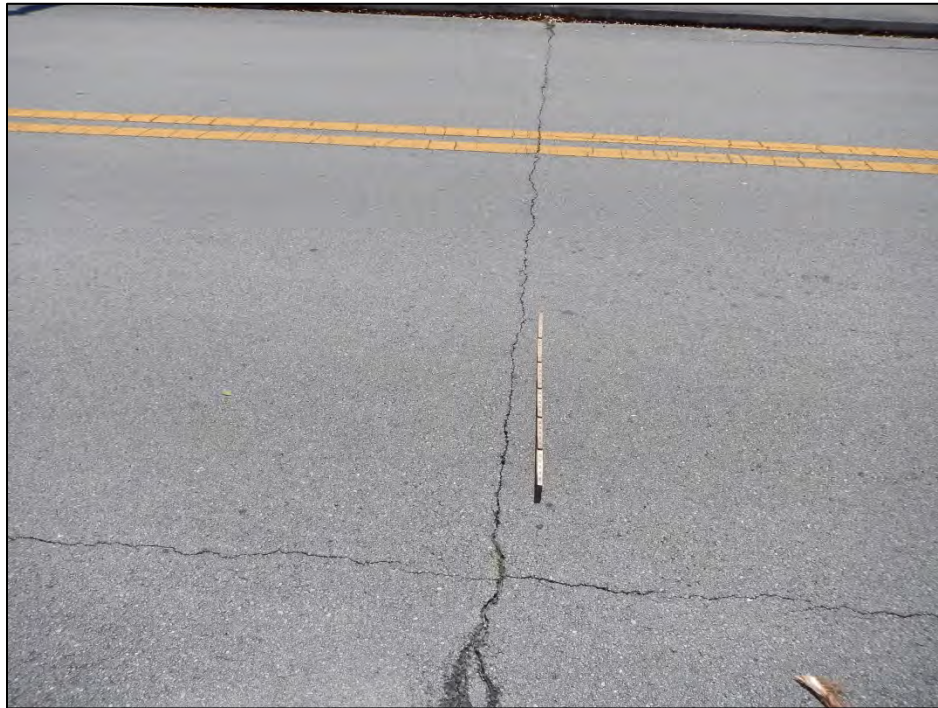
Photo 3 – Typical transverse crack in asphalt overlay at intermediate bent.

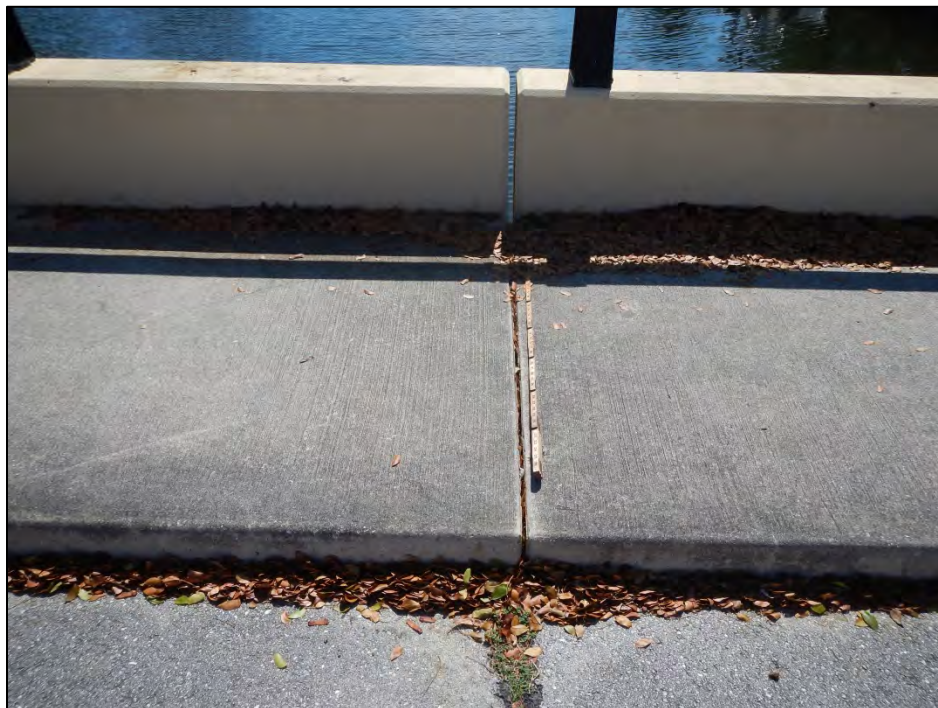
Photo 4 – Deteriorated sidewalk joint filled with dirt and debris.

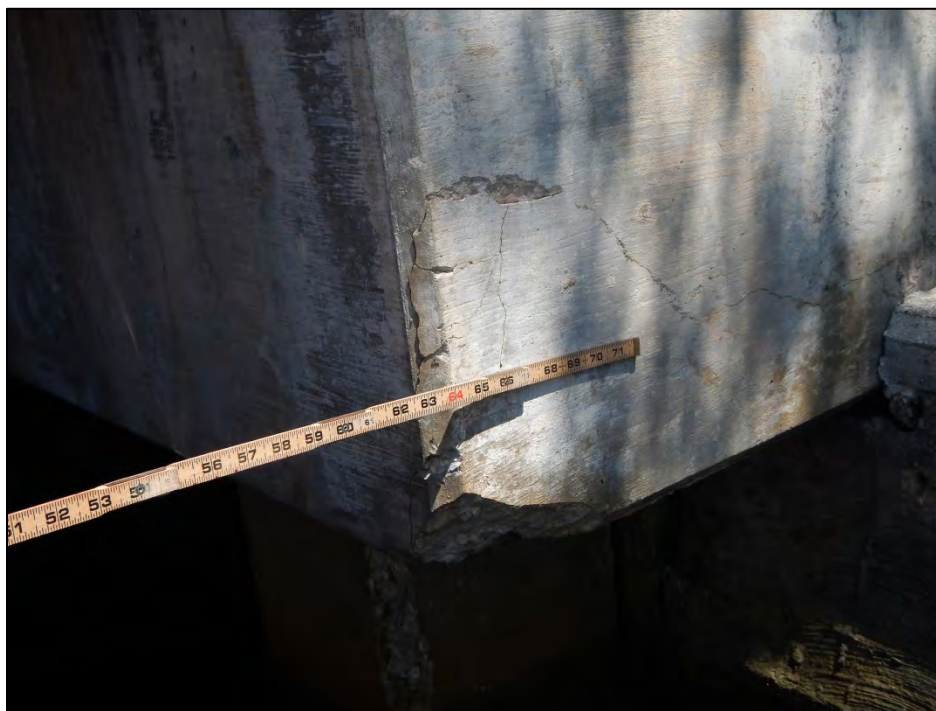
Photo 5 – Delamination in west end of Abutment I cap.

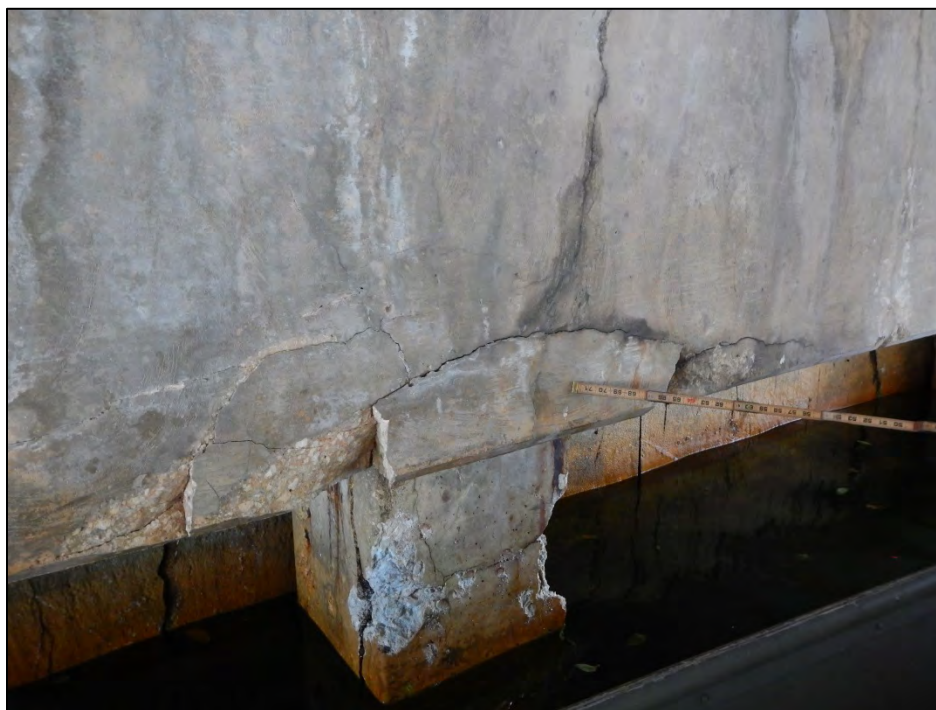
Photo 6 – Delamination/spall at Abutment I cap above Pile I-3. Note delaminated/spalled pile.

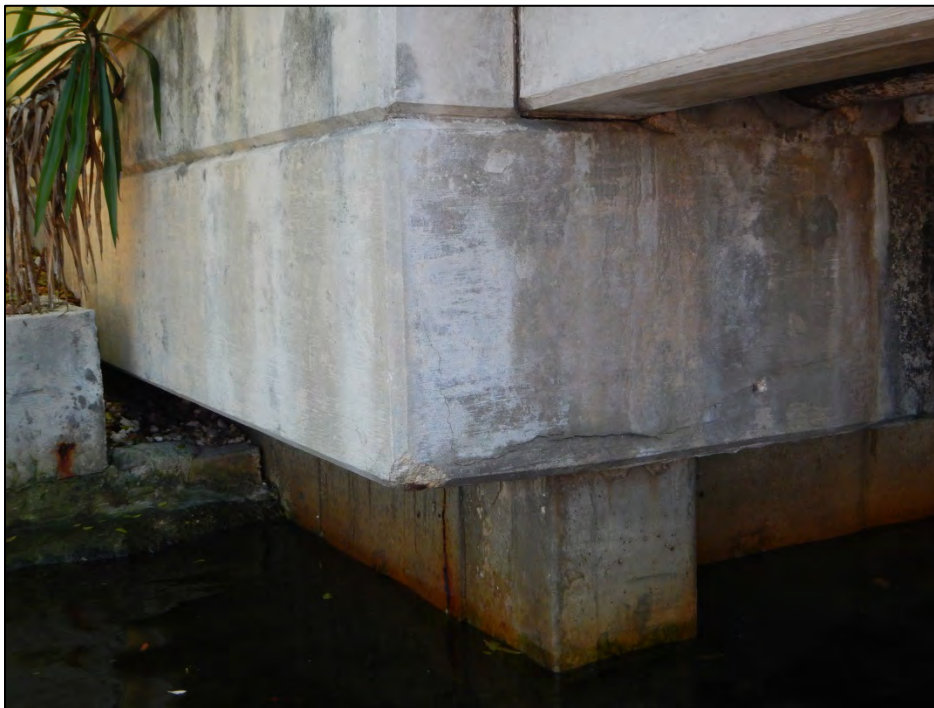
Photo 7 – Delamination/spall at east end of Abutment 1 cap.

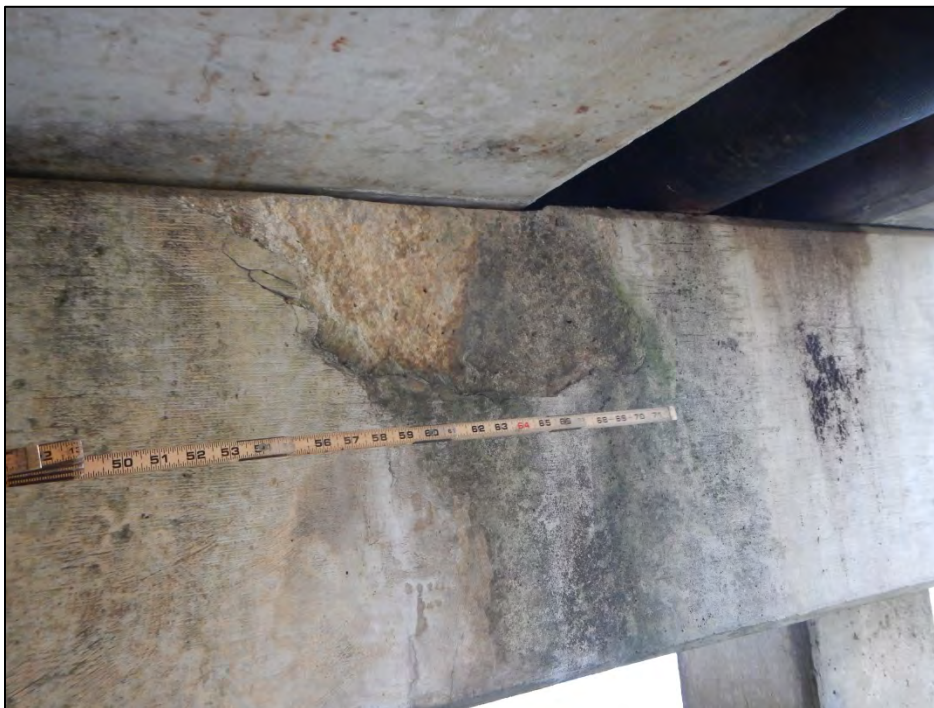
Photo 8 – Spall in south face of Bent 2 cap.

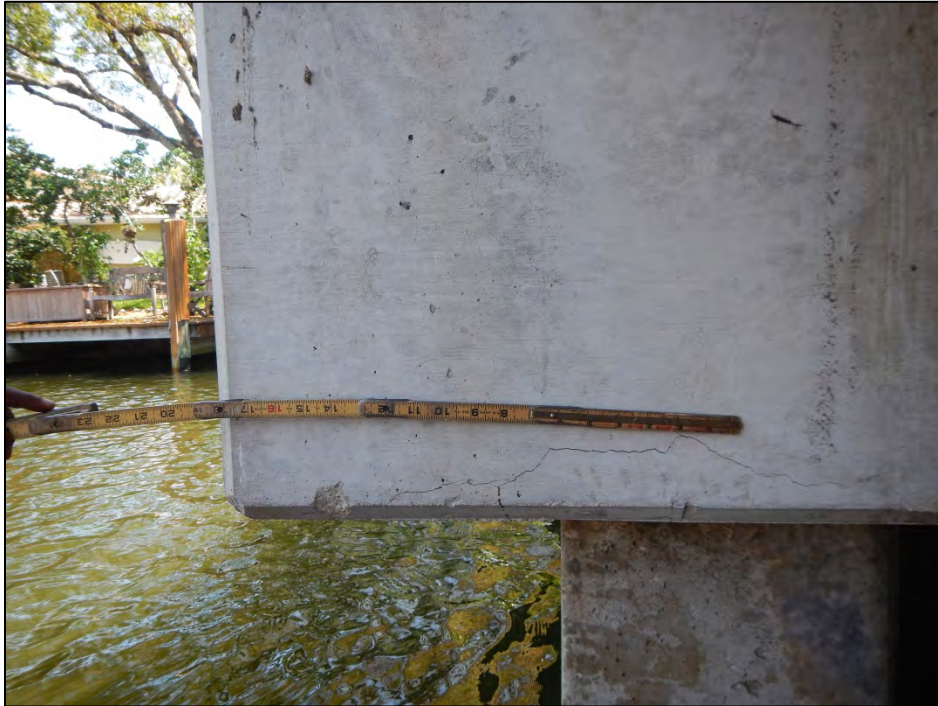
Photo 9 – Delamination in the north face of Bent 3 cap.

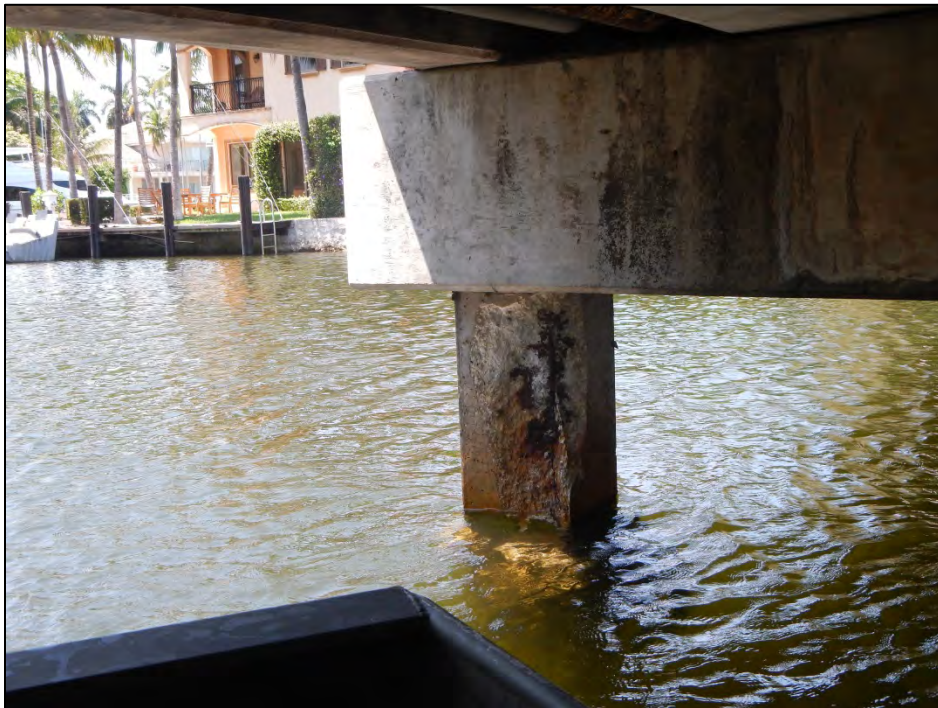
Photo 10 – Spall with exposed corroded steel at the southeast corner of Pile 2-1.

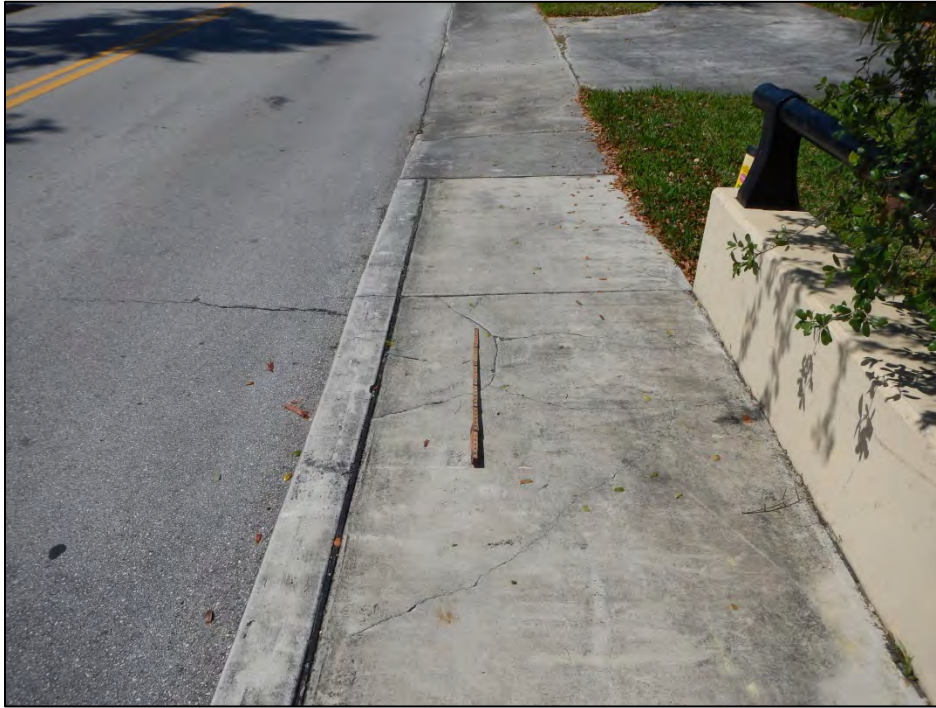
Photo 11 – Cracks in southwest approach sidewalk.

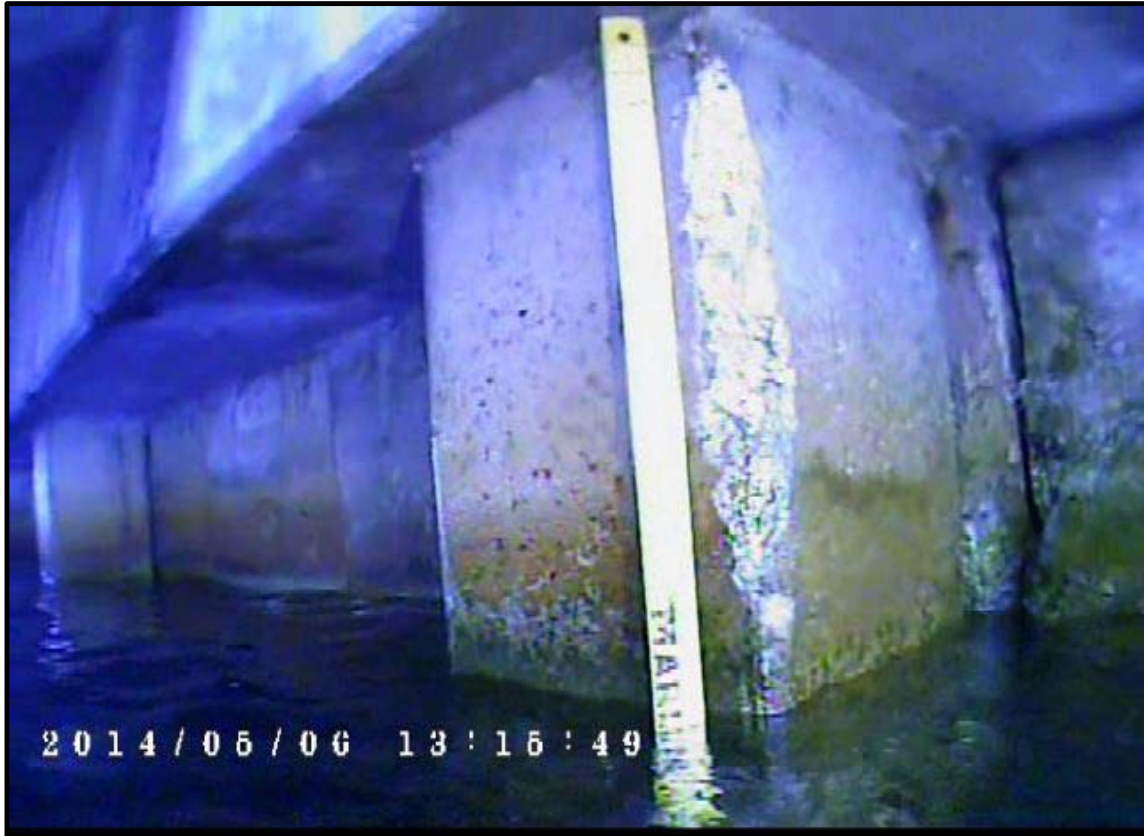
\_Pile 1-1, NW corner adjacent to the cap, spall/delamination 18" x 4" x 1", with associated cracks up to 1/4" wide. **UW Photo 01. INCREASE**

Description: Top: Pile 1-1, NW corner adjacent to the cap, spall/delamination. **UW Photo 01.**  
Bottom: Pile 1-3, all faces at the cap are delaminated and cracked. **UW Photo 02.**

\_Remove all unsound concrete and repair Piles 1-1, 1-3, 2-1, 3-2, 3-4, 3-5, 4-2 and 4-3.

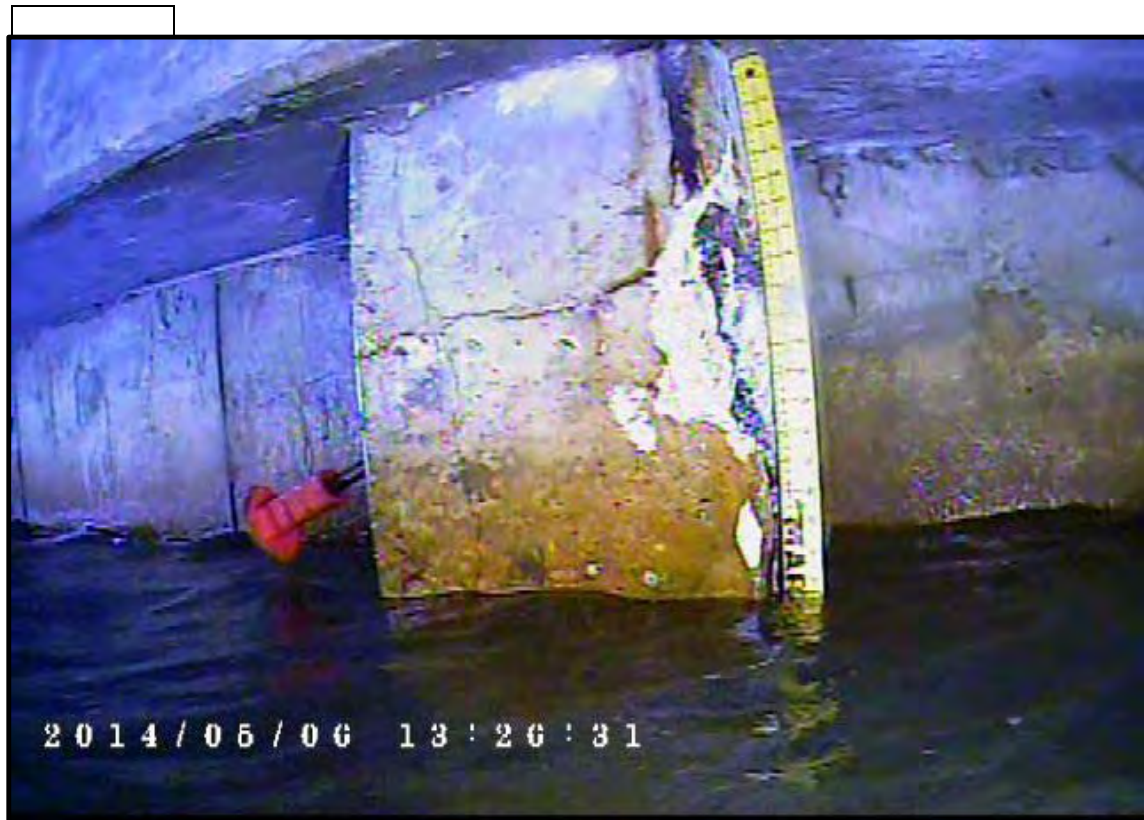
\_Pile 1-3, all faces starting at the cap are delaminated up to 36" x 10", with associated cracks up to 1/4" wide and corrosion bleed-out. **UW Photo 02. NO CHANGE**

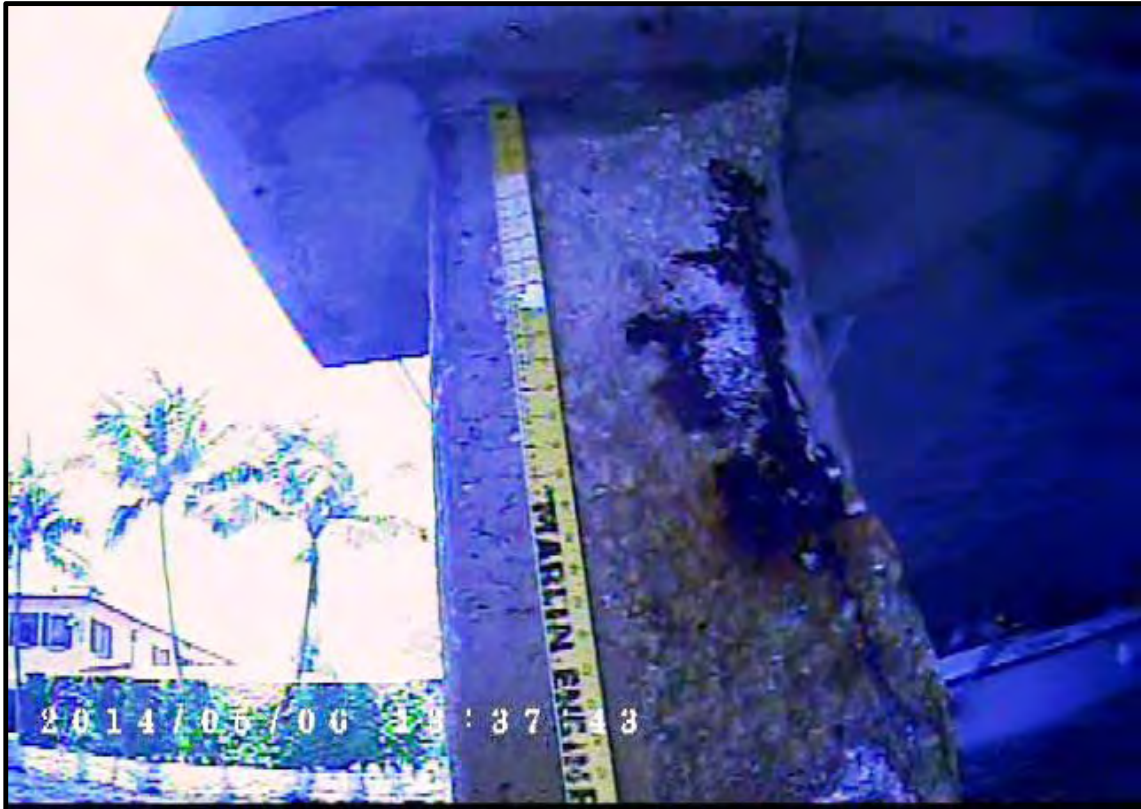
\_Pile 2-1, SE corner spall/delamination 32" x 13" x 2-1/2", extending 9" below the high watermark, with associated cracks up to 1/16", (1) exposed strand, 90% section loss. **UW Photo 03. INCREASE**

Description: Top: Pile 2-1, SE corner spall/delamination, w/exposed strand. **UW Photo 03.**  
Bottom: Pile 3-4, NE corner spall/delamination. **UW Photo 04.**

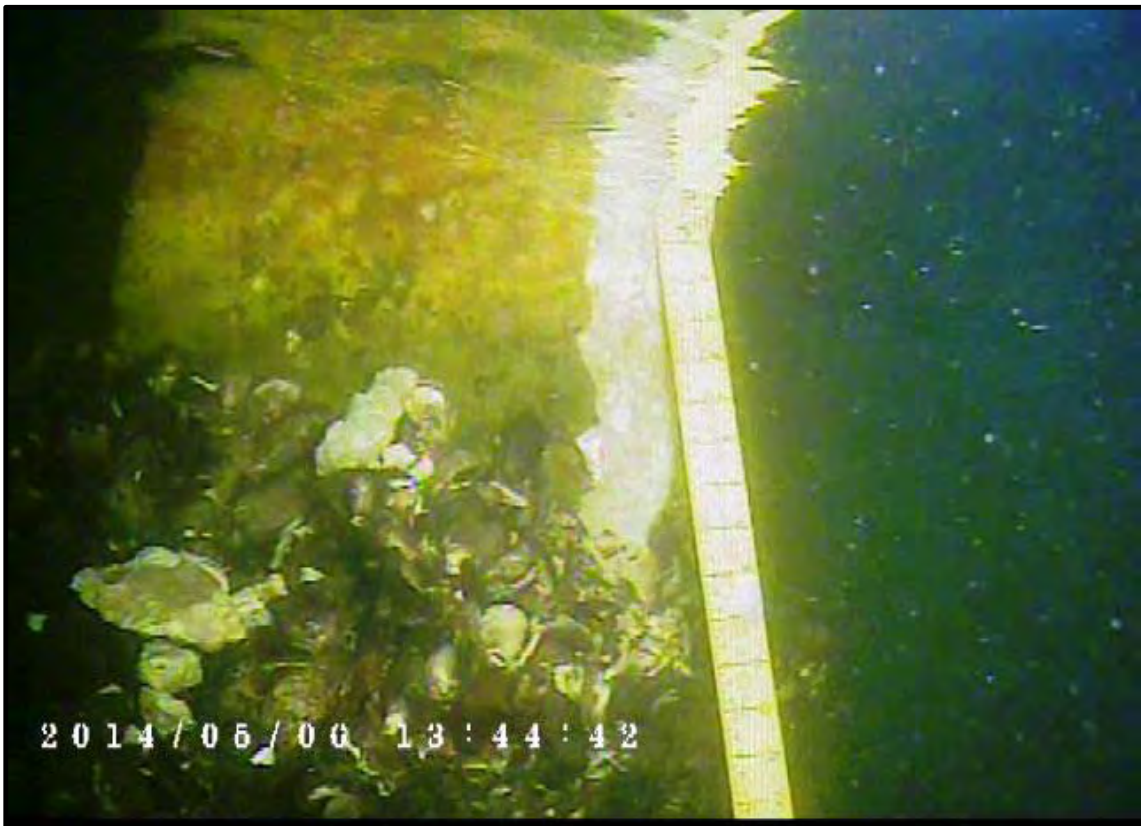
\_Pile 3-4, NE corner spall/delamination 33' x 7" x 3", extending 16" below the high watermark with cracks up to 1/16" and (1) exposed strand heavy corrosion. **UW Photo 04 and 05. INCREASE**

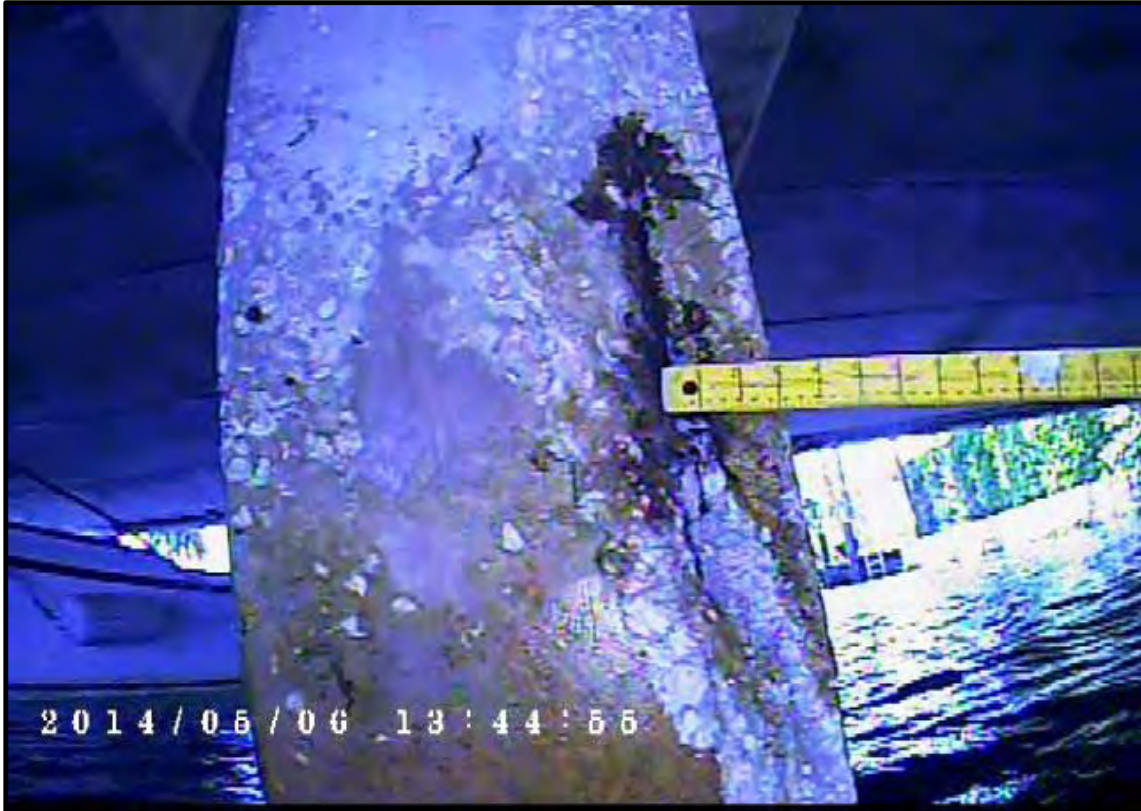
Description: Top: Pile 3-4, NE corner spall/delamination w/exposed strand. **UW Photo 05**  
Bottom: Pile 3-5, all faces at the cap are spall/delaminated, w/exp strand. **UW Photo 06**

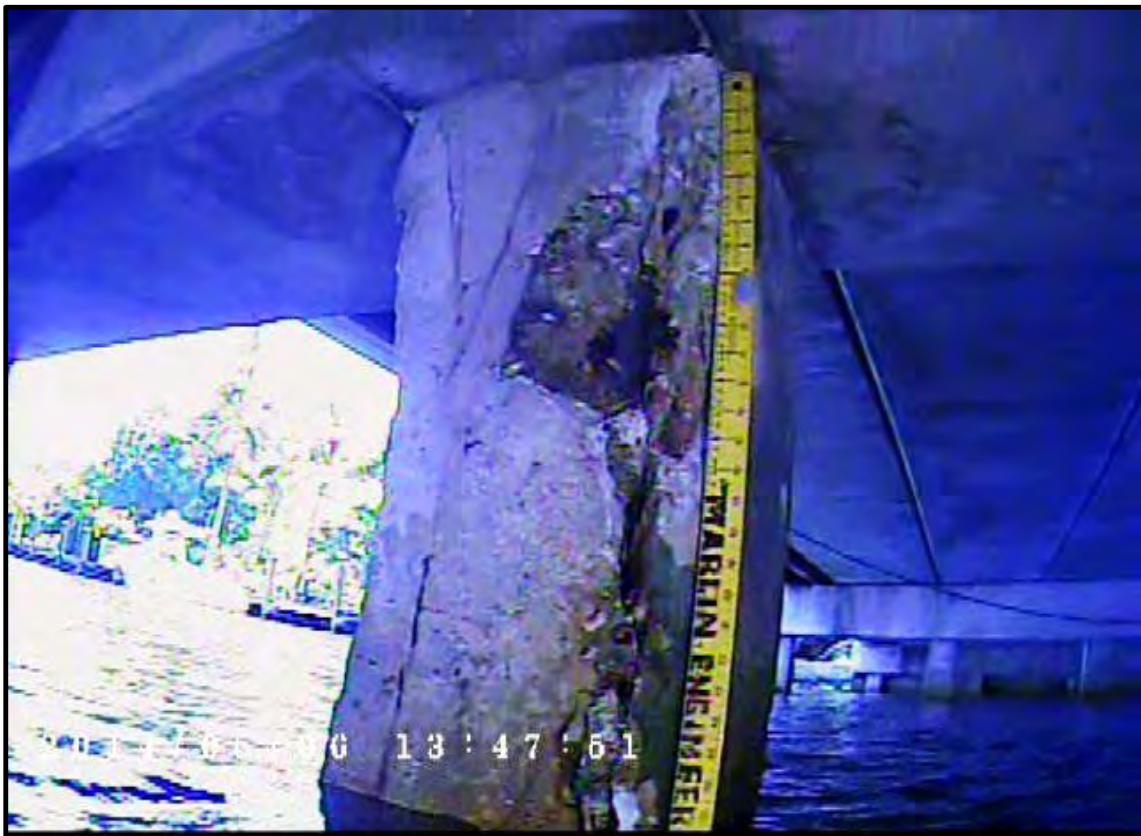
\_Pile 3-5, all faces starting at the cap spall/delamination up to 42" x pile width, extending 16" below the high watermark with associated cracks up to 1/4" wide. **UW Photo 06. INCREASE**
