## **EXECUTIVE SUMMARY**

TranSystems has been retained by the City of Fort Lauderdale to perform bridge inspections and prepare bridge inspection reports for each of the City's bridges as part of the project Structural Bridge Engineering Consulting Services Master Plan, RFQ No. 946-11310. Inspections were completed and reports prepared for 46 of the City's bridges. The remaining five bridges in the City's inventory were not inspected because they are in the process of being replaced.

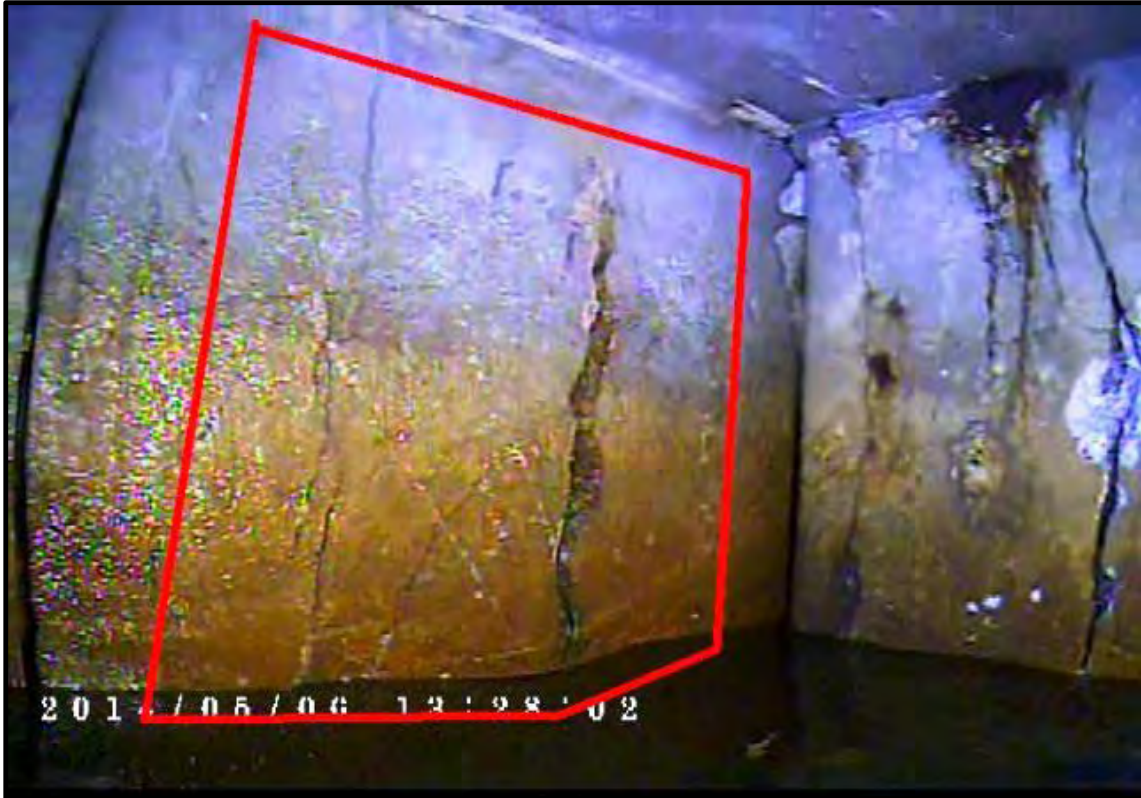
Description: Top: Abutment 1 backwall, east side of Pile 1-2, delamination. **UW Photo 07**  
Bottom: Abutment 1 backwall, behind Piles 1-2, spall. **UW Photo 08**

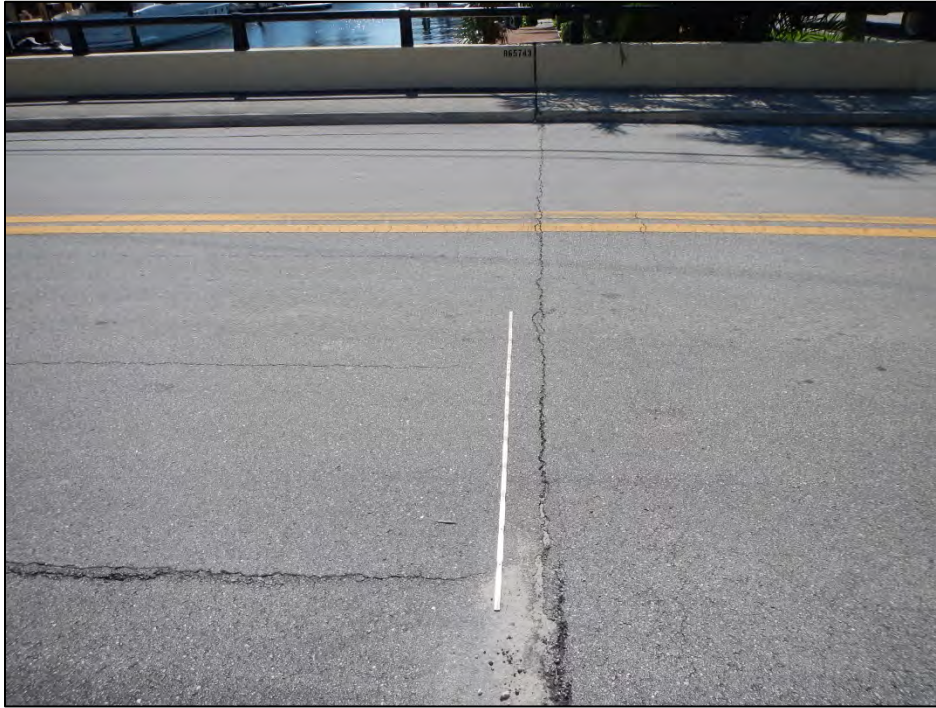
Photo 1 – Cracks in asphalt overlay at slab unit joints and expansion joints.

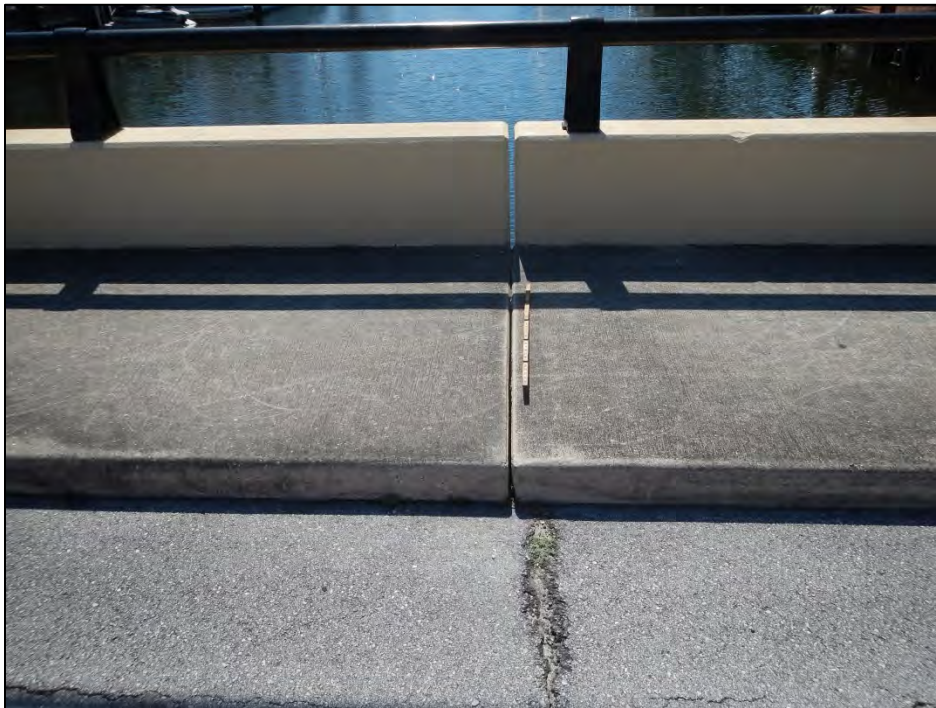
- The sidewalk joint sealant is deteriorated.

Photo 2 – Deteriorated sidewalk joint sealant.

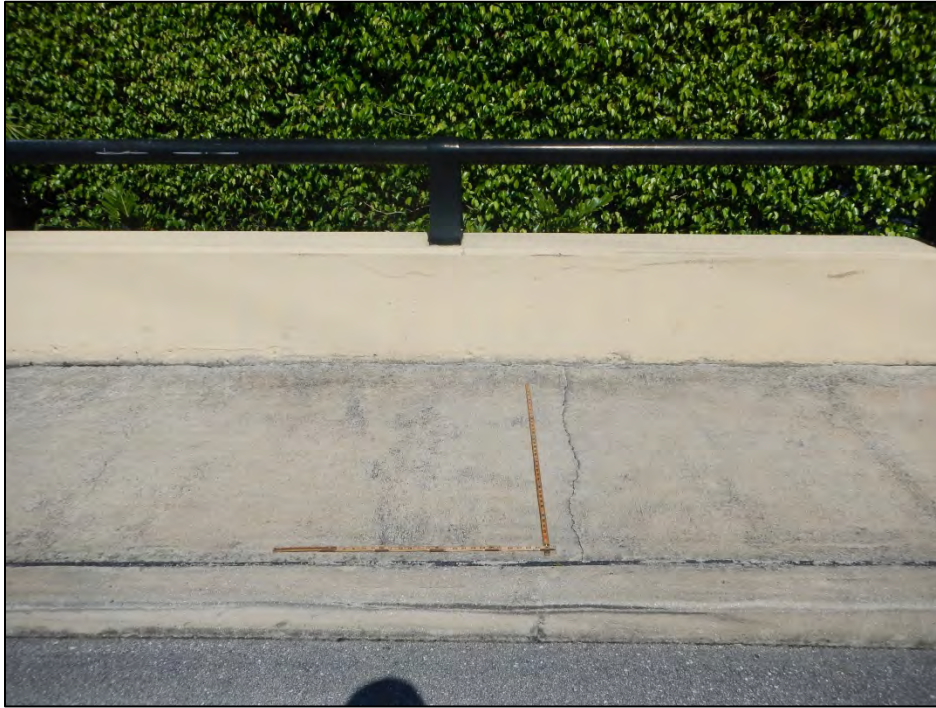
Photo 3 – Cracks in southwest approach sidewalk.

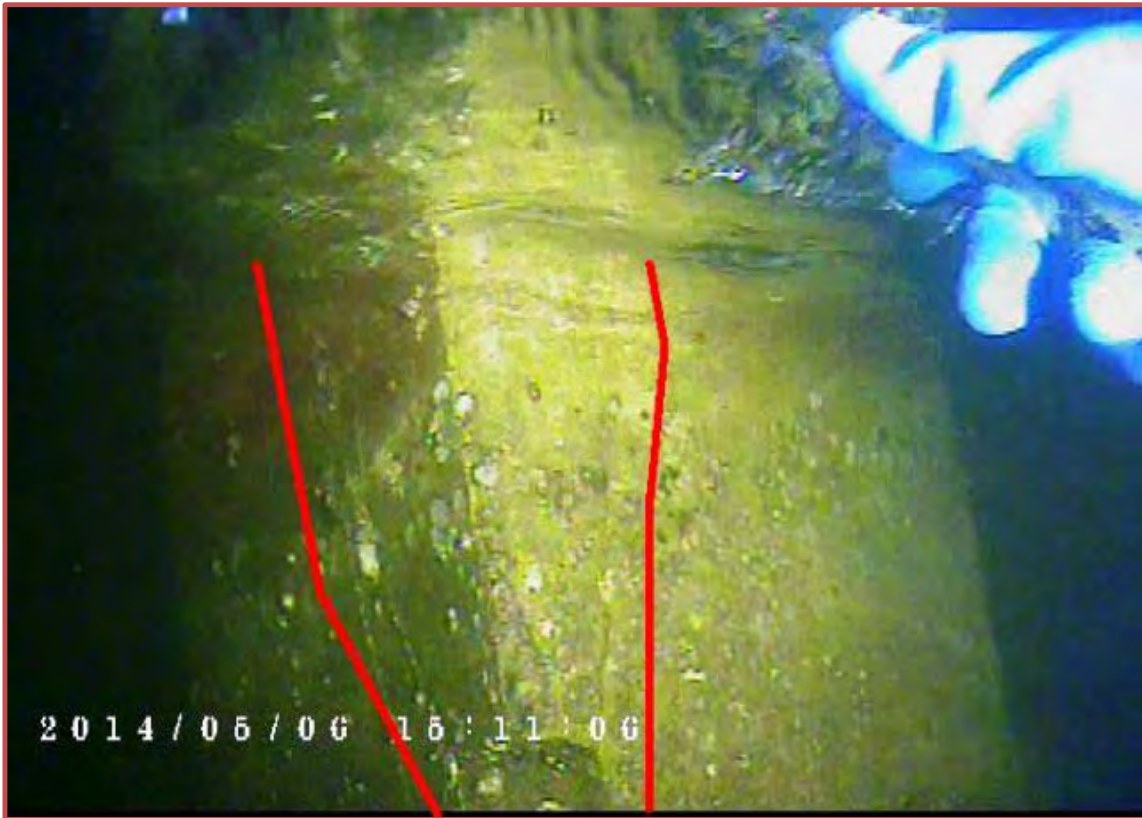
Description: Top: Pile 3-6, SE corner delamination. **UW Photo 01.**

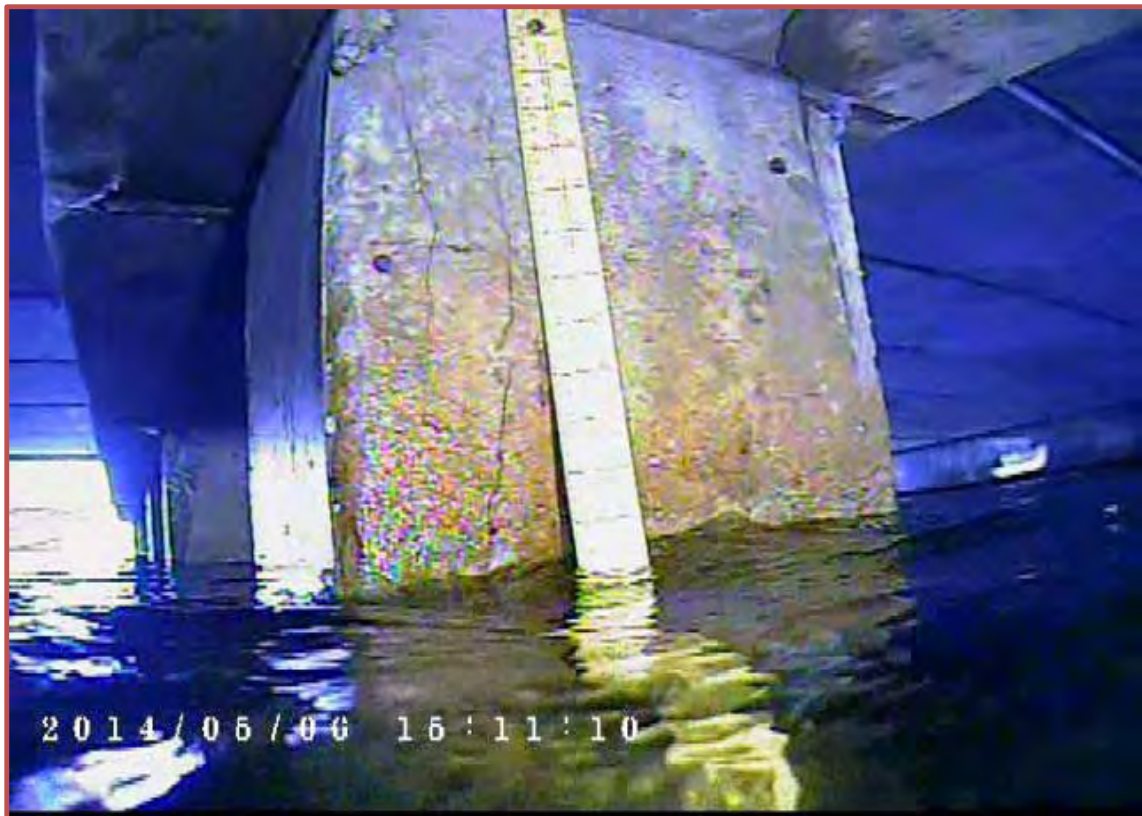
Bottom: Pile 3-6, SE corner delamination, starting at the cap. **UW Photo 02.**

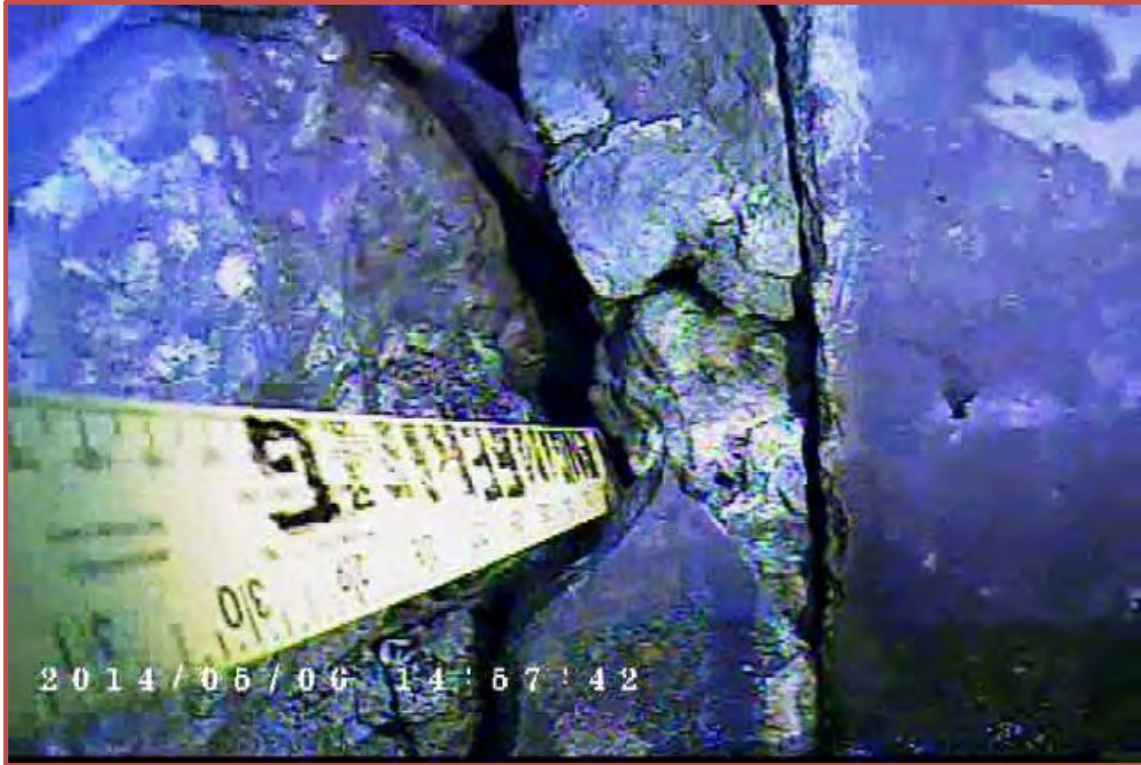
Description: South retaining wall void/open joint with up to 3', penetration at the East transition  
**UW Photo 03.**

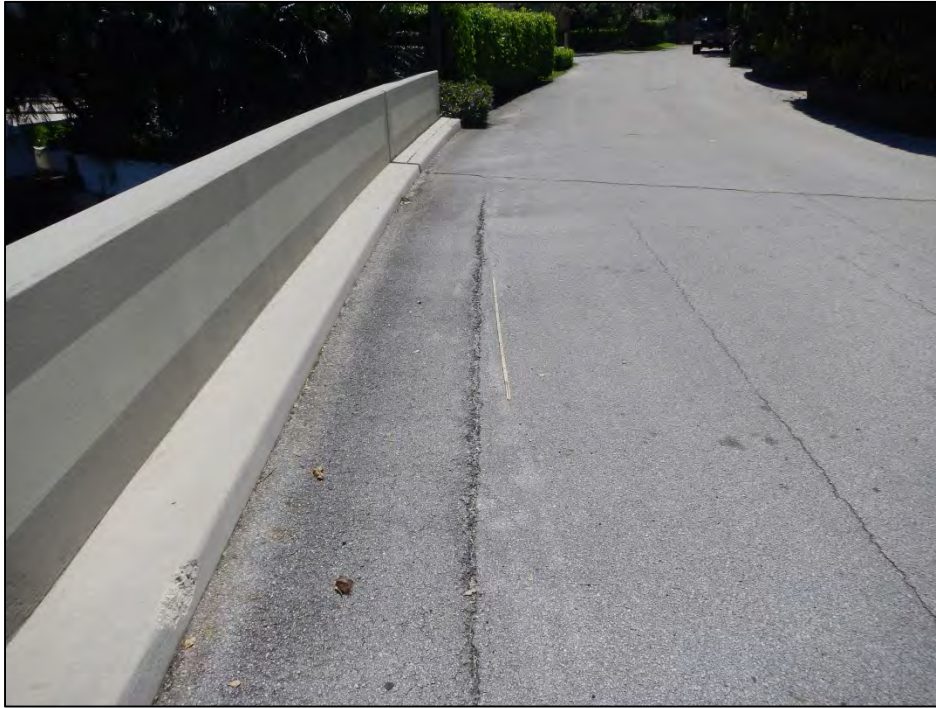
Photo 1 – Cracks in asphalt overlay.

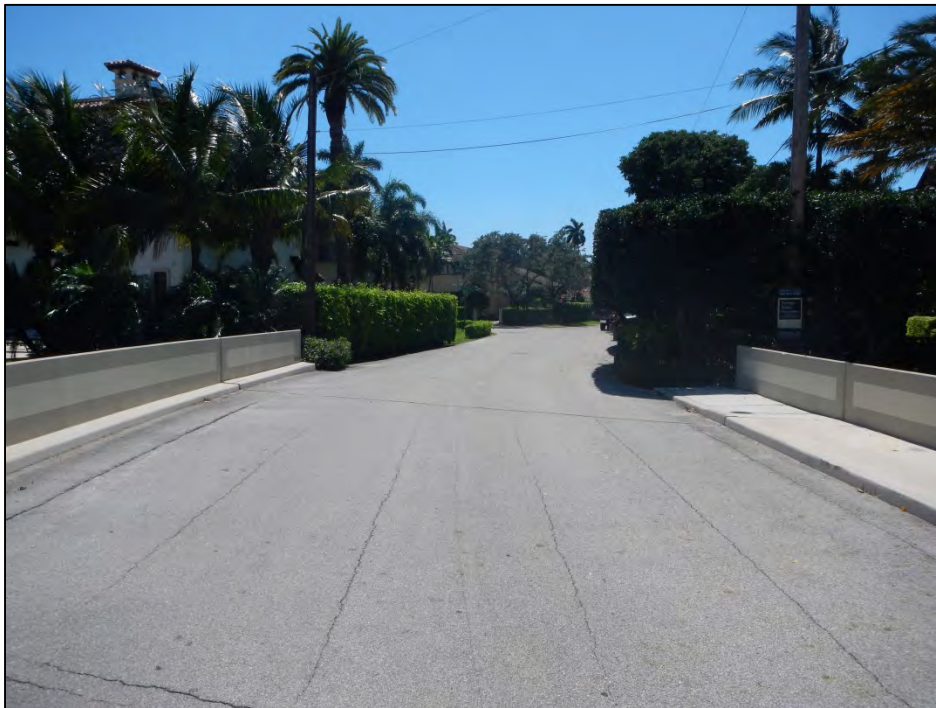
Photo 2 – General view of cracks in asphalt overlay.

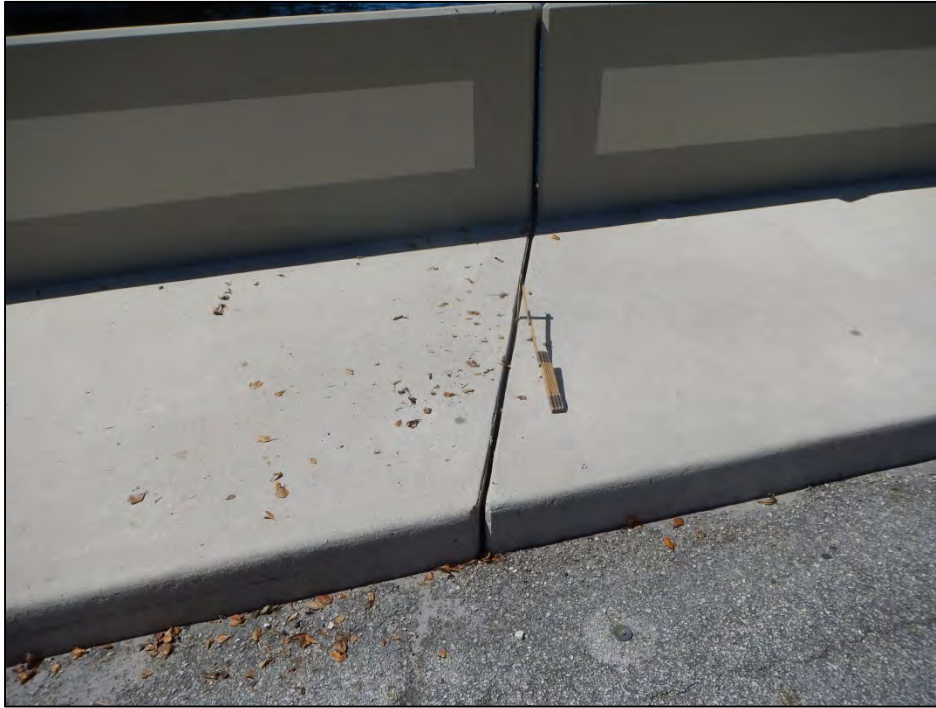
Photo 3 – Dirt and debris accumulating in failed sidewalk and curb sealant.

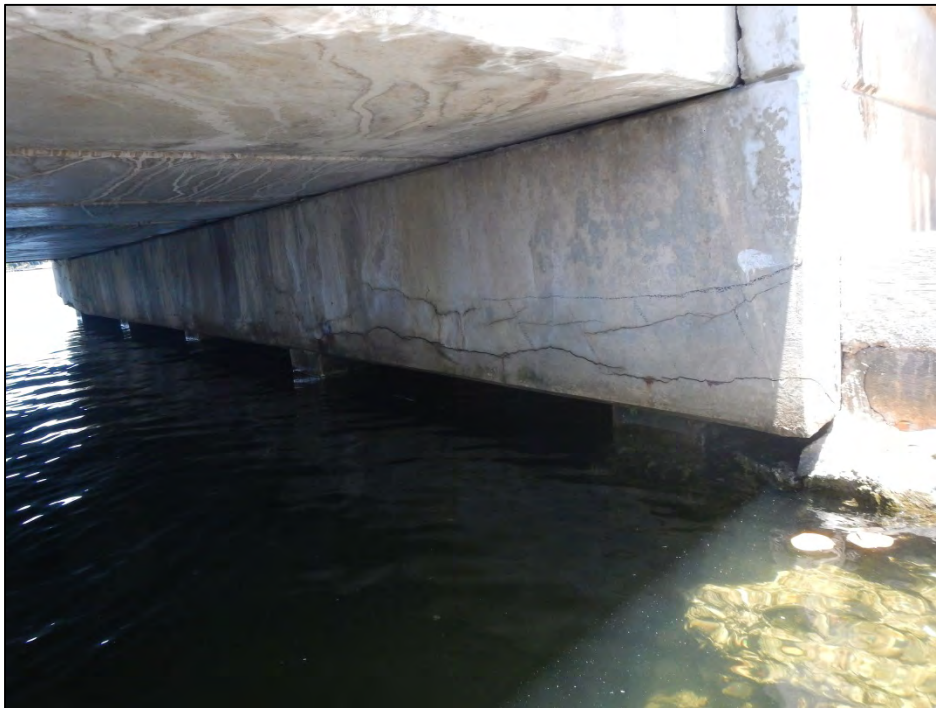
Photo 4 – Delamination in south end of east face of Abutment 1 cap.

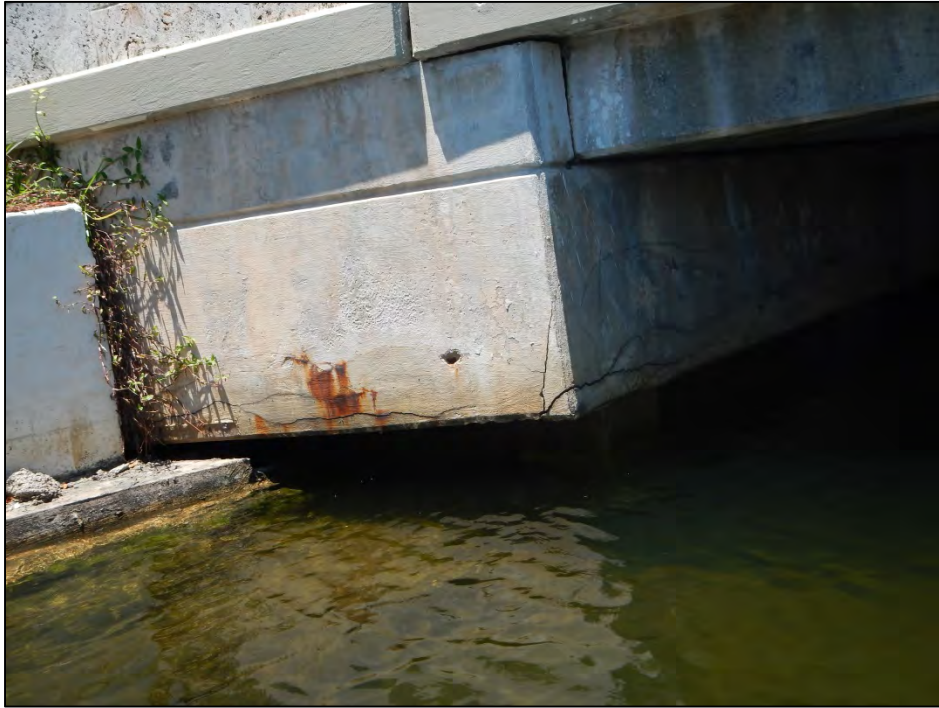
Photo 5 – Delaminated area in Abutment I cap.

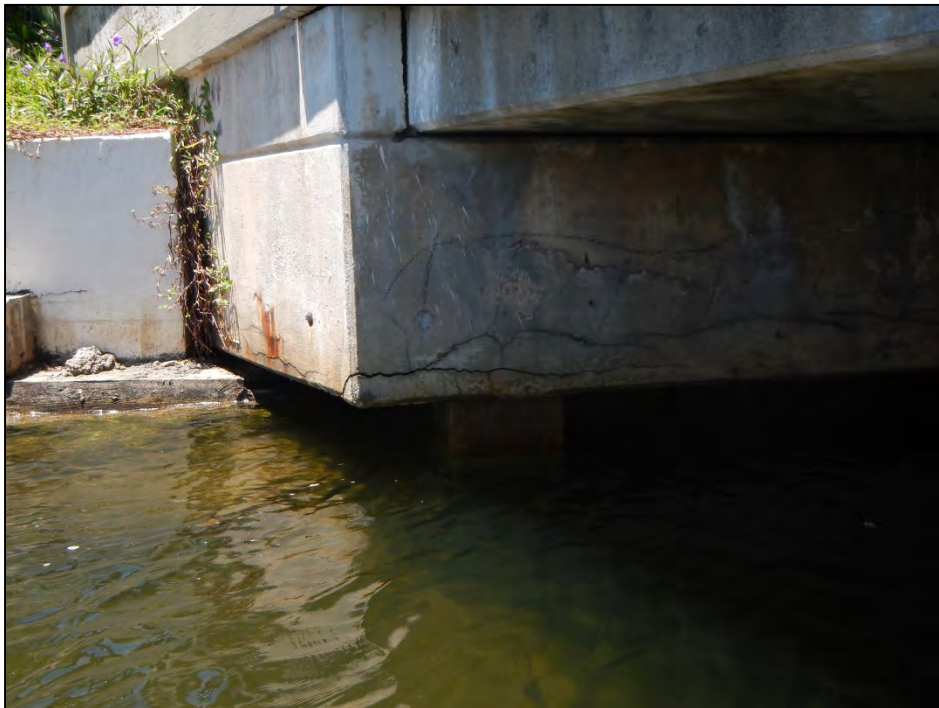
Photo 6 – Delaminated area in Abutment I cap.

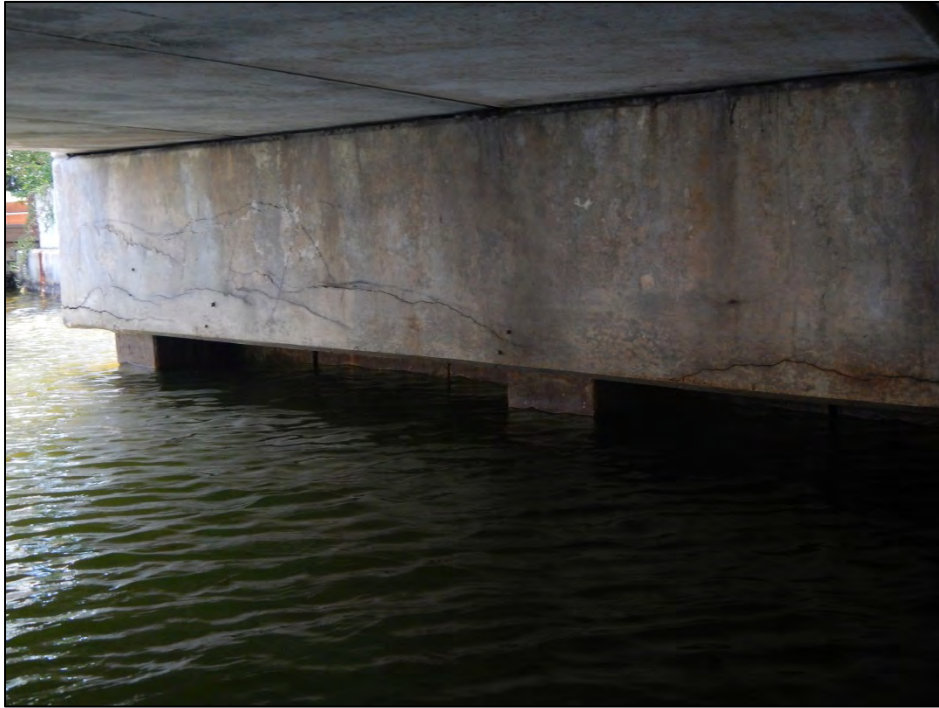
Photo 7 – Delaminated area in Abutment 1 cap.

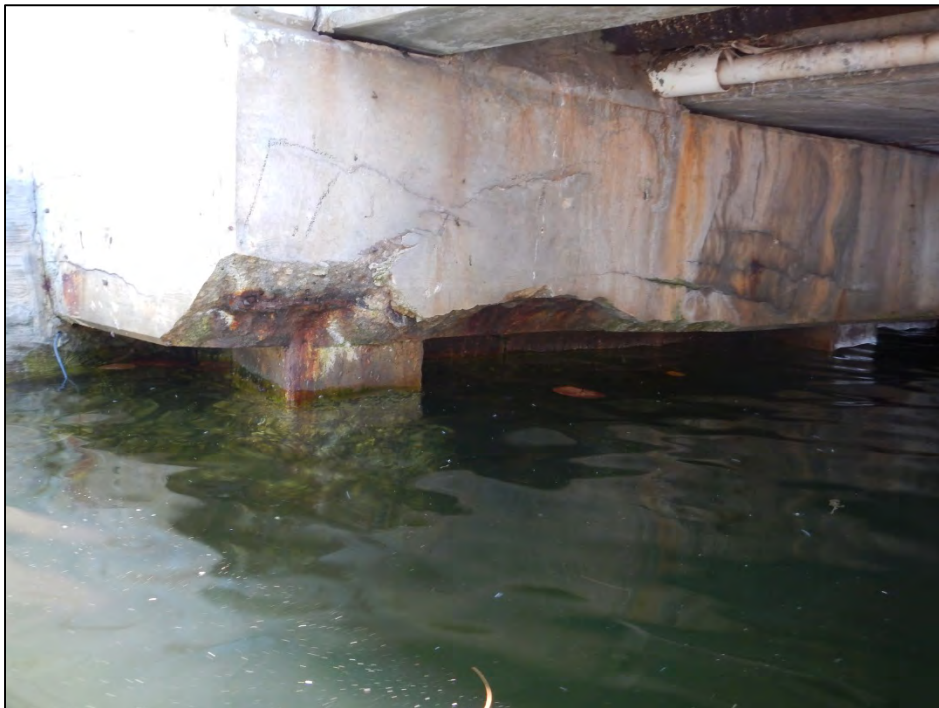
Photo 8 – Spalled area in Abutment 3 cap.

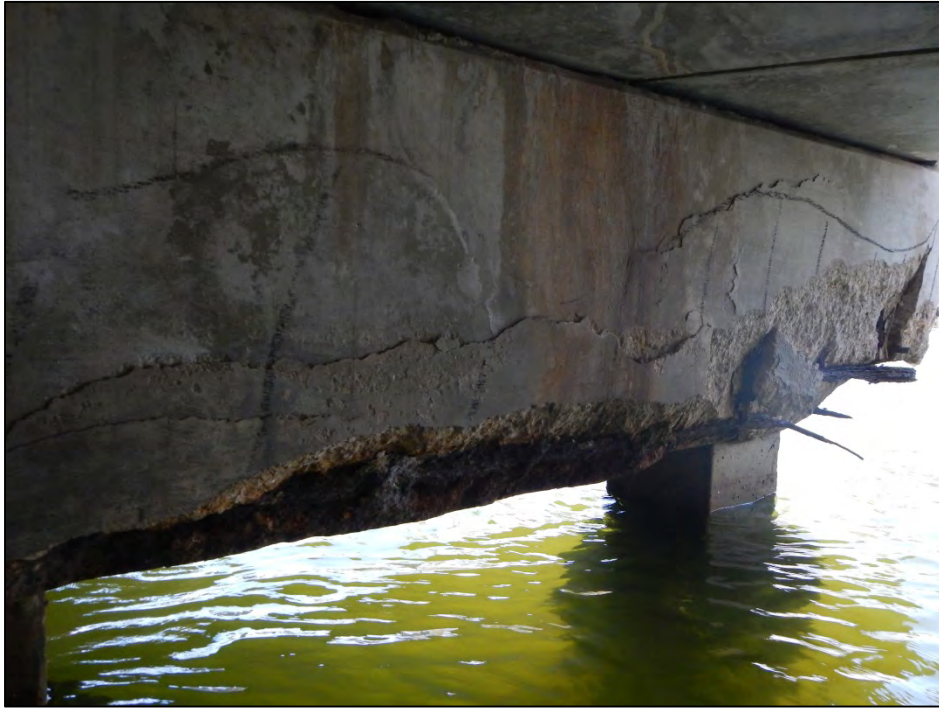
Photo 9 – Spall with exposed rebar at Bent 2 cap.

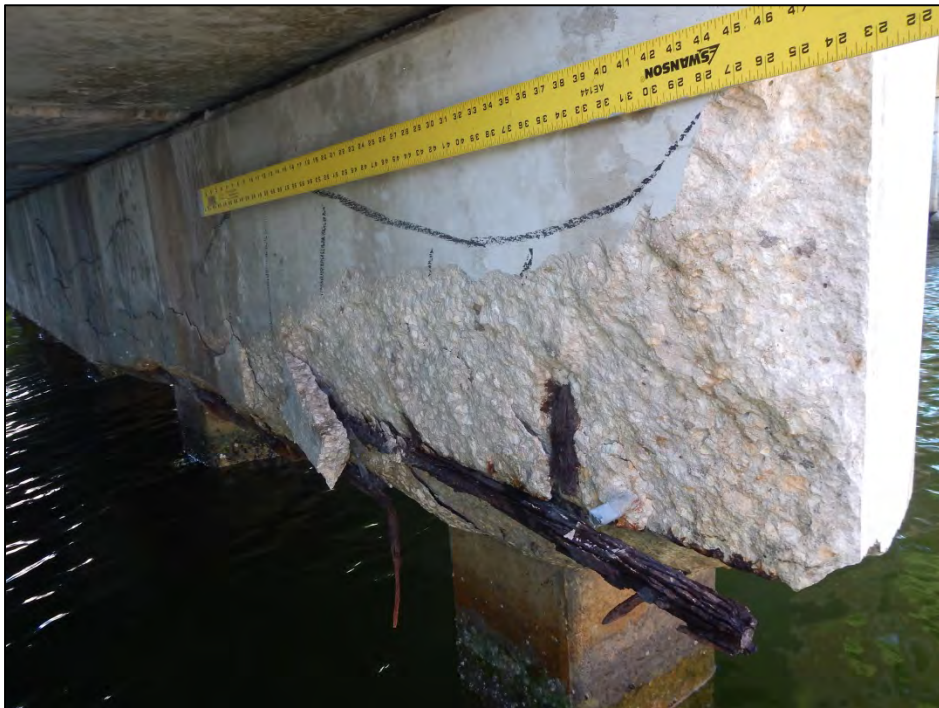
Photo 10 – Spall with exposed rebar at Bent 2 cap.

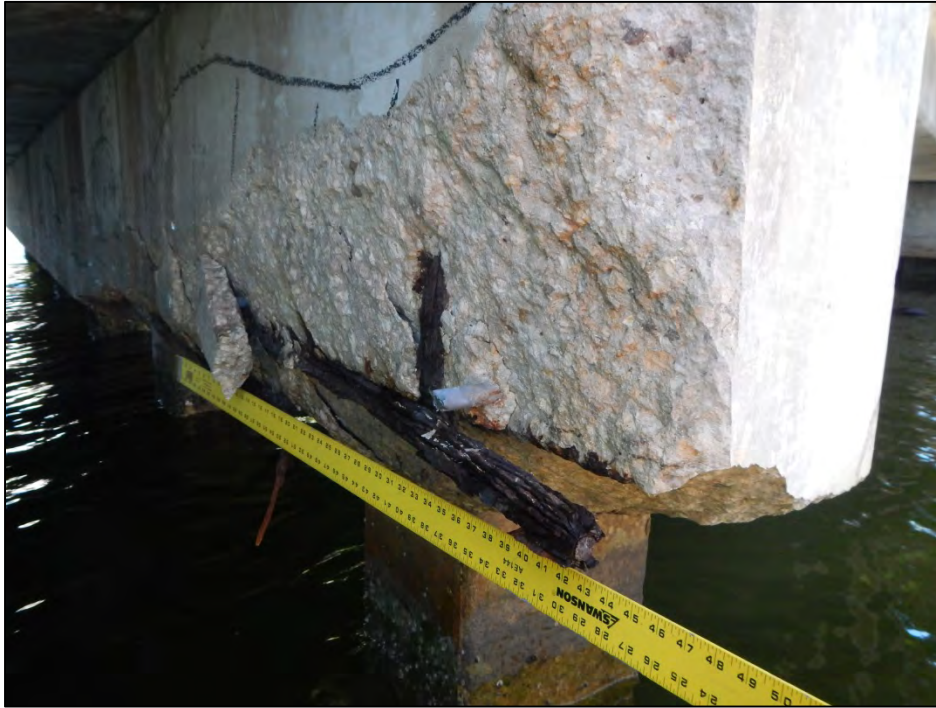
Photo 11 – Spall with exposed rebar at Bent 2 cap.

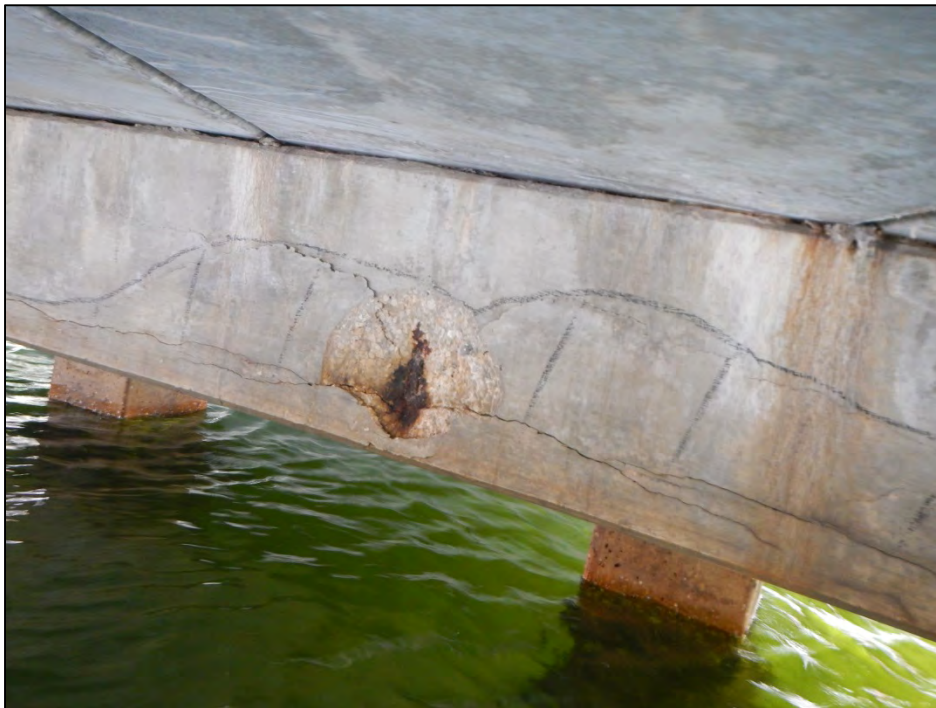
Photo 12 – Delamination/Spall with exposed rebar at Bent 2 cap.

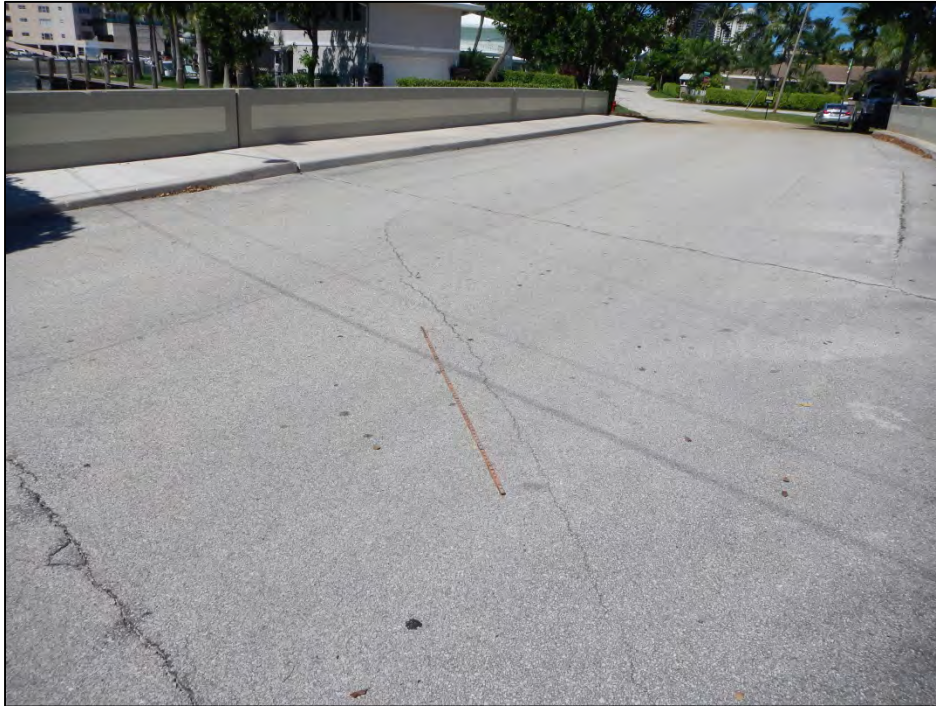
Photo 13 – Diagonal crack in asphalt surfacing over west approach slab.

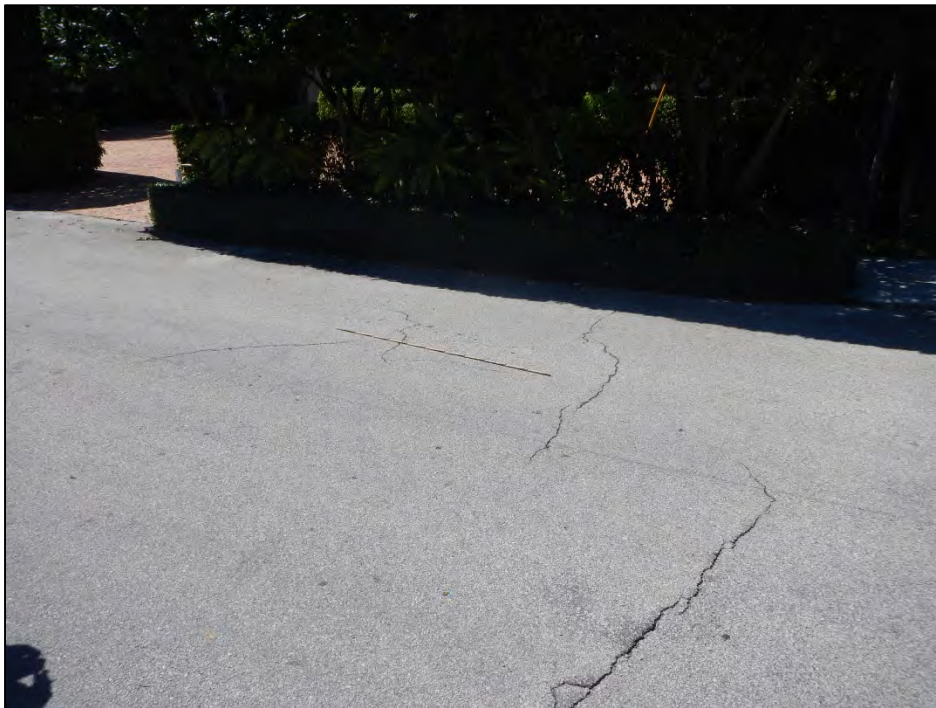
Photo 14 – Cracks in asphalt surfacing over west approach slab.

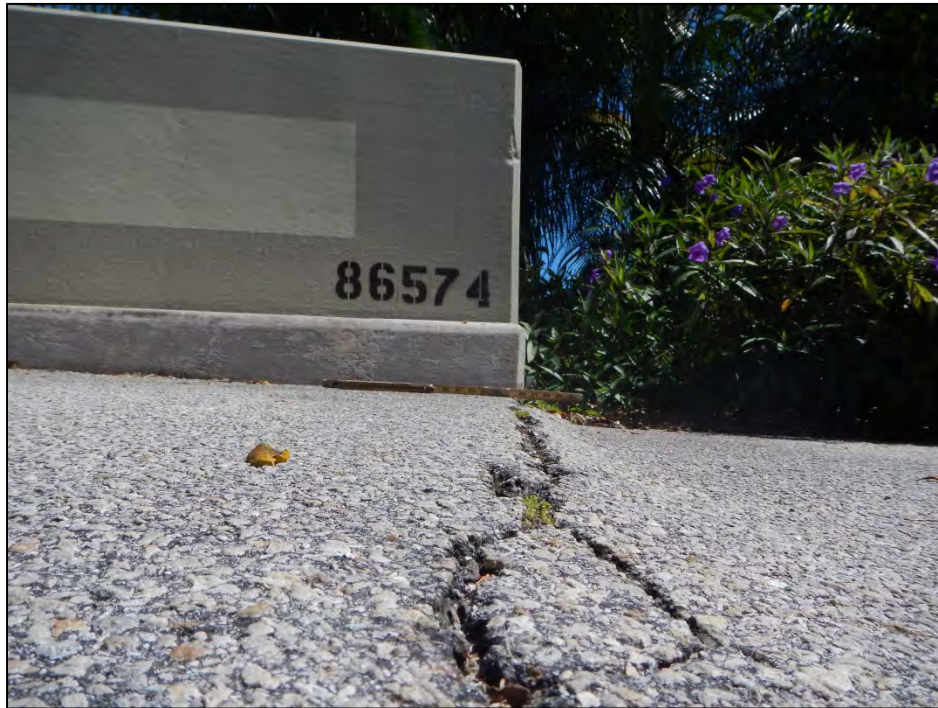
Photo 15 – Settlement of west roadway in relation to west approach slab.

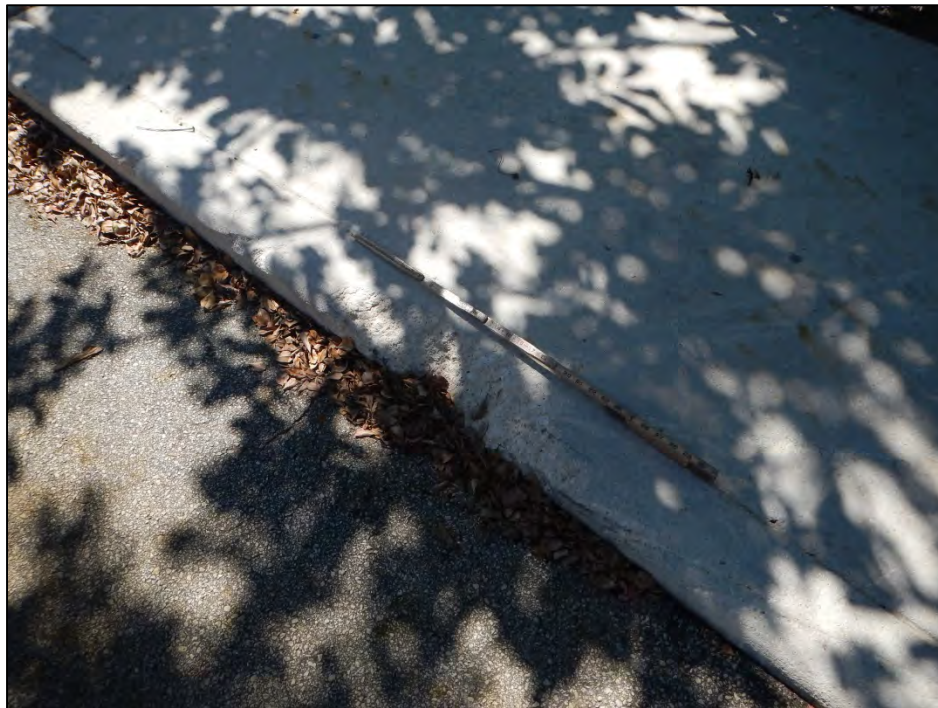
Photo 16 – Spall in northeast approach curb.

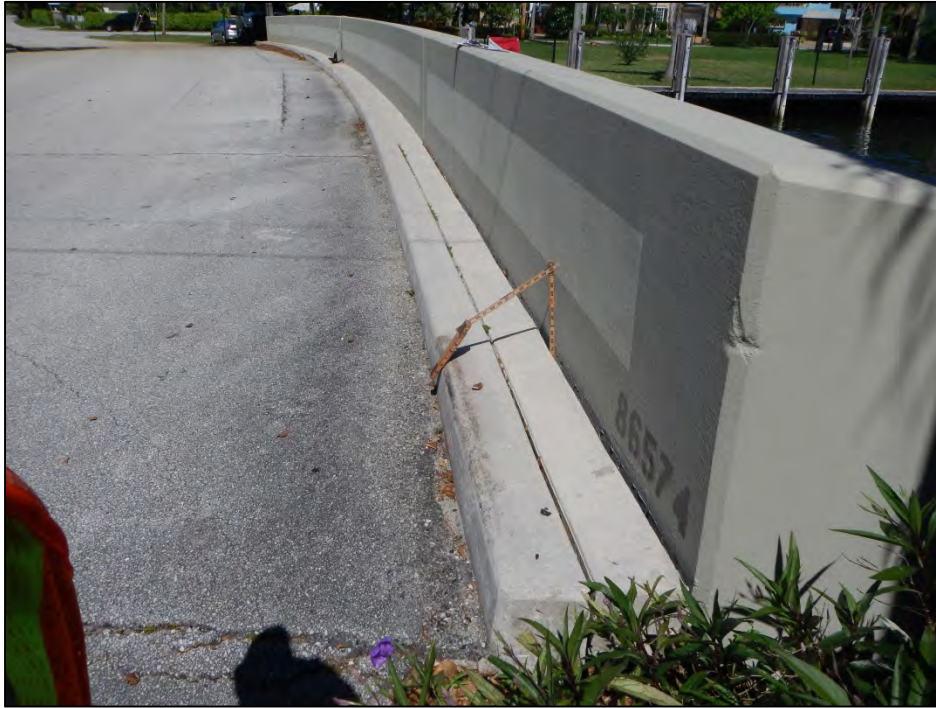
Photo 17 – Gap between wingwall and approach curb.

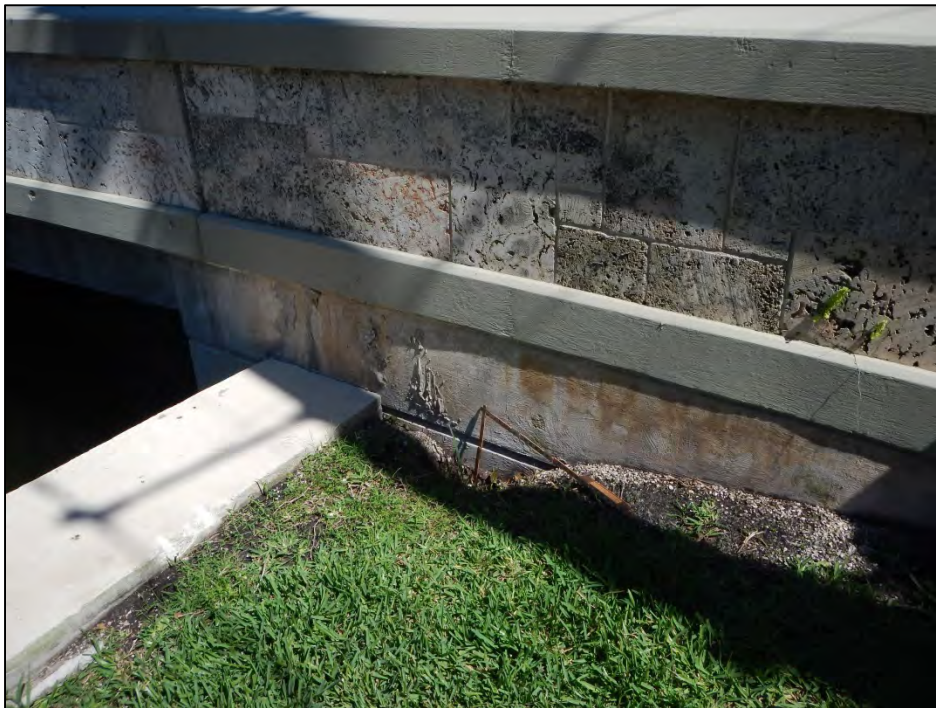
Photo 18 – Fill void at northwest wingwall.

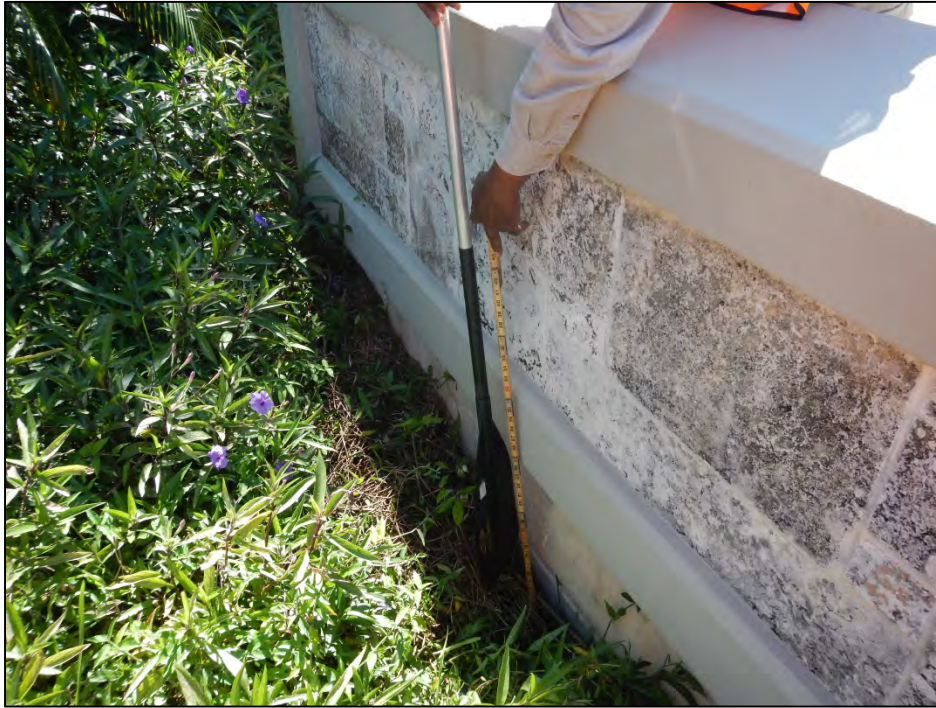
Photo 19 – Fill void at southwest wingwall.

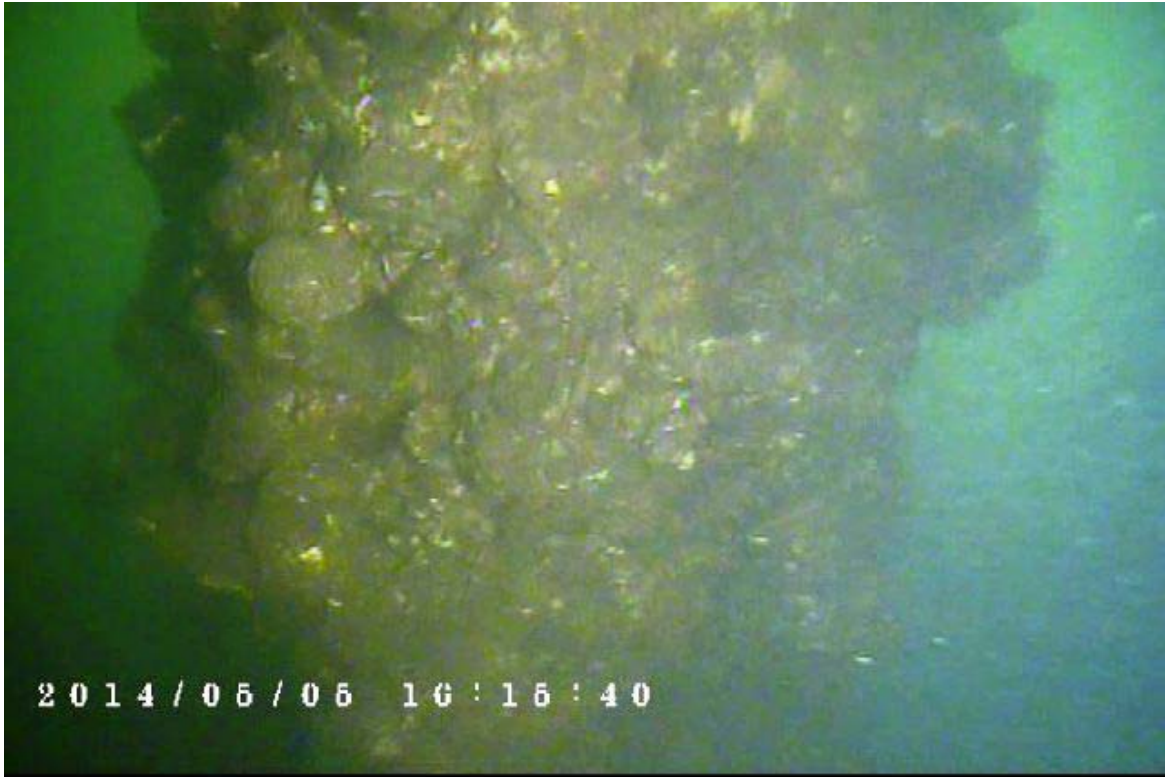
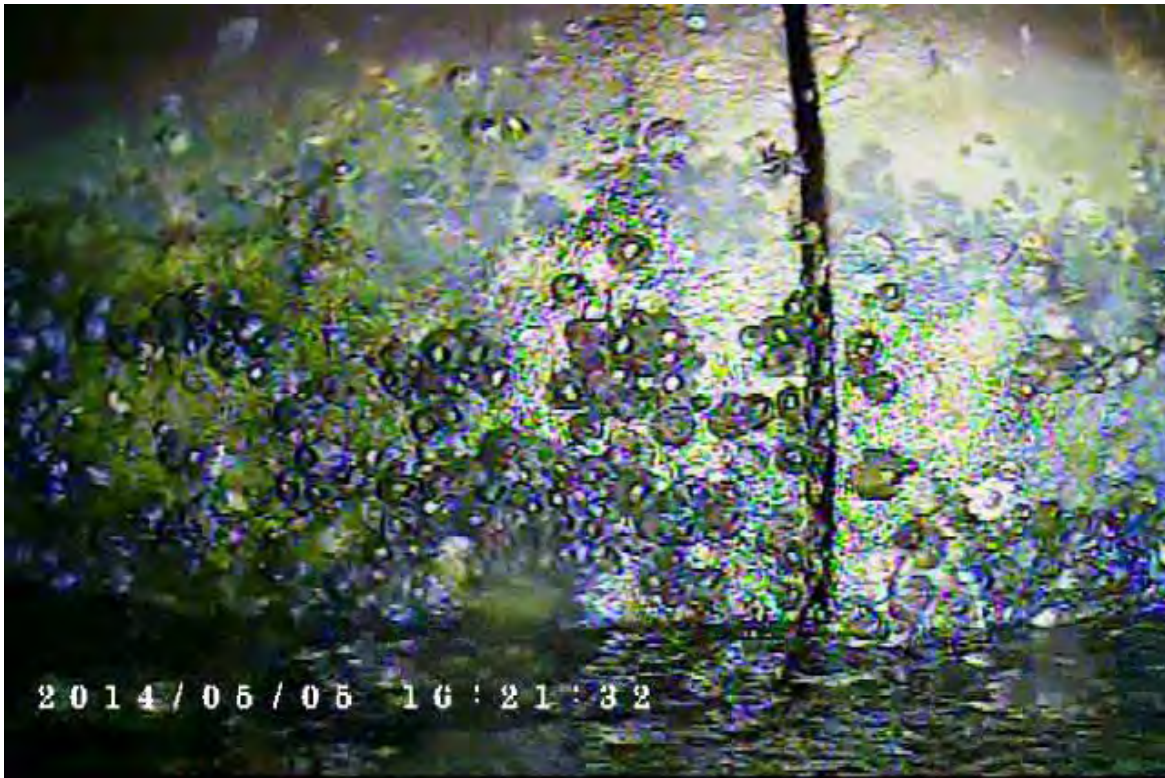
Description: Top: Piles are covered heavy marine growth starting 10in. below the caps. **UW Photo 01.**  
Bottom: The abutment retaining walls backfill loss was not active. **UW Photo 02.**

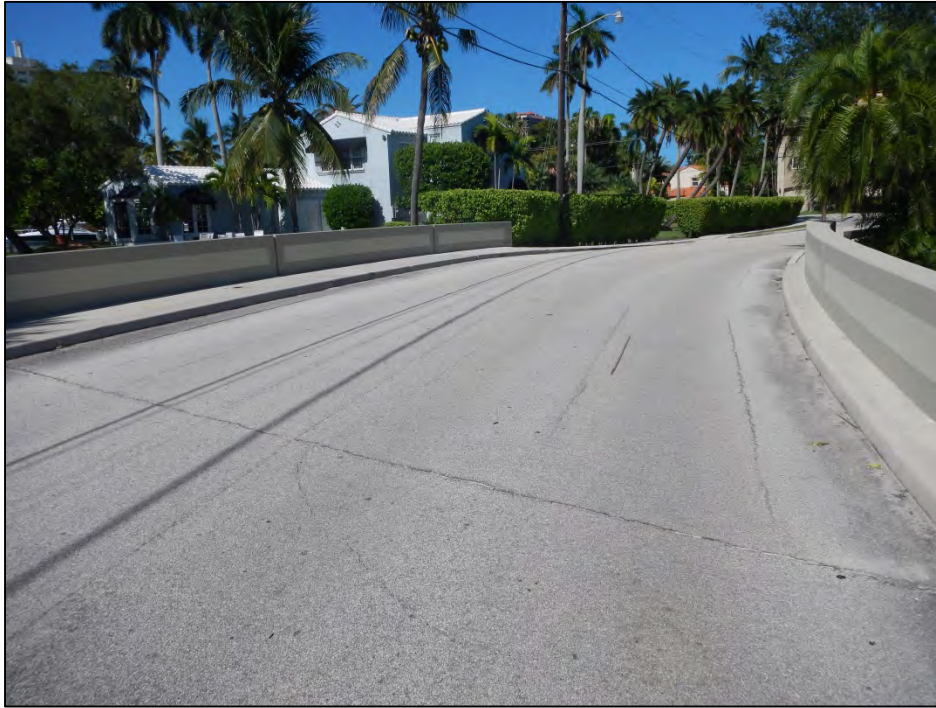
- The asphalt overlay has up to  $\frac{1}{16}$  in. wide longitudinal cracks over the slab unit joints and transverse cracks up to  $\frac{1}{4}$  in. wide over the expansion joints. See Condition Photo I.

Photo 1 – Cracks in asphalt overlay.

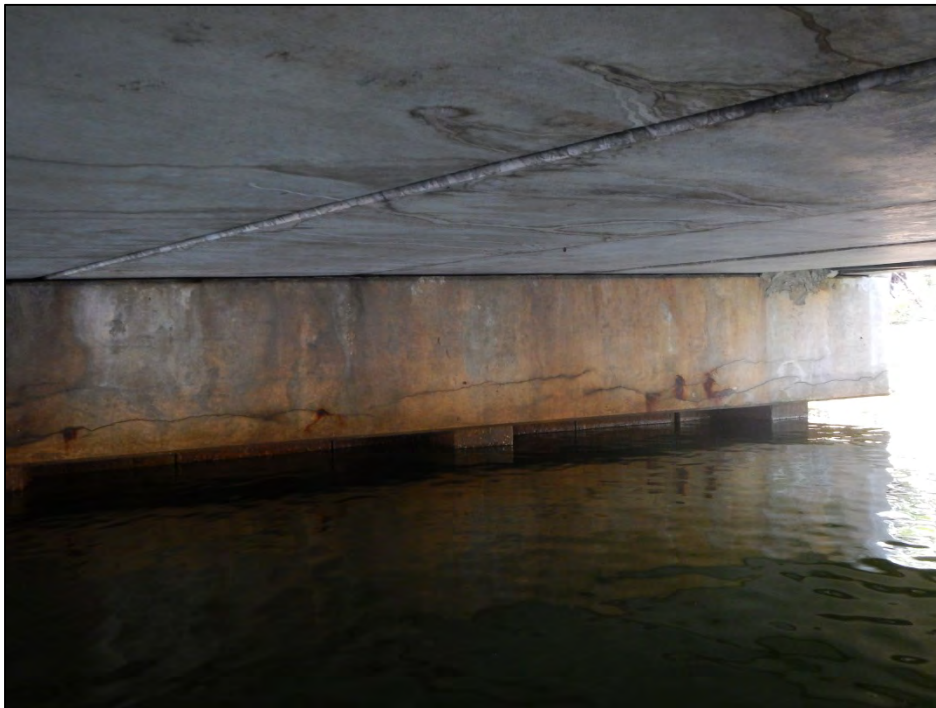
Photo 2 – Delamination in Abutment 1 cap.

\_Abutment 1 cap has a delamination 24' x 12", with associated cracks up to 1/8", and corrosion bleed-out, extending from the North end of the cap past Pile 1-3. **UW Photo 01. NO CHANGE**

\_Remove all unsound concrete and patch. Also epoxy inject all the cracks at both abutments.

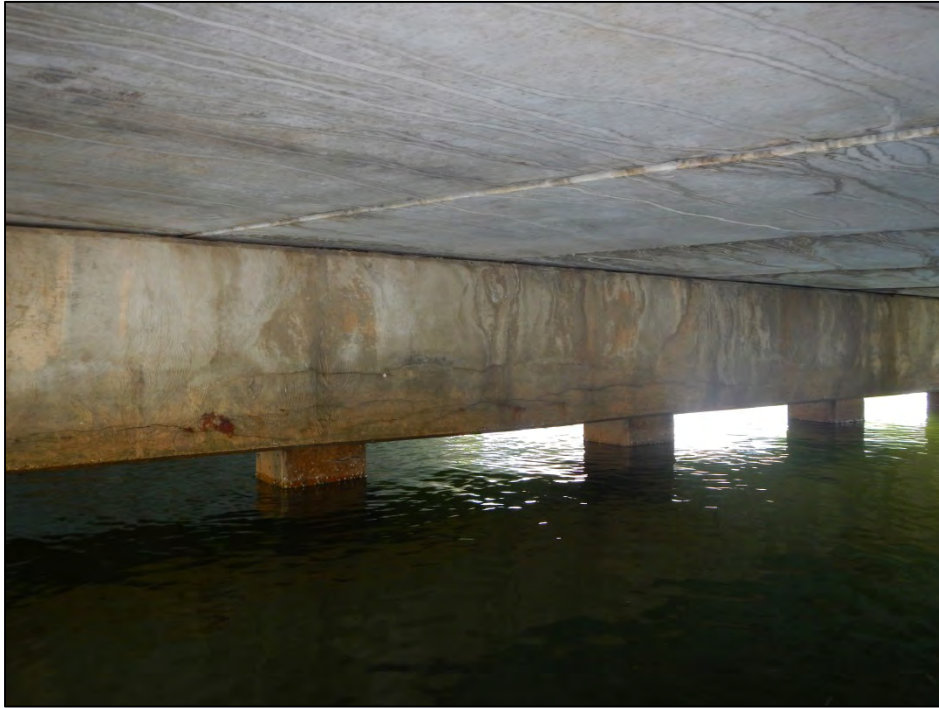
Photo 3 – Delamination in Bent 2 cap.
