## **EXECUTIVE SUMMARY**

TranSystems has been retained by the City of Fort Lauderdale to perform bridge inspections and prepare bridge inspection reports for each of the City's bridges as part of the project Structural Bridge Engineering Consulting Services Master Plan, RFQ No. 946-11310. Inspections were completed and reports prepared for 46 of the City's bridges. The remaining five bridges in the City's inventory were not inspected because they are in the process of being replaced.

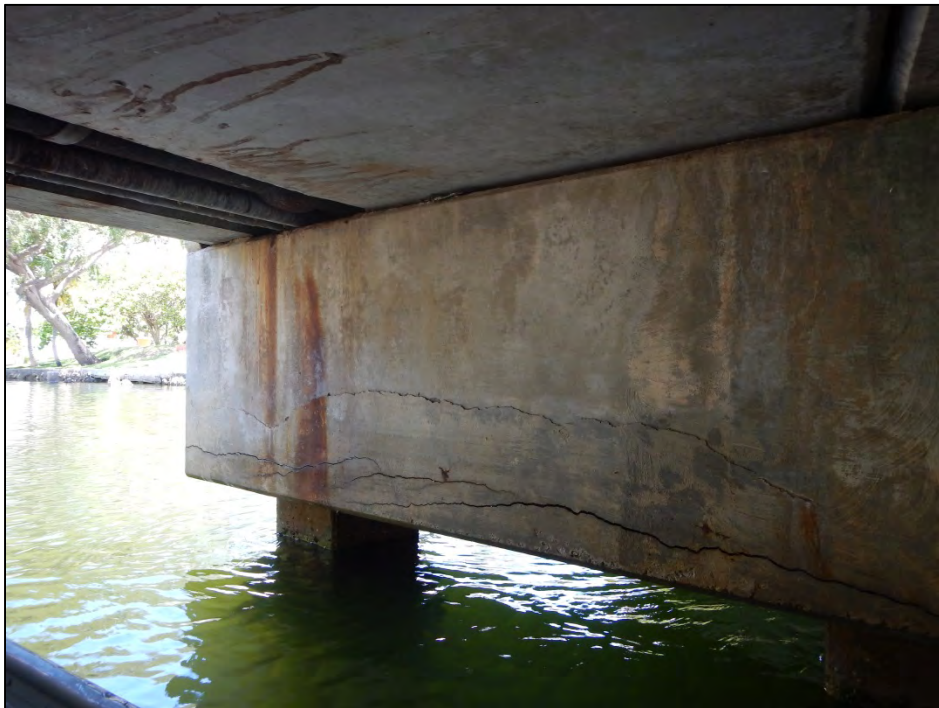
Photo 4 – Delamination in Bent 2 cap.

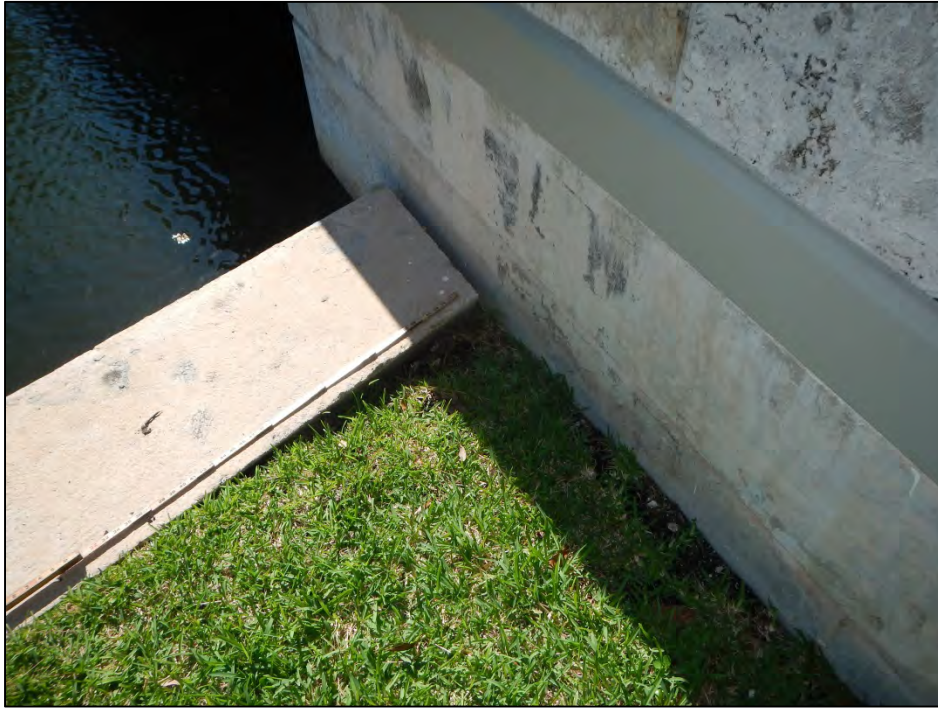
Photo 5 – Washout at southeast bulkhead.

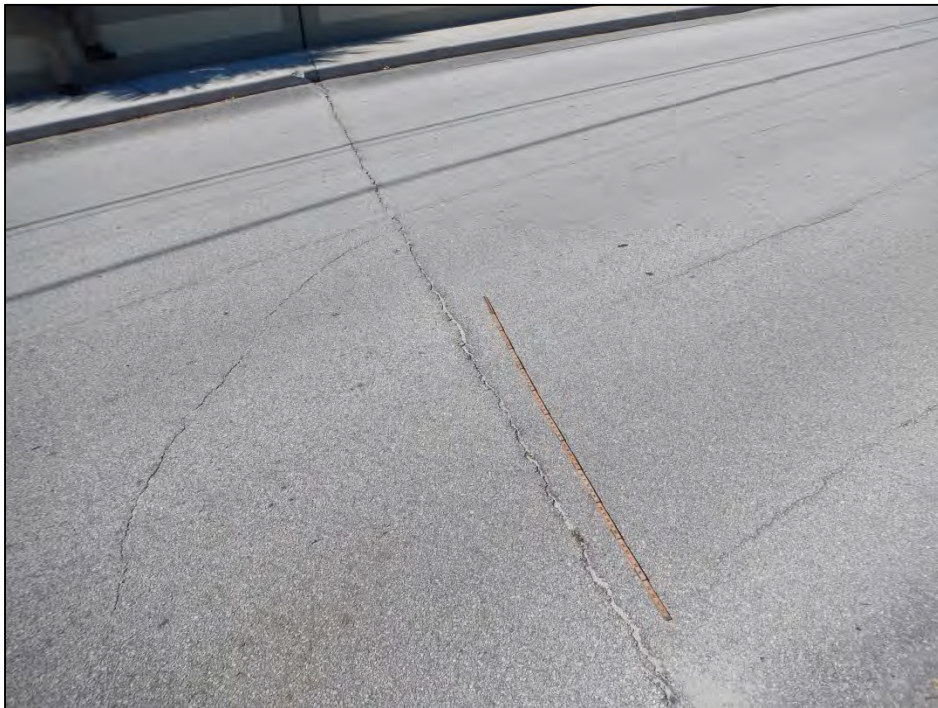
Photo 6 – Diagonal crack in asphalt over west approach slab.

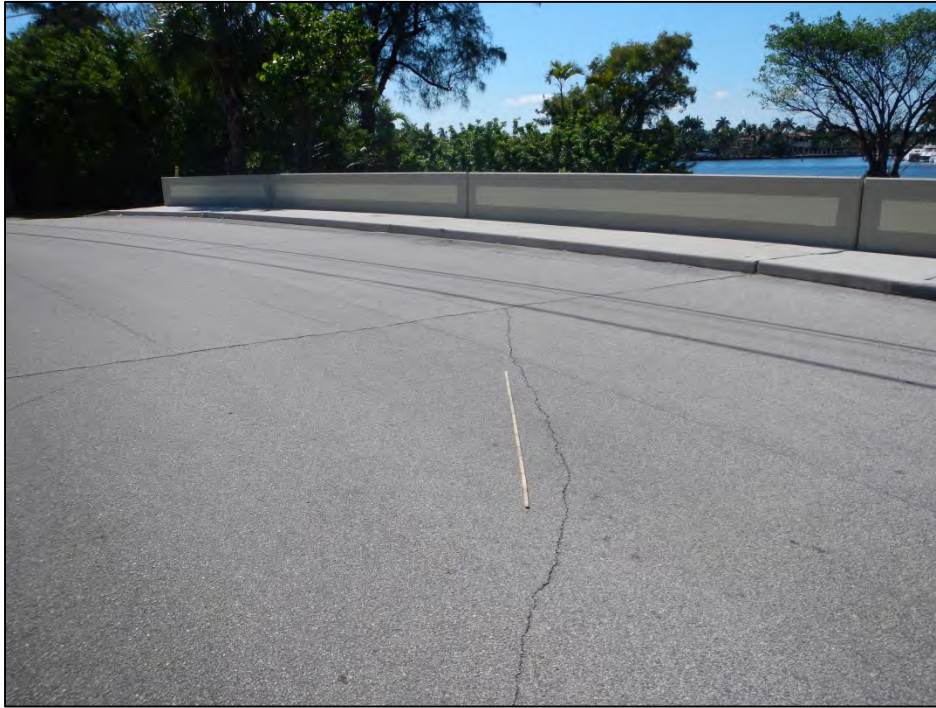
Photo 7 – Diagonal crack in asphalt over east approach slab.

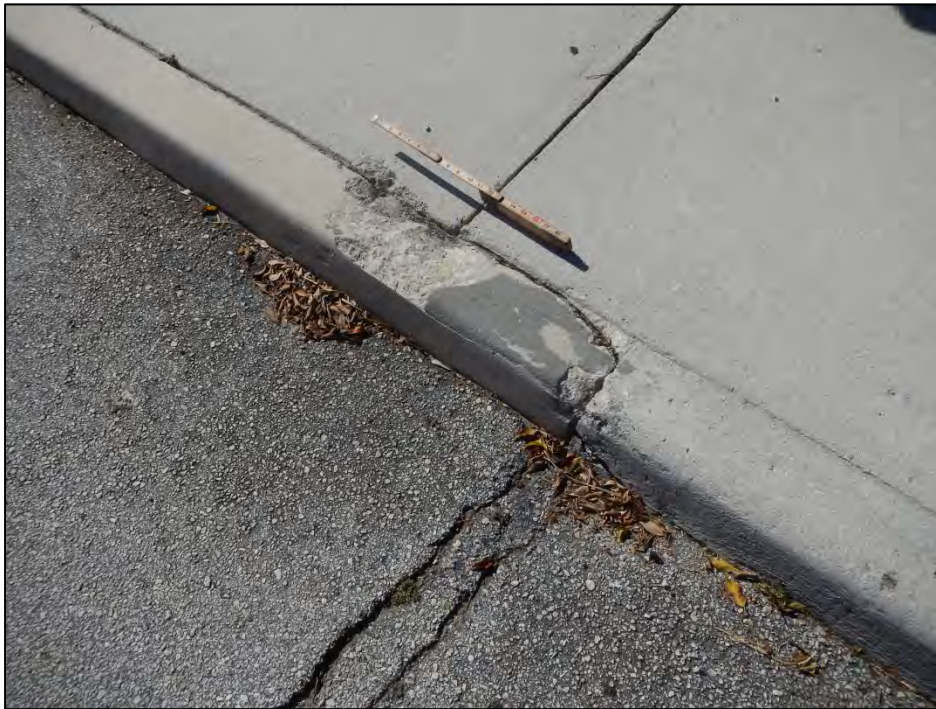
Photo 8 – Spall in northeast approach curb.

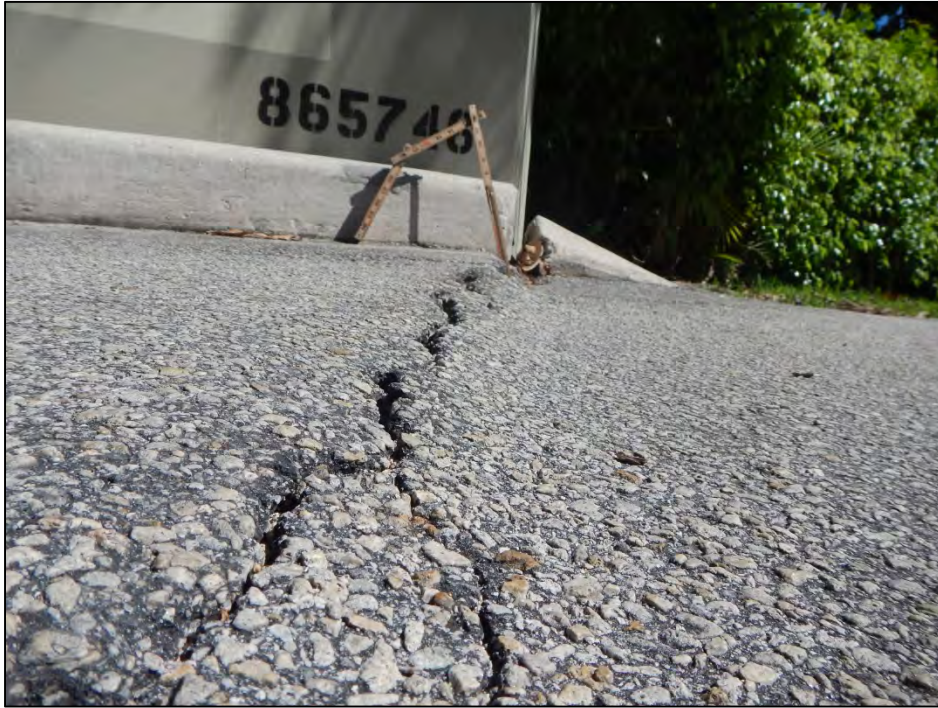
Photo 9 – Typical elevation differential between approach roadway and approach slab.

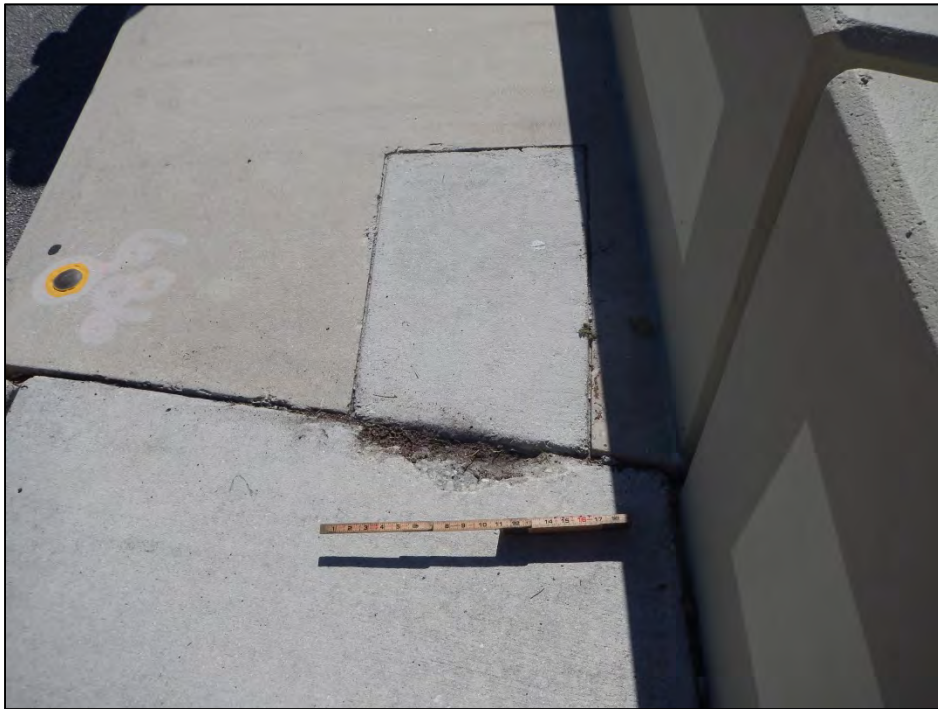
Photo 10 – Spall in northeast approach sidewalk.

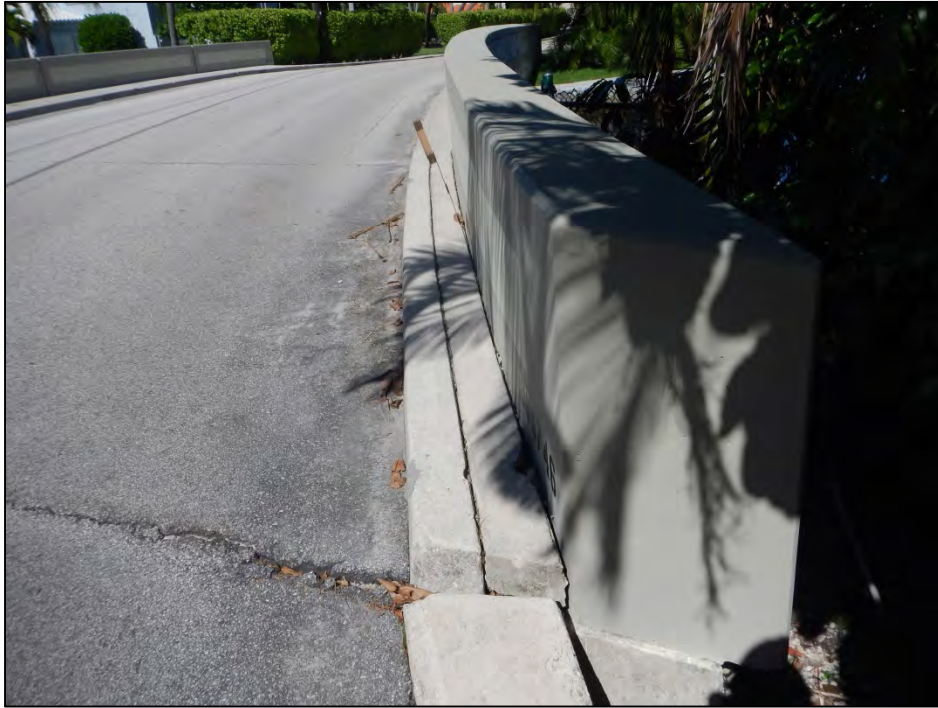
Photo 11 – Gap between wingwall and approach curb.

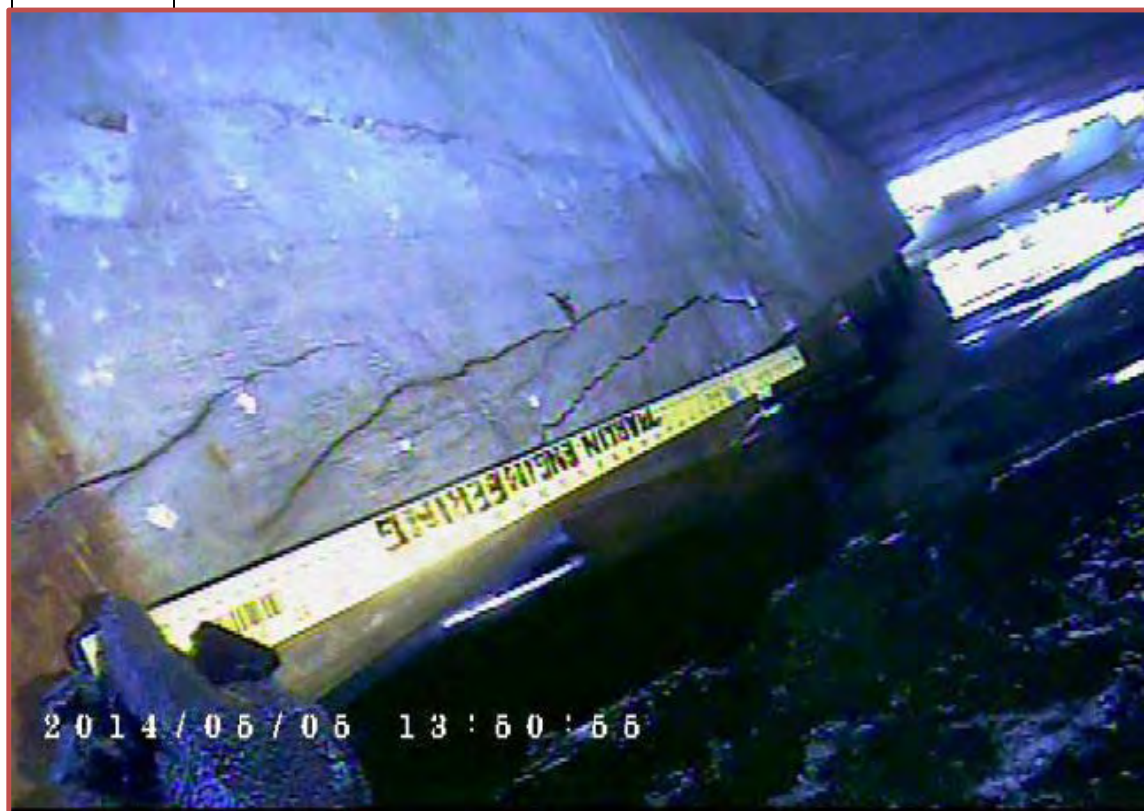
\_Abutment 1 cap has a delamination 24' x 12", with associated cracks up to 1/8", and corrosion bleed-out, extending from the North end of the cap past Pile 1-3. **UW Photo 01. NO CHANGE**

\_Bent 2 cap, West and East faces has a delamination full length x 20" H, with associated cracks up to 1/8" wide, and corrosion bleed-out. **UW Photo 02. INCREASE**

Description: Top: Abutment 1 cap has a delamination, with associated cracks. **UW Photo 01.**  
Bottom: Bent 2 cap, both faces delaminations with associated cracks. **UW Photo 02.**

\_Remove all unsound concrete and patch. Also epoxy inject all the cracks at both abutments.

\_Remove all unsound concrete and patch. Also epoxy inject all the cracks at Bent 2.

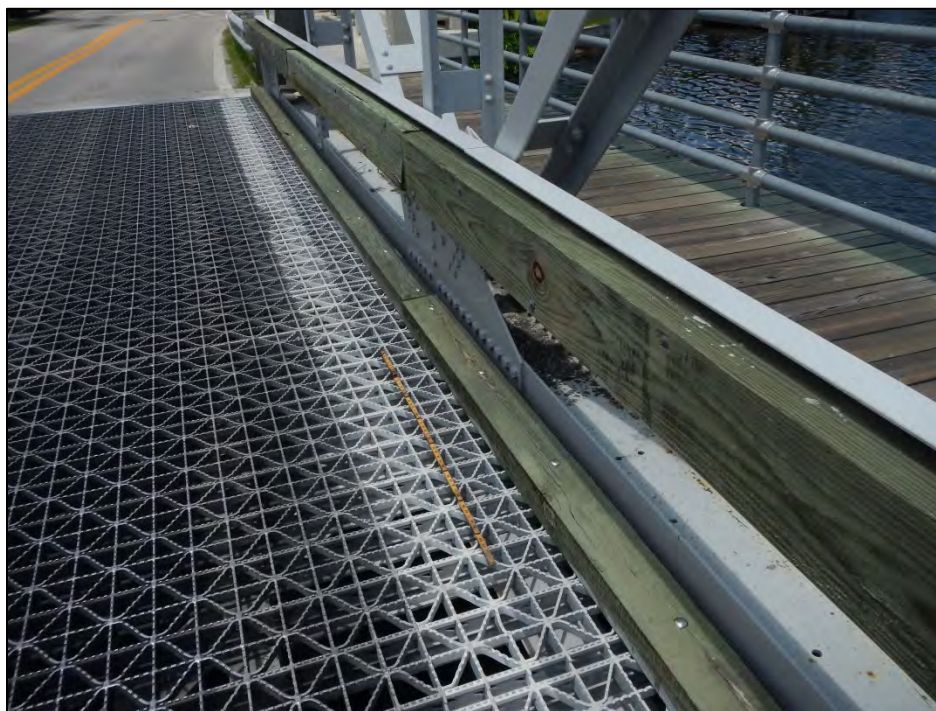
Photo 1 – General location of cracked weld between Stringer 8-8 and grid deck.

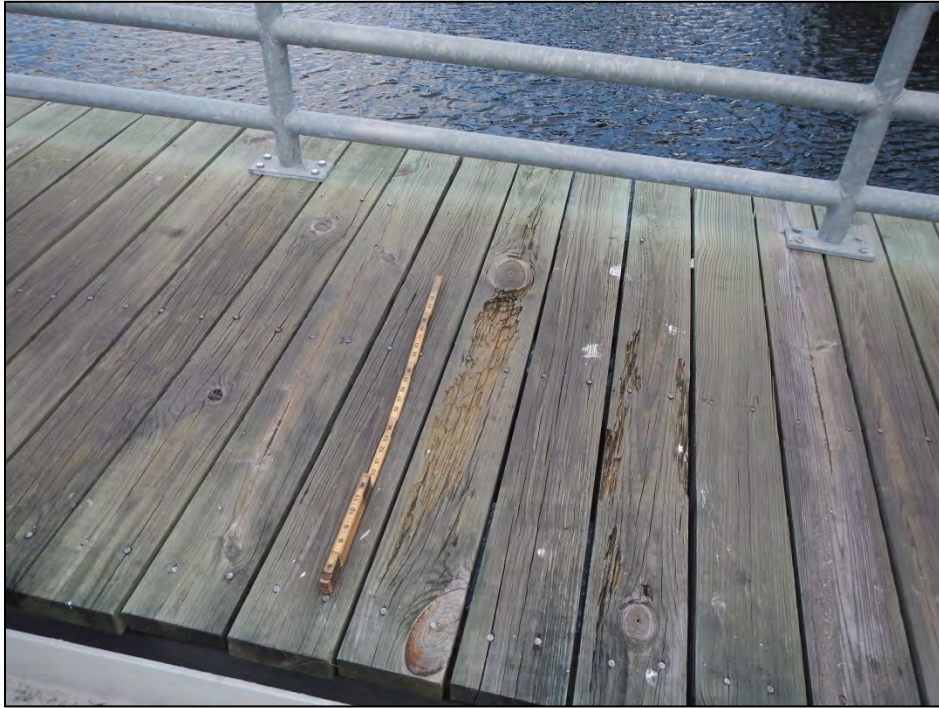
Photo 3 – Decay at the west sidewalk.

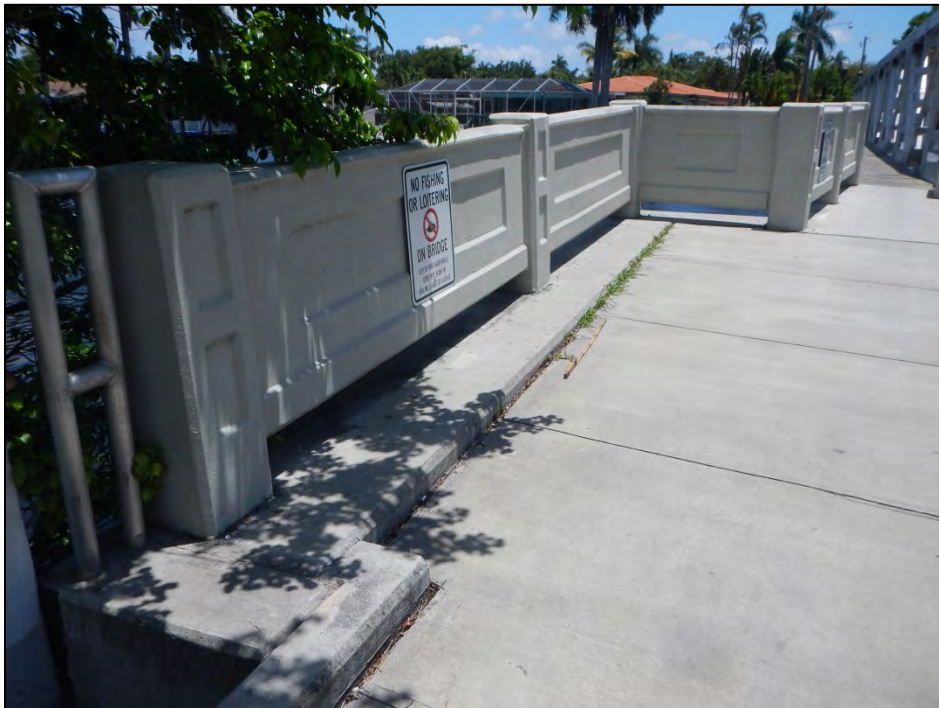
Photo 4 – Typical deteriorated approach sidewalk seal.

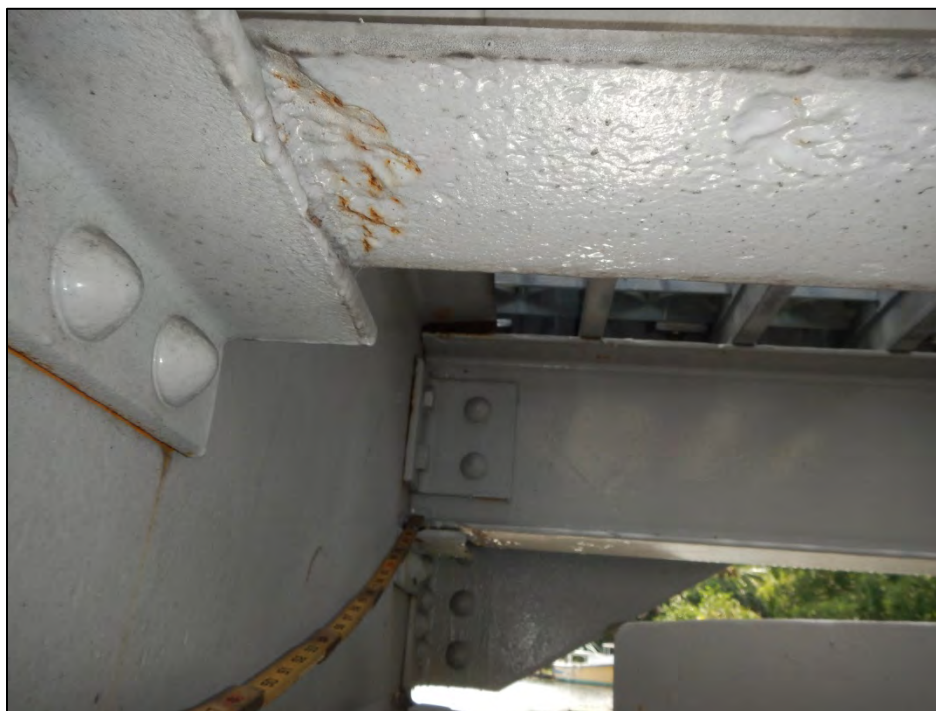
Photo 5 – Typical pitting and section loss at stringers.

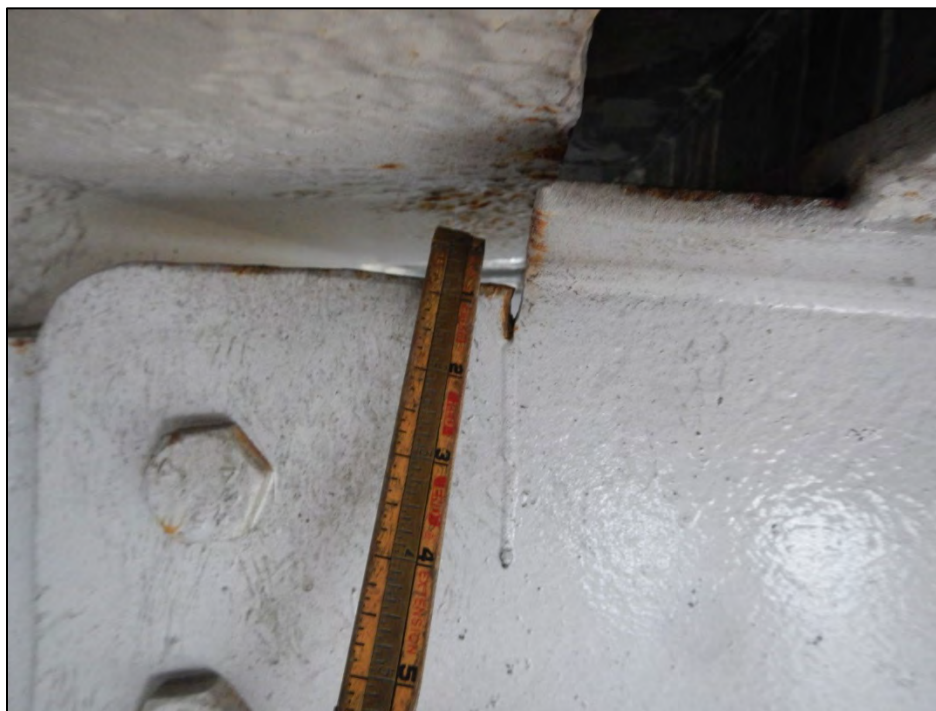
Photo 6 – Gouge within coping of Stringer 5-6.

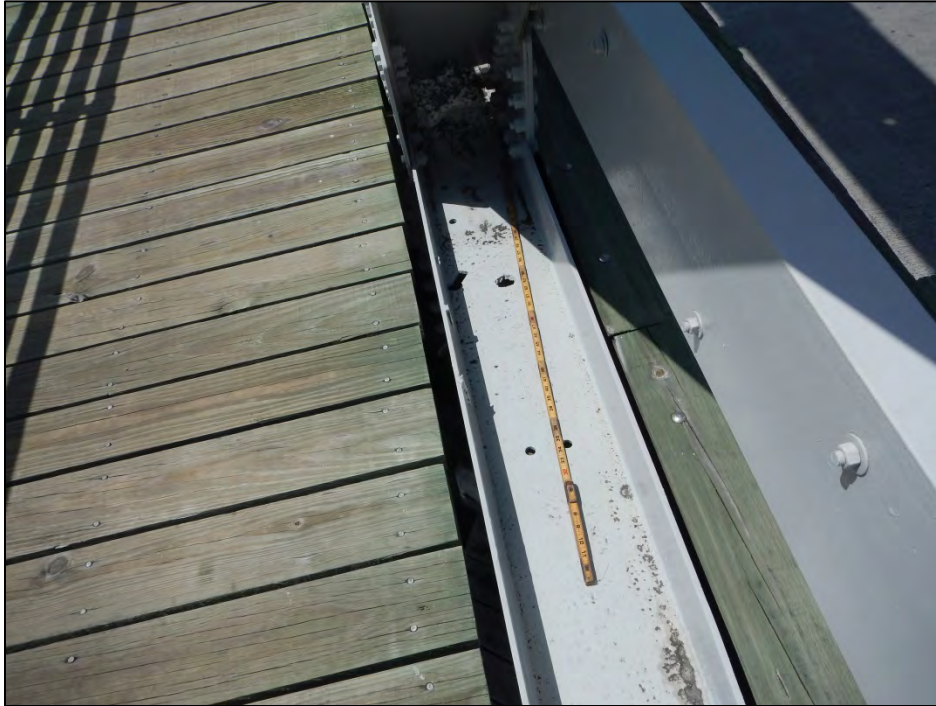
Photo 7 – Typical holes in bottom chord.

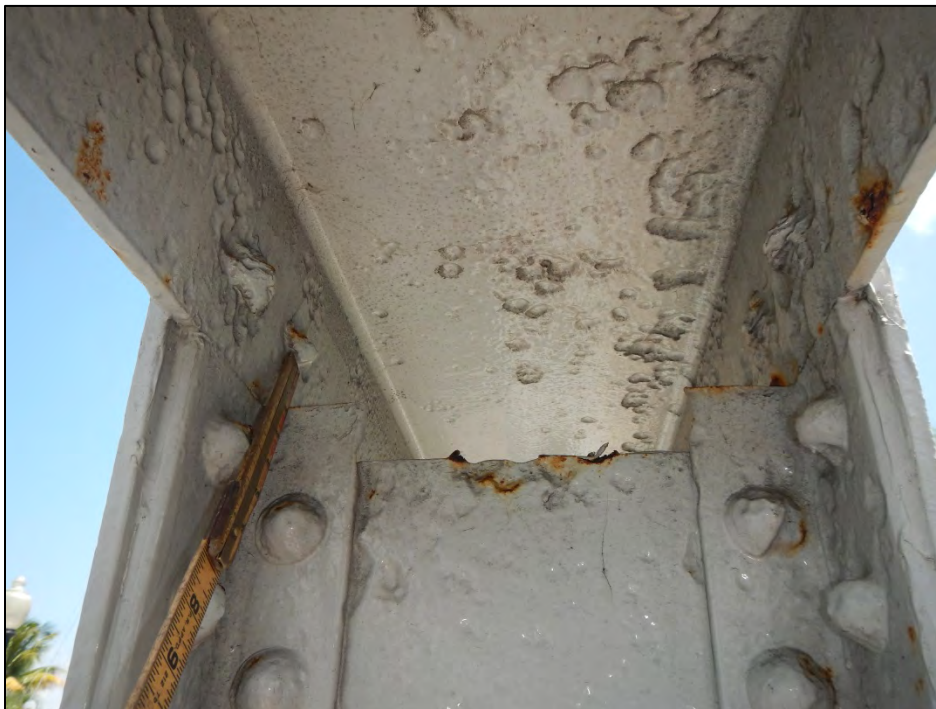
Photo 8 – Typical painted section loss and pitting in upper chords. Note section loss on rivets.

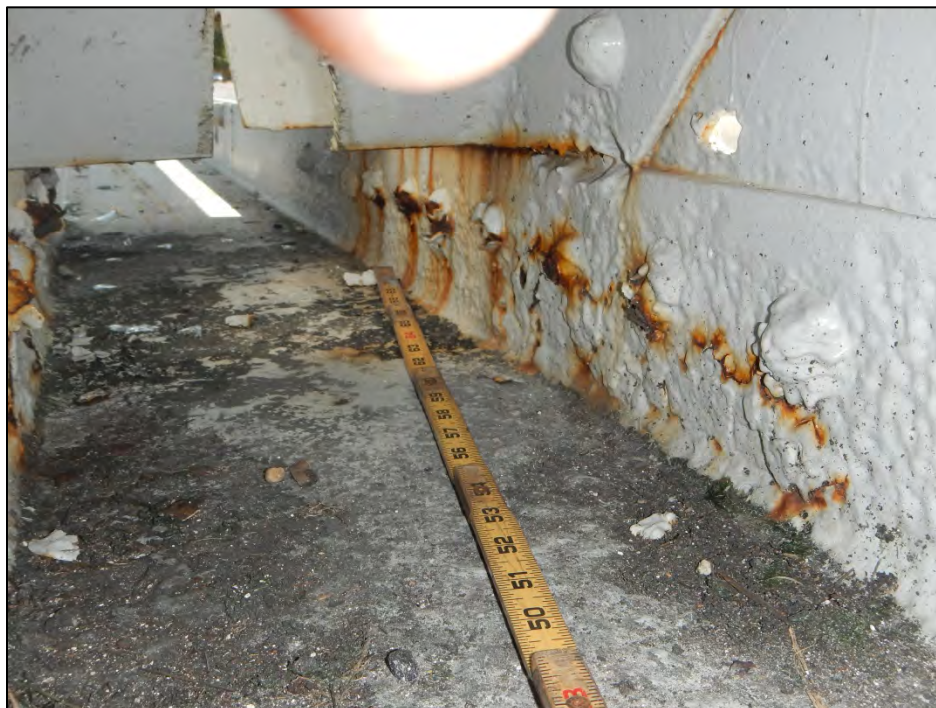
Photo 9 – Corrosion with section loss on rivets.

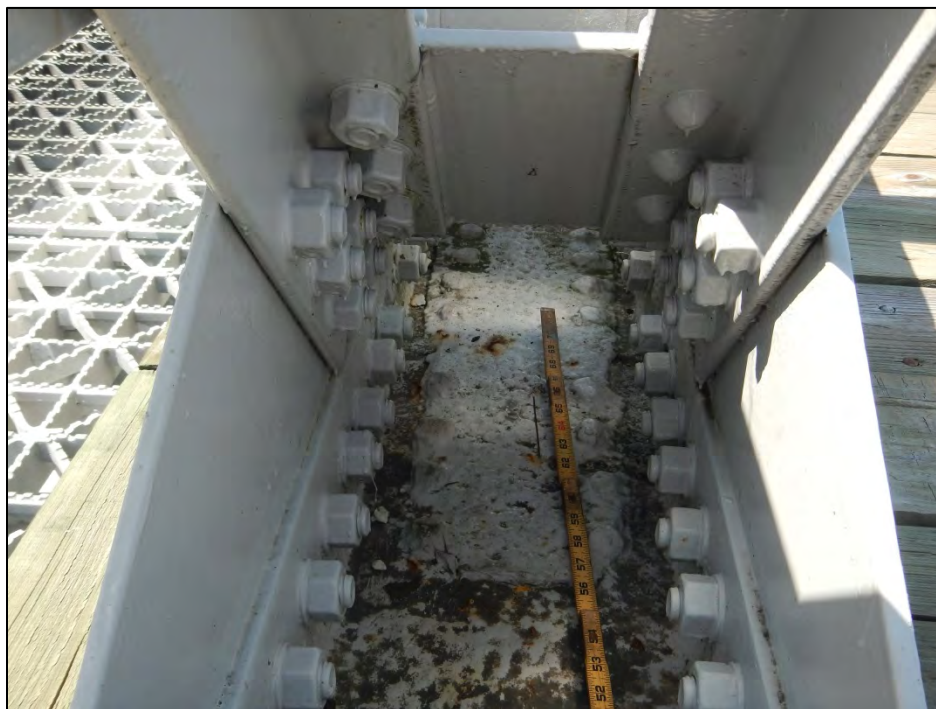
Photo 10 – Typical corrosion with section loss on splice plates and connection bolts.

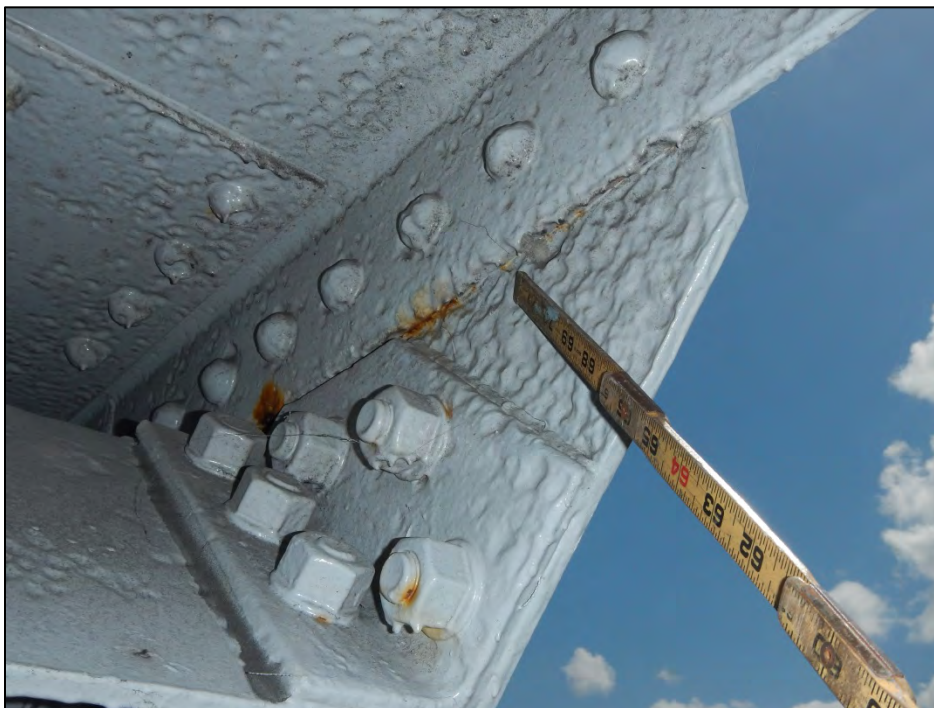
Photo 11 – Typical painted section loss on gusset plates.

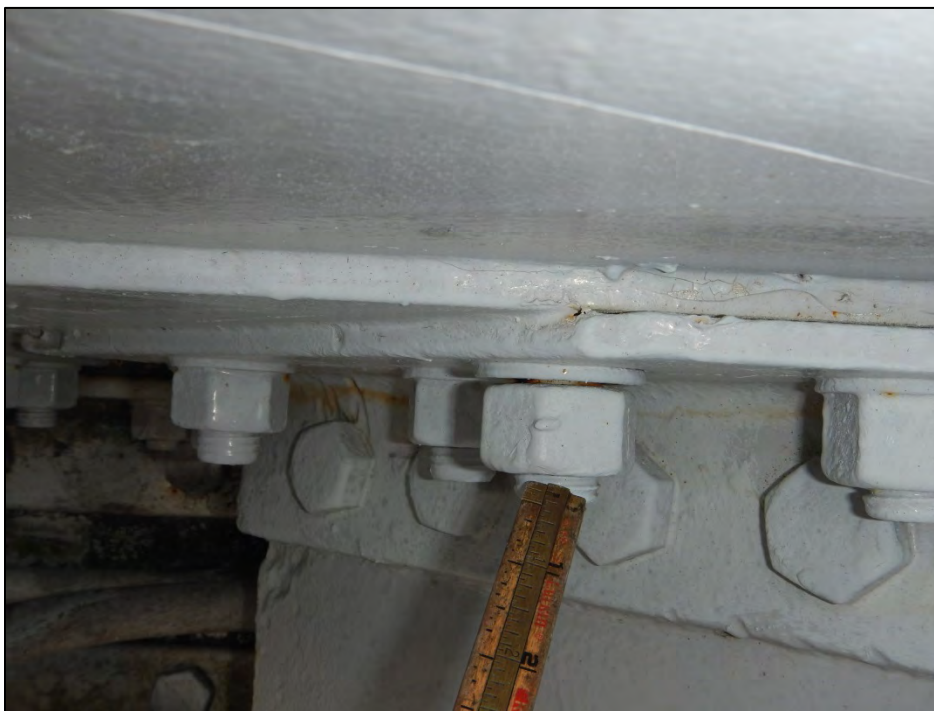
Photo 12 – Loose connection bolt at the east vertical connection to L6.

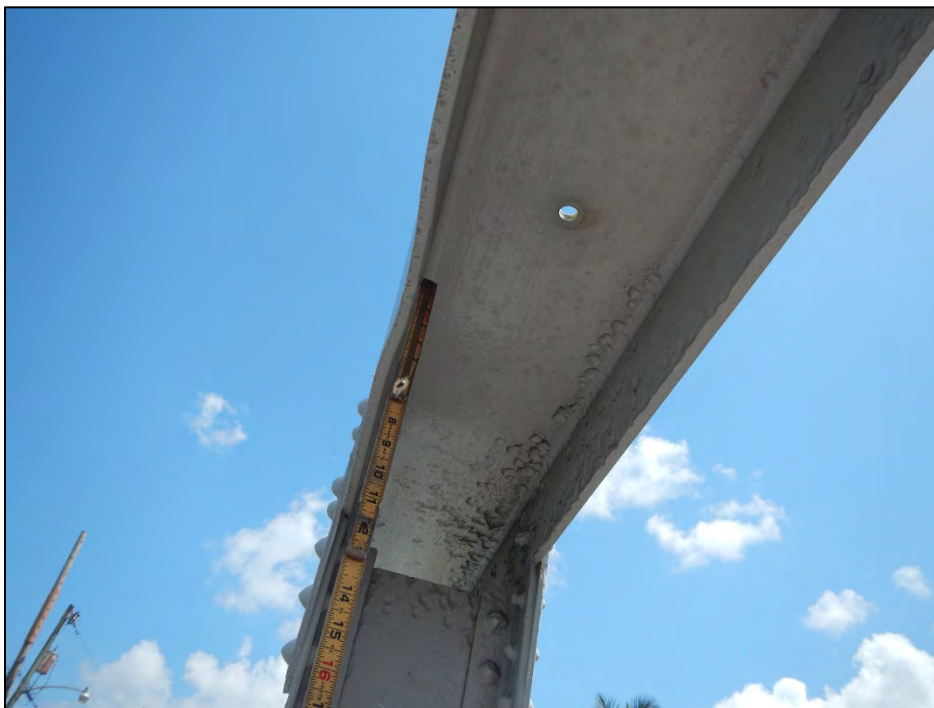
Photo 13 – Bent west top chord adjacent to U6.

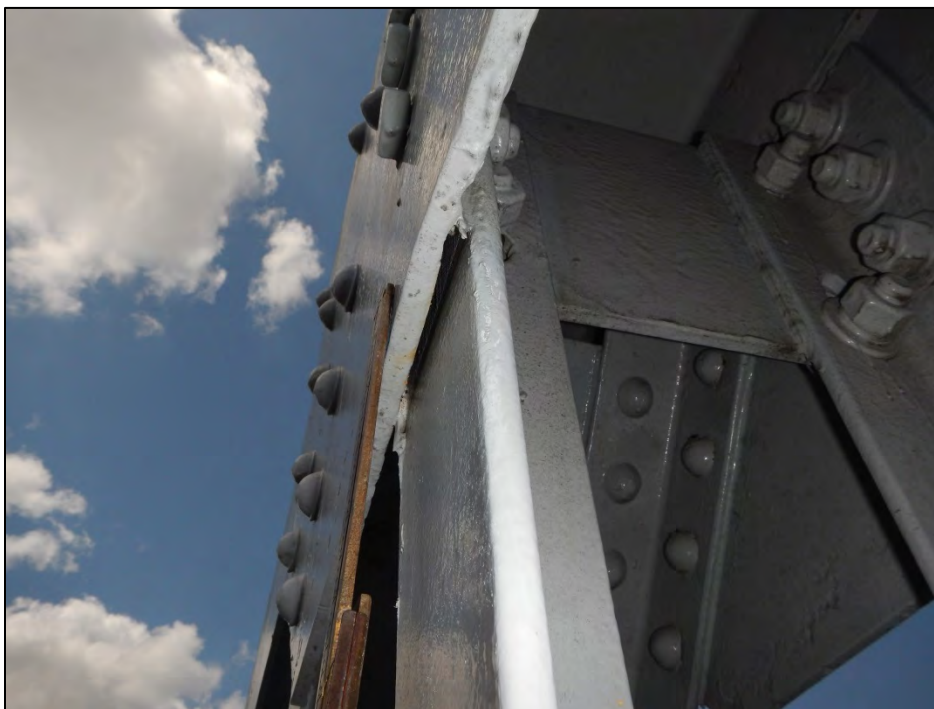
Photo 14 – Bent gusset plate at west top chord U11 connection to vertical member.

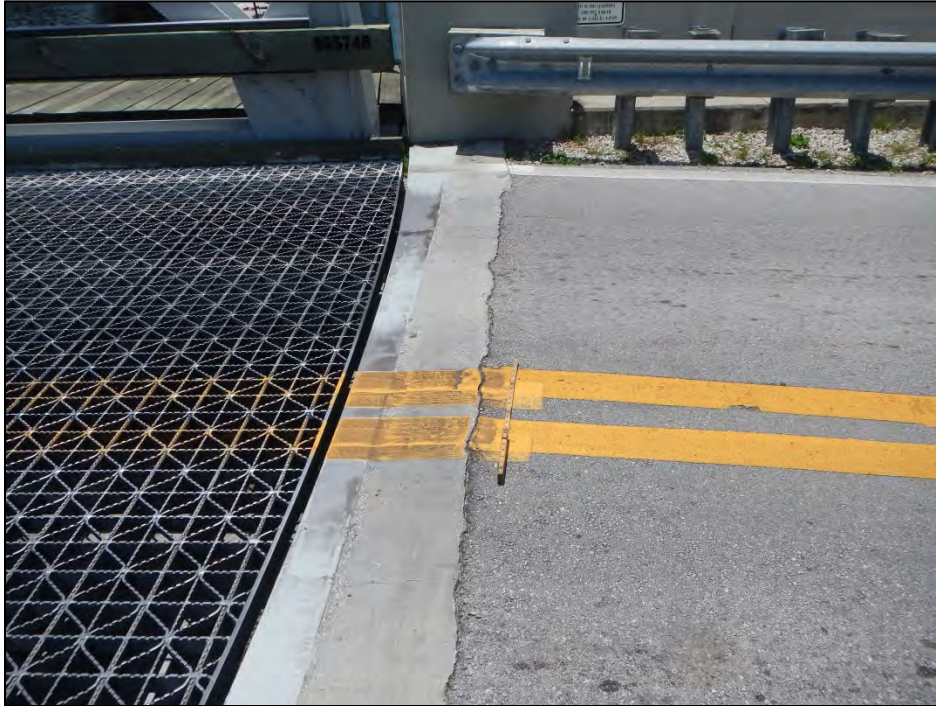
Photo 15 – Depressed north approach slab relative to abutment backwall.

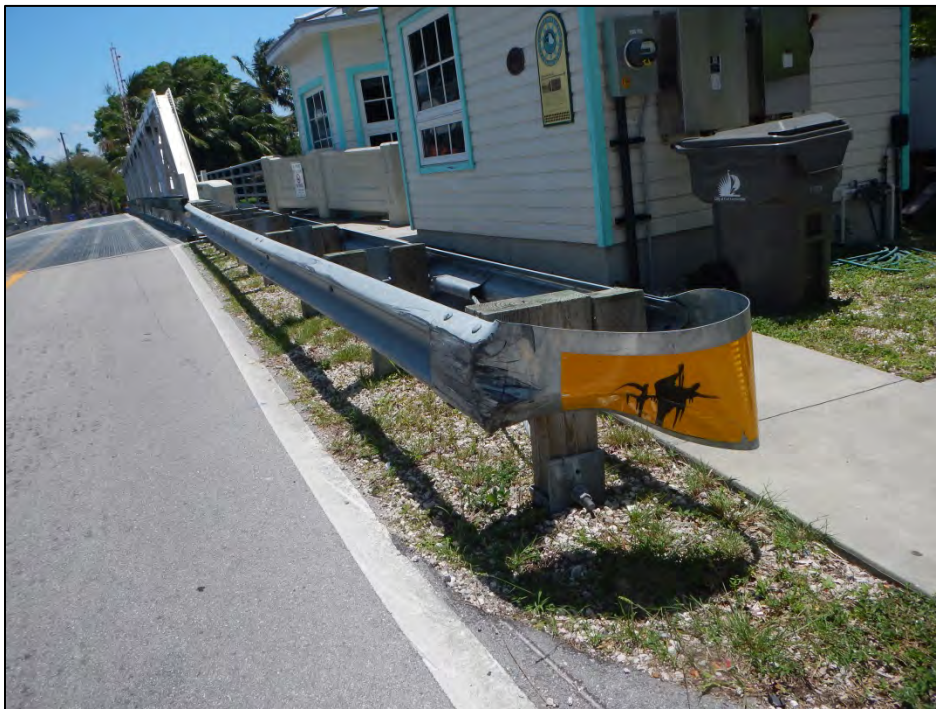
Photo 16 – Impact damage at northwest guardrail end terminal.

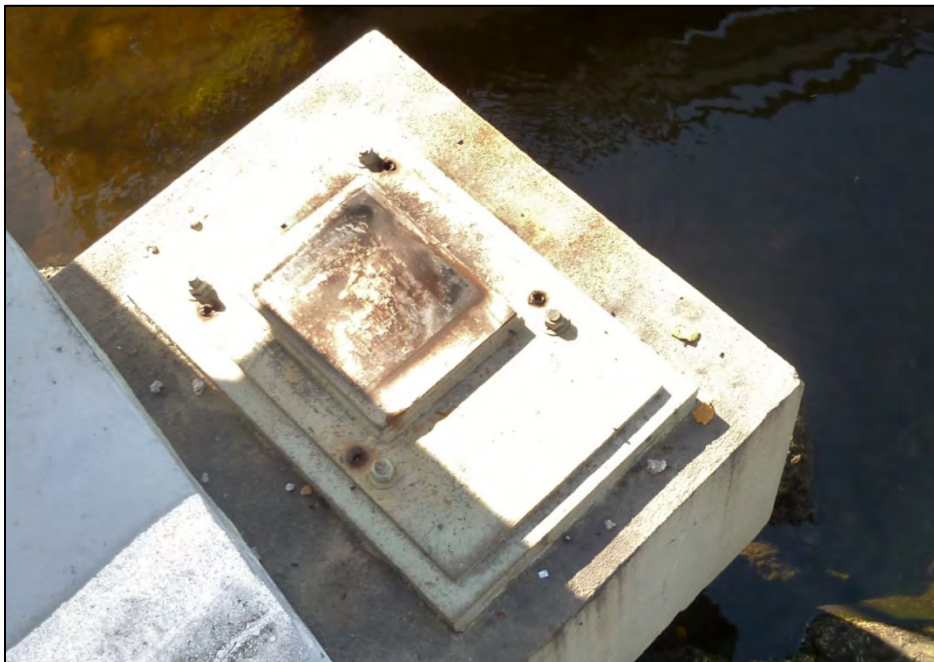
Photo 17 – Northwest Live Load Bearing: Note surface corrosion on Strike Plate.

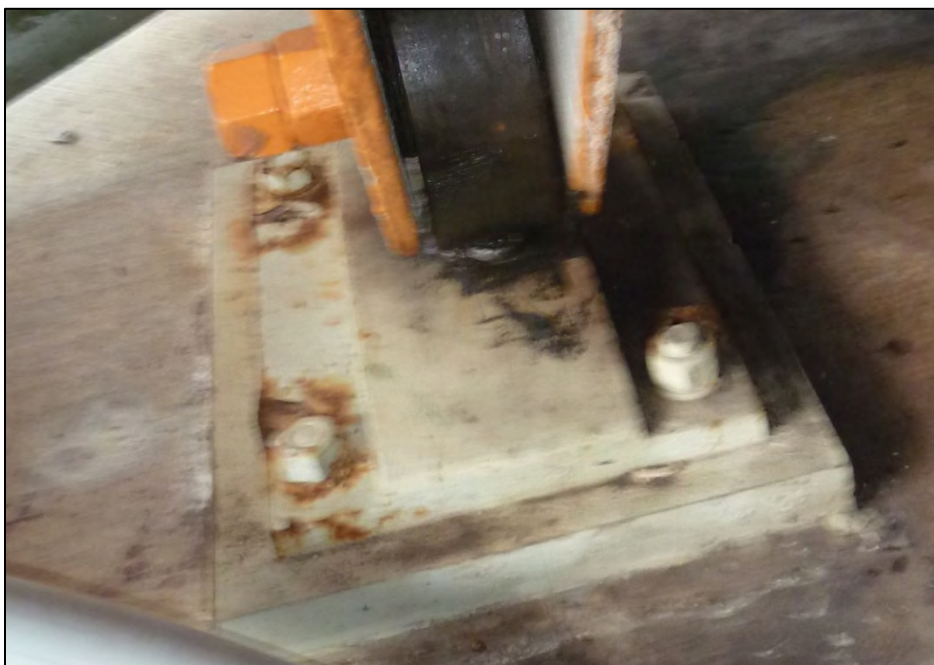
Photo 18 – West Elevator Wheel: Note surface corrosion on Strike Plate.

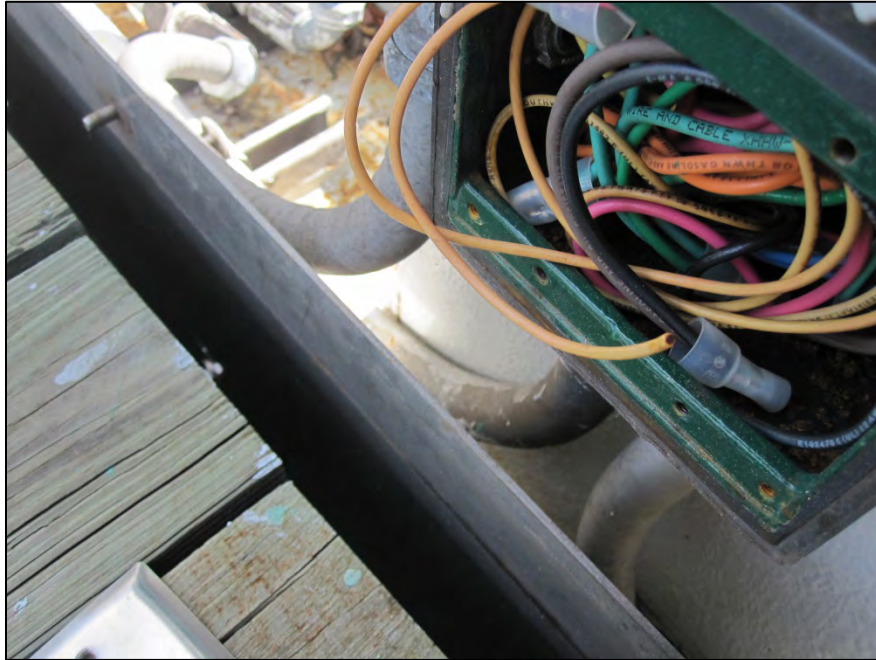
- The junction box feeding Lock A has an uncapped conductor inside. See Condition Photo 19.
- The limit switch enclosure at Lock A has an uncapped hole. See Condition Photo 20.
- The conductor color coding in the local disconnect switches is inconsistent between the line and load sides of the switch. See Condition Photo 21. The labels for the disconnect switches have fallen off.
- A flexible conduit fitting at Lock B is not secure. See Condition Photo 22.

Photo 19 – Uncapped conductor within junction box feeding Lock A.

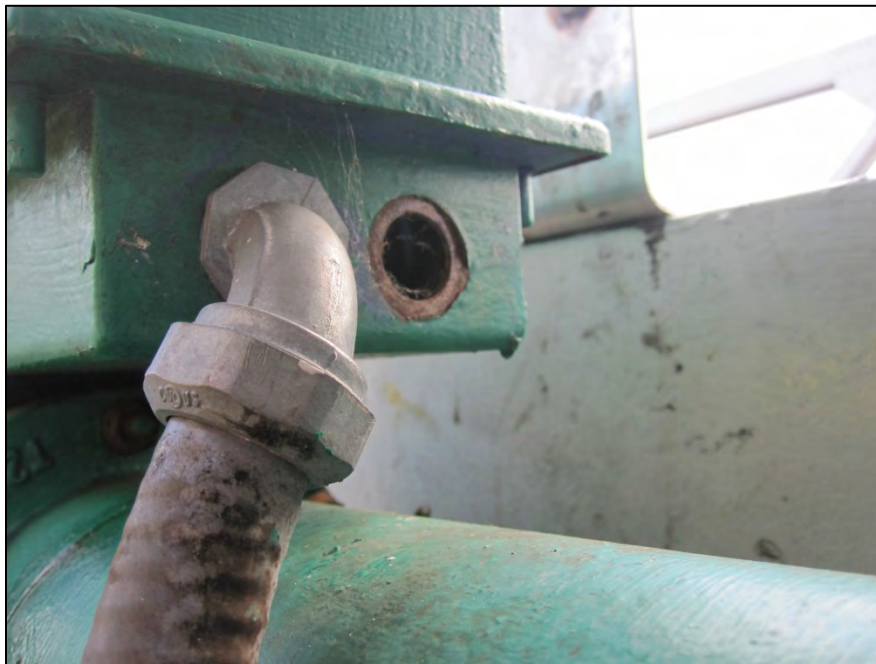
Photo 20 – Unplugged hole in Lock A limit switch enclosure.

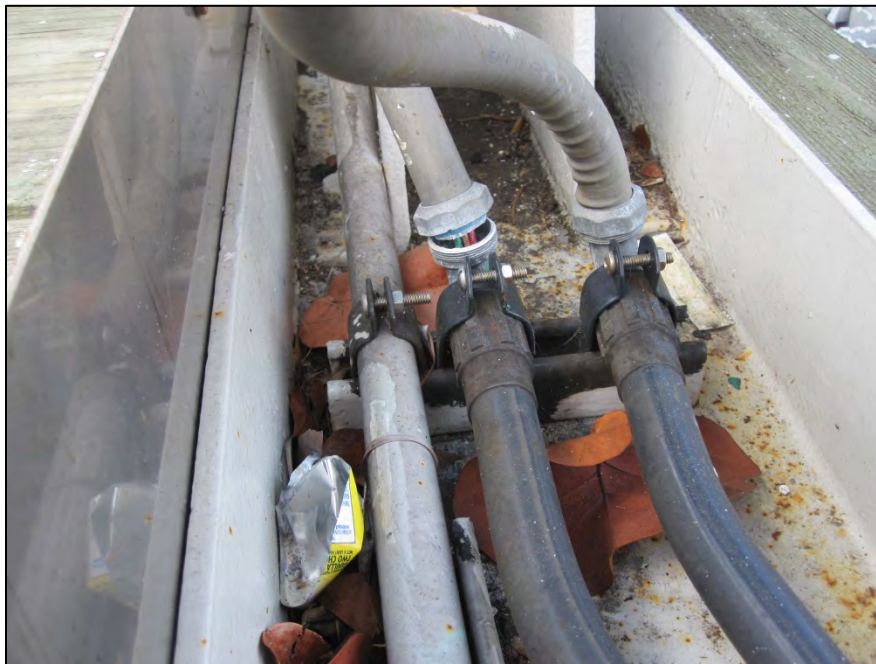
Photo 22 – Insecure flexible conduit fitting at Lock B.

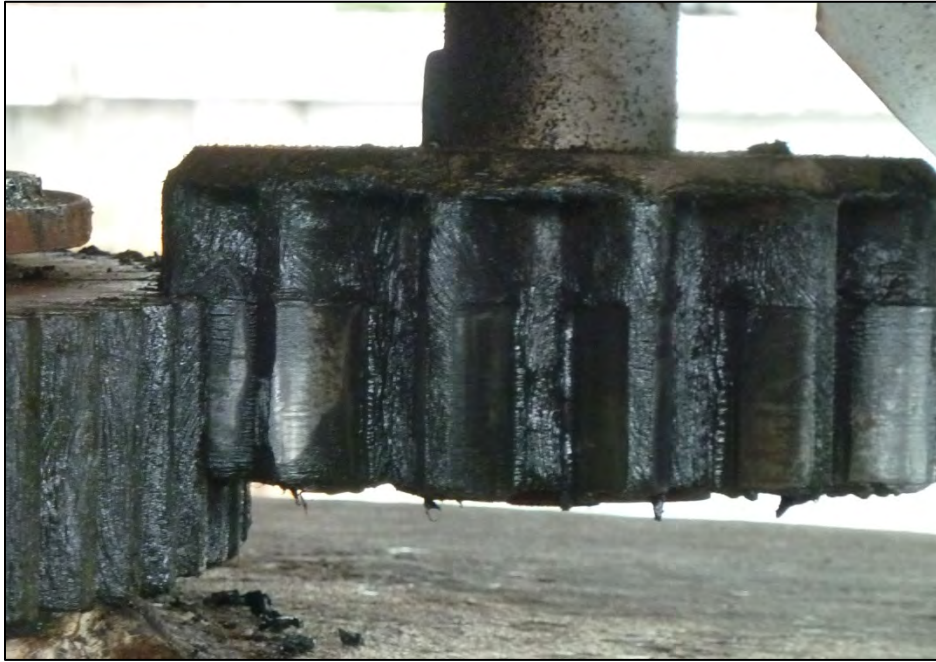
- The emergency power is generated from a portable diesel generator that is stored off site. The condition and functionality of this unit could not be verified. The manual emergency drive operation is reported to perform without incident.
- The emergency drive pinion and emergency drive rack do not fully mesh (60% engagement). See Condition Photo 23.

Photo 23 – Emergency Drive Pinion: About 60% engagement with Emergency Drive Rack.

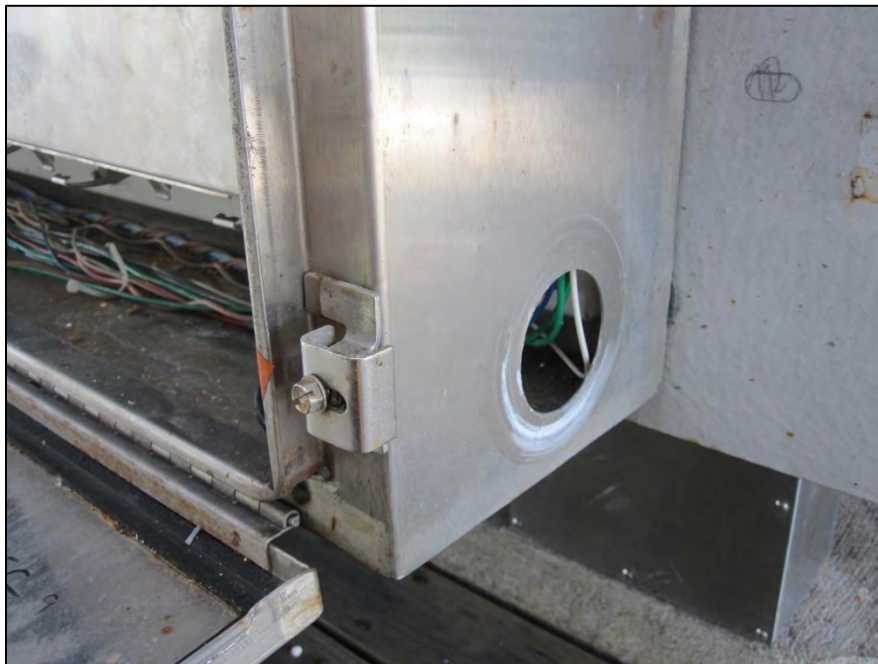
Photo 24 – Unplugged hole at the terminal box in the machinery area.

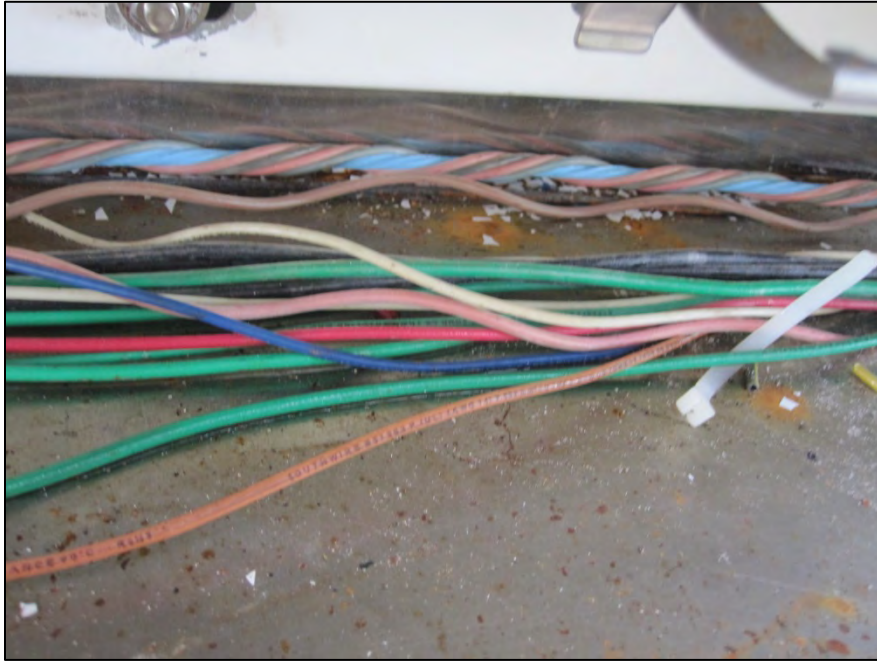
Photo 25 – Evidence of water intrusion at the terminal box in the machinery area.

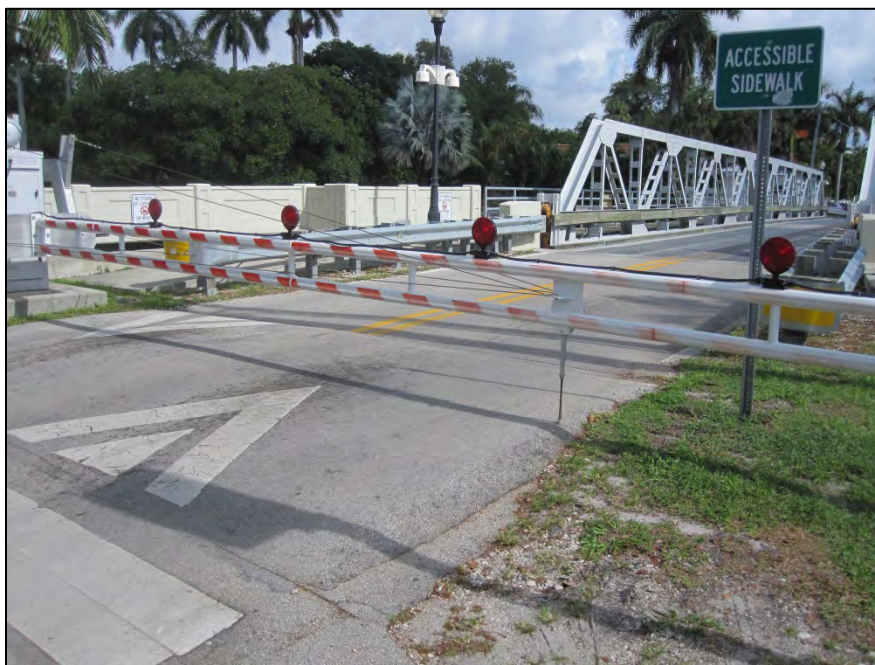
Photo 29 – Faded striping on the far gate arm.
