## **EXECUTIVE SUMMARY**

TranSystems has been retained by the City of Fort Lauderdale to perform bridge inspections and prepare bridge inspection reports for each of the City's bridges as part of the project Structural Bridge Engineering Consulting Services Master Plan, RFQ No. 946-11310. Inspections were completed and reports prepared for 46 of the City's bridges. The remaining five bridges in the City's inventory were not inspected because they are in the process of being replaced.

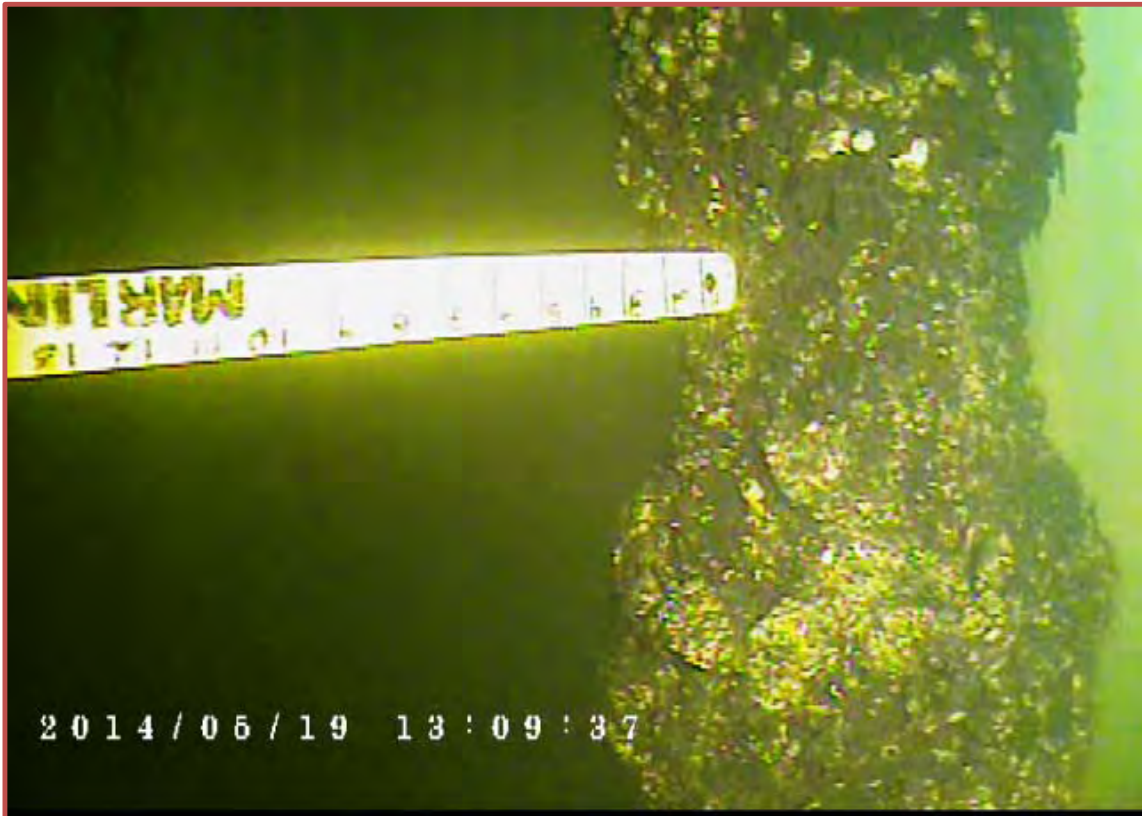
\_The timber piling under the machinery work platform have not been replaced and exhibit up to 40% section loss. **UW Photo 01. INCREASE.**

\_Pivot pier wall has several vertical crack up to 16" x 1/64", starting at the top edge.

Description: Top: Timber Piling under the machinery platform, up to 40% section loss. **UW Photo 01.**  
Bottom: Pivot pier wall has several vertical cracks, starting at the top edge. **UW Photo 02.**

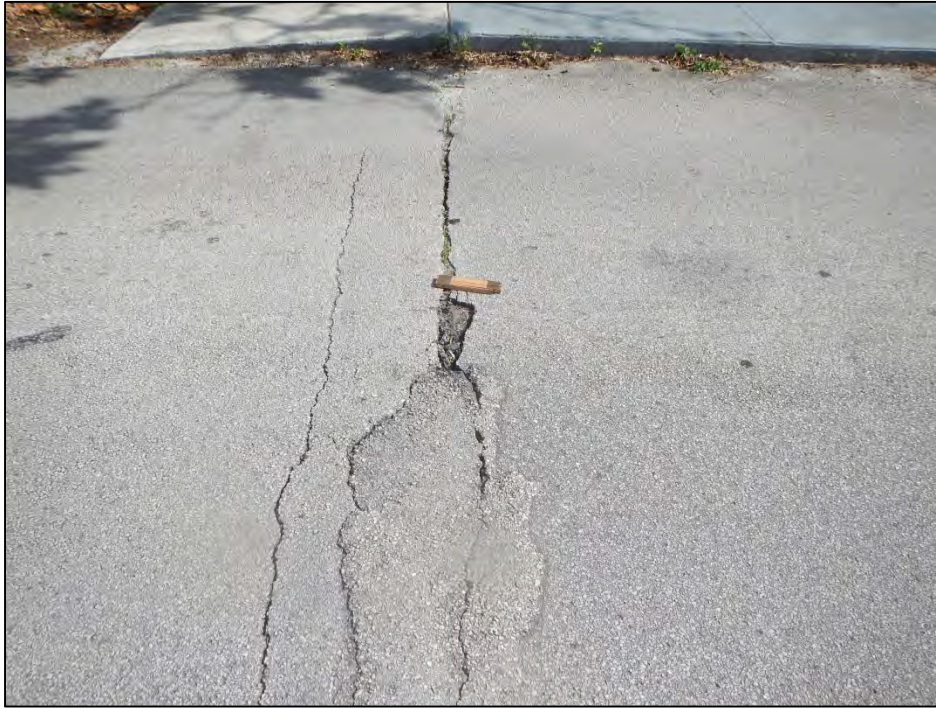
Photo 1 – Overlay exhibits transverse cracks at Abutment 2.

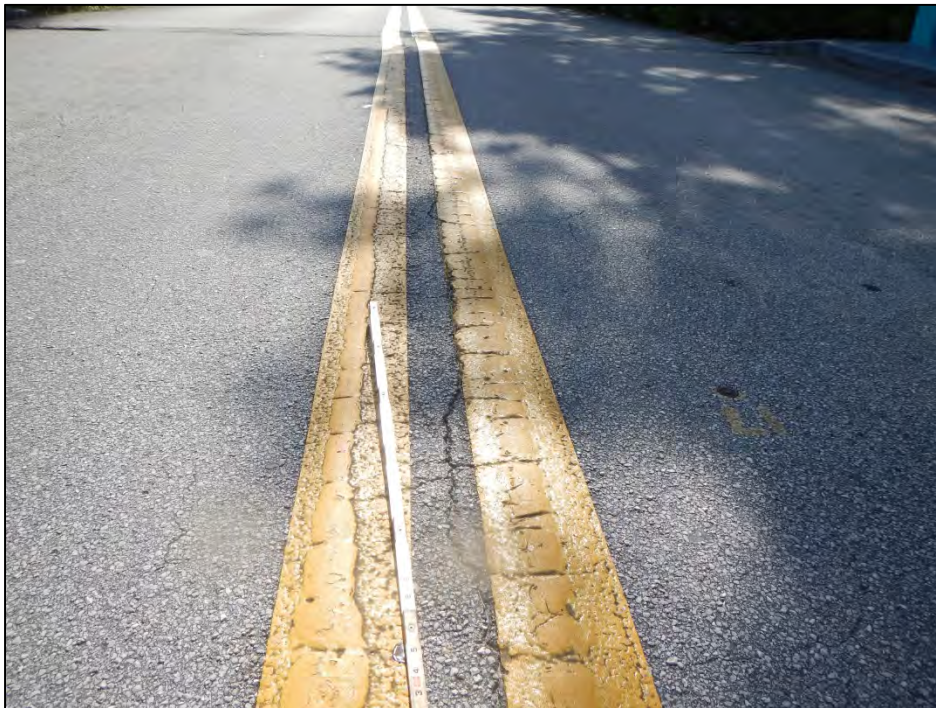
Photo 2 – The deck top exhibits intermittent longitudinal cracks.

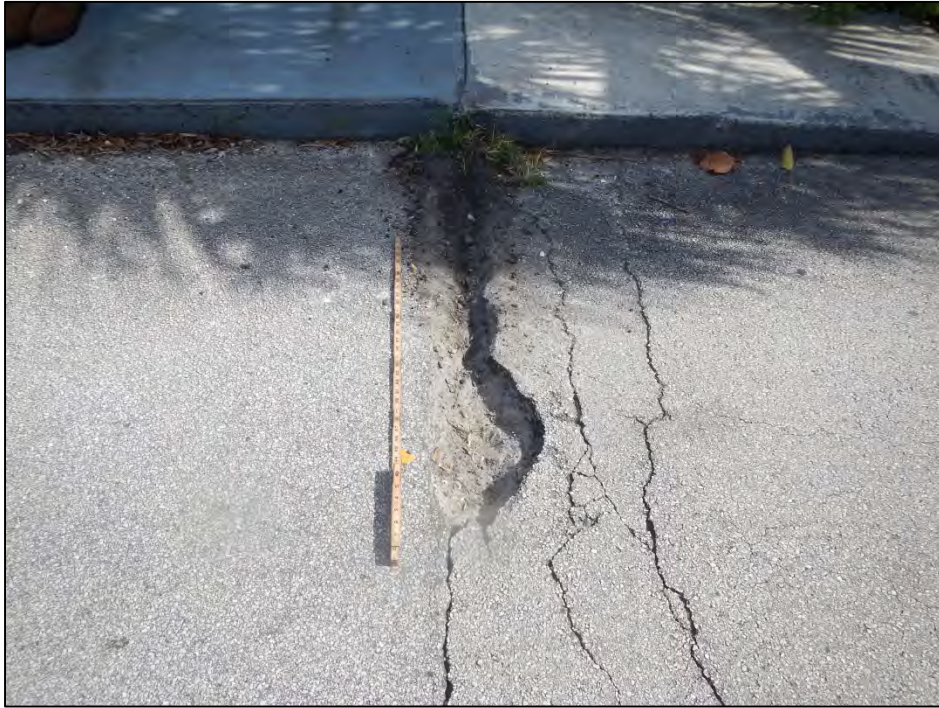
Photo 3 – The westbound deck top exhibits a pothole over Abutment I.

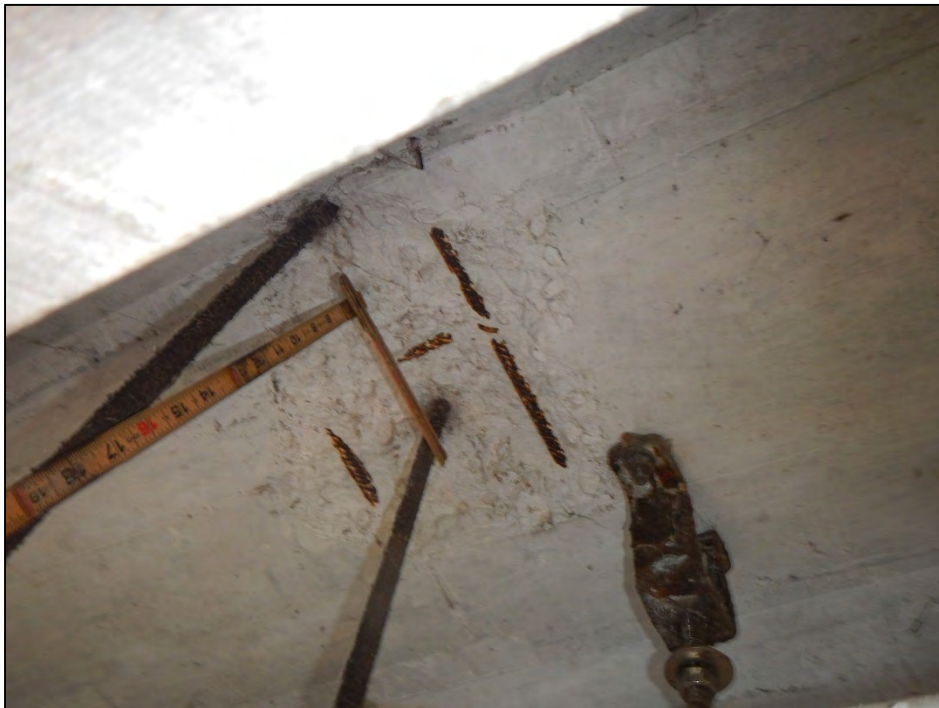
Photo 4 – Bay I mid span exhibits a spall with exposed steel.

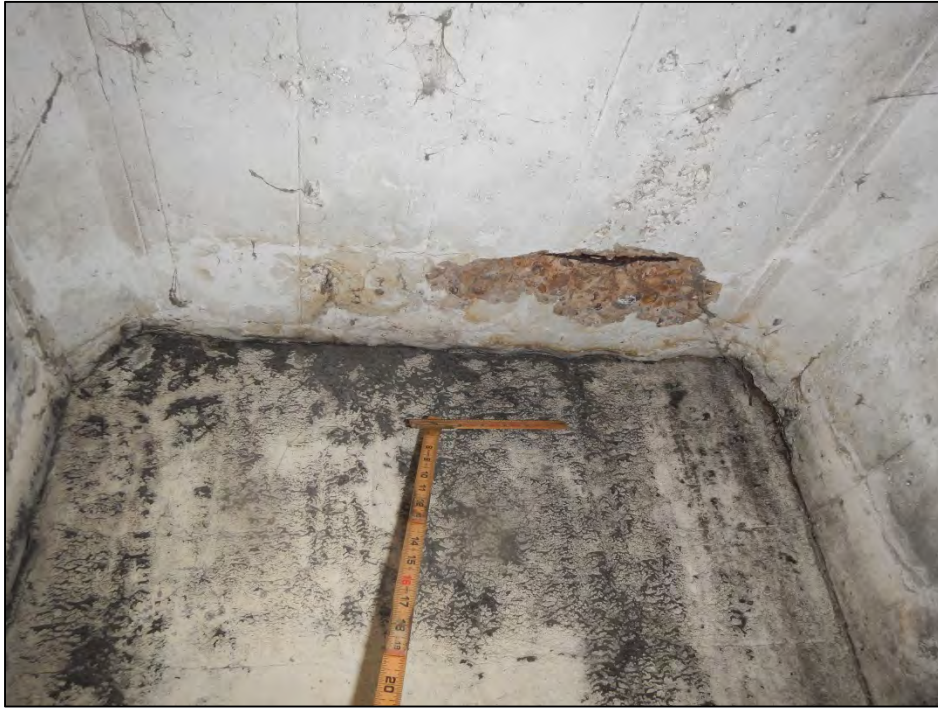
Photo 5 – Bay 5 over Abutment 2 exhibits a spall with exposed steel.

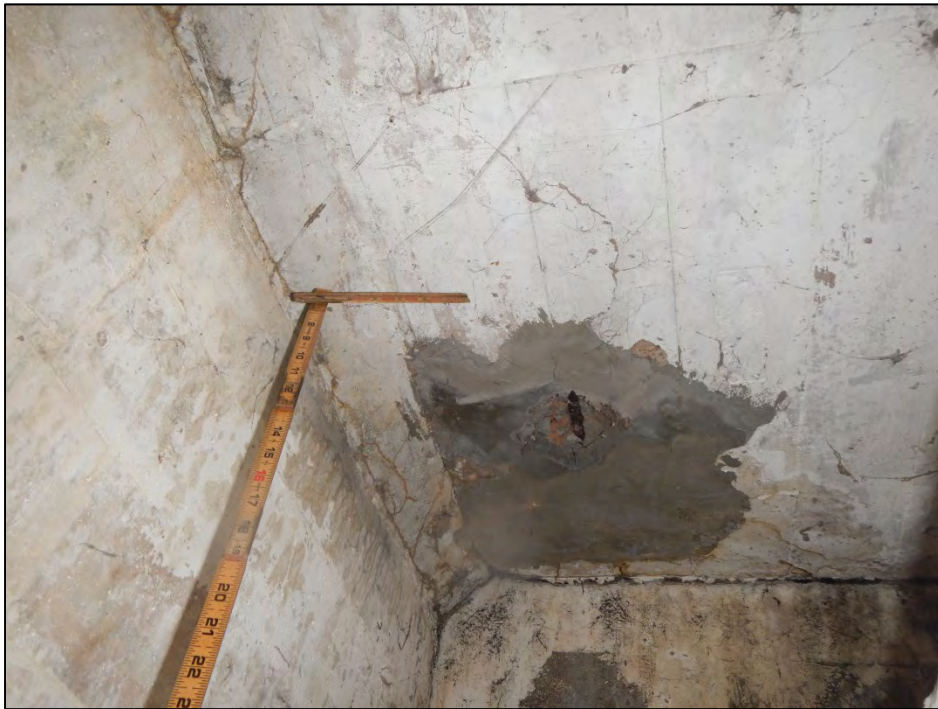
Photo 6 – Bay 7 over Abutment 1 exhibits a spall/delamination with exposed steel.

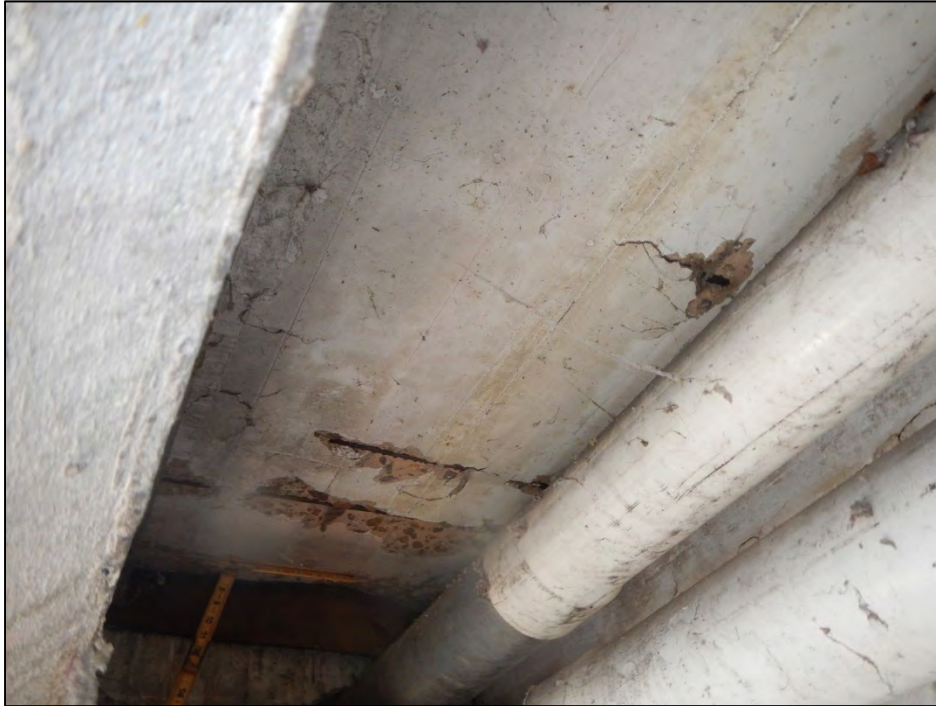
Photo 7 – Bay 8 over Abutment I exhibits a spall/delamination with exposed steel.

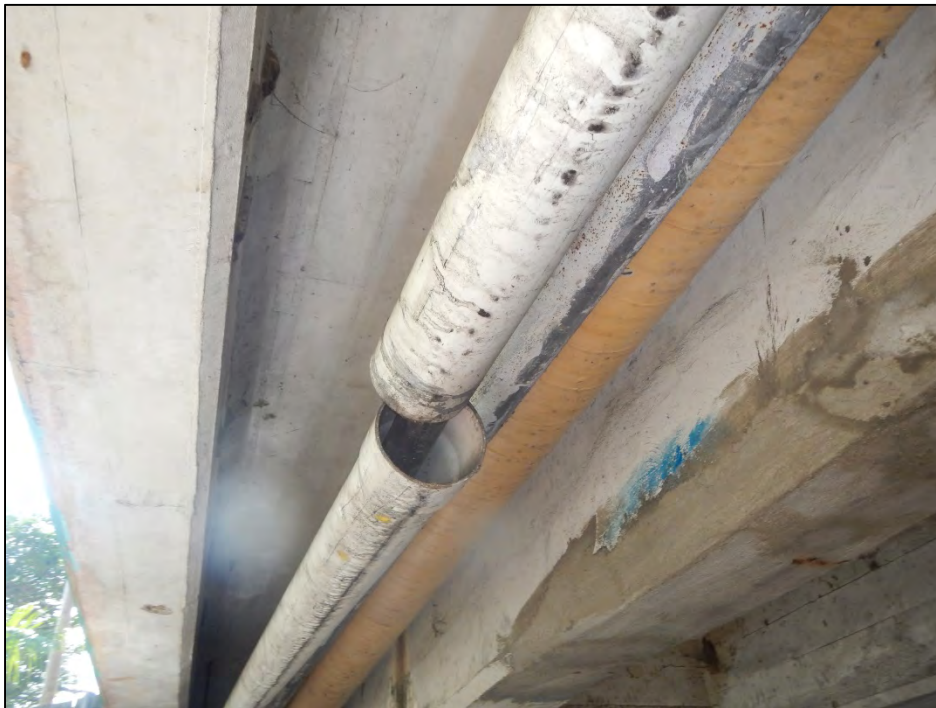
Photo 8 – The utility conduit under Bay I is disconnected.

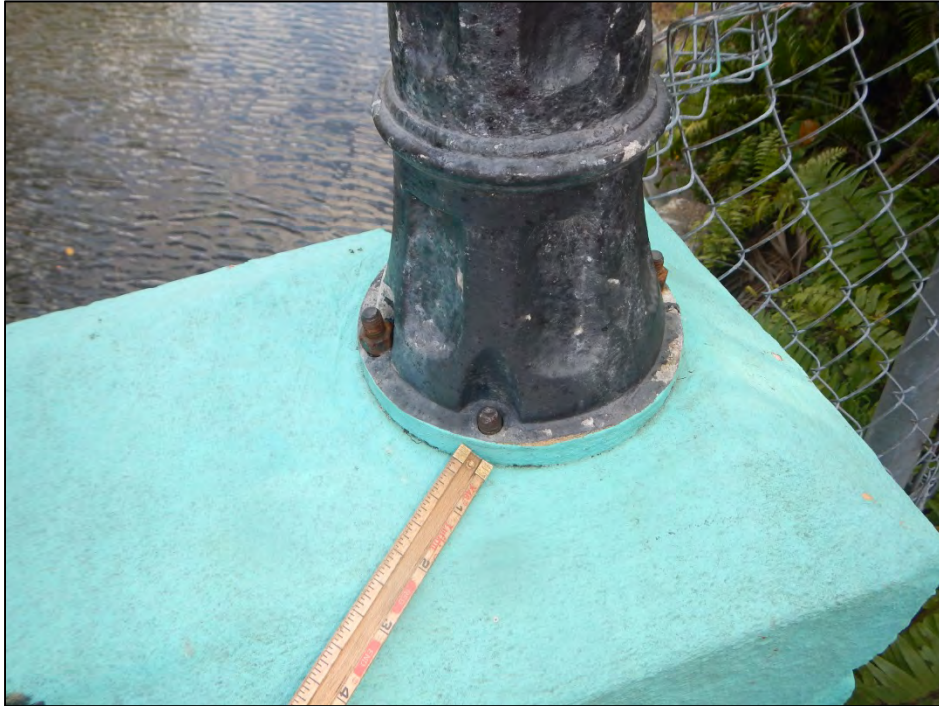
Photo 9 – The first light pole on the south barrier is missing 1 of 4 anchor bolt nuts.

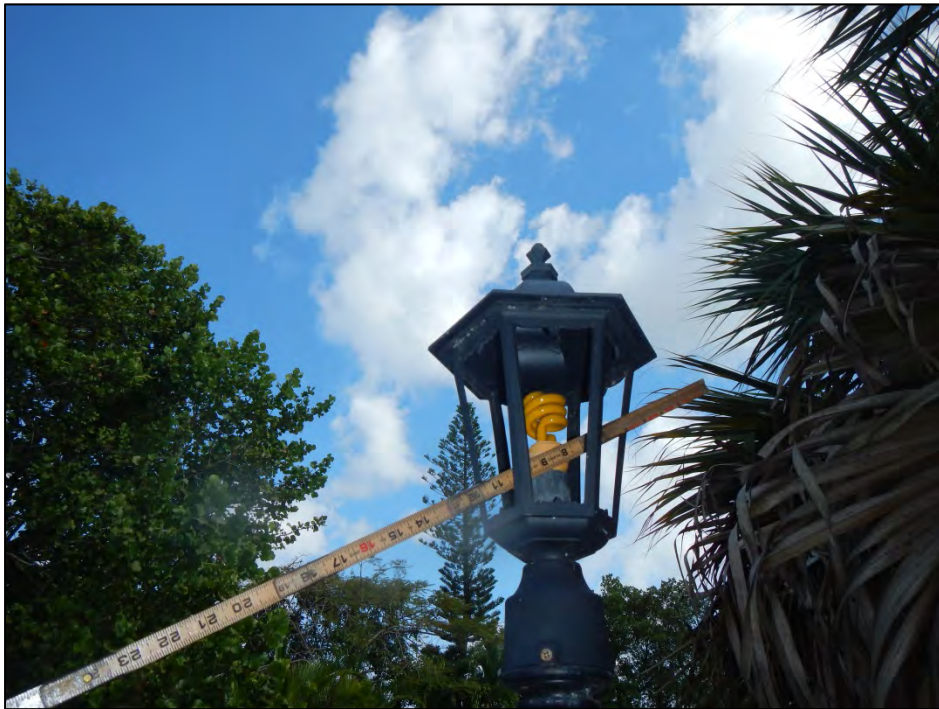
Photo 10 – The first light pole on the south barrier is missing glass panels at the lamp fixture.

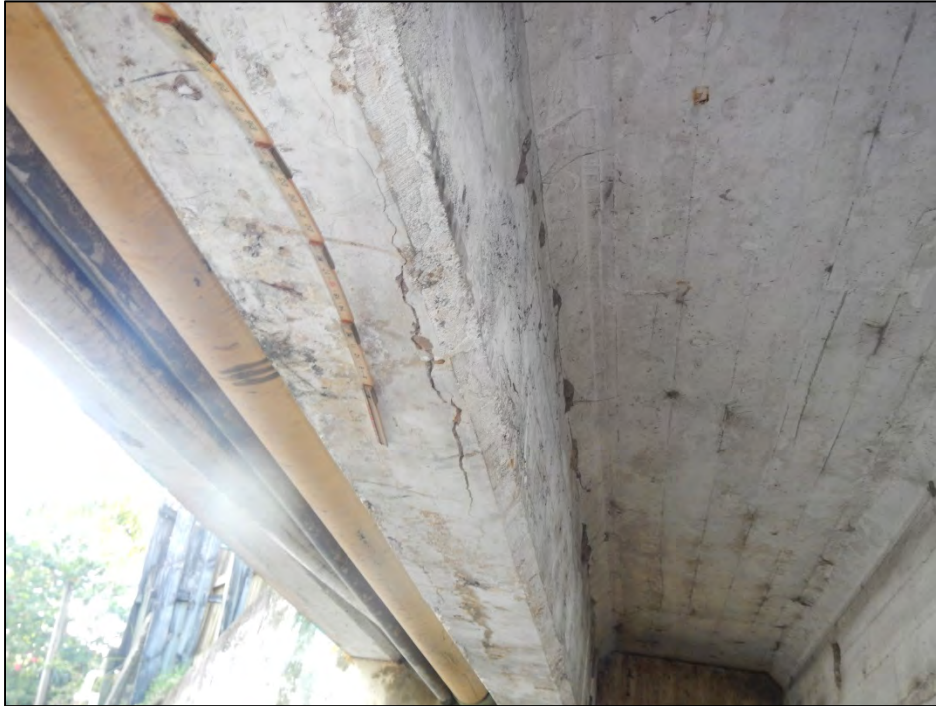
Photo 11 – The bottom face of Beam 1-2, 8 ft. from Abutment 2, exhibits a delamination.

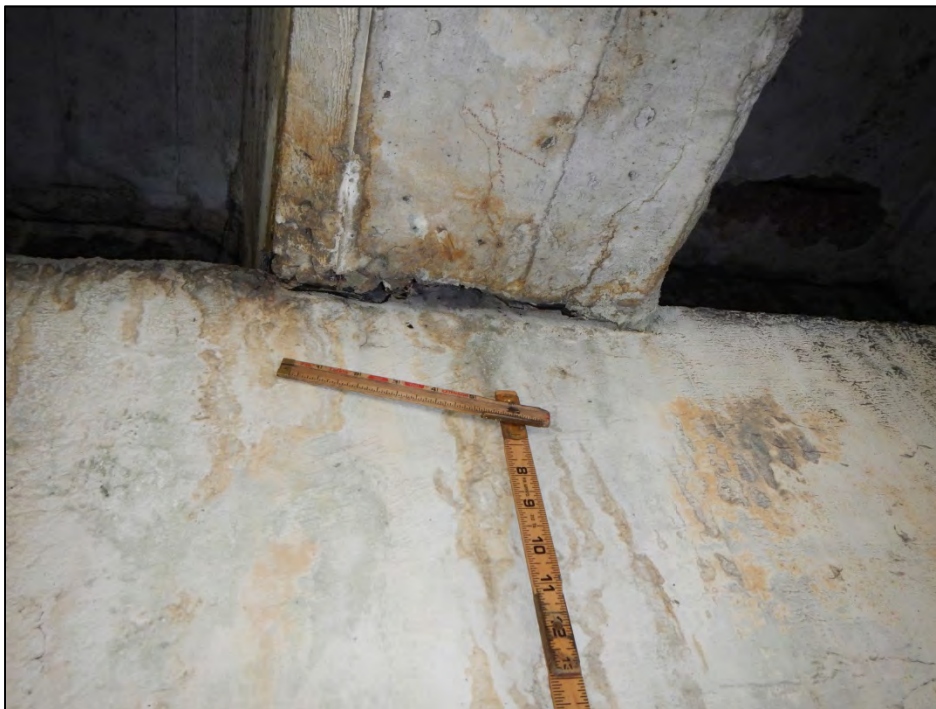
Photo 12 – Beam 1-5 over Abutment 2 exhibits a void.

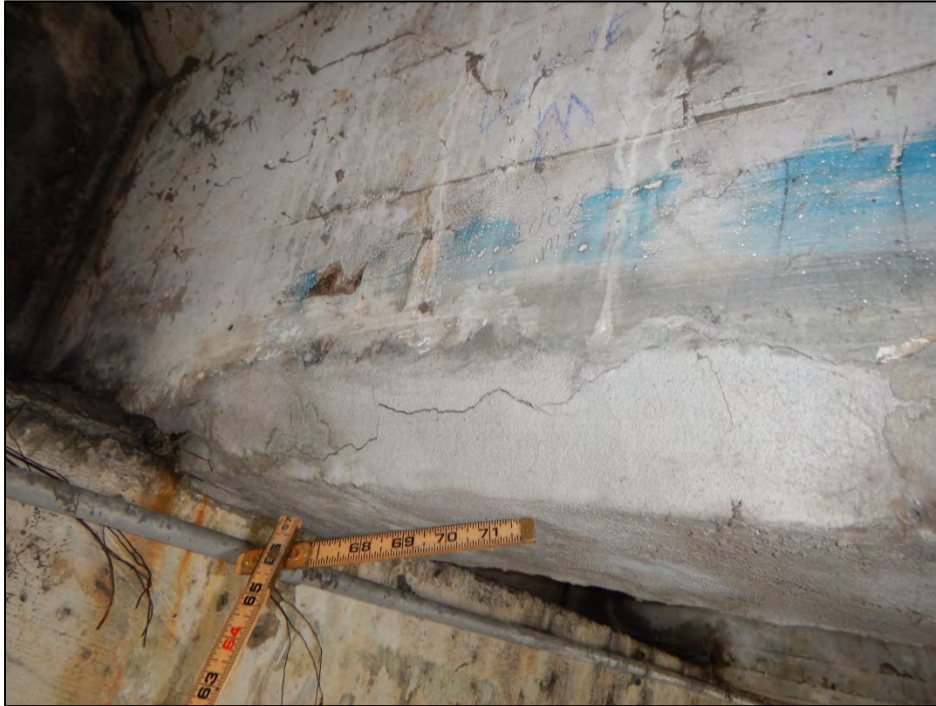
Photo 13 – Beam I-7 over Abutment I exhibits a delamination.

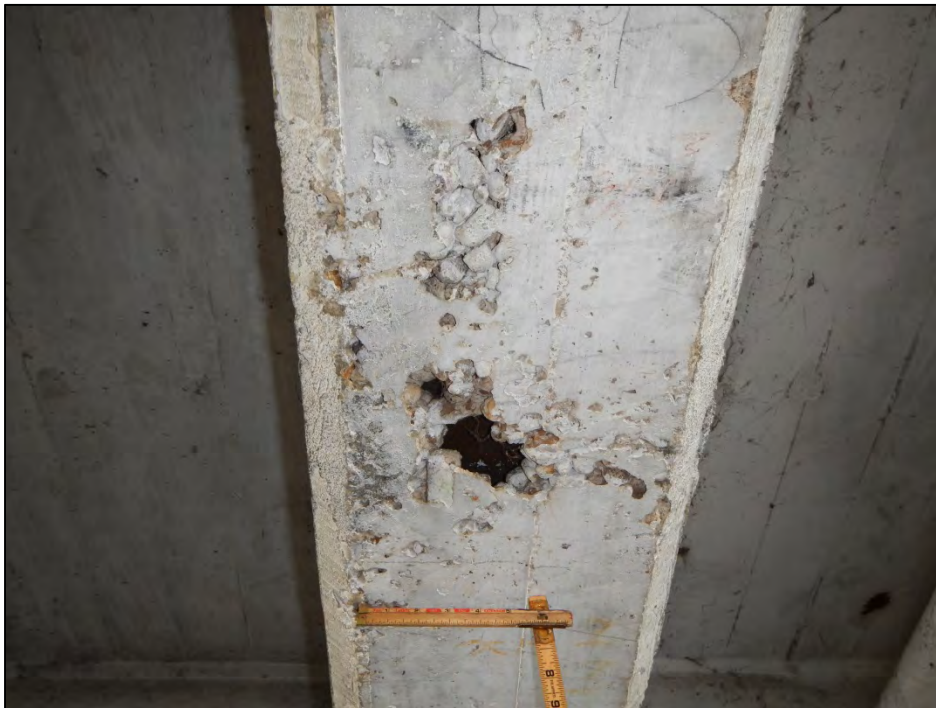
Photo 14 – Beam I-7 mid span exhibits a void.

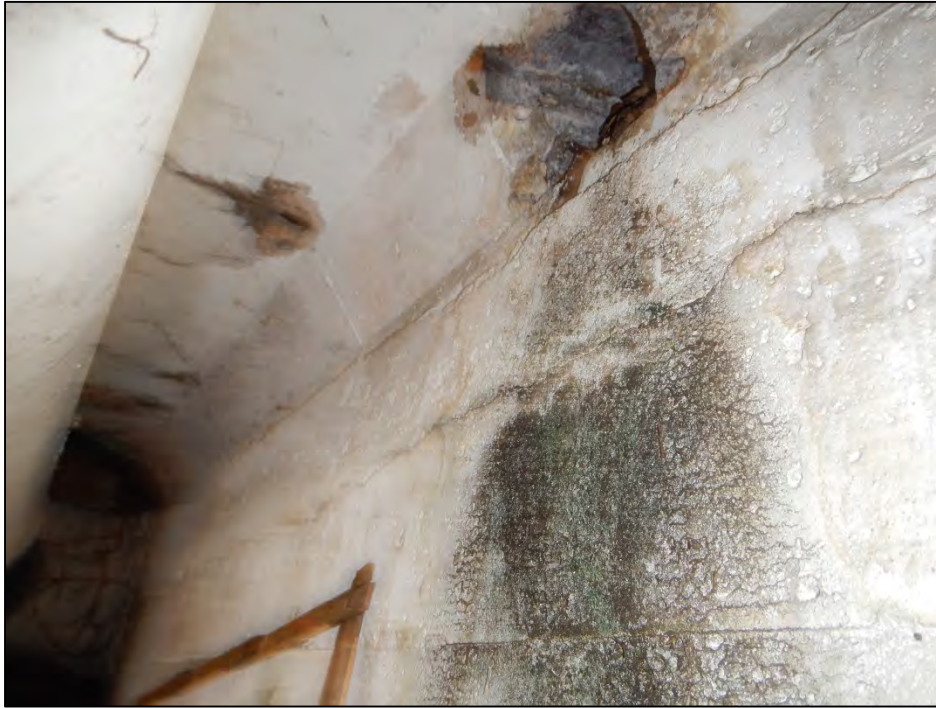
Photo 15 – Beam 1-8 over Abutment 1 exhibits a horizontal crack.

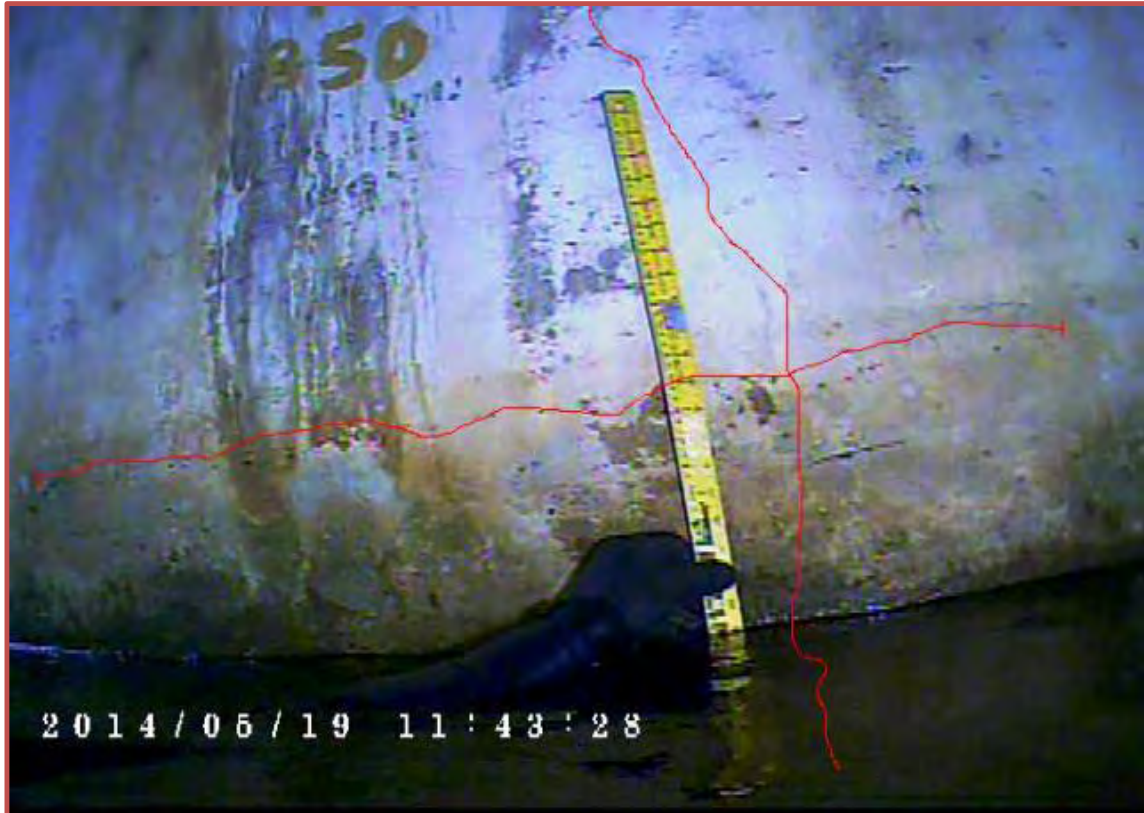
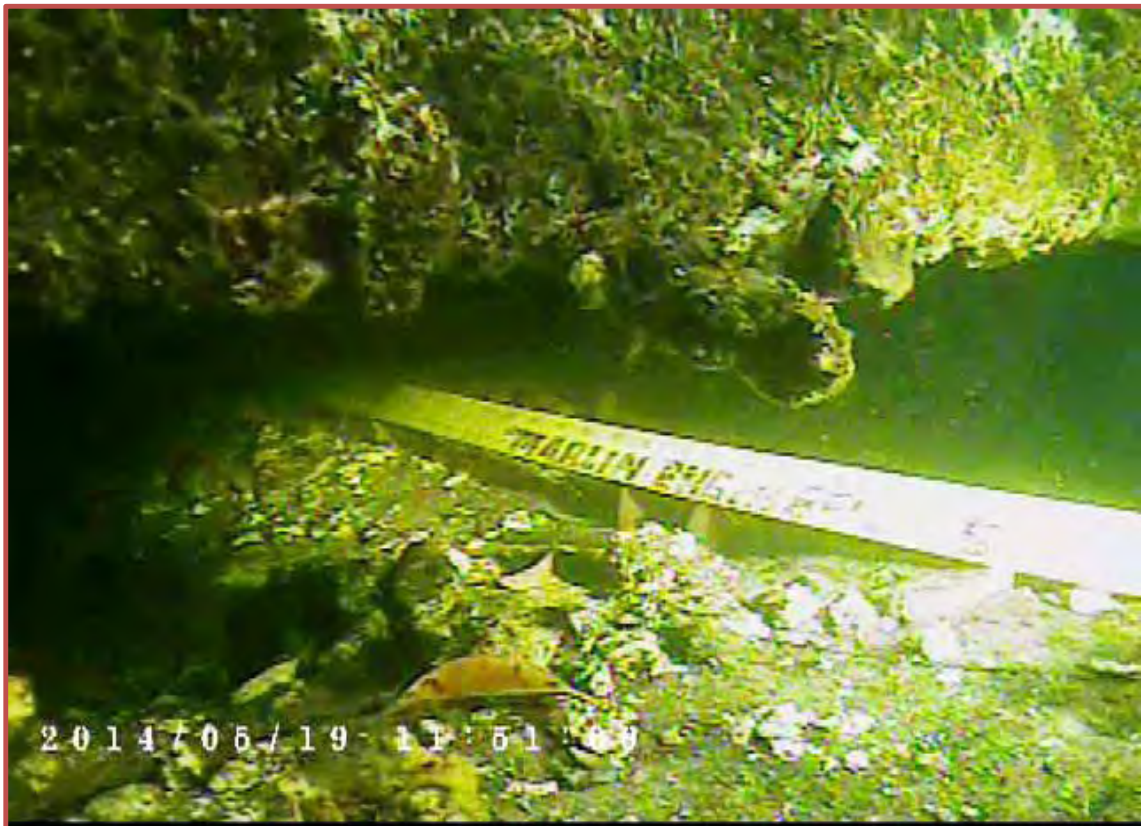
\_Abutment caps exhibit several vertical and horizontal cracks up to 1/64" wide, at random locations.

\_Abutment 1 footer has a 27" x 8", section of missing concrete under Bay 1-1. No backfill leakage was observed during this inspection cycle. **UW Photo 02. NO CHANGE.**

Description: Top: Abutment caps, vertical/horizontal cracks at random locations. **UW Photo 01.**  
Bottom: Abutment 1 footer, section of missing concrete under Bay 1-1. **UW Photo 02.**

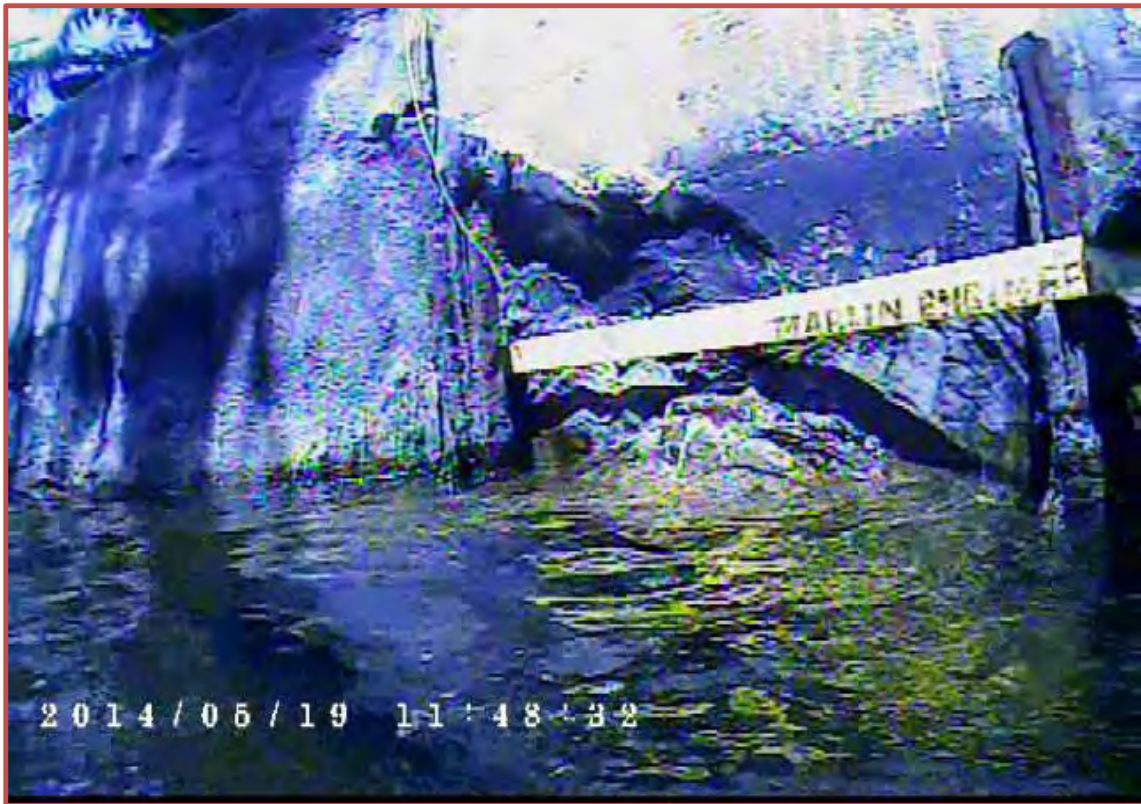
\_The SW wall at the junction to private sector has a spall 17" x 14" x 1-1/2". **UW Photo 03. NEW.**

Description: SW wall at the junction to private sector has a spall. **UW Photo 03.**

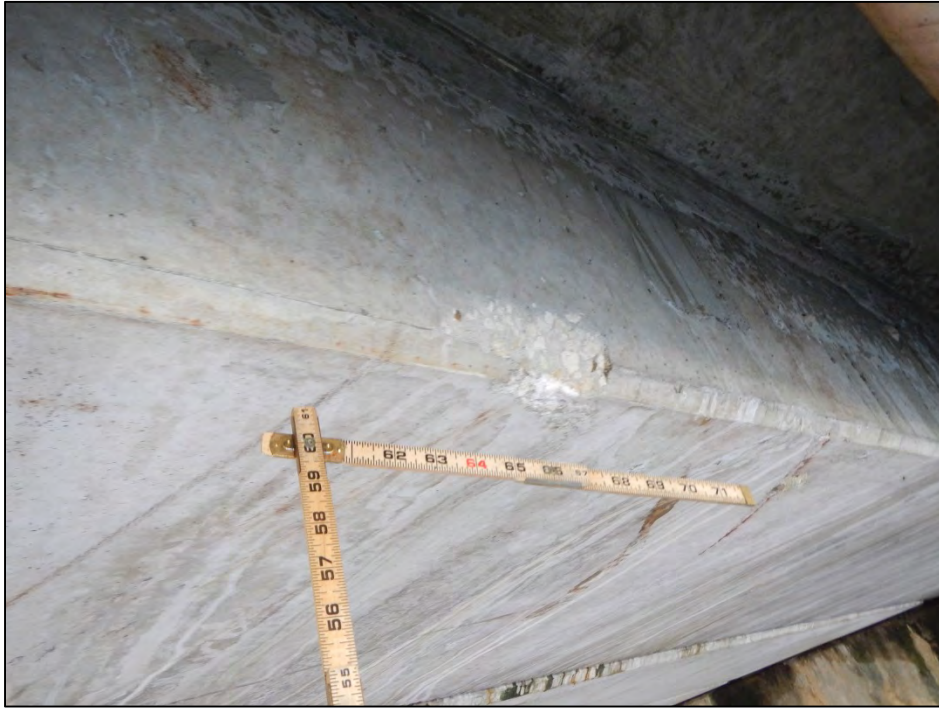
Photo 1 – Spall in the deck underside, Slab Unit I-I.

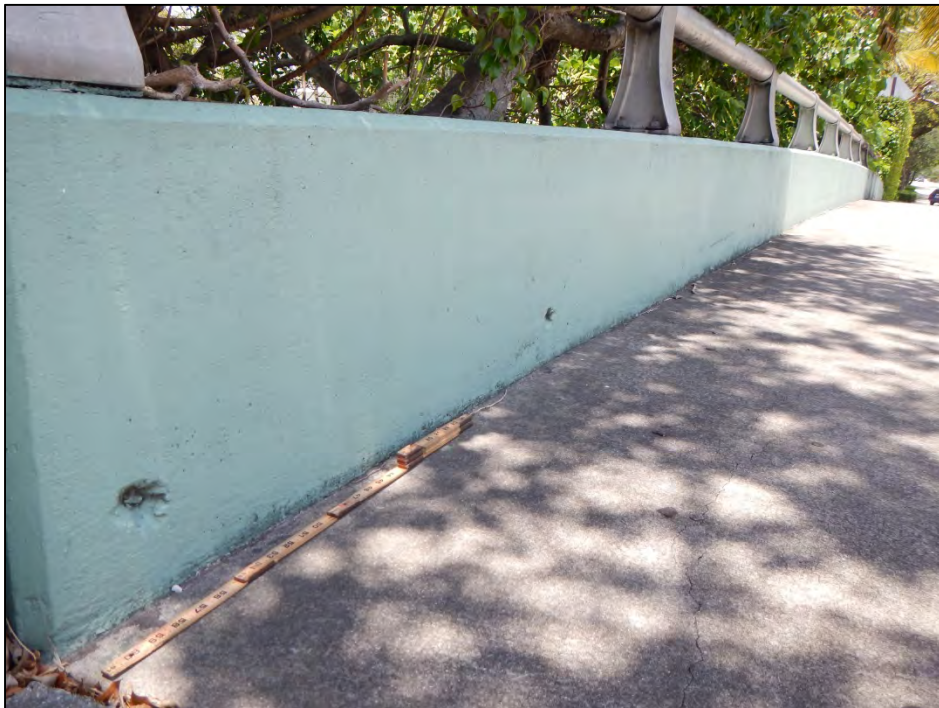
Photo 2 – Pop outs in the barrier.

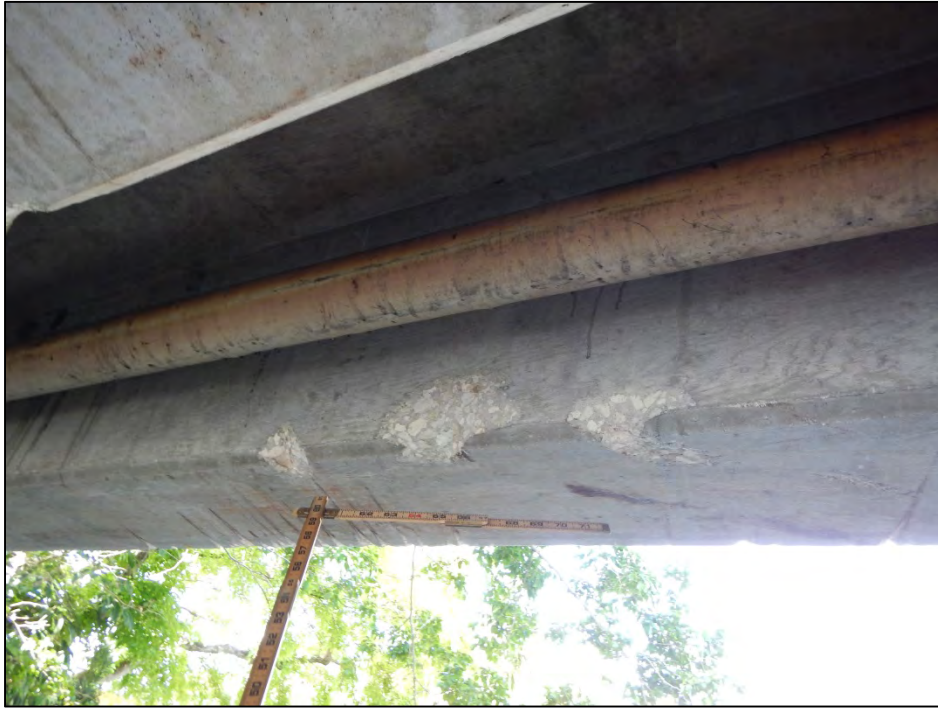
Photo 3 – Beam I-I spalls with no exposed steel.

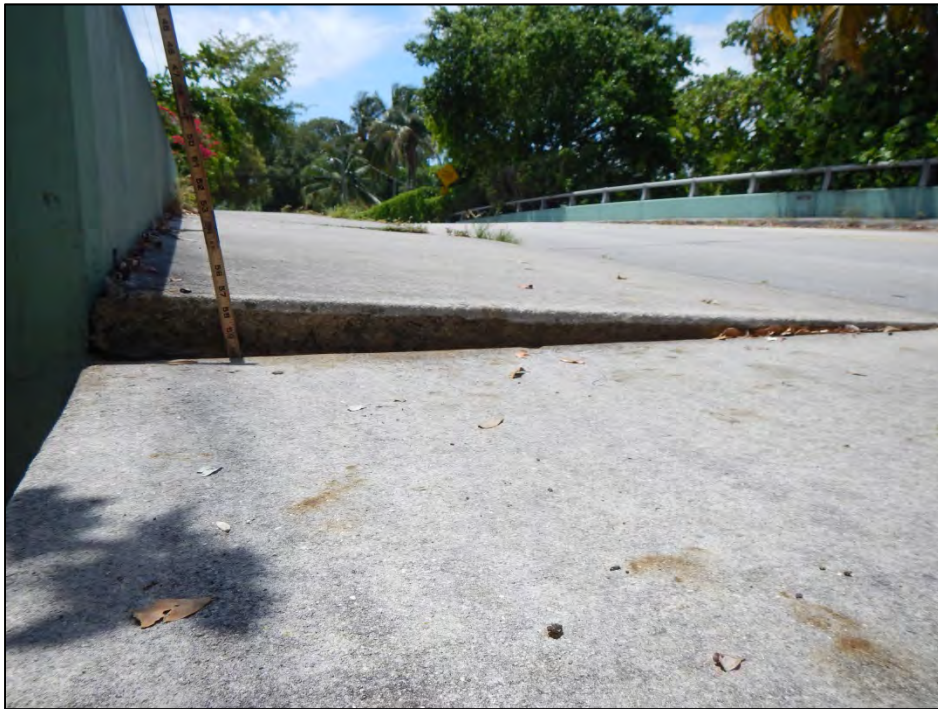
Photo 4 – Settlement of the northeast approach sidewalk.

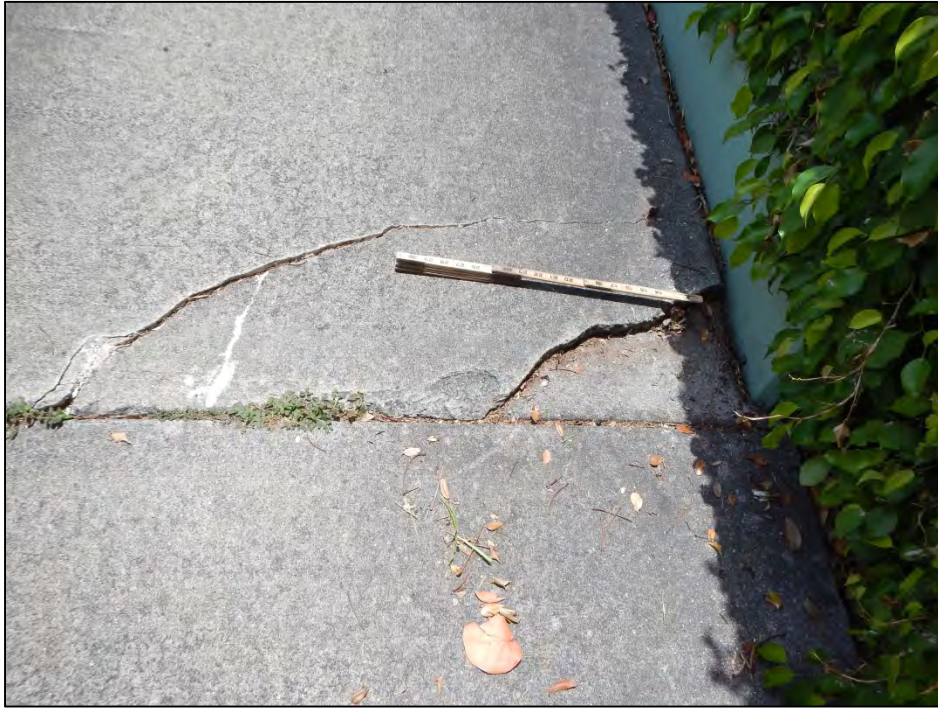
Photo 5 – Cracks in the northwest approach sidewalk.

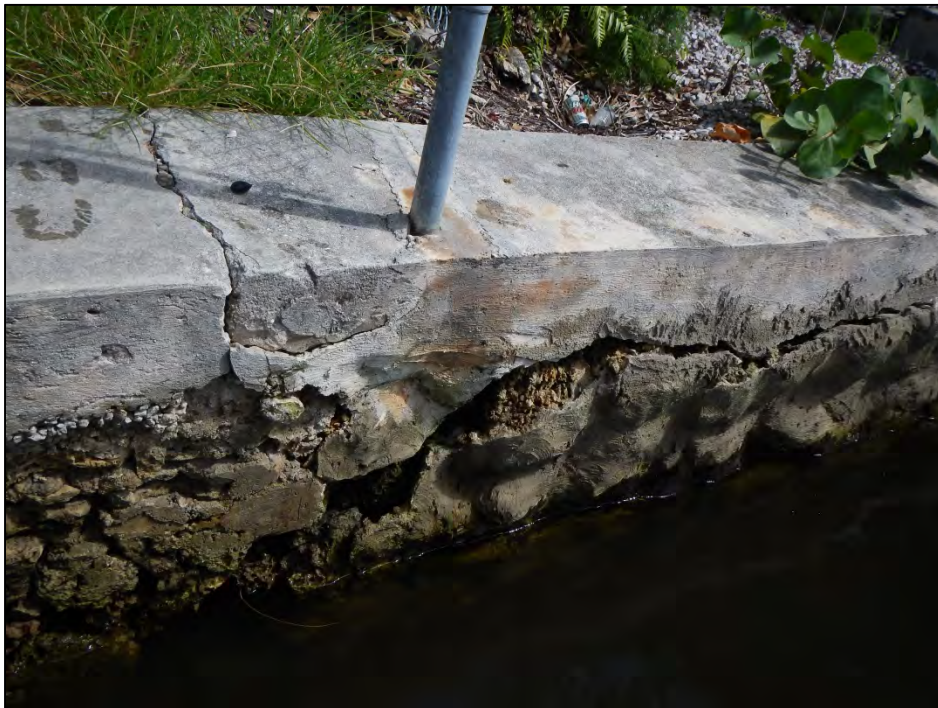
Photo 6 – Crack and rotation in the northeast retaining wall.

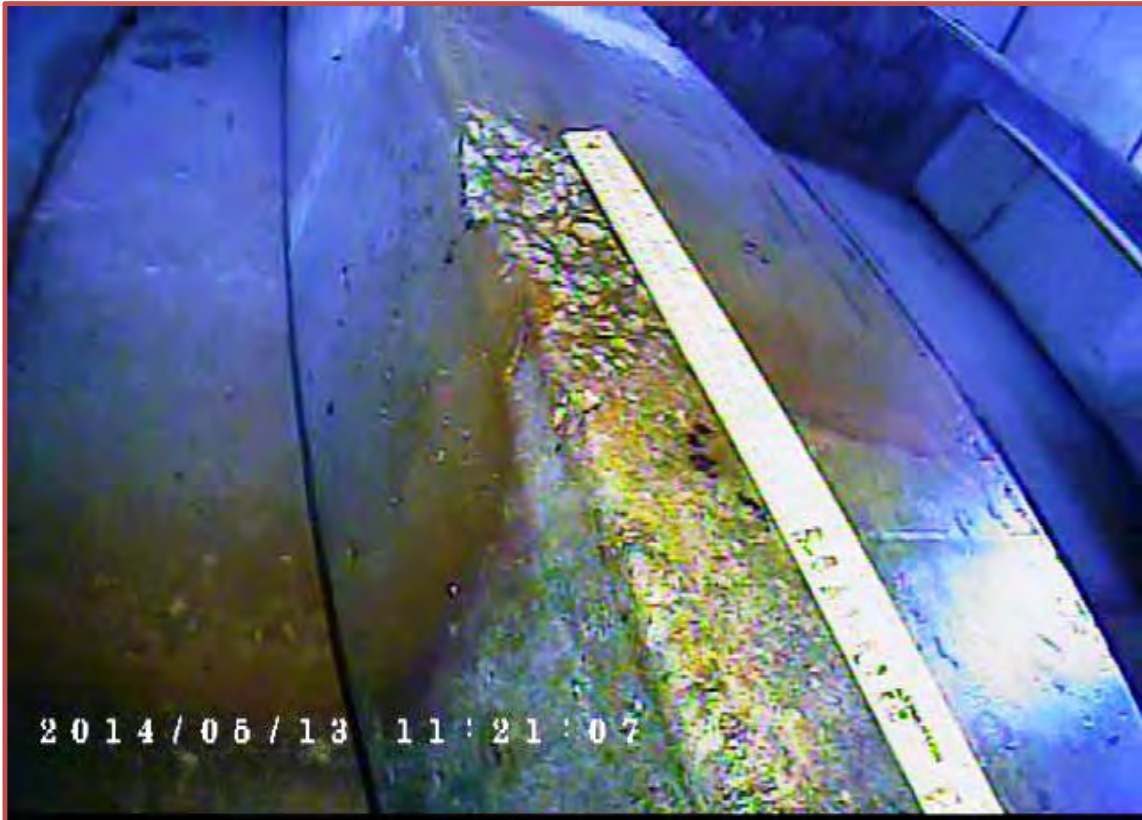
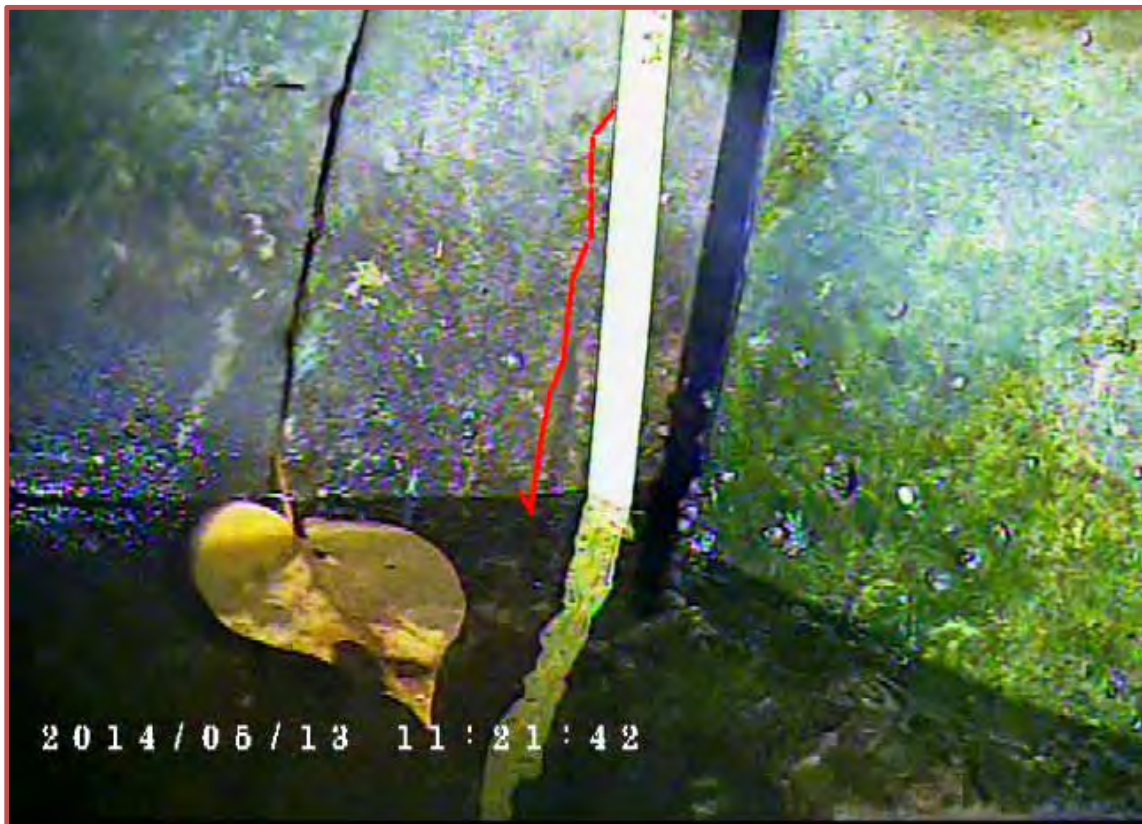
\_Piles 1-1, 1-7, 2-1, 2-2, 2-3, 2-5 and 2-7 have minor construction-related spalls up to 8" x 6" x 3/4".

\_Abutment 2 backwall, West side of Pile 2-2 has a vertical crack 12" x 1/64". **UW Photo 02. NEW.**

Description: Top: Piles have minor construction-related spalls up to 8" x 6" x 3/4". **UW Photo 01.**  
Bottom: Abutment 2 backwall, West side of Pile 2-2, vertical crack. **UW Photo 02.**

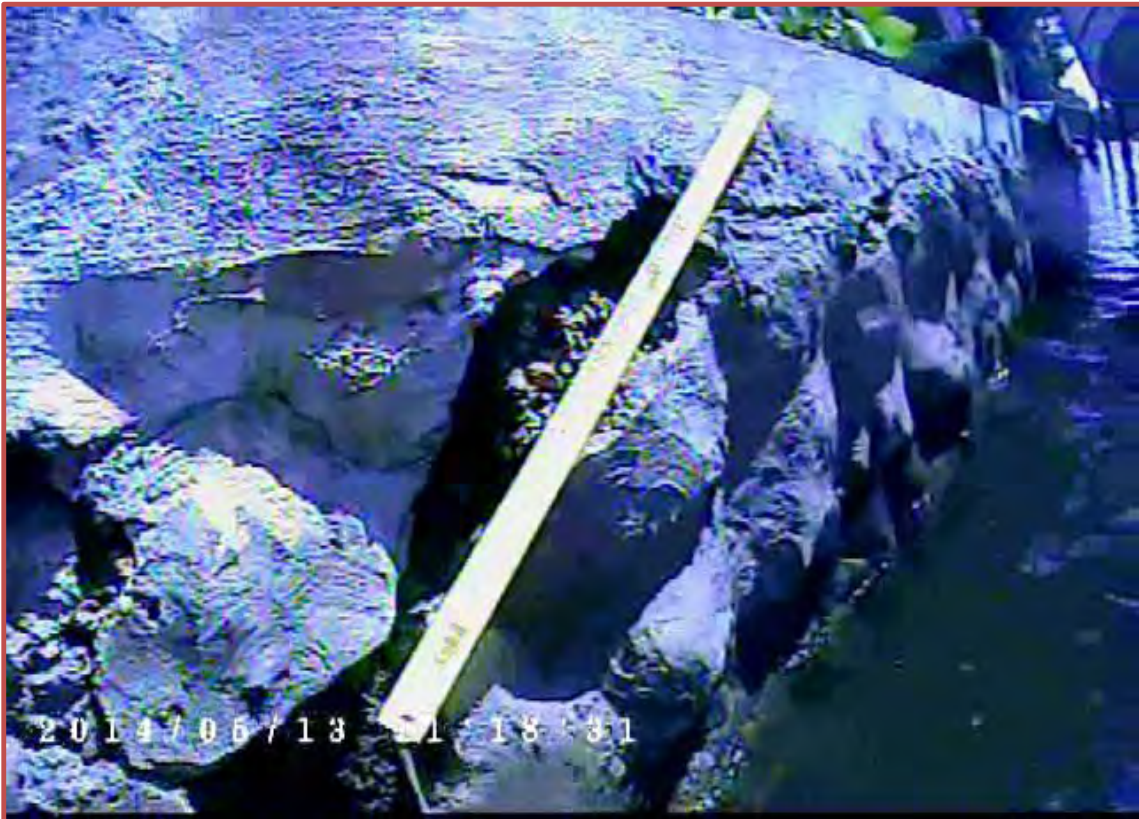
\_Abutment 2, NE seawall adjacent to the private sector, has a diagonal/void 30" L x 4" W, with up to 25" penetration. Minor backfill leakage was observed during this inspection. **UW Photo 03. NEW**

Description: Abutment 2 NE seawall, has a diagonal/void with up to 25" penetration. **UW Photo 03.**

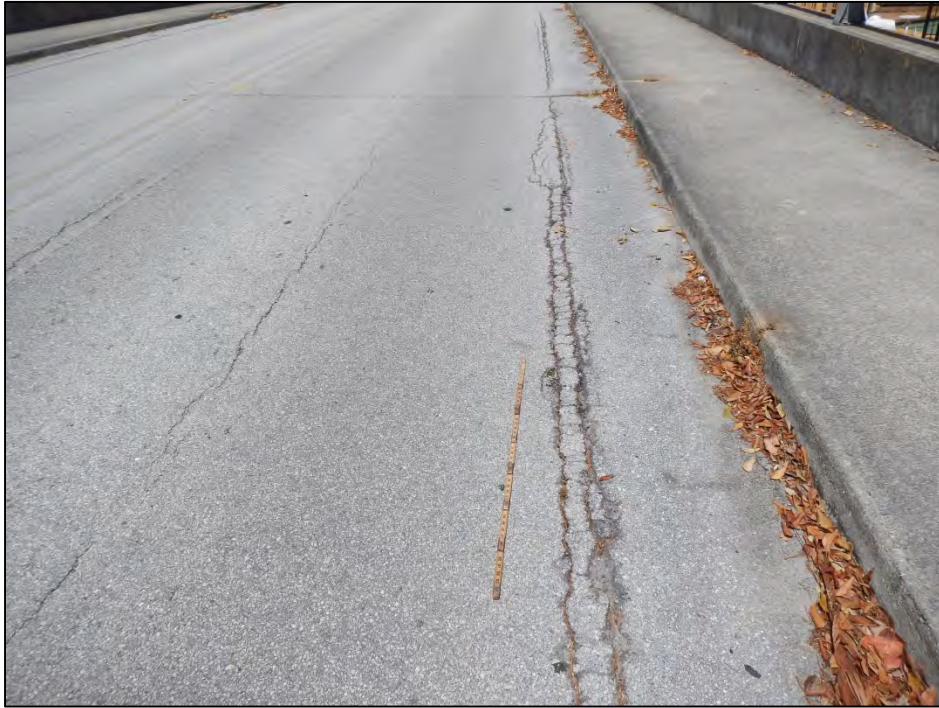
- The asphalt overlay has up to  $\frac{1}{8}$  in. wide longitudinal cracks over the slab unit joints.
- The asphalt overlay in all three spans is starting to upheave with minor rutting and impending potholes along the longitudinal cracks located 2 ft. from the curbs. See Condition Photo 1.
- The asphalt overlay over the expansion joints has transverse cracks up to  $\frac{1}{4}$  in. wide.
- The sidewalks have up to  $\frac{1}{64}$  in. wide longitudinal cracks over the bents.

Photo 1 – Rutting in the asphalt overlay.

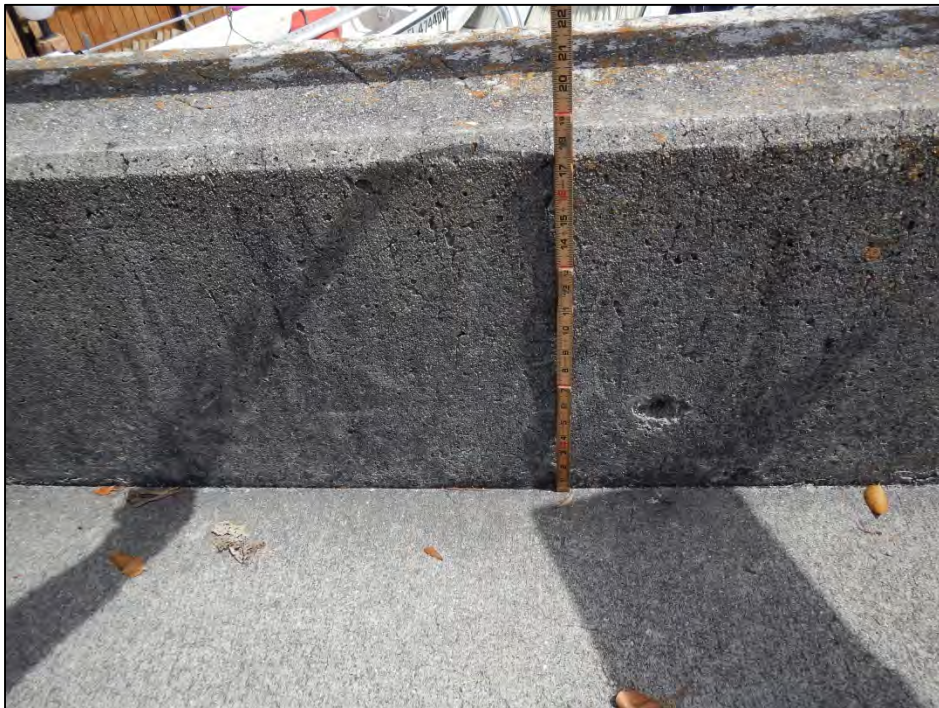
- The south face of the left parapet, 3 ft. from Bent 2, has a 2 in. x 2 in. spall with exposed steel. See Condition Photo 2.
- The concrete parapets have up to  $\frac{1}{64}$  in. wide vertical cracks, primarily under the aluminum handrail anchors.
- The mounting hardware for the aluminum handrails has minor surface corrosion.
- The tree growing from the south end of Abutment 1 is beginning to grow into the right (south) bridge rail and around the aluminum handrail.

Photo 2 – Spall in the south face of the left parapet.
