## **EXECUTIVE SUMMARY**

TranSystems has been retained by the City of Fort Lauderdale to perform bridge inspections and prepare bridge inspection reports for each of the City's bridges as part of the project Structural Bridge Engineering Consulting Services Master Plan, RFQ No. 946-11310. Inspections were completed and reports prepared for 46 of the City's bridges. The remaining five bridges in the City's inventory were not inspected because they are in the process of being replaced.

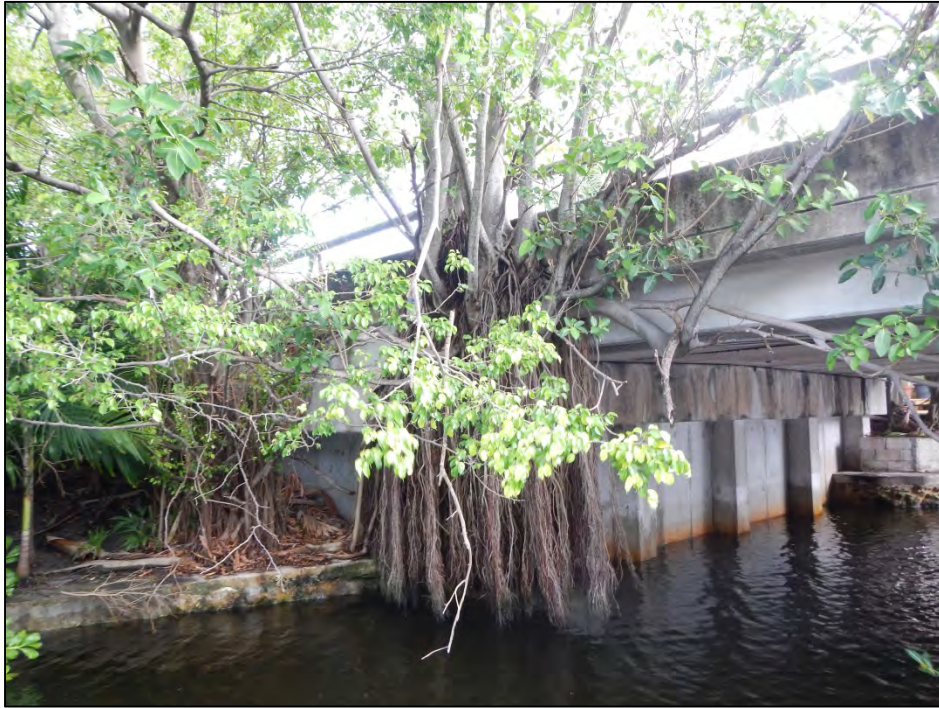
Photo 3 – Tree growing at the south end of the Abutment I cap.

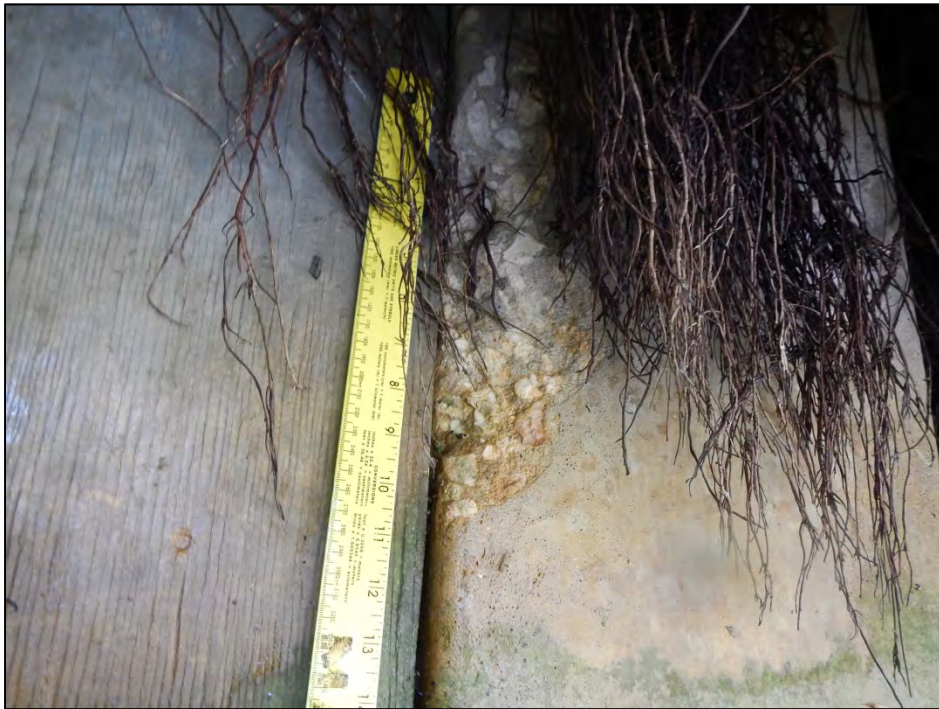
Photo 4 – Spall in Pile I-5.

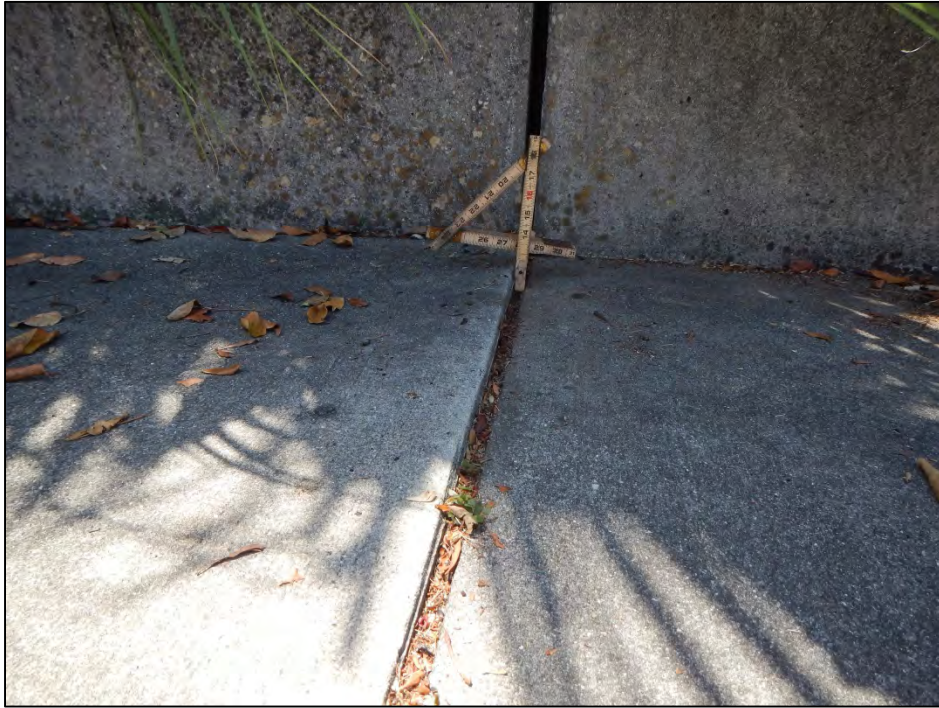
Photo 5 – Settlement in the southeast approach sidewalk.

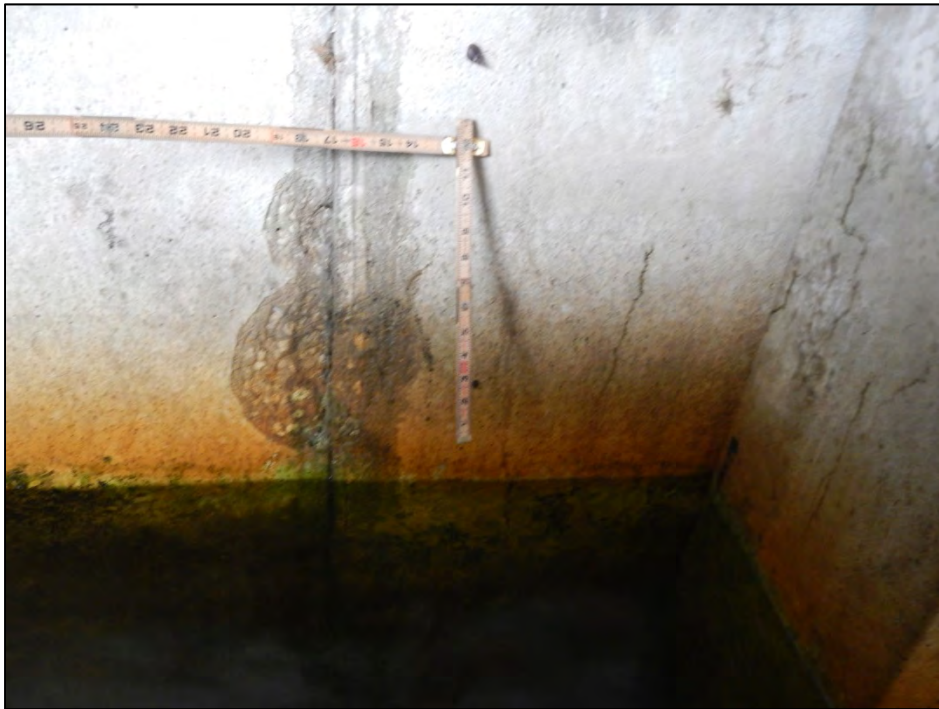
Photo 6 – Spall in the sheet piles at Abutment I retaining wall.

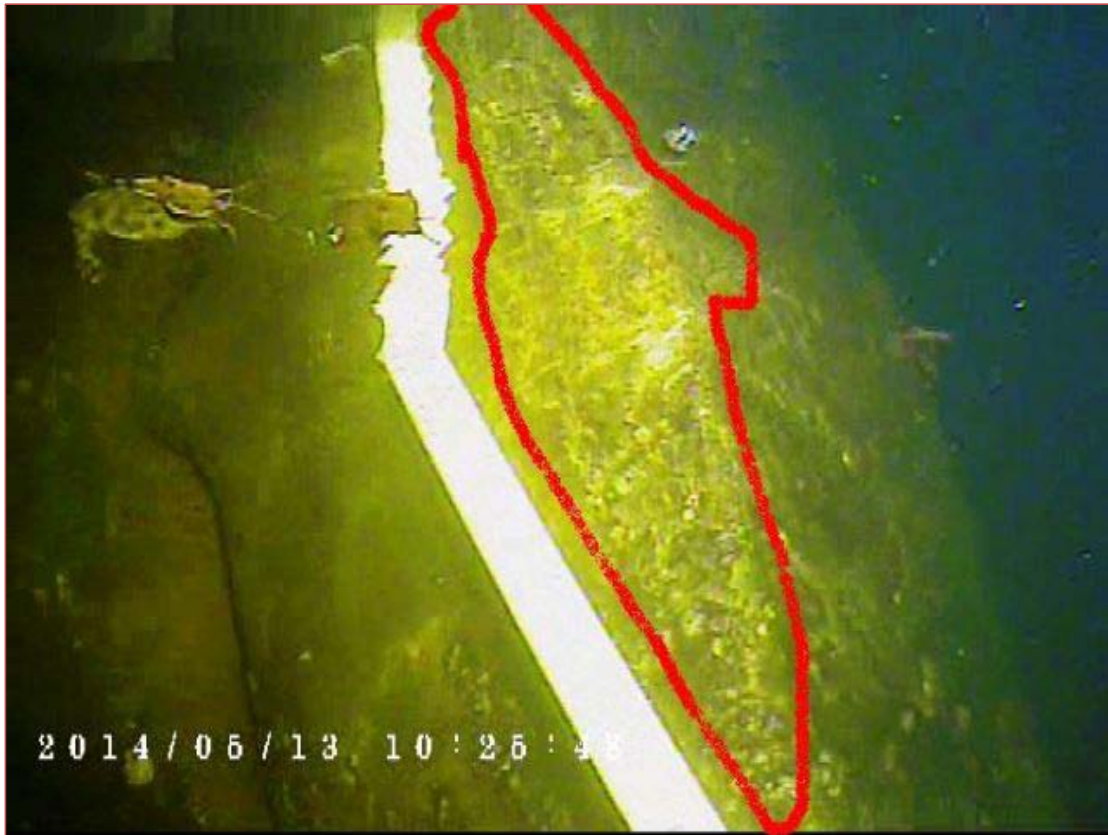
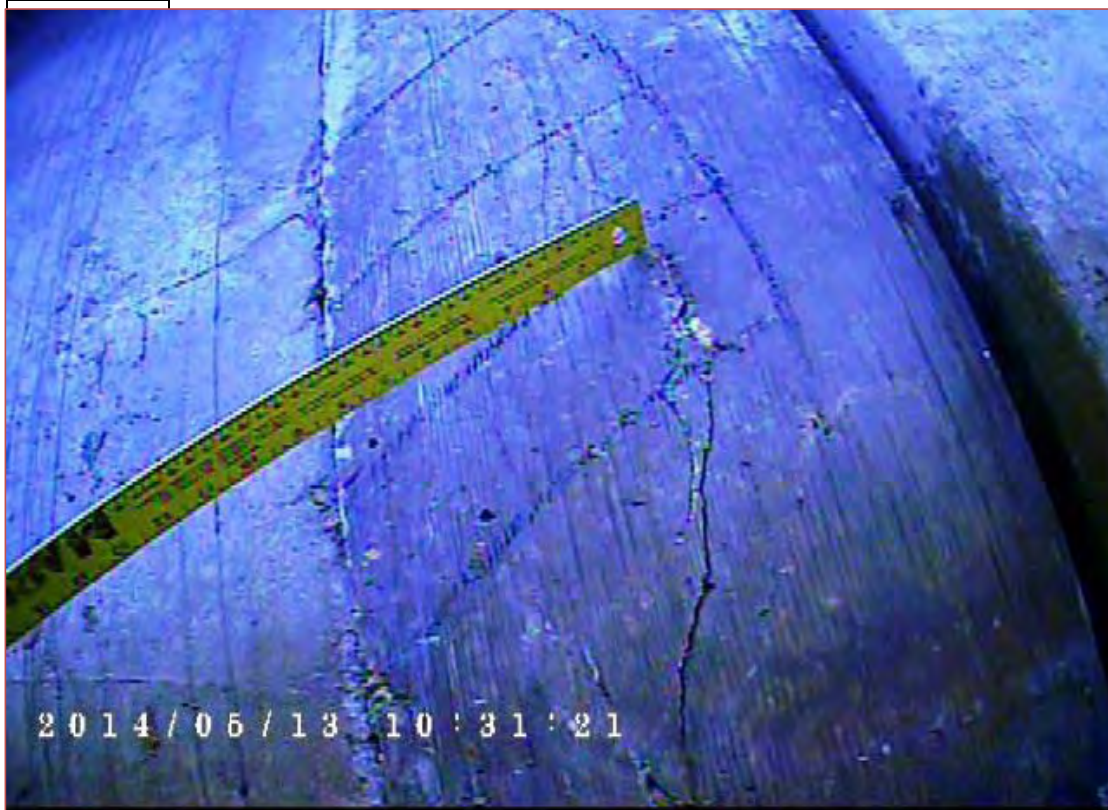
Description: Top: Pile 4-4, NW corner spall, starting 60" below the cap. **UW Photo 01.**  
Bottom: Westernmost sheet pile of the NE retaining wall, delamination. **UW Photo 02.**

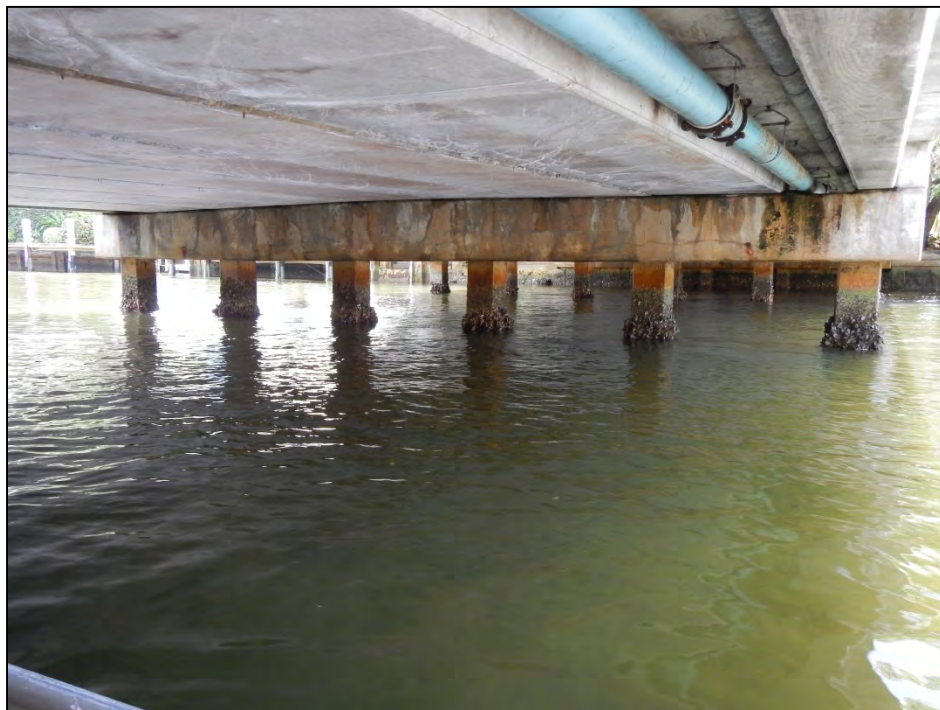
Concrete Slab Underside and Concrete T-beam. Note Utility Pipe.

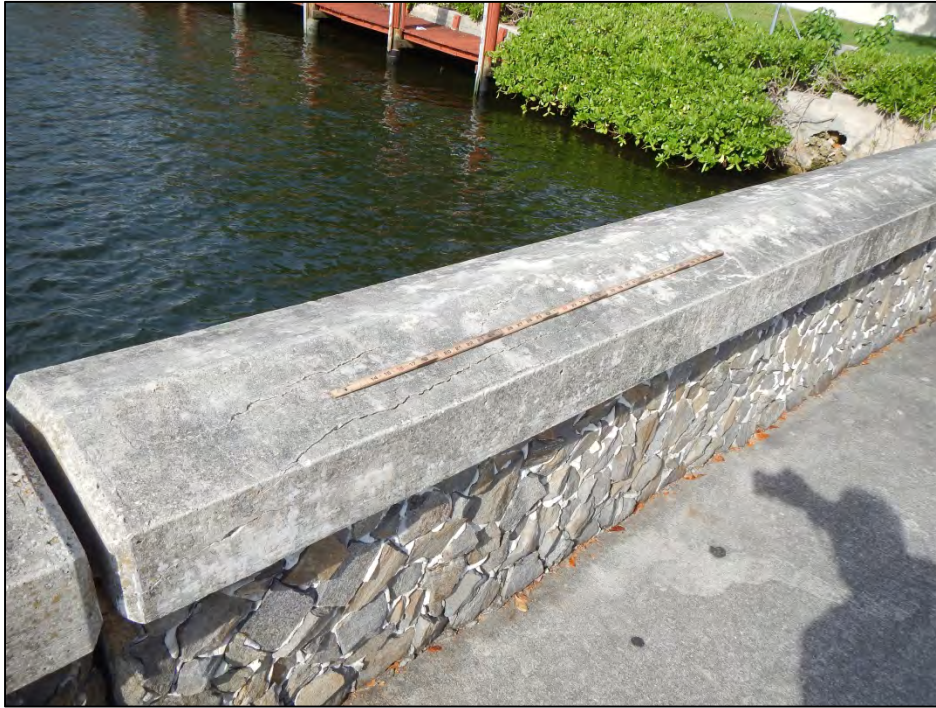
Photo 1 – Delamination in the top face of the railing in Span I.

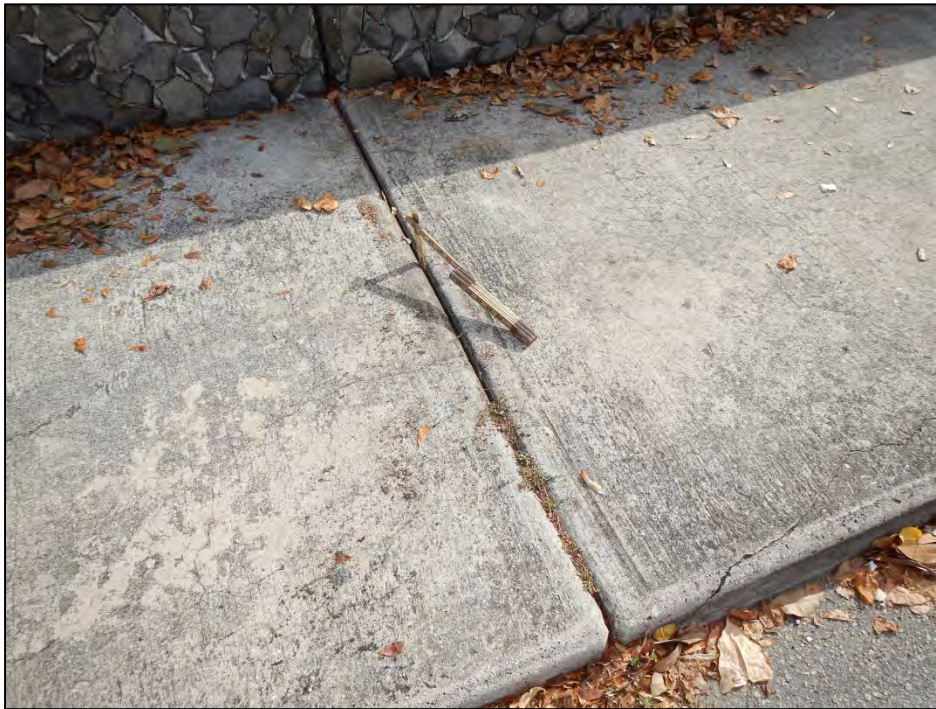
Photo 2 –Deteriorated sidewalk joint sealant.

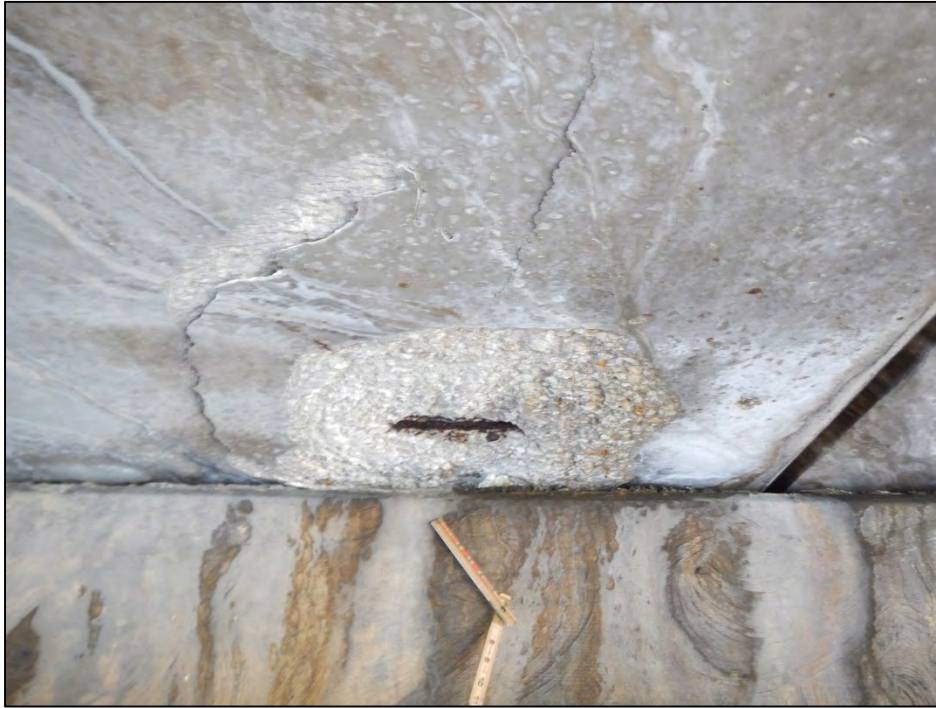
Photo 3 – Spall with exposed rebar in the underside of Slab Unit 1-2.

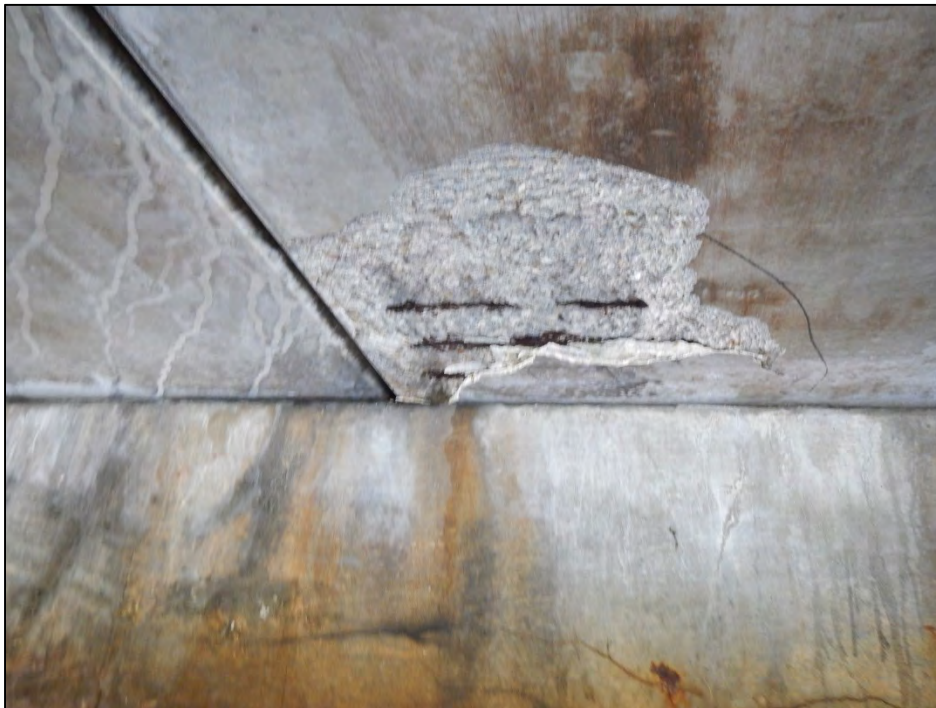
Photo 4 – Spall with exposed rebar in the underside of Slab Unit 3-4.

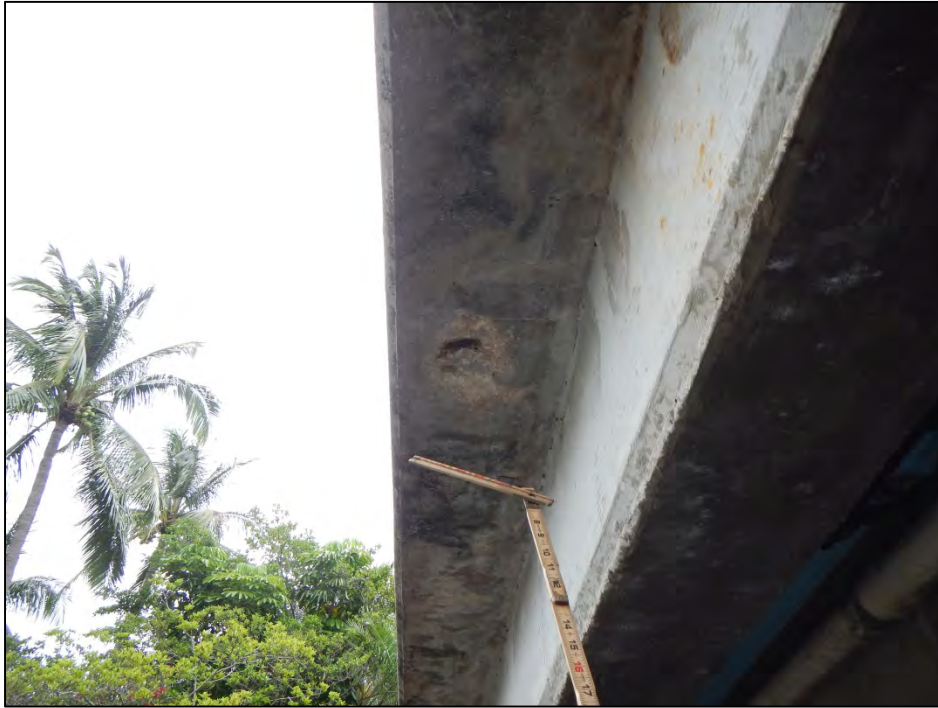
Photo 5 – Spall in the underside of the left sidewalk in Span 2.

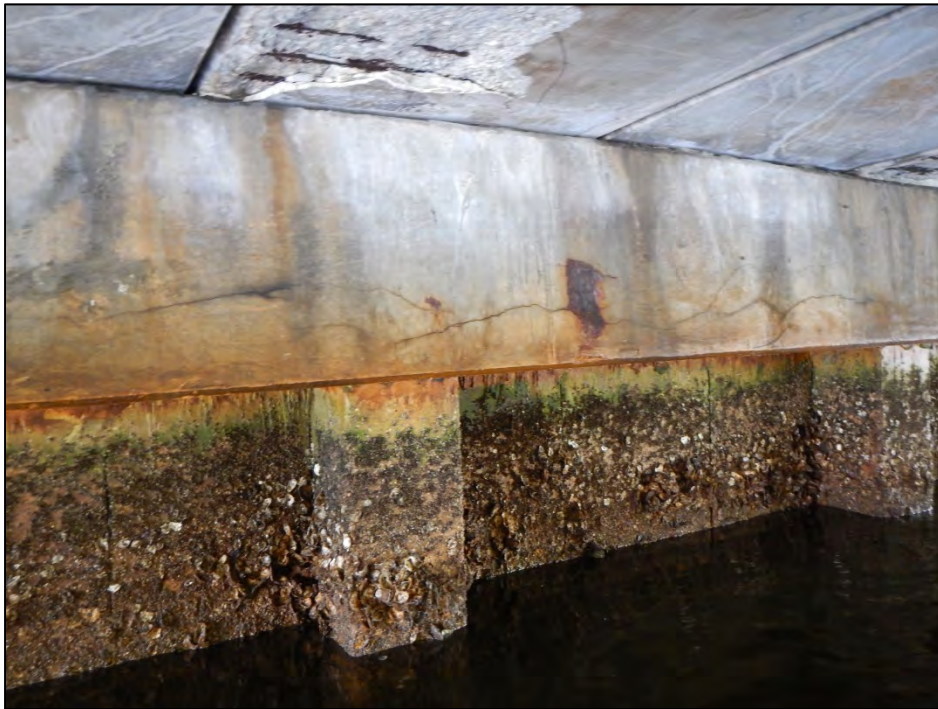
Photo 6 –Delamination at Abutment 4 cap.

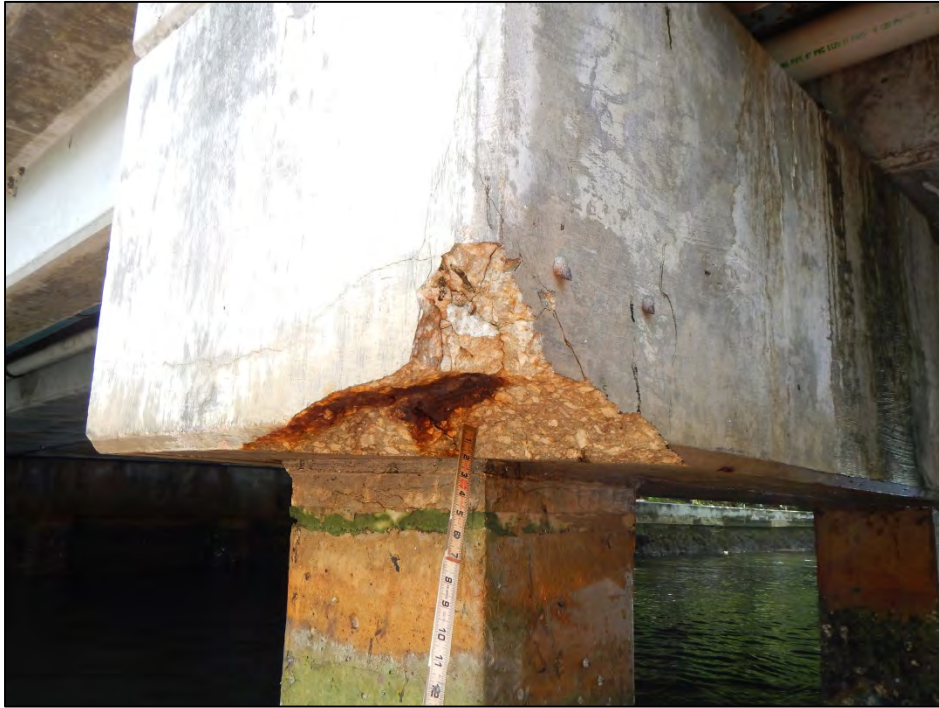
Photo 7 – Spall in the underside of the Bent 3 cap.

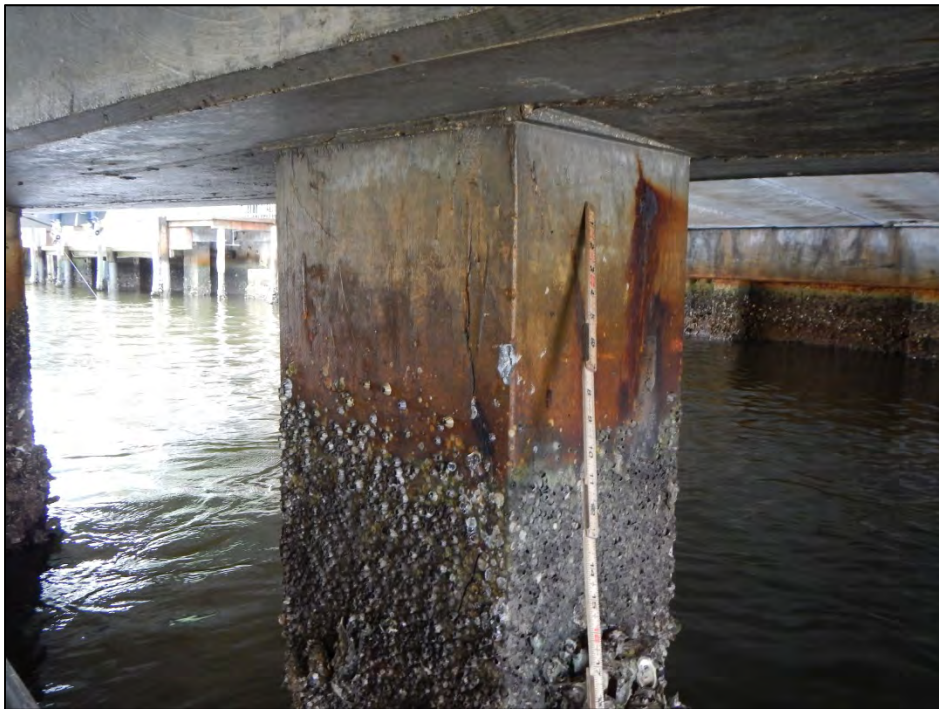
Photo 8 – Typical delamination and corrosion staining on Pile 3-4.

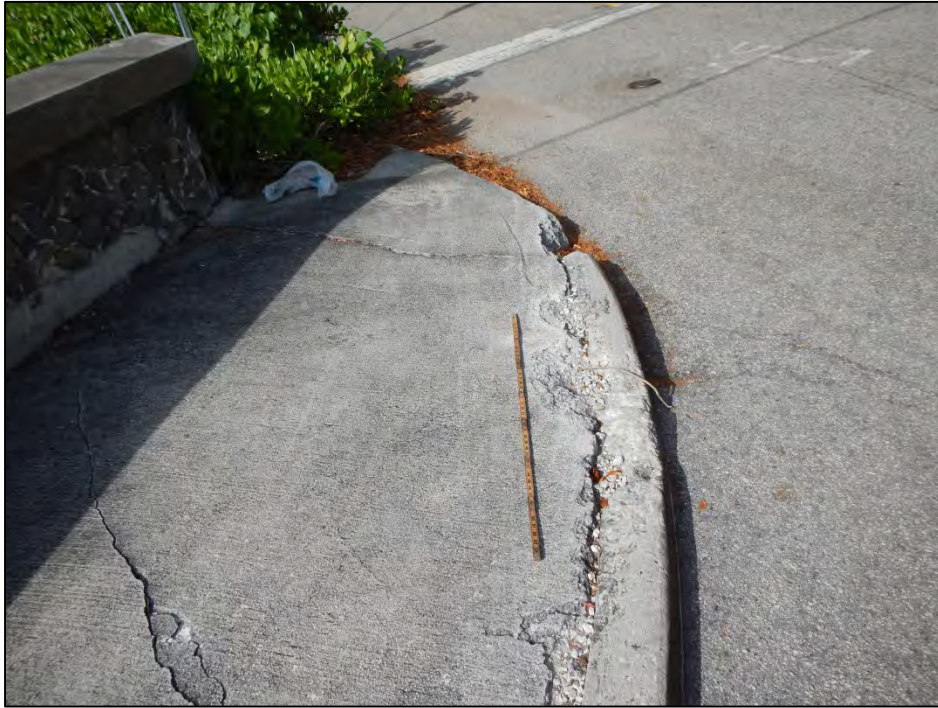
Photo 9 –Spall in the southwest approach curb.

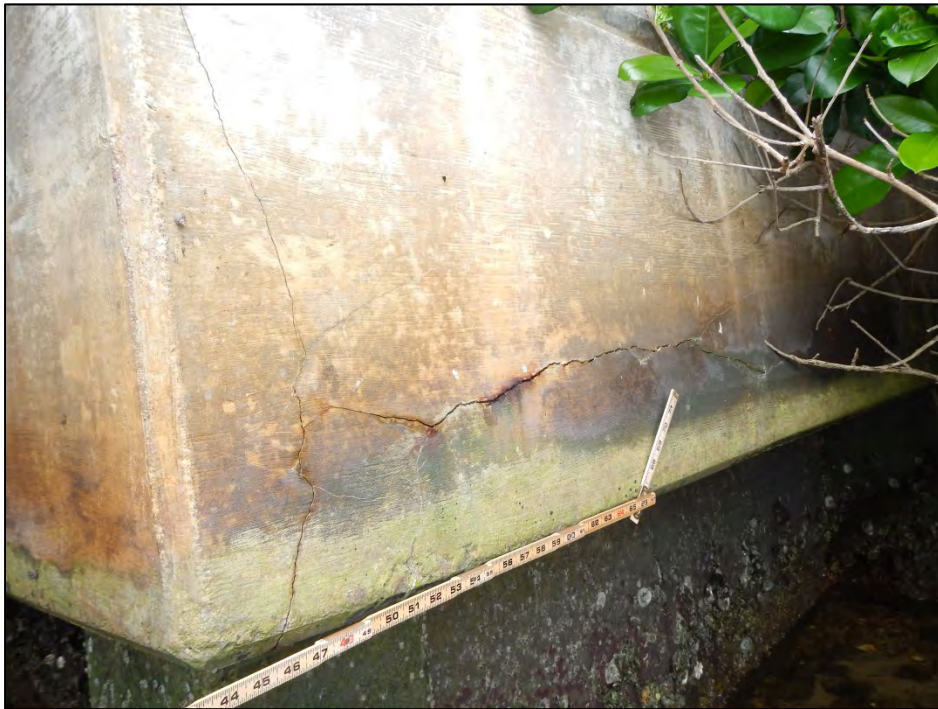
Photo 10 – Delamination in the northwest retaining wall cap.

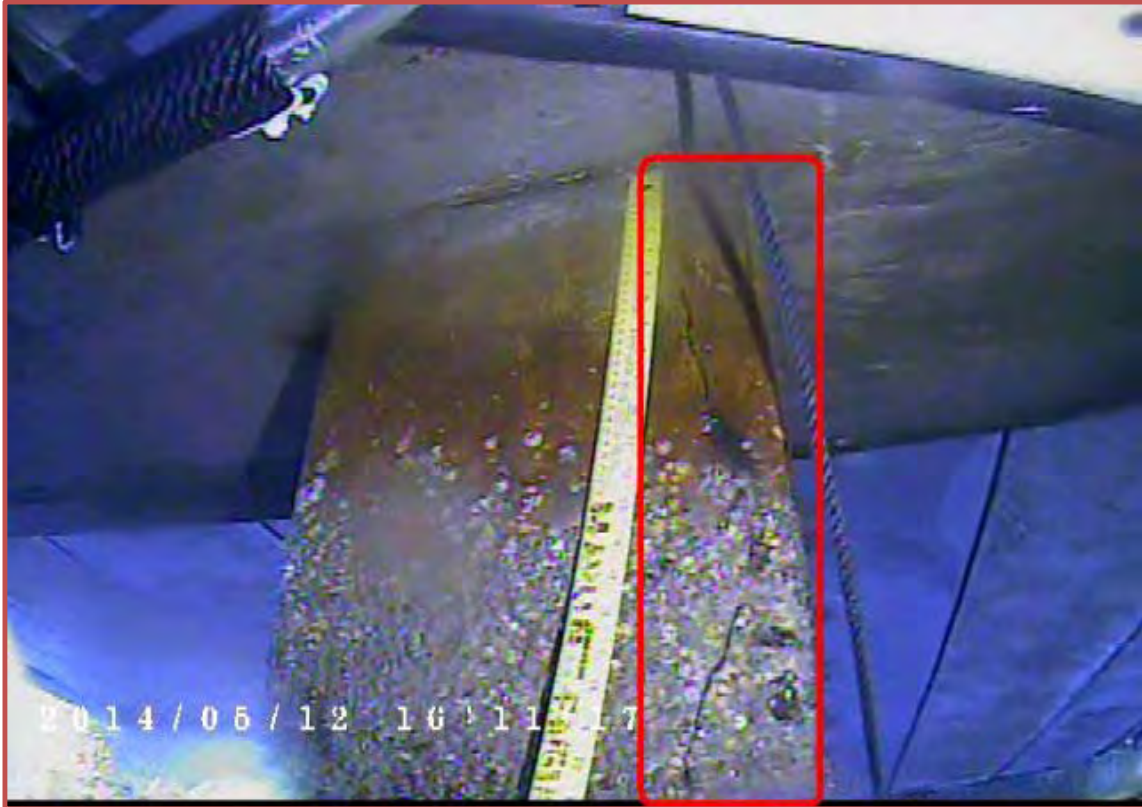
\_Pile 3-4, all four corners are delaminated up to 24" x 10", with corrosion bleed-out starting at the cap.

Description: Top: Pile 3-4, all four corners are delaminated, with corrosion bleed-out. **UW Photo 01.**  
Bottom: Pile 3-5, NW, SW and SW corners, delaminated with CBO. **UW Photo 02.**

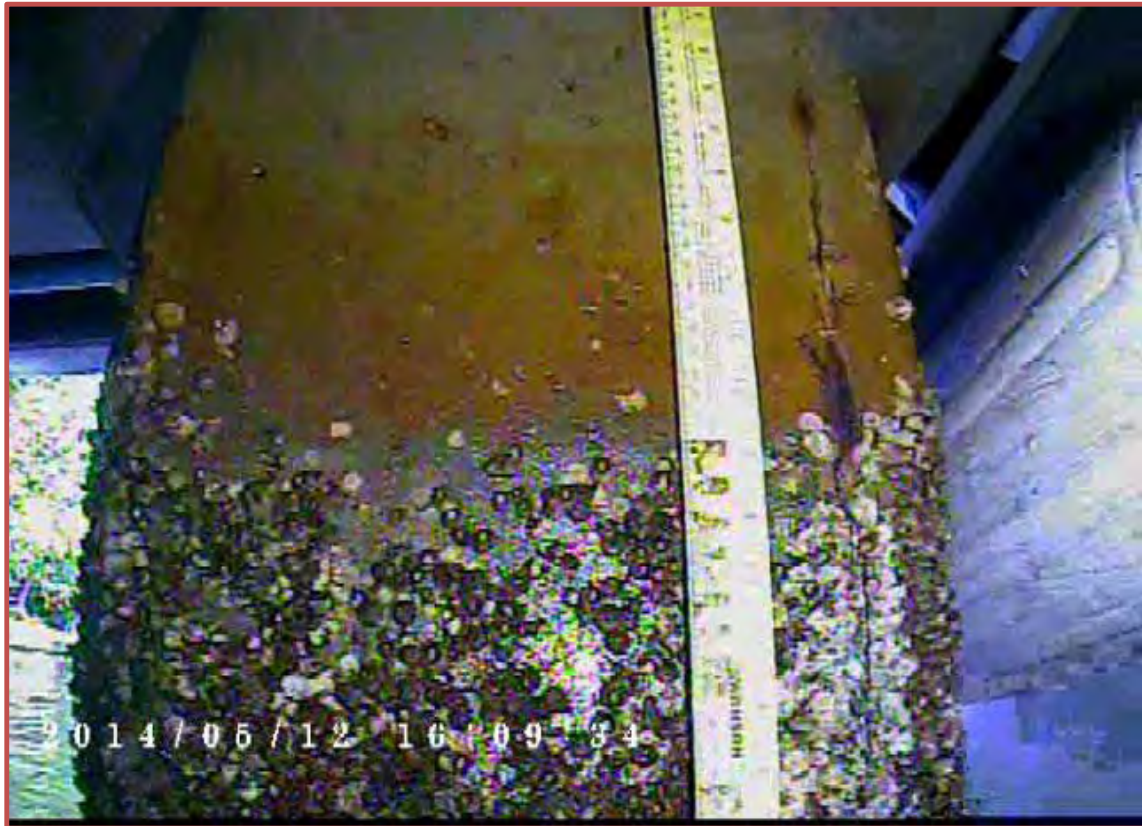
\_Pile 3-5, NW, SW and SE corners are delaminated up to 22" x 7", with corrosion bleed-out, starting at the cap. **UW Photo 02. NO CHANGE.**

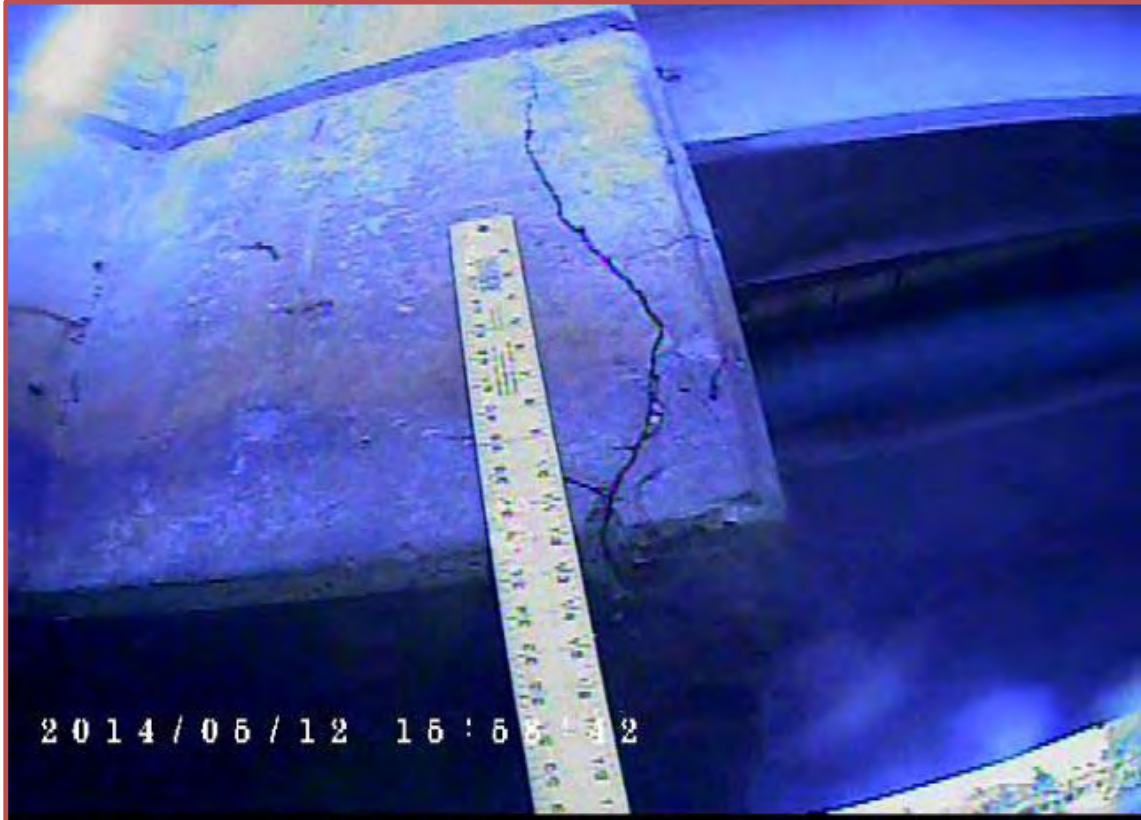
\_Abutment 1 cap, South end has a delamination 28" x 18", with corrosion bleed-out. **UW Photo 03. INCREASE.**

Description: Top: Abutment 1 cap, South end, delamination with corrosion bleed-out. **UW Photo 03.**  
Bottom: Abutment 4 cap, North end, spall/delamination, with exposed steel. **UW Photo 04.**

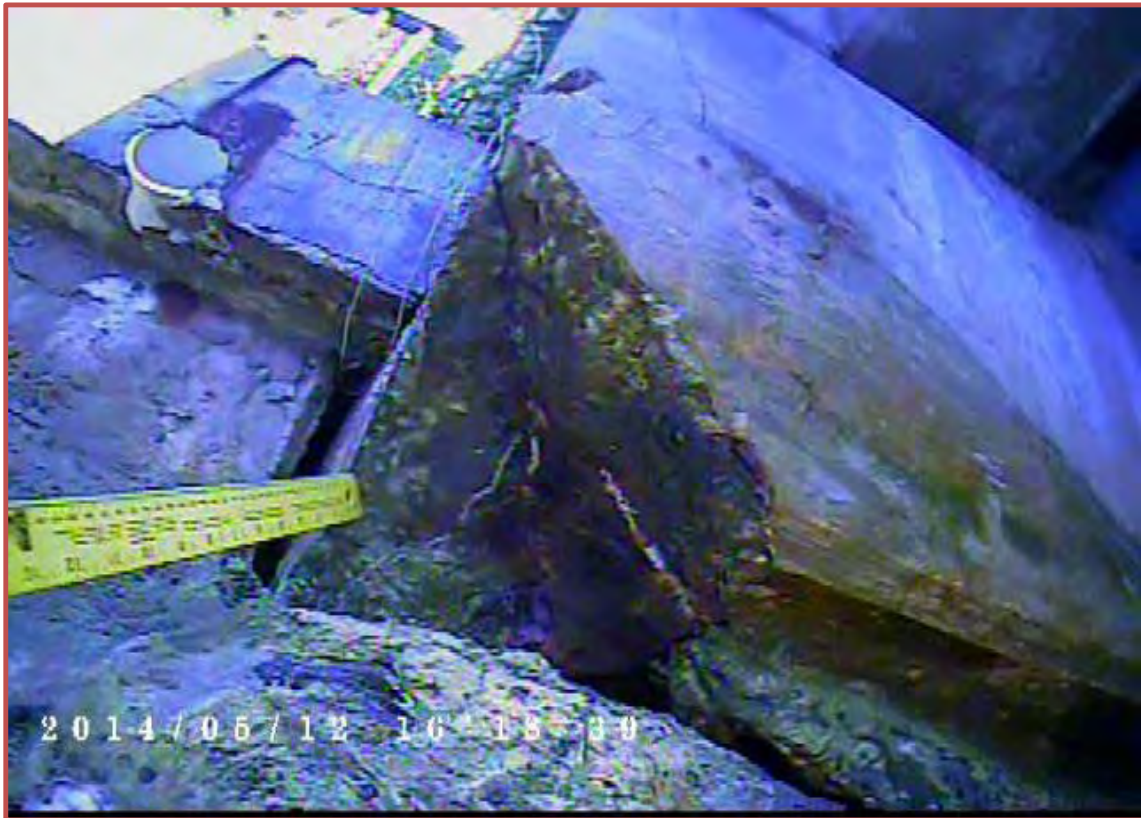
\_Abutment 4 cap, NW end, spall/delamination 28" x 24" x 4", with exposed steel and associated cracks up to 1/32", corrosion bleed-out. **UW Photo 04. INCREASE.**

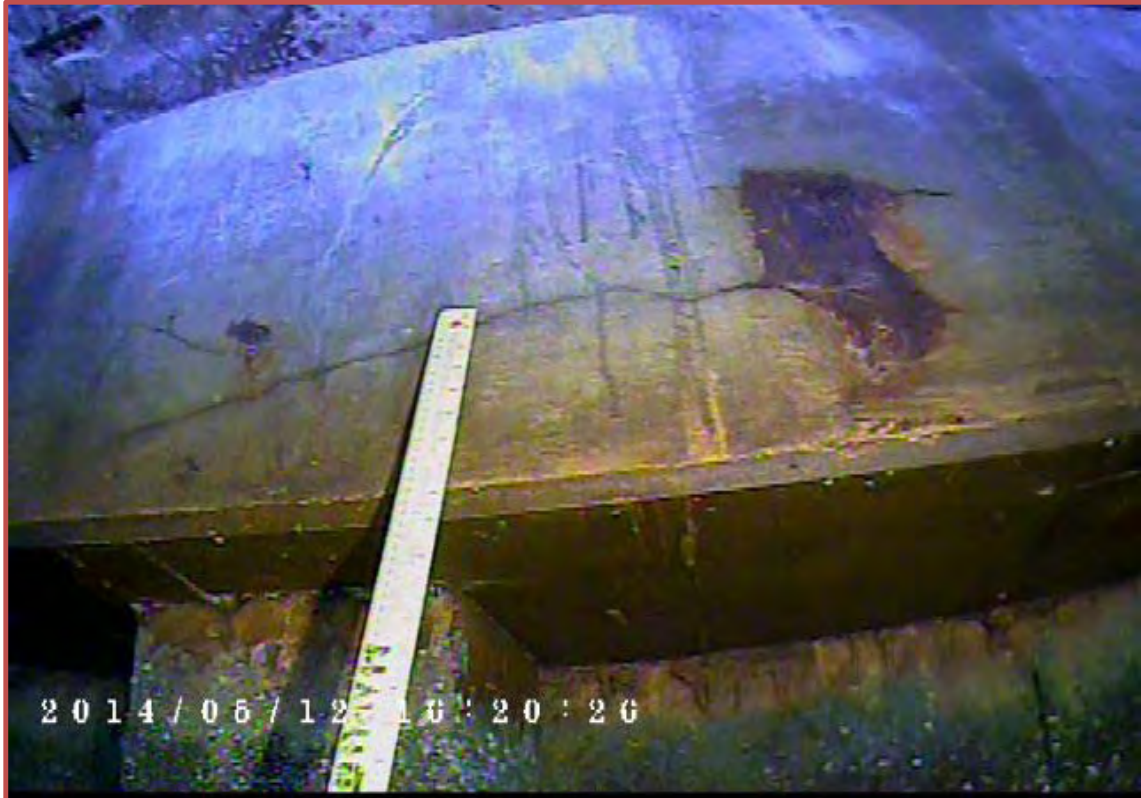
\_Abutment 4 cap, over Piles 3-3 to 3-4, delamination up to 8' x 10", with associated cracks up to 1/32" and corrosion bleed-out. **UW Photo 05. INCREASE.**

Description: Top: Abutment 4 cap, over Piles 3-3 to 3-4, delamination with cracks. **UW Photo 05.**  
Bottom: Abutment 4 cap, South end, delamination with associated cracks. **UW Photo 06.**

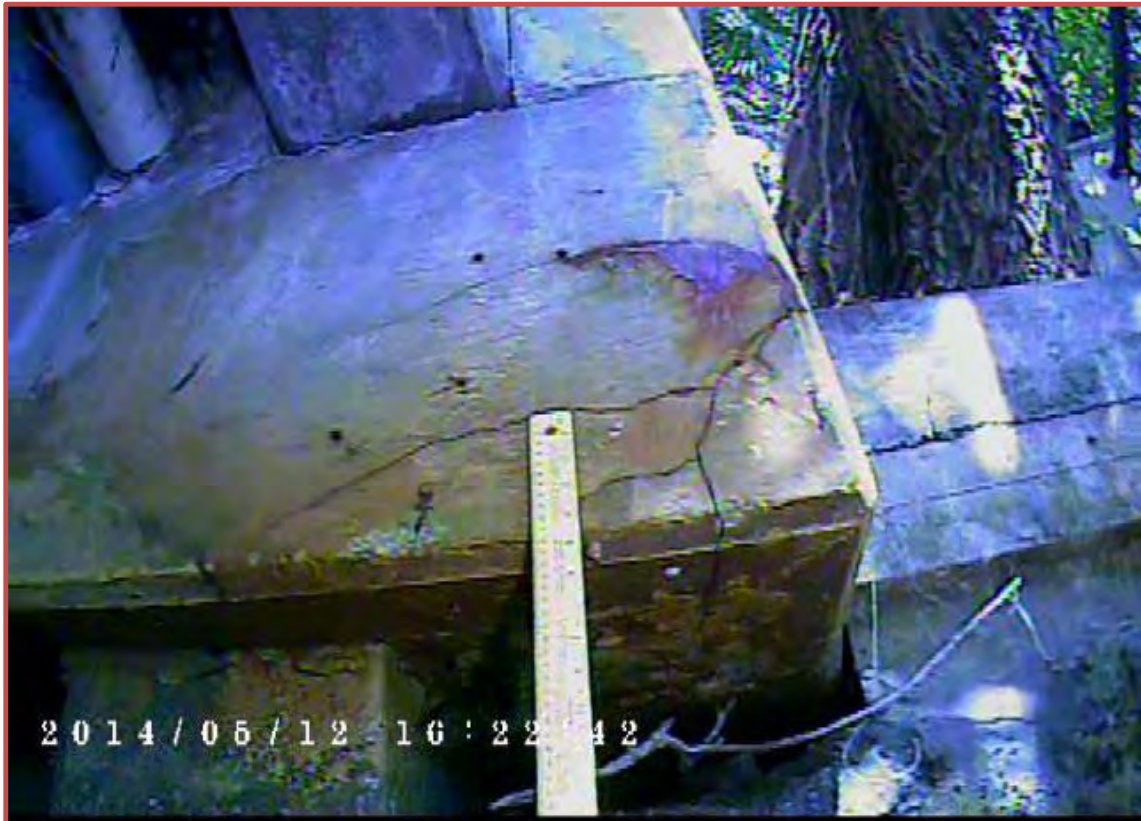
\_Abutment 4 cap, South end, delamination 22" x 20", with associated cracks up to 1/32", and corrosion bleed-out. **UW Photo 06. NEW.**

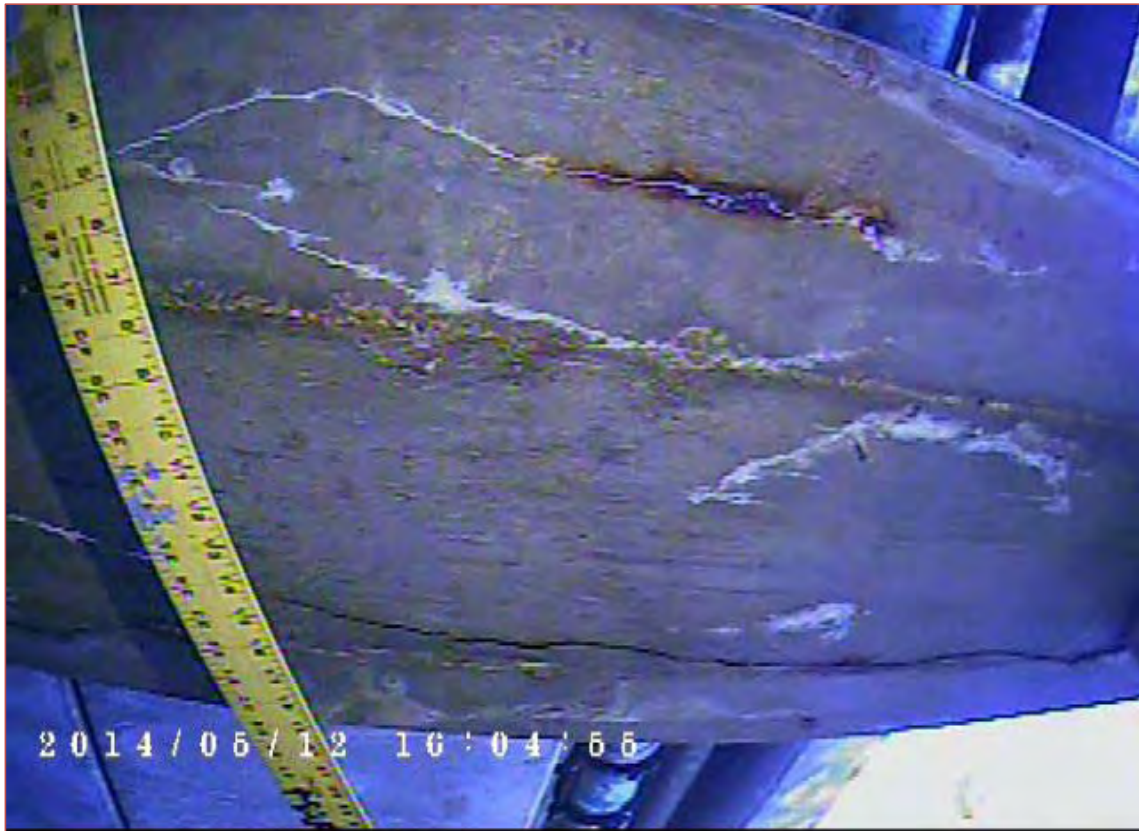
\_Bent 2 and 3 caps each exhibit full length x 18" H, delamination with associated cracks up to 1/8" W and corrosion bleed-out along the bottom 18" of the East and West faces. **UW Photo 07. INCREASE.**

Description: Top: Bent 2 and 3 caps, delamination with associated cracks and CBO. **UW Photo 07.**  
Bottom: Bent 3 cap NW end, spall/delamination, with associated cracks. **UW Photo 08.**

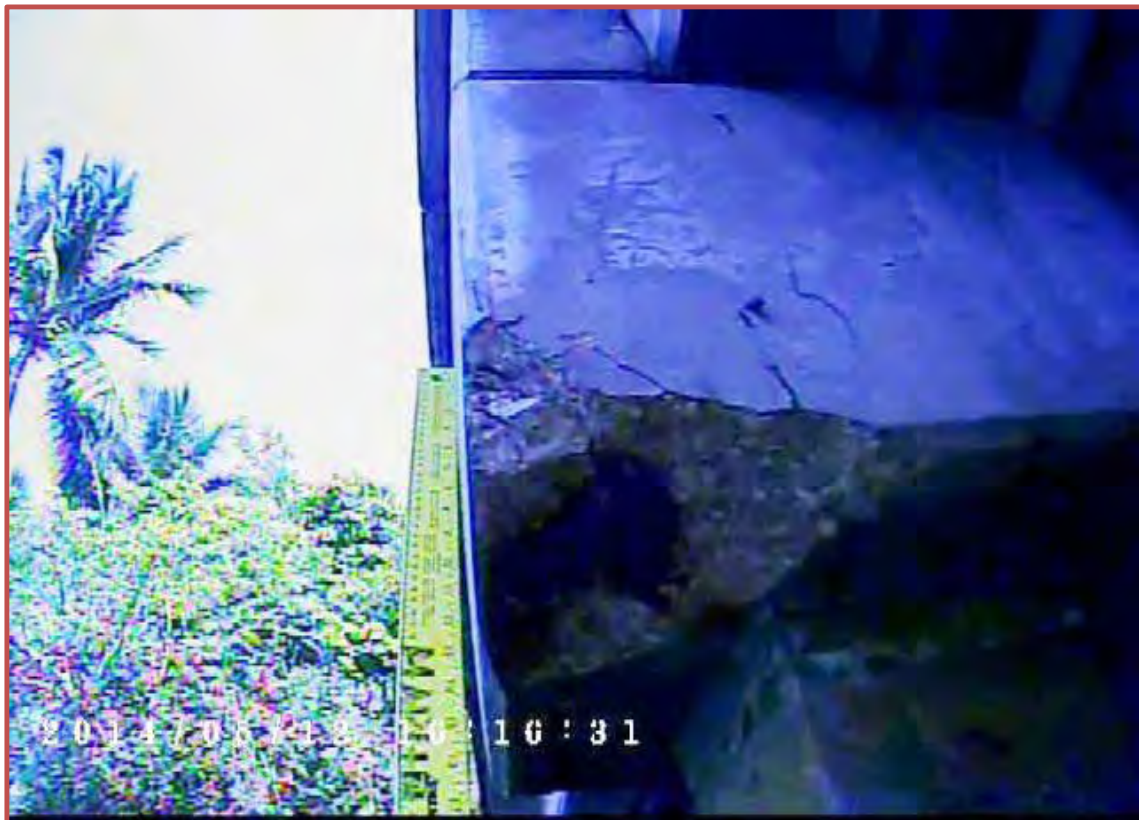
\_Bent 3 cap NW end has a spall/delamination 16" x 13" x 4" with associated cracks up to 1/16" W and corrosion bleed-out. **UW Photo 08. INCREASE.**

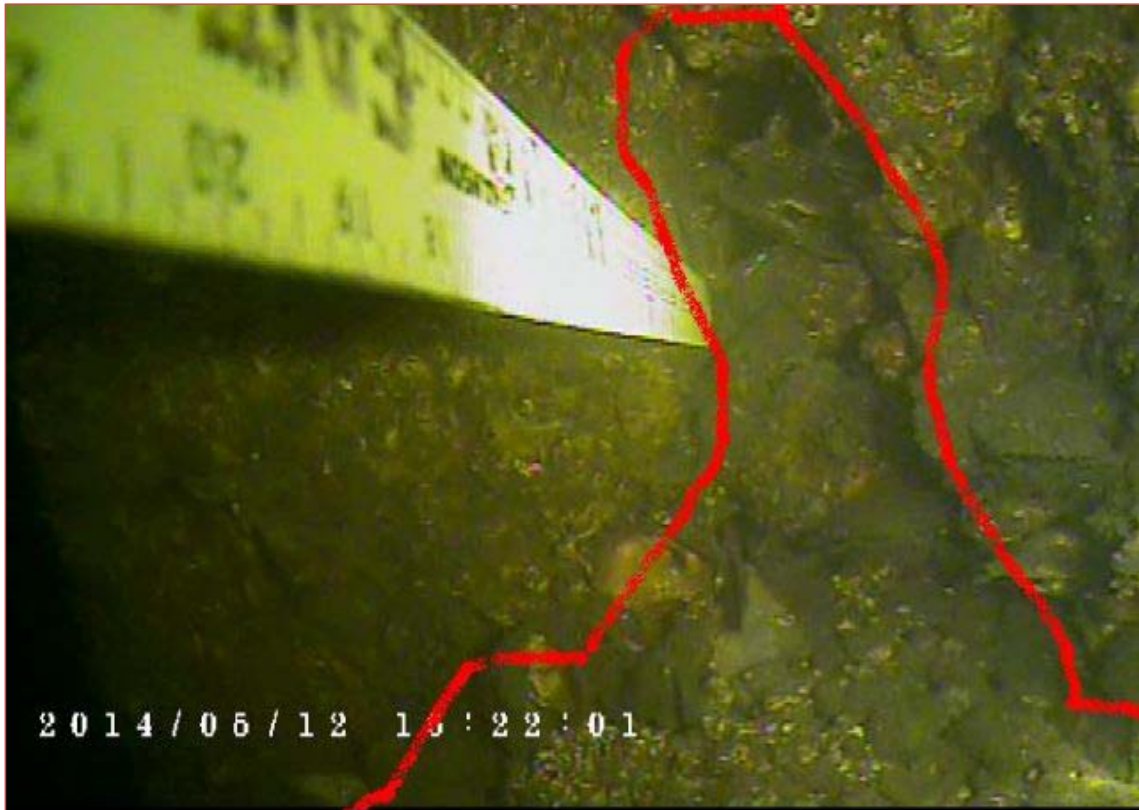
\_South side of Pile 4-5 at Abutment 4, there is a spall/void 6" x 4", at the ground-line with minor backfill leakage. **UW Photo 09. NEW**

Description: Top: South side of Pile 4-5, at Abutment 4, spall/void, at the ground-line. **UW Photo 09.**  
Bottom: South side of Pile 4-5, at Abutment 4, void below the cap. **UW Photo 10.**

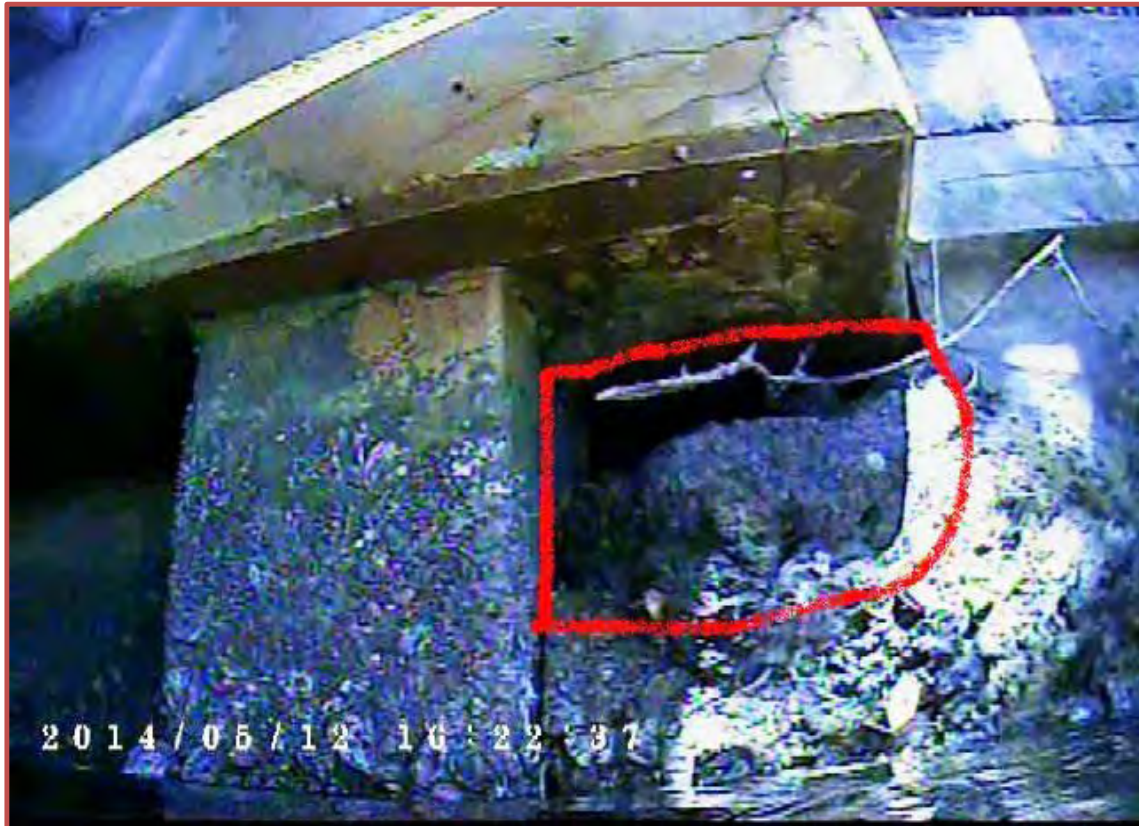
\_South side of Pile 4-5 at Abutment 4, below the cap there is a void area approximately 18" x 10" with 13" penetration. No backfill was observed at the joint locations during this inspection cycle.

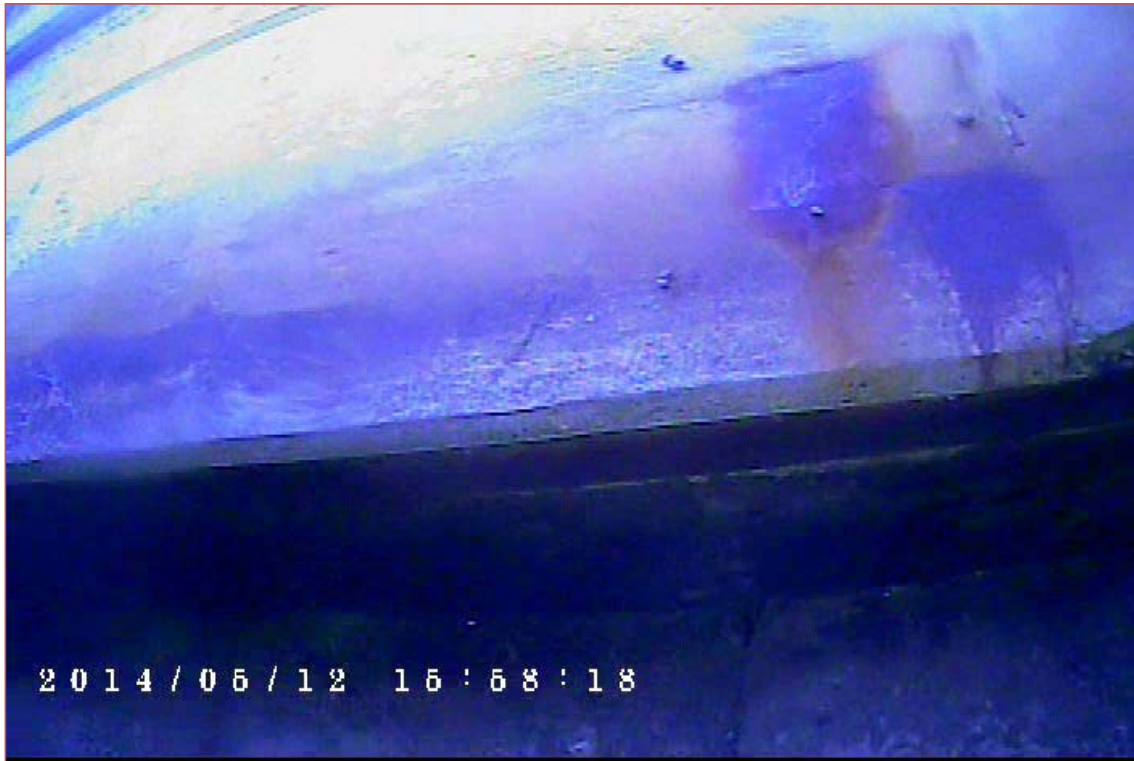
\_SW retaining wall cap has horizontal cracks with corrosion bleed-out, up to 1/16" wide throughout.

Description: Top: SW retaining wall cap has horizontal cracks with CBO, throughout.. **UW Photo 11.**  
Bottom: NW retaining wall cap has a delamination with CBO, East end. **UW Photo 12.**
