## **EXECUTIVE SUMMARY**

TranSystems has been retained by the City of Fort Lauderdale to perform bridge inspections and prepare bridge inspection reports for each of the City's bridges as part of the project Structural Bridge Engineering Consulting Services Master Plan, RFQ No. 946-11310. Inspections were completed and reports prepared for 46 of the City's bridges. The remaining five bridges in the City's inventory were not inspected because they are in the process of being replaced.

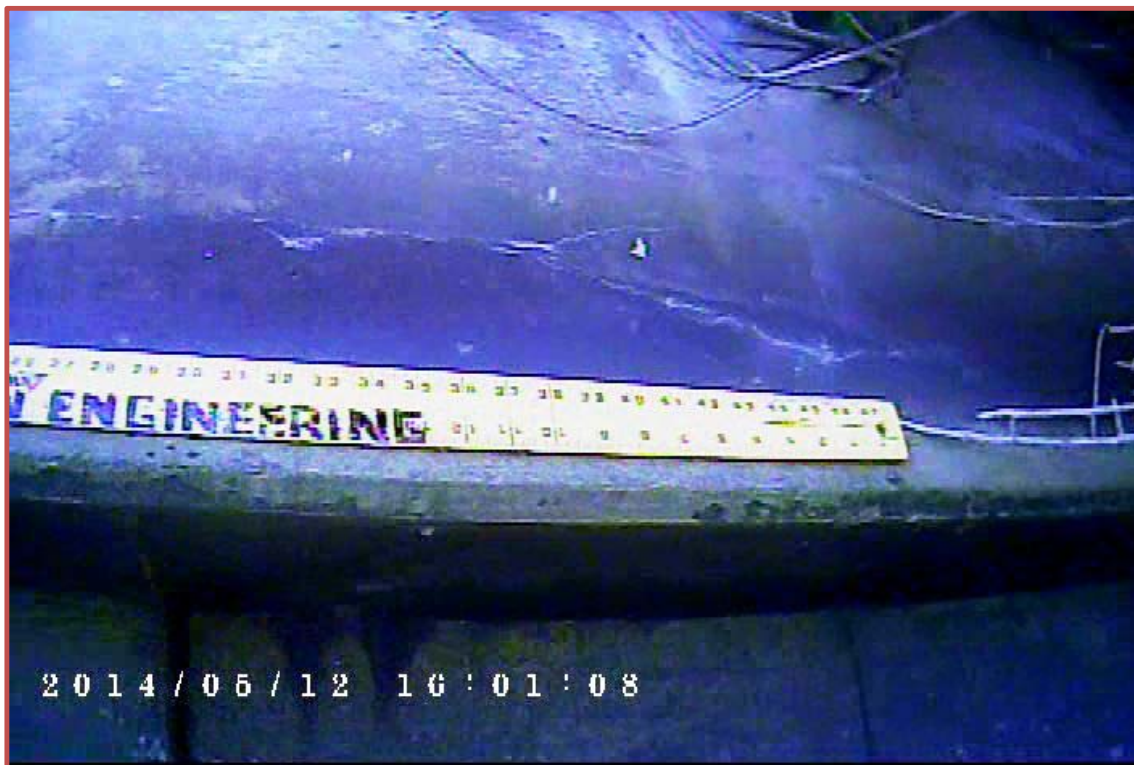
\_NW retaining wall cap has a delamination 8' x 16", with corrosion bleed-out along the East end.

Description: Top: SW retaining wall cap has horizontal cracks with CBO, throughout.. **UW Photo 11.**  
Bottom: NW retaining wall cap has a delamination with CBO, East end. **UW Photo 12.**

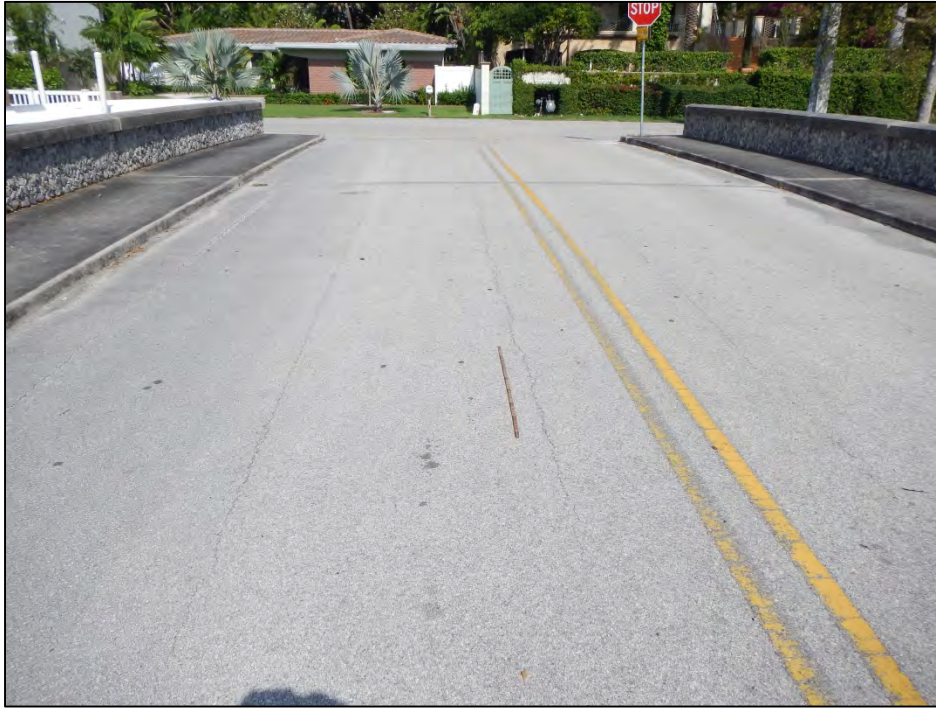
Photo 1 – Longitudinal crack in the asphalt.

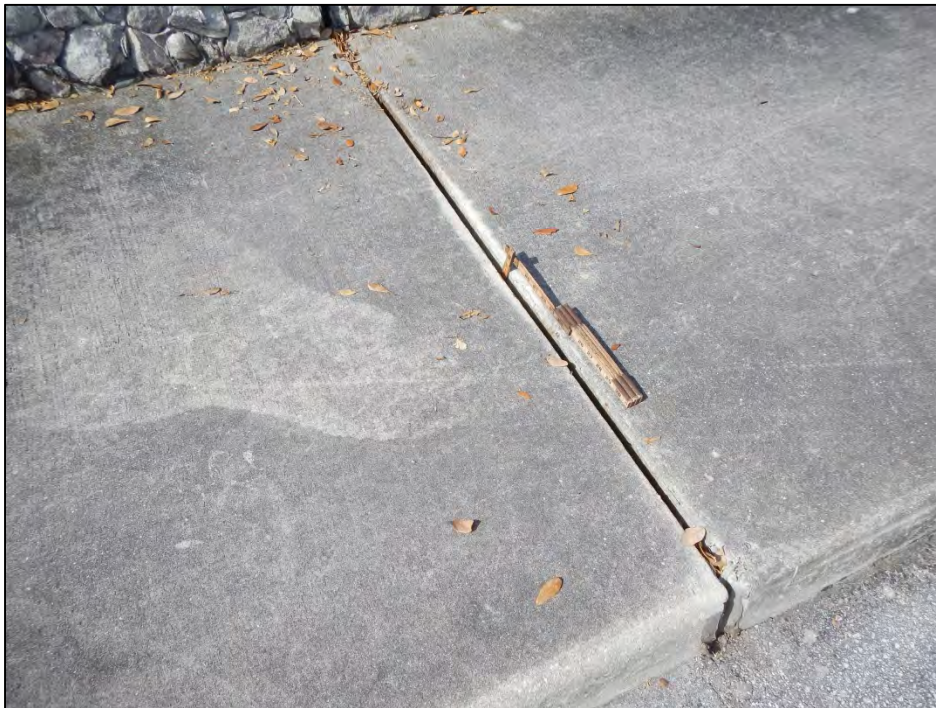
Photo 2 – Deteriorated sidewalk joint sealant.

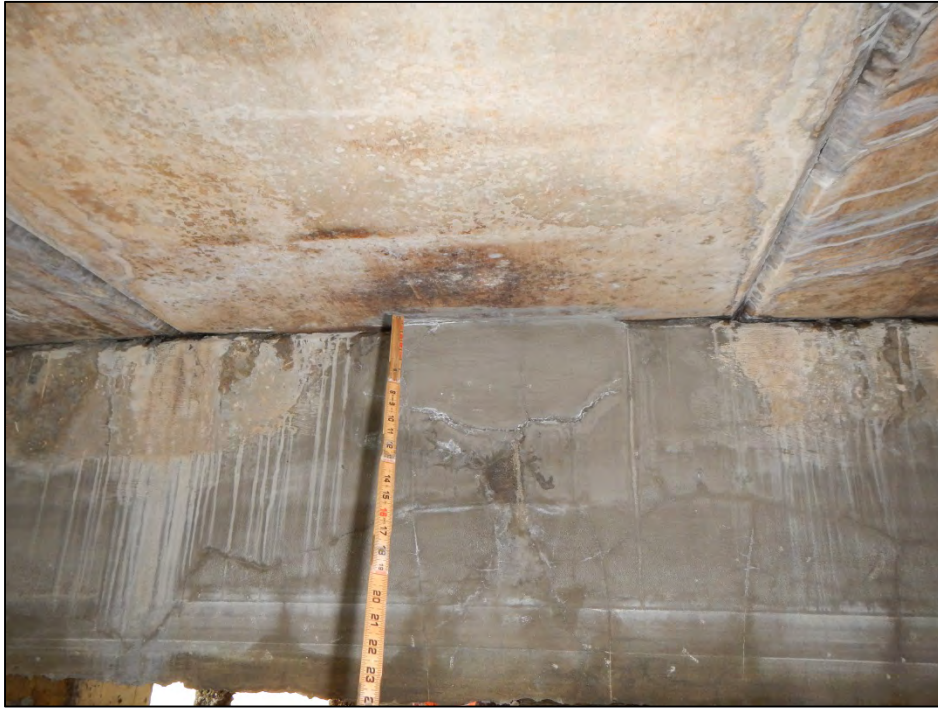
Photo 3 – Bent 2 cap delamination.

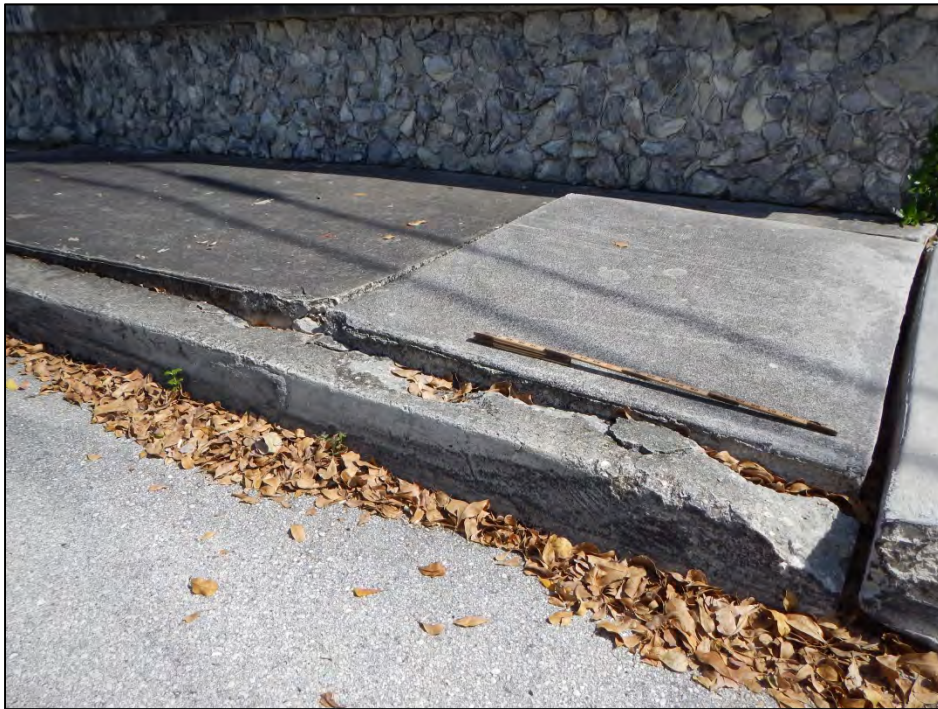
Photo 4 – Spalls and delaminations along the approach slab curb and sidewalk.

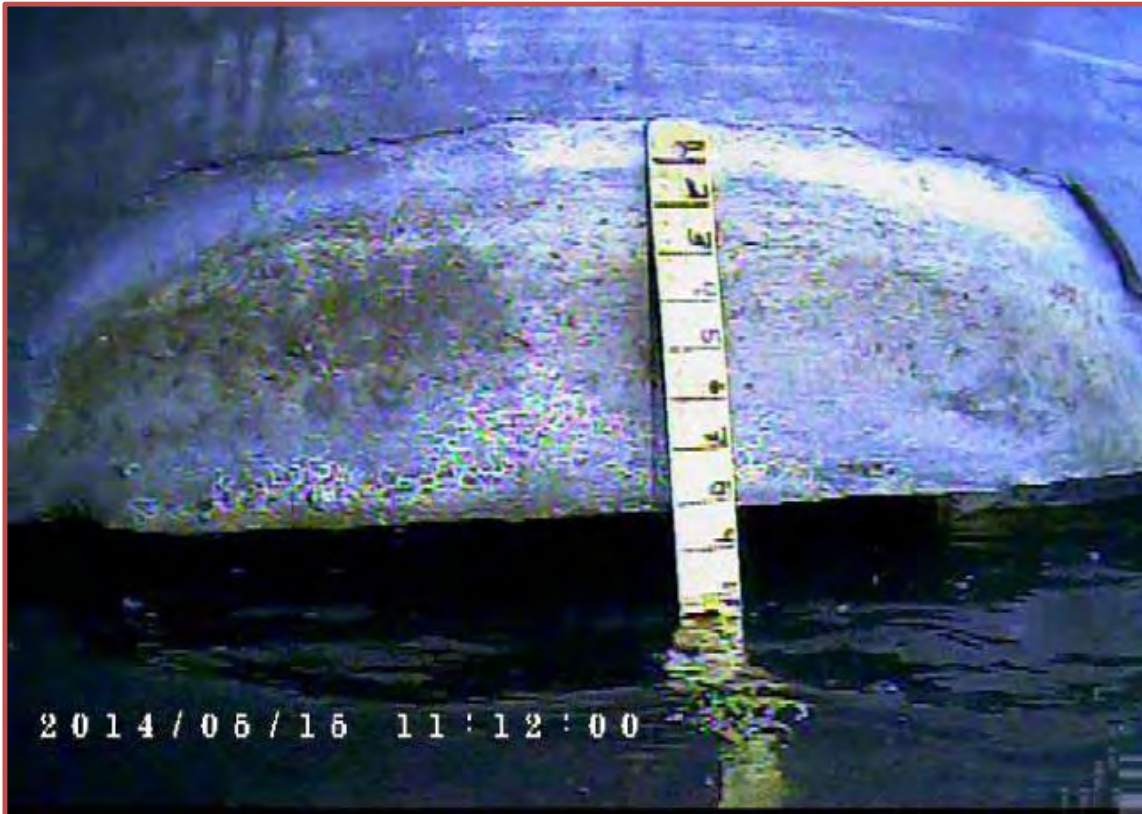
\_Abutment 4 cap over Pile 4-5 has an area 33" x 8", that is missing the concrete cover at a repaired. **UW Photo 01. NEW.**

Description: Top: Abutment 4 cap over Pile 4-5 has an area missing the concrete cover. **UW Photo 01.**  
Bottom: Bent cap 3, have areas of map cracking with hollow sounding. **UW Photo 02.**

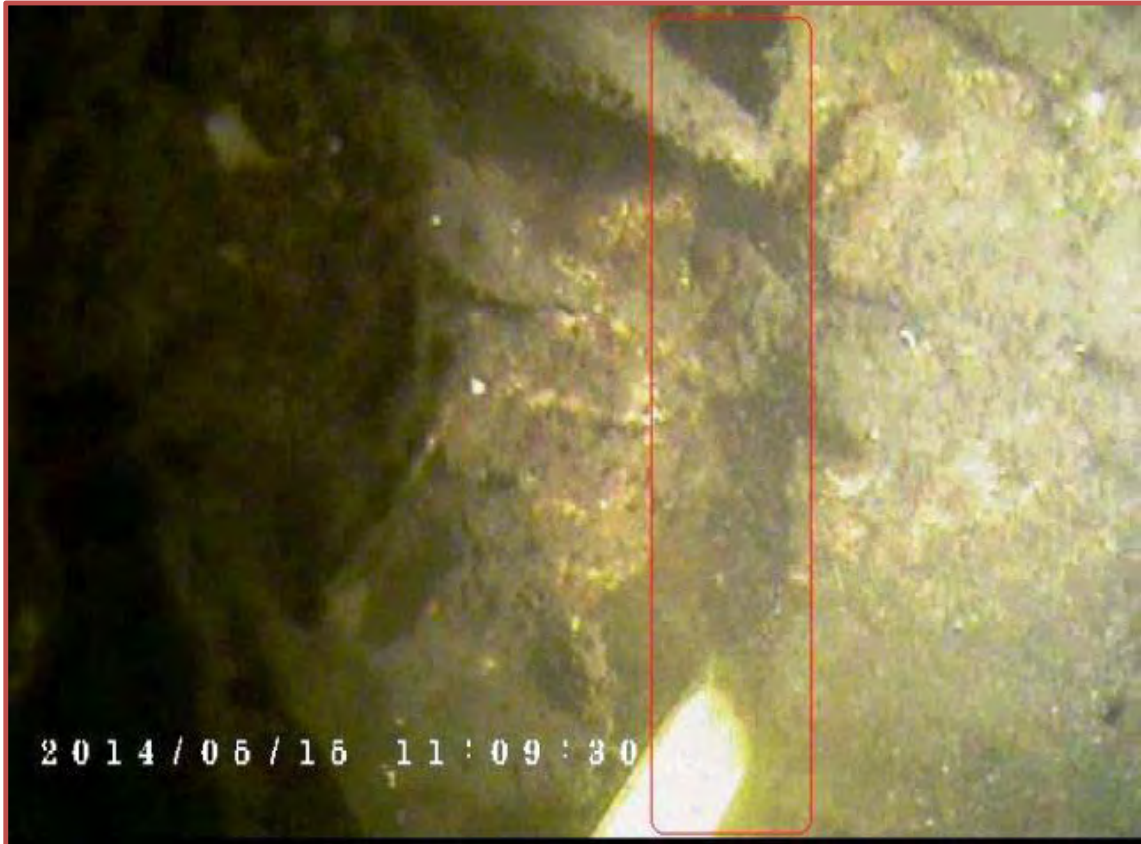
\_The wall on the South side of Pile 4-1 has a joint open up to 1" wide, with light backfill leakage and the panel pushed outward (misaligned) approximately 1". **UW Photo 03. NO CHANGE.**

Description: Top: Backwall on the South side of Pile 4-1 has a joint open up to 1" wide. **UW Photo 03.**

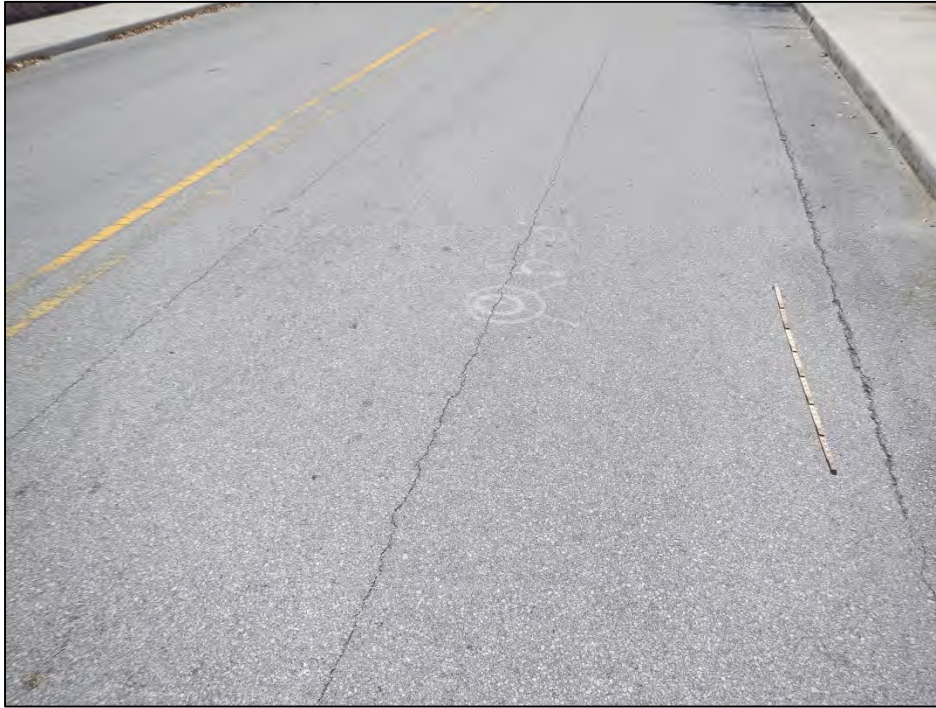
Photo 1 – Longitudinal cracks in the asphalt overlay.

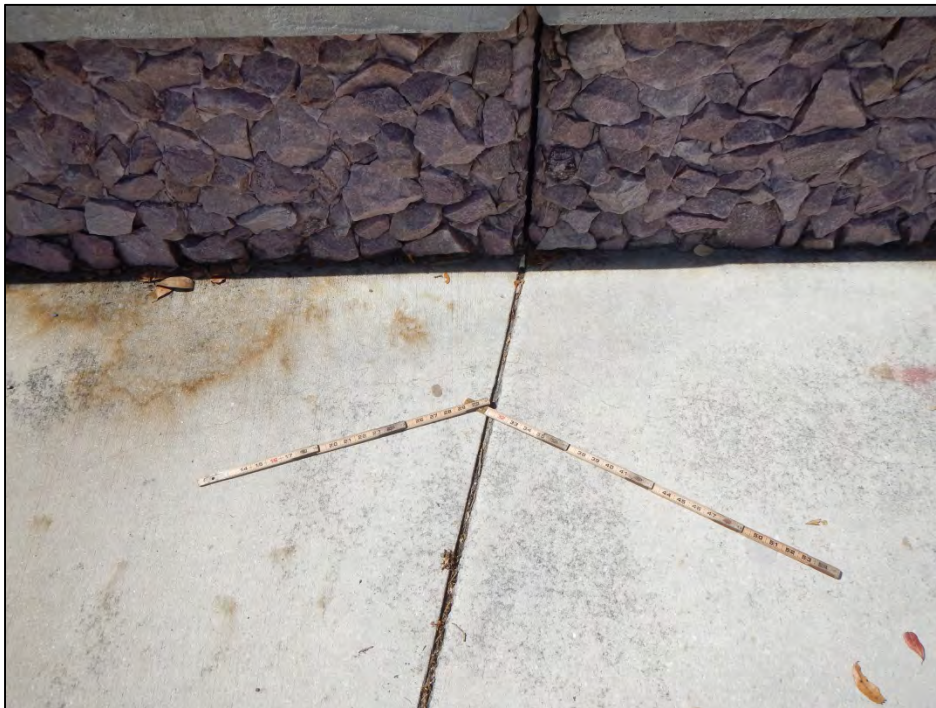
Photo 2 – Typical cracks in the sidewalk.

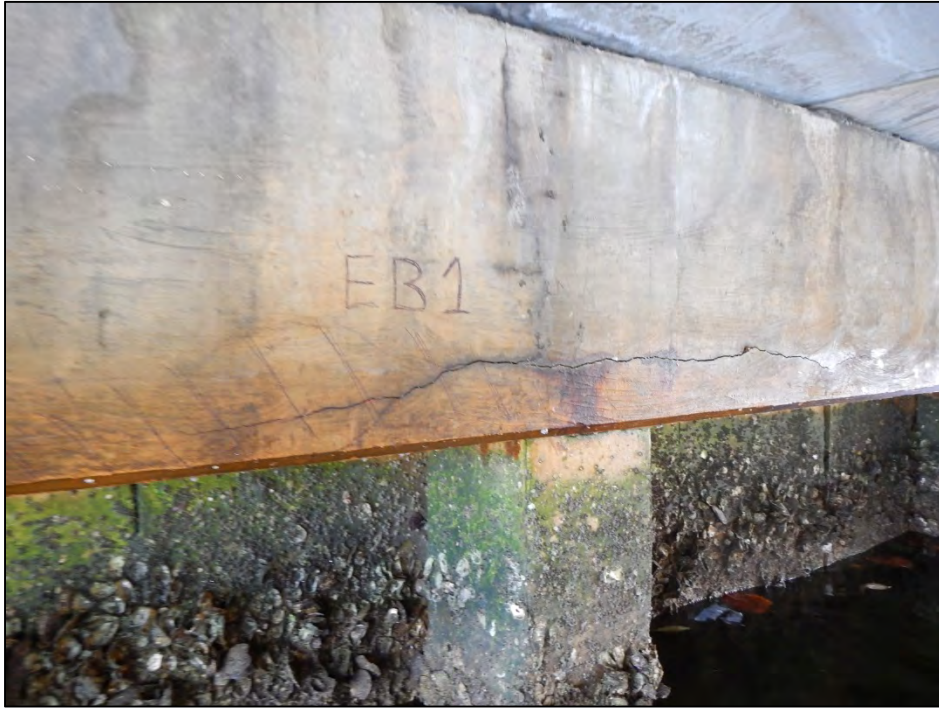
Photo 3 –Delaminations and cracks in the End Bent 1 cap.

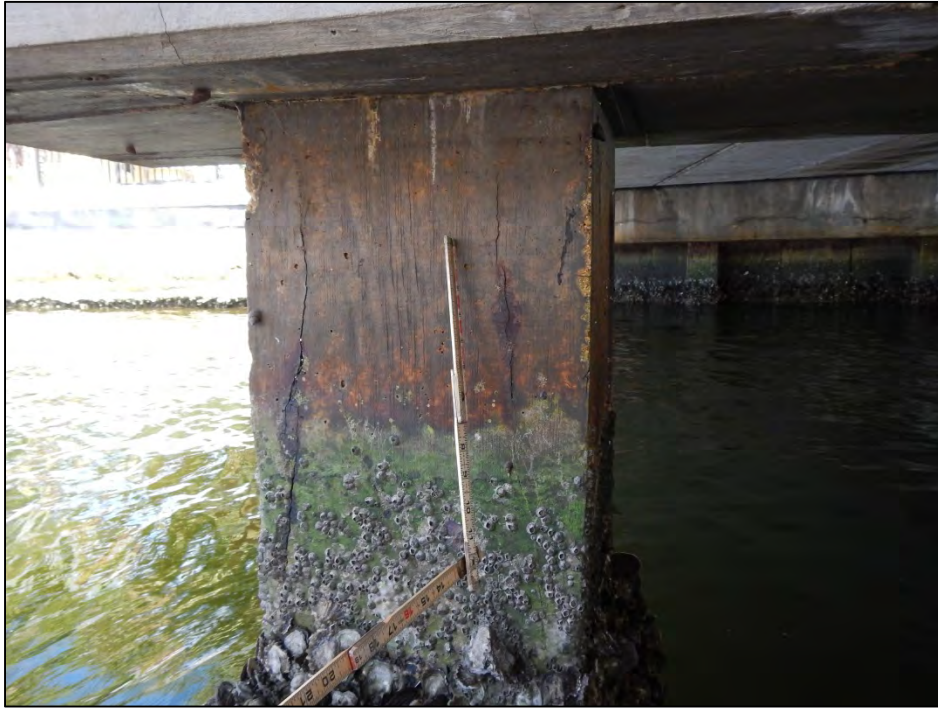
Photo 5 – Corrosion staining and cracks on Pile 3-I.

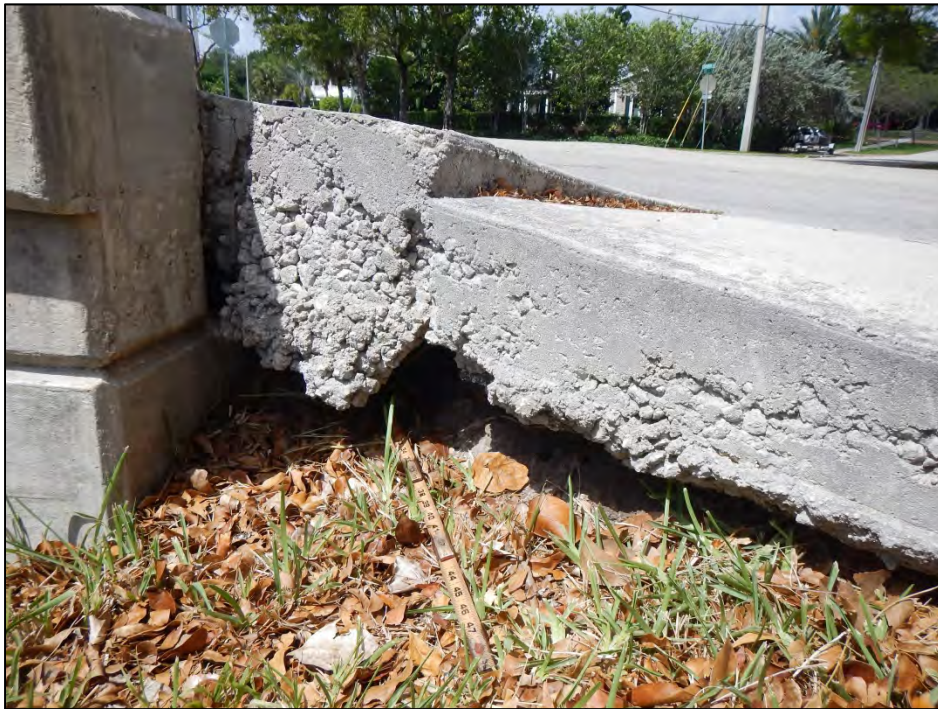
Photo 6 – Undermining at the northwest approach sidewalk.

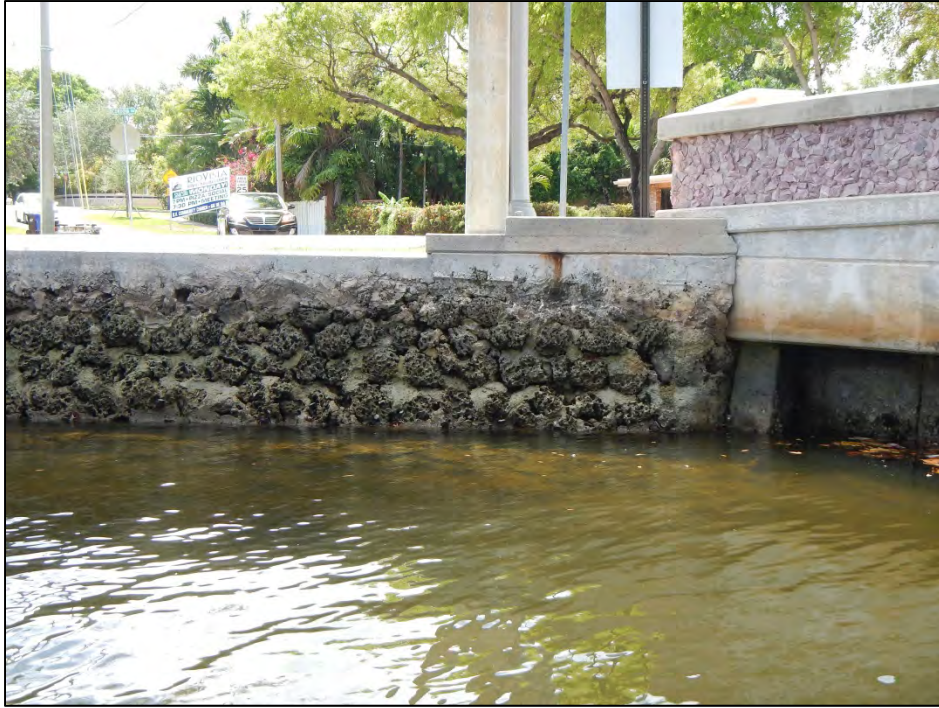
Photo 7 – Cracked and delaminated area at the transition to the southwest wingwall.

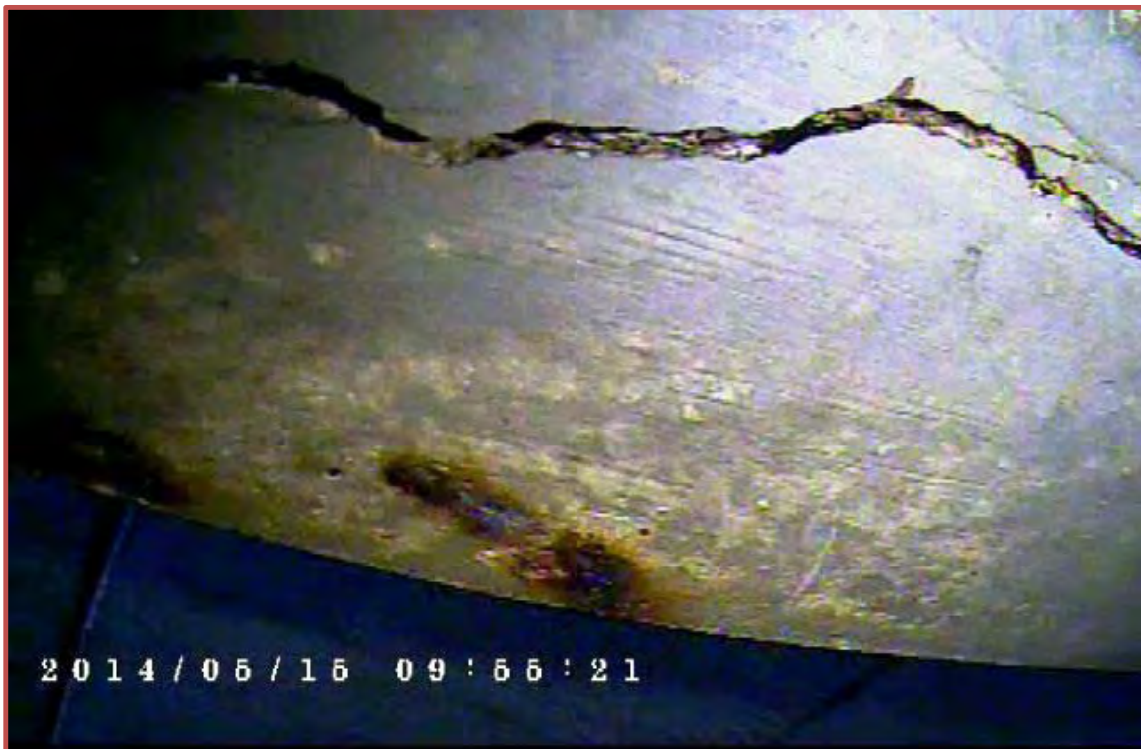
Description: Top: Abutment caps are intermittently delaminated along the entire length. **UW Photo 03.**  
Bottom: Bent caps 2 and 3 full length x up to 1/8" horizontal vertical cracks. **UW Photo 04.**

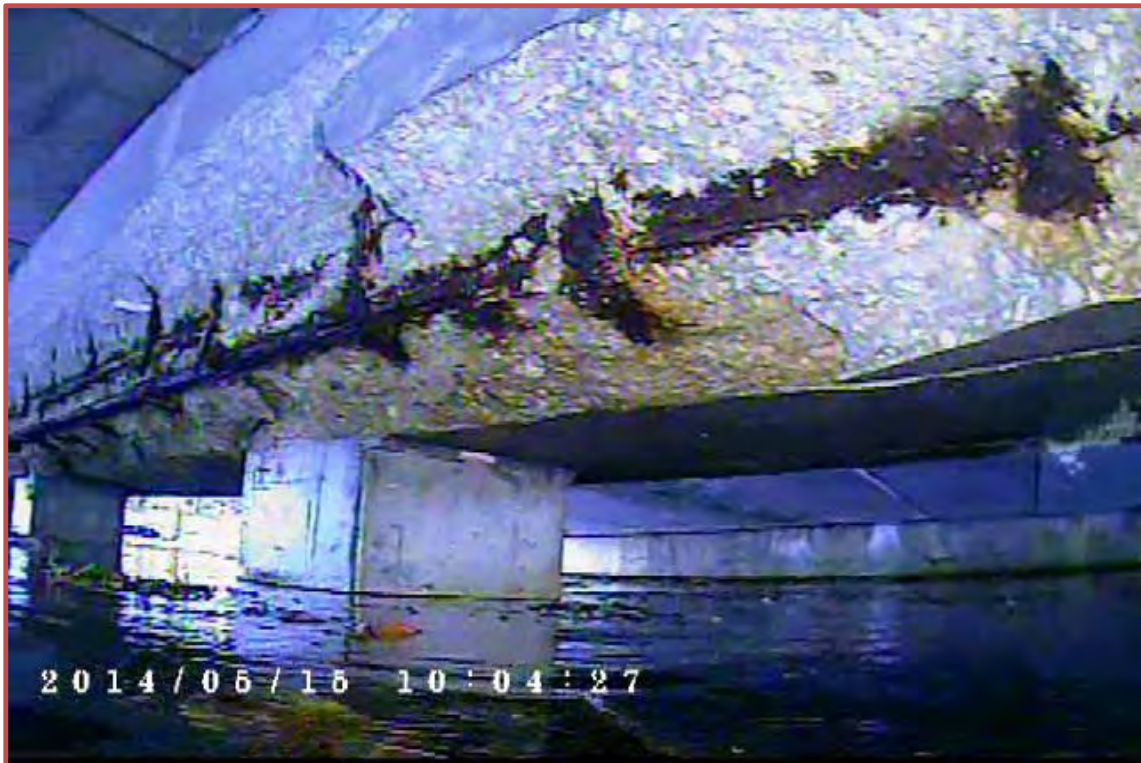
Description: Top: Bent cap 2, South end delaminated with a spall on the West face. **UW Photo 05.**  
Bottom: Bent cap 3, West face spall/delamination, up to cap length. **UW Photo 06.**

\_Remove unsound concrete and patch and seal the cracks as needed at both Bent caps.

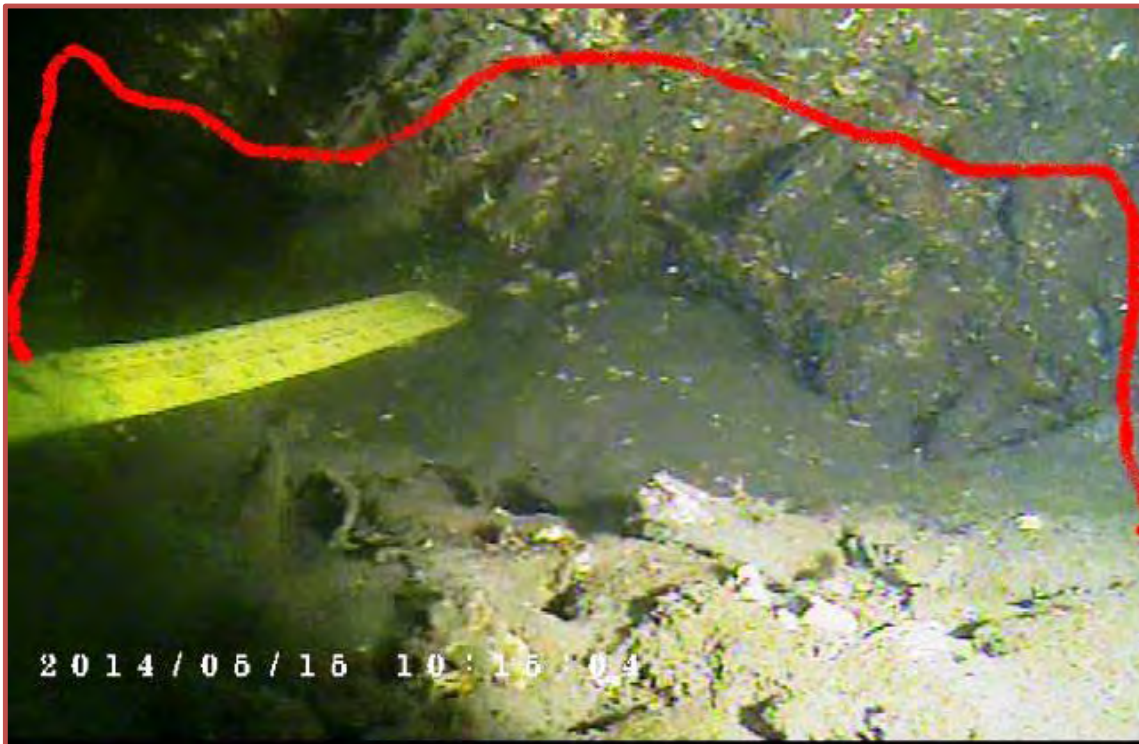
Description: Top: Bent cap 3, West face, spall/delamination, exposed rebar. **UW Photo 07.**  
Bottom: Seawall, South end of Abutment 4 has a void, minor loss of fill. **UW Photo 08.**

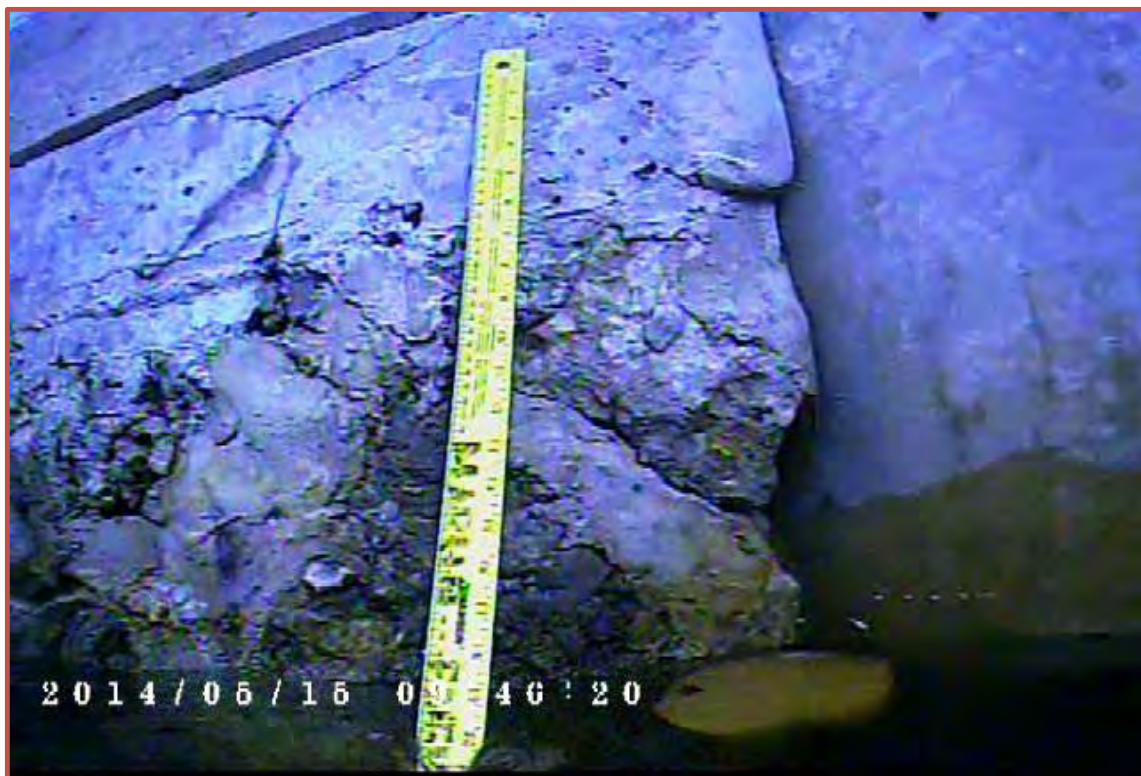
Description: Top: SW wingwall cap delamination, with associated cracks up to 1/8". **UW Photo 09.**  
Bottom: SW wingwall transition, delamination, with associated cracks. **UW Photo 10.**

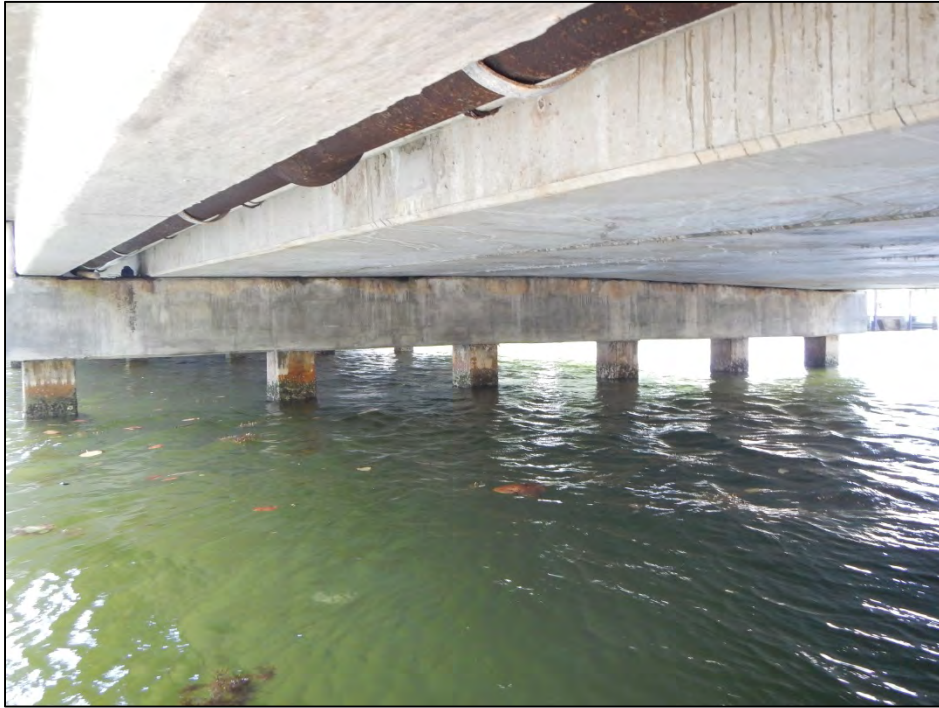
Concrete Slab Underside and Concrete T-beam. Note Utility Pipe in the Bay.

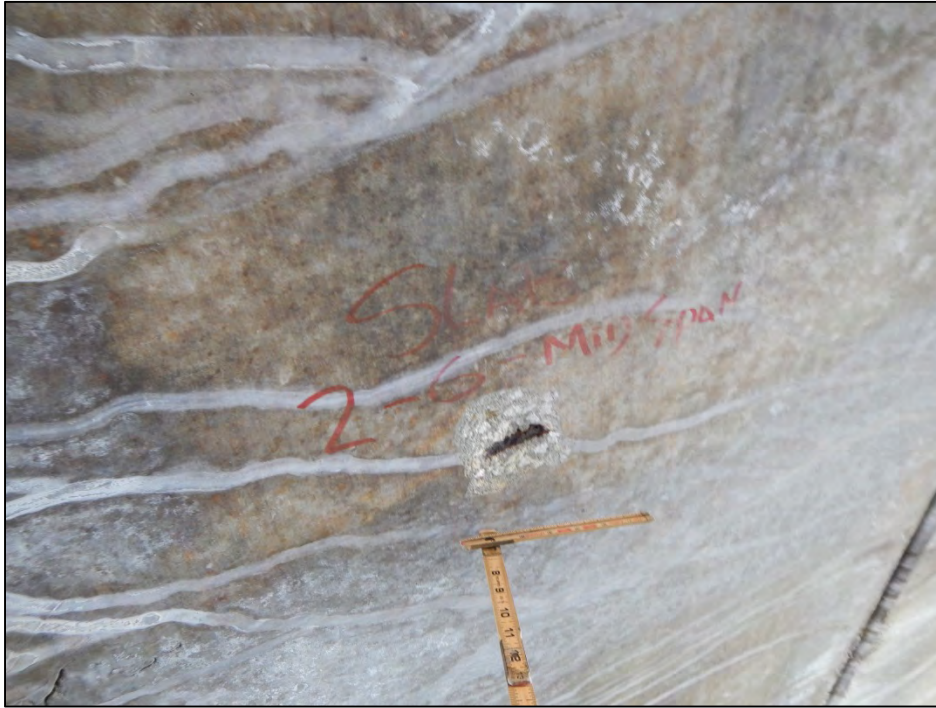
- Slab Unit 2-6 has a 4 in. x 3 in. x ½ in. spall with exposed steel with 90% section remaining in the underside near mid-span. See Condition Photo 1.

Photo 1 – Spall in the underside of Slab Unit 2-6.

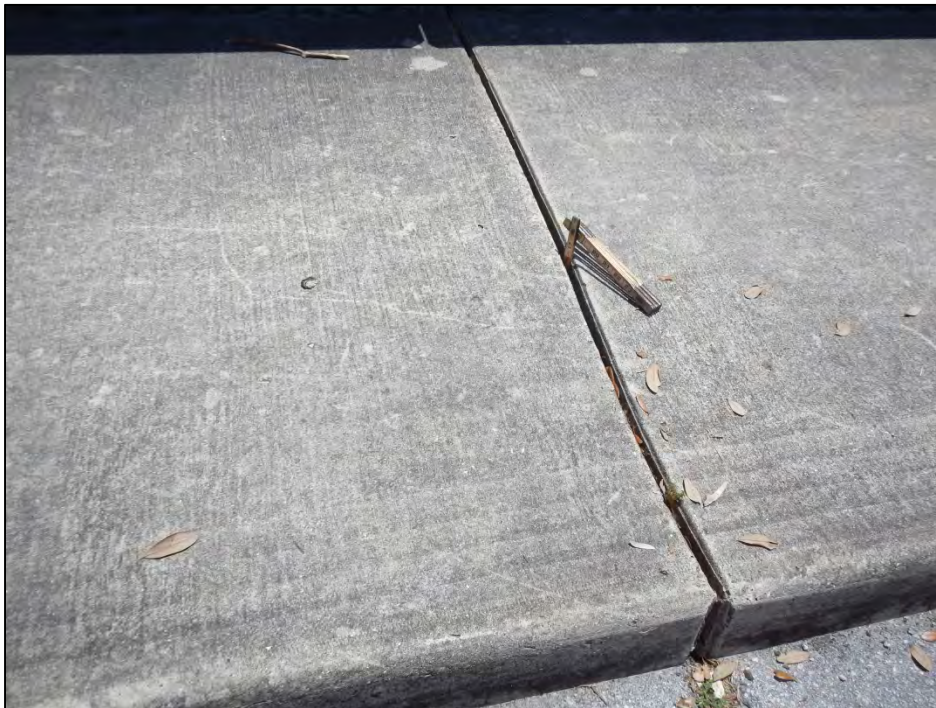
- The sidewalk joint sealant is deteriorated. See Condition Photo 2.
- The staining on the caps indicates that the joints are leaking.

Photo 2 – Deteriorated sidewalk joint sealant.

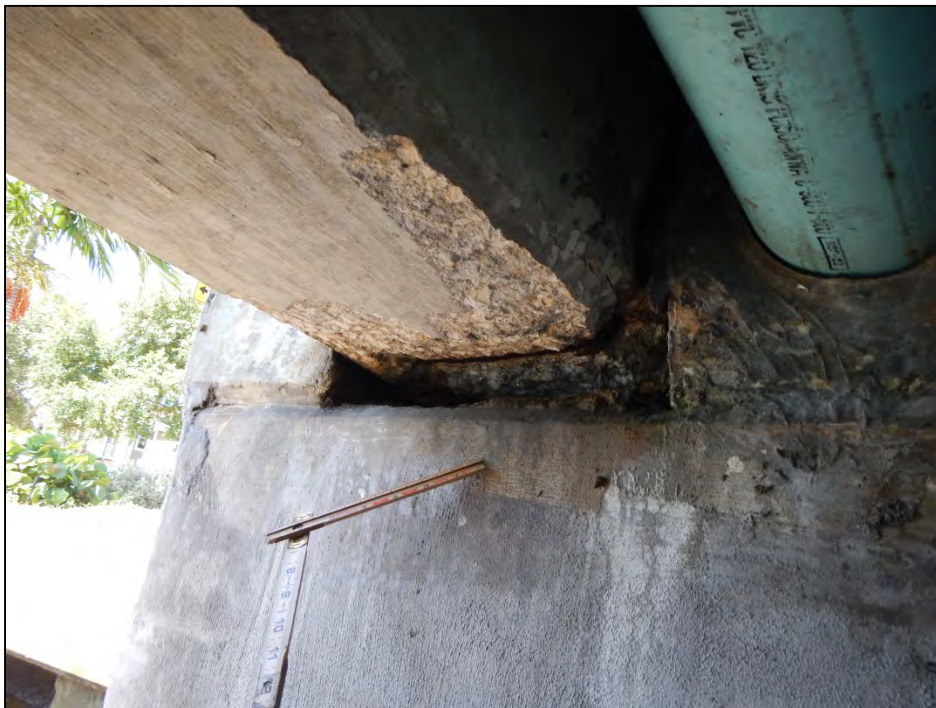
- Beam 1-2 in Span 1 has a 1 ft. 6 in. x beam width x 1 in. spall/delamination with exposed rebar over Abutment 1. See Condition Photo 3.

Photo 3 – Spall in Beam I-2 over Abutment I.

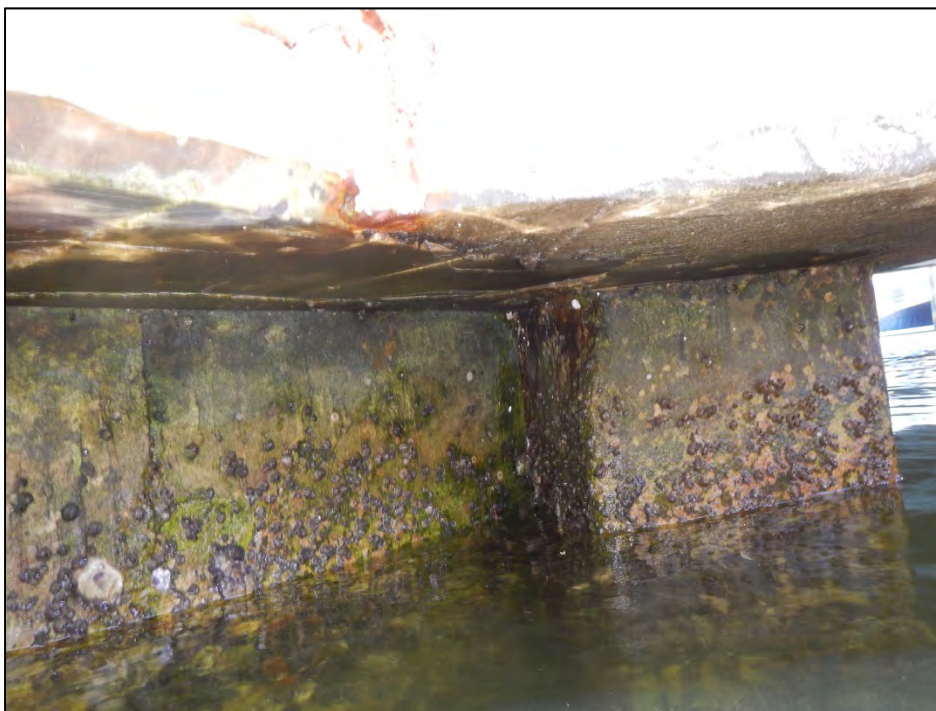
Photo 4 – Spall in Pile I-5.

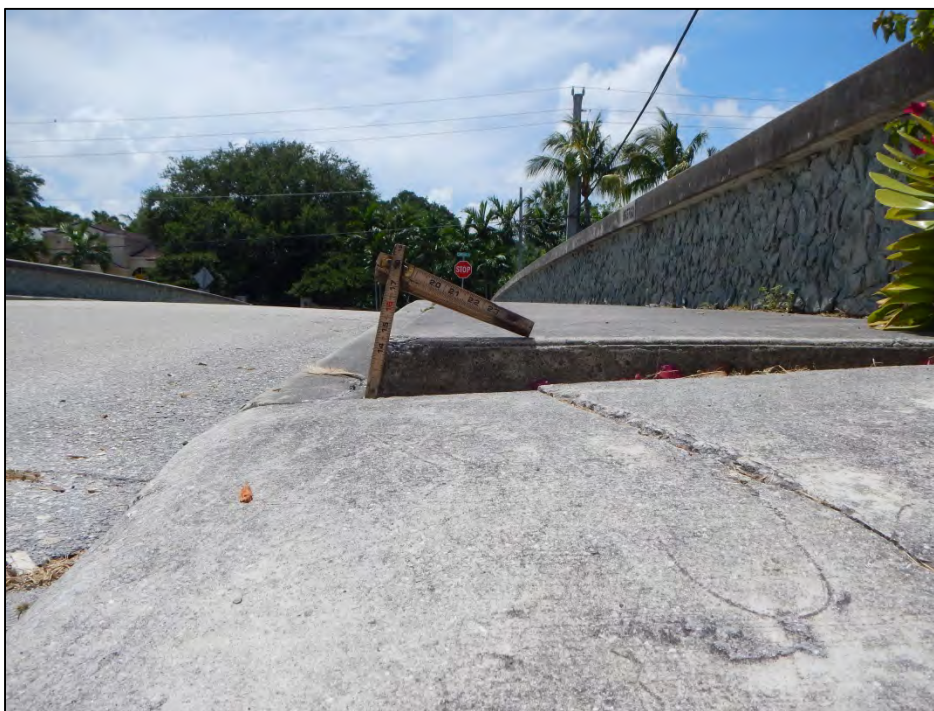
Photo 5 – Elevation differential in the northeast approach sidewalk.

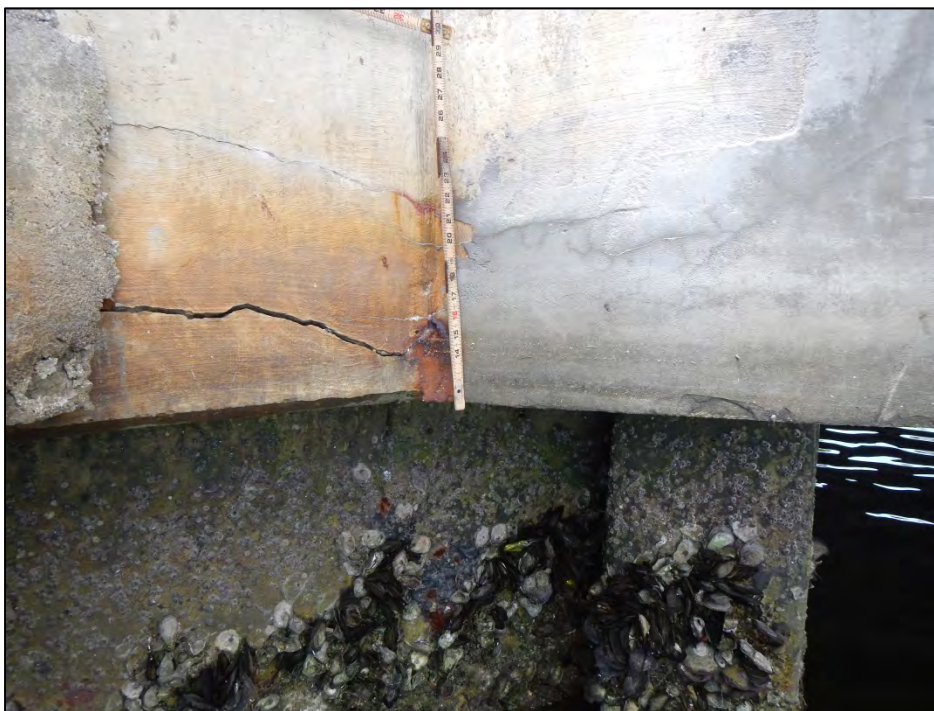
Photo 6 – Delamination with corrosion staining in the southwest wingwall cap.

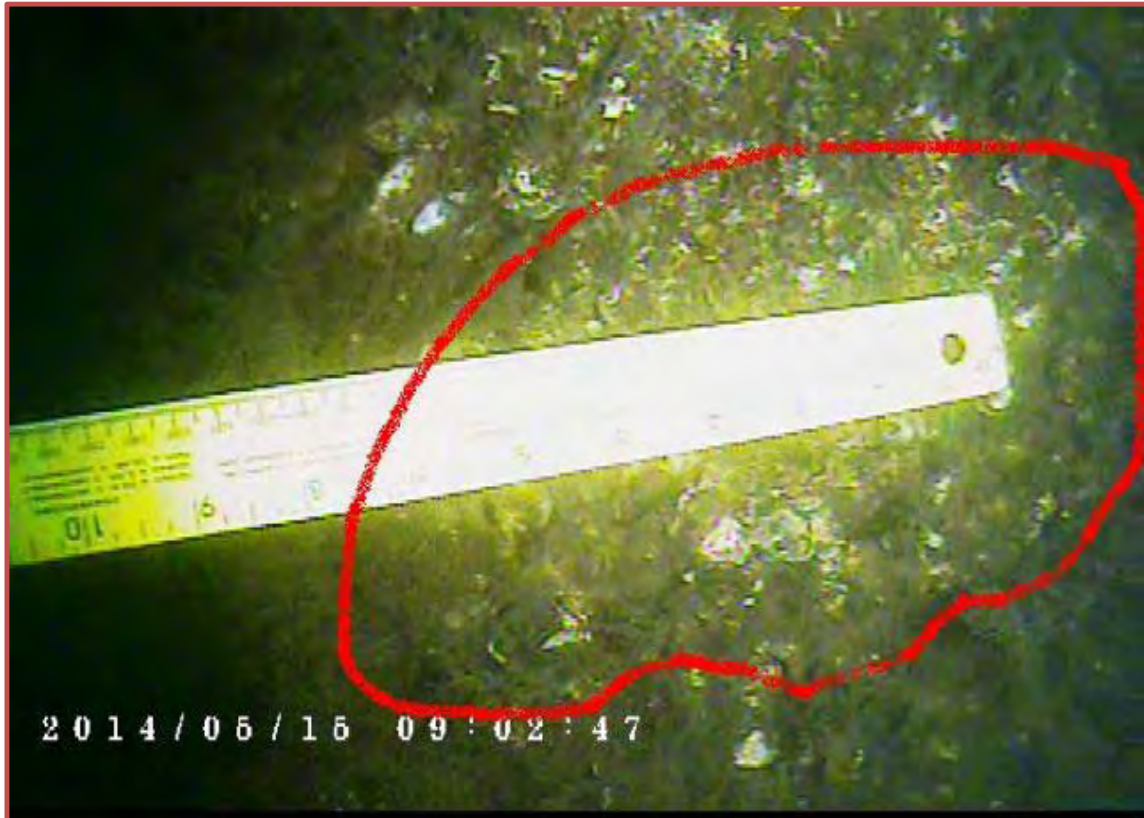
Description: Top: Pile 2-6, South face has a spall, 2' above the groundline. **UW Photo 01.**

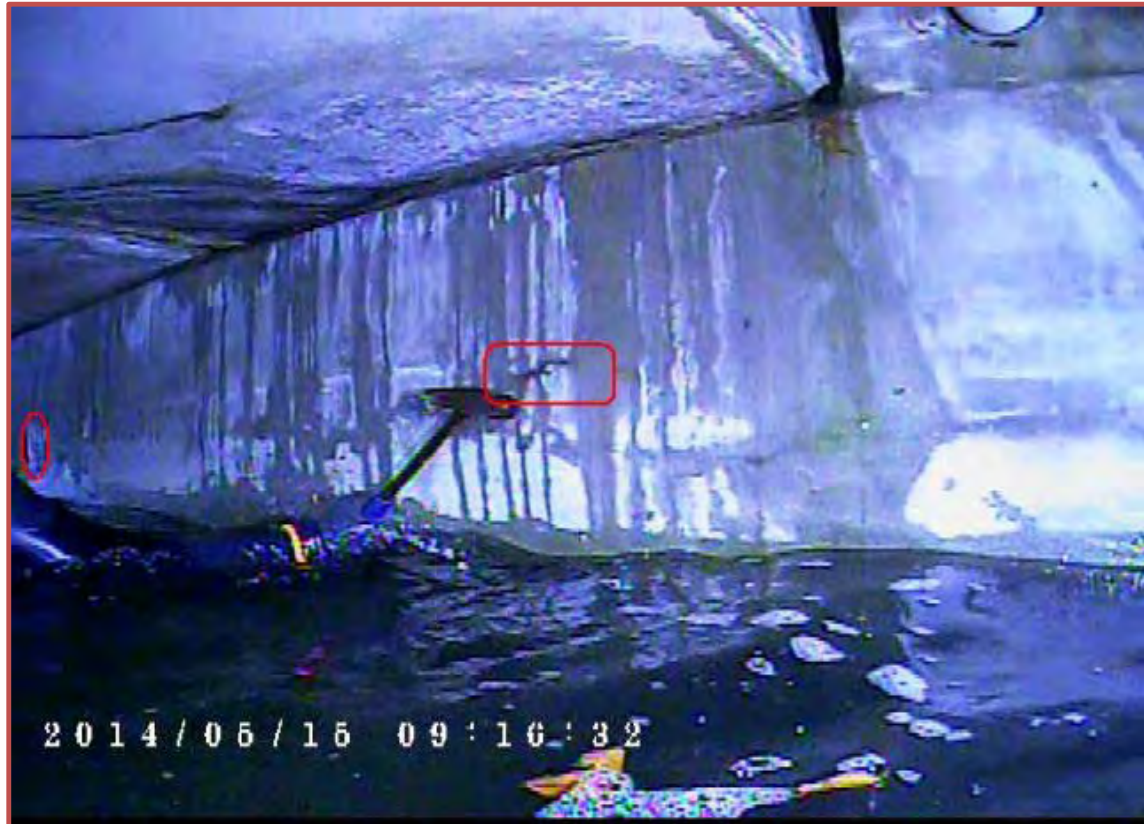
Bottom: Abut 1 cap has intermittent horizontal cracks, w/corrosion bleed-out. **UW Photo 02.**

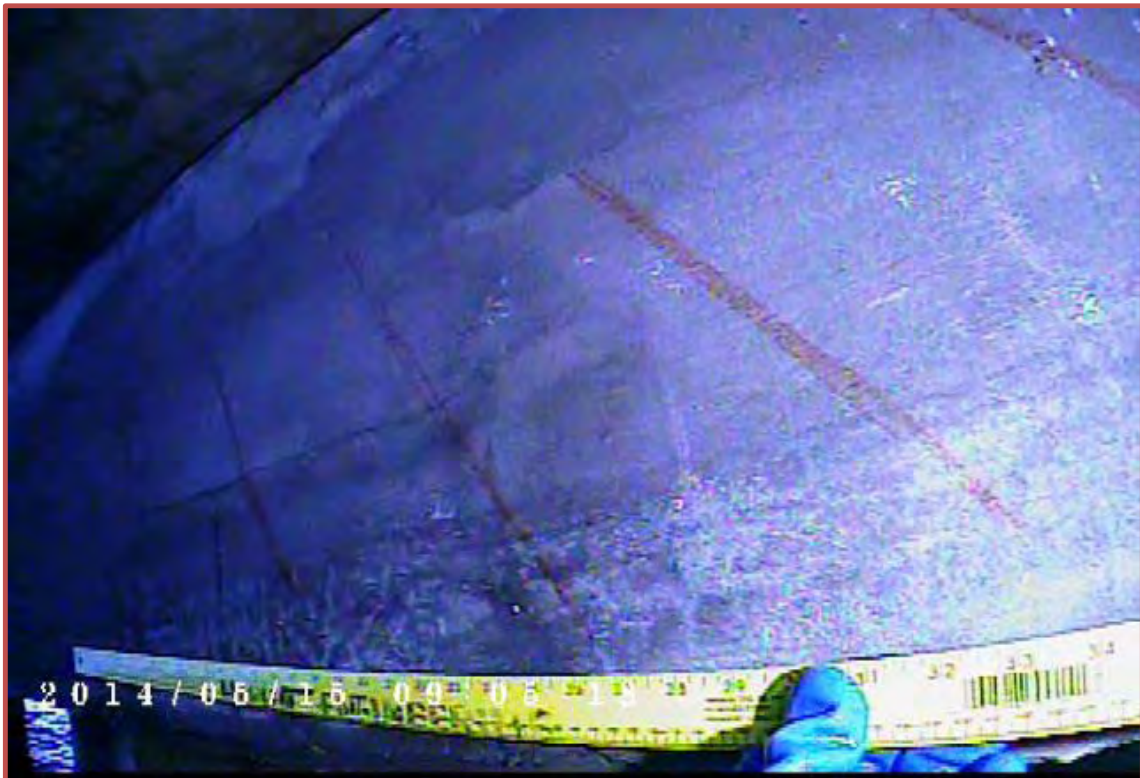
Description: Top: Bent 2 cap intermittent horizontal cracks, with corrosion bleed-out. **UW Photo 03.**  
Bottom: Bent 3 cap West face, intermittent delaminated areas. **UW Photo 04.**

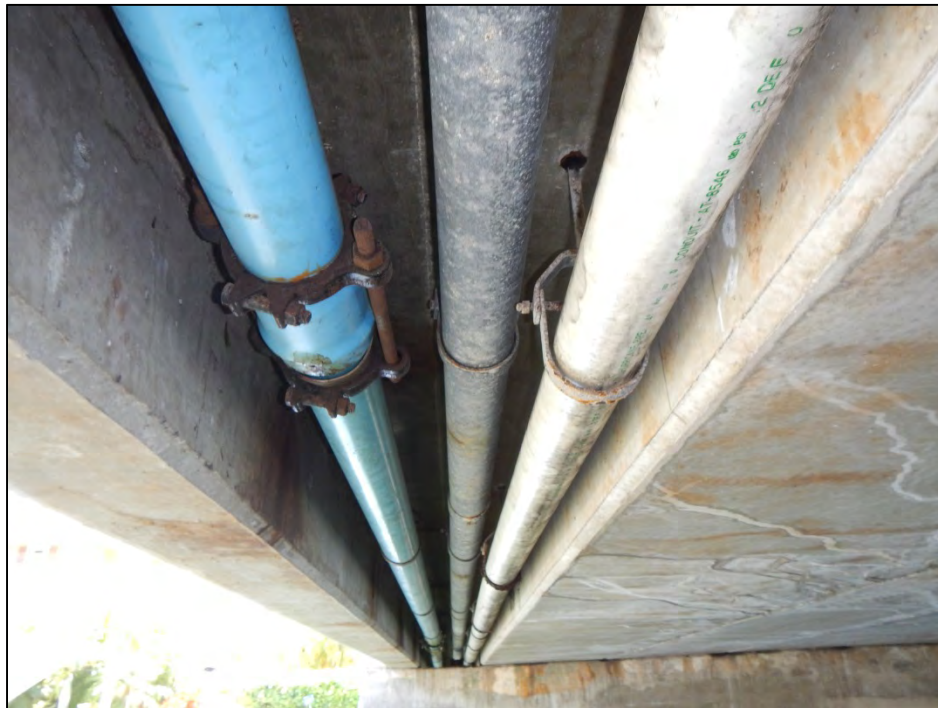
Concrete Slab Underside and Concrete T-beam. Note Utility Pipe.

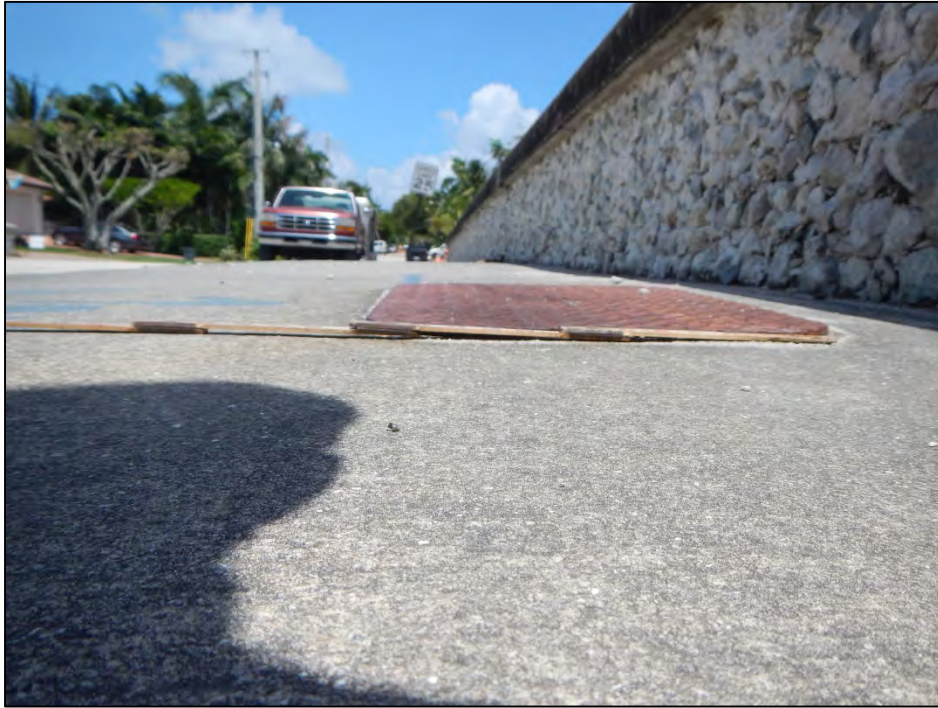
Photo 1 – Elevated water main access cover.
