## **EXECUTIVE SUMMARY**

TranSystems has been retained by the City of Fort Lauderdale to perform bridge inspections and prepare bridge inspection reports for each of the City's bridges as part of the project Structural Bridge Engineering Consulting Services Master Plan, RFQ No. 946-11310. Inspections were completed and reports prepared for 46 of the City's bridges. The remaining five bridges in the City's inventory were not inspected because they are in the process of being replaced.

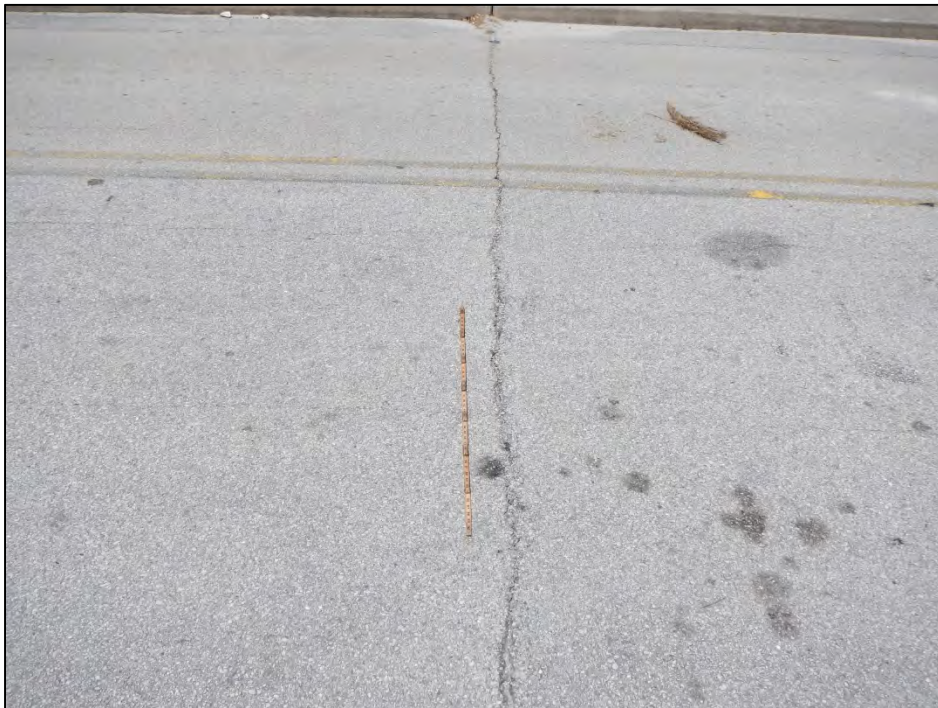
Photo 2 – Crack in the asphalt over the joints.

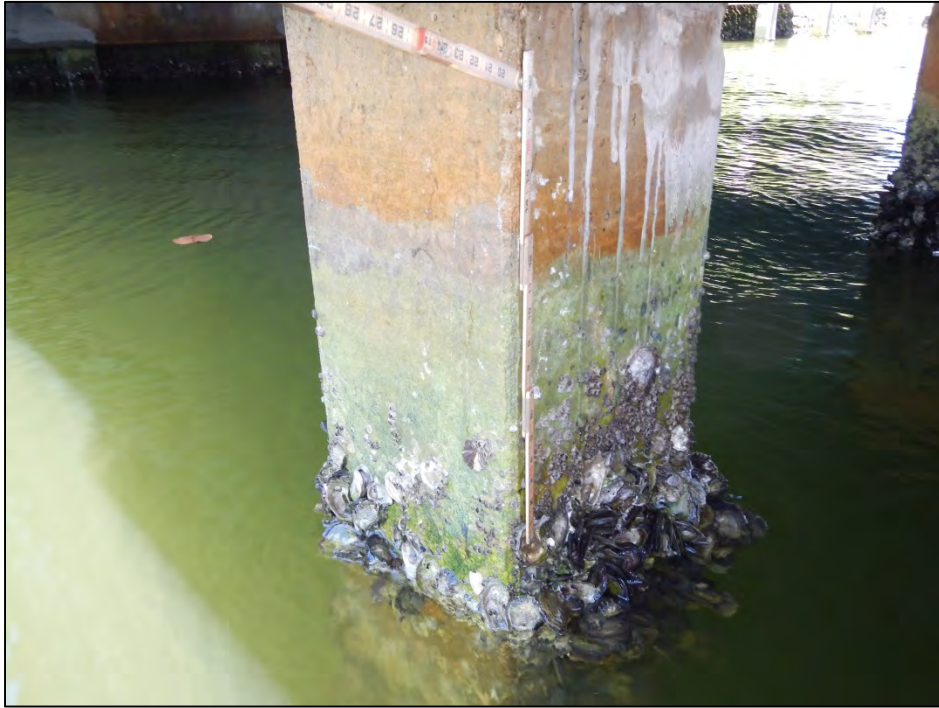
Photo 3 – Vertical cracks on Pile 2-6.

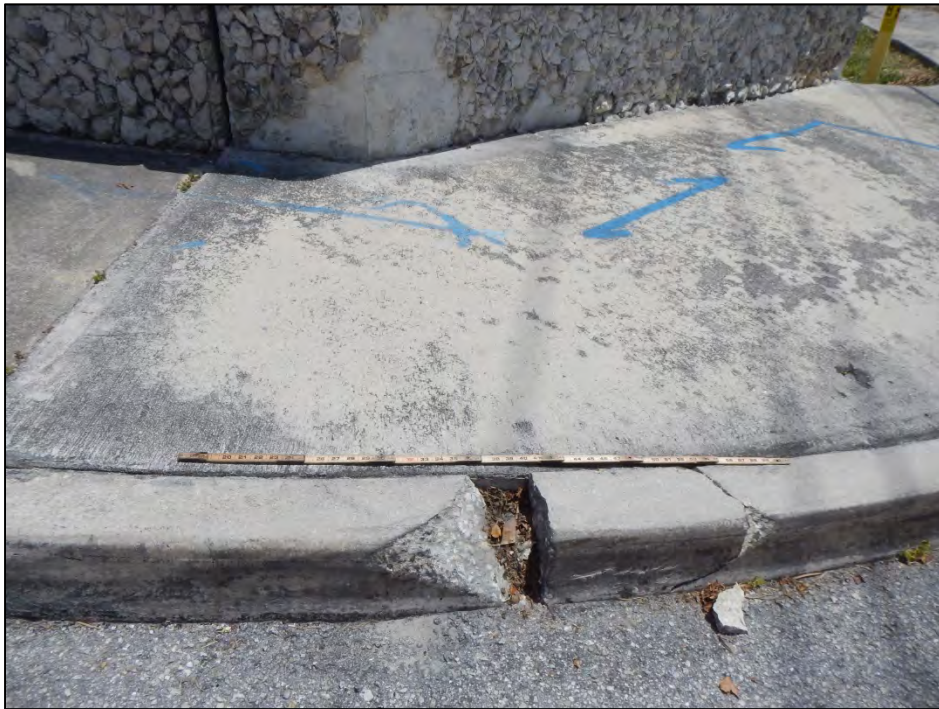
Photo 4 – Spall in the south approach sidewalk curb.

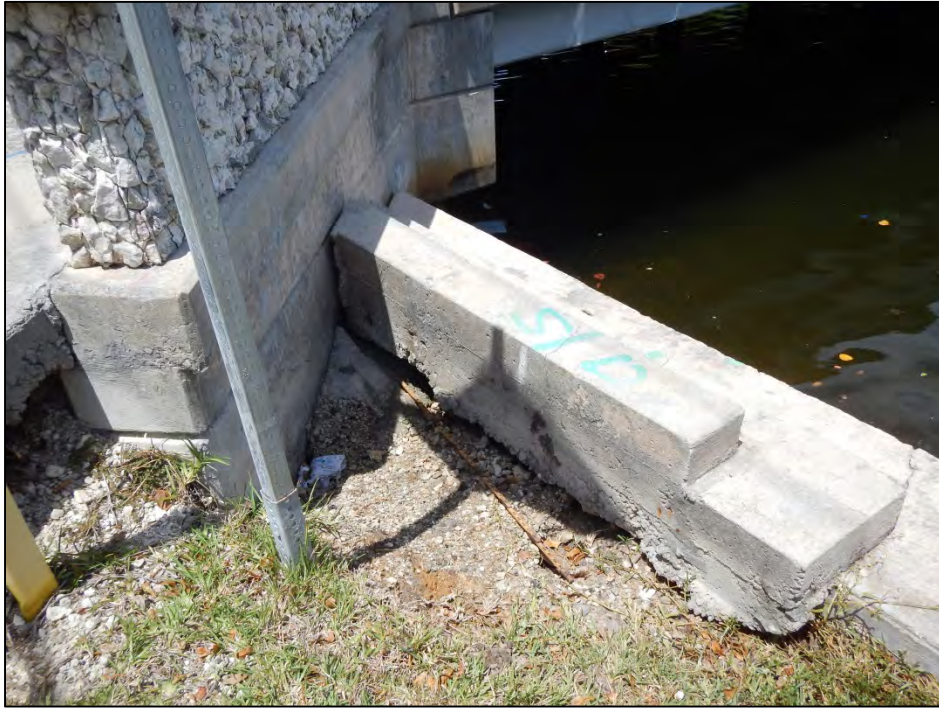
Photo 5 – Washout area behind the retaining wall adjacent to the southwest concrete barrier.

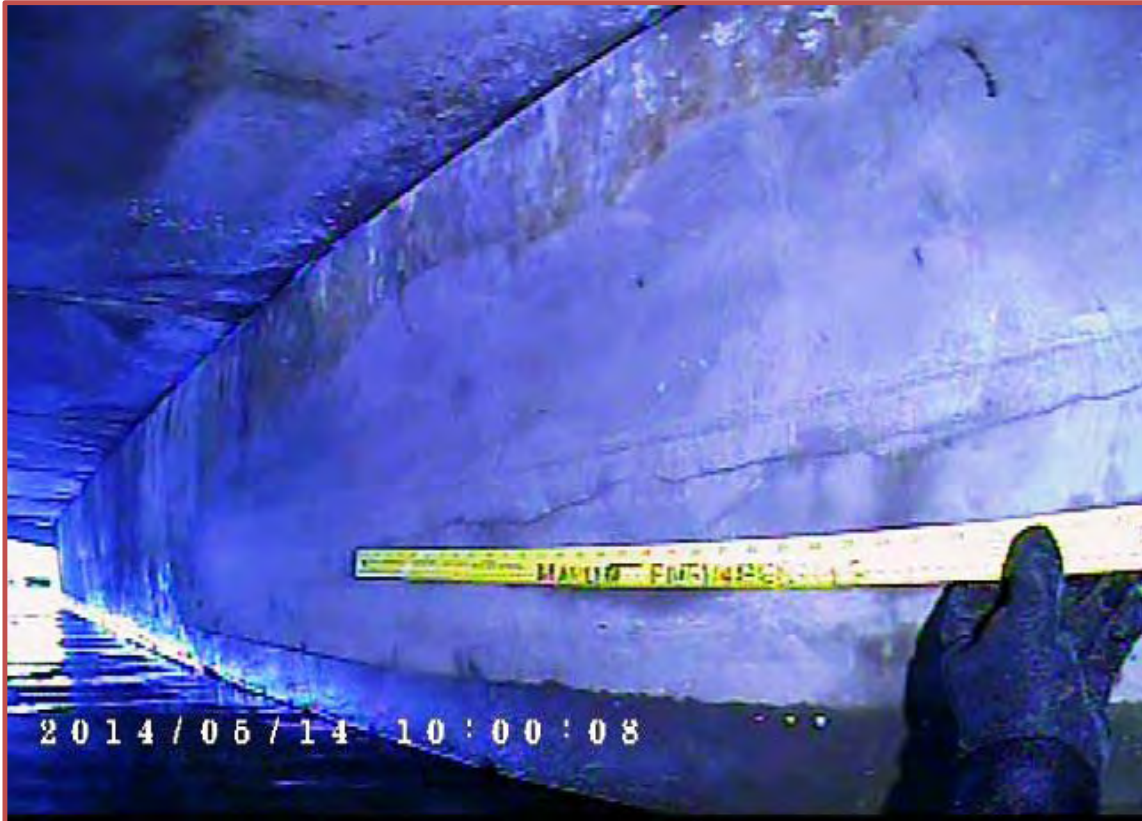
\_Both Abutments have intermittent horizontal and vertical cracks x up to 1/16" wide, along the repaired locations. **UW Photo 01. NEW.**

Description: Top: Abutments have intermittent cracks along the repaired areas. **UW Photo 01.**  
Bottom: Bent caps 2 and 3, intermittent cracks along repaired areas. **UW Photo 02.**

\_Seal all the cracks on Abutments 1 and 4 as needed.

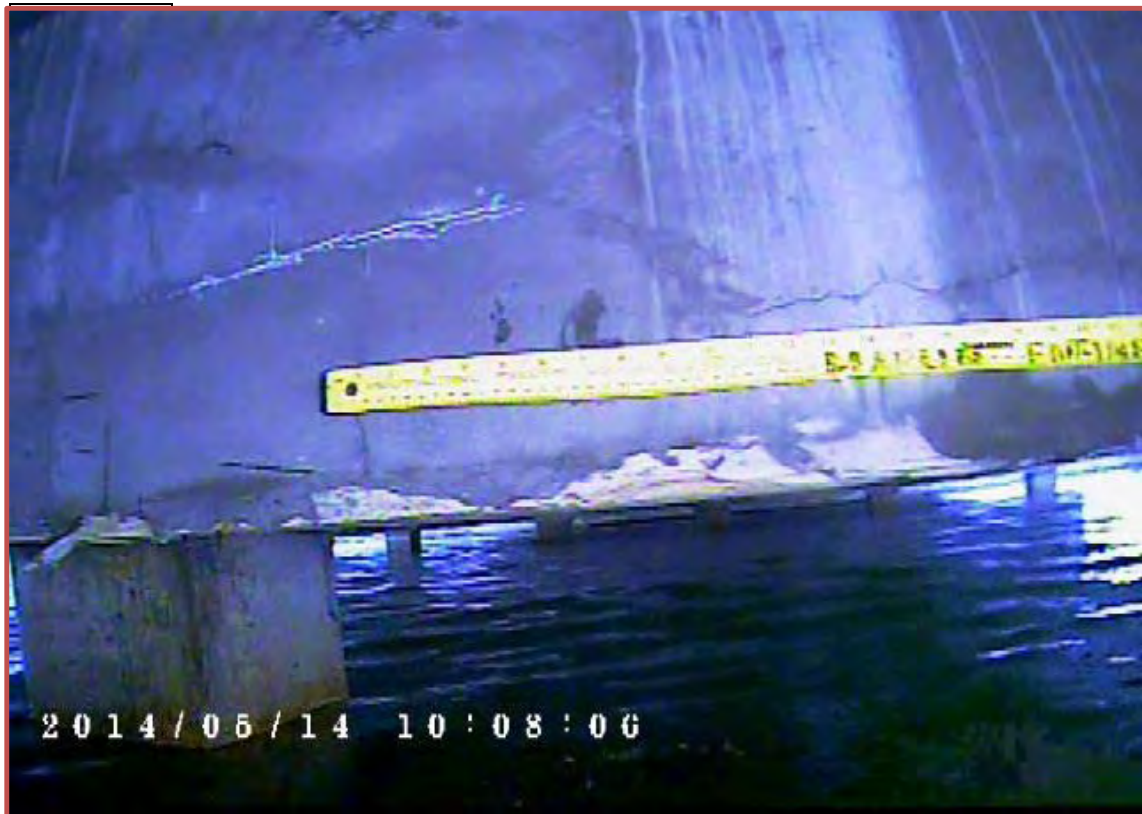
\_Bent cap 2 and 3 have intermittent horizontal and vertical cracks x up to 1/16" wide, with efflorescence, along the repaired locations. **UW Photo 02. NEW.**

\_Seal all the cracks on Bents 2 and 3 as needed.

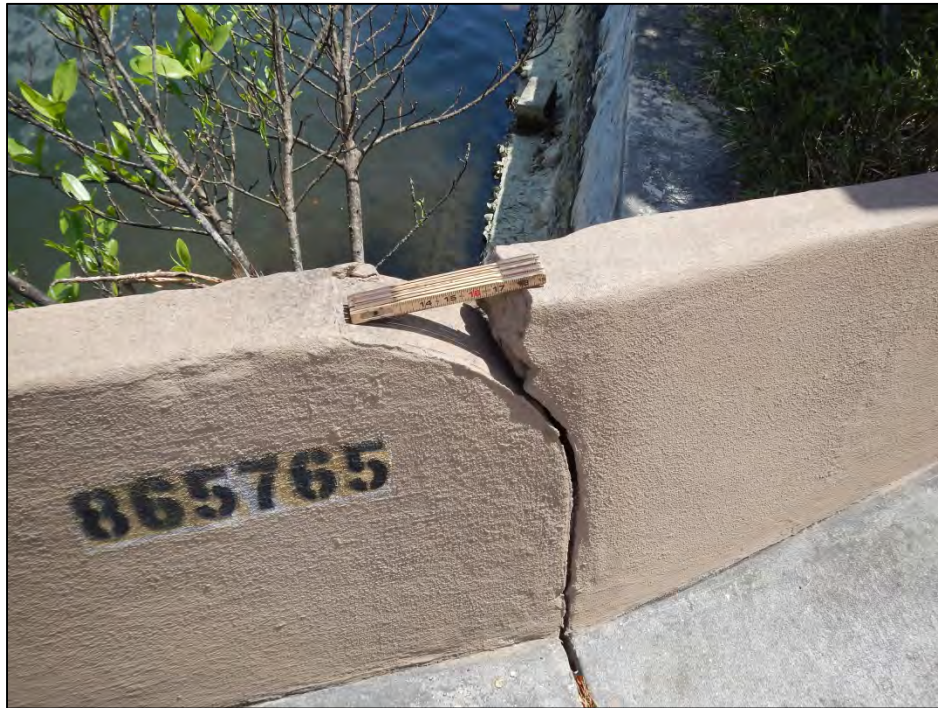
Photo 1 – Spall in the barrier.

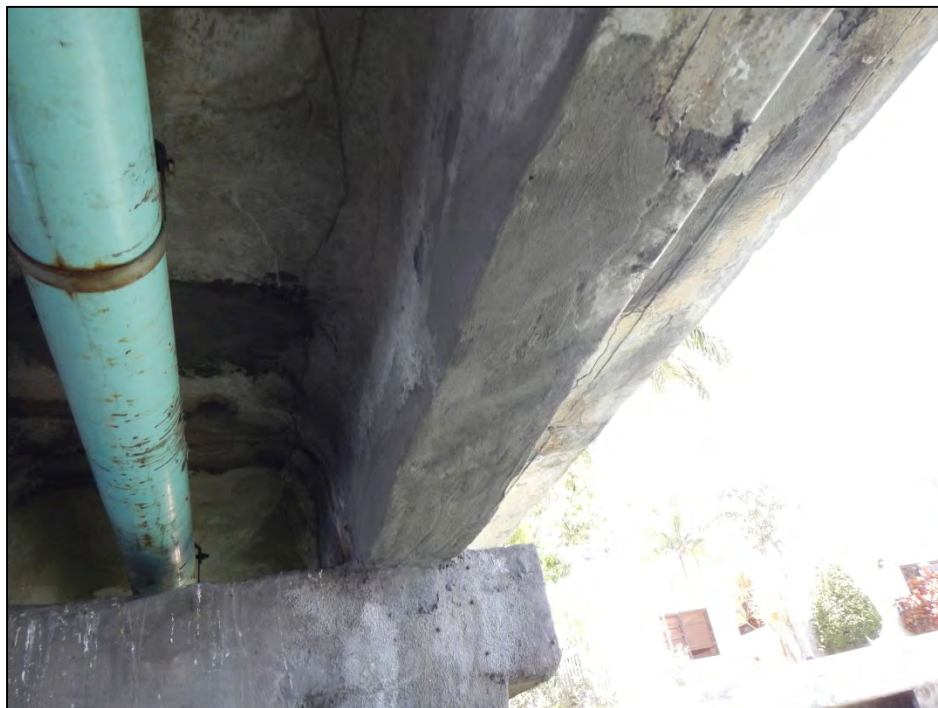
Photo 2 – Typical patching on the T-beams.

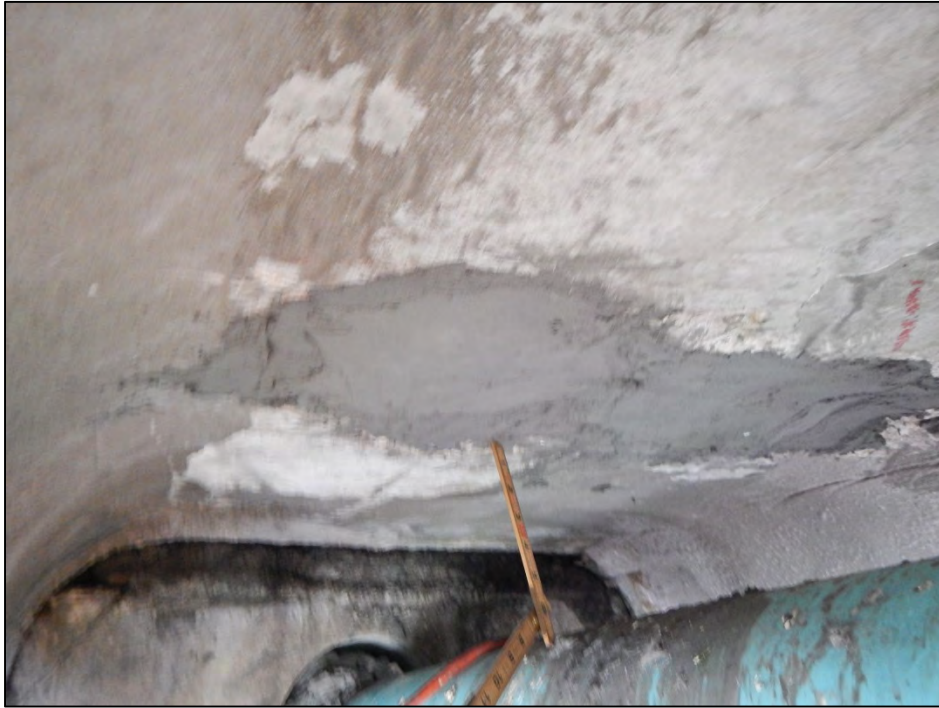
Photo 3 – Typical repair patch on bottom flange of T-beams.

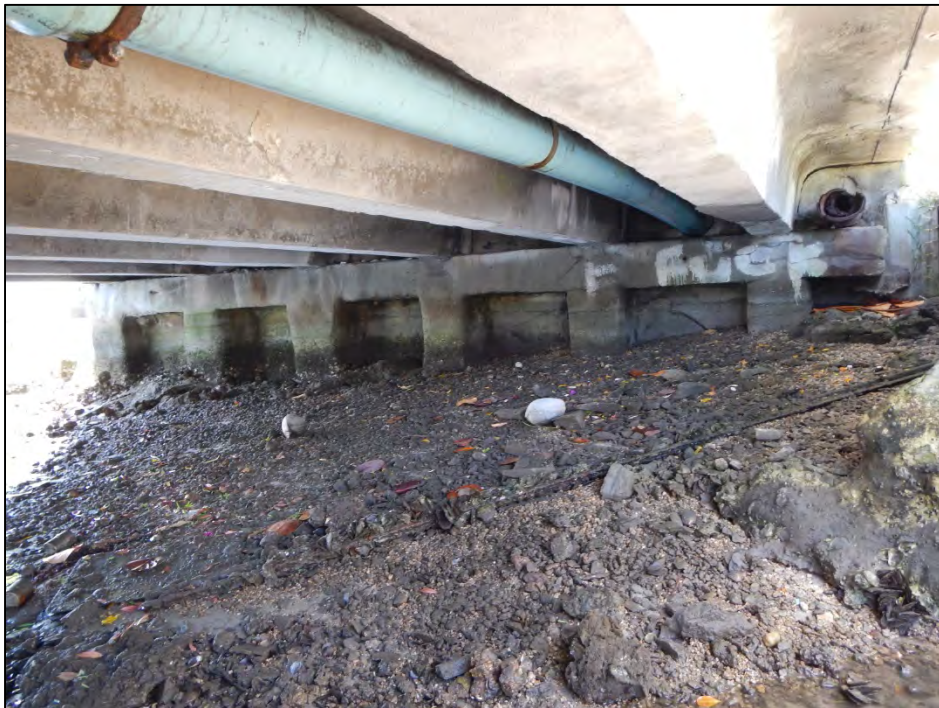
Photo 4 – Abutment 4 face with typical repair patches.

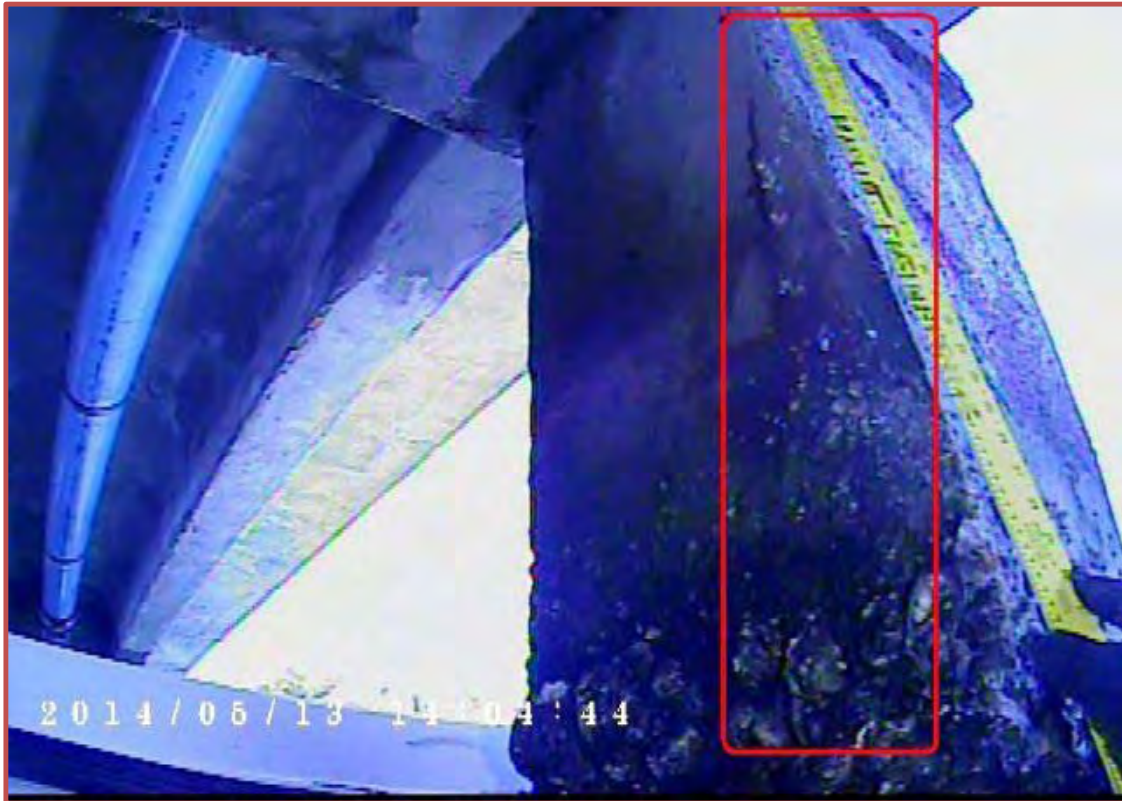
Description: Top: PJ 5-6, NW corner delamination with associated cracks. **UW Photo 01.**

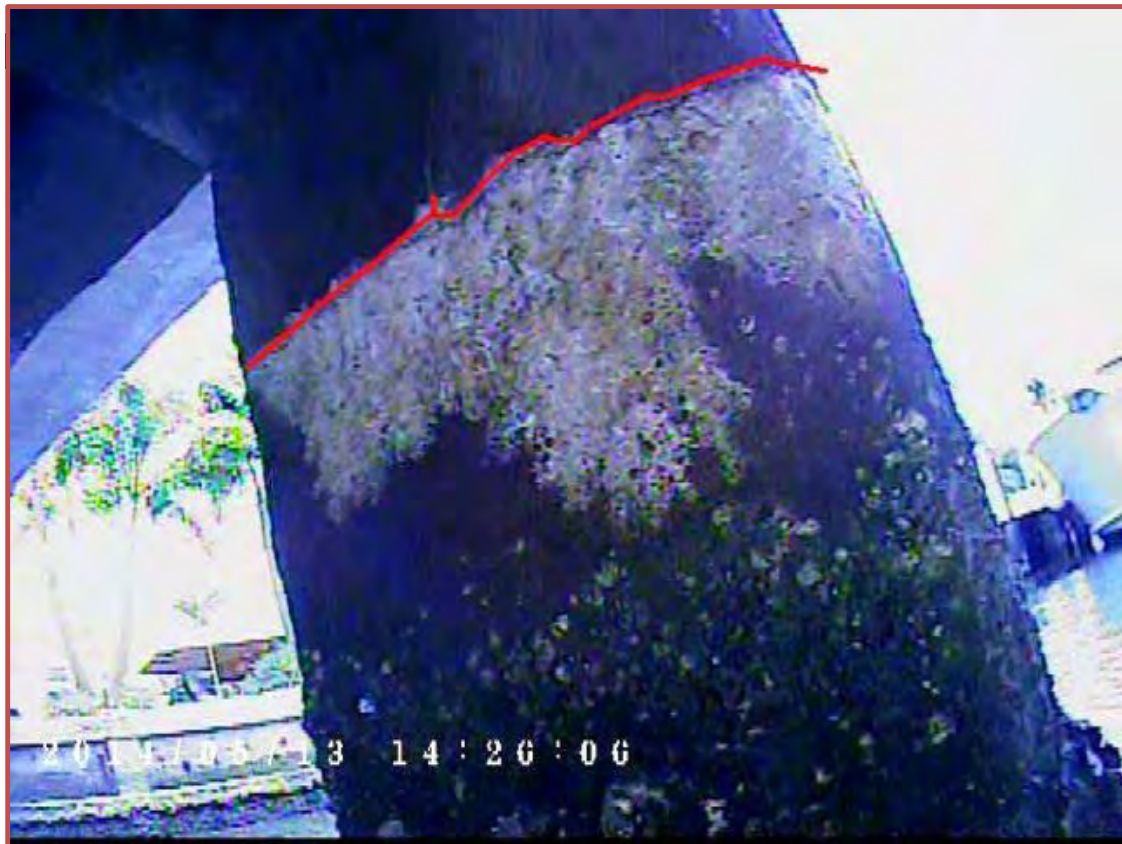
Bottom: PJ 8-6, N, W and E faces, horizontal cracks with efflorescence. **UW Photo 02.**

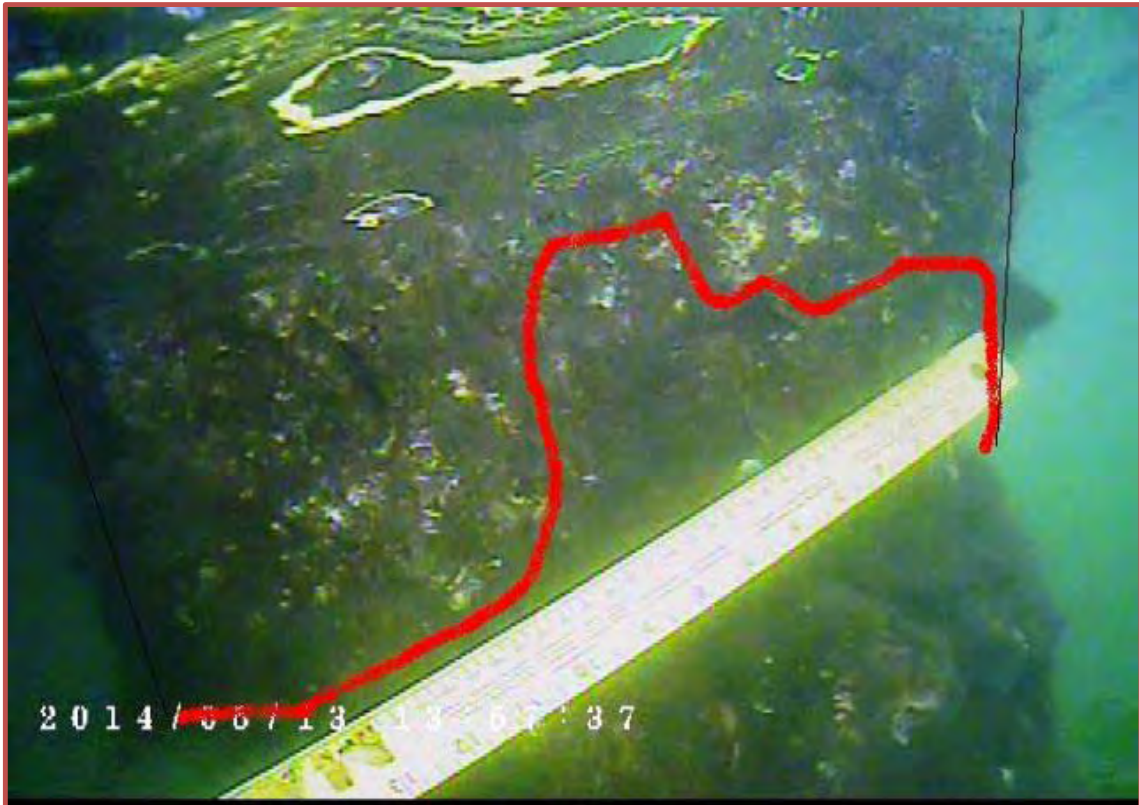
Description: Top: All the pile jackets have minor voids at the bottom corners. **UW Photo 03.**  
Bottom: SE retaining wall, area of undermining, up to 14" penetration. **UW Photo 04.**

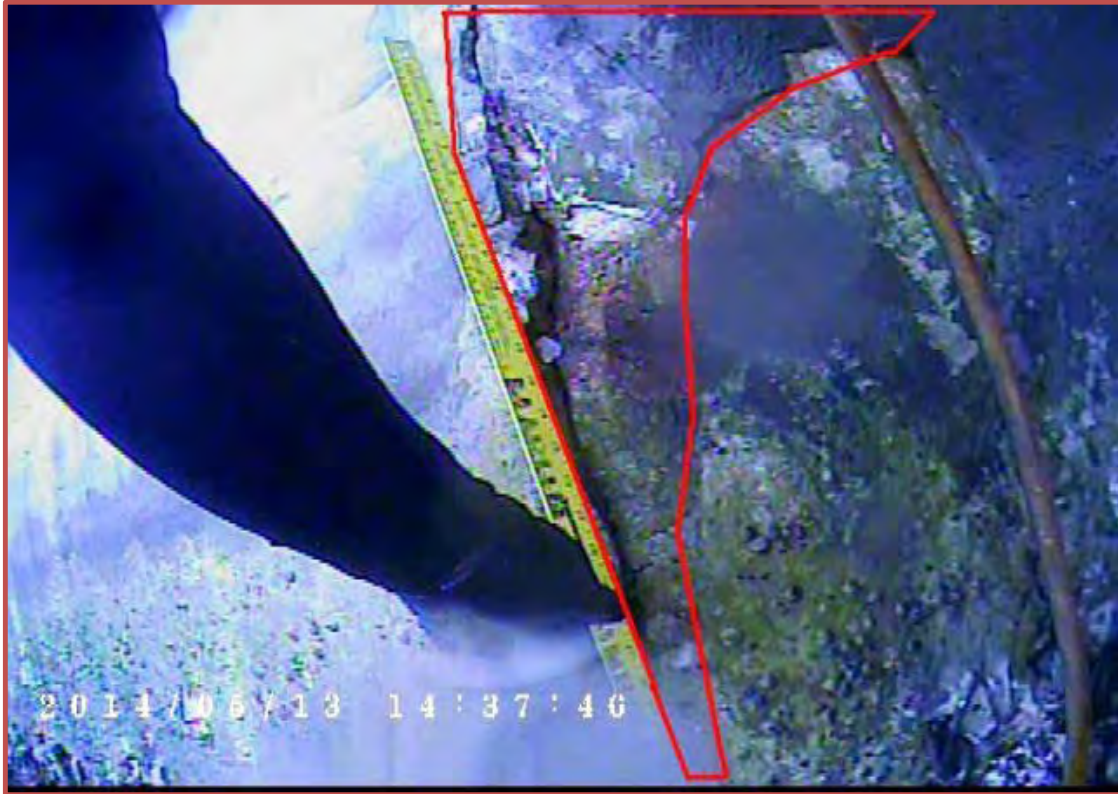
Description: Top: NW retaining wall transition, spall with corrosion bleed-out. **UW Photo 05.**  
Bottom: SE retaining wall has intermittent areas of corrosion bleed-out. **UW Photo 06.**

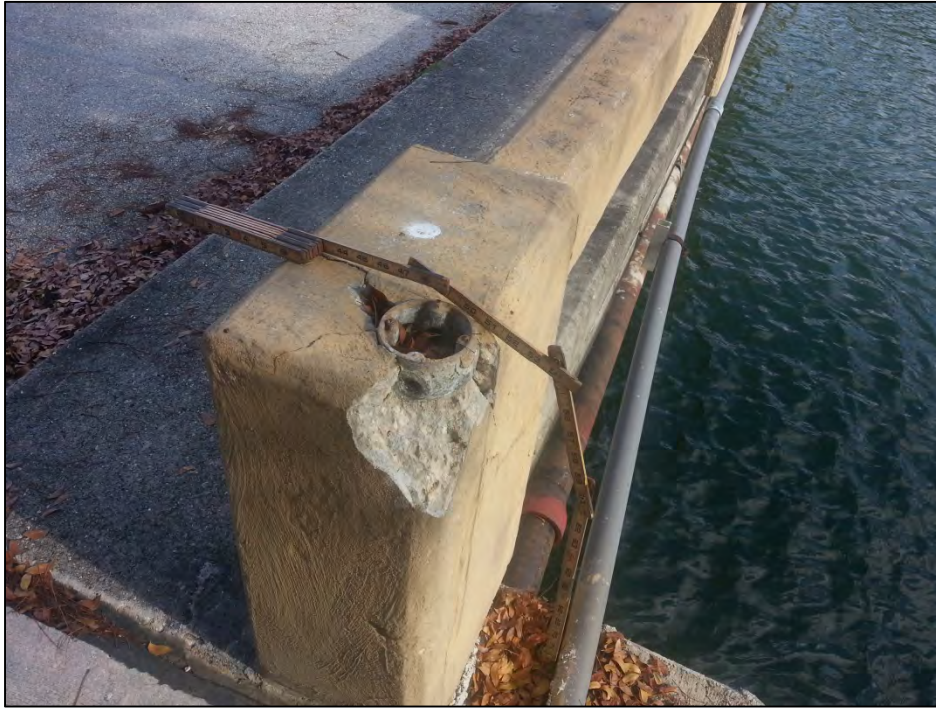
Photo 1 – Spall in Post 5-3, left.

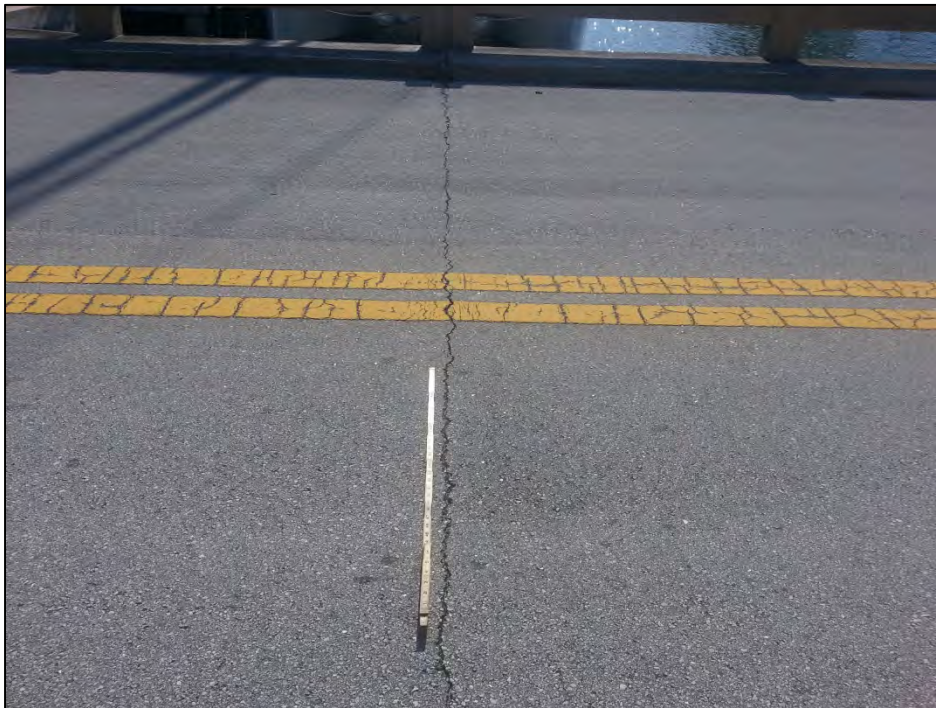
Photo 2 – Cracks in the asphalt over the expansion joints.

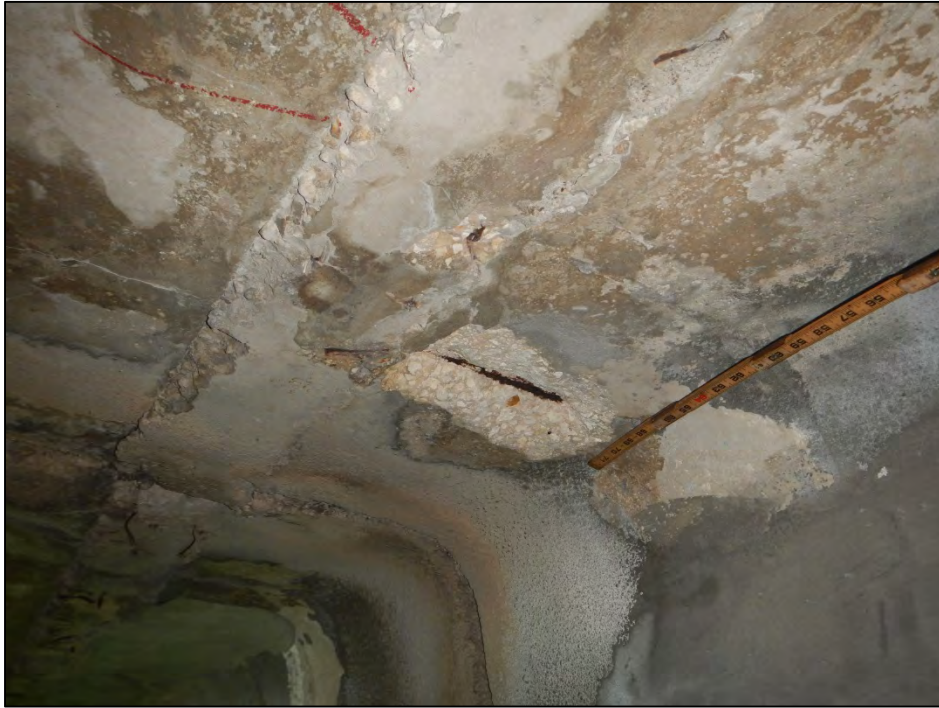
Photo 3 – Spall in the Double T-beam.

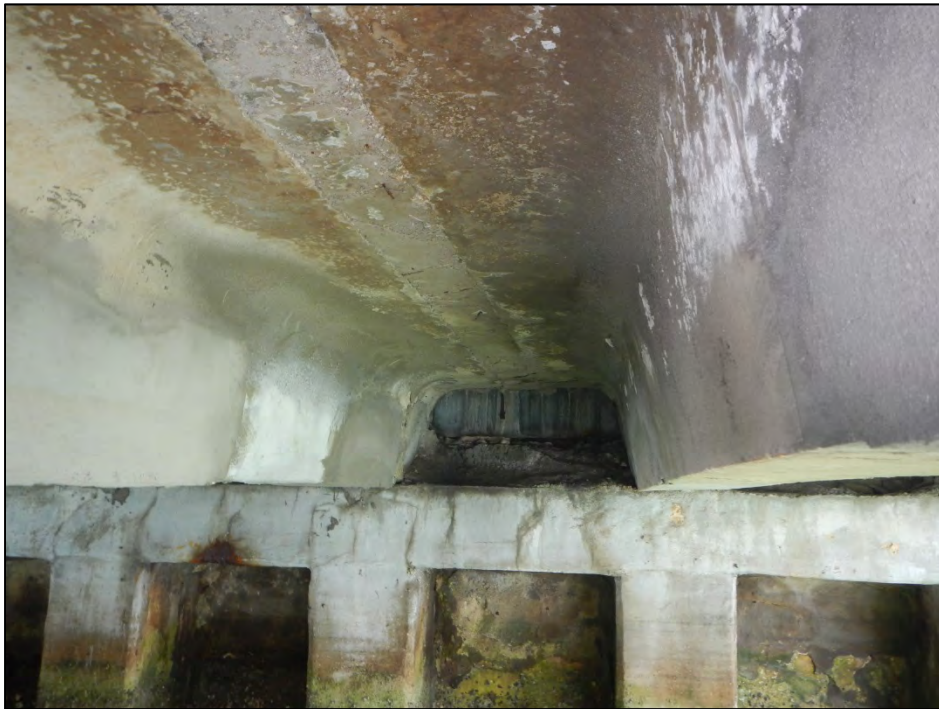
Photo 4 – Spall in Abutment I cap.

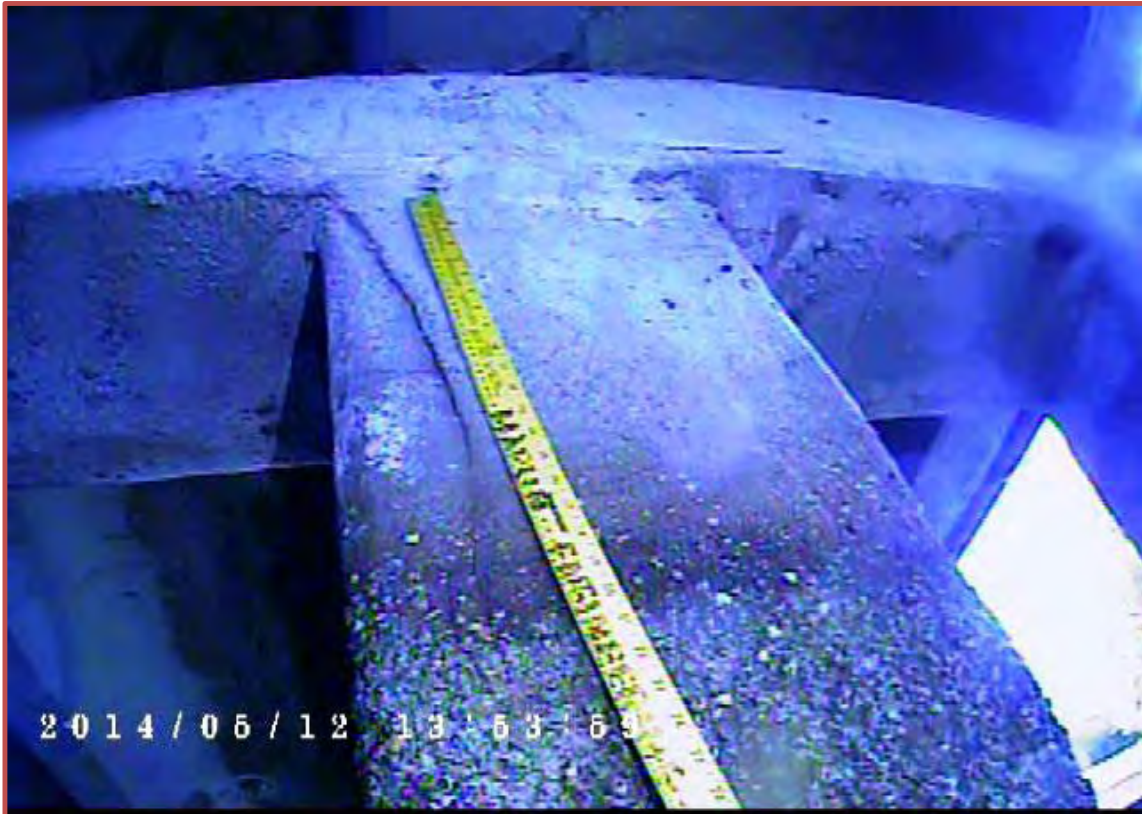
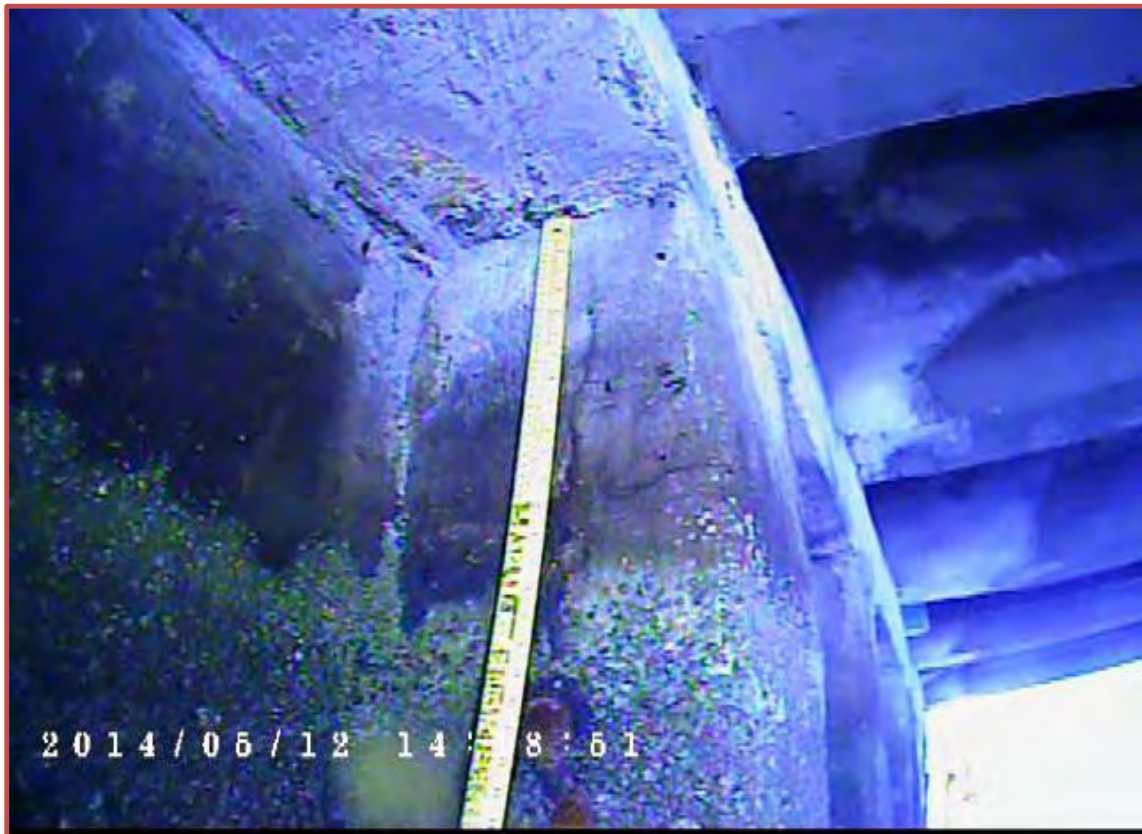
\_PJ 2-2, North face, (1) vertical crack 26" x 1/8", with corrosion bleed-out, starting at the cap.

\_PJ 6-4, West face, (1) vertical crack 22" x 1/64", with corrosion bleed-out, starting at the cap and extending 8" into the marine growth. **UW Photo 02. NEW.**

Description: Top: PJ 2-2, North face, (1) vertical crack with CBO, starting at the cap. **UW Photo 01.**  
Bottom: PJ 6-4, West face, (1) vertical crack with CBO, starting at the cap. **UW Photo 02.**

\_Remove all unsound concrete and patch and seal the cracks as needed.

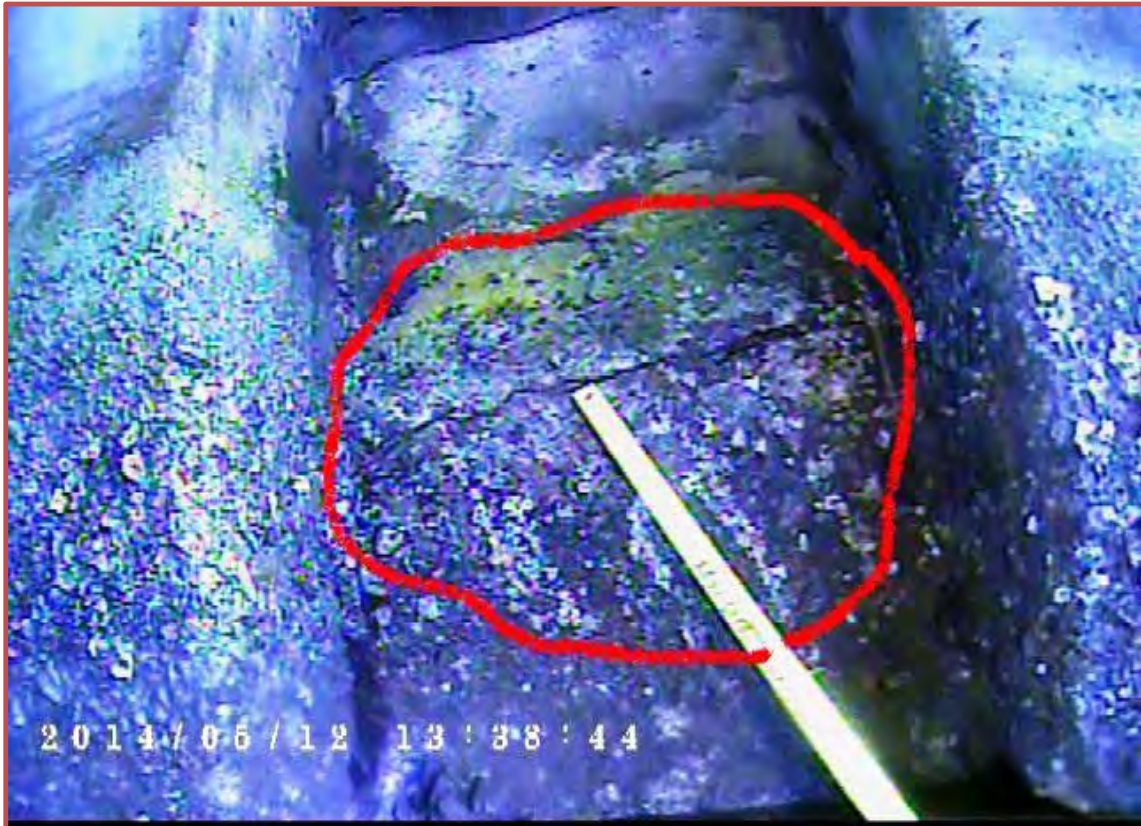
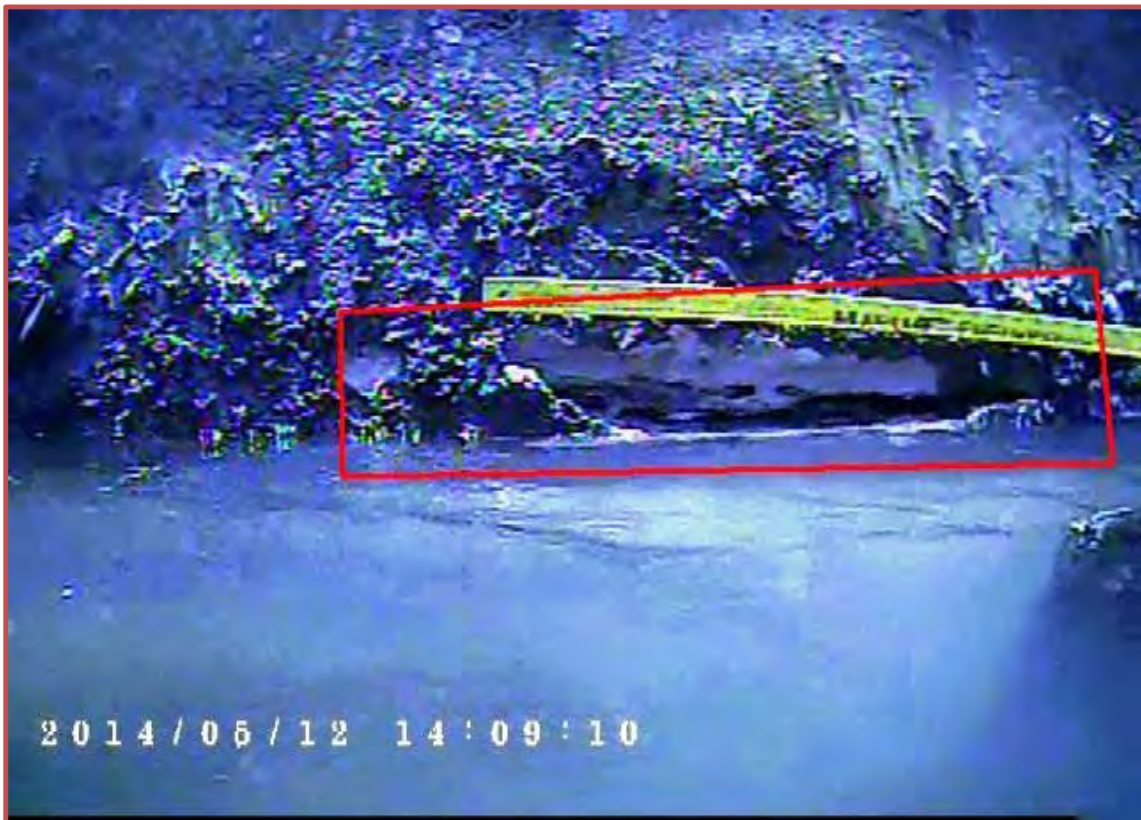
\_Abutment 1, between Piles 1-1 thru 1-3 exhibits a horizontal crack up to 1/8" wide, at various elevations along the backwall, also with hollow sounding area adjacent to the crack. **UW Photo 03. NEW.**

\_SW wingwall, has a spall/void 19" x 5" x 4". **UW Photo 04. NEW.**

Description: Top: Abutment 1, horizontal crack up to 1/8" wide at various elevations. **UW Photo 03.**  
Bottom: Southwest wingwall, has a spall/void 19" x 5" x 4". **UW Photo 04.**

\_Remove unsound concrete and patch the spall/void at the SW wingwall.

\_Remove all unsound concrete and patch and seal the horizontal crack along the Abutment 1 backwall.

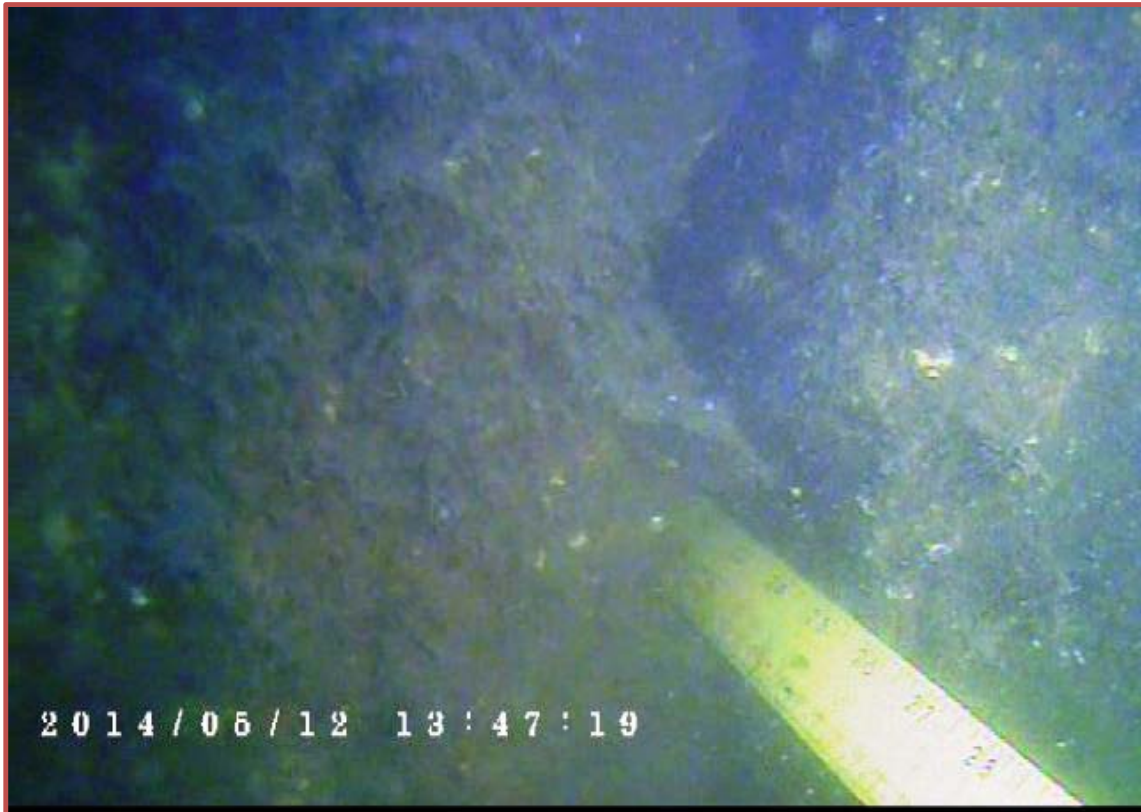
\_SE wingwall at transition to the backwall, has a gap/void 24" x 5" x 4" with 26" of penetration and with backfill leakage. **UW Photo 05. NEW.**

Description: Top: SE wingwall at transition to the backwall, has a gap/void. **UW Photo 05.**  
Bottom: SW corner wingwall, West side of Pile 1-1 has a delamination. **UW Photo 06.**

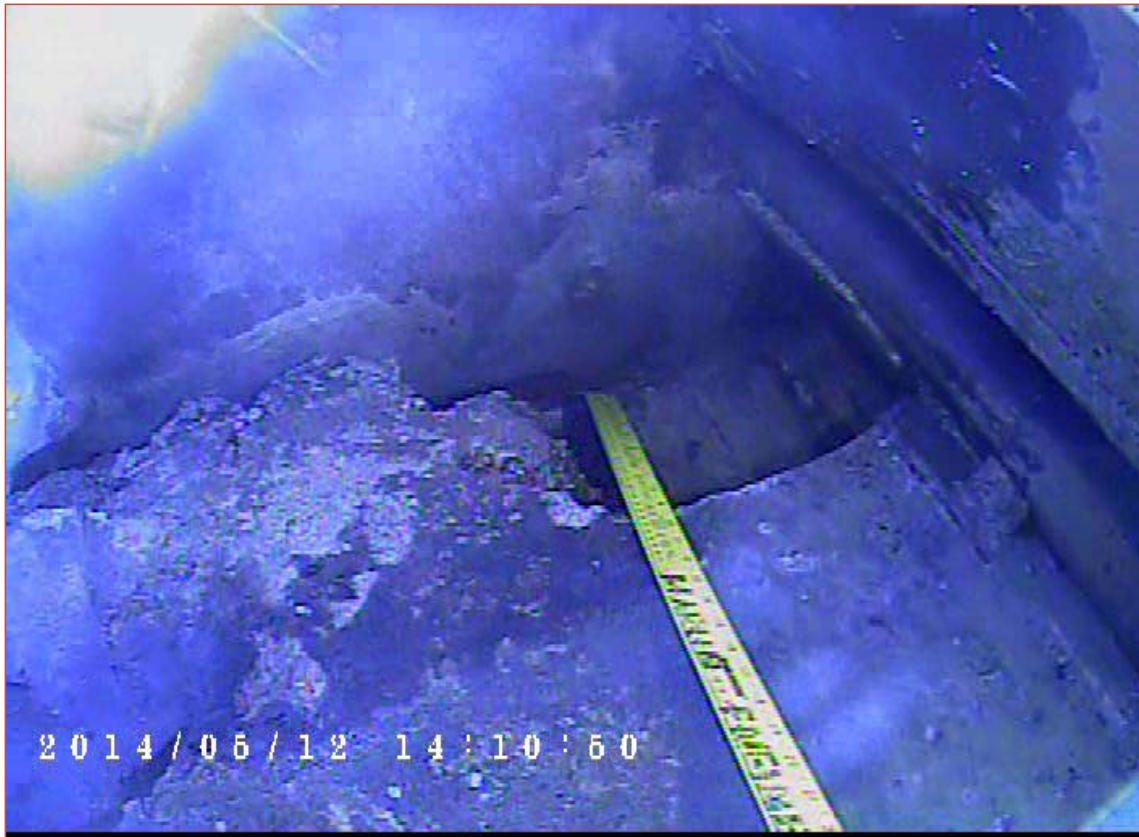
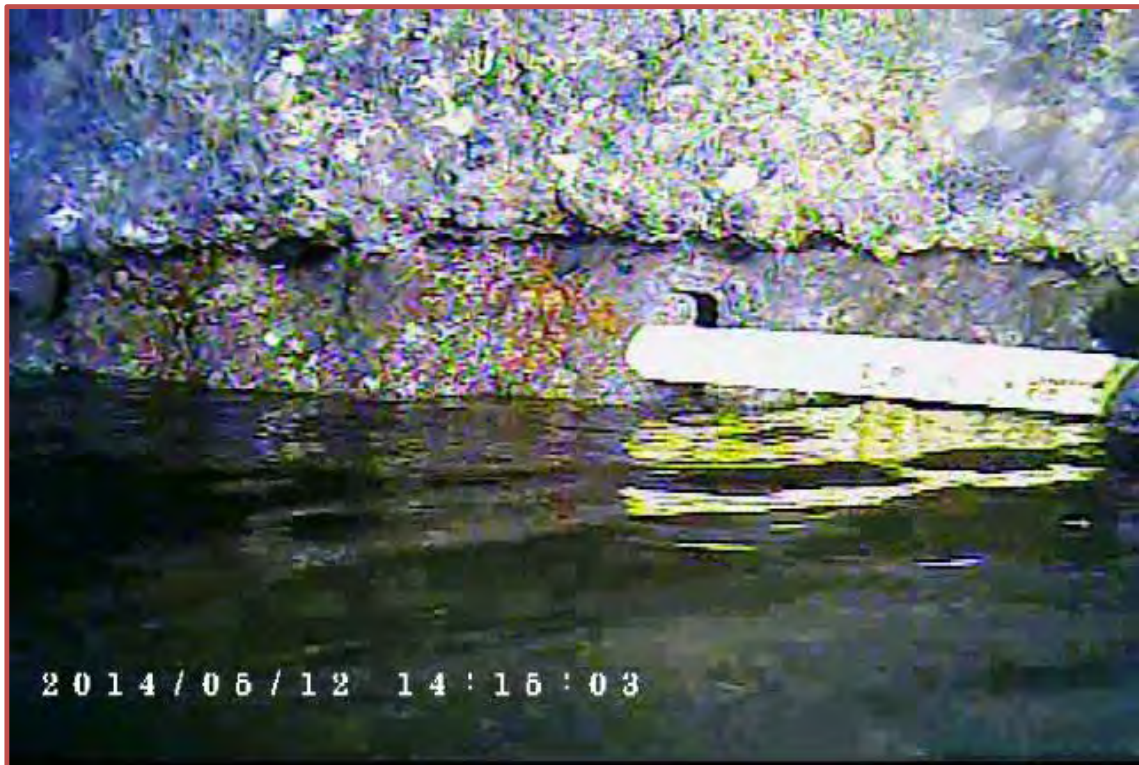
\_NE wingwall below the cap spall/void 13" x 13" x 11". **UW Photo 07. NEW.**

Description: Top: Northeast wingwall below the cap has a spall/void. **UW Photo 07.**  
Bottom: Abutment 6, corrugated panel have multiple holes at random location. **UW Photo 08.**

\_Repair the spall/void on the NE wingwall below the cap.

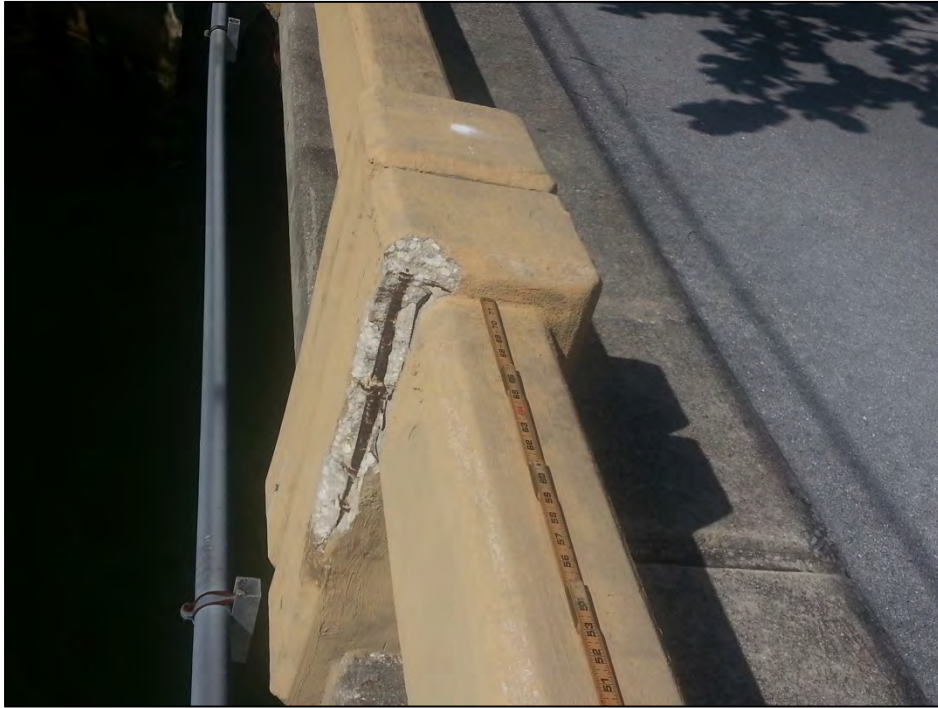
Photo 1 – Spall in Post 4-3, left.

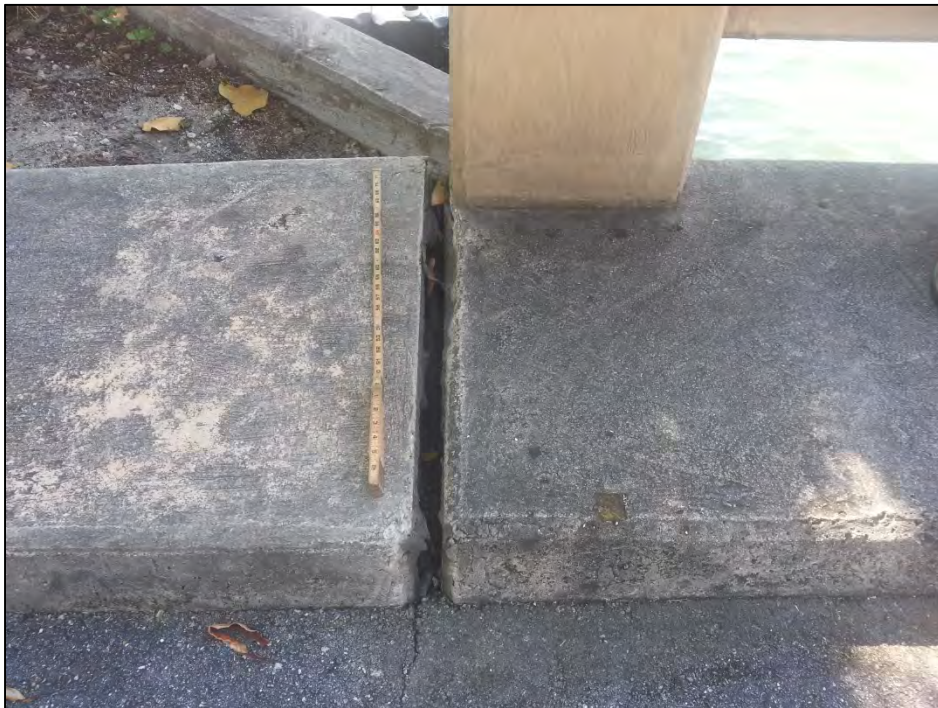
Photo 2 – Complete adhesion failure of the joints in the left sidewalk.

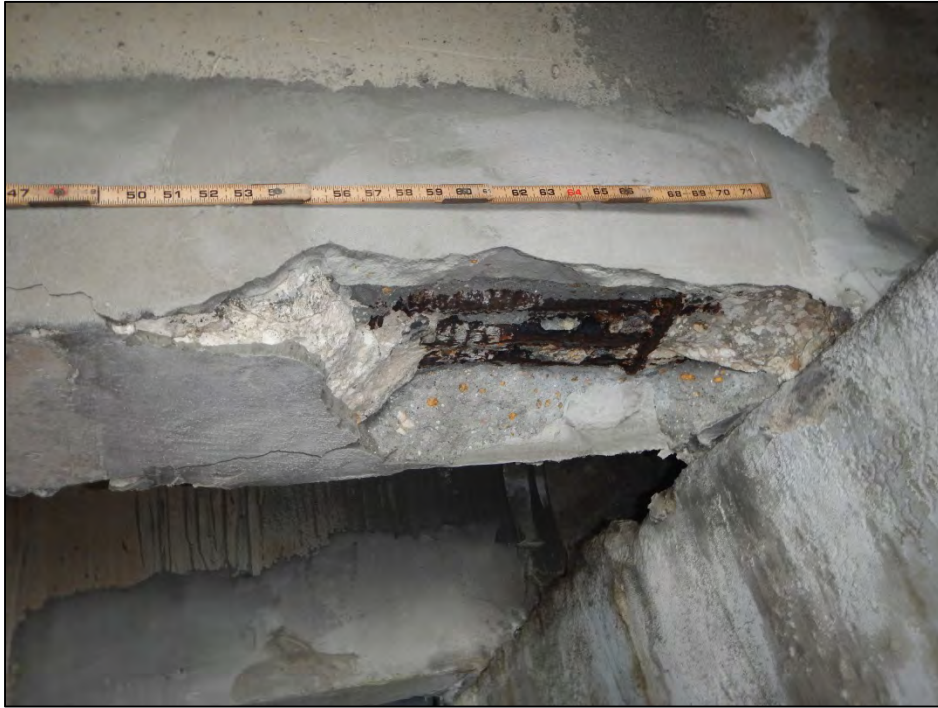
Photo 3 – Spall in the Double T-beam I-2 Right Leg.
