## **EXECUTIVE SUMMARY**

TranSystems has been retained by the City of Fort Lauderdale to perform bridge inspections and prepare bridge inspection reports for each of the City's bridges as part of the project Structural Bridge Engineering Consulting Services Master Plan, RFQ No. 946-11310. Inspections were completed and reports prepared for 46 of the City's bridges. The remaining five bridges in the City's inventory were not inspected because they are in the process of being replaced.

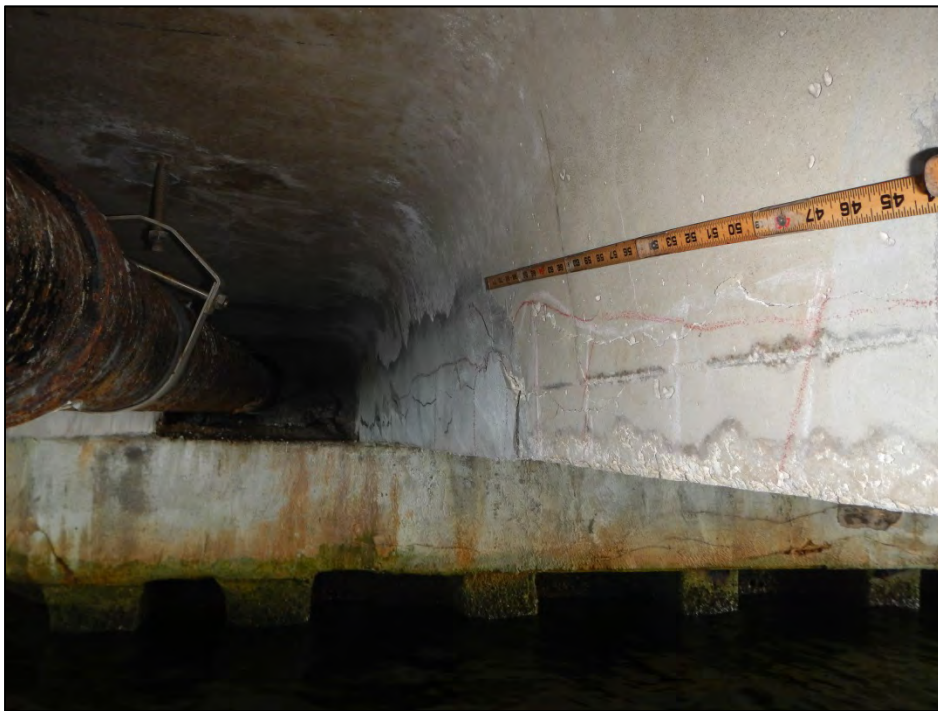
Photo 4 – Delaminated patch on Beam I-4.

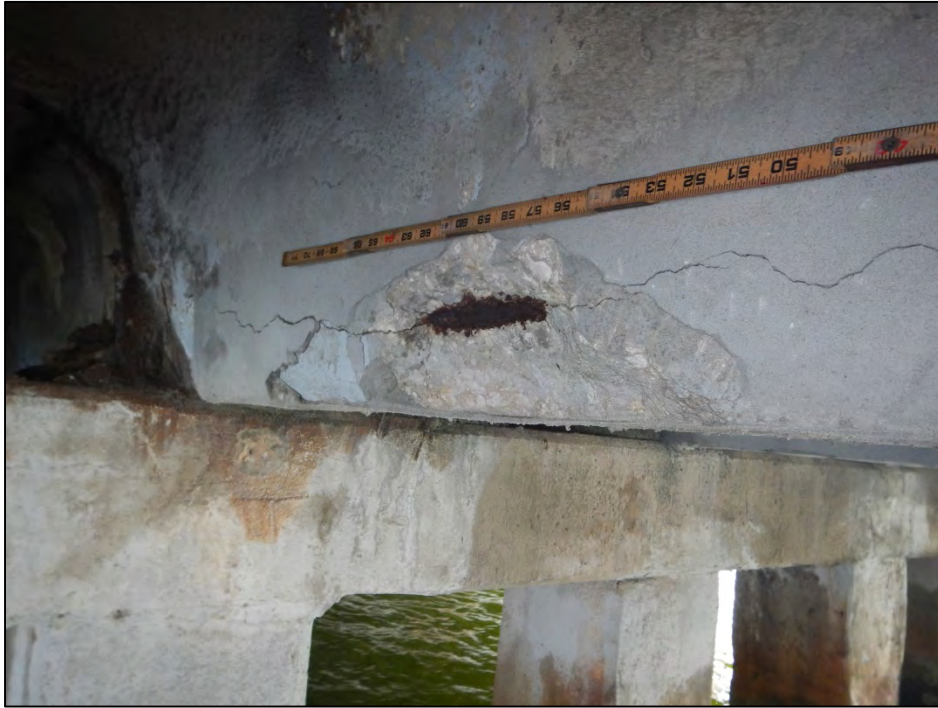
Photo 5 – Spall and delamination on Beam 2-3 right leg.

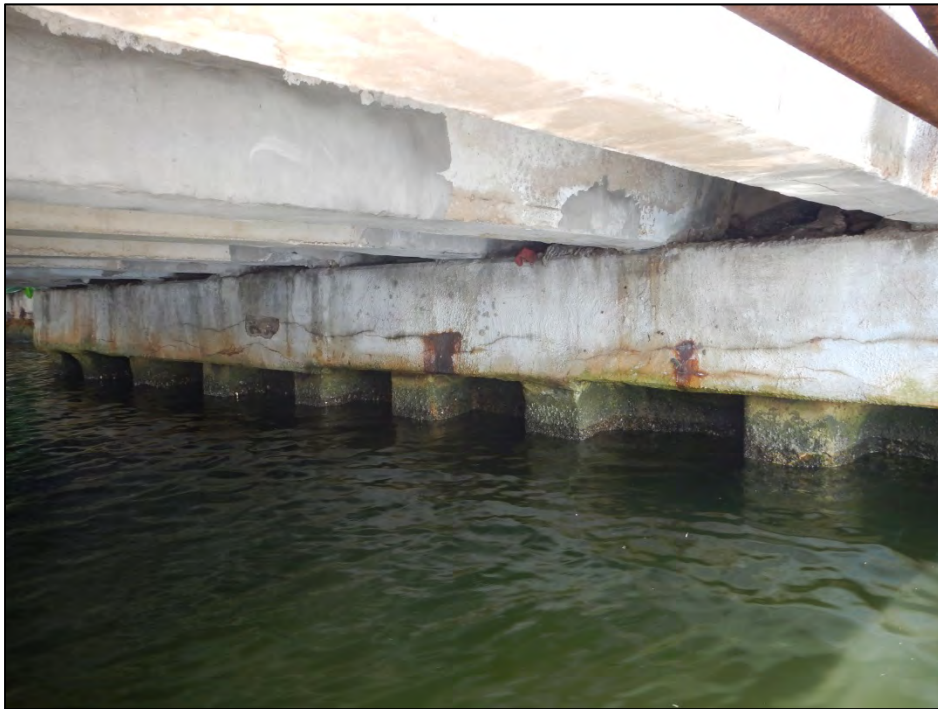
Photo 6 – Delamination on the Bent 5 cap.

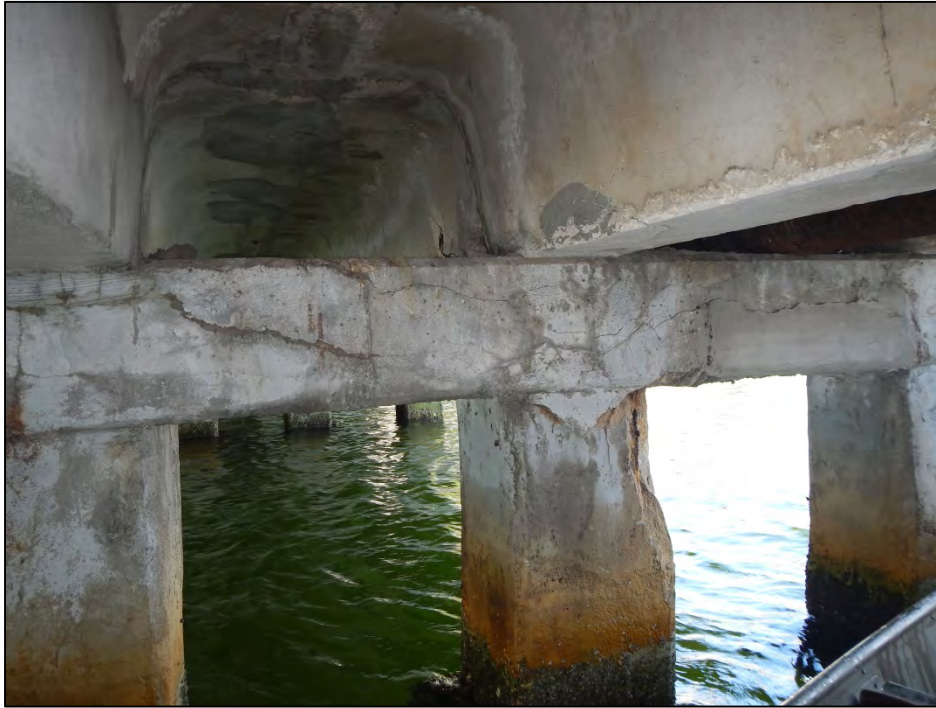
Photo 7 – Spall and delamination on the southeast corner of Pile Jacket 4-7.

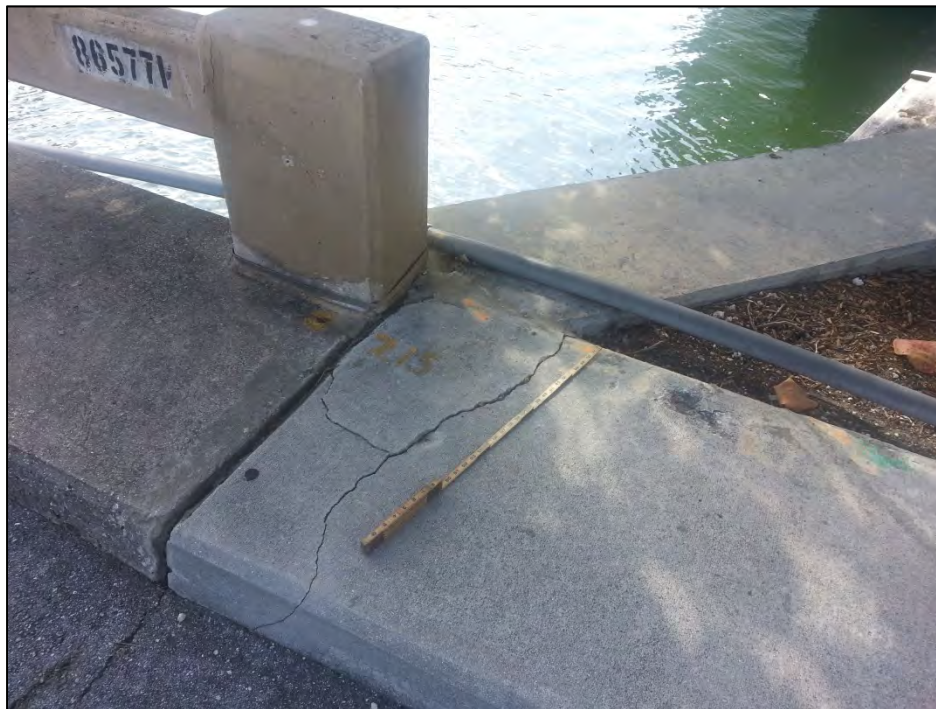
Photo 8 – Delamination on the northwest approach sidewalk.

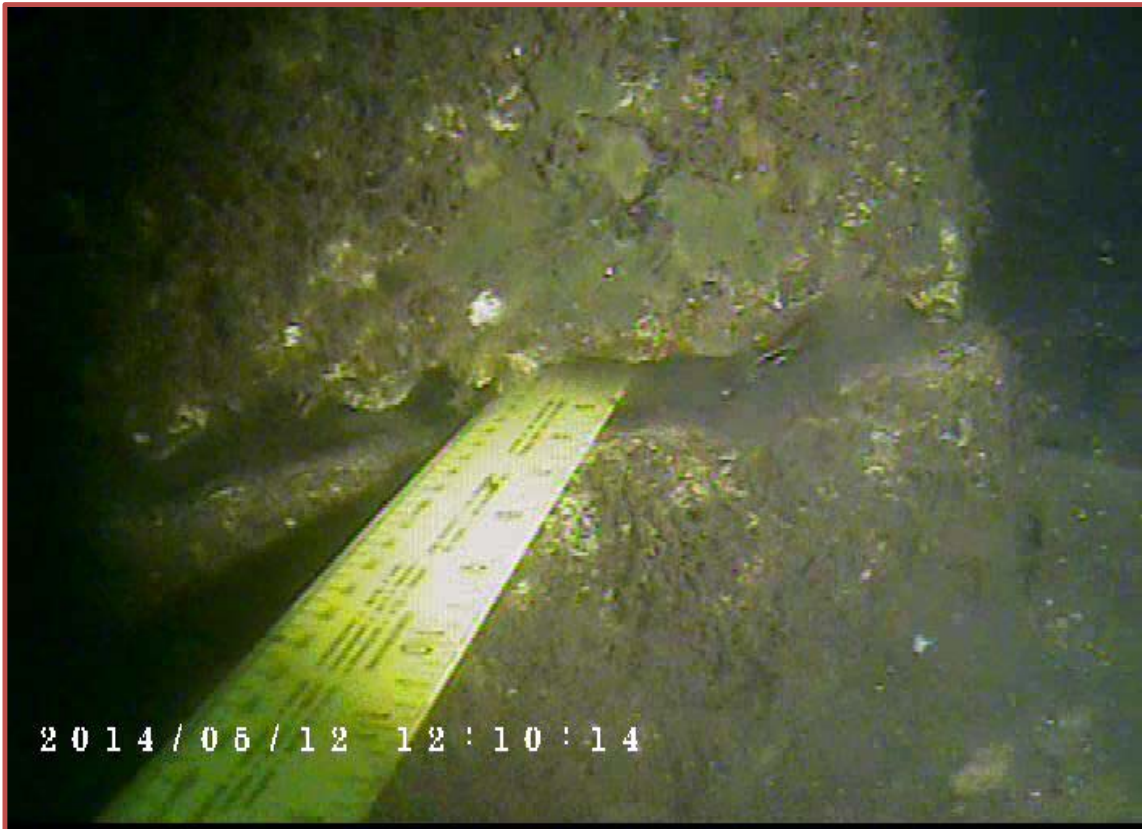
\_Pile 6-1 is fractured with a 1/2" wide crack along the South face, 12" above ground-line.

\_Pile 6-4 is fractured with (4) pieces of rebar exposed up to 100% section loss, 18" above ground-line.

Description: Top: Pile 6-1, South face, fractured, 12" above ground-line. **UW Photo 01.**  
Bottom: Pile 6-4, fractured, (4) pieces of rebar exposed. **UW Photo 02.**

\_Repair the fractured Piles 6-1 and 6-4 as needed.

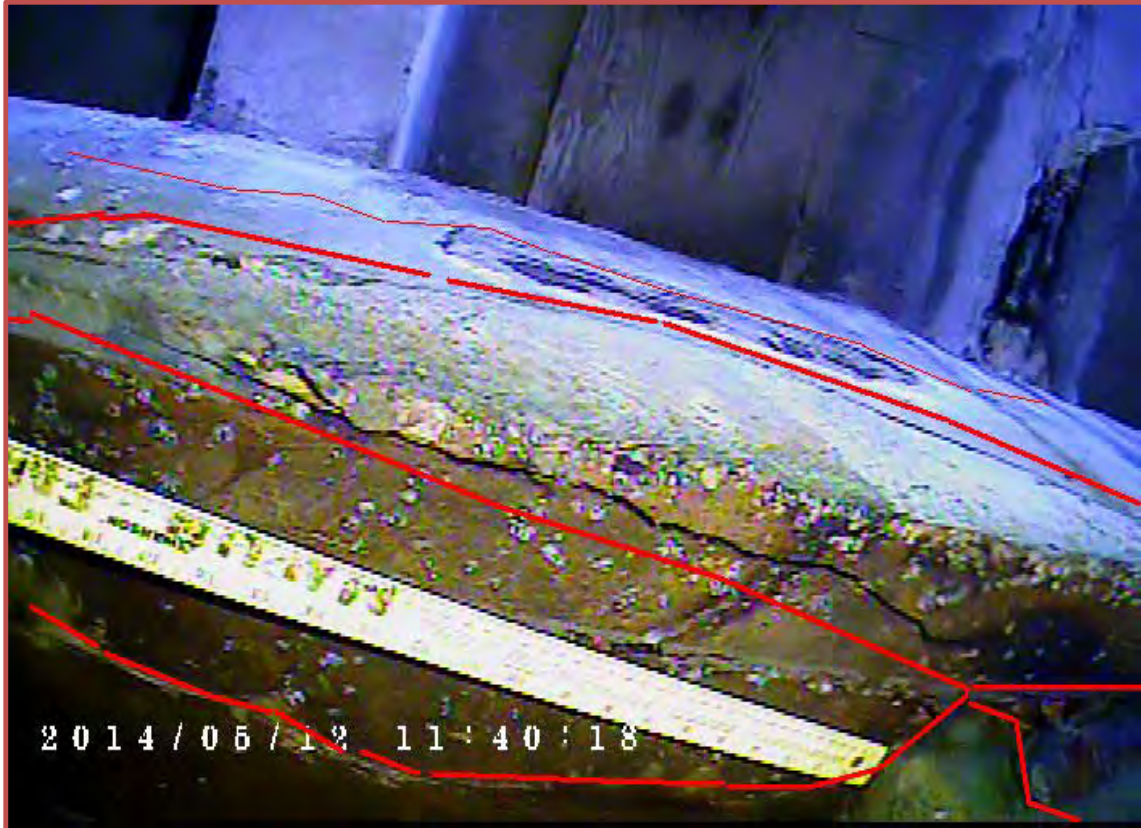
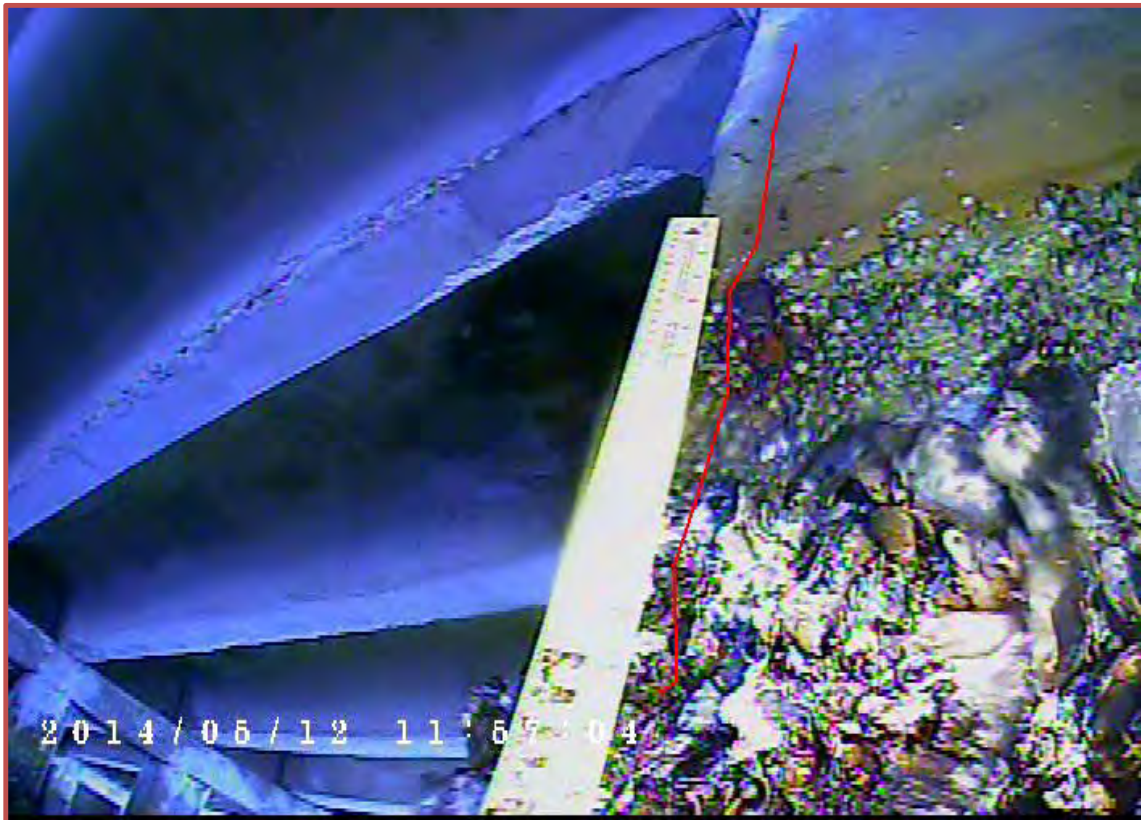
\_Abutment 1 cap has horizontal cracks full-length x up to 1/8" wide, with corrosion bleed-out. Also, along the bottom edge is delaminated full-length x up to 15". **UW Photo 03. INCREASE.**

\_PJ 4-4, South and West faces (previously documented East) have (2) vertical cracks up to 8" x 1/32", with corrosion bleed-out, starting 26" below the cap. **UW Photo 04. INCREASE.**  
\_PJ 4-7, Southeast corner has a spall/delamination 21" x 7" x 2", with corrosion bleed-out. **NO CHANGE.**  
\_PJ 5-1, East face has (1) vertical crack 36" x 1/32", extending 12" into the marine growth. **NEW.**  
\_PJ 6-1, East face has (1) vertical crack 24" x 1/32", starting at the cap with corrosion bleed-out. **NO CHANGE.**

Description: Top: Abutment 1 cap, delamination with associated cracks and CBO. **UW Photo 03.**  
Bottom: PJ 4-4, South and West faces (2) vertical cracks and CBO. **UW Photo 04.**

\_Remove all unsound concrete and patch and seal the cracks at Abutment 1 cap and Abutment 6 cap.

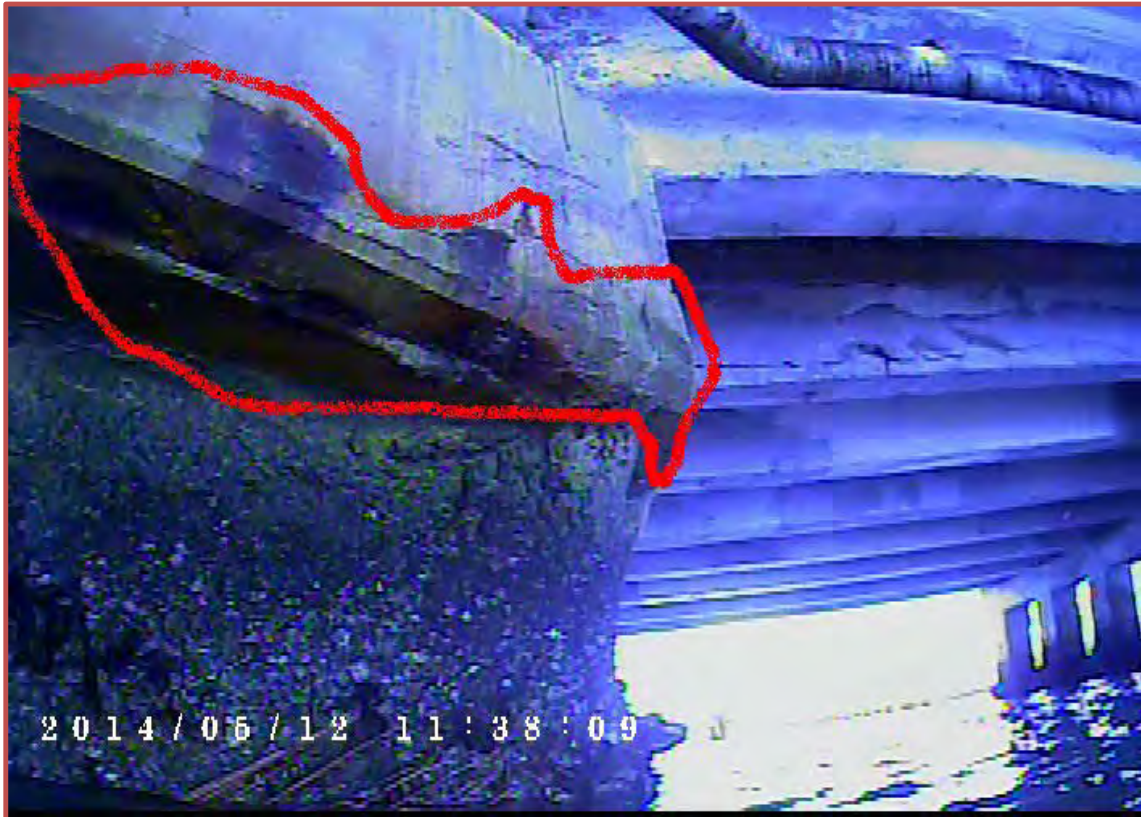
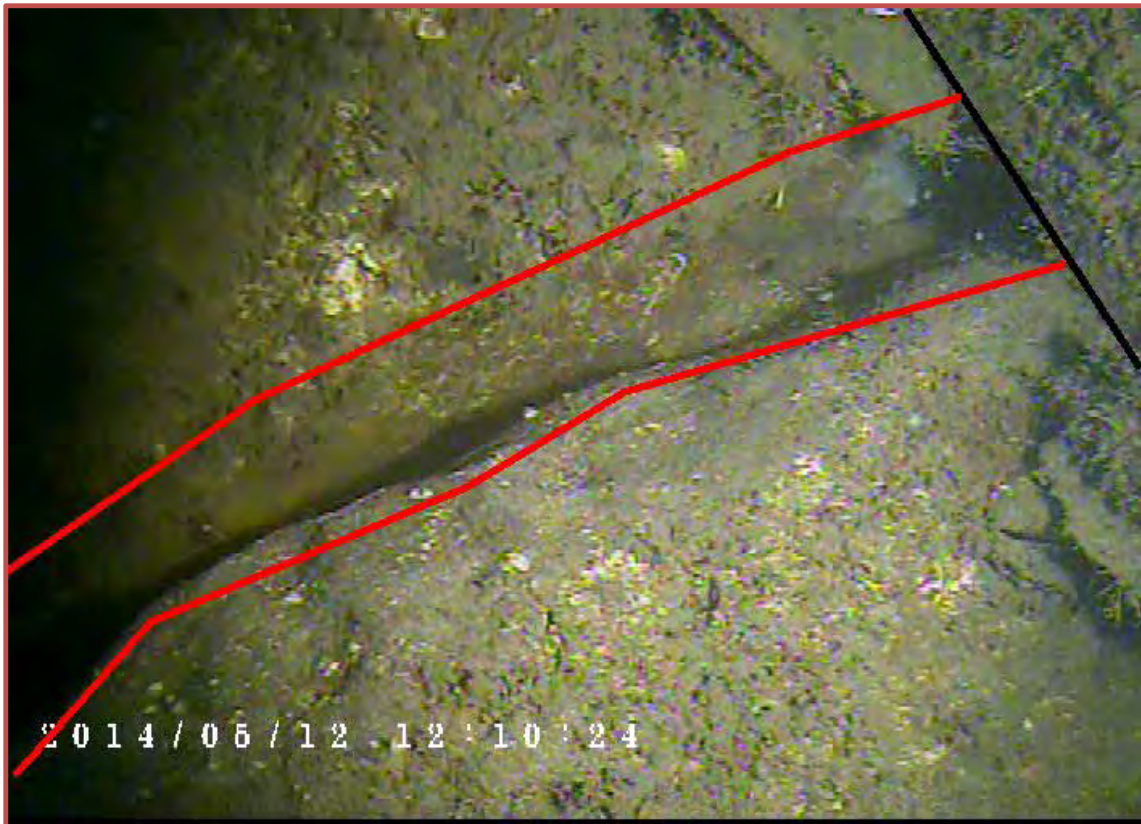
\_SE retaining wall cap has a delamination 36' x 6", with corrosion bleed-out. **UW Photo 05. NO CHANGE.**

\_Abutment 6 backwall between Piles 6-8 thru 6-10 has a horizontal crack up to 16' L x 1/2" W, at various elevation and the wall appears to be pushed out 1/2" in several location. No backfill leakage was observed during this inspection cycle. **UW Photo 06. NO CHANGE.**

Description: Top: SE retaining wall cap, delamination with corrosion bleed-out. **UW Photo 05.**  
Bottom: Abutment 6 backwall between Piles 6-8 thru 6-10, horizontal crack. **UW Photo 06.**

\_Remove all unsound concrete and patch and seal the cracks at both Abutment backwalls.

\_Remove all unsound concrete and patch and seal the cracks along the retaining walls.

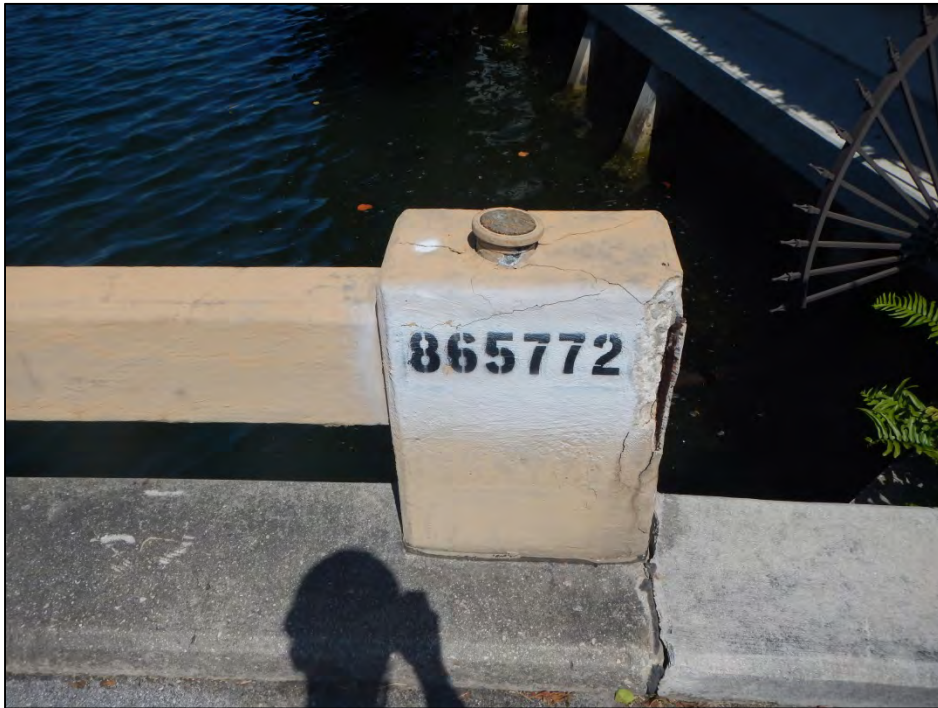
Photo 1 – Delamination and spall with exposed rebar in Post 1-1, Left.

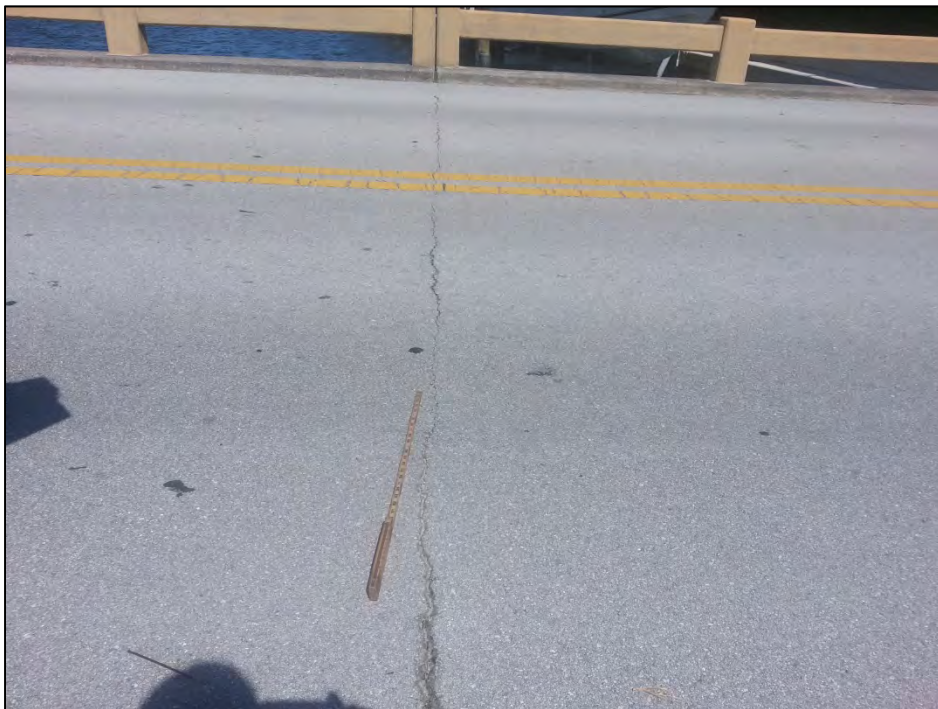
Photo 2 – Typical cracking in the asphalt over intermediate bents.

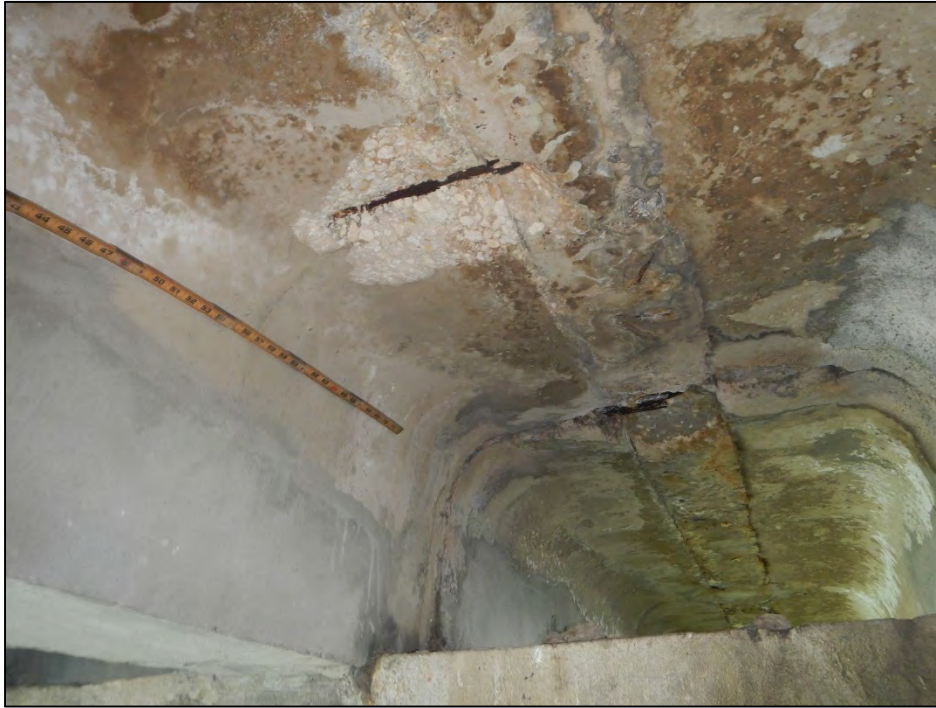
Photo 3 – Spall with exposed reinforcing in the top flange of the left leg of Beam 1-2.

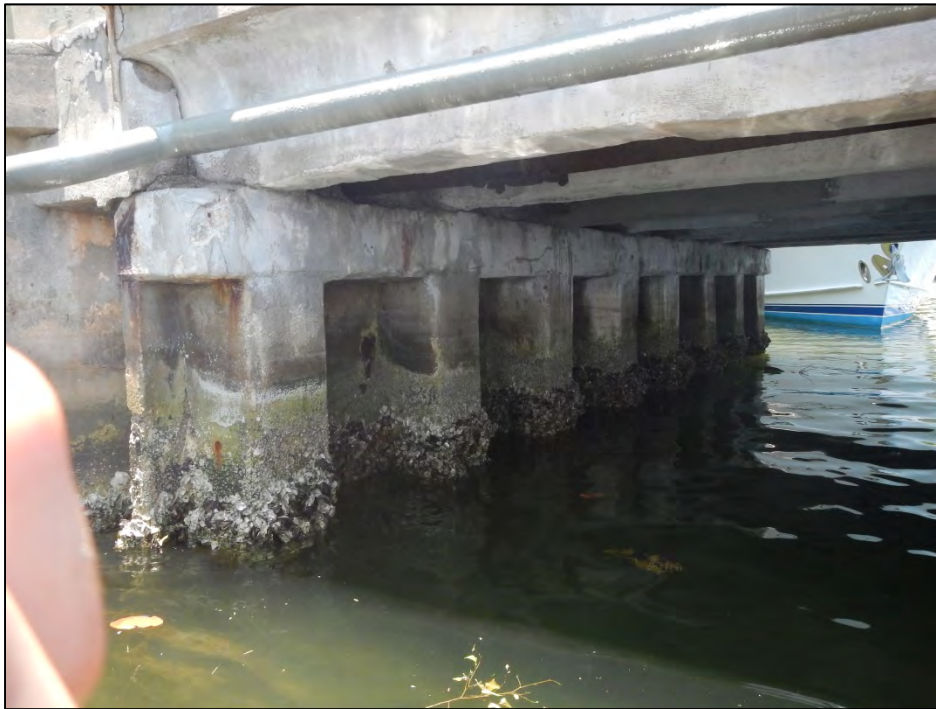
Photo 4 – Delamination with corrosion staining on the cap at Abutment 1.

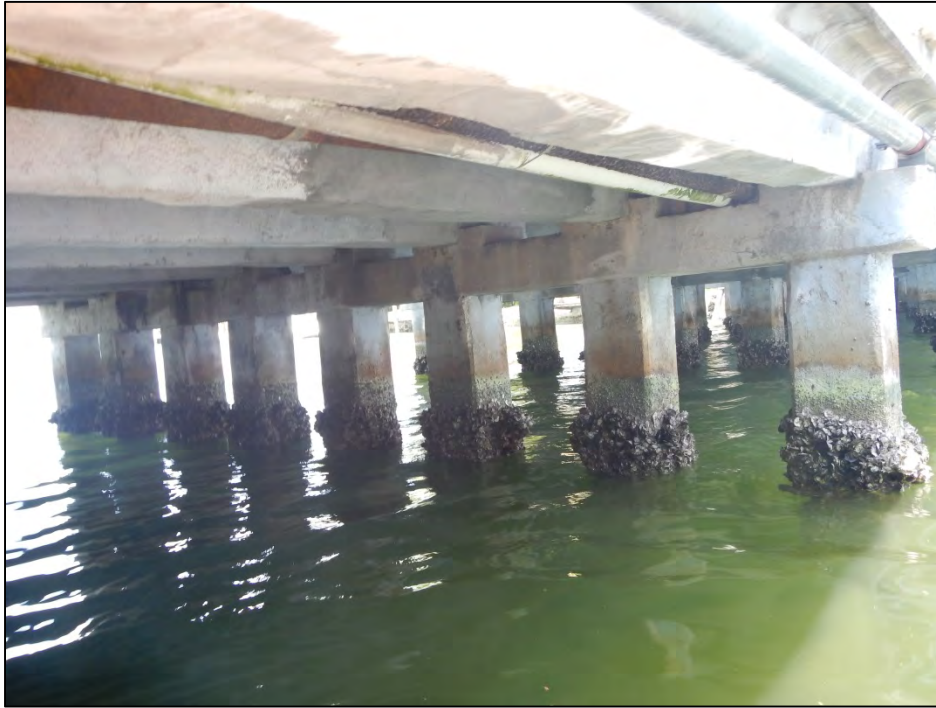
Photo 5 – Delaminations and cracks in the cap at Bent 2.

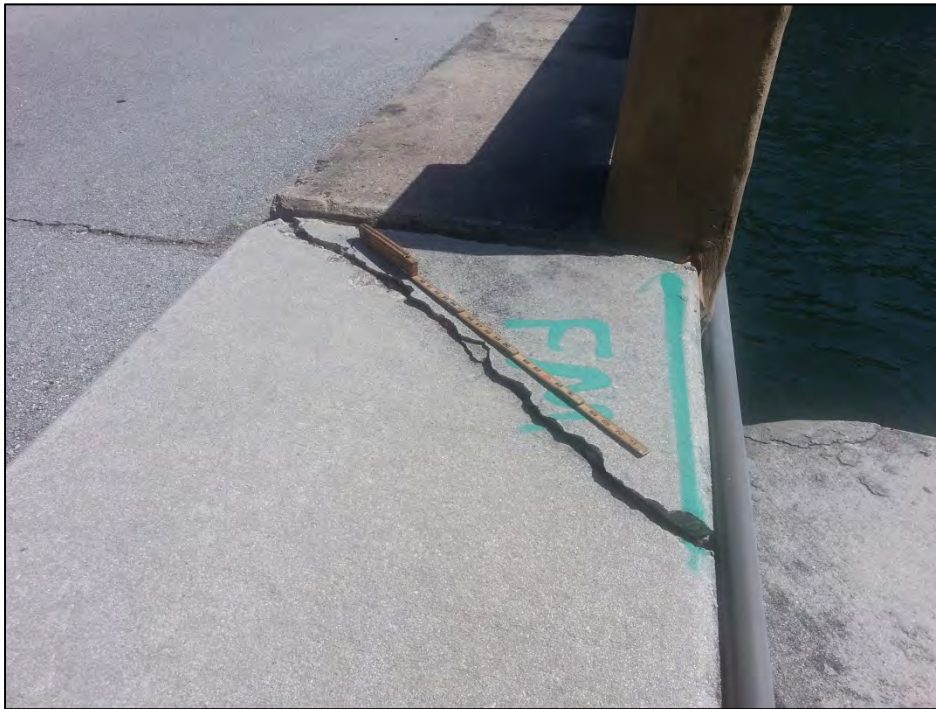
Photo 6 – Crack in the north approach sidewalk.

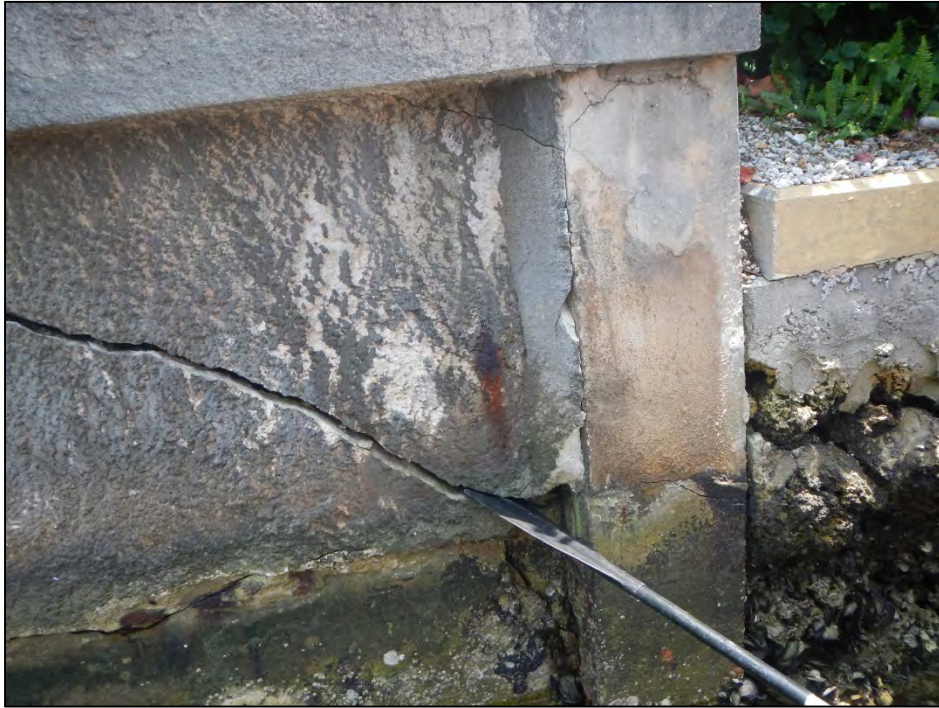
Photo 7 – Southwest wingwall crack/fracture.

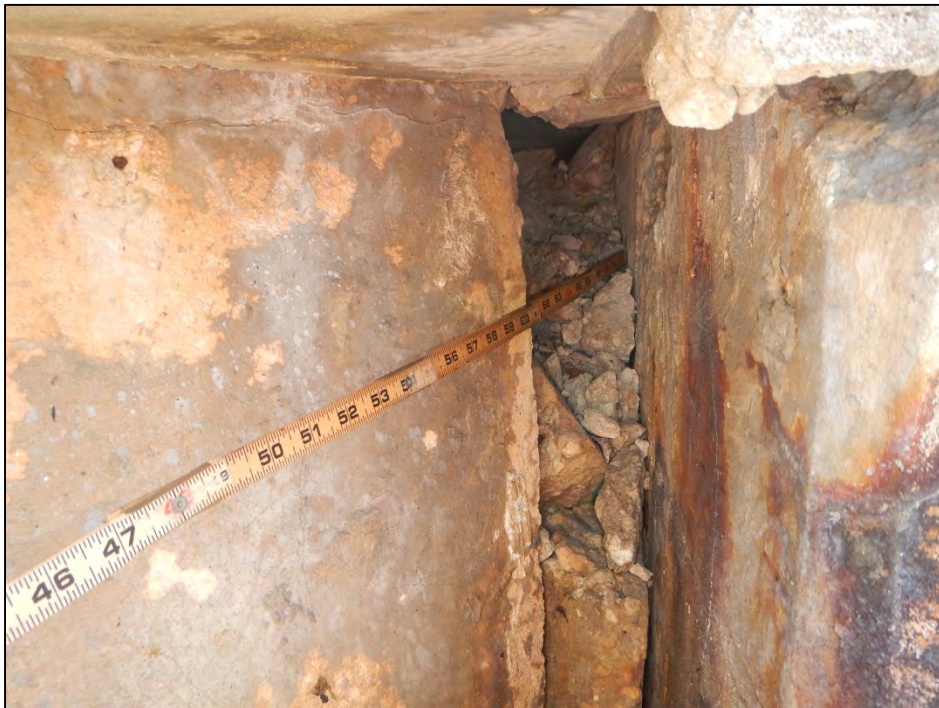
Photo 8 – Southeast corner open transition joint in the wingwall.

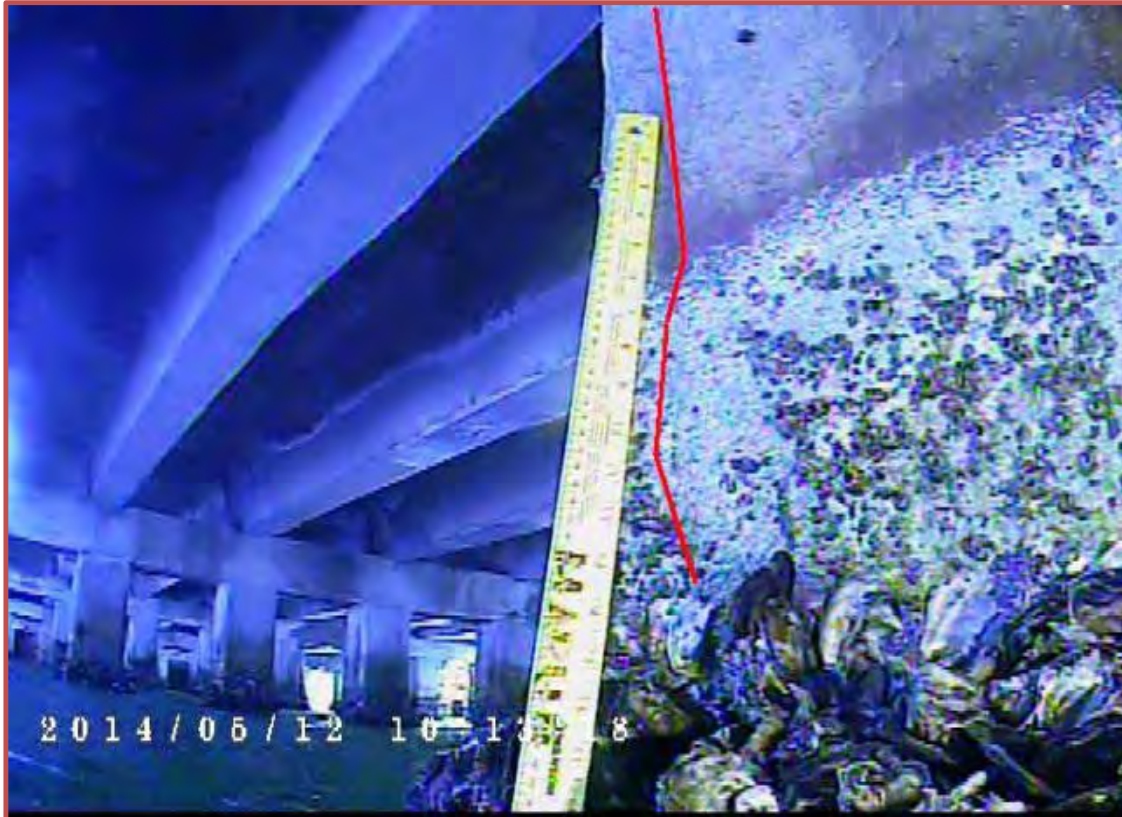
\_PJ 2-2, West face (2) vertical cracks up to 15" x 1/32", extending 10" into the marine growth with corrosion bleed-out. **UW Photo 01. NEW.**

Description: Top: PJ 2-2, West face (2) vertical cracks, with CBO. **UW Photo 01.**

\_Seal the cracks on Pile Jackets 2-1, 2-2, 2-3, 2-7, 3-1, 3-1, 3-6, 3-7 and 4-1.

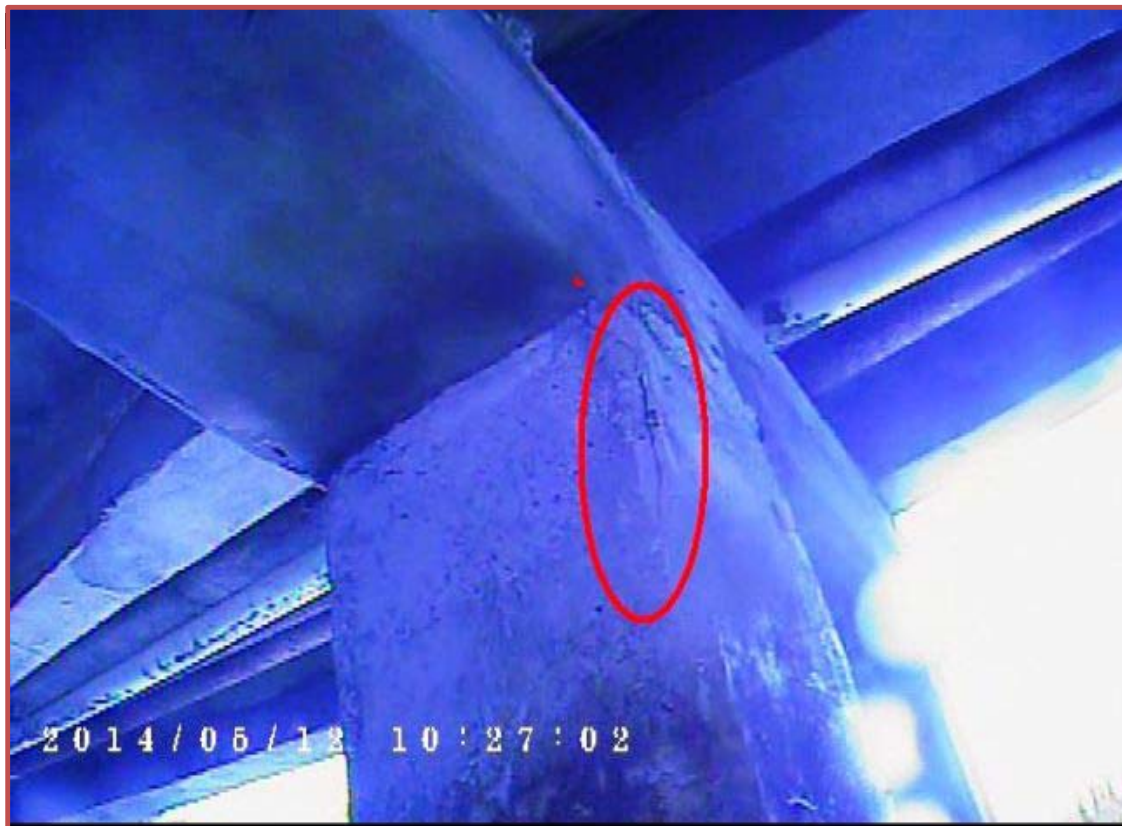
\_PJ 3-7, Southeast corner (1) vertical crack 13" x 1/8", starts at the cap with corrosion bleed-out. **UW Photo 02. NEW.**

Bottom: PJ 3-7, SE corner (1) vertical crack, starts at the cap with CBO. **UW Photo 02.**

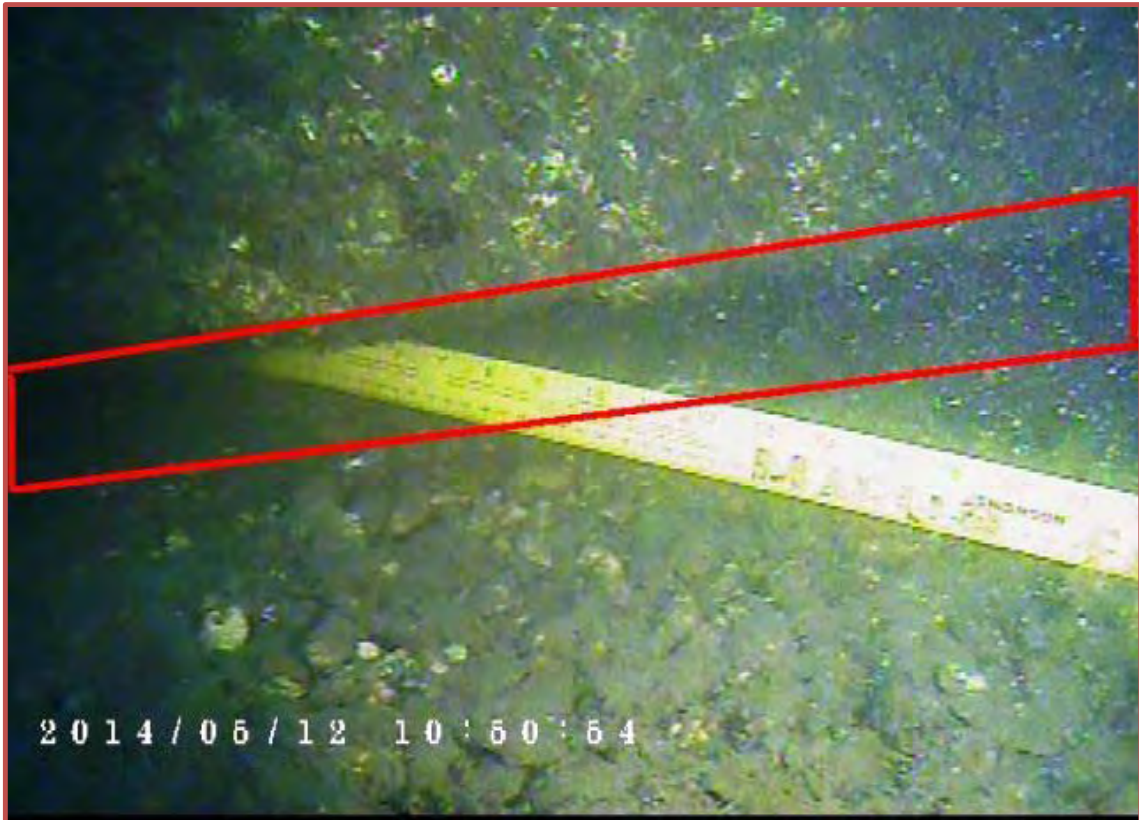
\_NW wingwall has an undermined area 10' long x 4" high, with up to 16" of penetration and backfill leakage. **UW Photo 03. INCREASE.**

Description: Top: NW wingwall has an undermined area, up to 16" of penetration. **UW Photo 03.**  
Bottom: Abutment 6 backwall between Piles 6-3 thru 6-8, undermined area. **UW Photo 04.**

\_Repair the areas of undermining to prevent backfill from leaking out.

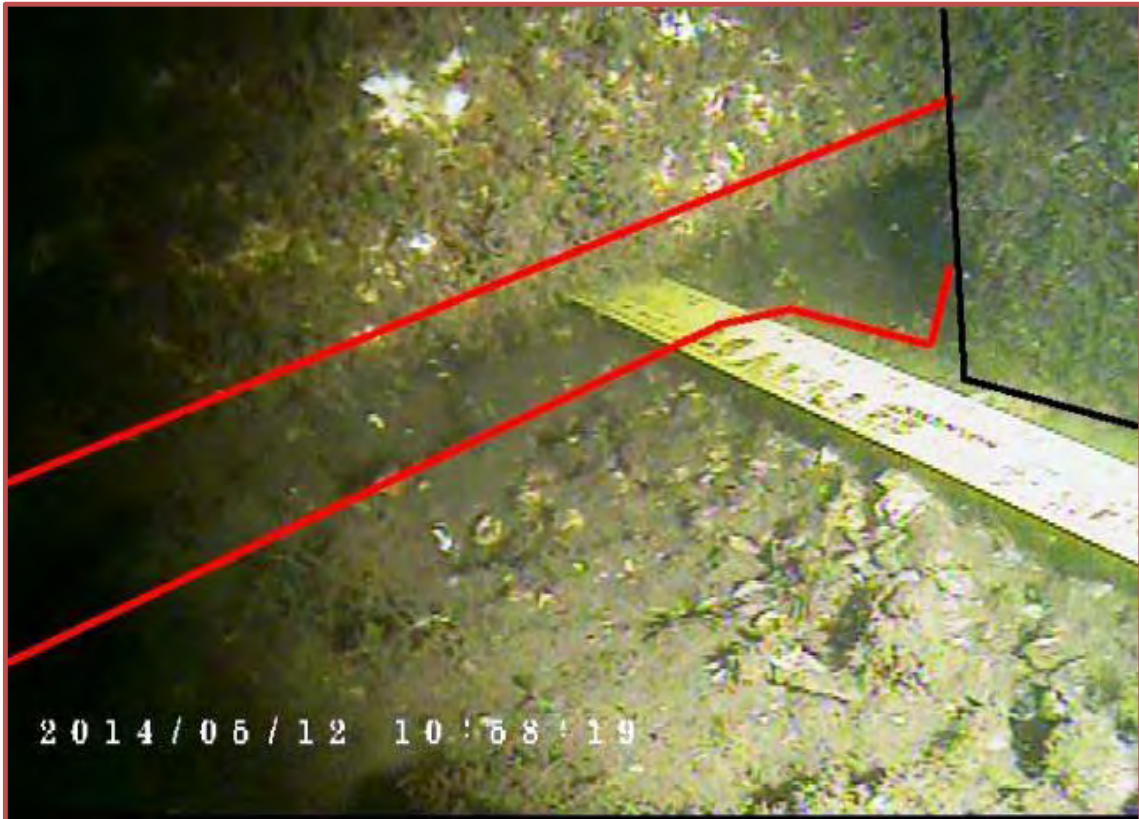
\_Abutment 6, backwall between Piles 6-3 thru 6-8 has an undermined area 4" H, with up to 20" penetration and backfill leakage. **UW Photo 04. INCREASE.**

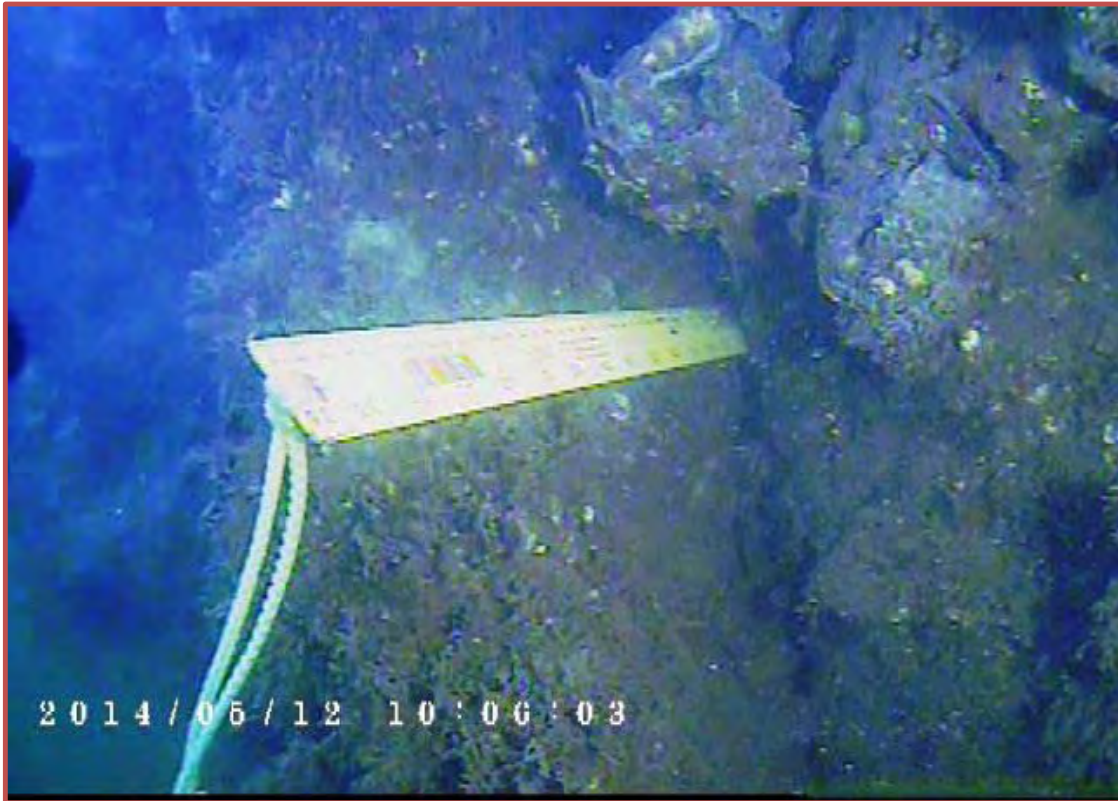
\_Abutment 1, the backwall panel on the West side of Pile 1 has a gap 2" wide with up to 36" penetration approximately 18" below the high watermark. No backfill leakage was observe during this inspection cycle. **UW Photo 05. NEW.**

Description: Top: Abutment 1, backwall panel on the West side of Pile 1 gap 2" wide. **UW Photo 05.**  
Bottom: SW wingwall, has (2) diagonal fractures up 3/4" wide, with CBO. **UW Photo 06.**

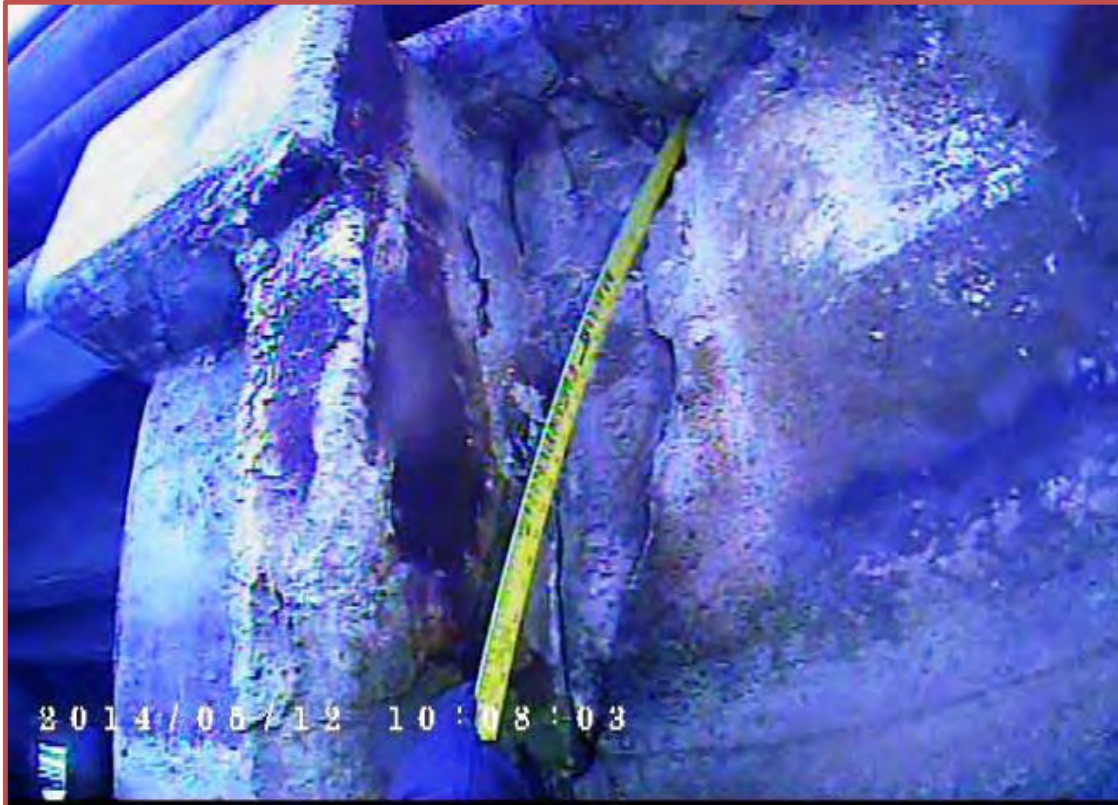
\_SW wingwall/backwall, has a spall/delaminated area 30" x 8" x 3". **UW Photo 07. NEW.**

Description: Top: SW wingwall/backwall, has a spall/delaminated area. **UW Photo 07.**  
Bottom: SE wingwall/backwall transition joint, delamination/void. **UW Photo 08.**

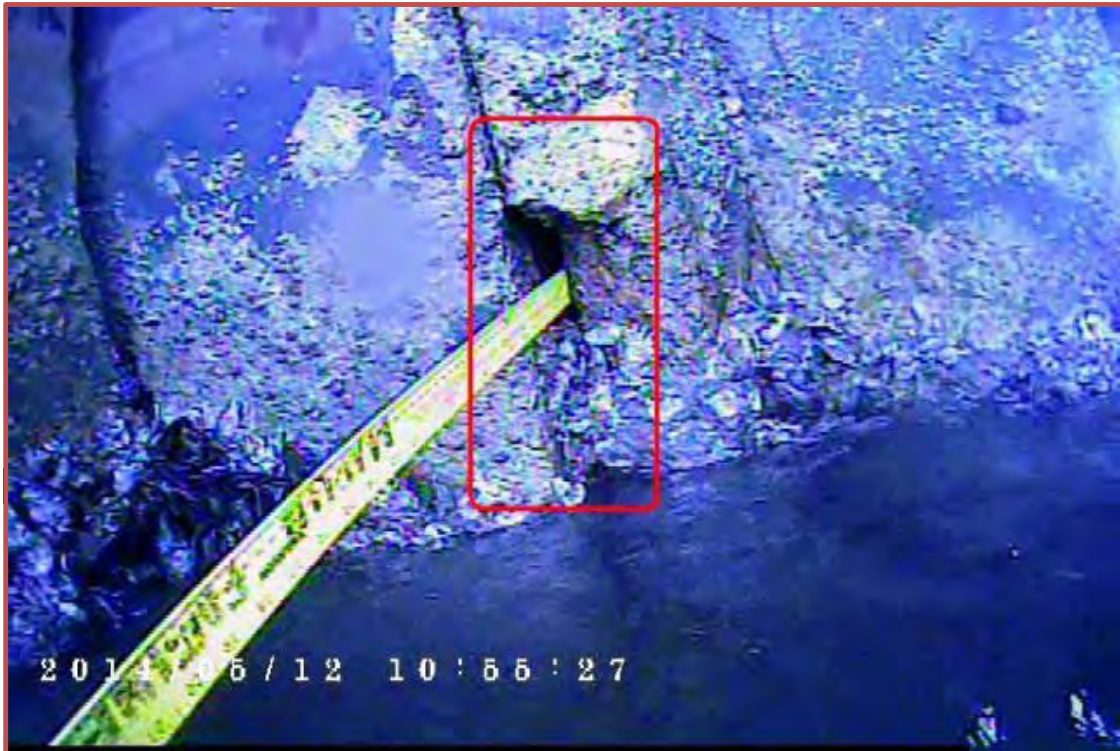
Description: NW wingwall/backwall joint has an 18" x 12" x 18" void. **UW Photo 09.**

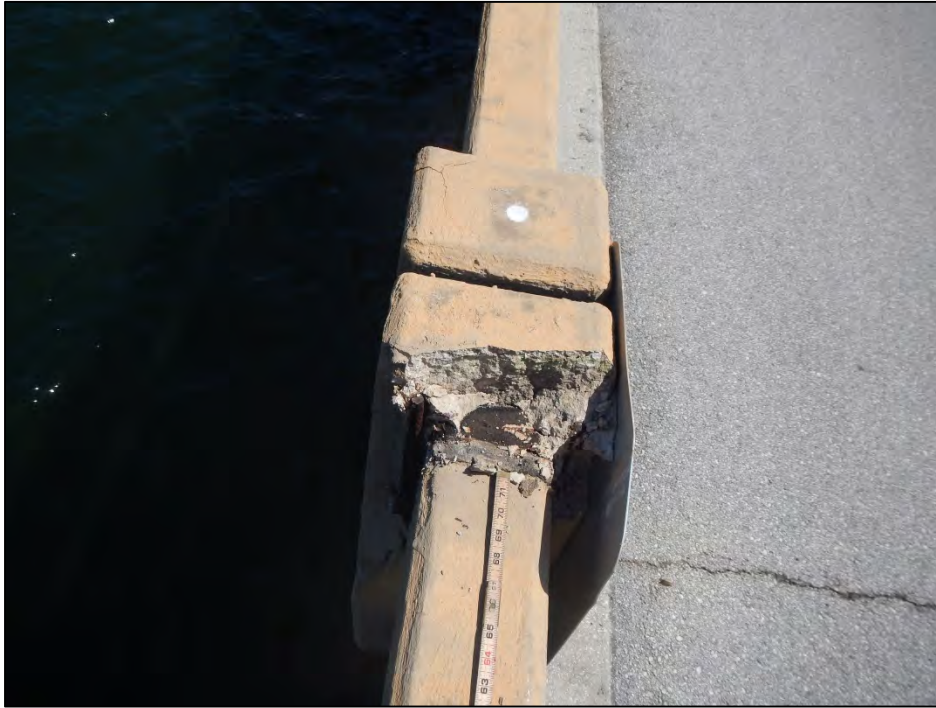
Photo 1 – Spall in Post 5-1, right.

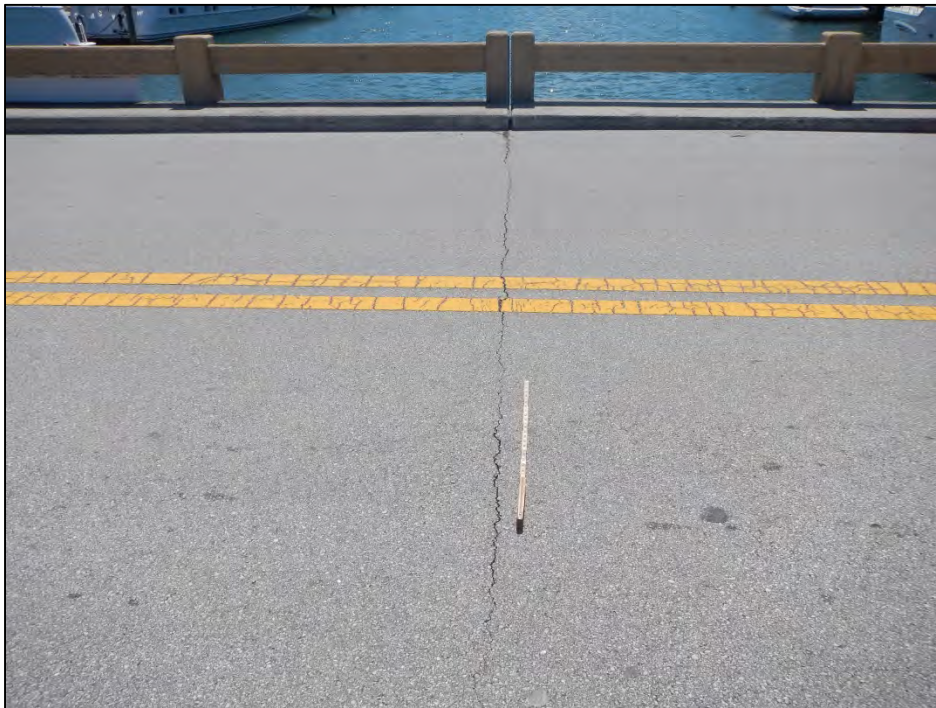
Photo 2 – Cracks in the asphalt over the expansion joints.

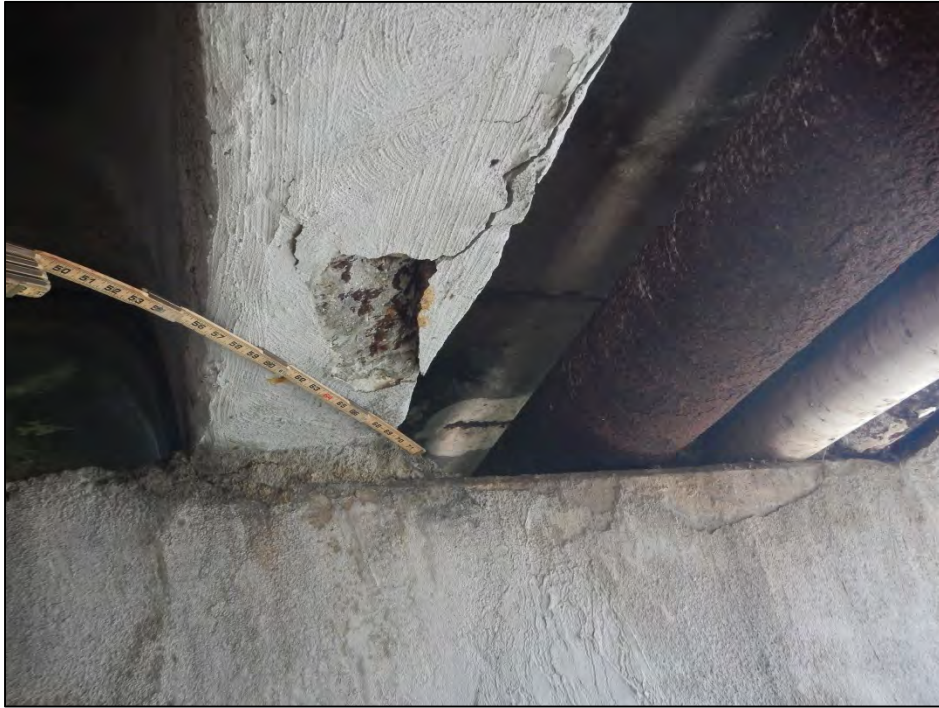
Photo 3 – Spall in Beam 4-I north of Bent 5.
