## **EXECUTIVE SUMMARY**

TranSystems has been retained by the City of Fort Lauderdale to perform bridge inspections and prepare bridge inspection reports for each of the City's bridges as part of the project Structural Bridge Engineering Consulting Services Master Plan, RFQ No. 946-11310. Inspections were completed and reports prepared for 46 of the City's bridges. The remaining five bridges in the City's inventory were not inspected because they are in the process of being replaced.

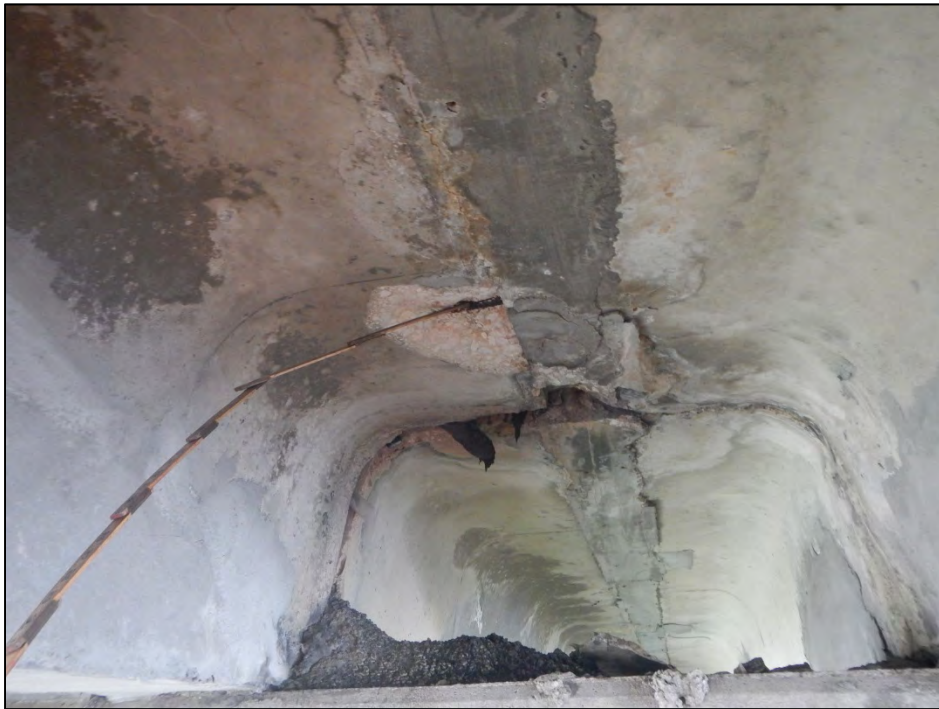
Photo 4 – Typical spall with exposed rebar and delamination in the double T-beams.

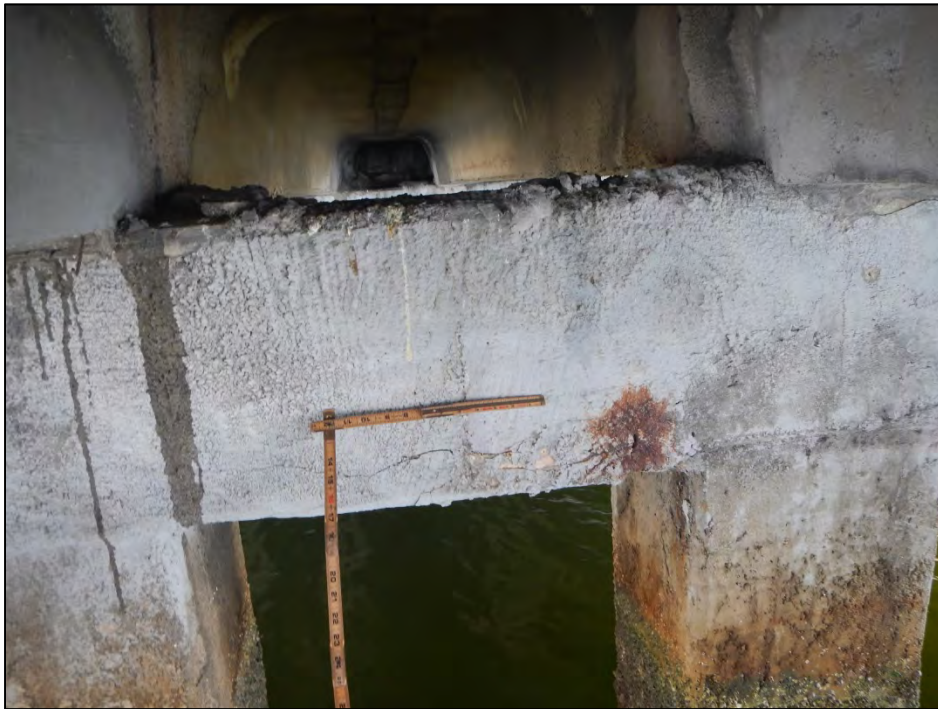
Photo 6 – Delamination in the cap at Bent 8.

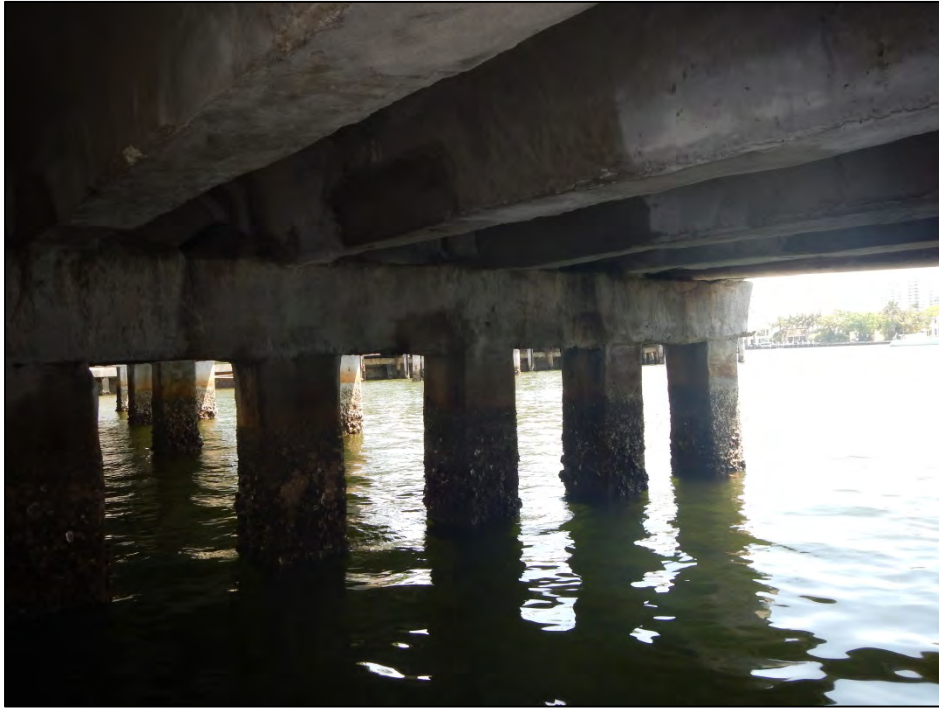
Photo 7 – Typical spalling (UW may take out).

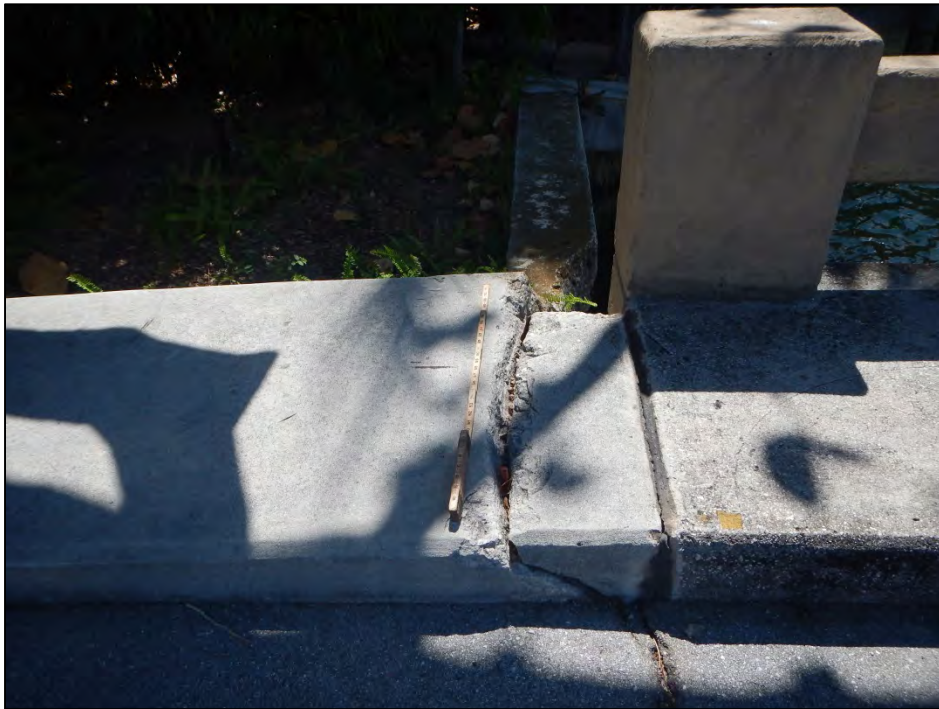
Photo 8 – Spall with exposed reinforcing steel in the Approach Slab sidewalk.

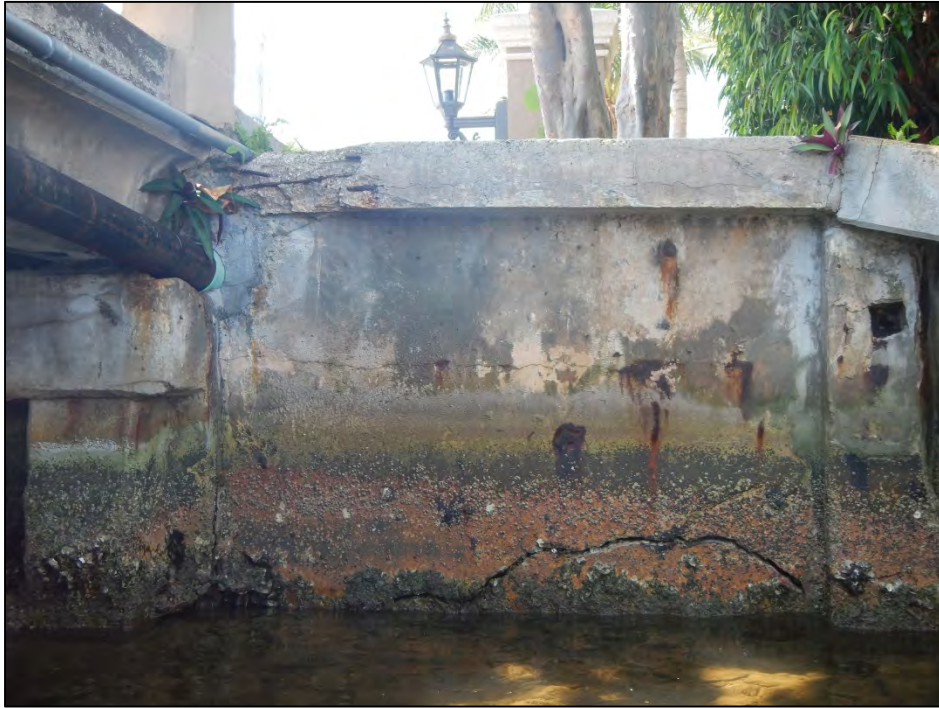
Photo 9 – Spall with exposed reinforcing steel in the southwest retaining wall.

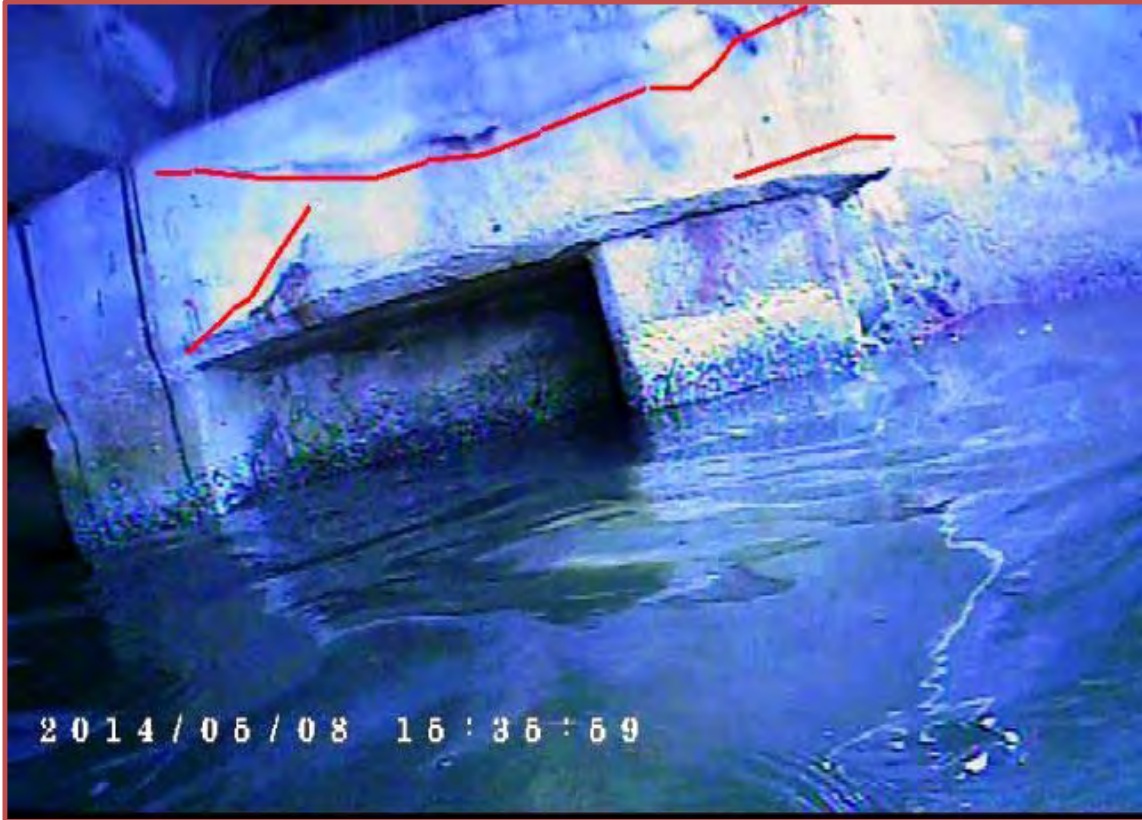
Description: Top: Both abutment caps, gunite coating has vertical and horizontal cracks. **UW Photo 01.**  
Bottom: Bent caps have several intermittent cracks with CBO. **UW Photo 02.**

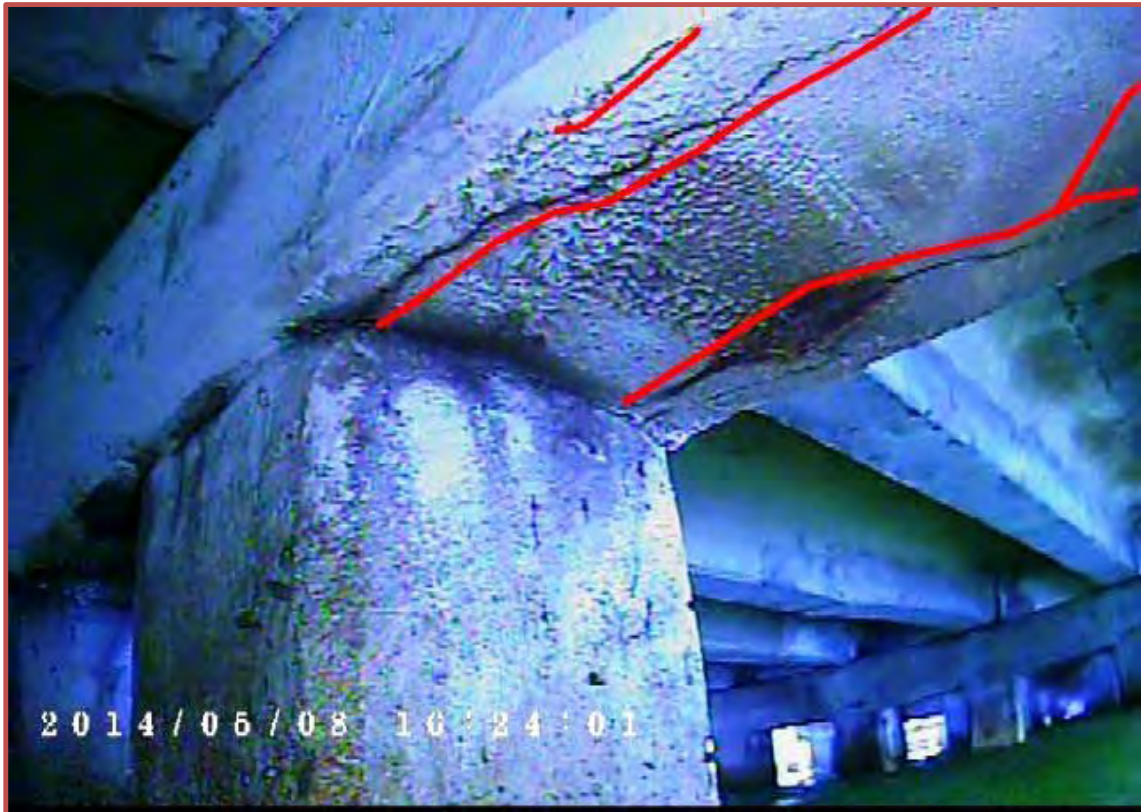
Description: Top: Bent caps have several intermittent cracks with corrosion bleed-out. **UW Photo 03.**  
Bottom: PJ 3-4, South face, (1) vertical crack, with corrosion bleed-out. **UW Photo 04.**

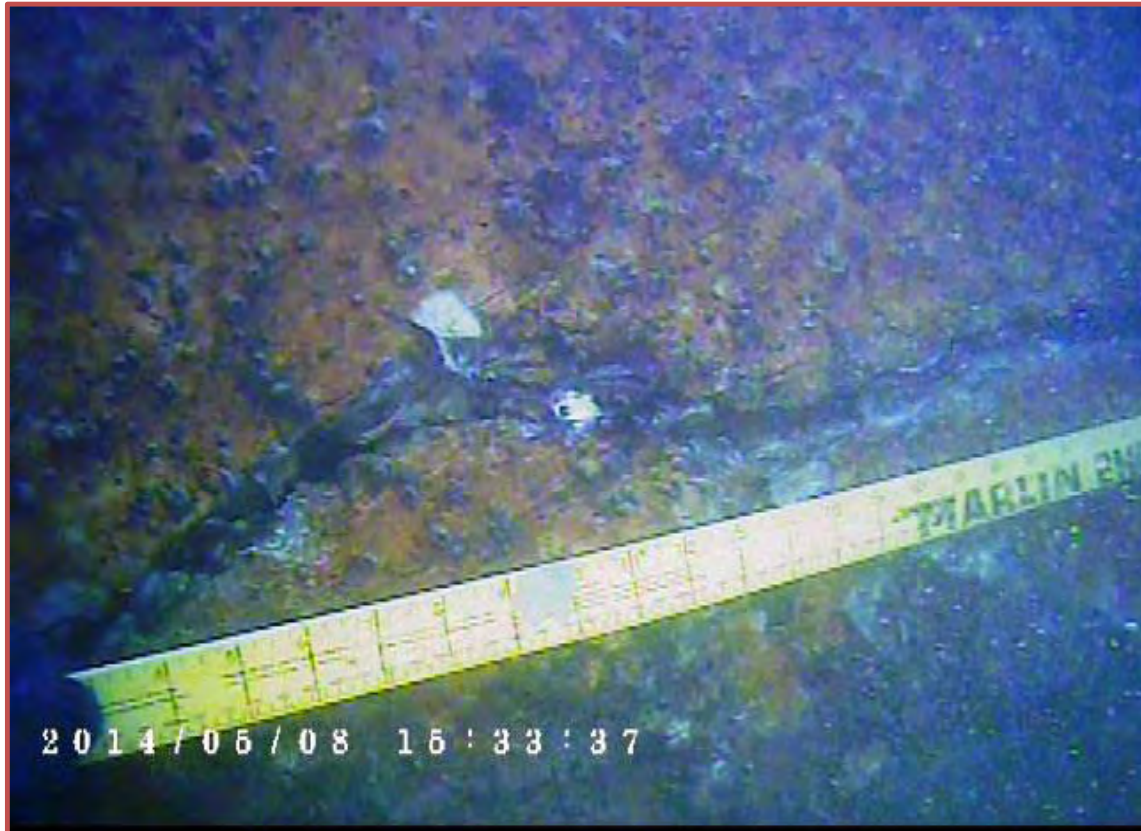
Description: Top: SW wingwall has several horizontal and diagonal cracks up to 1" W. **UW Photo 07.**  
Bottom: Abutment 9 backwall between Piles 9-1 and 9-3, joint separation. **UW Photo 08.**

\_Seal the horizontal and diagonal cracks on the SW and NW wingwalls.

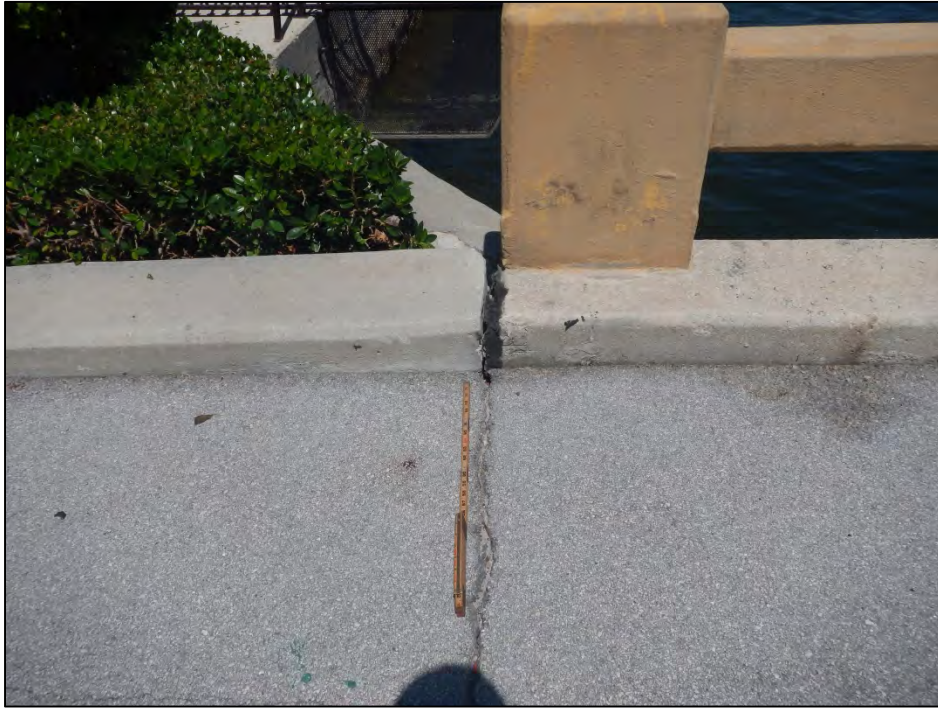
- The left sidewalk over Abutments 1 and 7 and the right curb over Abutment 7 have deteriorated joint sealant. See Condition Photo 1.
- The asphalt overlay has intermittent transverse cracks up to 1/16 in. over the joint.

Photo 1 – Deteriorated joint sealant in the left sidewalk over Abutment 1.

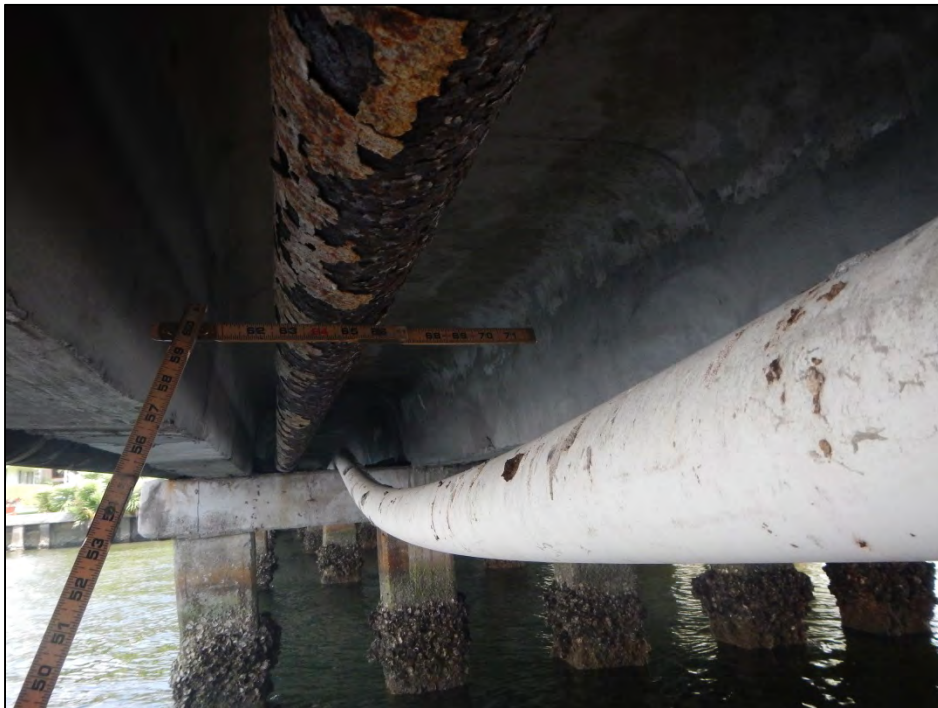
Photo 2 – Sagging utility line in Span 2.

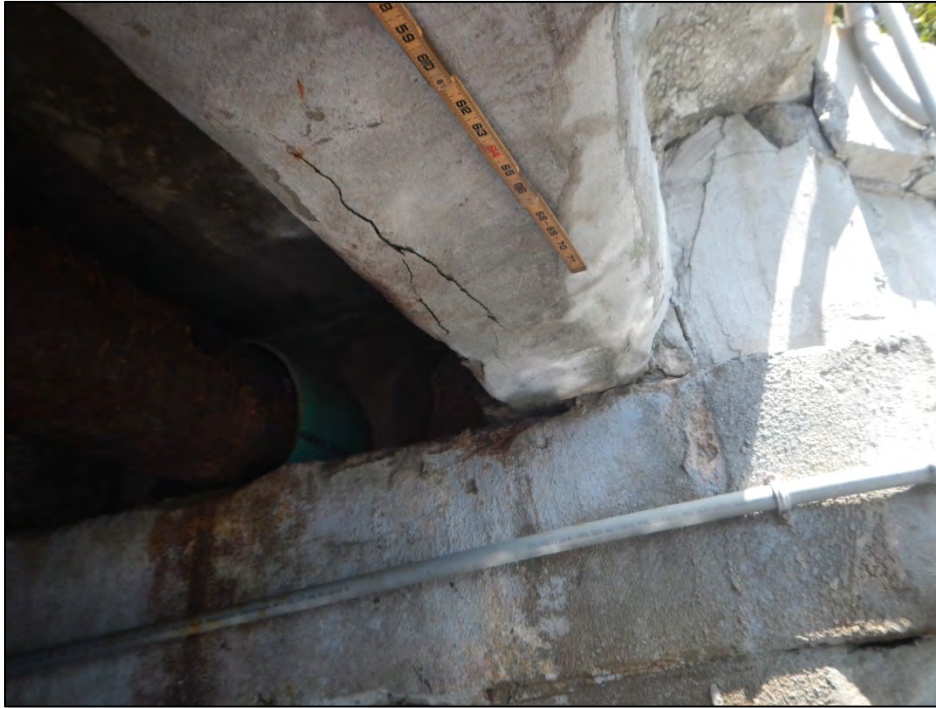
Photo 3 – Delaminated patch on Beam 6-4, right leg at Abutment 7.

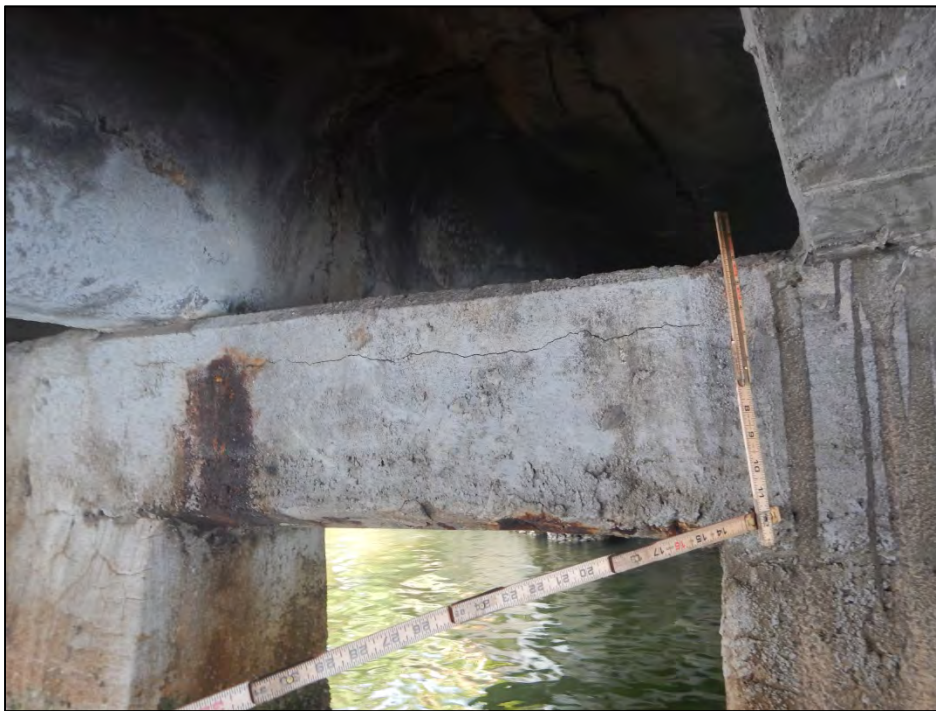
Photo 4 – Cracks and corrosion staining on the intermediate Bent caps.

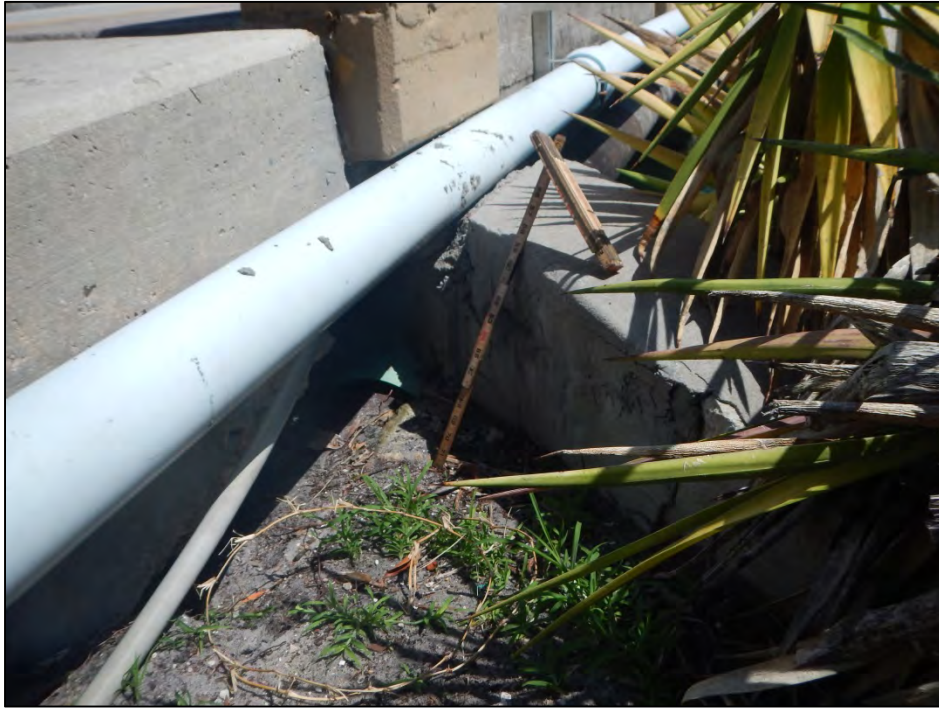
Photo 5 – Area of washout around the utilities at the northwest wingwall.

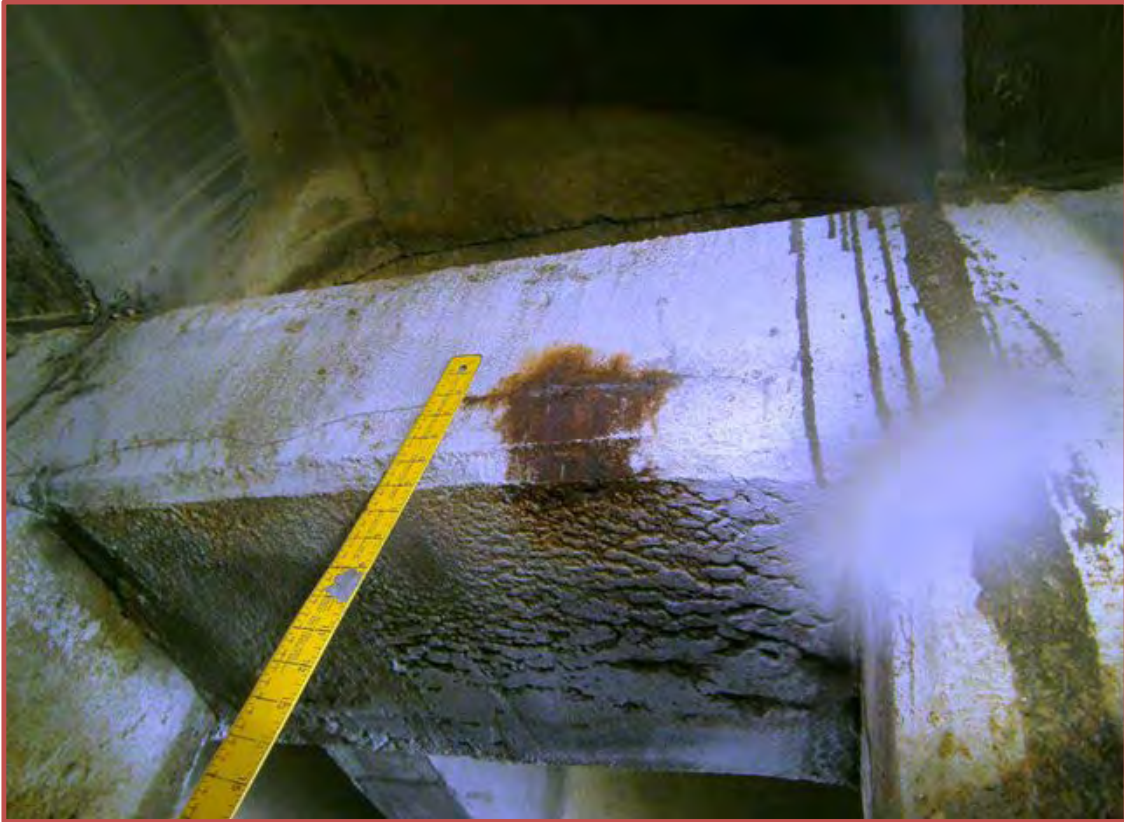
Description: Top: Bent caps have several intermittent cracks and spall/delaminations. **UW Photo 01.**  
Bottom: Bent 3, bottom face adjacent to Pile 3, spall/delamination. **UW Photo 02.**

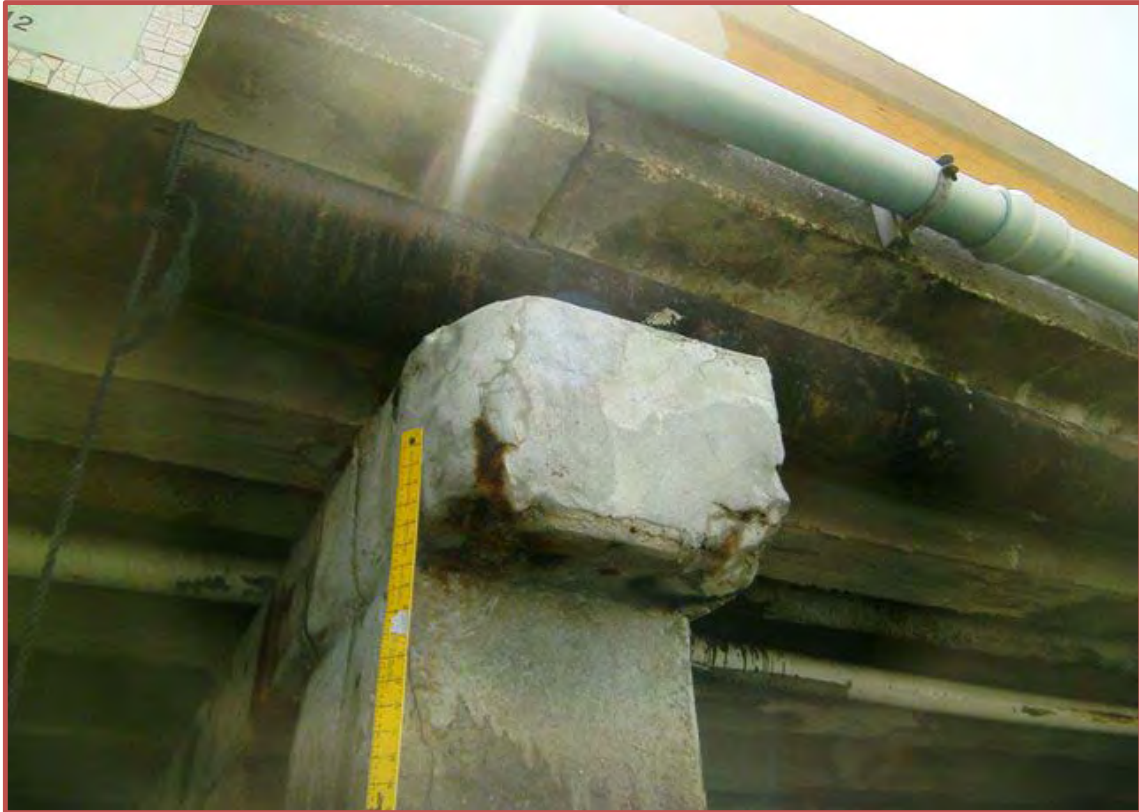
Description: Top: Bent 4 West end, has a spall/delamination, with exposed rebar. **UW Photo 03.**  
Bottom: PJ 2-4, SE corner has a delamination, with associated cracks. **UW Photo 04.**

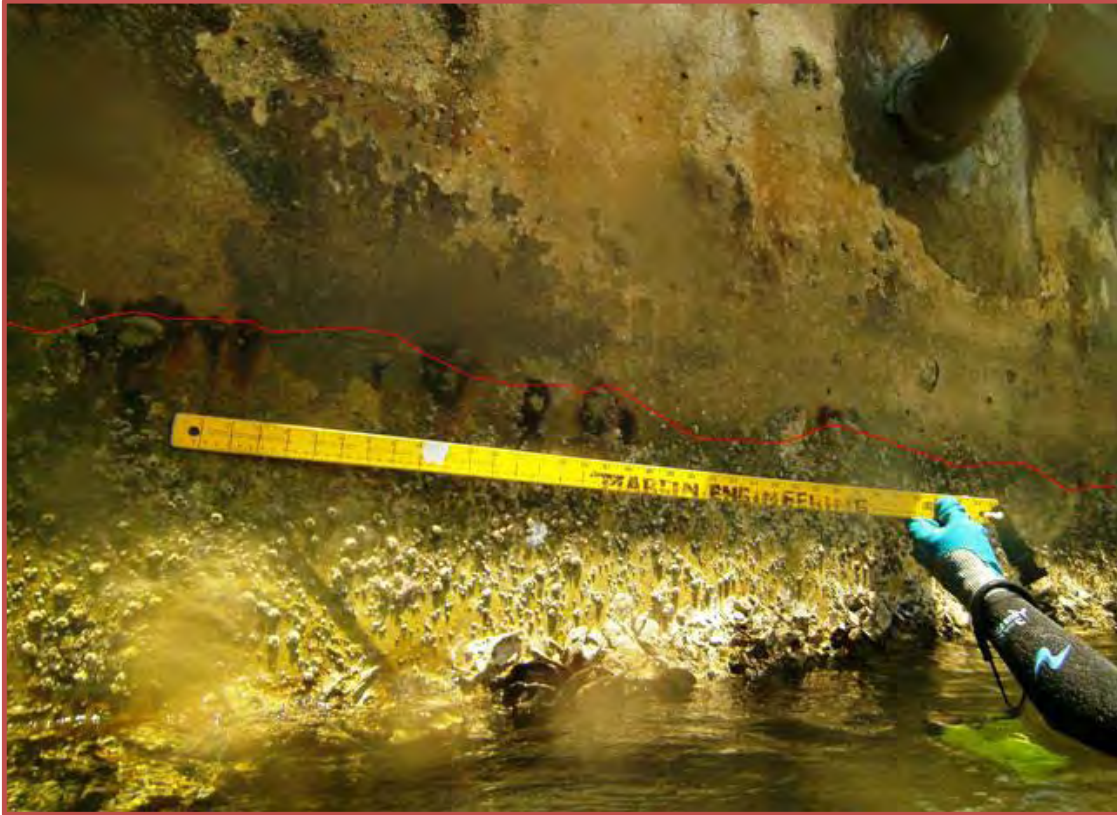
Description: Top: NE wingwall, top of the marine growth, horizontal cracks with CBO. **UW Photo 05.**  
Bottom: PJ 2, NE corner delamination with associated cracks. **UW Photo 06.**

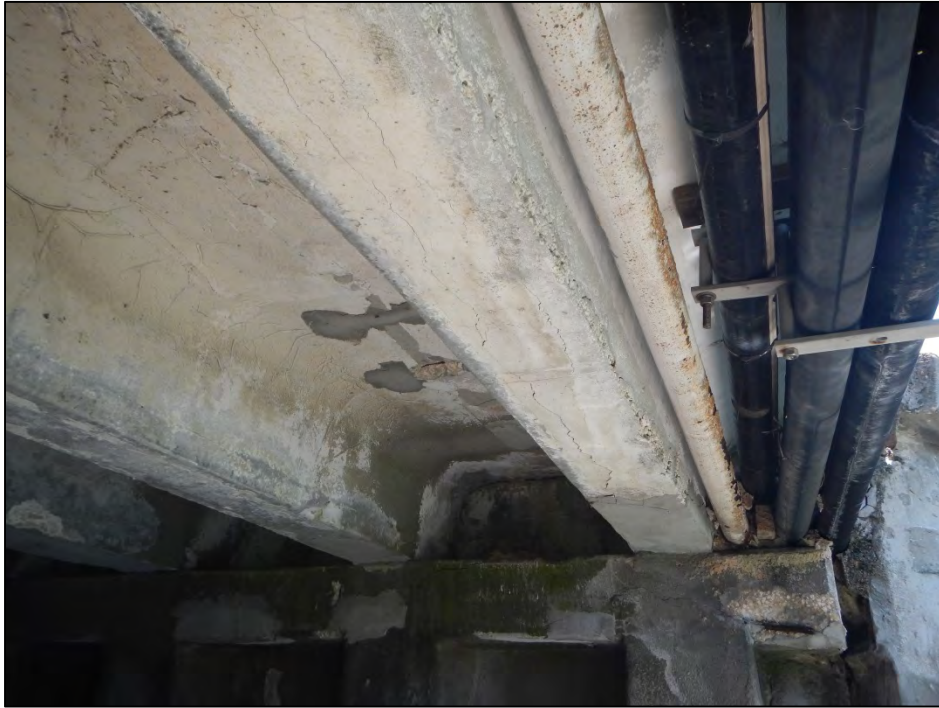
Typical Double T-Beam. Note Utilities Mounted at West Fascia

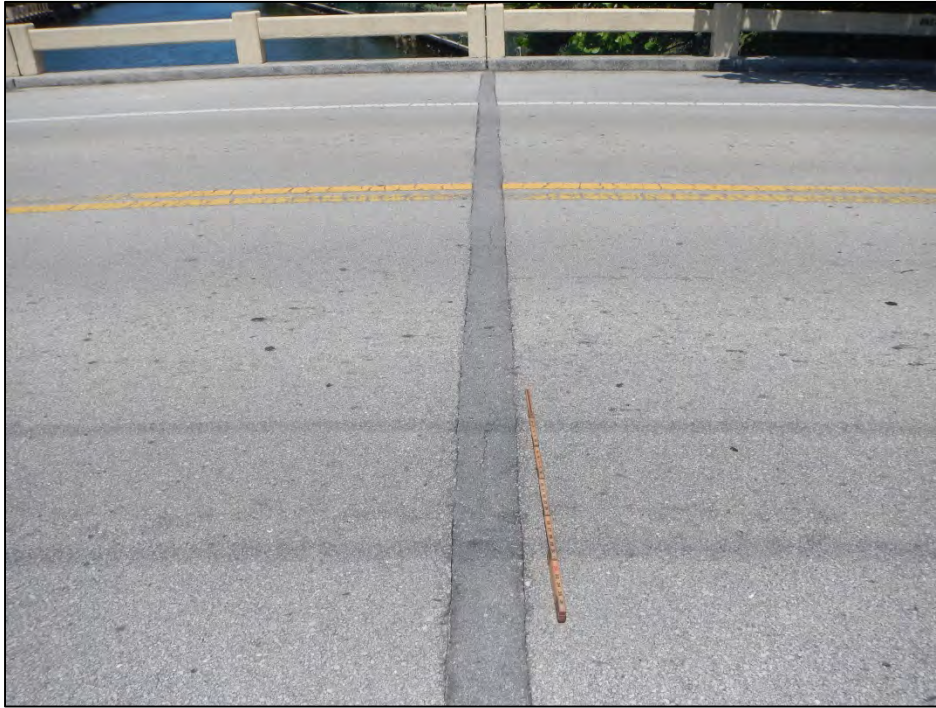
Photo 1 – Repaired asphalt over expansion joint.

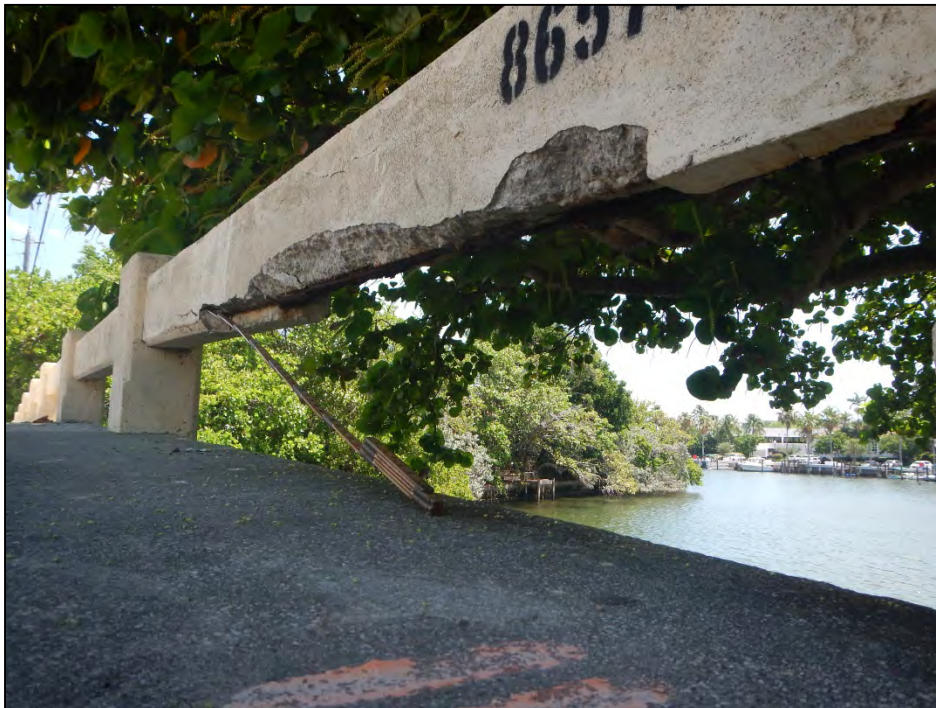
Photo 2 – Spalled concrete railing with exposed reinforcing steel.

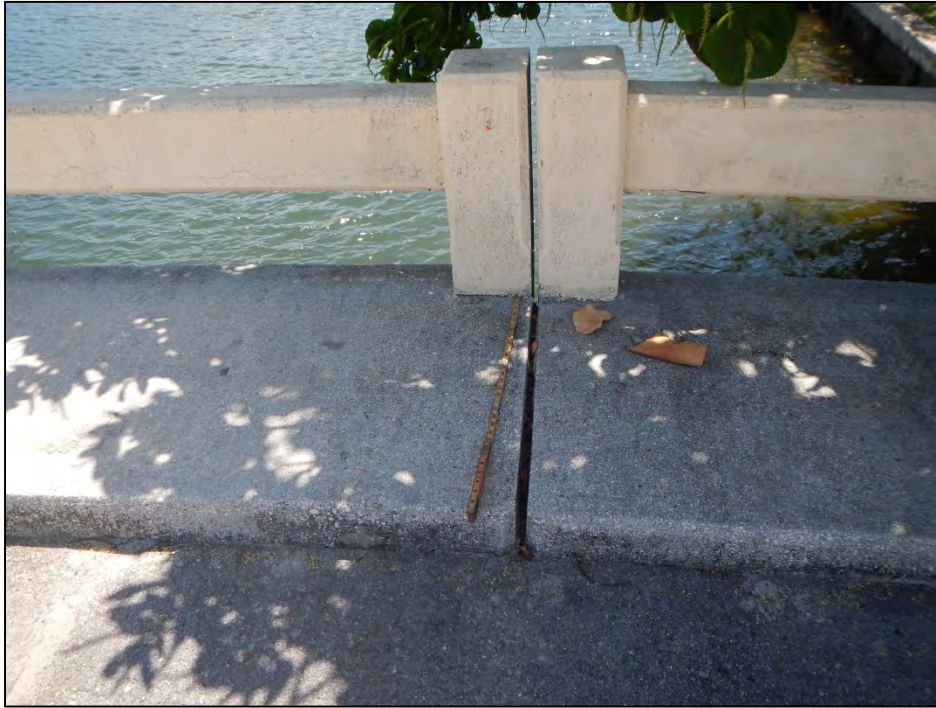
Photo 3 – Deteriorated joint over the right sidewalk.

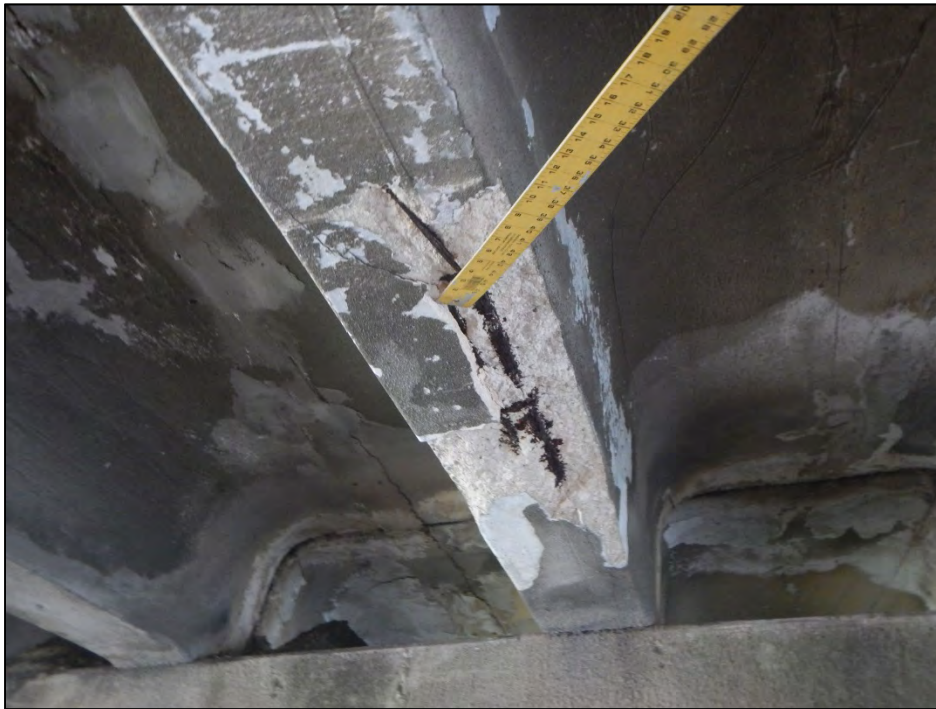
Photo 4 – Typical spall with exposed rebar and delamination in the double T-beams.

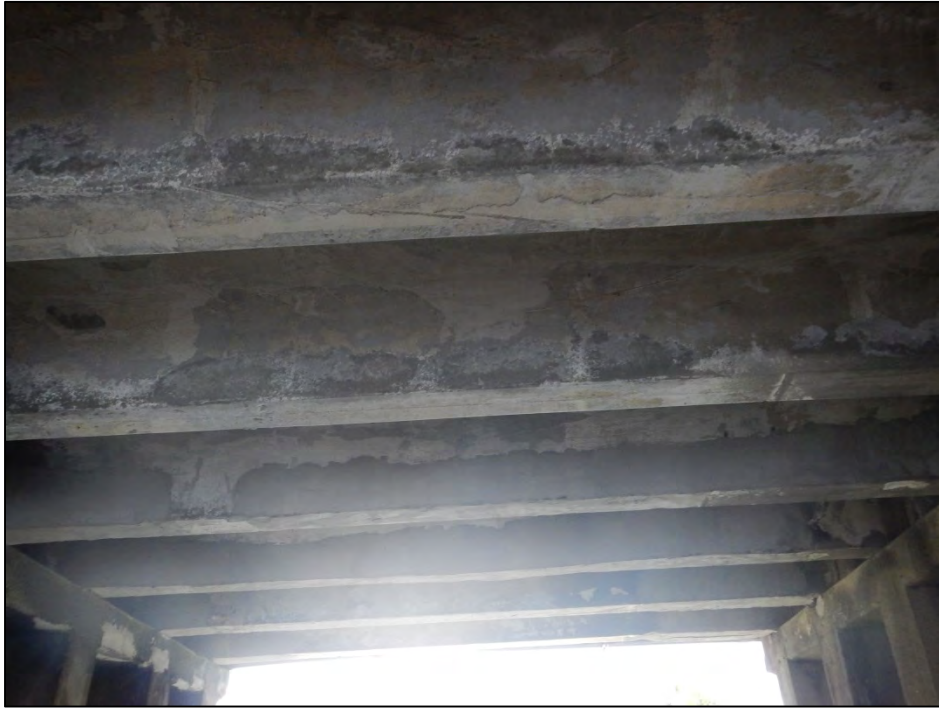
Photo 5 – Typical cracks in previously repaired areas on the double T-Beams

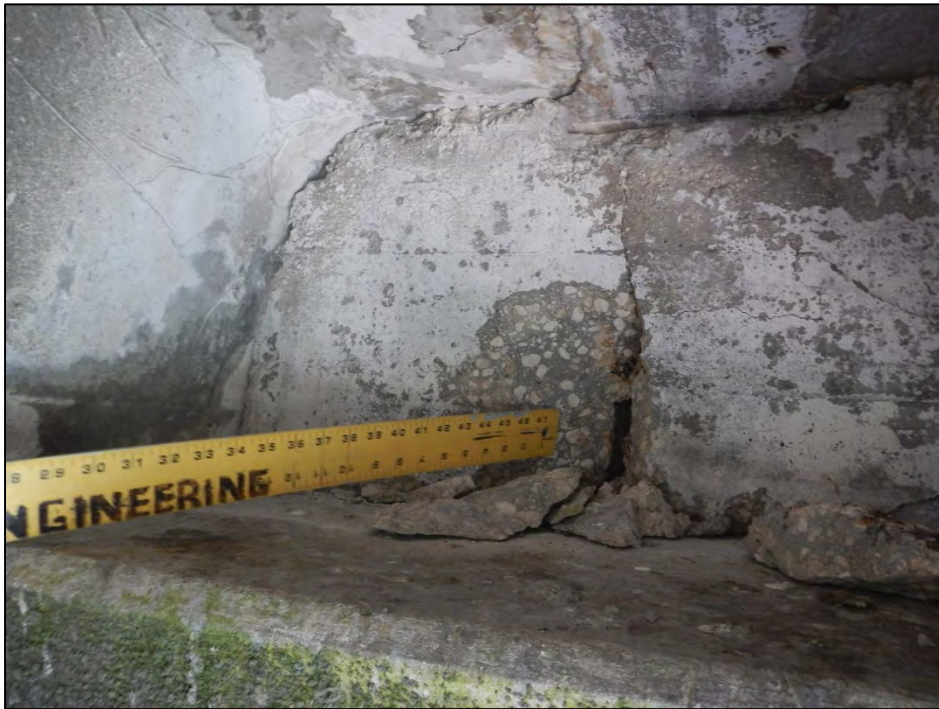
Photo 6 – Spall with exposed reinforcing steel in the backwall at Abutment I.

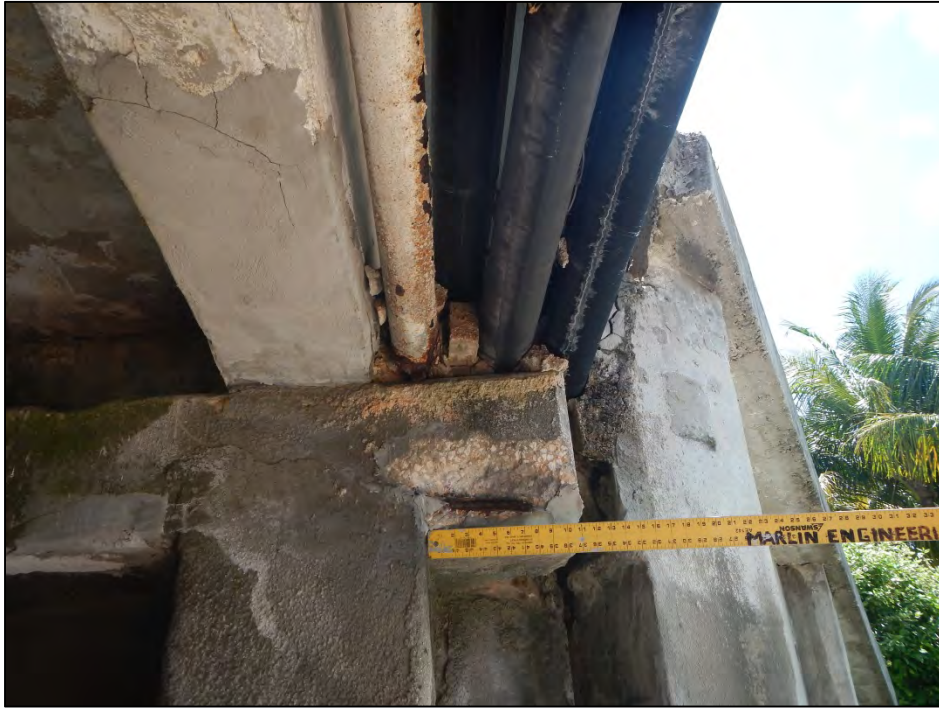
Photo 7 – Spall in the cap at Abutment I with exposed reinforcing steel.

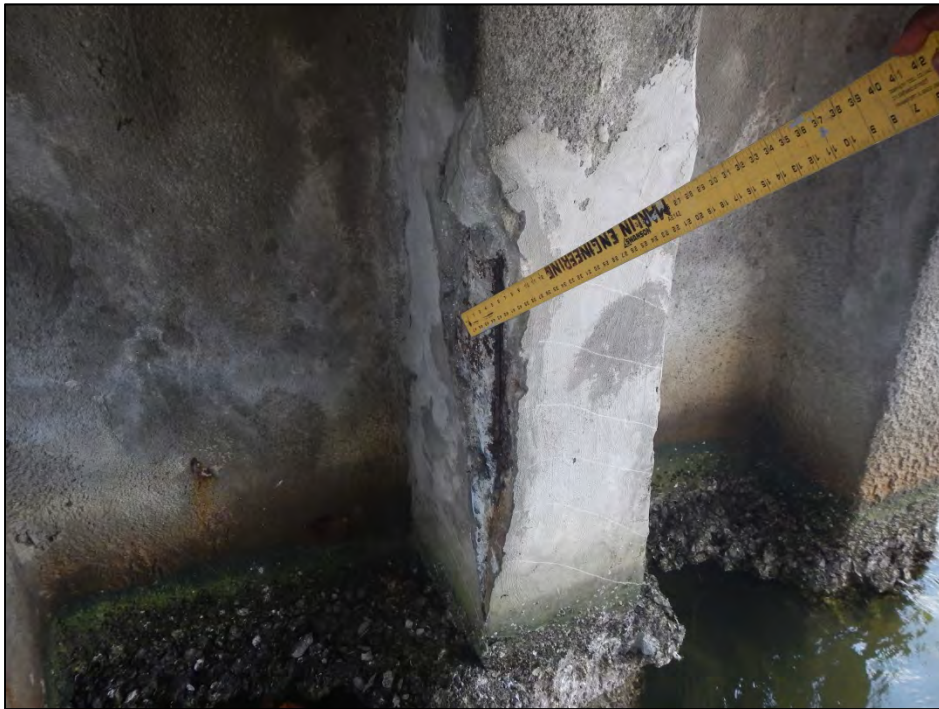
Photo 8 – Spall with exposed reinforcing steel in Pile I-2 at Abutment I.

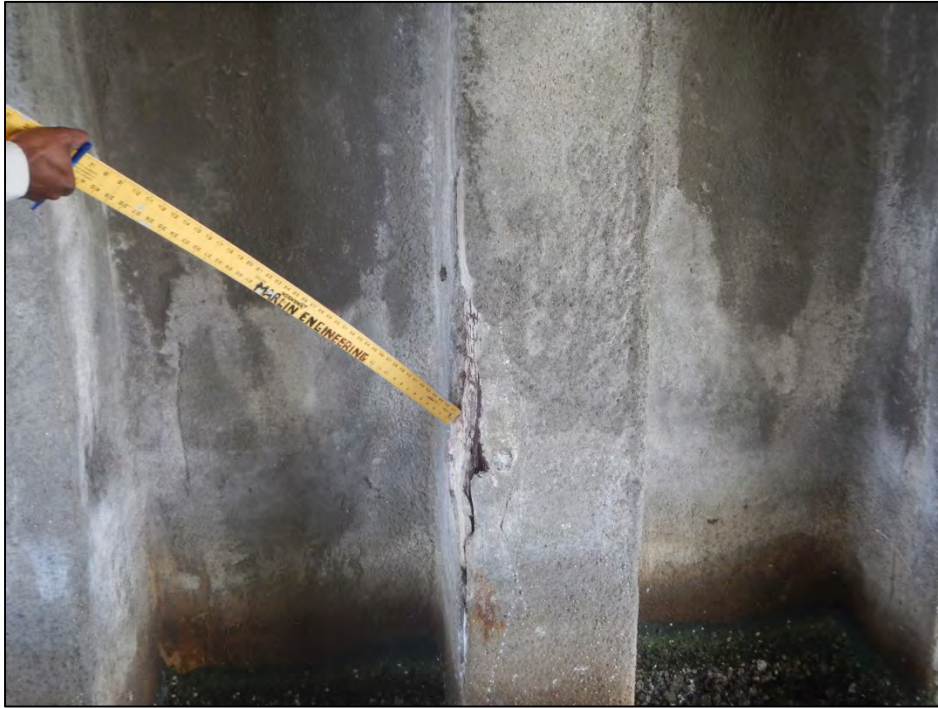
Photo 9 – Spall with exposed reinforcing steel and crack in Pile I-5 at Abutment I.

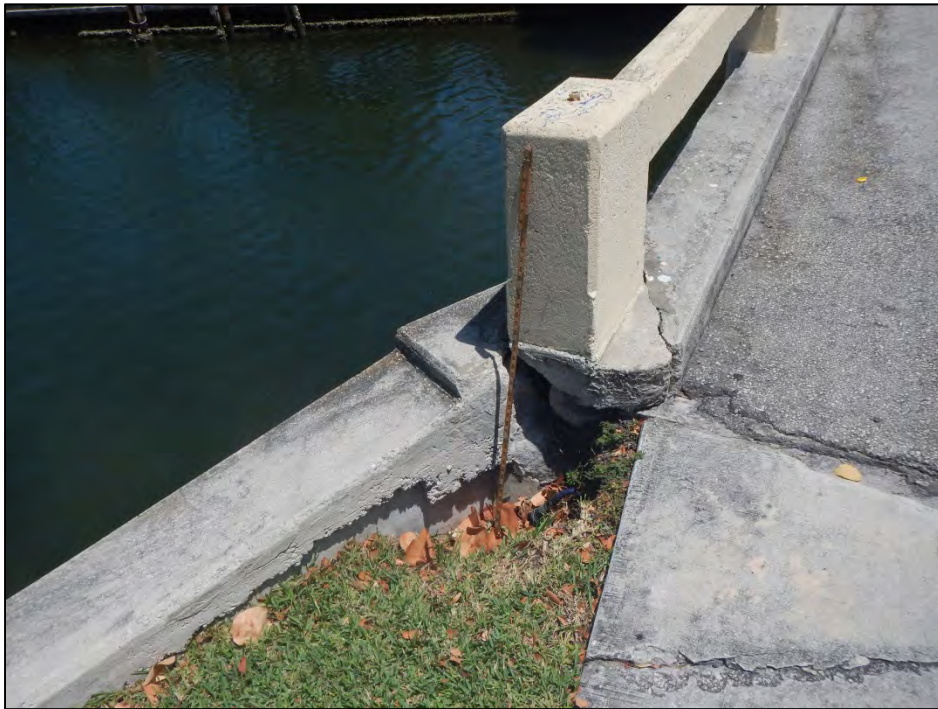
Photo 10 – Void behind the southwest retaining wall at railing post I-I.

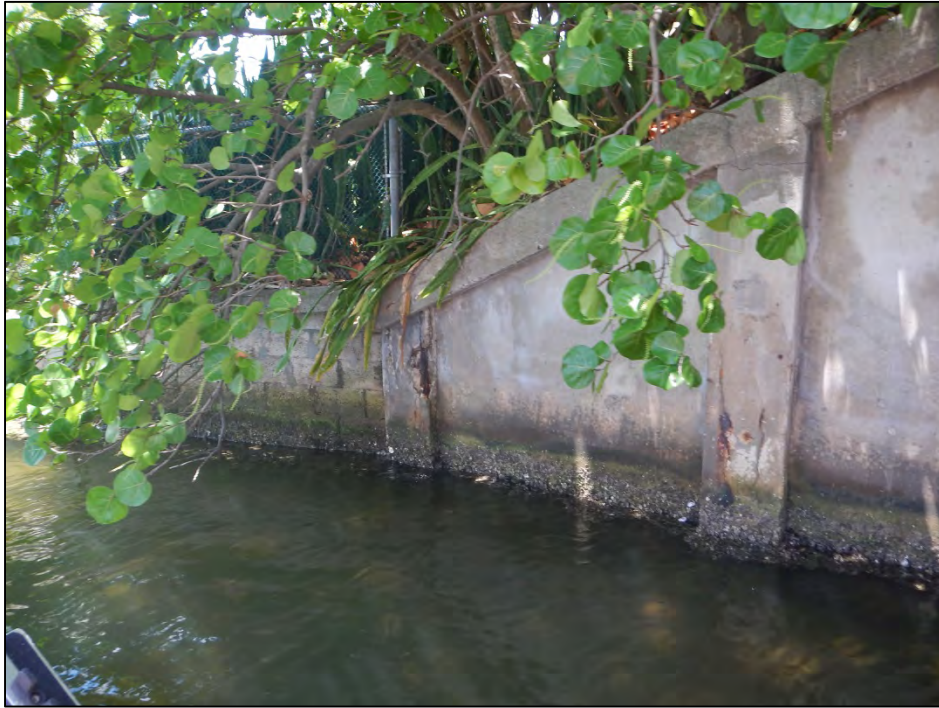
Photo 11 – Spalls in the piles at the northwest wingwall.

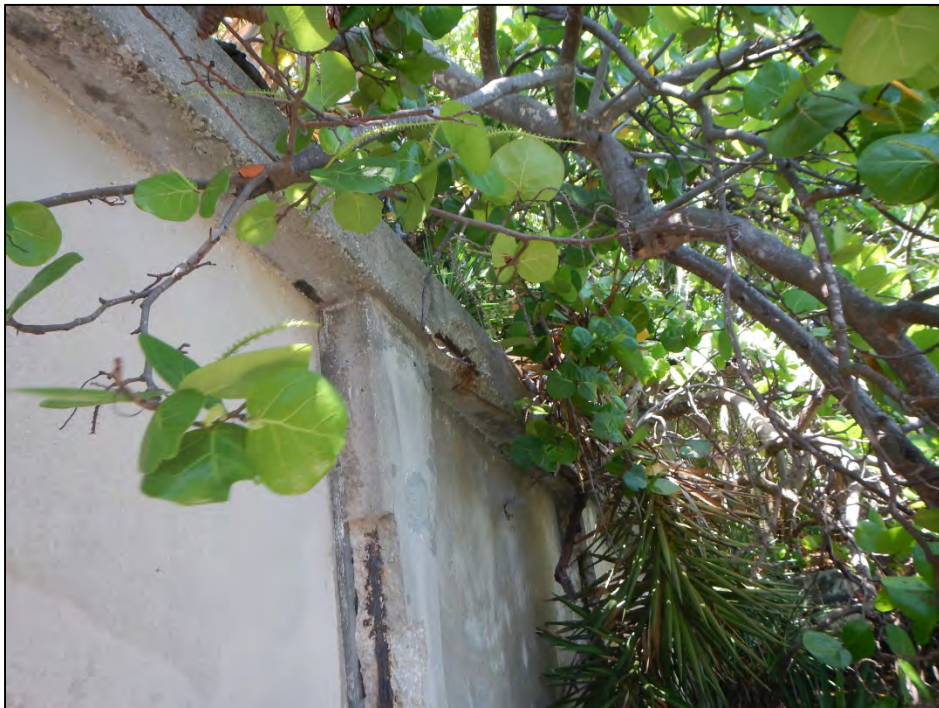
Photo 12 – Spalls in the piles at the northeast wingwall.
