## **EXECUTIVE SUMMARY**

TranSystems has been retained by the City of Fort Lauderdale to perform bridge inspections and prepare bridge inspection reports for each of the City's bridges as part of the project Structural Bridge Engineering Consulting Services Master Plan, RFQ No. 946-11310. Inspections were completed and reports prepared for 46 of the City's bridges. The remaining five bridges in the City's inventory were not inspected because they are in the process of being replaced.

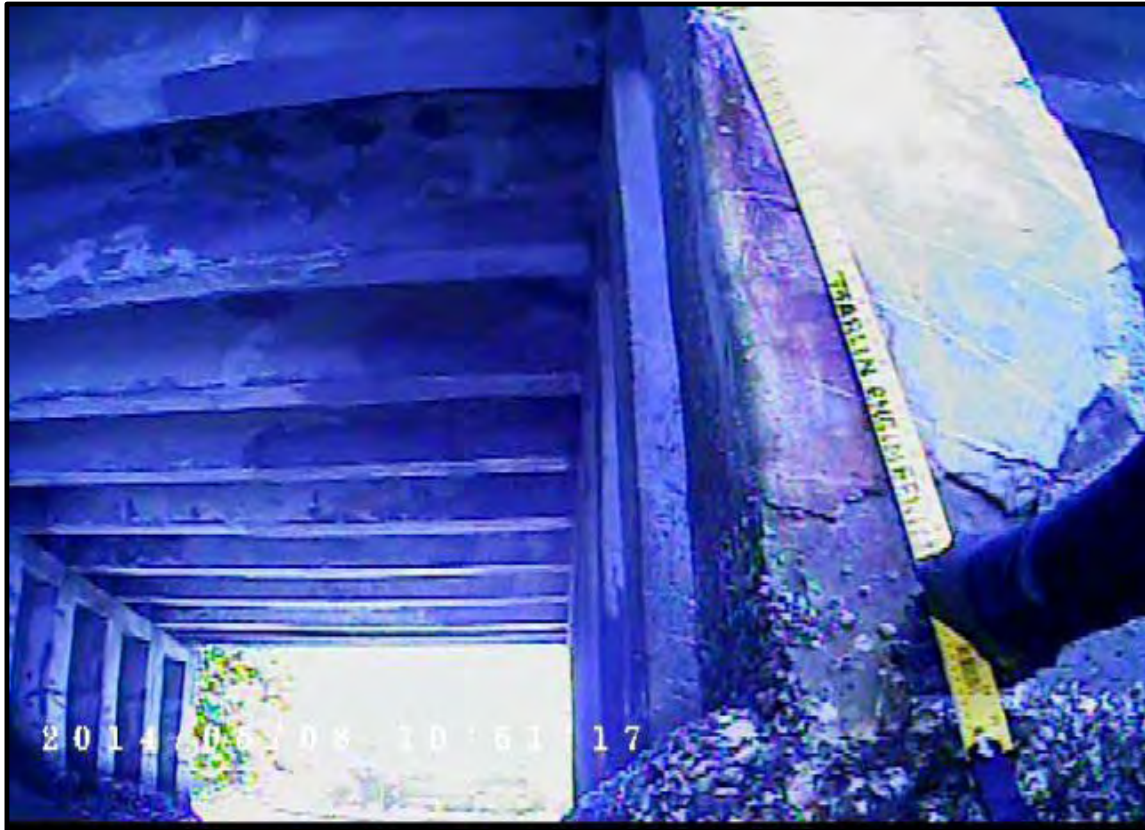
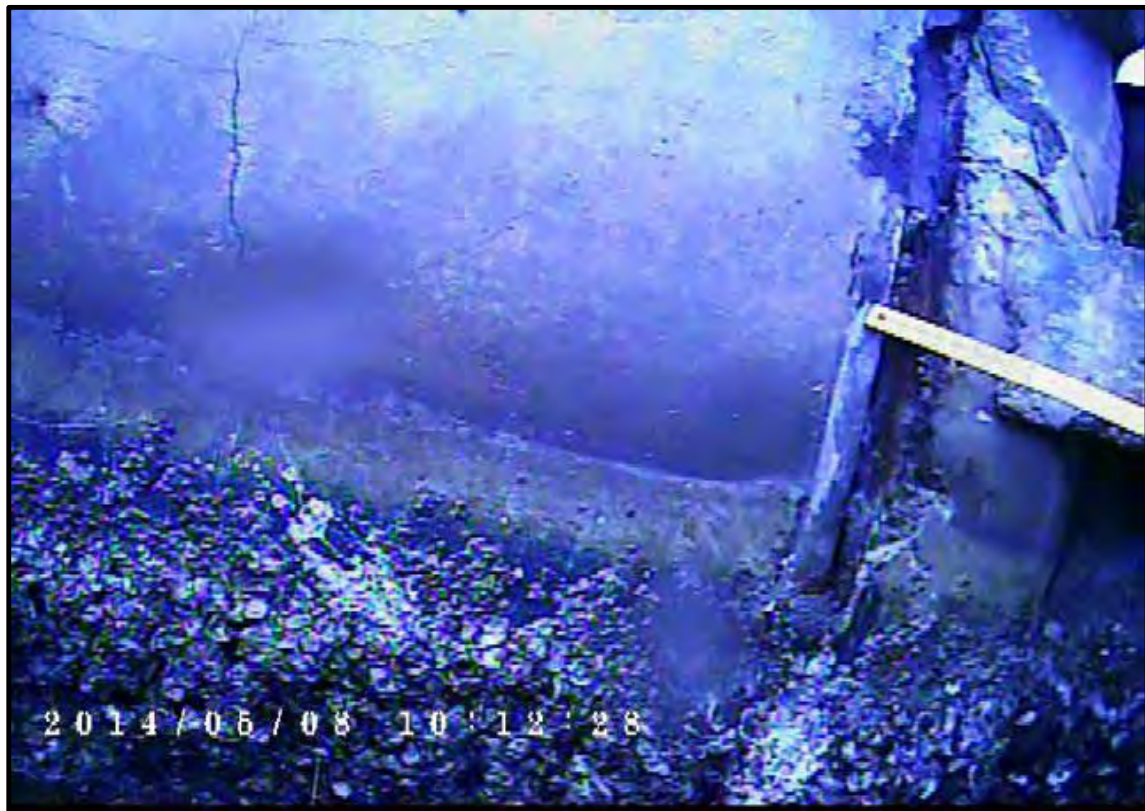
\_There are several spalls and delaminations with corrosion bleed-out throughout following Pile Jackets (PJ). **INCREASE**

\_SW retaining wall at junction to private sector, spall 36" x 6" x 3", ext 6" BHWB, with (1) exposed rebar.

Description: Top: Pile Jackets typical spall/delaminations (Photo taken at Pile 4-1). **UW Photo 01.**  
Bottom: SW retaining wall spall at junction to private sector. **UW Photo 02.**

\_Repair all pile jackets with spalls and delaminations.

\_Remove all unsound concrete and patch and epoxy inject the cracks as needed.

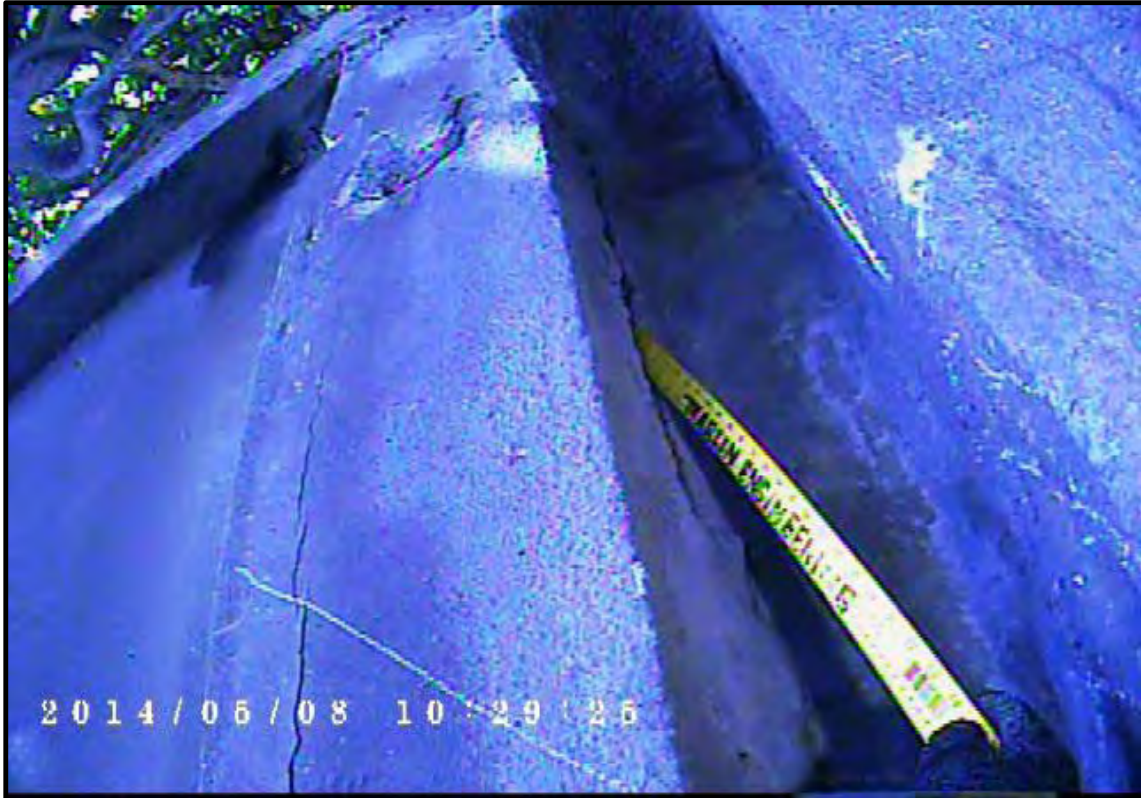
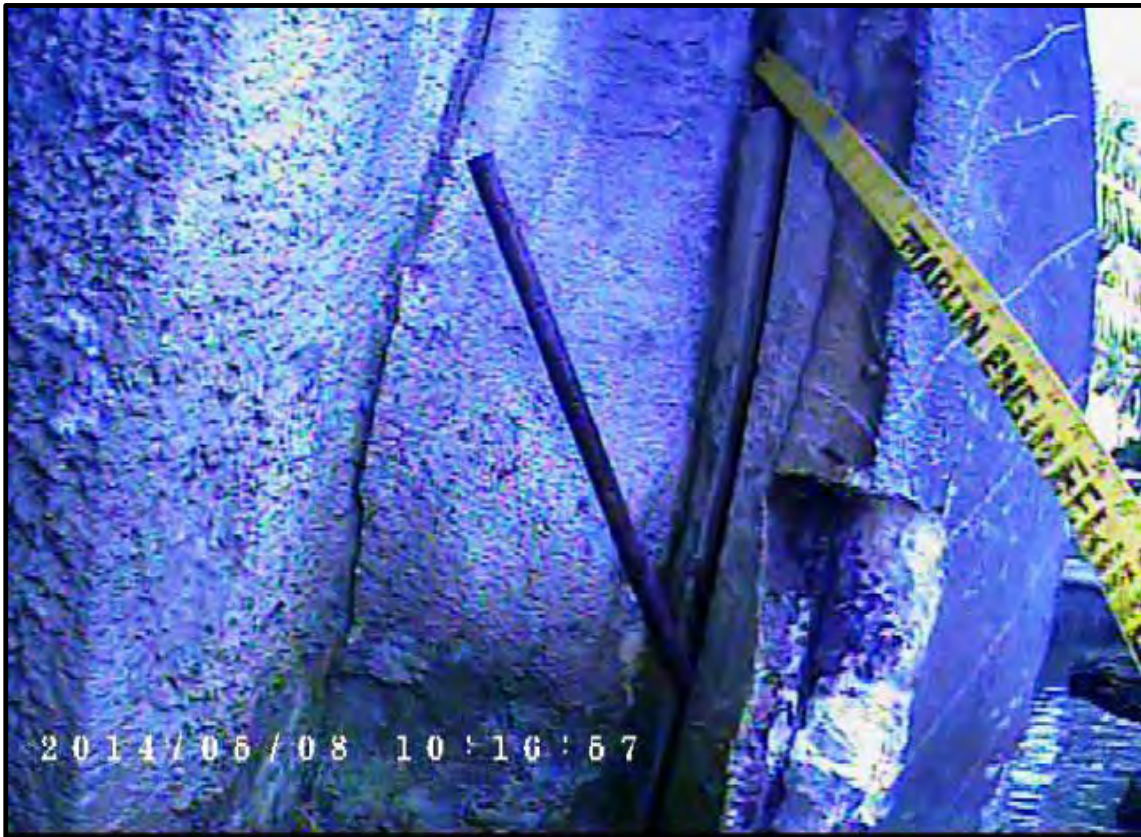
\_SE retaining wall behind Pile 1 has a gap 12" L. No backfill loss was observed during this inspection cycle. **UW Photo 03. NEW**

\_SE retaining wall Pile 5, spall/delamination full high x 16" wide with associated cracks up to 1/16", (1) exposed rebar. **UW Photo 04. INCREASE**

Description: Top: SE retaining wall behind Pile 1 has a gap, no back fill loss. **UW Photo 03.**  
Bottom: SE retaining wall Pile 5, spall/delamination, with associated cracks. **UW Photo 04.**

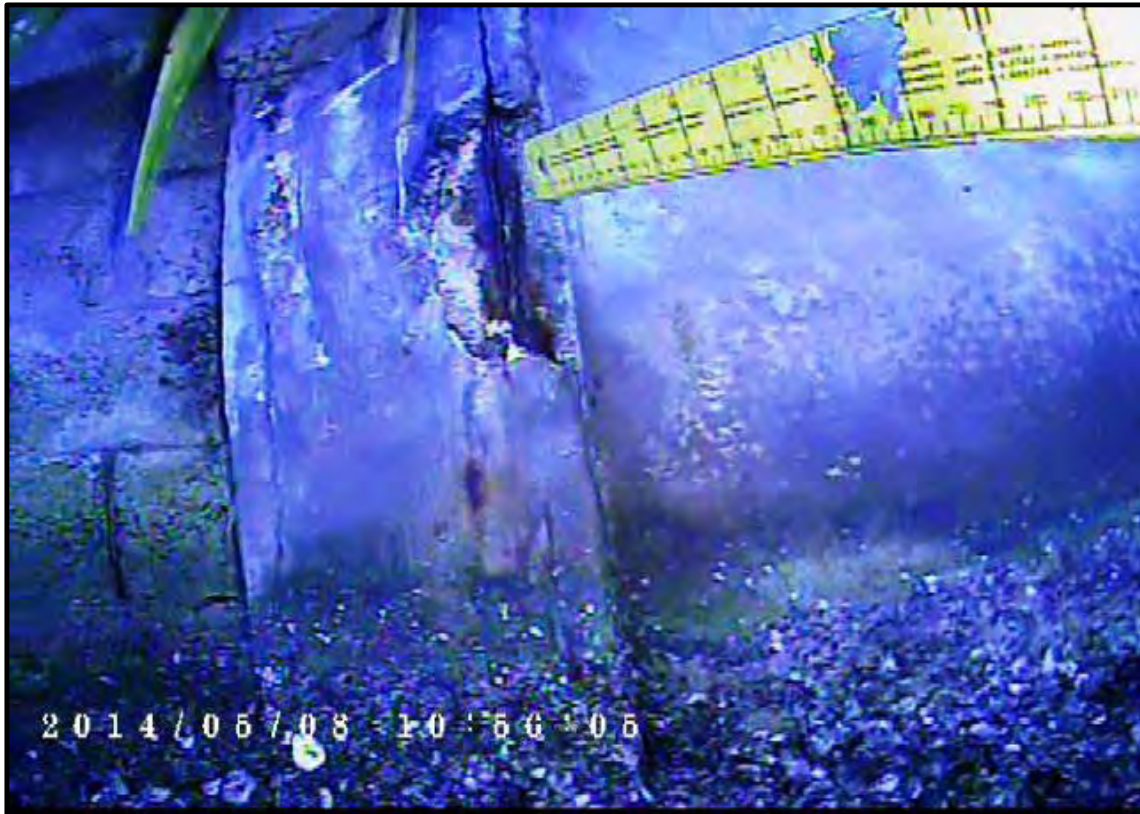
\_NW retaining wall Pile 1, spall/delamination 36" x 16" x 2", with associated cracks up to 1/16", (1) exposed rebar. **UW Photo 05. INCREASE**

Description: NW retaining wall Pile 1, spall/delamination, with associated cracks. **UW Photo 05**

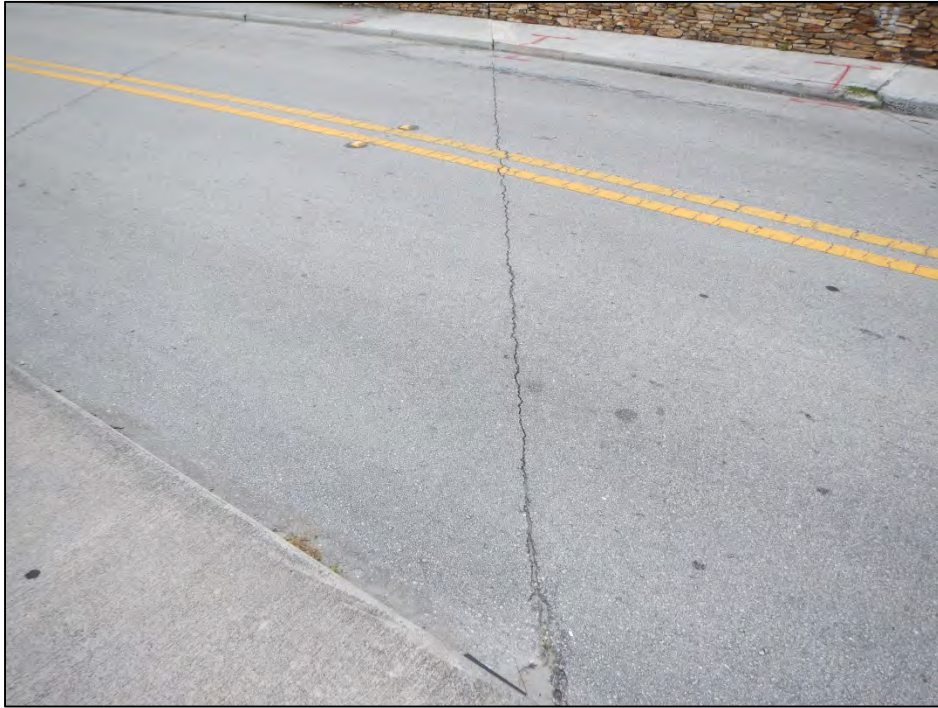
Photo 1 – End Bent 1 joint seal exhibits a transverse crack.

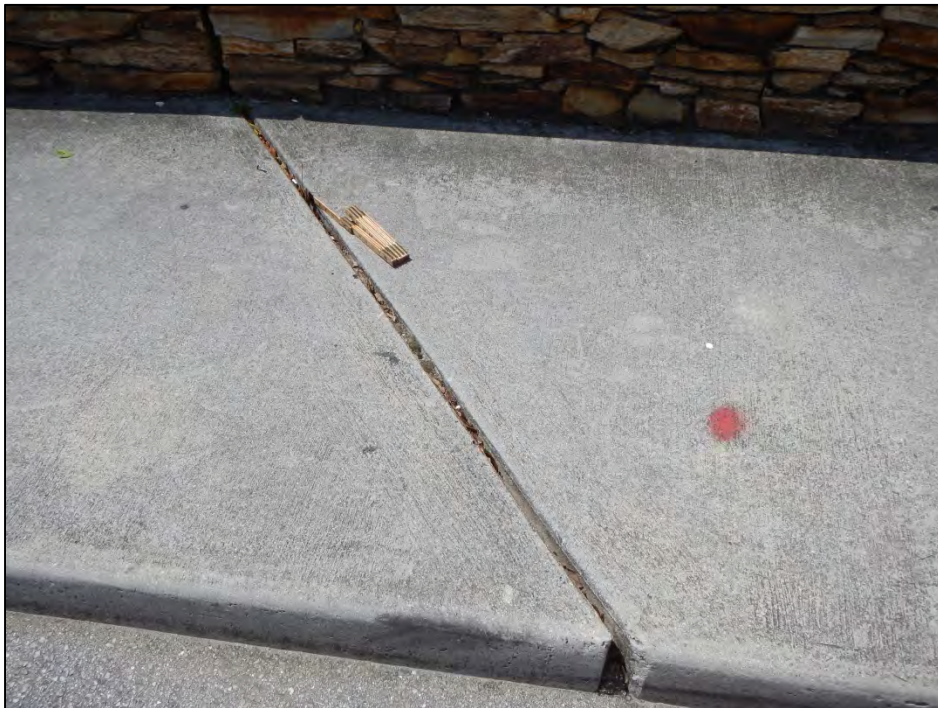
Photo 2 – The right sidewalk joint seal over Bent 3 is deteriorated.

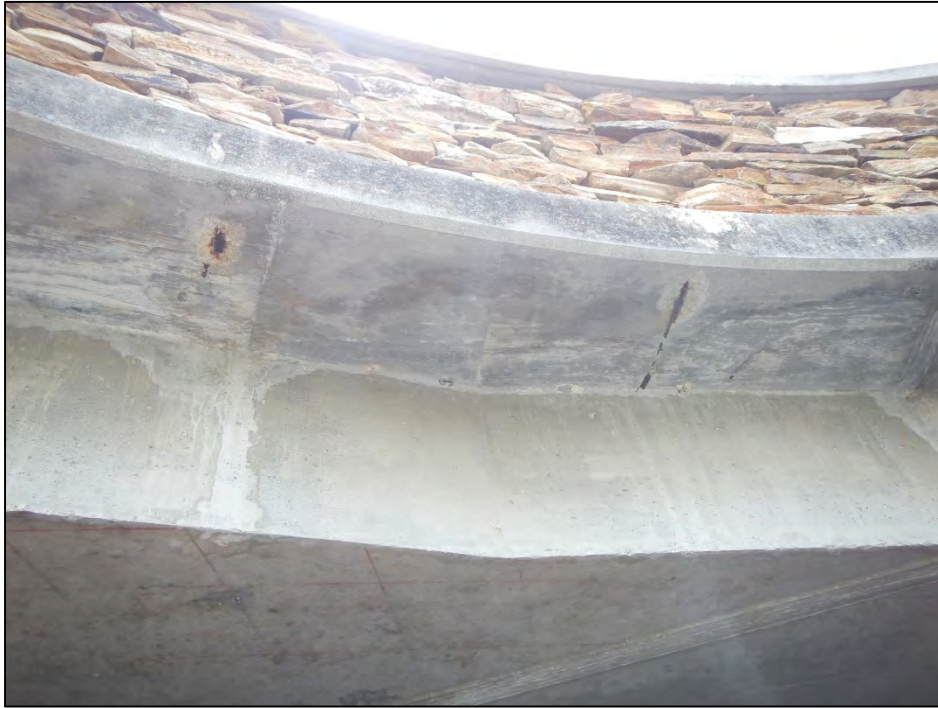
Photo 3 – The left side of Span 3, mid span, exhibits a spall.

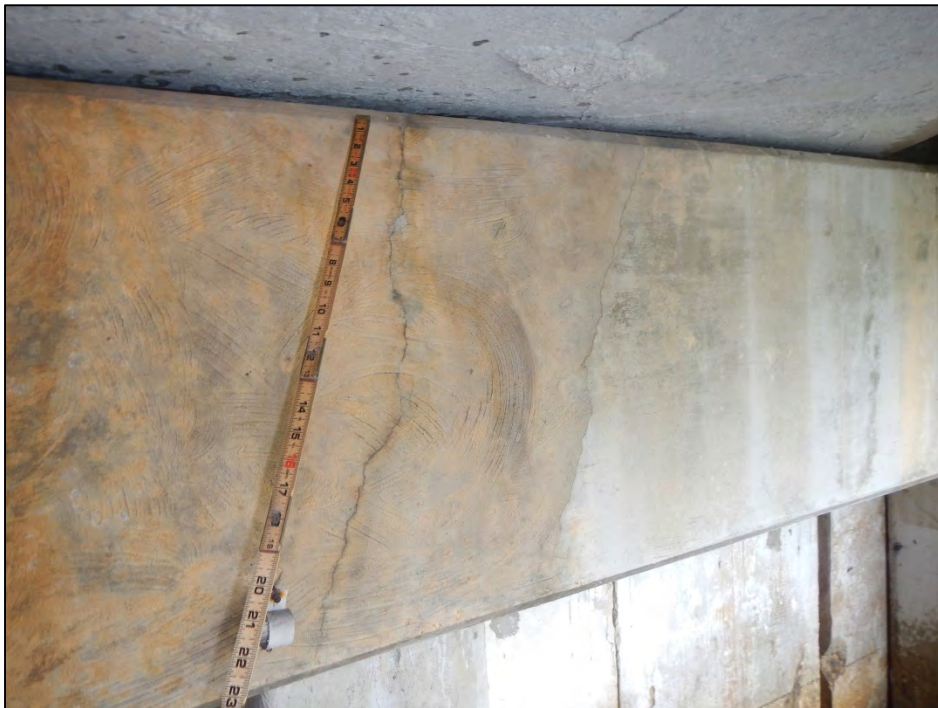
Photo 4 – Abutment I cap exhibits a vertical crack.

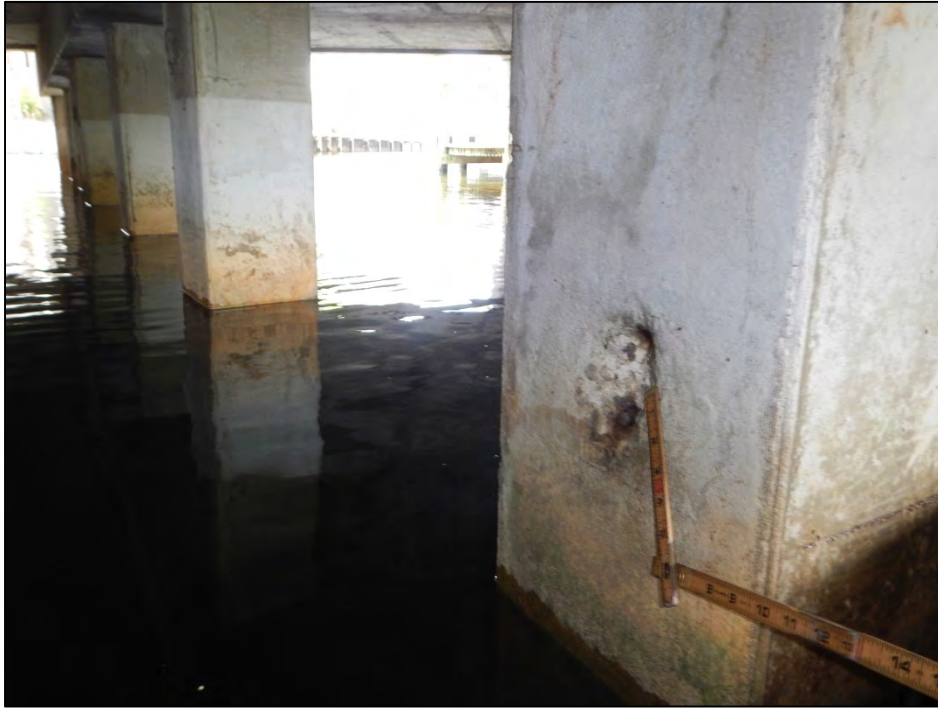
Photo 5 – The east face of Pile 3-2 exhibits an unpatched pickup point.

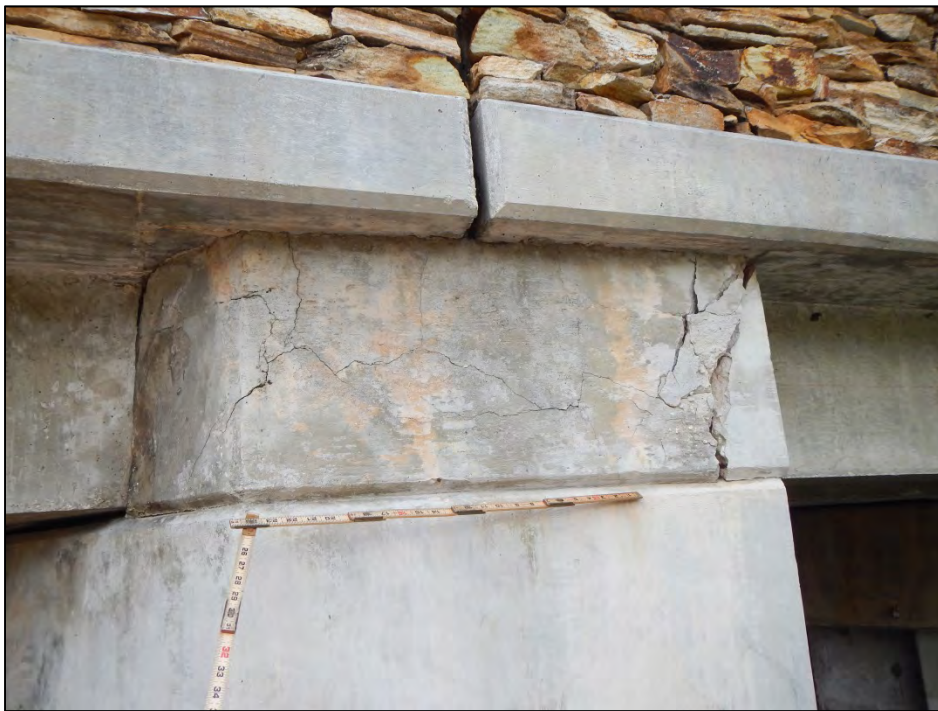
Photo 6 – The Bent 2 cap has a delamination in the north end.

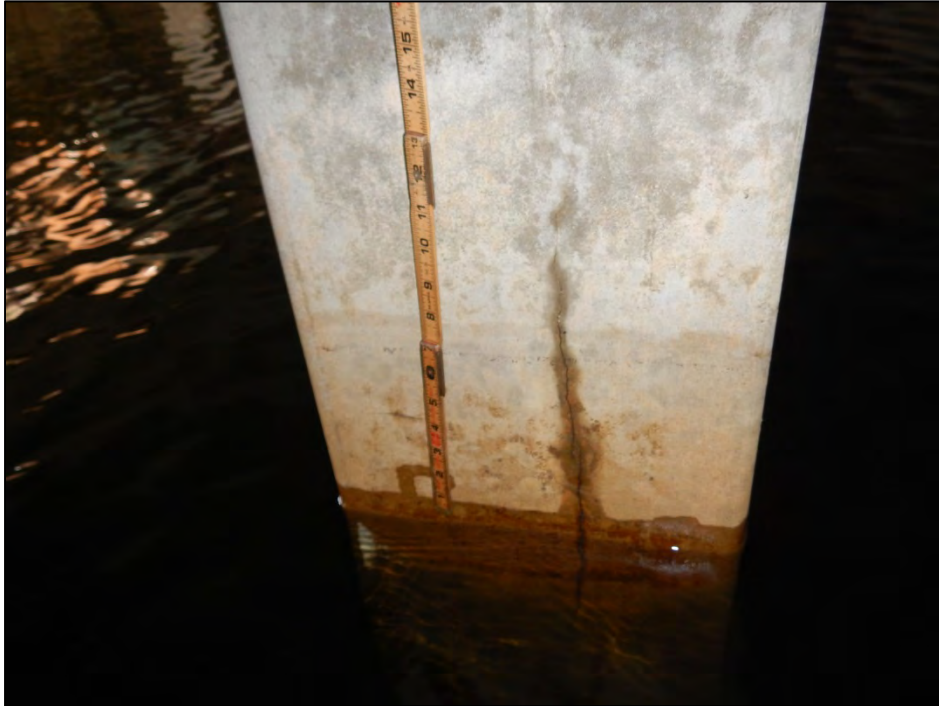
Photo 7 – The east face of Pile 2-4 exhibits a vertical crack.

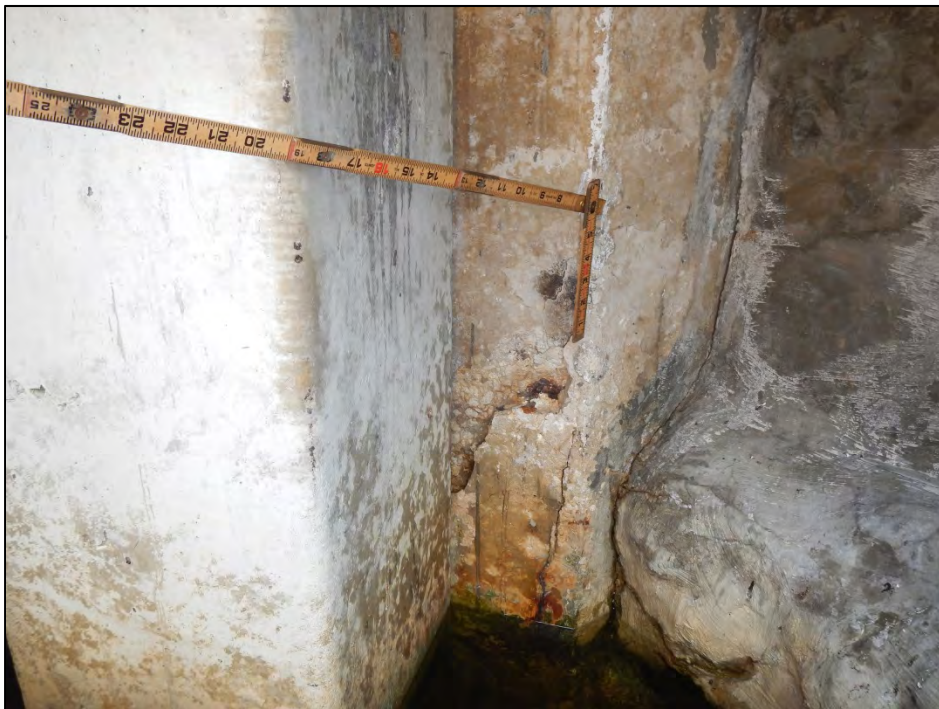
Photo 8 – The south end of the End Bent 4 retaining wall exhibits a spall.

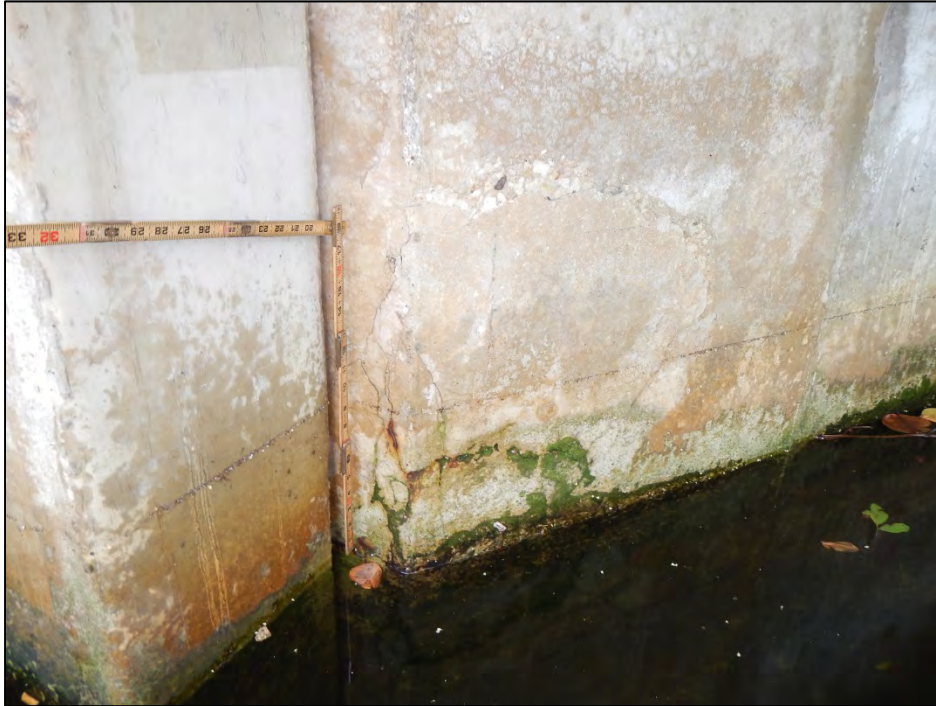
Photo 9 – The northwest retaining wall exhibits a delamination.

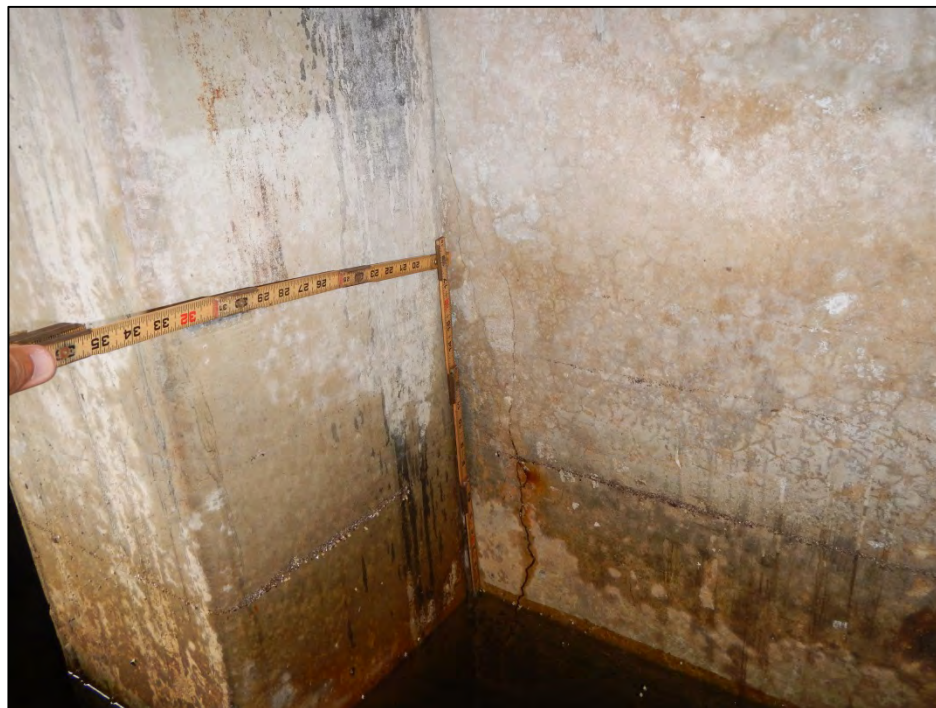
Photo 10 – The End Bent I retaining wall north of Pile I-7 exhibits a vertical crack.

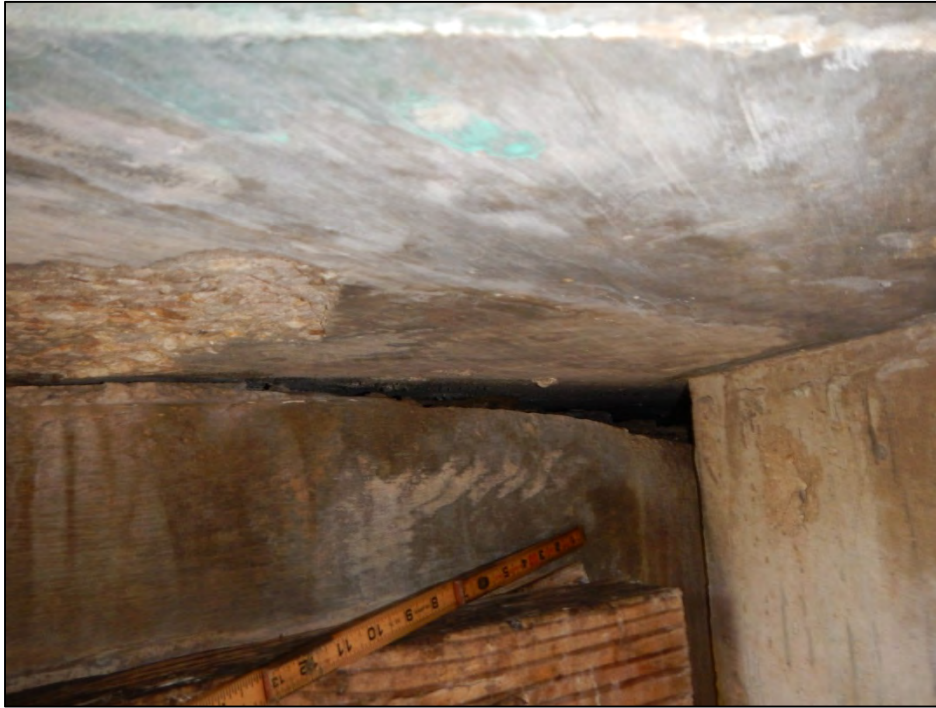
Photo 11 – The End Bent 1 retaining wall exhibits a void behind Pile 1-7.

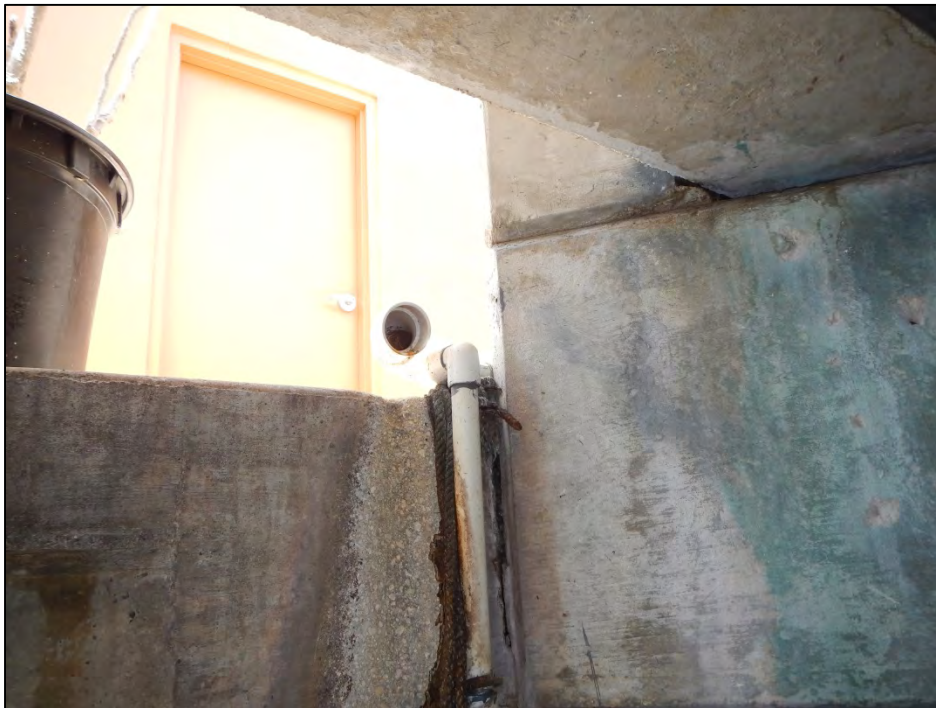
Photo 12 – The southwest wingwall has a utility pipe disconnection.

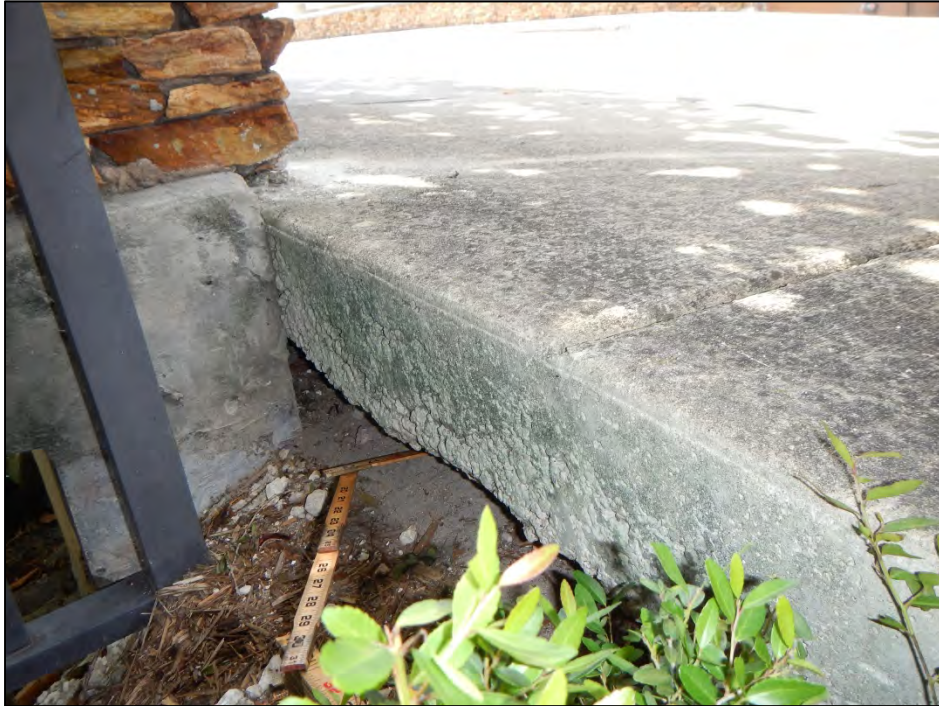
Photo 13 – The northwest sidewalk exhibits undermining.

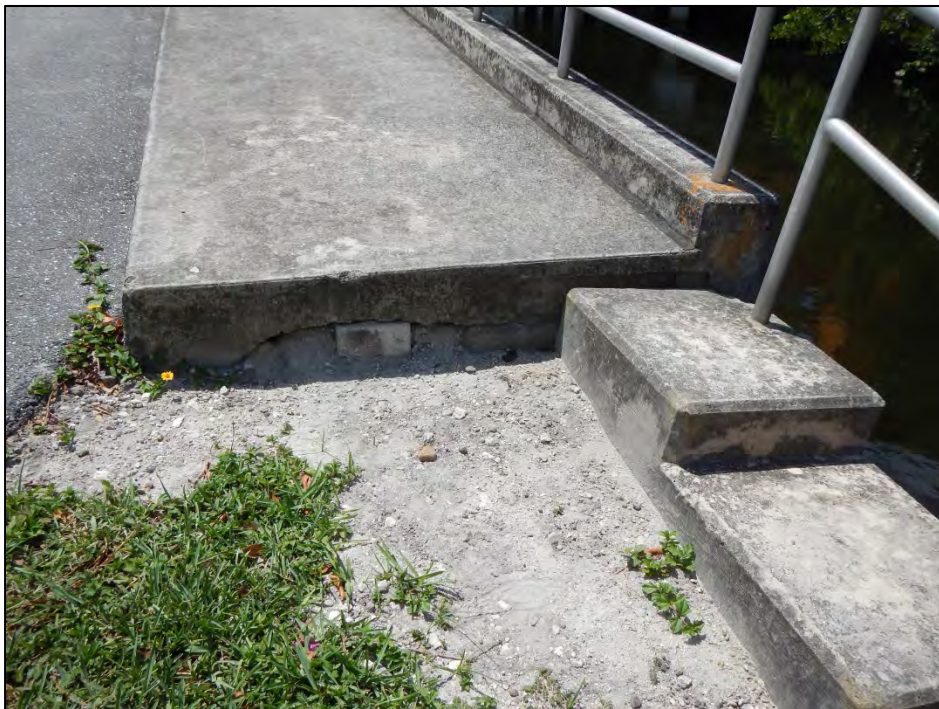
Photo 14 – The northeast sidewalk exhibits a drop-off.

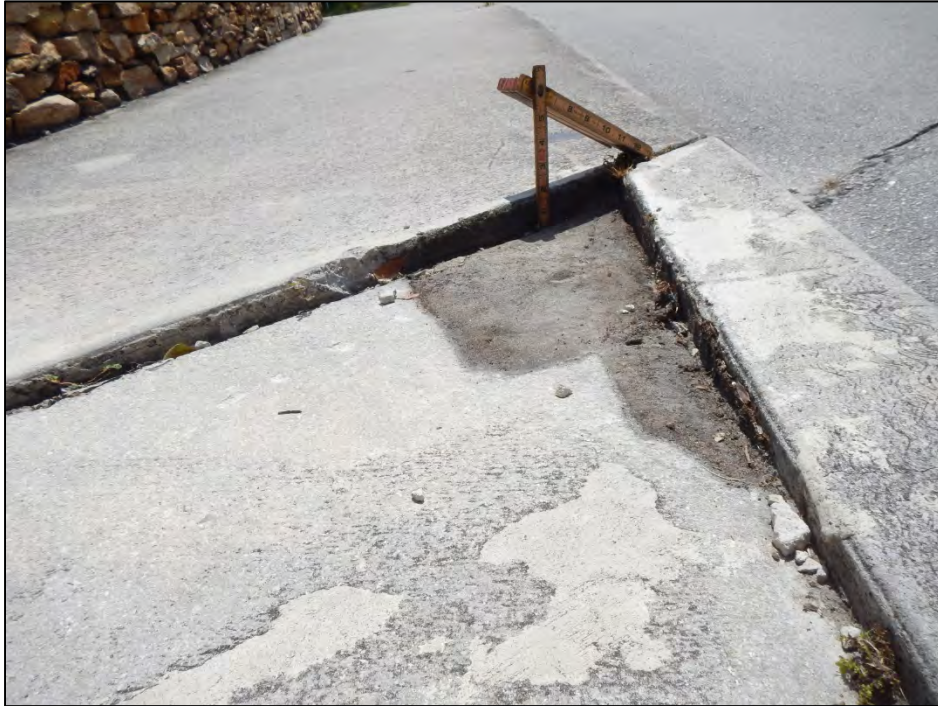
Photo 15 – The northwest sidewalk exhibits a drop-off.

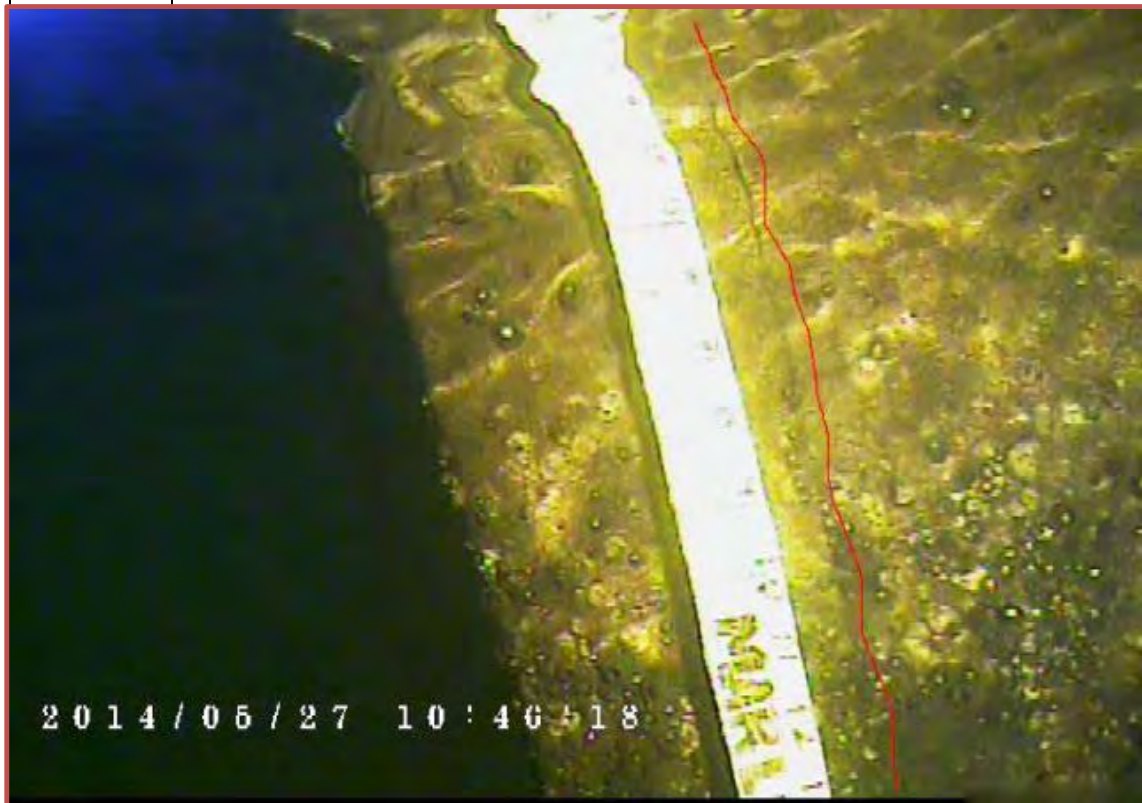
\_The following Piles have pick-up points with shallow spalls with exposed steel and vertical cracks up to 36" long x 1/16" wide. Piles 2-4, 2-7, 3-2 and 3-5. **UW Photos 01 and 02. INCREASE.**

Description: Top: Pick-up points, shallow spalls with exposed steel and vertical cracks. **UW Photo 01.**  
Bottom: Pick-up points, shallow spalls and vertical cracks up to 1/16". **UW Photo 02.**

\_Epoxy inject the cracks at the following Piles: 2-2, 2-4, 2-7, 3-2, 3-5 and 4-6.

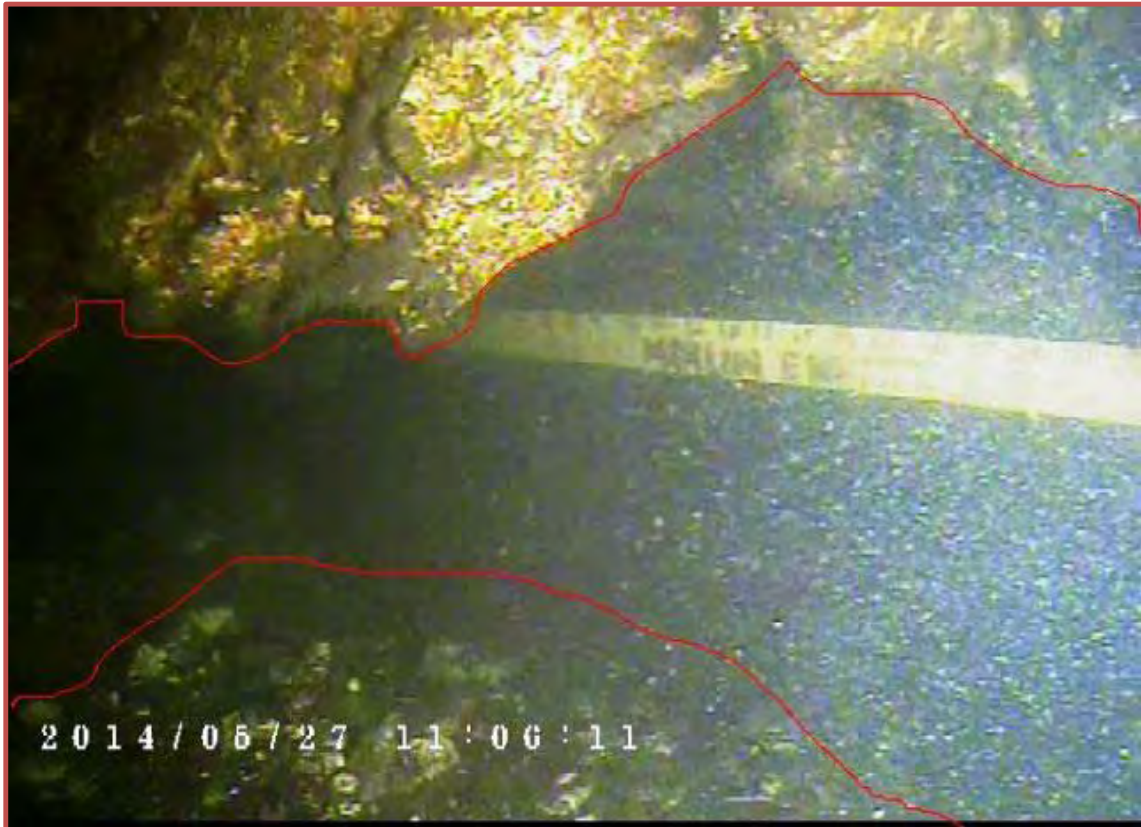
Description: Top: Storm drain concrete apron at Abutment 4 is undermined. **UW Photo 03.**  
Bottom: Abutment 4 backwall NE end delamination, with cracks. **UW Photo 04.**

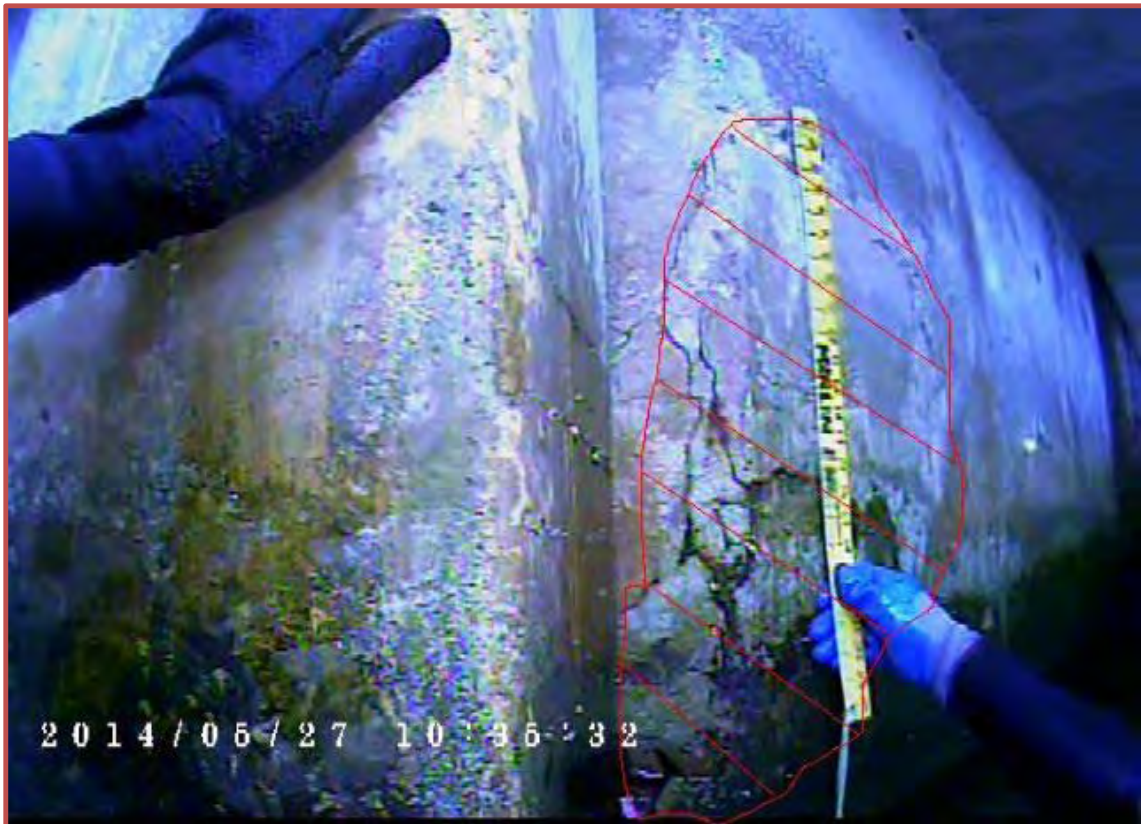
\_Abutment 4 backwall NE end has a delamination 36" x 36", with associated cracks up to 1/6" wide, at and below the high watermark. **UW Photo 04. NO CHANGE.**

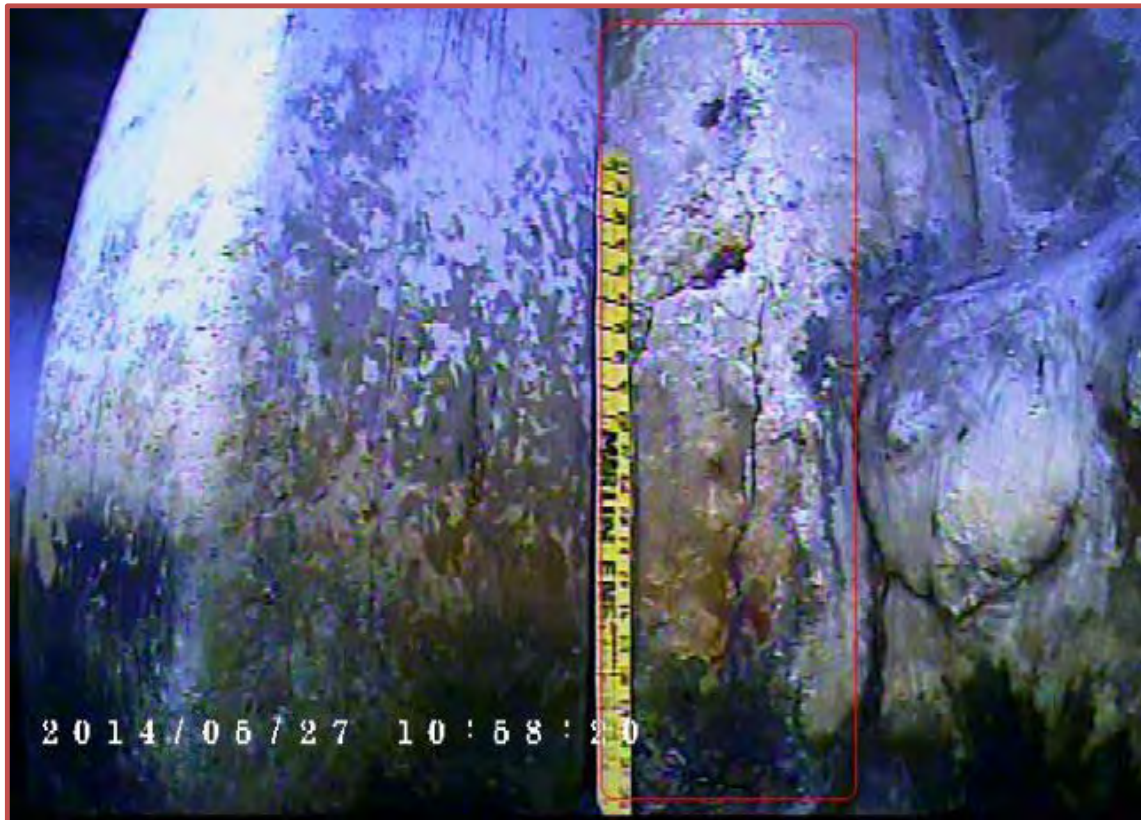
\_Abutment 4, SE end backwall has an spall/delamination 28" x 7" x 1-1/2", with associated cracks up to 1/6" wide, and corrosion bleed-out, starting 2' below the cap. **UW Photo 05. NEW.**

Description: Top: Abutment 4, SE end backwall, spall/delamination, with cracks. **UW Photo 05.**

\_Remove all unsound concrete and patch and epoxy inject the cracks as needed.

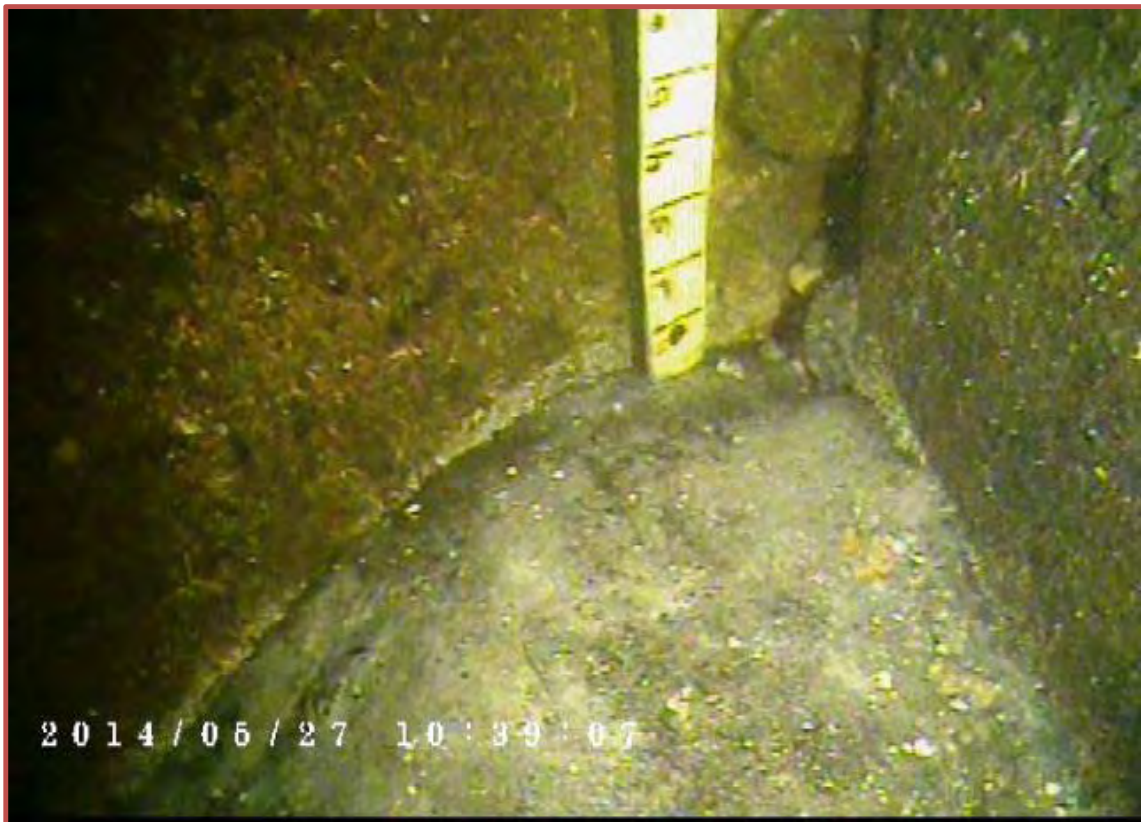
\_Behind Pile 1-7 at the SW corner of the West retaining wall has a moderate amount of backfill leakage, joint is not visible. Active backfill leakage was observed during this inspection cycle.

Bottom: Behind Pile 1-7, SW corner of the West retaining, backfill leakage. **UW Photo 06.**

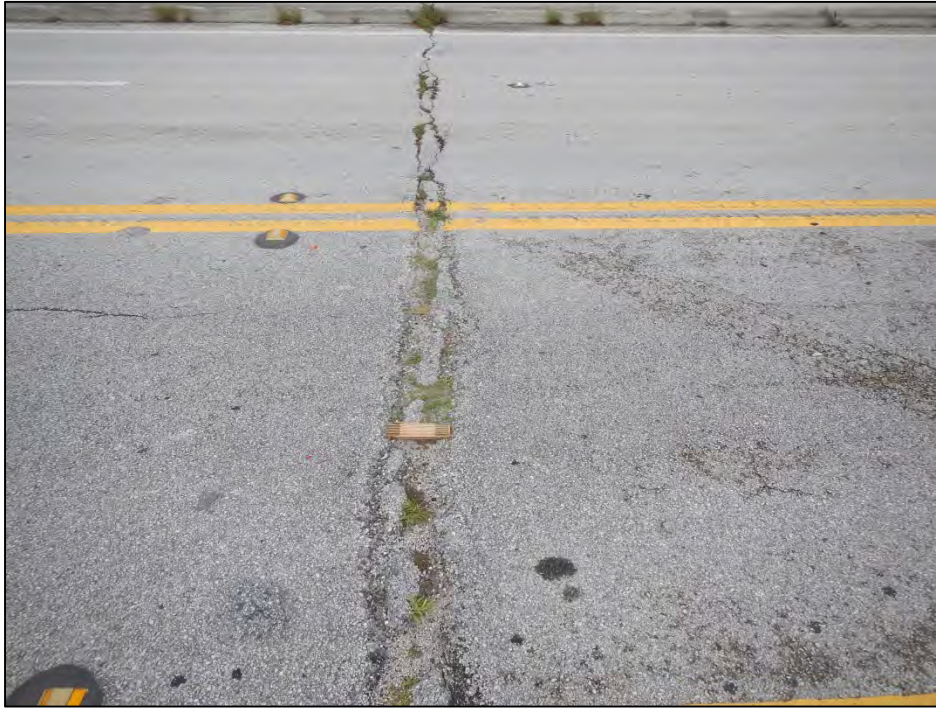
Photo 1 – Bent 2 joint seal transverse crack.

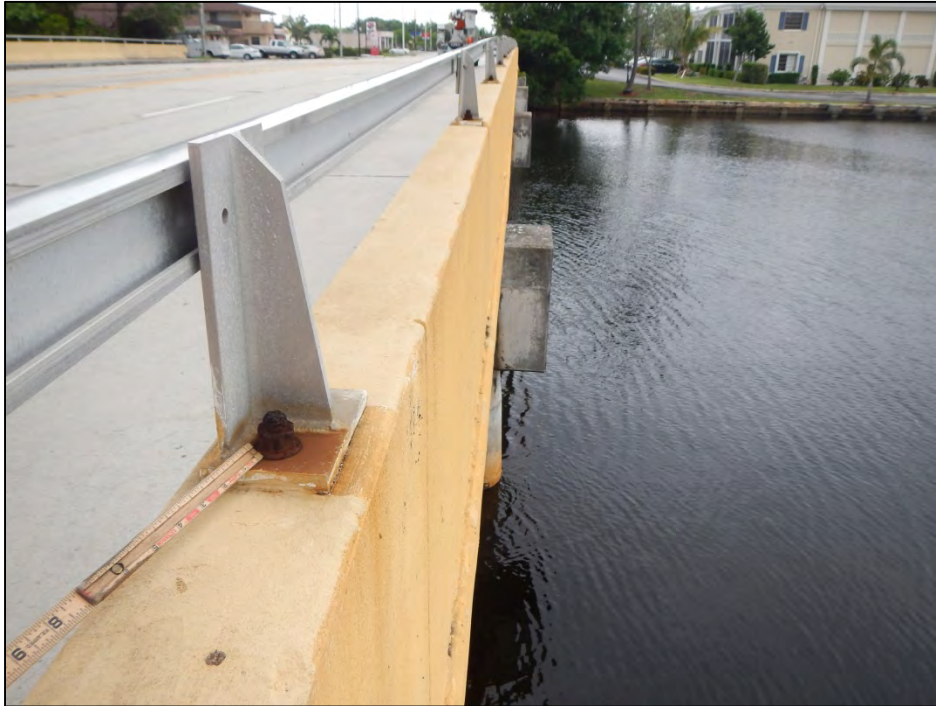
Photo 3 – The aluminum railing Post I-3 right exhibits bolt corrosion.

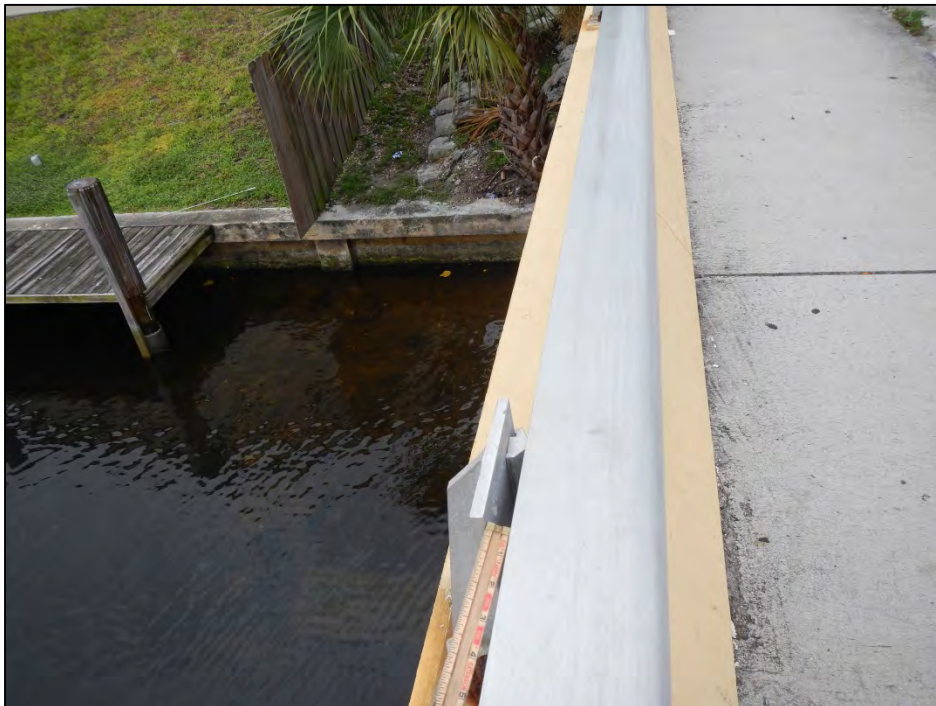
Photo 4 – Bolts are missing at Post I-3R.

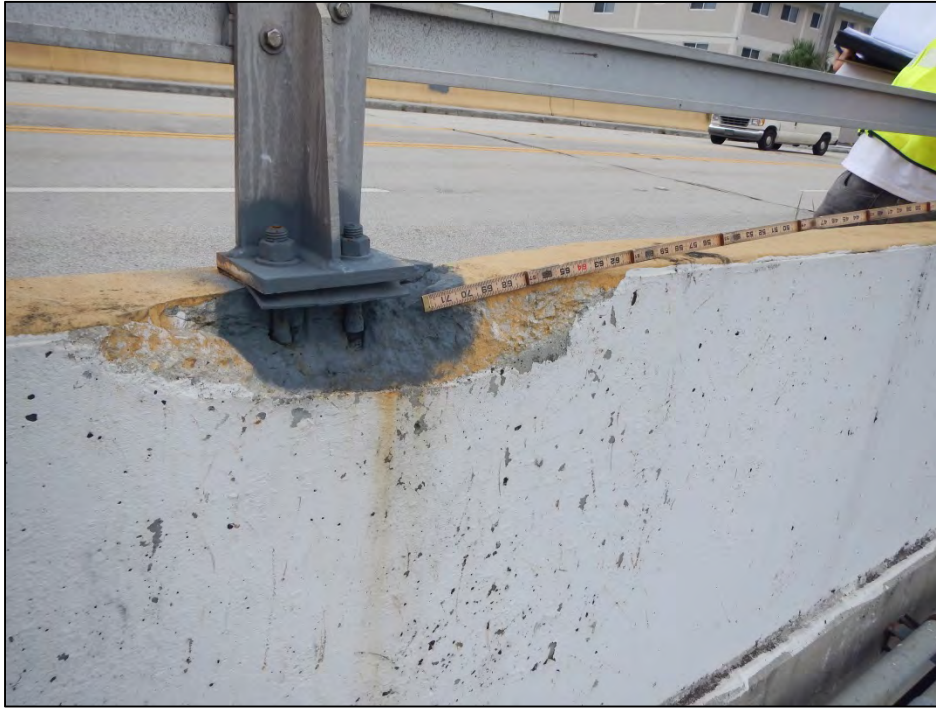
Photo 5 – Spall with exposed steel below Post 3-4L.
