## **EXECUTIVE SUMMARY**

TranSystems has been retained by the City of Fort Lauderdale to perform bridge inspections and prepare bridge inspection reports for each of the City's bridges as part of the project Structural Bridge Engineering Consulting Services Master Plan, RFQ No. 946-11310. Inspections were completed and reports prepared for 46 of the City's bridges. The remaining five bridges in the City's inventory were not inspected because they are in the process of being replaced.

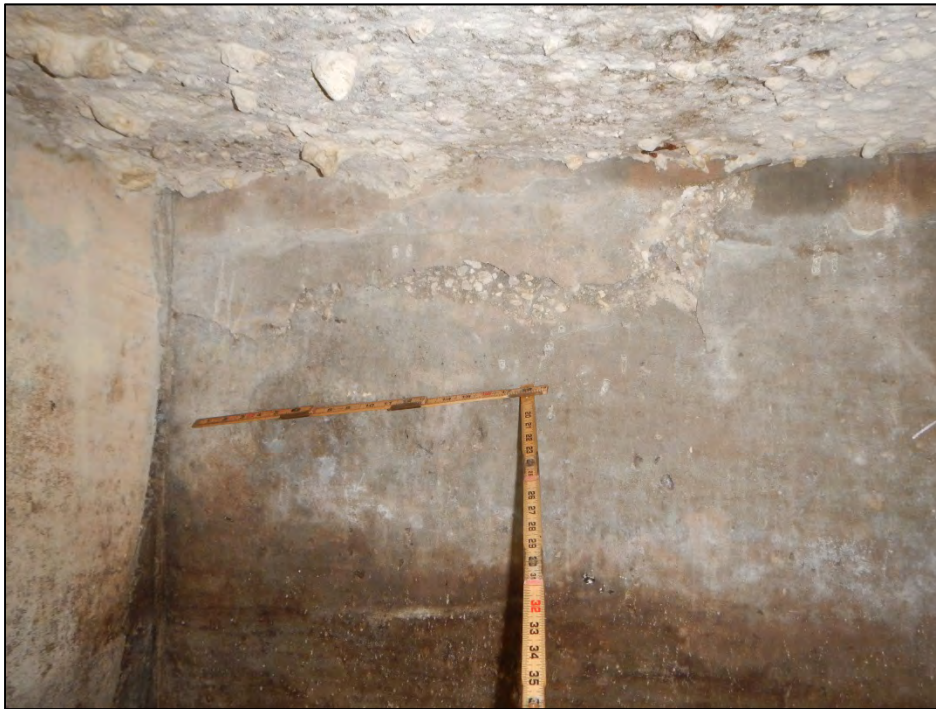
Photo 6 – End Bent I backwall spall and delamination

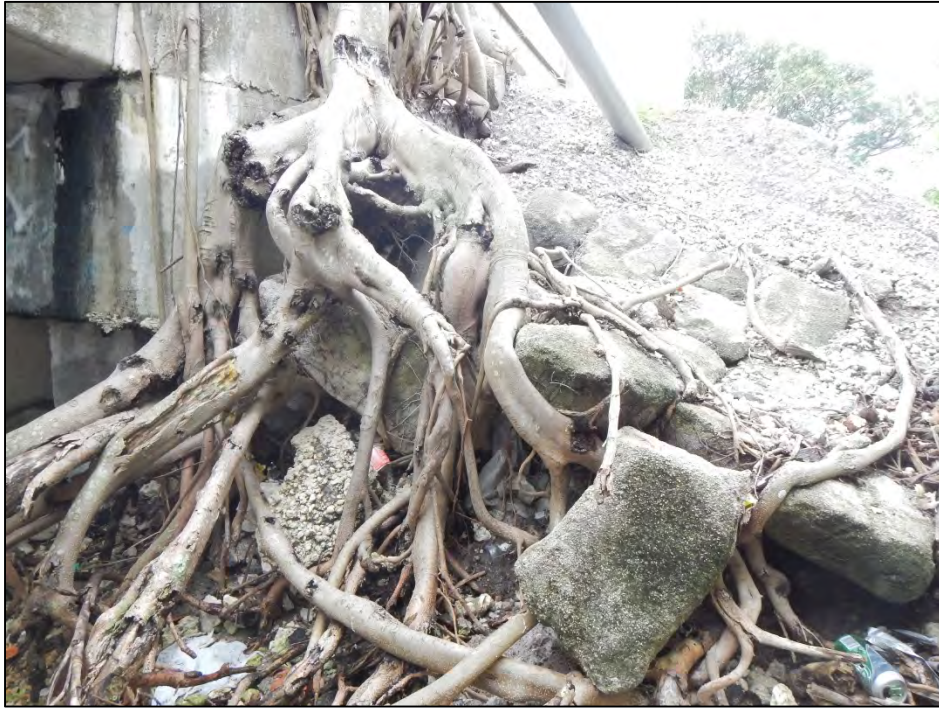
Photo 7 – Tree root is undermining the west end of End Bent 1.

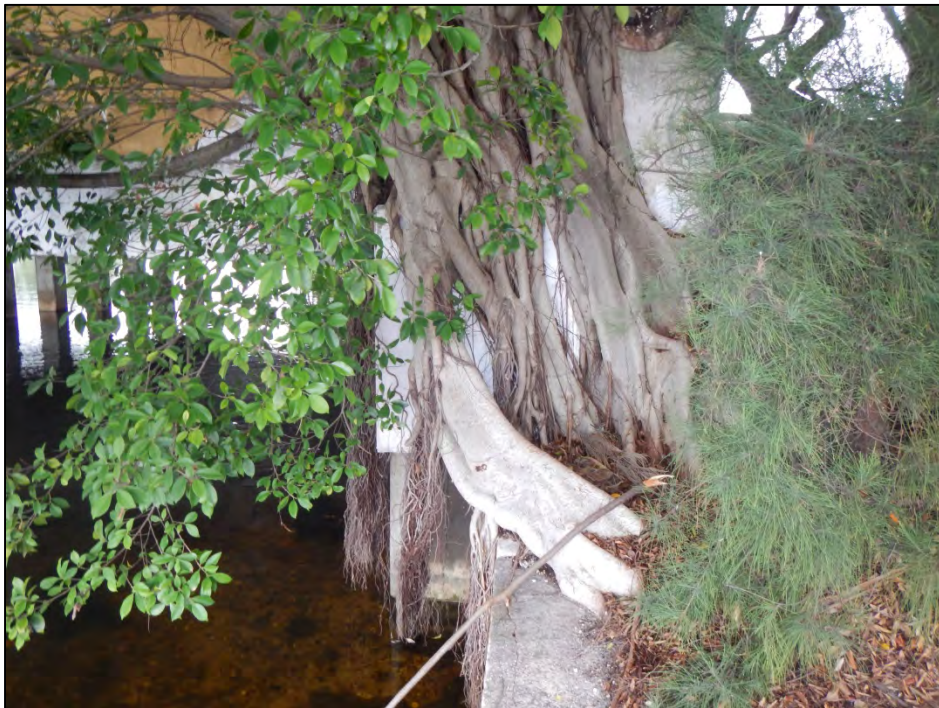
Photo 8 – Tree growth at End Bent 6 cap.

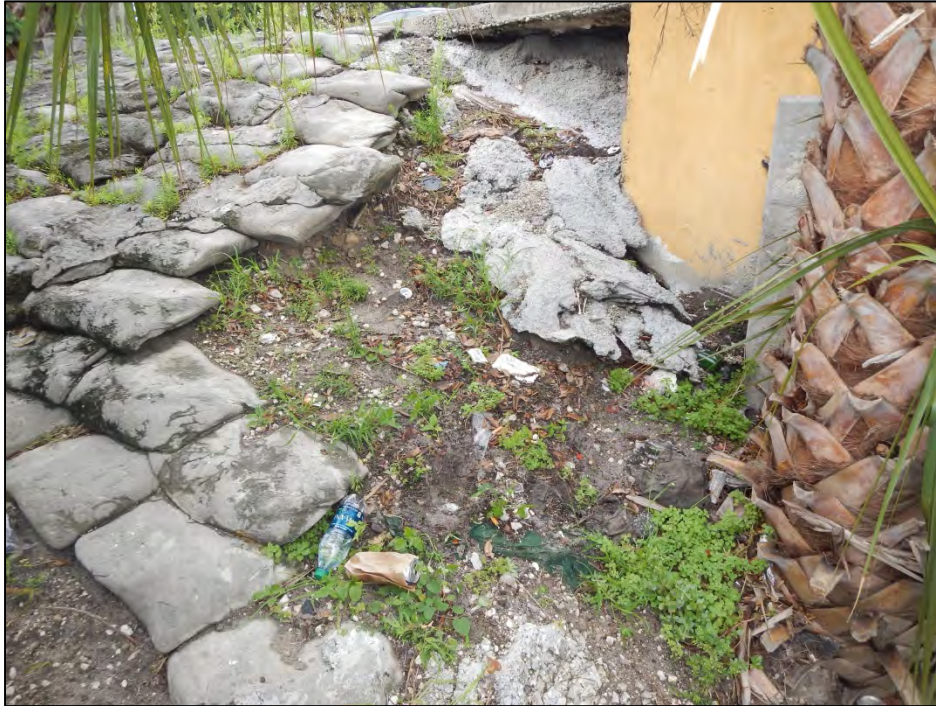
Photo 9 – Southeast abutment corner exhibits missing riprap and an erosion.

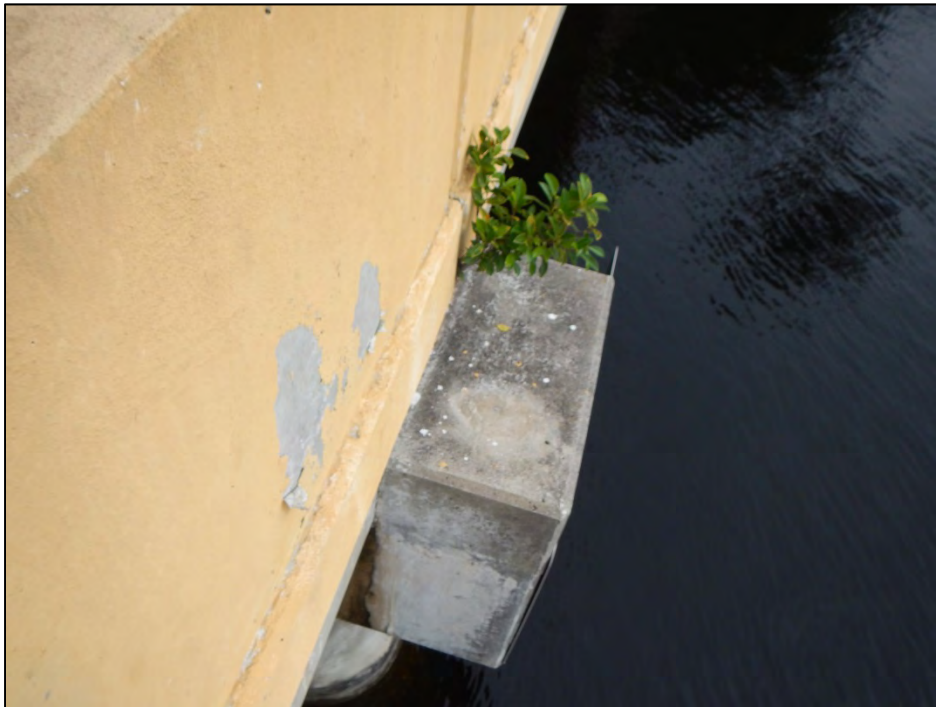
Photo 10 – The east end of Bent 4 exhibits vegetative growth.

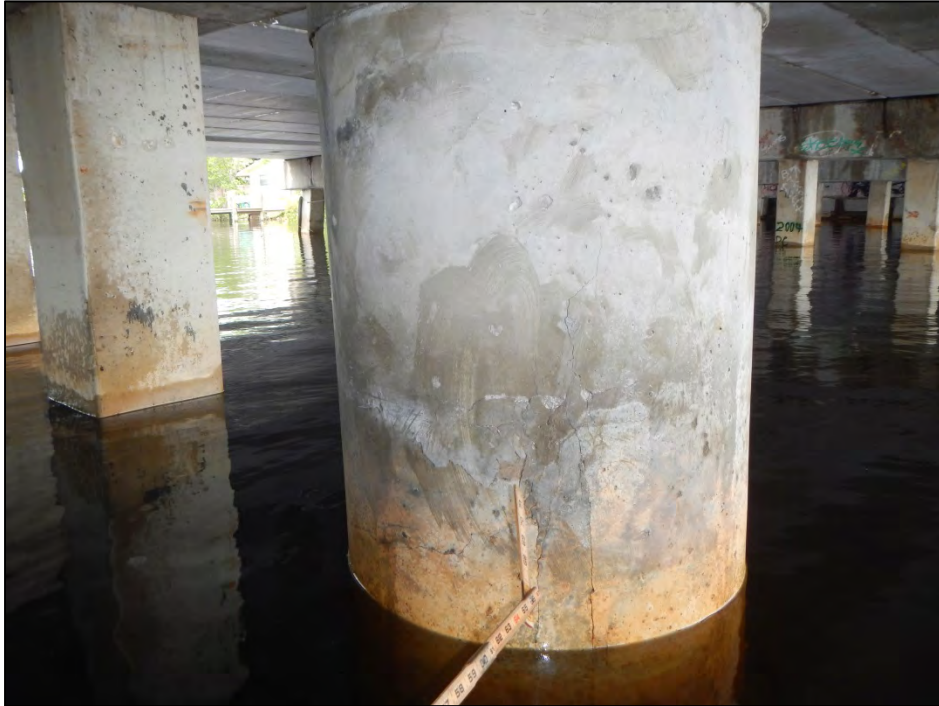
Photo 11 – The southwest quadrant of Pile 3-10 exhibits a delamination.

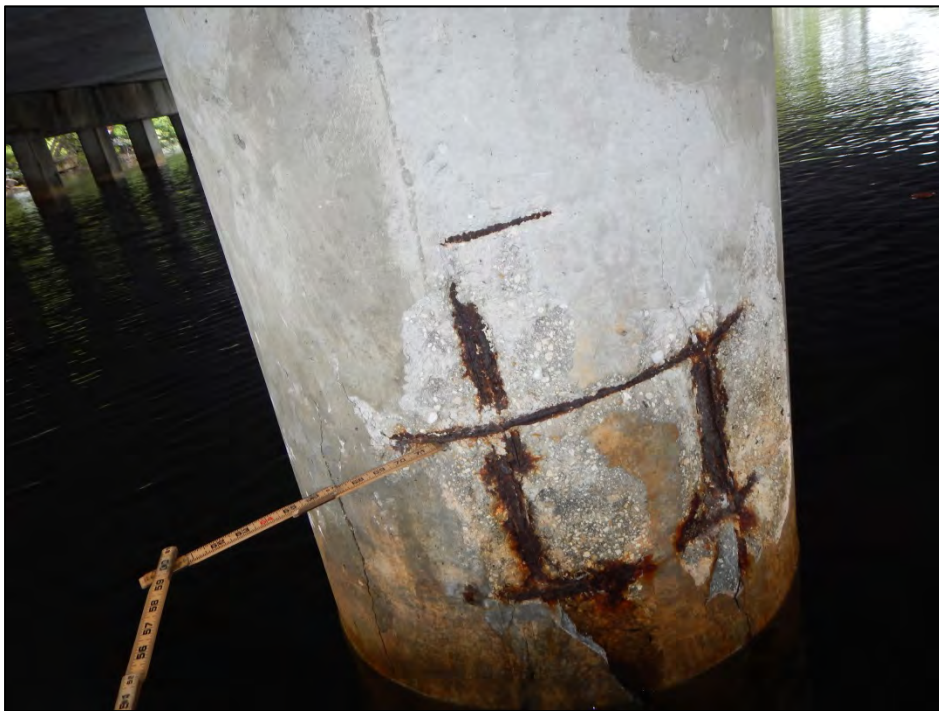
Photo 12 – Pile 3-11 exhibits a spall with exposed steel.

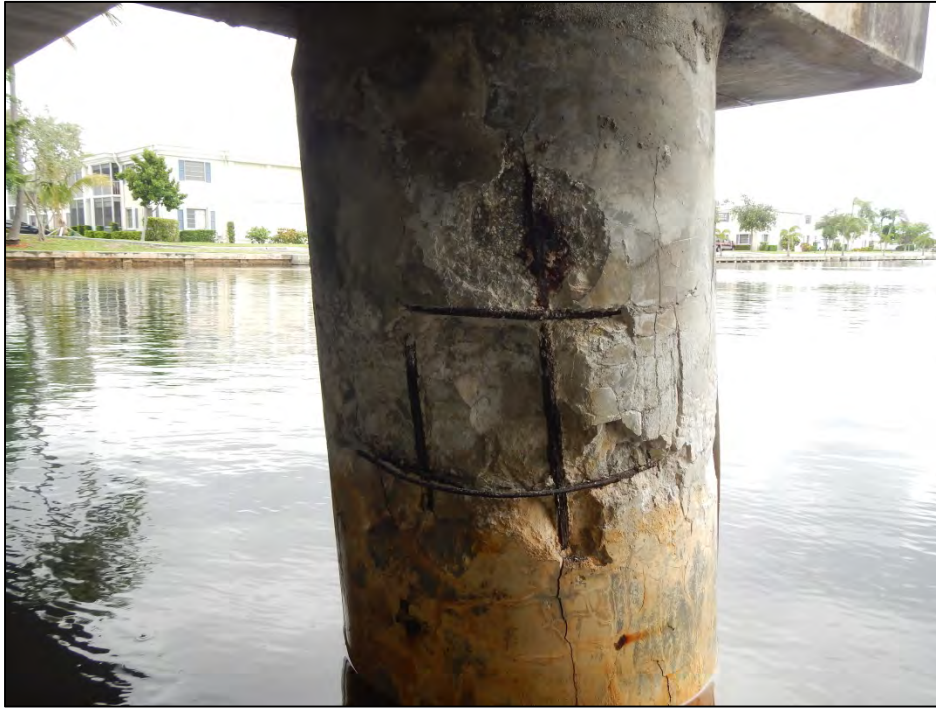
Photo 13 – Pile 3-12 exhibits spalls and delaminations.

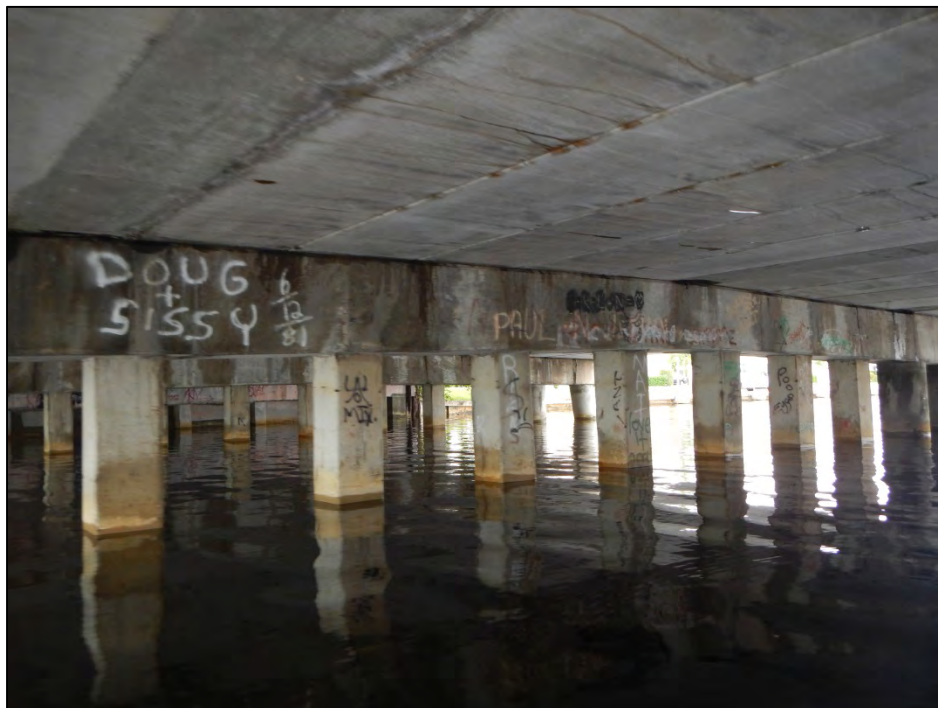
Photo 14 – Graffiti at Bent 4.

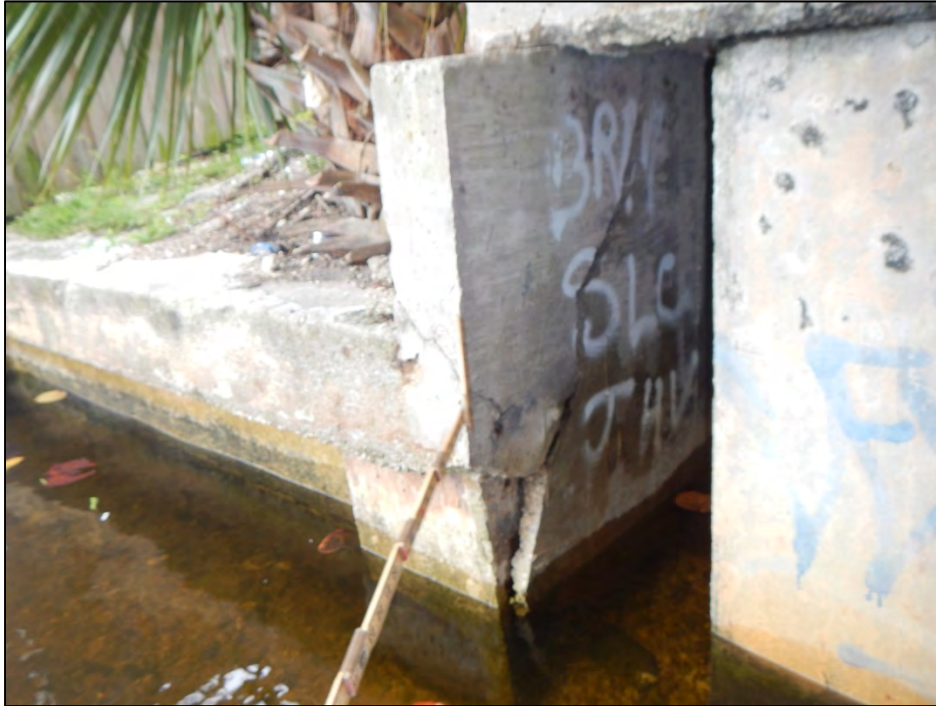
Photo 15 – Crack at the west face of the southeast corner retaining wall.

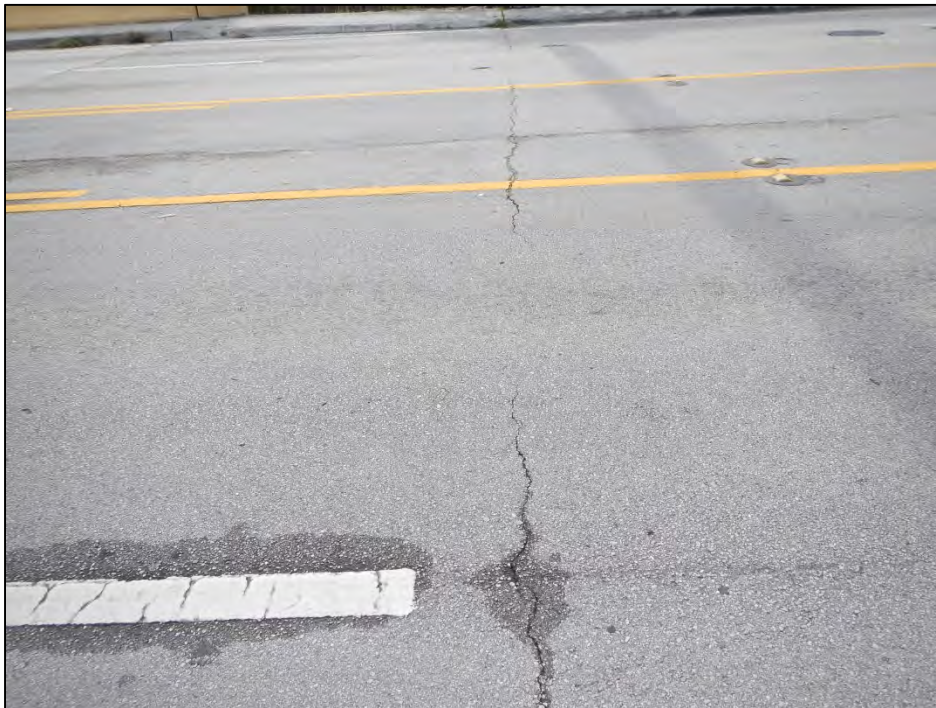
Photo 16 – Approach slab roadway transverse crack.

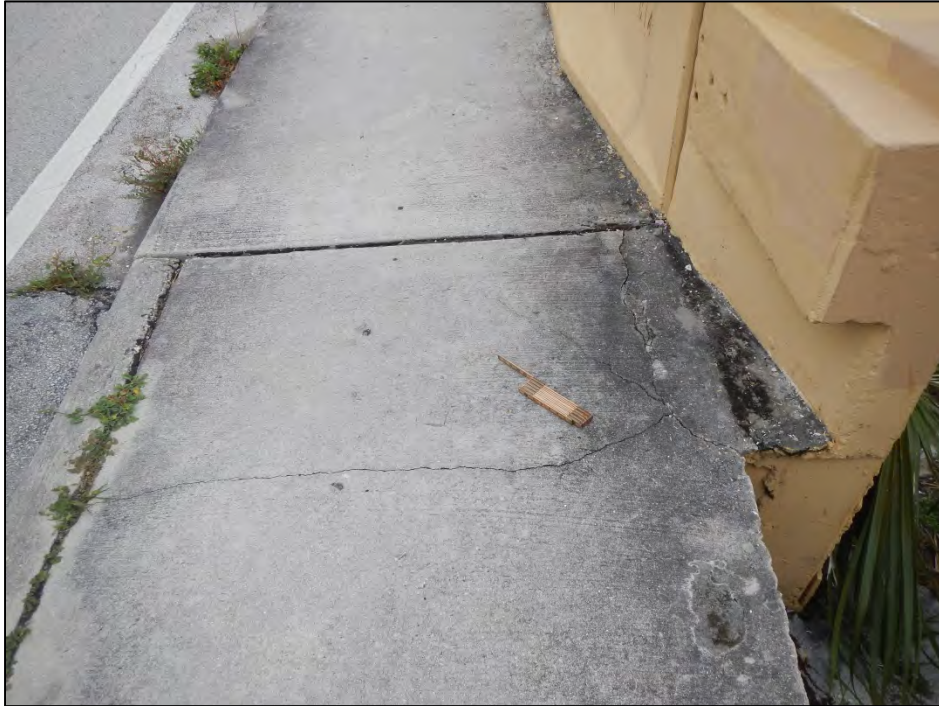
Photo 17 – Southeast approach sidewalk exhibits multi-directional cracks.

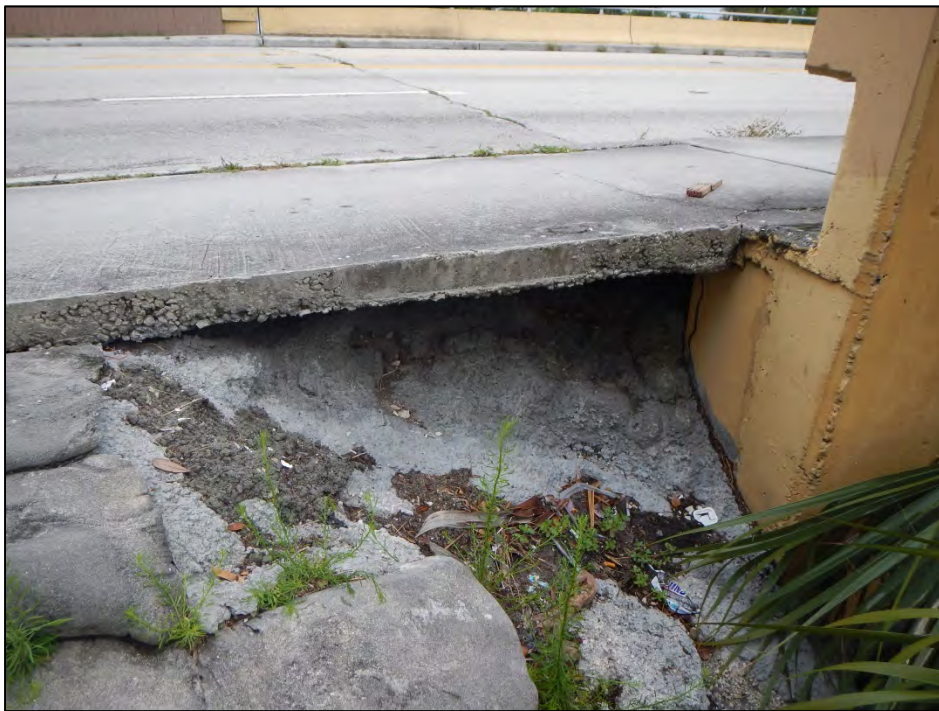
Photo 18 – Southeast approach sidewalk undermining.

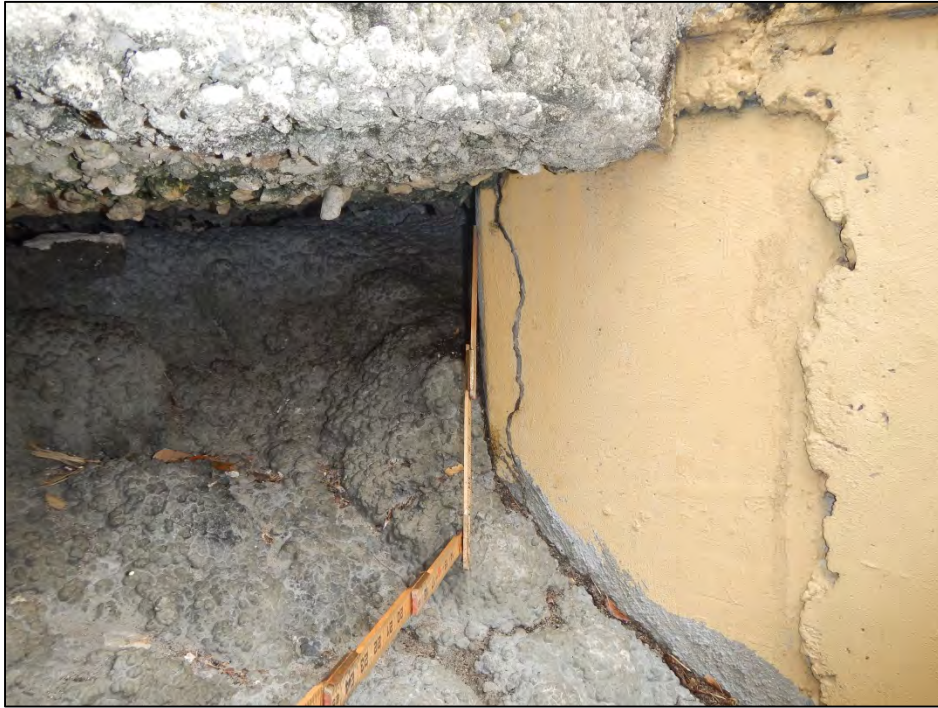
- The southeast wingwall below the sidewalk panel exhibits a 1 ft. high x 2 in. wide delamination. This condition was not previously noted. See Condition Photo 19.

Photo 19 – Southeast wingwall exhibits a delamination.

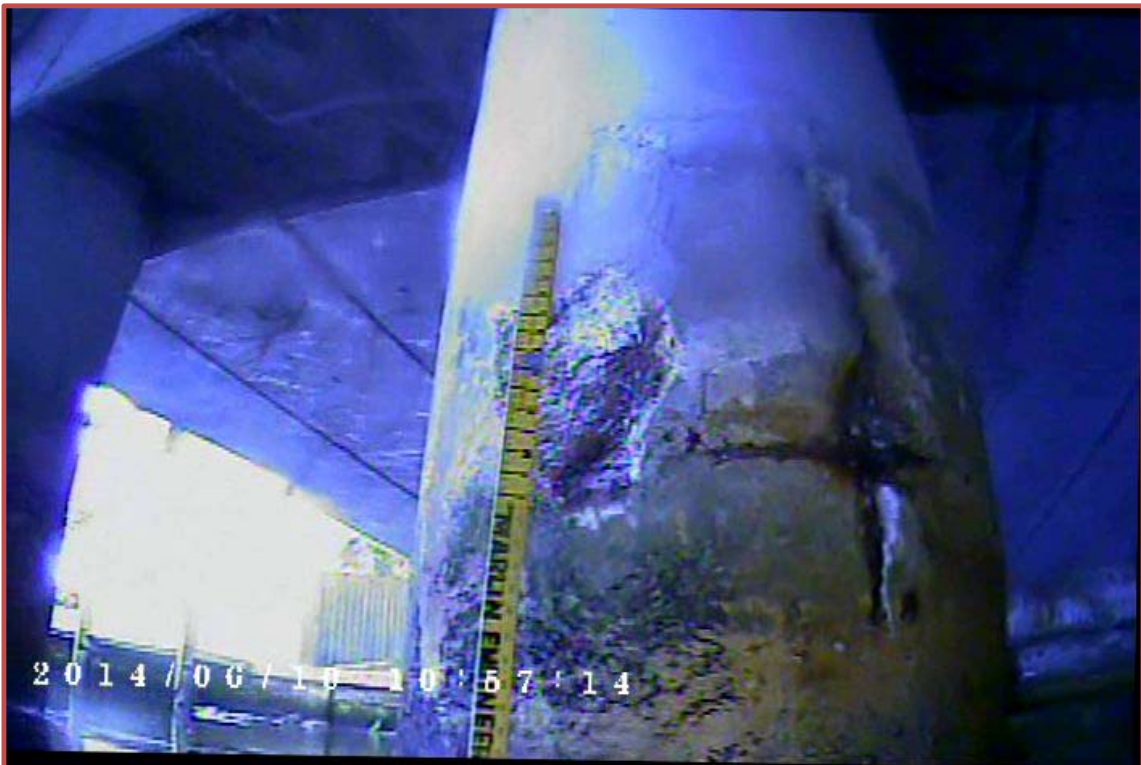
\_Jacket 2-10 spall/delamination 60" x 30" x 1-1/2", with exposed rebar 50% section loss, in the North quadrant, 48" below the cap. **UW Photo 02. INCREASE**

Description: Top: Bottom 6" to 12" of the piles are exposed at some jackets. **UW Photo 01.**  
Bottom: Jacket 2-10 spall/delamination with exposed rebar. **UW Photo 02.**

- \_Repair the bottom 6" to 12" of the bottom of the jacket on Piles 3-10, 3-11 and 3-12.
- \_Repair spalls and delaminations at Jackets 2-10, 2-11, 2-12, 3-10, 3-11 and 3-12.

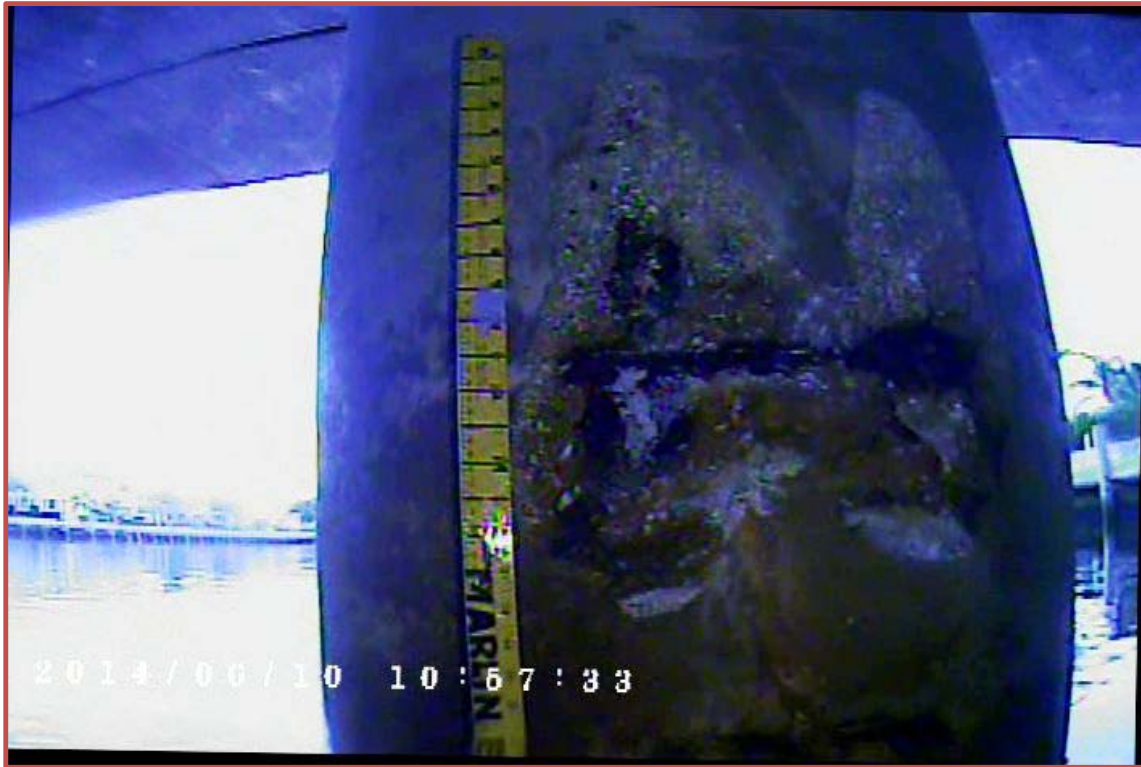
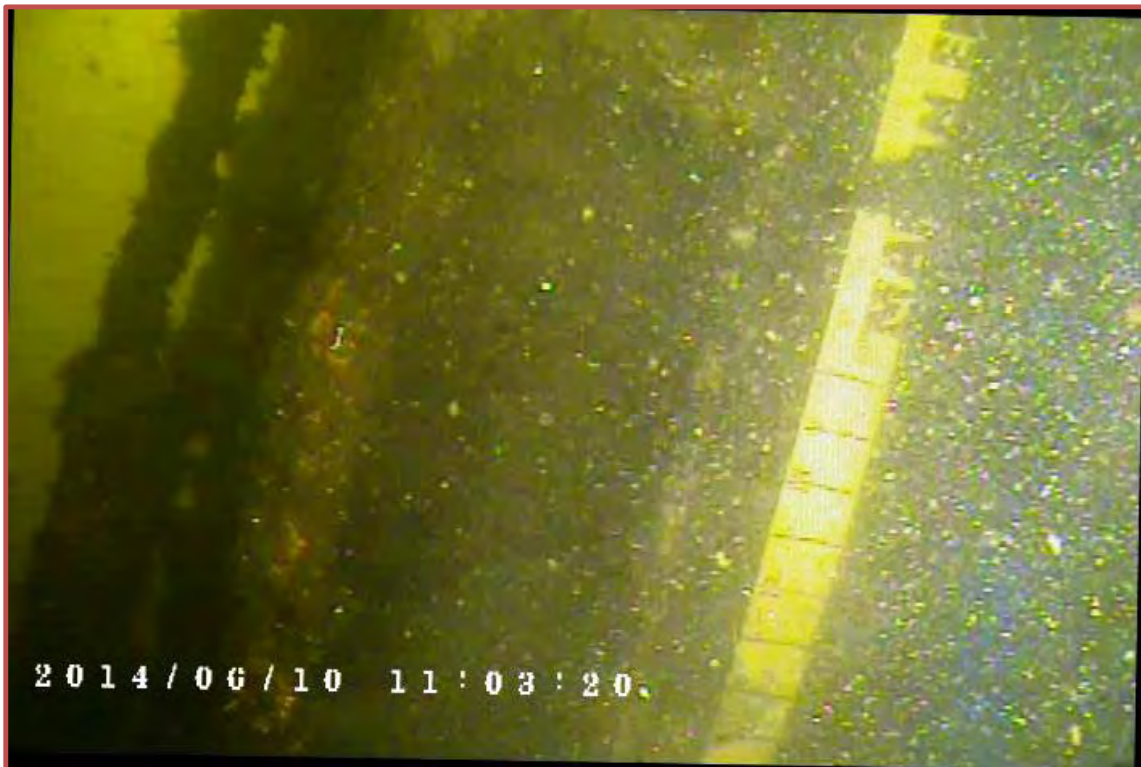
\_Jacket 2-11 spall/delamination 18" x 18" x 1", with exposed rebar 50% section loss, in the West quadrant, 30" below the cap. **UW Photo 03. NEW**

Description: Top: Jacket 2-11 spall/delamination with exposed rebar. **UW Photo 03.**  
Bottom: Jacket 3-12, vertical voids w/exposed rebars, near the groundline. **UW Photo 04.**

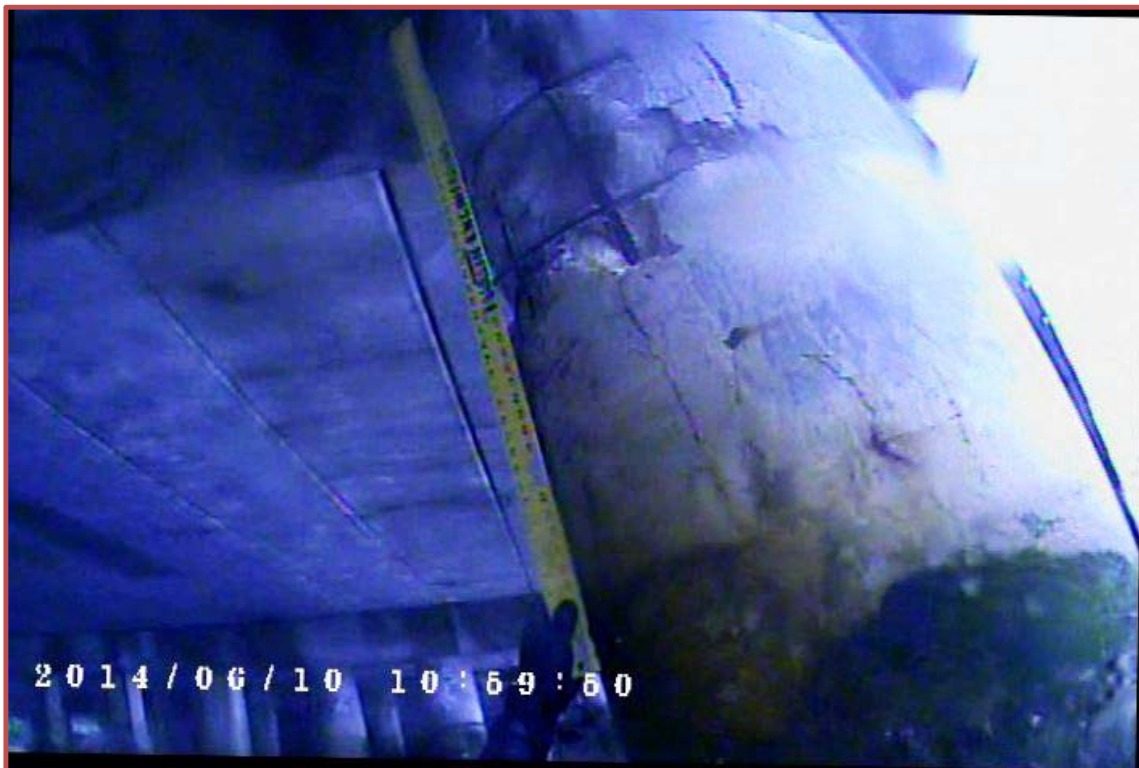
\_Jacket 3-12, spall/delamination 48" x 40" x 2", with associated cracks up to 1/8" wide, 18" below the cap, with exposed rebar 50% section loss. **UW Photo 05. INCREASE**

Description: Jacket 3-12, spall/delamination with exposed rebar. **UW Photo 05.**

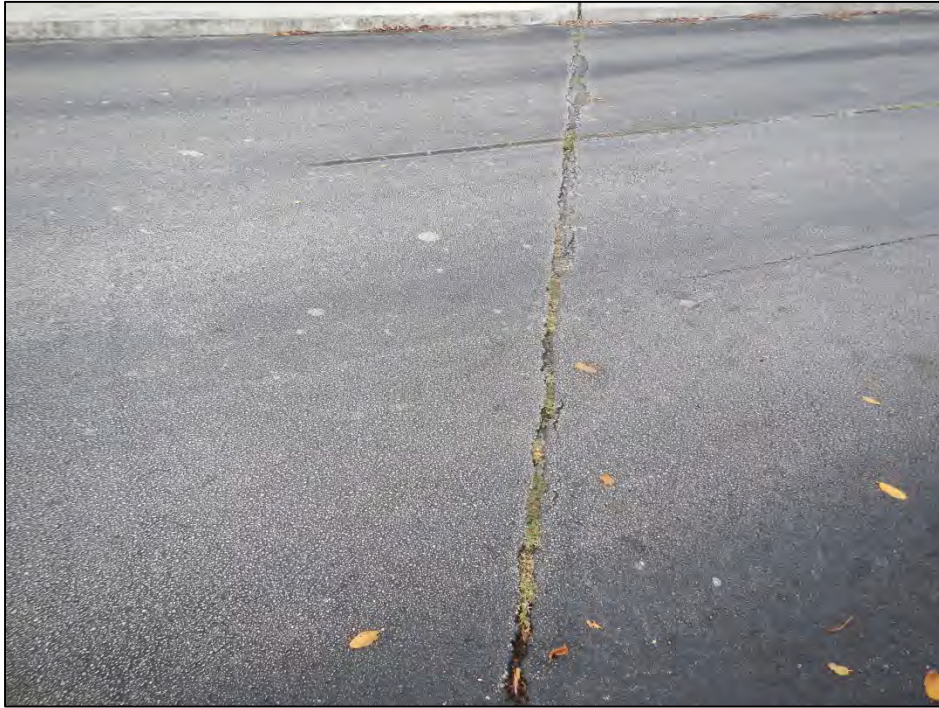
Photo 1 – End Bent 1 joint seal transverse crack.

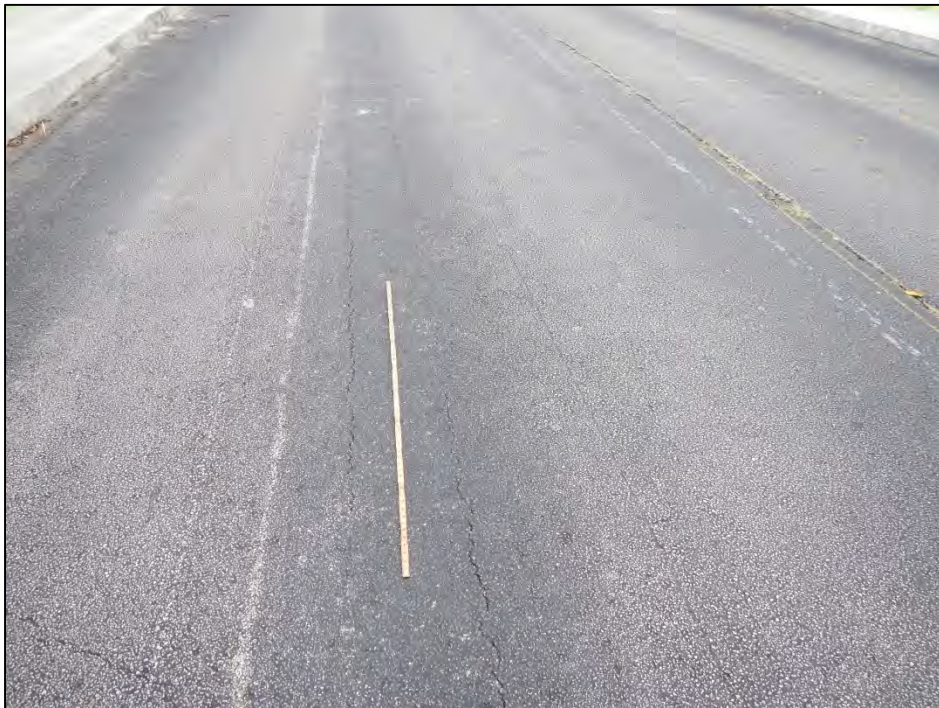
Photo 2 – Deck top longitudinal cracks at Span 4.

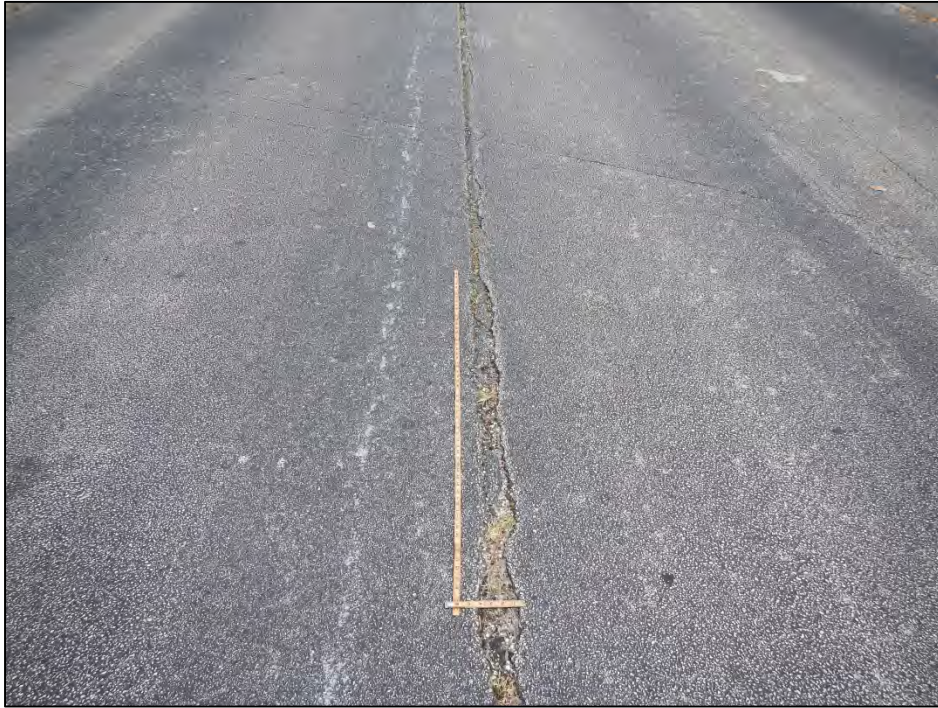
Photo 3 – Centerline longitudinal crack.

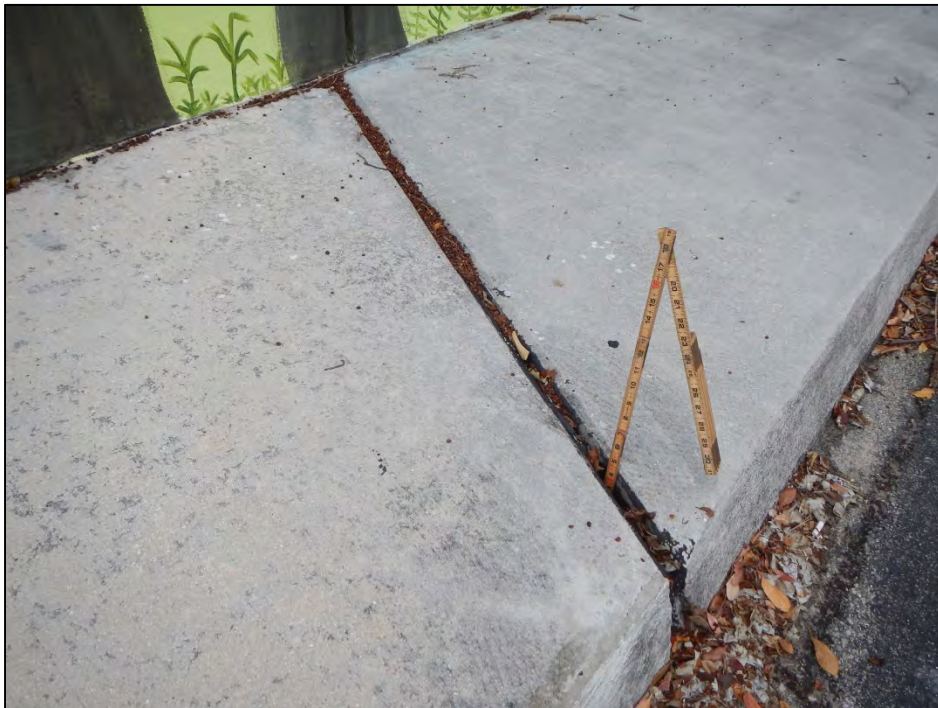
Photo 4 – End Bent 6 sidewalk right side joint deterioration.

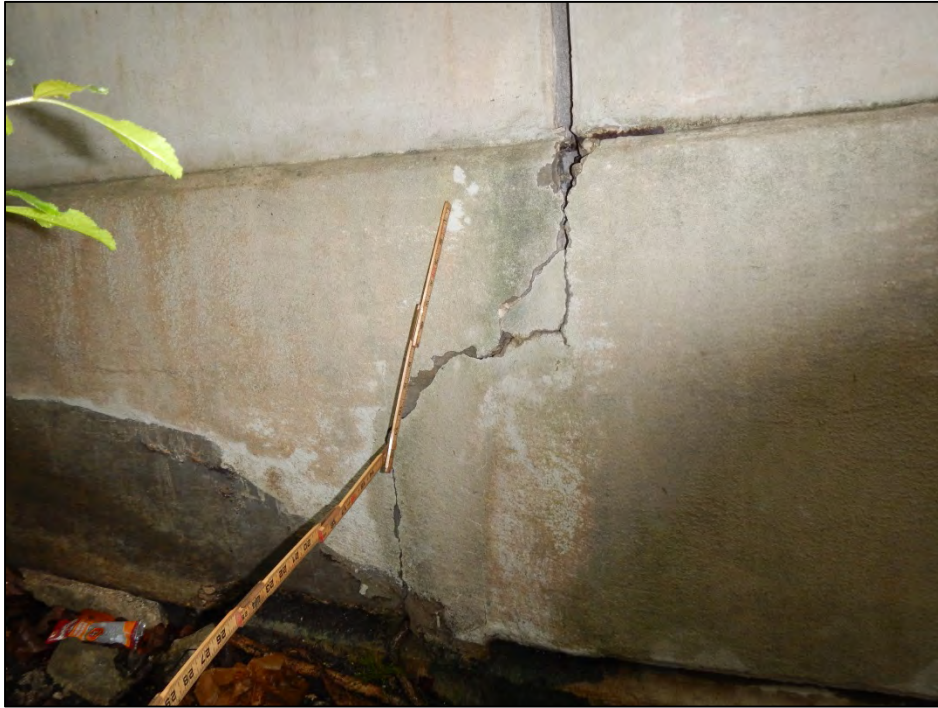
Photo 5 – Vertical crack in the south face of Slab Unit 6-1.

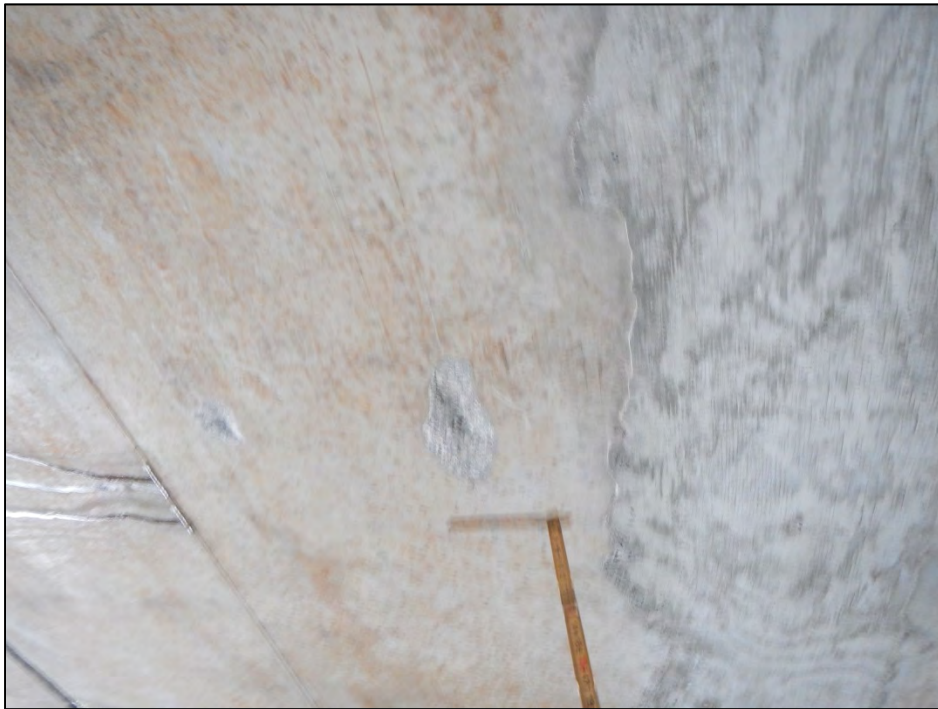
Photo 6 – Slab 3-3 spalls mid-span.

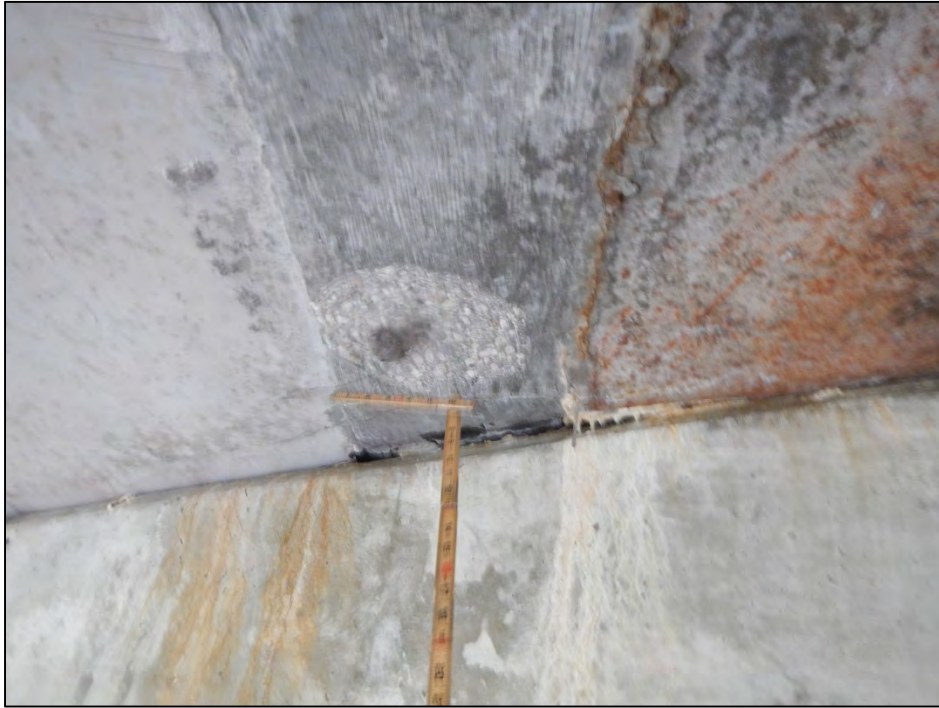
Photo 7 – Slab 4-I joint spall.

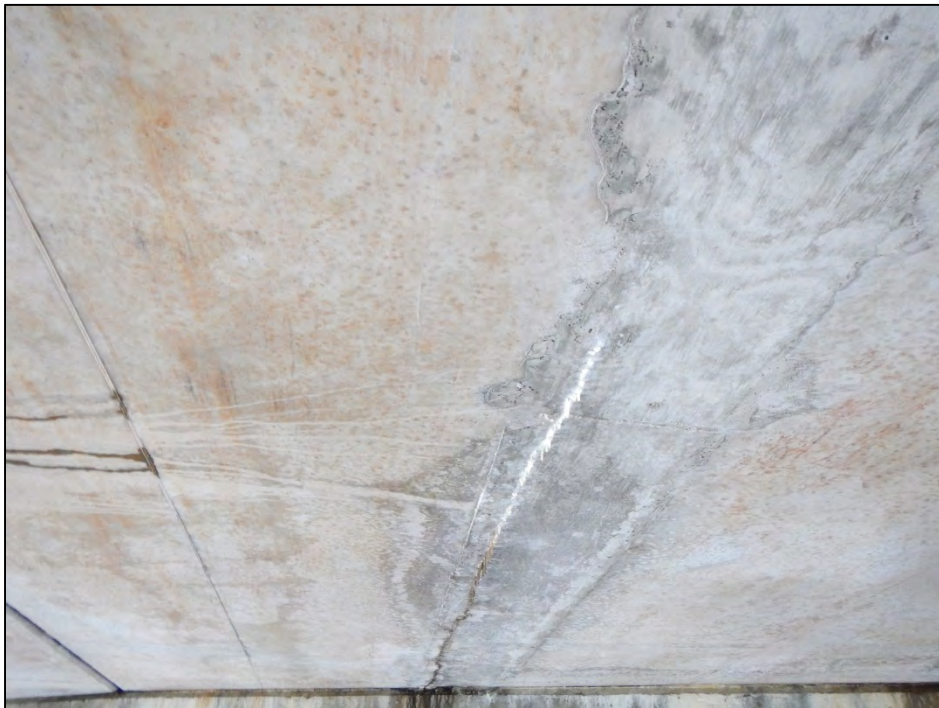
Photo 8 – Slab 3-2 to 3-3 longitudinal crack.

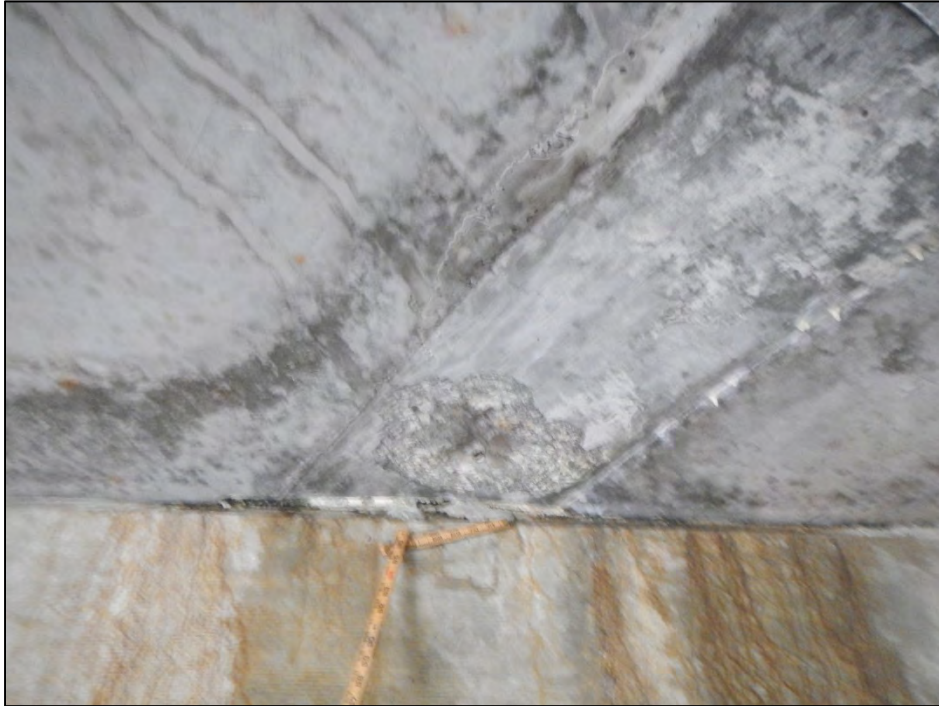
Photo 9 – Spall at the joint between Slab Units 2-2 and 2-3.

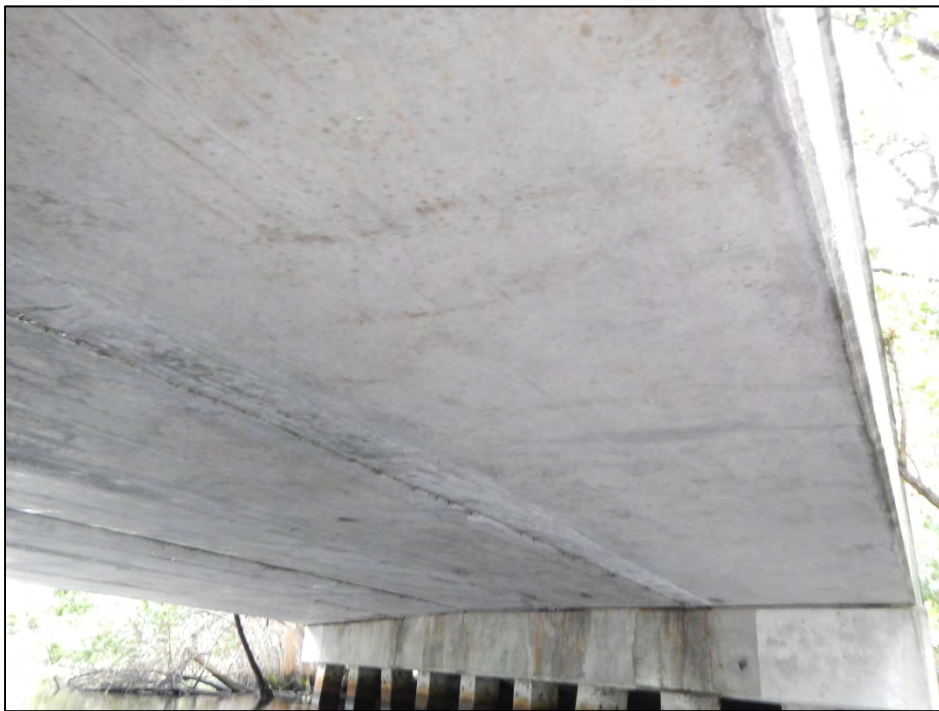
Photo 10 – Span 2 deck underside exhibits hairline cracks with efflorescence.

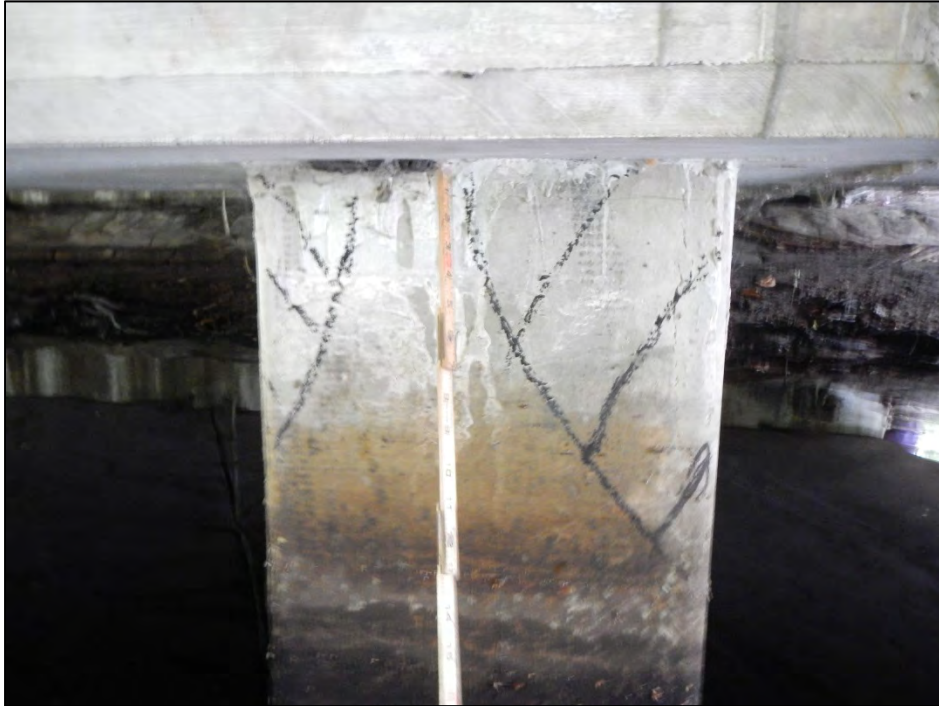
Photo 11 – Pile 5-5 exhibits delaminations in the west face.

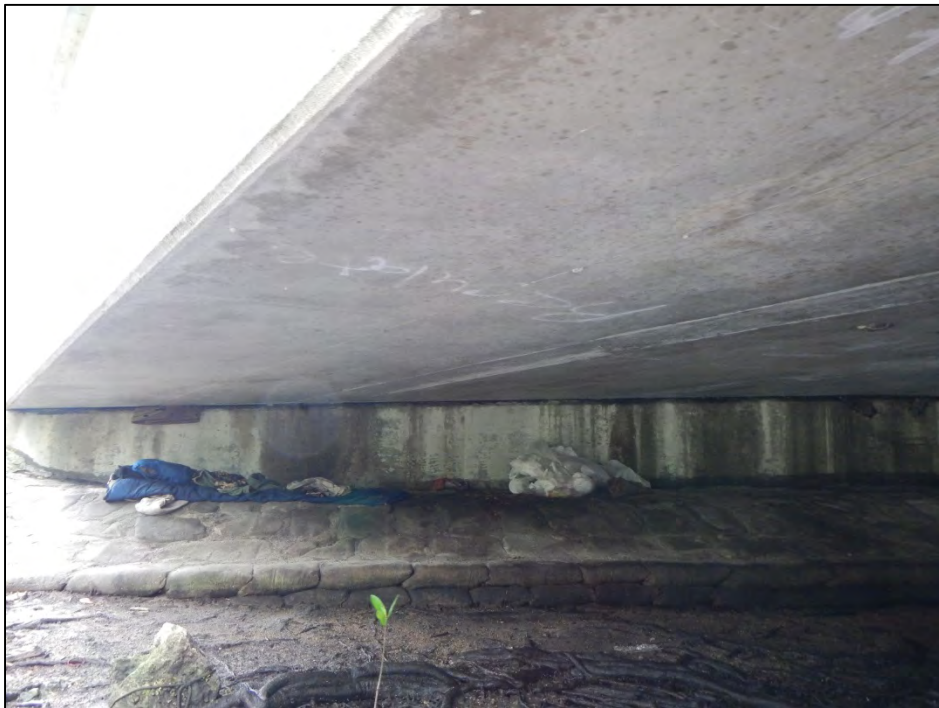
Photo 12 – Vagrant possessions near Abutment 6.

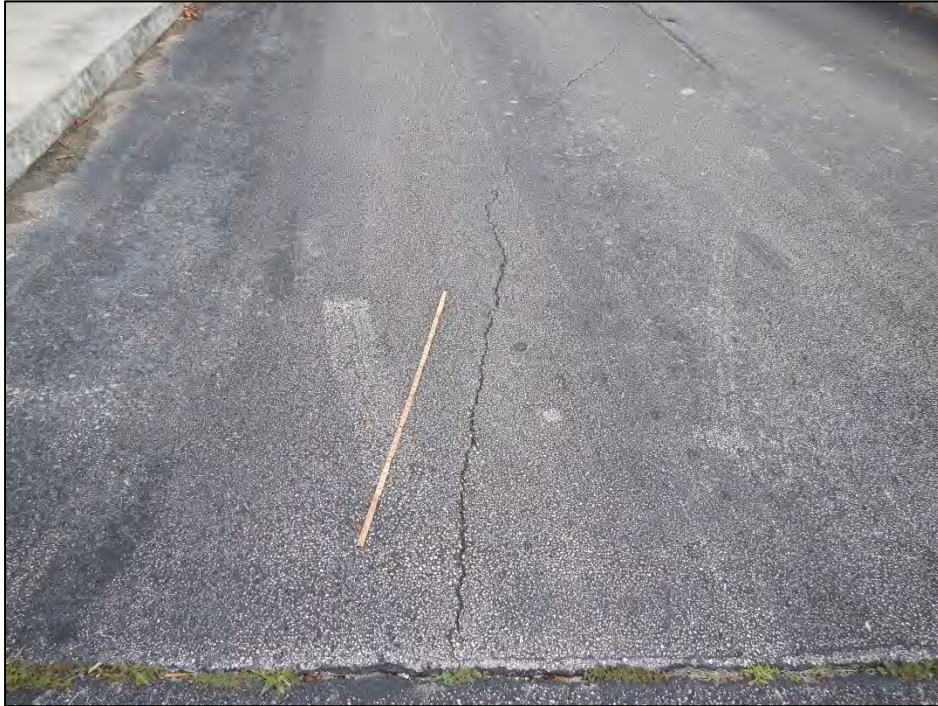
Photo 13 – East approach slab diagonal crack.

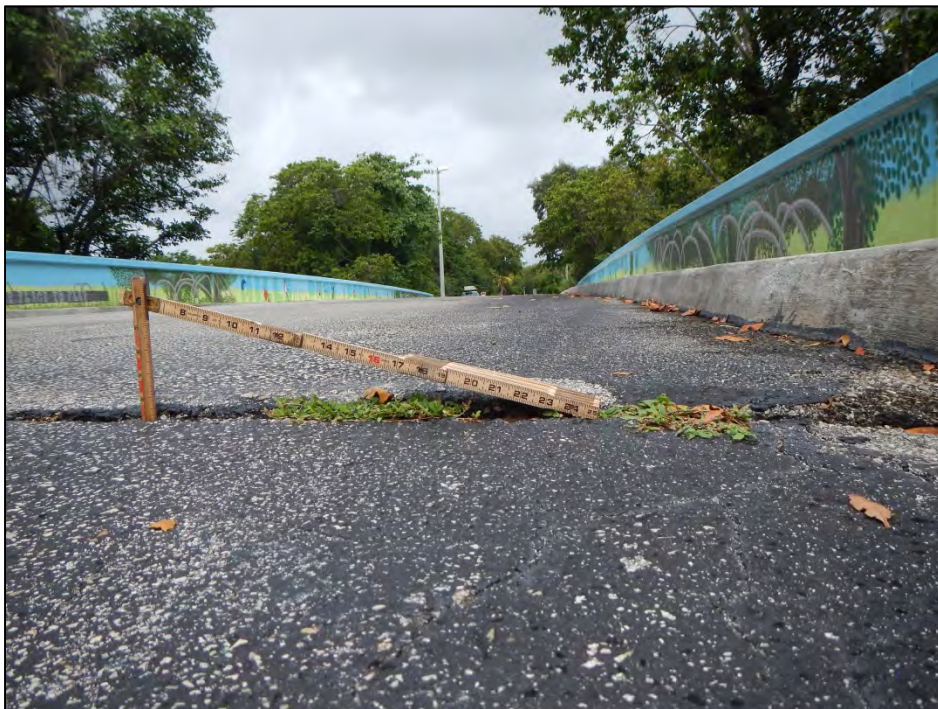
Photo 14 – East approach slab difference in elevation.
