## **EXECUTIVE SUMMARY**

TranSystems has been retained by the City of Fort Lauderdale to perform bridge inspections and prepare bridge inspection reports for each of the City's bridges as part of the project Structural Bridge Engineering Consulting Services Master Plan, RFQ No. 946-11310. Inspections were completed and reports prepared for 46 of the City's bridges. The remaining five bridges in the City's inventory were not inspected because they are in the process of being replaced.

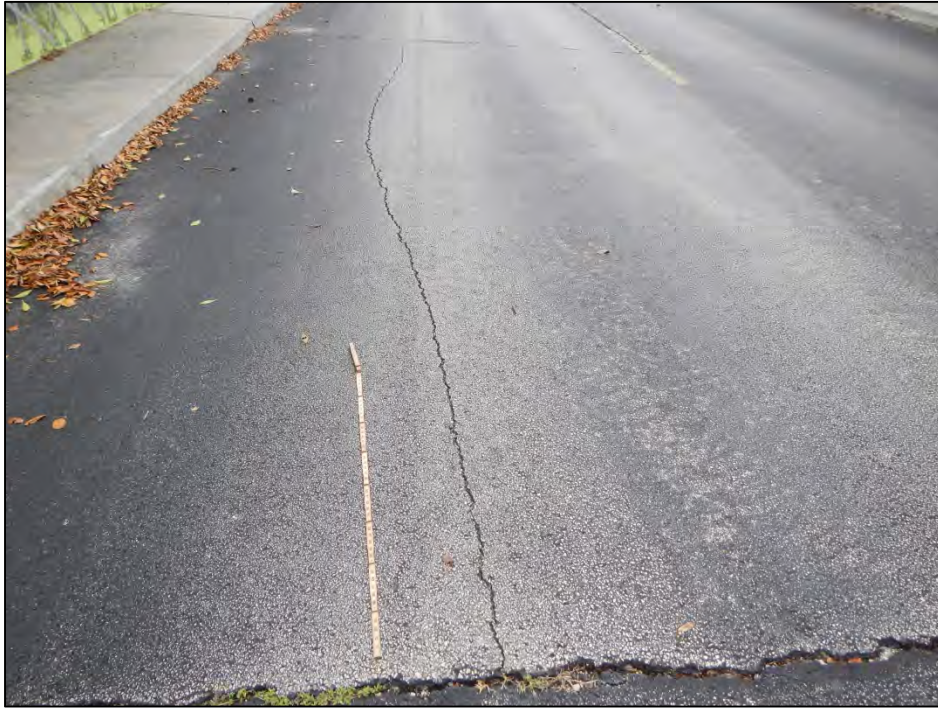
Photo 15 – West approach slab longitudinal crack.

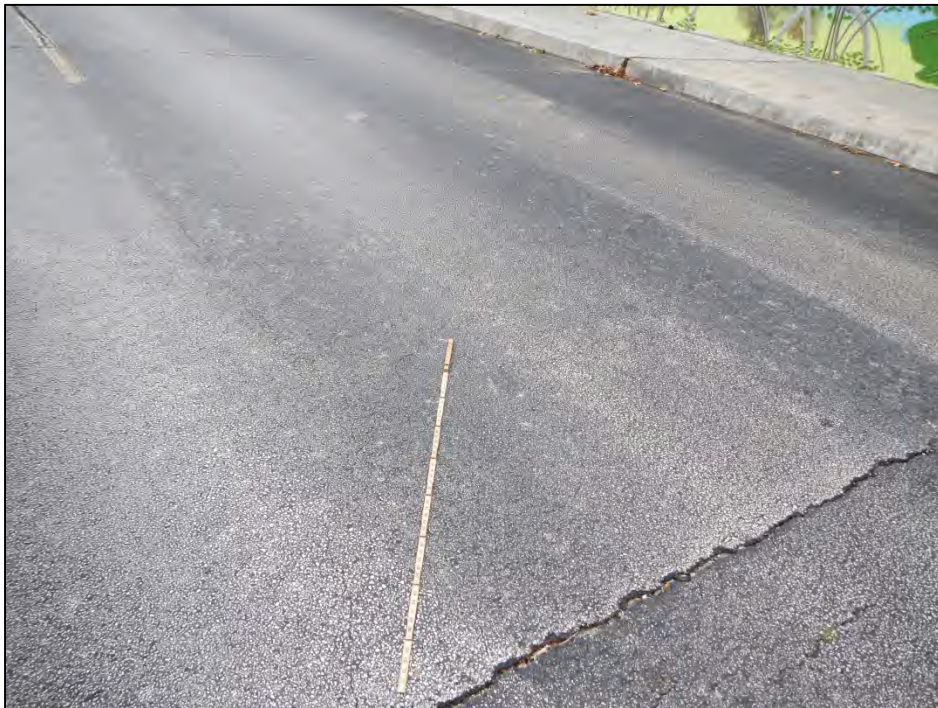
Photo 16 – West approach slab diagonal crack.

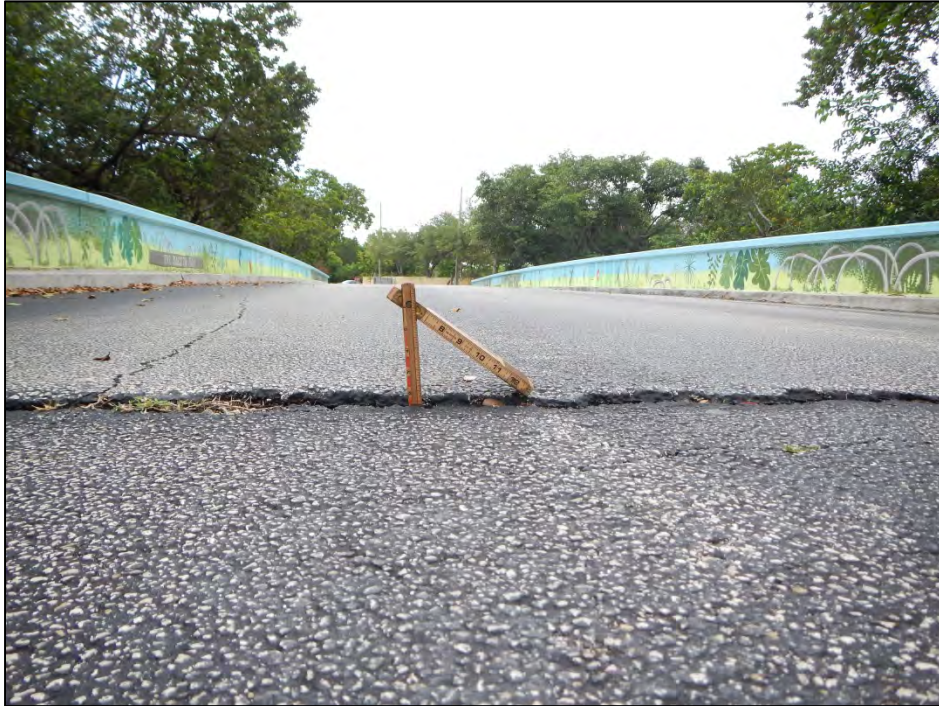
Photo 17 – West approach slab difference in elevation.

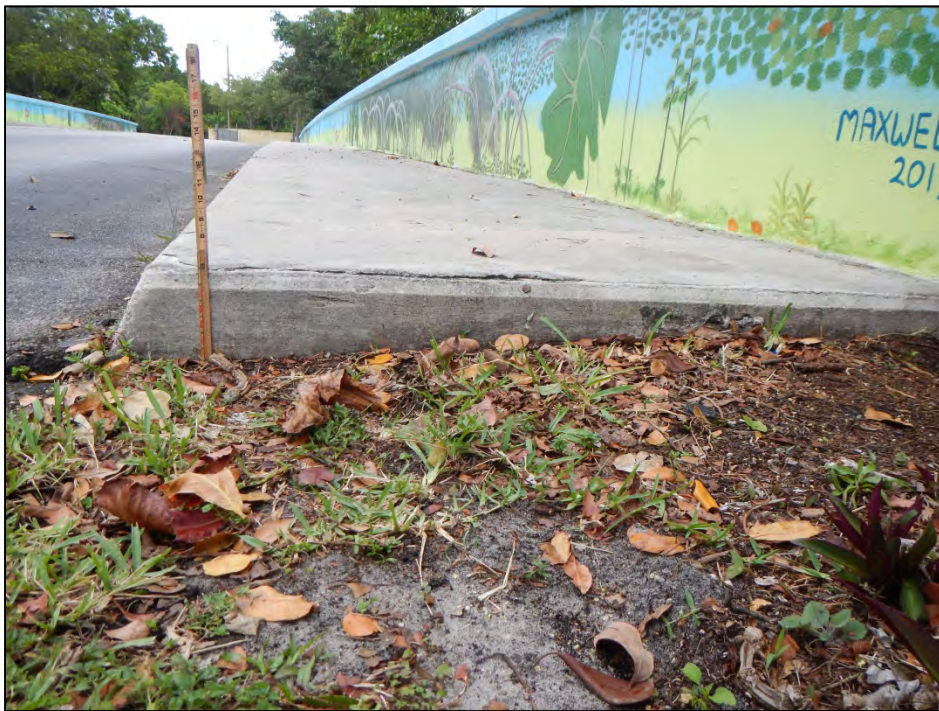
Photo 18 – Southwest approach sidewalk exhibits a difference in elevation.

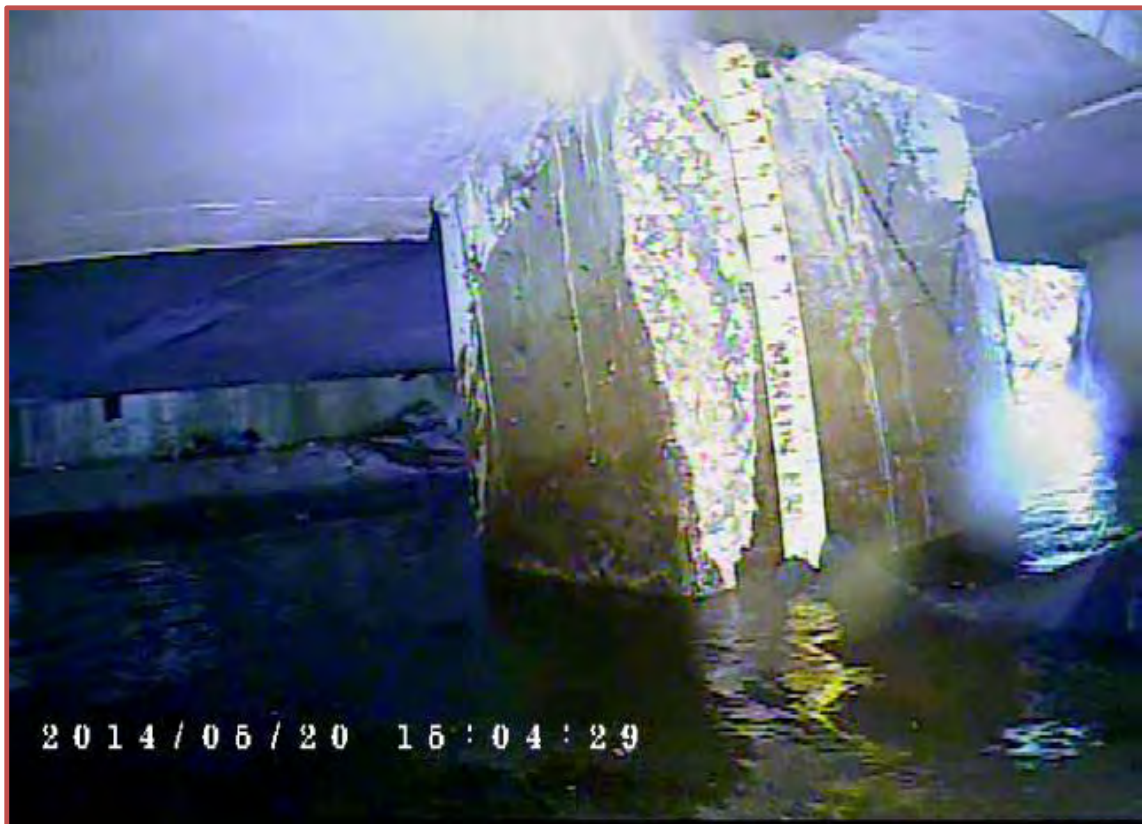
\_Pile 2-1, SW corner spall/delamination 24" x 3" x 1", starting at the cap. **UW Photo 01. NEW.**

\_Pile 5-5, North and West faces have (2) spall/delamination 18" x 12" x 1-1/2", starting at the cap.

Description: Top: Pile 2-1, SW corner spall/delamination, starting at the cap. **UW Photo 01.**  
Bottom: Pile 5-5, N and W faces, (2) spall/delamination, starting at the cap. **UW Photo 02.**

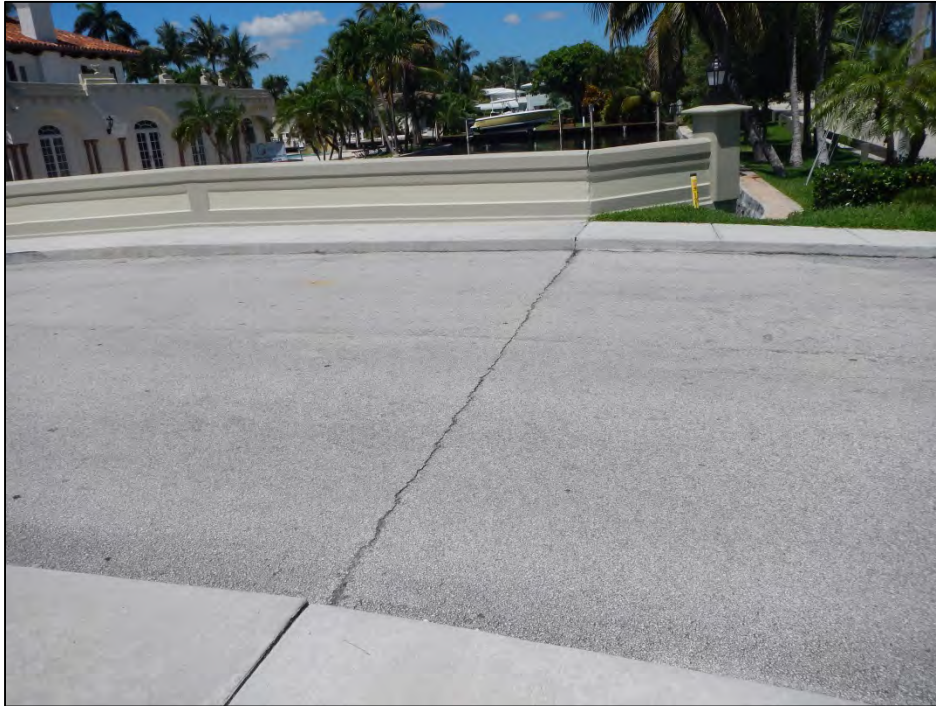
- The asphalt surfacing has up to ½ in. wide transverse cracks over the expansion joints. See Condition Photo 1.
- The asphalt exhibits several ⅛ in. wide x up to 10 ft. long longitudinal cracks. See Condition Photo 2. This condition was not previously noted.

Photo 1 – Cracks in asphalt surfacing over joints.

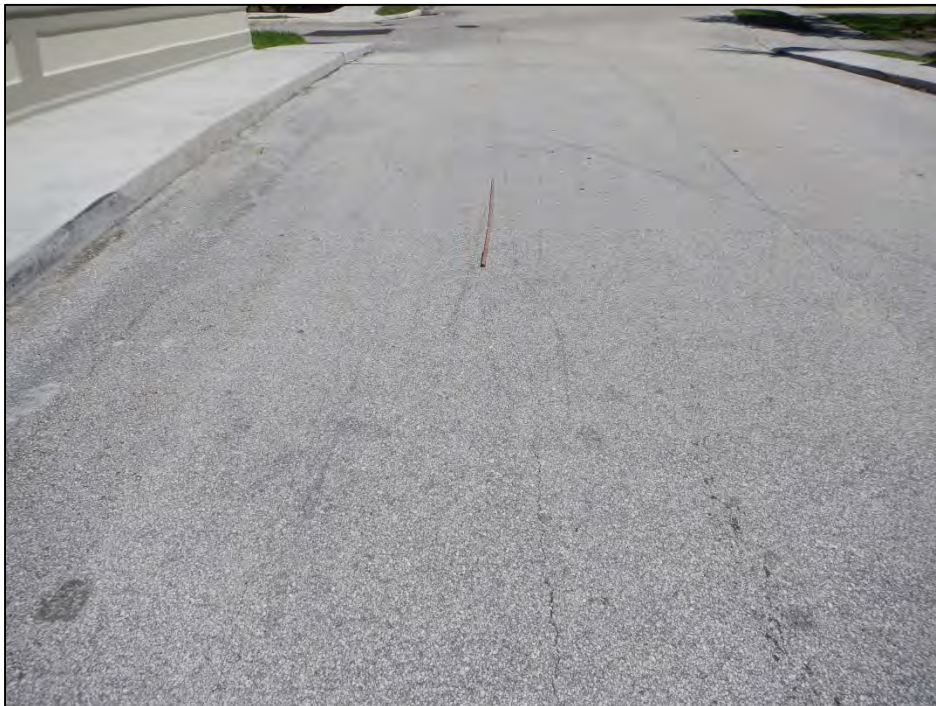
Photo 2 – Longitudinal cracks in asphalt surfacing.

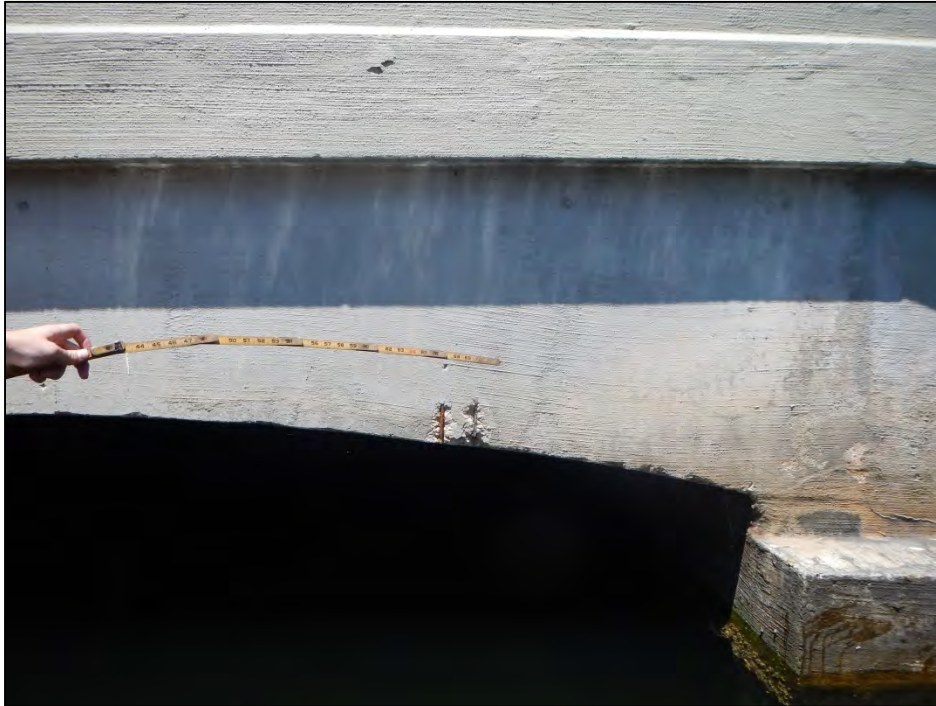
- The east face of Span 1 has two 3 in. x 1 in. x ½ in. spalls with exposed steel due to lack of cover, 3 ft. from Bent 2 and at midspan. See Condition Photo 3.

Photo 3 – Spall with exposed steel at east face of Span 1.

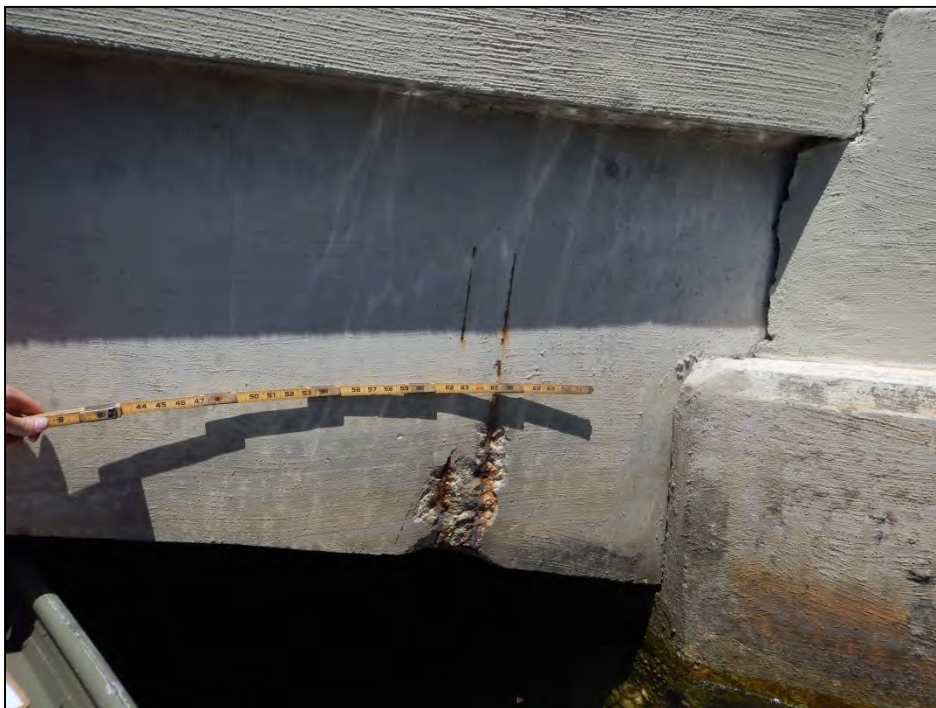
Photo 4 – Spall with exposed steel at east face of Span 2.

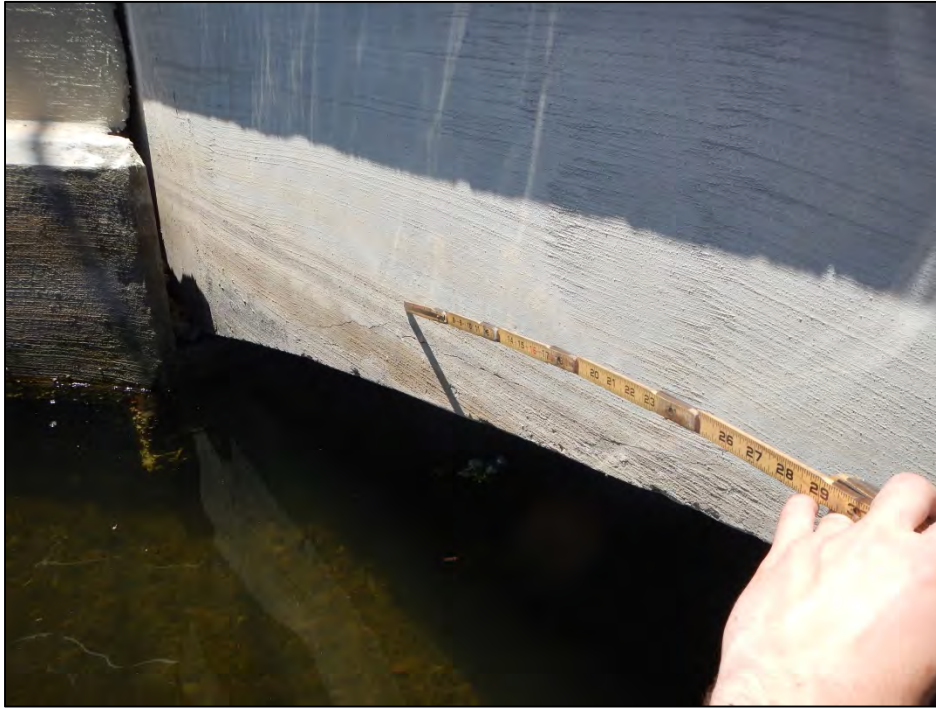
Photo 5 – Crack in east face of Span I near Abutment I.

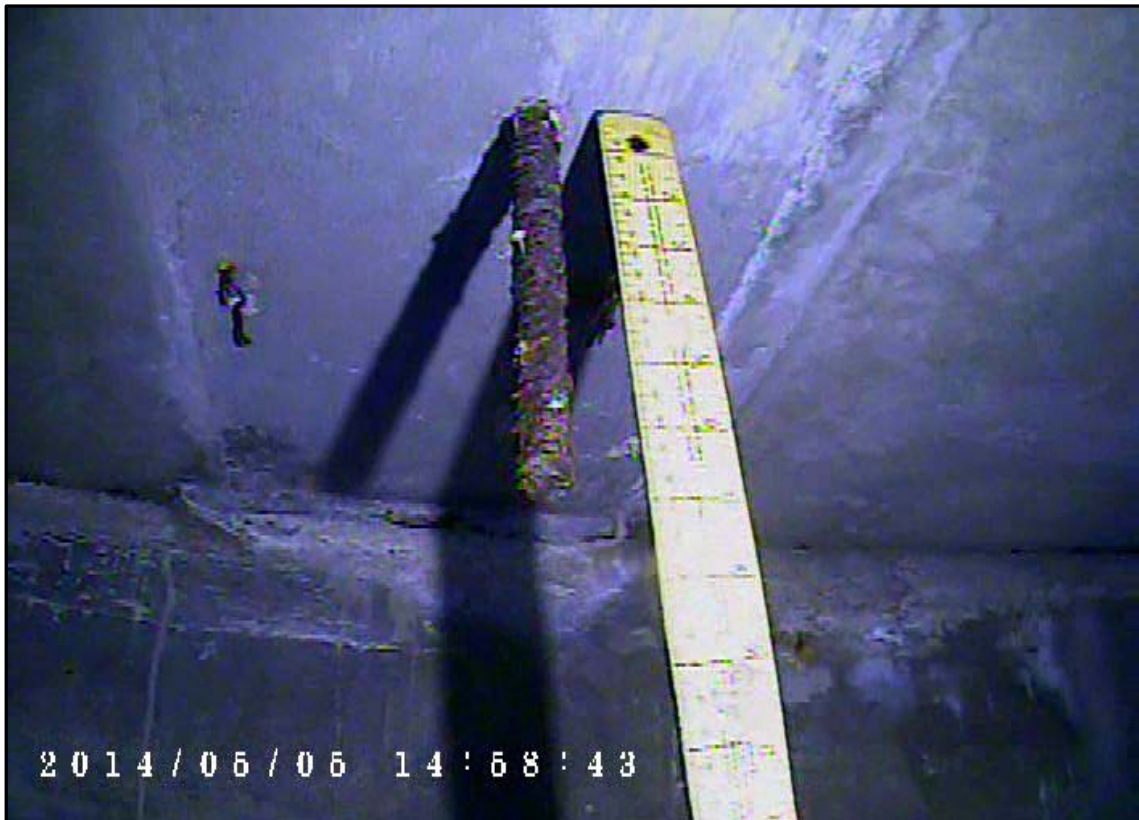
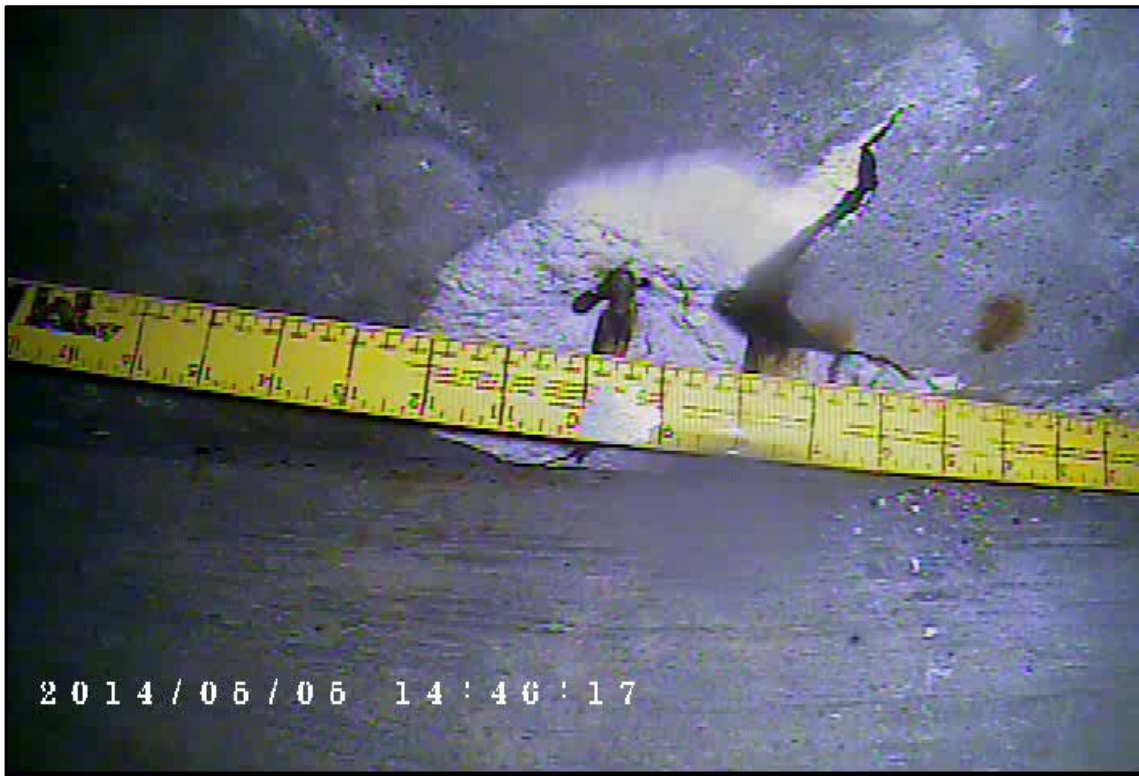
Description: Top: Deck underside, Span 1 has a piece of protruding all-thread. **UW Photo 01.**  
Bottom: Span 1, 6' from East end, at Abutment 1, spall/delamination. **UW Photo 02.**

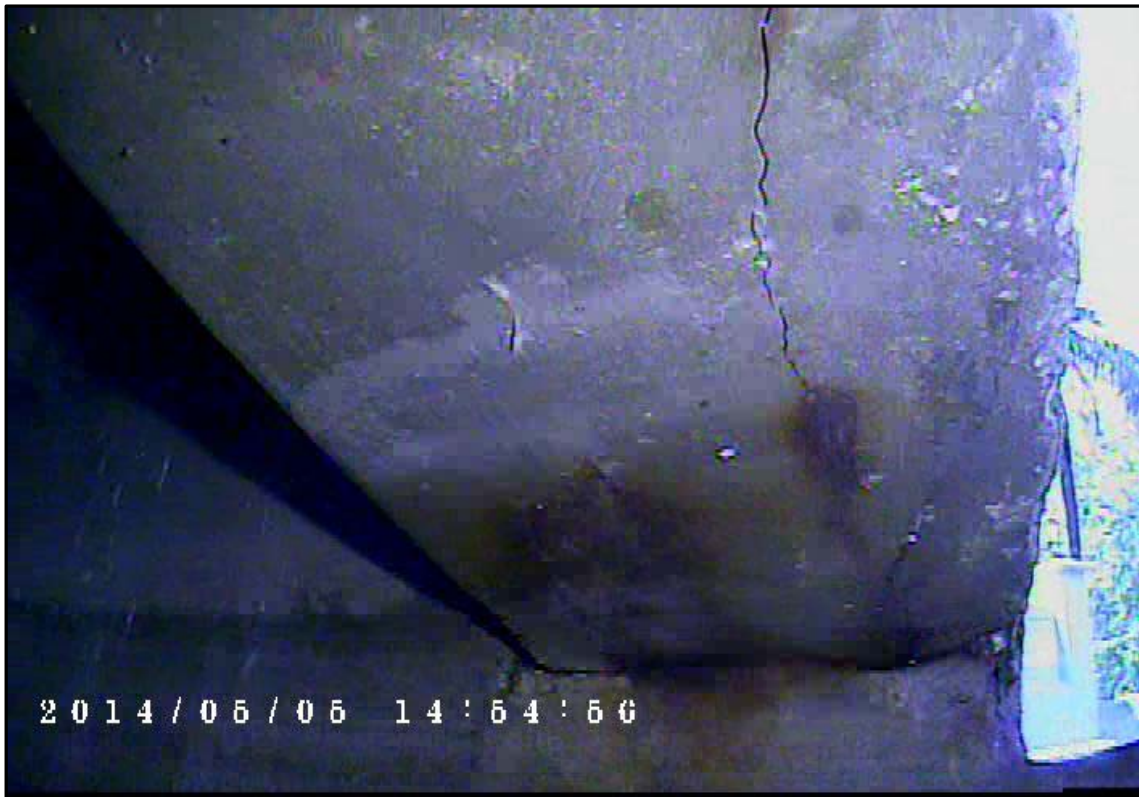
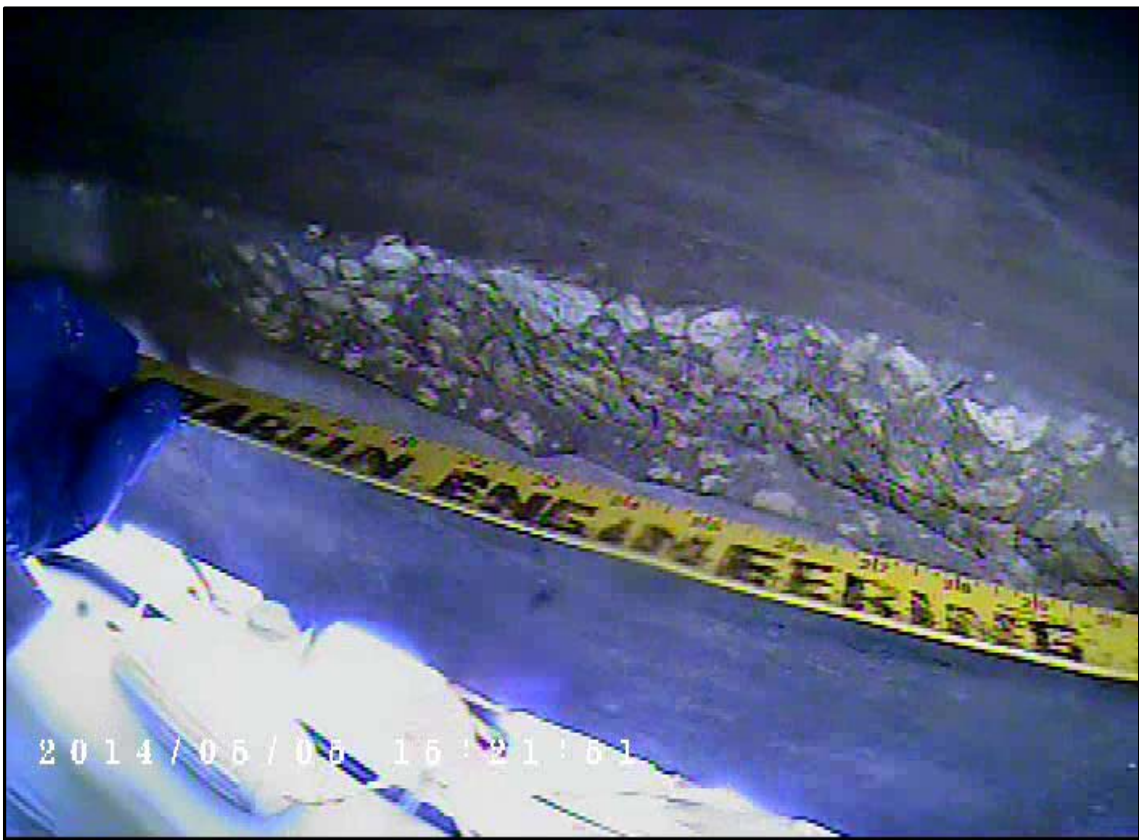
Description: Top: East arch bottom face adjacent to abutment 1 has a delamination. **UW Photo 03.**  
Bottom: West arch, Span 2 bottom fascia has a spall/delamination. **UW Photo 04.**

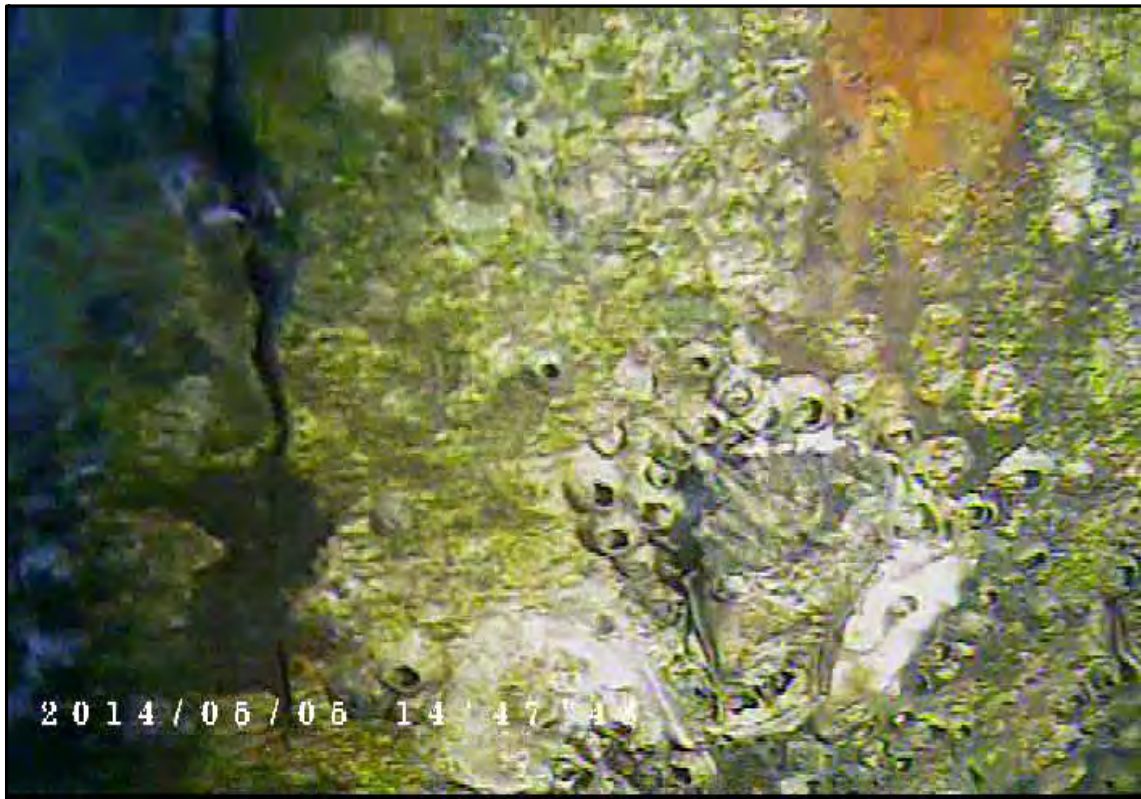
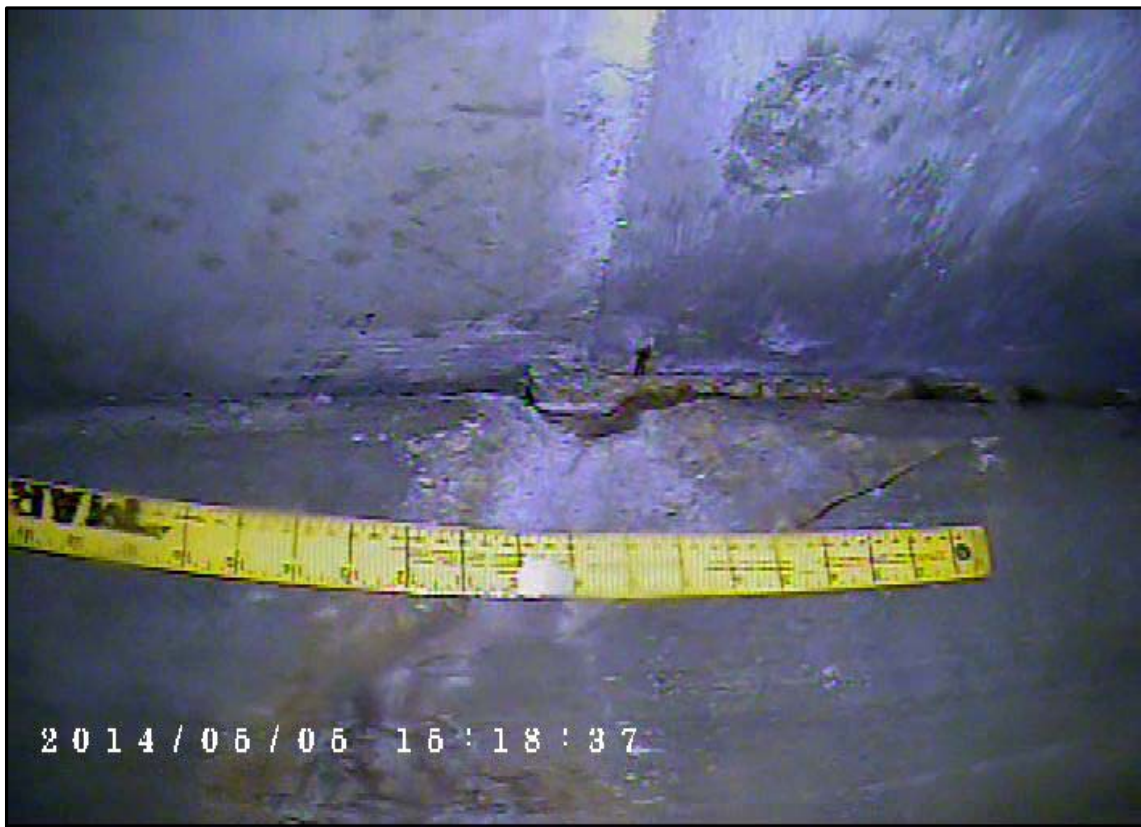
Description: Top: Both abutment caps have vertical cracks with corrosion bleed-out. **UW Photo 05**  
Bottom: Abutment 3 cap, spall/delamination under Slab Unit 2-1. **UW Photo 06**

\_Remove all unsound concrete and patch and epoxy inject all the cracks at both abutments.

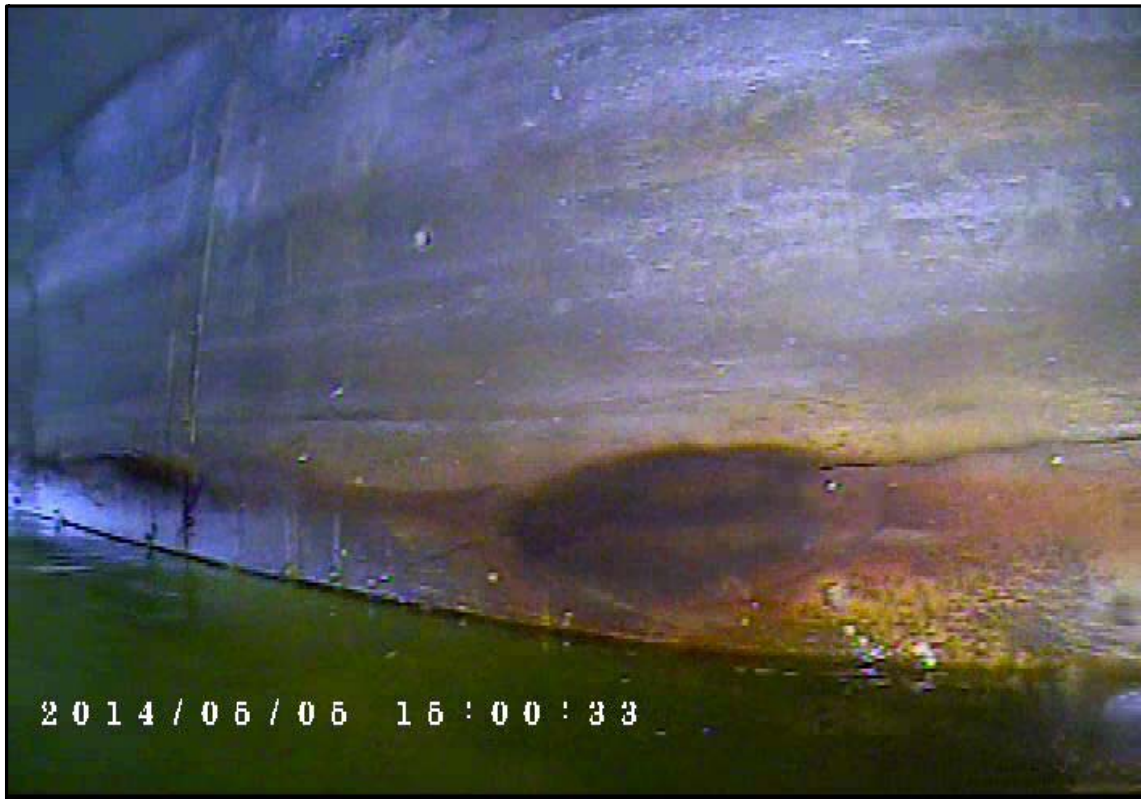
Description: Top: Bent 2 cap North face, vertical and horizontal cracks. **UW Photo 07**  
Bottom: NW wingwall at the junction to the private sector diagonal crack. **UW Photo 08**

\_Remove all unsound concrete and patch. Epoxy inject all the cracks at Bent 2 and 3.

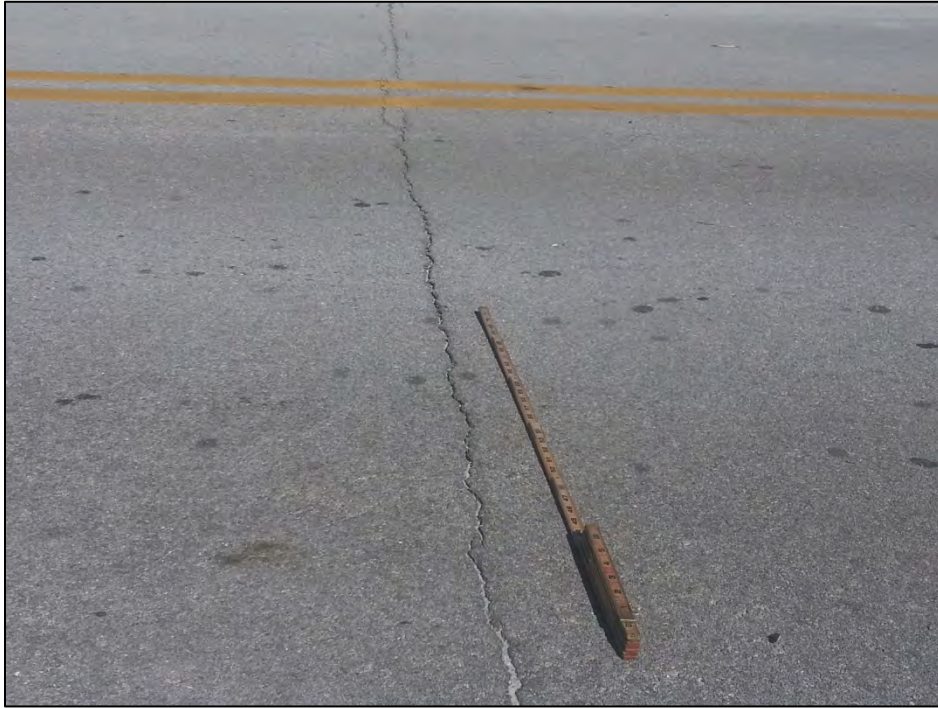
- The asphalt overlay within the travel lanes has up to  $\frac{1}{8}$  in. wide transverse cracks over both abutments. See Condition Photo 1.
- The west sidewalk has up to full width x  $\frac{1}{64}$  in. wide transverse cracks in all spans.
- There is a  $\frac{1}{16}$  in. wide longitudinal crack near the center line of the roadway.

Photo 1 – Cracks in the asphalt overlay.

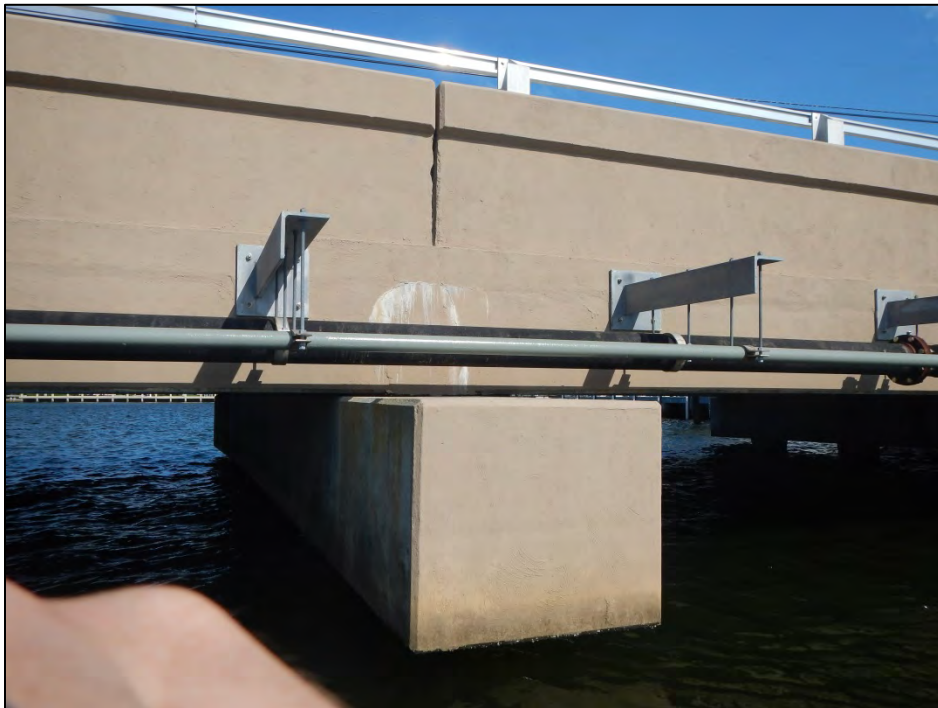
- The underside of the slab units exhibit several  $\frac{1}{32}$  in. wide cracks with efflorescence over each bent. See Condition Photo 2.

Photo 2 – Cracks in the slab unit over each bent.

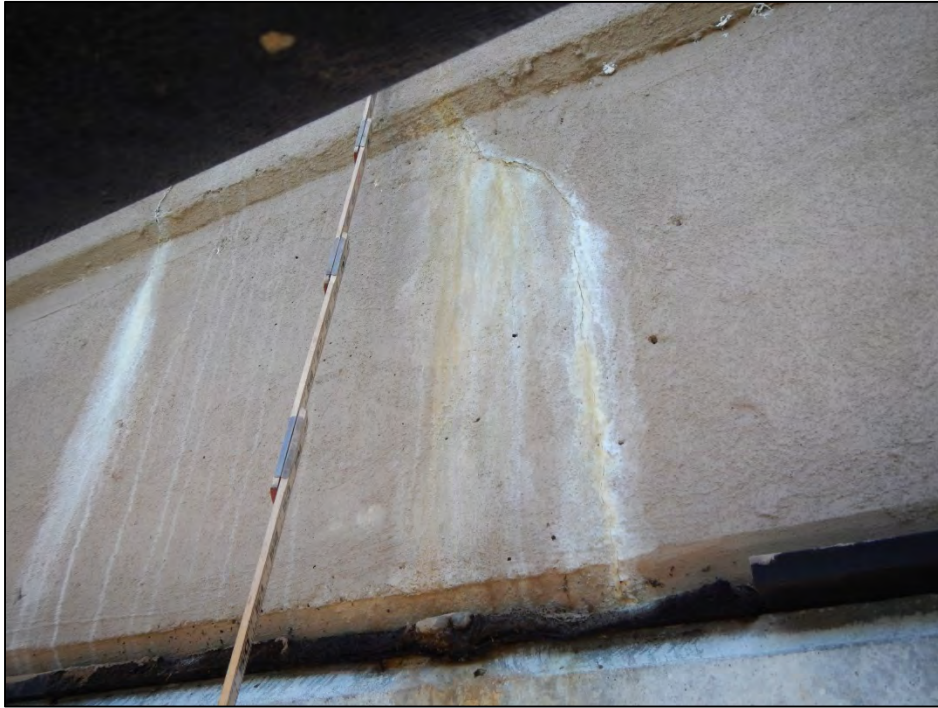
Photo 1 – Vertical cracks in the east fascia over Bent 3.

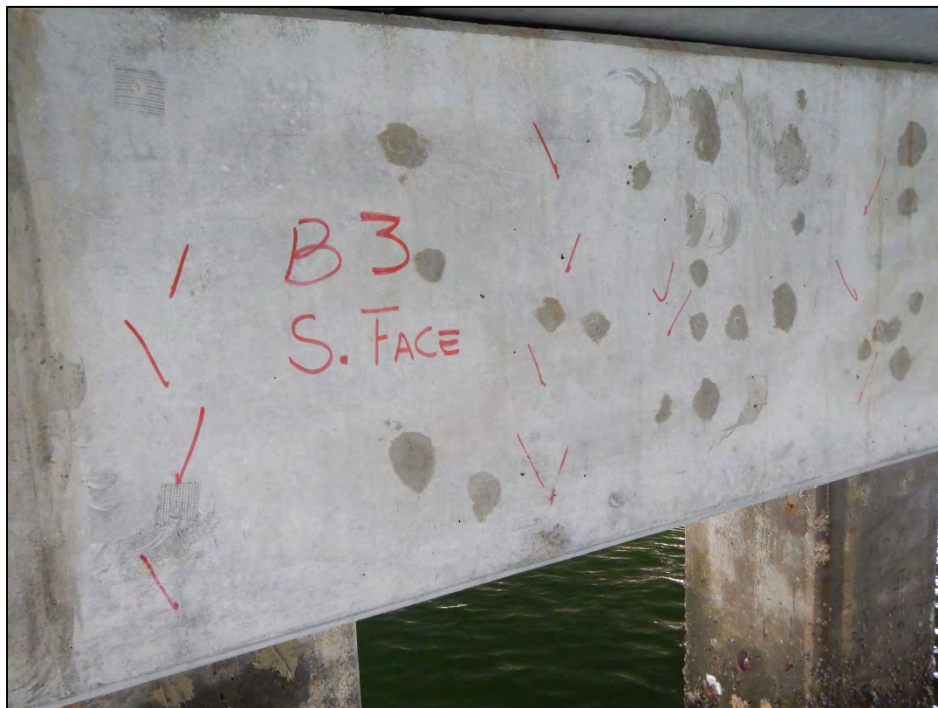
Photo 2 – Cracks in the south face of the Bent 3 cap.

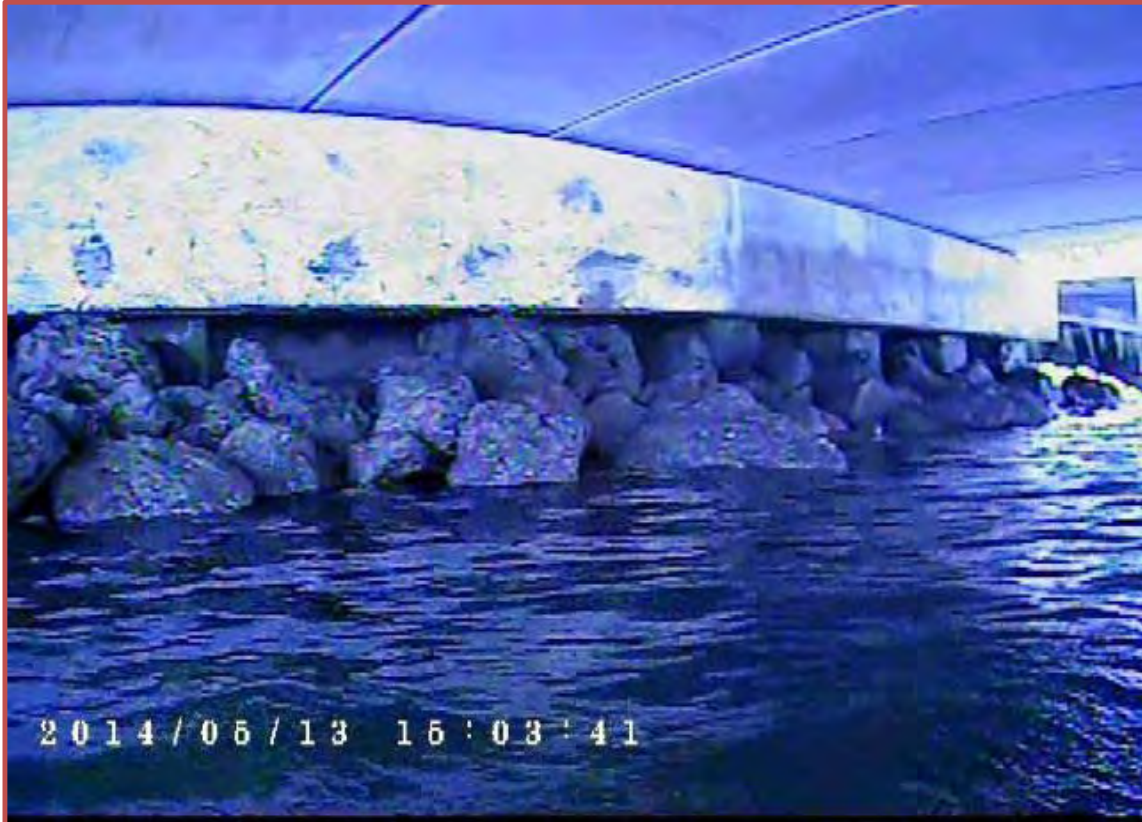
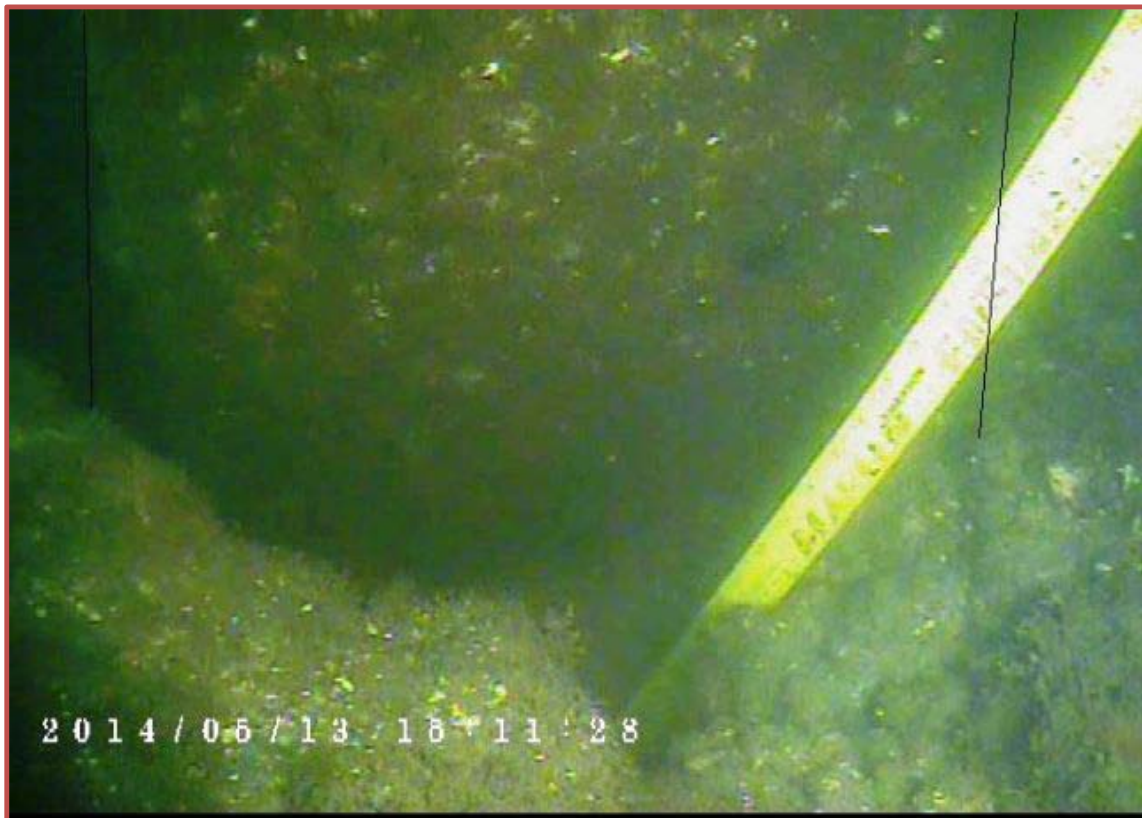
Description: Top: Rock rubble slope protection at the Abutments and retaining walls. **UW Photo 01.**  
Bottom: Pile 2-6, the predilled hole (20" D x 8" W) has not filled in. **UW Photo 02.**

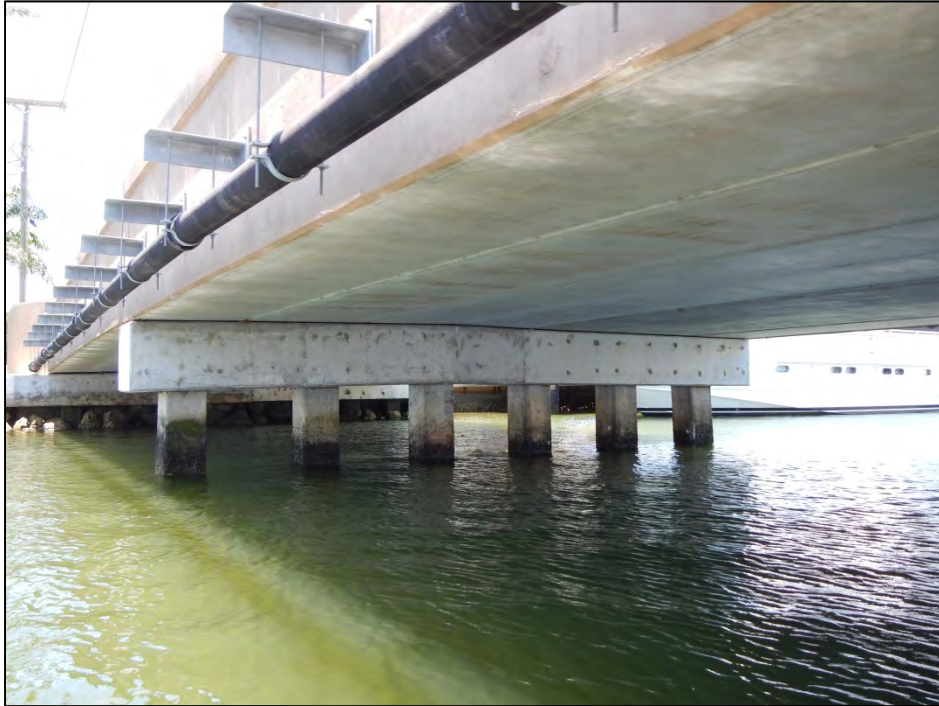
Slab Underside and Intermediate Bent. Note Utility Pipe.

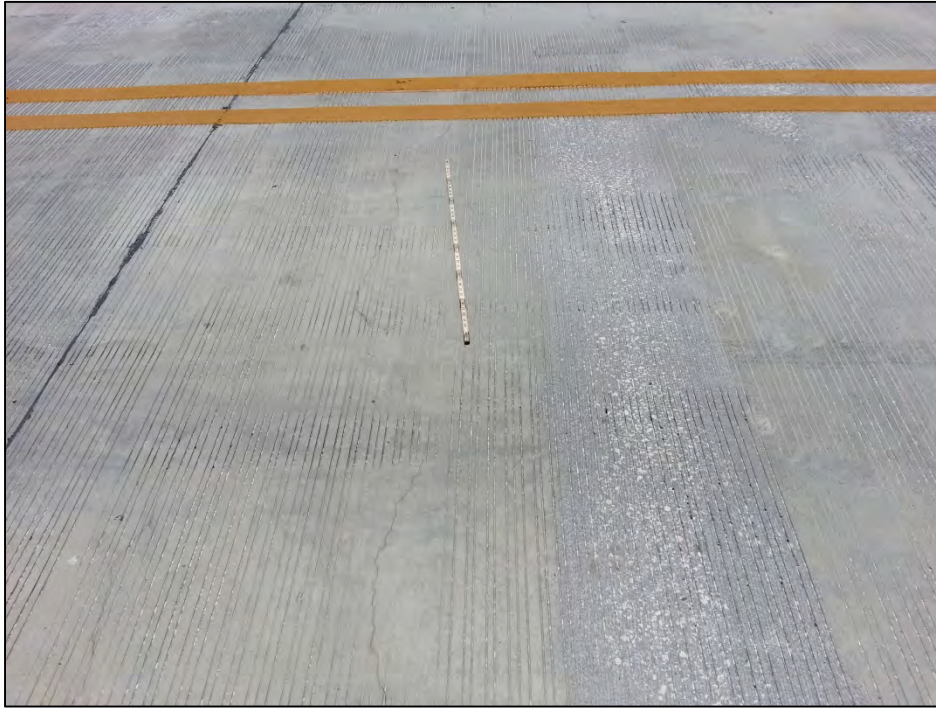
Photo I – Cracks in the Deck Top.

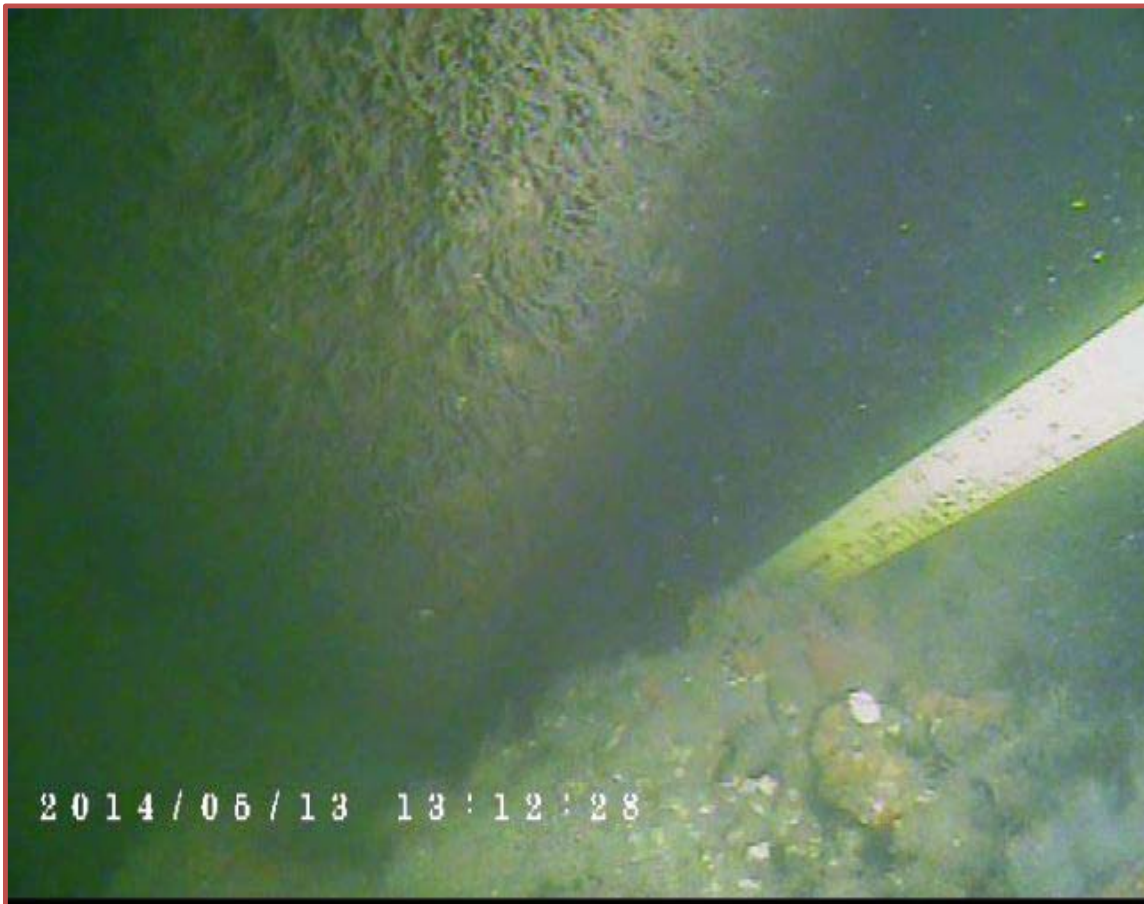
Description: Several of the predrilled holes around the piles have not filled in. **UW Photo 01.**
